Understanding Friction in MoS₂, Part 2: Water, Oxidation and Run-in

SAND2017-5128C

Fundamental Studies and Applied Challenges

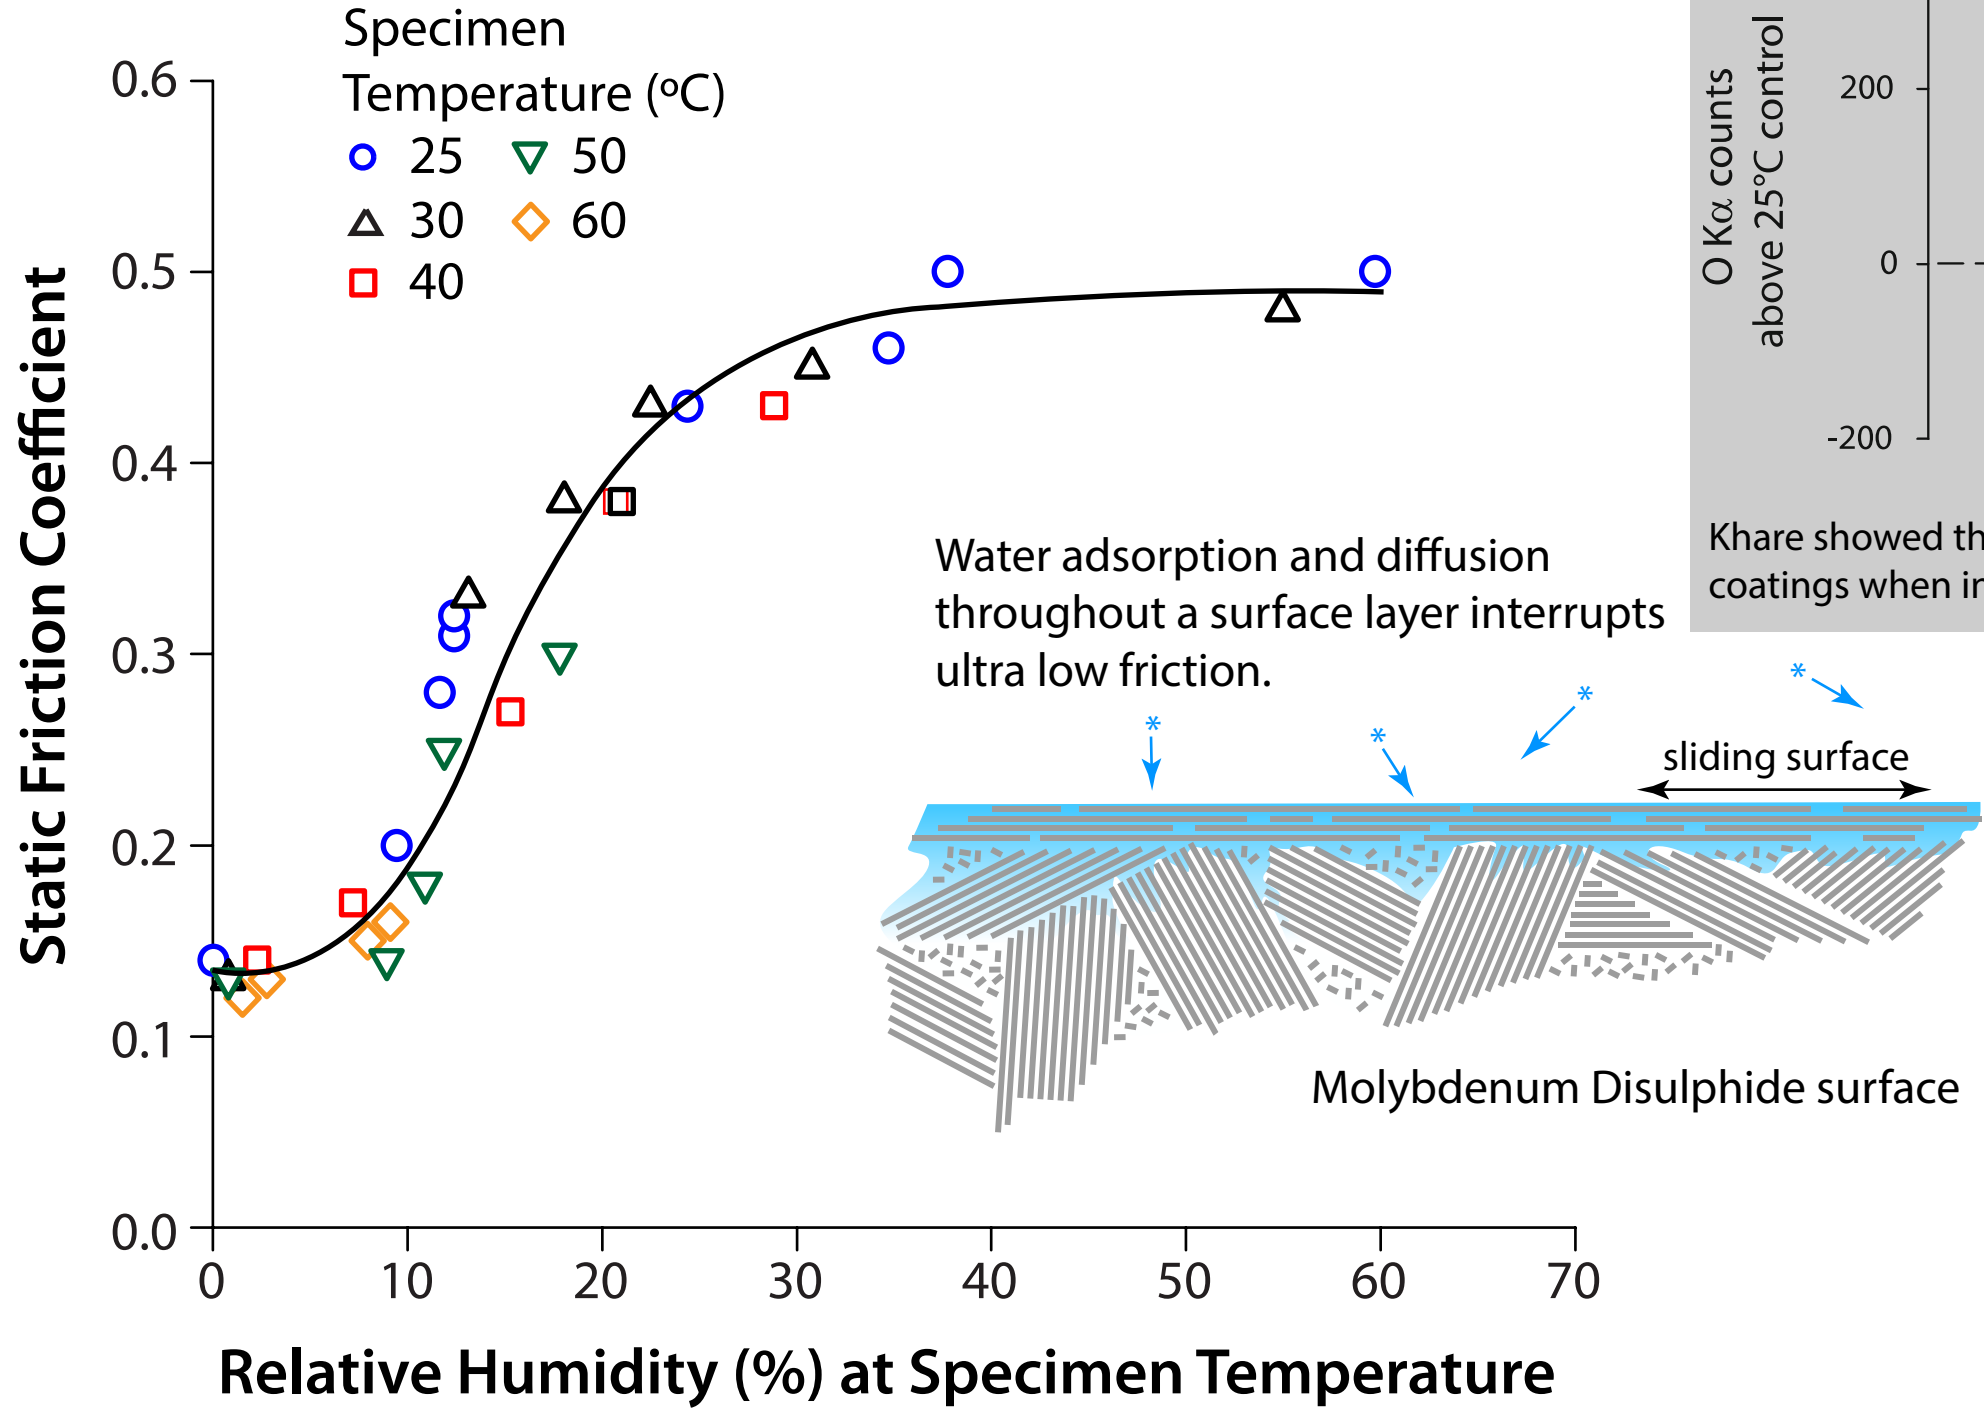
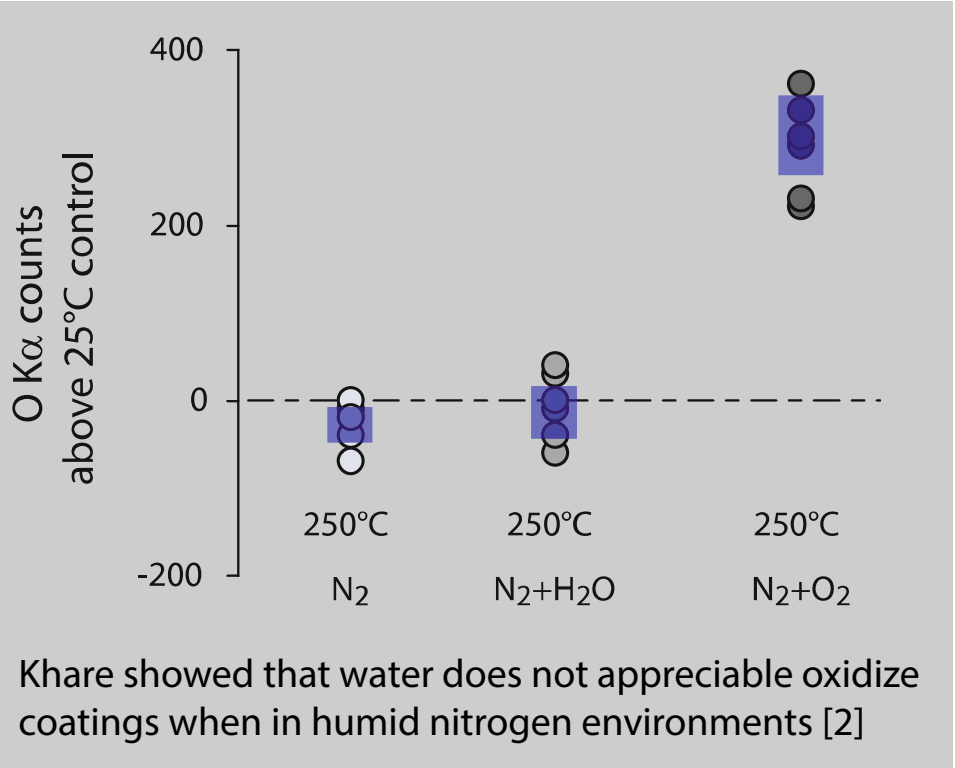
Water Vapor Increases Friction in MoS2 Coatings

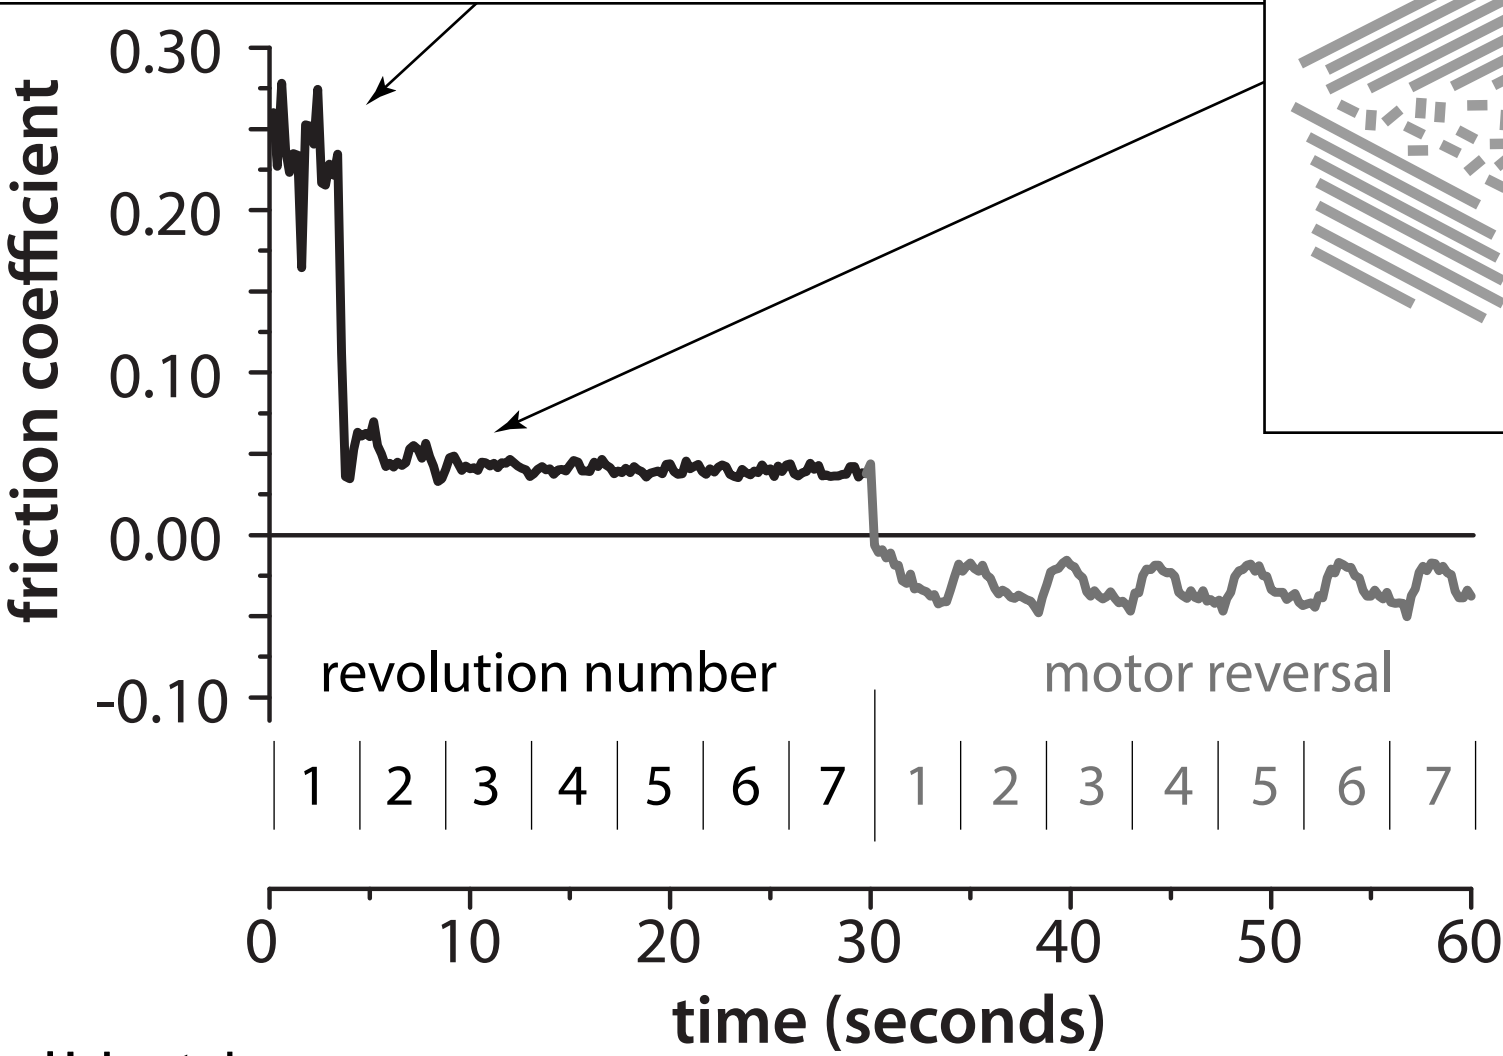
Low friction is restored after wear removes the oxidized surface film and restores the lubricous MoS₂ surface layer.

data from
cycle 140
