Failure Modes and Mechanics of Fracture in Co-Fired Engineering Ceramics- LTCC

SAND2017-5344C

Rajan Tandon, Clay Newton
Sandia National Laboratories, Albuquerque, NM

Title: Failure analysis and sub-critical crack growth (SCG) characterization of Pt-Al₂O₃ high temperature co-fired (HTCC) ceramics

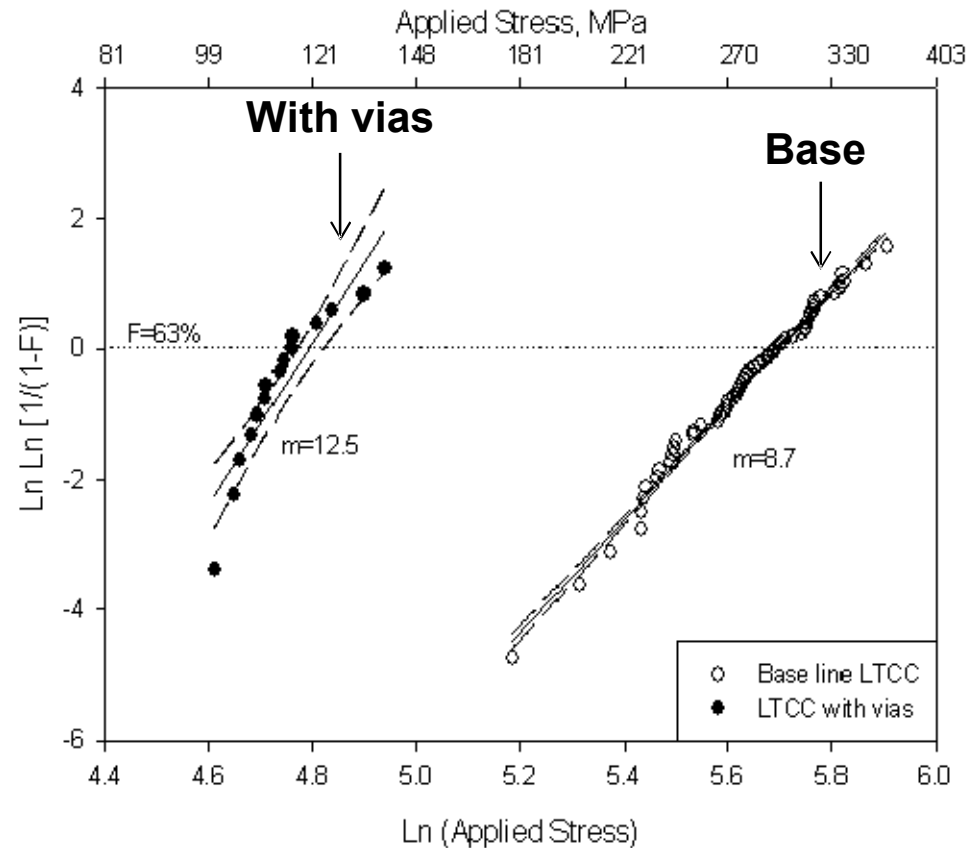
Piston on Ring Strength Tests on a 6x6 via Array (R=190 μm)

Presence of vias leads to a ~60% reduction in strength.

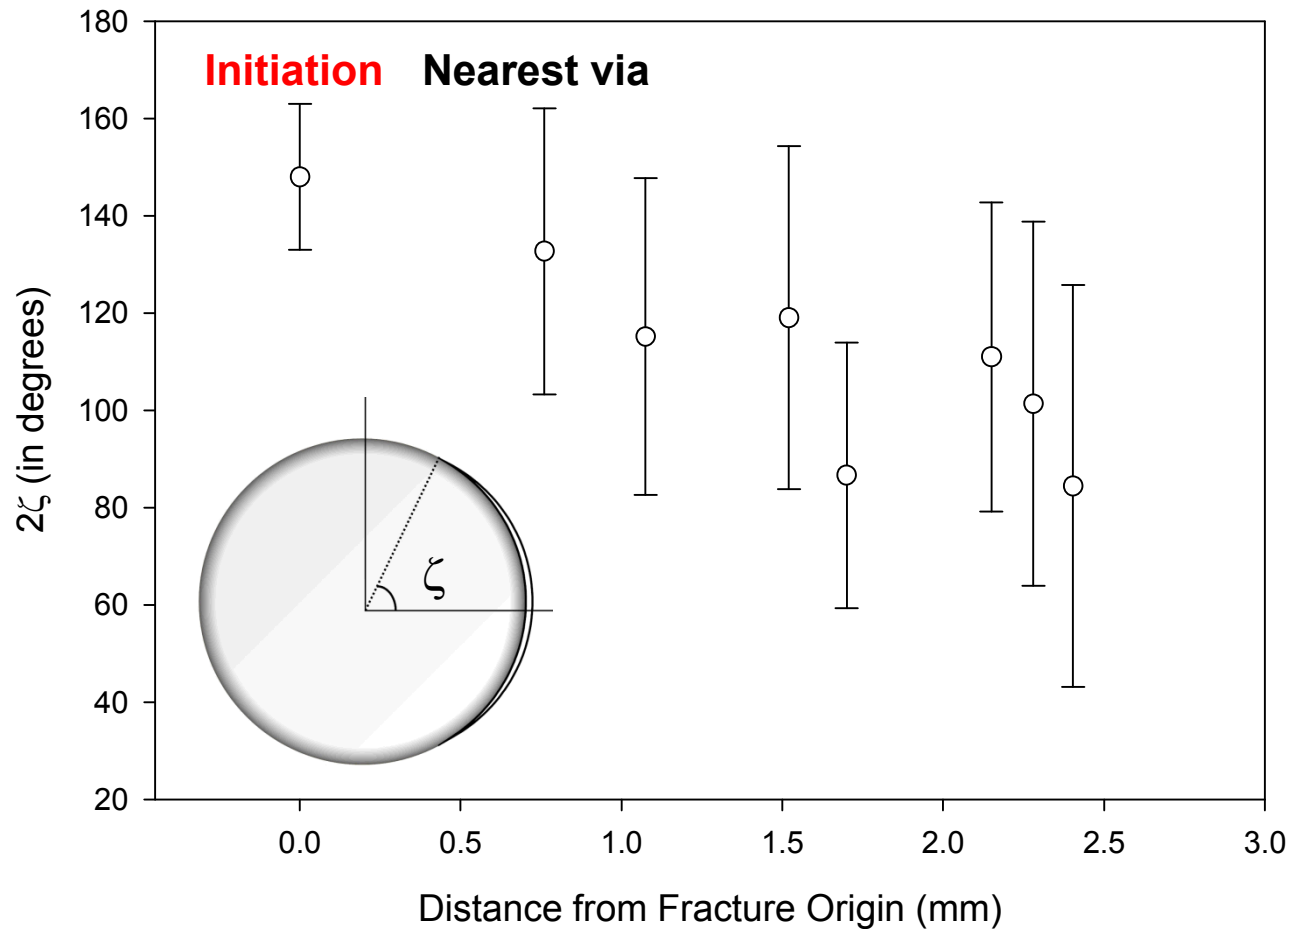
Distribution of Arc Crack Angles

The via causing fracture was identified, and the crack angle at which kinking occurred was measured. **$2\zeta=148\pm 15^\circ$.**

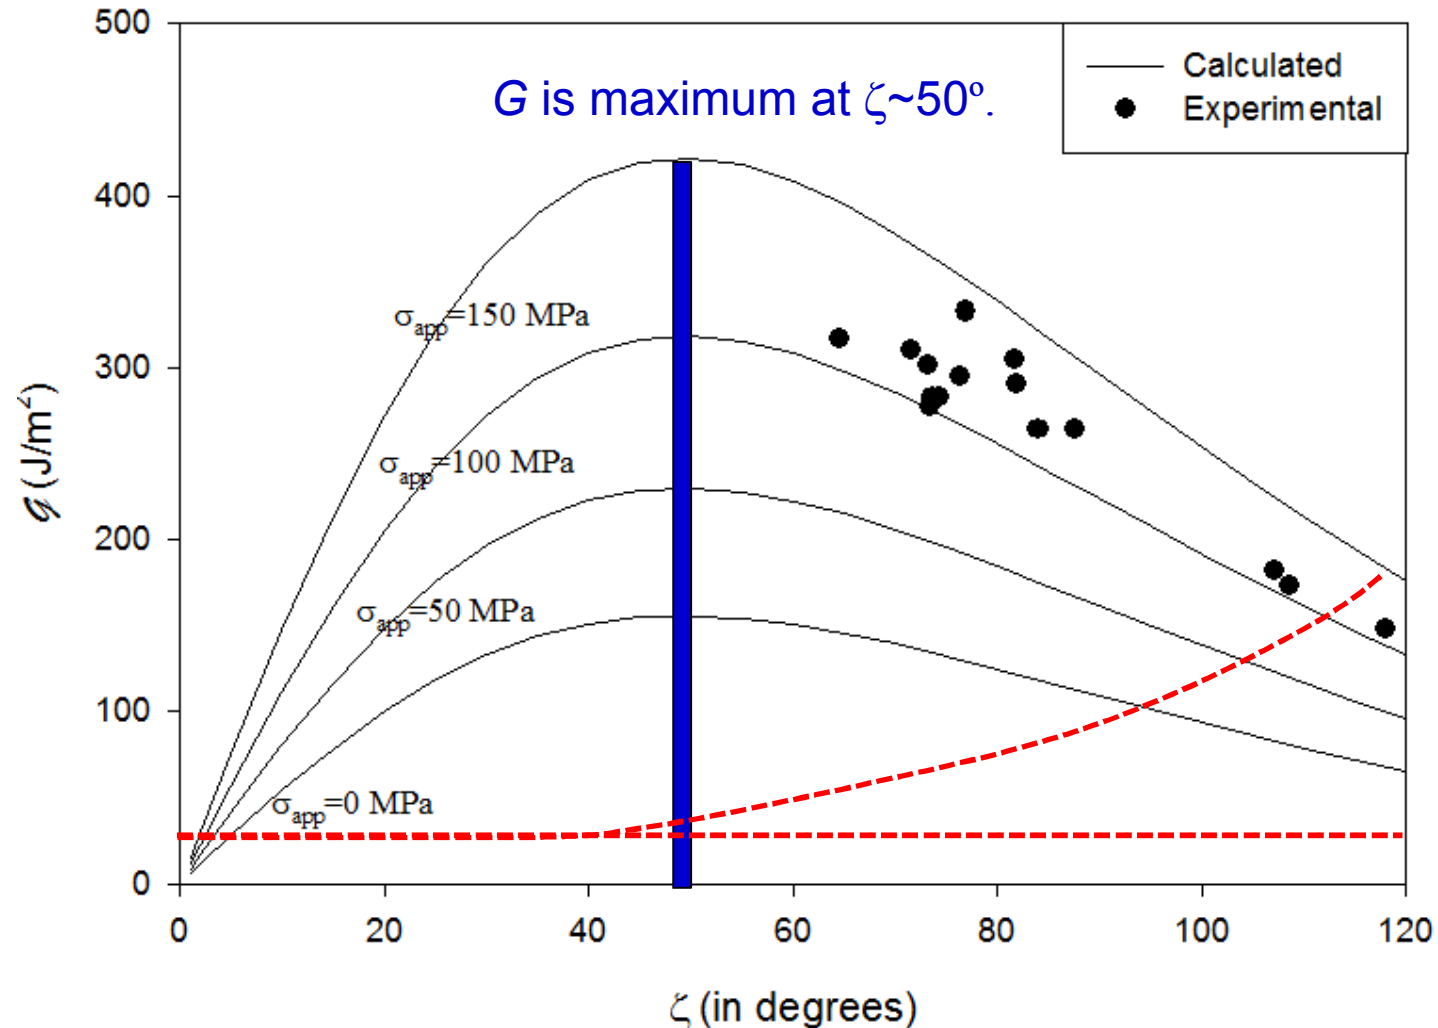
G as function of Crack Length (ζ)

Crack kinking out of interface (into the matrix) occurs on the decreasing portion of G-curve.

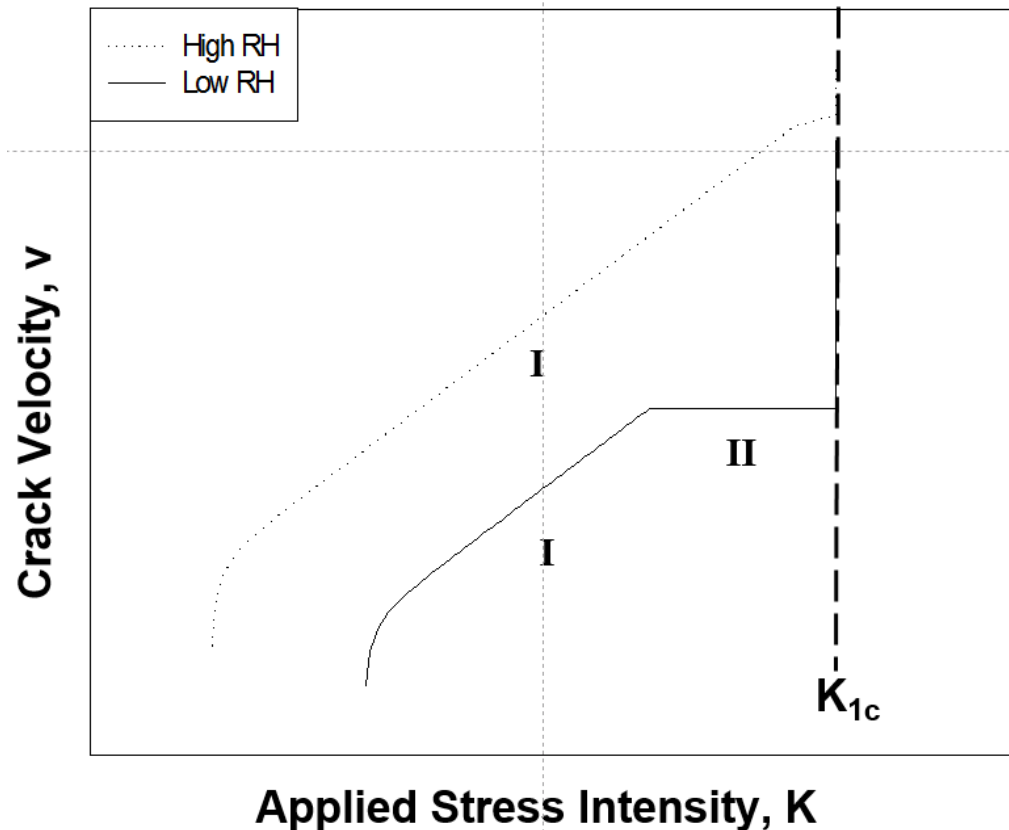
Sub-Critical Crack Growth (SCG)

$$v = A \left(\frac{K_I}{K_{Ic}} \right)^n$$

SCG behavior was quantified by conducting strength tests as a function of loading rates (*ASTM C1368: Test method for SCG Parameters*)

Materials with and without vias were strength tested in 20% RH, and in 0.9% saline (simulated body fluid)*

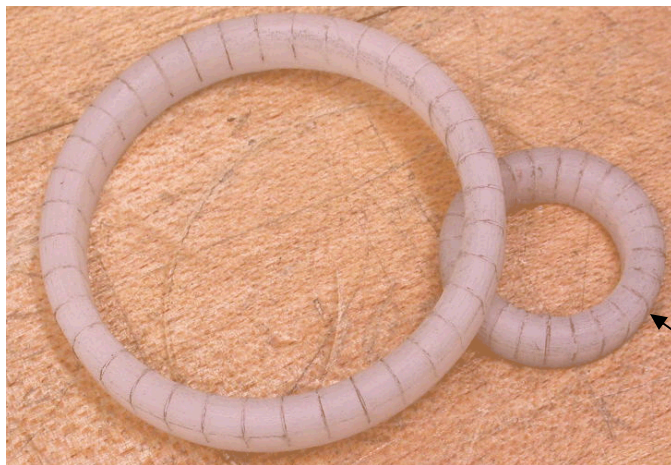
(ASTM C1368 strength testing)

Sample Size: 40mm² x 2mm

Loading rings made of Tefzel material
