SANDIA REPORT

SAND2017-5684

Pipe Overpack Container Fire Testing: Phase I & II

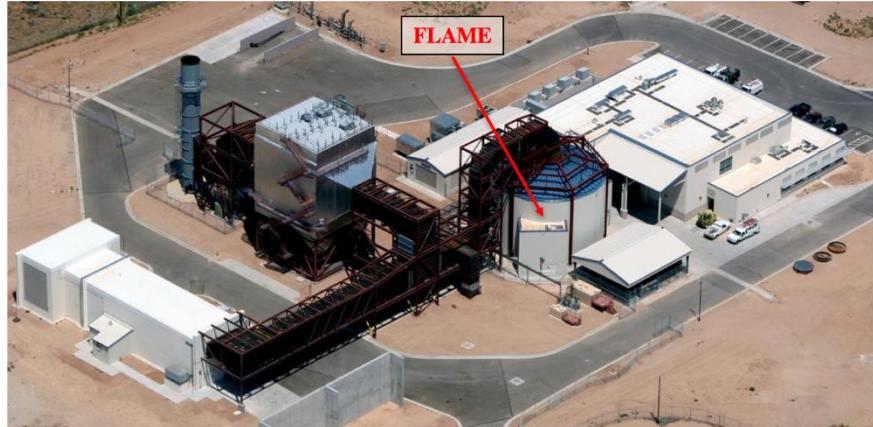
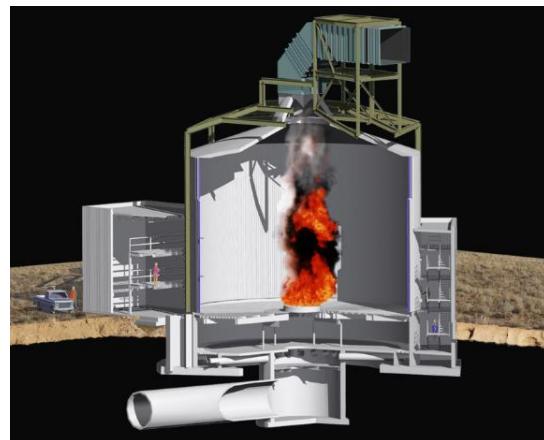
Figure 2. (a) Location of FLAME within the TTC and (b) interior of the FLAME facility.

In all, four tests were performed at SNL between October of 2015 and April of 2016. All tests were conducted inside the Fire Laboratory for Accreditation of Models and Experiments (FLAME) test cell located in SNL's Thermal Test Complex (TTC) (see Figure 2). FLAME is a vertical wind tunnel design for conducting pool fires tests under calm conditions. The test cell has an inner diameter of 18.3 m and is 12.2 m tall along its perimeter walls. The walls are made of steel channel sections and are filled with water to keep the perimeter of the facility cool. At the top of these perimeter walls, the ceiling slopes upwards ($\sim 18^\circ$) from the end of the walls to a height of 15 m over the center of the facility. A round hole 4.9 m in diameter at the top of the test cell transitions to a chimney duct, allowing fumes to escape the test cell.

Most of the test cell floor is made up of metal grid panels. At the center of the grid floor of the test cell is a fuel pan or gas burner. FLAME works with either a 3 m diameter gas burner (H_2 , CH_4 , etc.) or a liquid fuel pool (JP8, Jet-A, methanol, etc.) For this test, only the liquid fuel pool was used. Air channeled vertically through the grid floor, via a vent ring several feet below the floor and adjacent to the perimeter walls, allows air to be entrained naturally into the fire, as it would be in an outdoor fire.

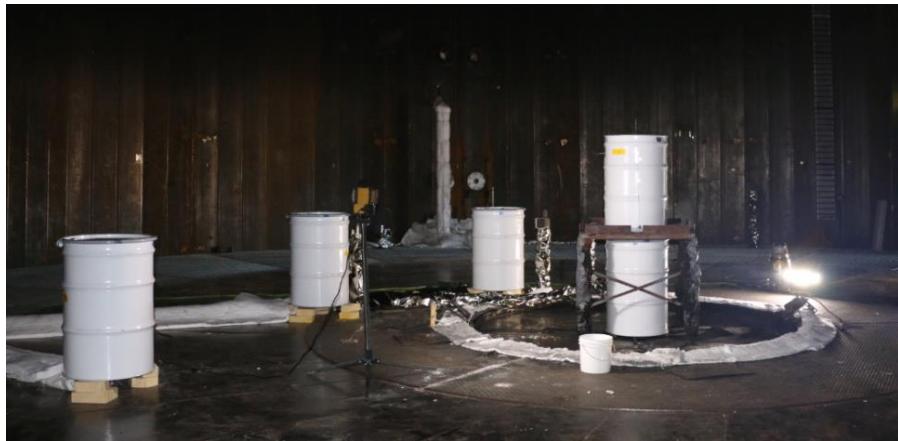
Figure 3. Typical fuel-pool/drum layout inside of FLAME.

Figure 3 shows the typical test layout in this test series. The 3 m circular pool shown at the center of the pool was initially filled with Jet-A fuel in all tests. A remote refueling system added fuel to the pool in discrete amounts during tests to keep the POC fully engulfed. To limit the fire to the desired time, the pool has a drain system that dumped all remaining fuel at the end of the test, almost immediately terminating the fire. Typical fuel consumption rate for these tests was 0.3 kg/sec. All tests in this series consisted of one POC placed at the center of the pool, with additional drums placed on the grid floor outside of the fuel pan at various distances, as depicted Figure 3. The POC at the center of the pool was always resting on a square-grid table, 1 m above the fuel pool surface and directly above an empty 55 gallon drum. This vertical configuration is typical of what is seen in storage facilities, where drums are stacked on top of each other, typically in a drum-array arrangement within a single drum level, as seen in Figure 4. In these tests, there were no drums adjacent to other drums as depicted in Figure 4 and the stack was only two drums high. This

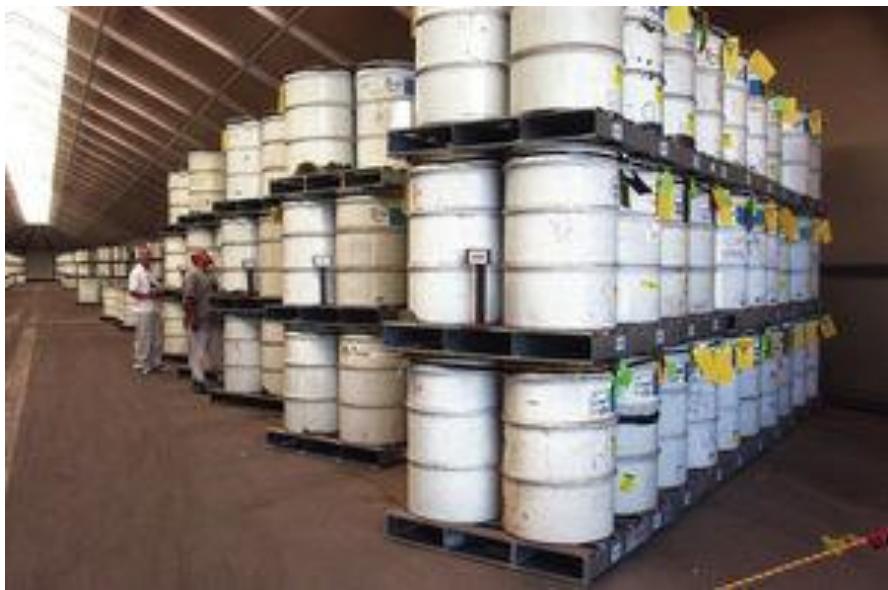
Figure 4. Drums in a typical storage configuration at LANL

test configuration, without the third stack of drums above the POC drum or adjacent drums within the same level as the POC drum, exposes the POC drum to higher thermal loads than would be experienced within the typical drum-array arrangement depicted in Figure 4.

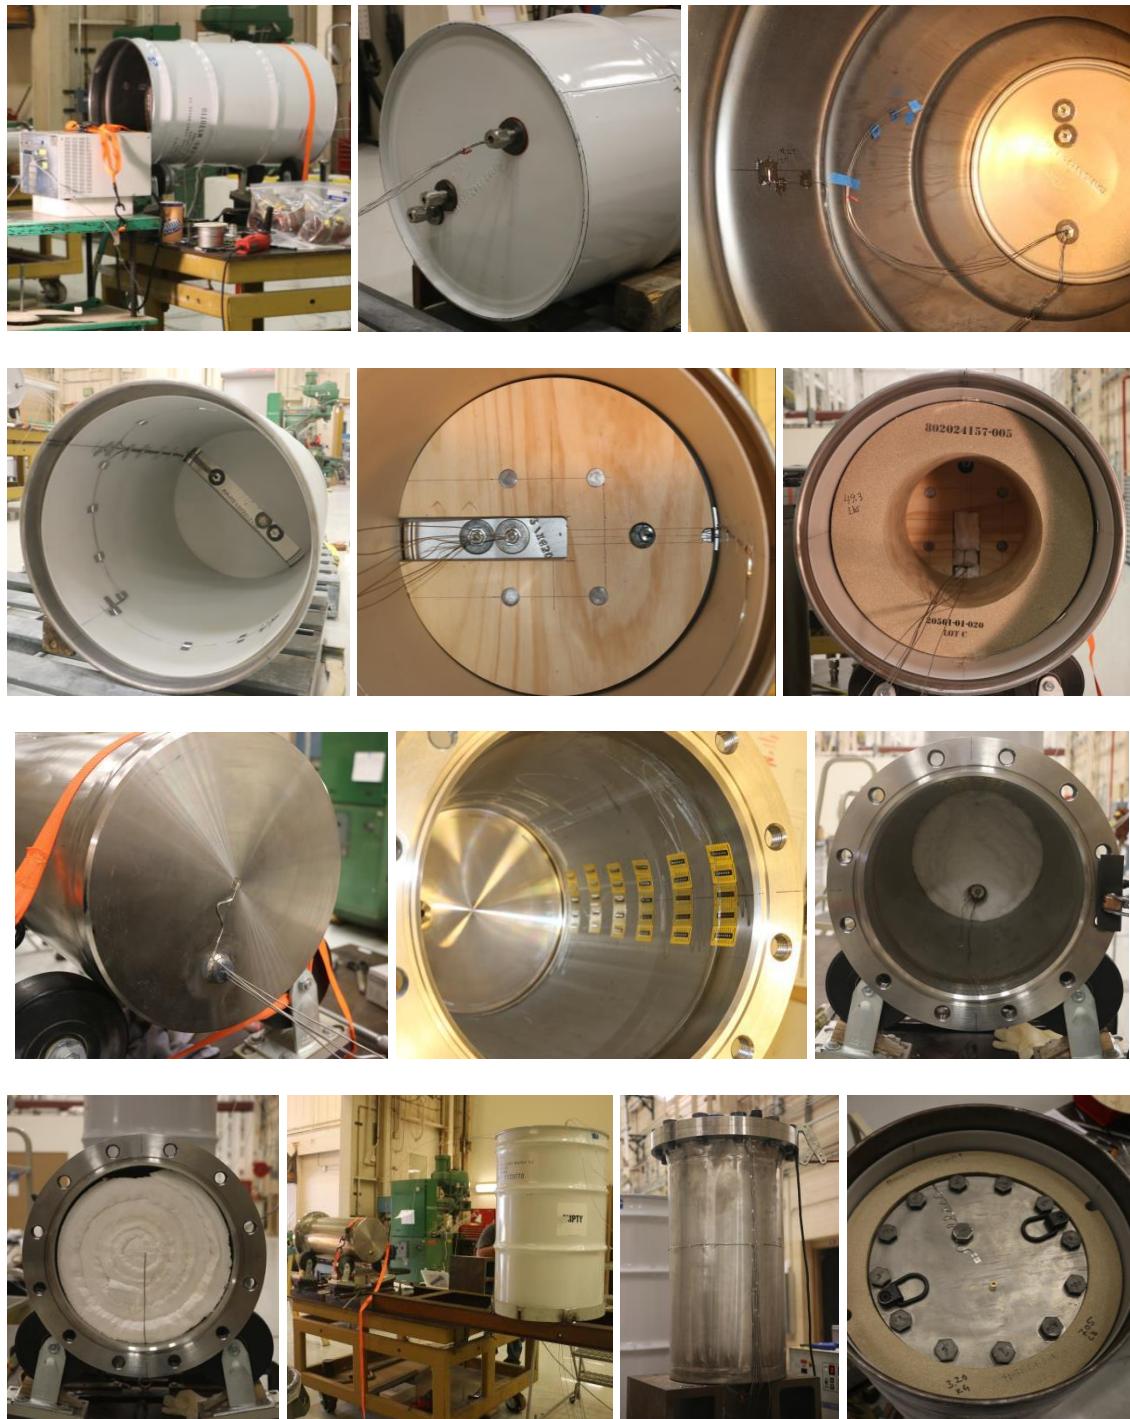
Figure 8. Series of images showing the process of instrumenting and assembling POCs in preparation for Phase I test. Images are from the first test.

All TCs were type K, mineral insulated, and sheathed with a 1/16 inch outside diameter. The tables in Appendix A show the exact location of the TCs in these drums. As shown in those tables, the TCs were distributed every 90 degrees inside and throughout the height of the POC. TCs were placed on the interior plastic liner, and on the outer surface and on the interior of the PC. TCs were also placed outside of the POC drum to measure flame temperatures outside of the fire to ensure that flames fully covered the top and sides of the drum. Instrumentation of the POCs required modifications to the design of the POCs. Appendix B shows a drawing detailing this modification in addition to some pictures showing the results of the modifications.

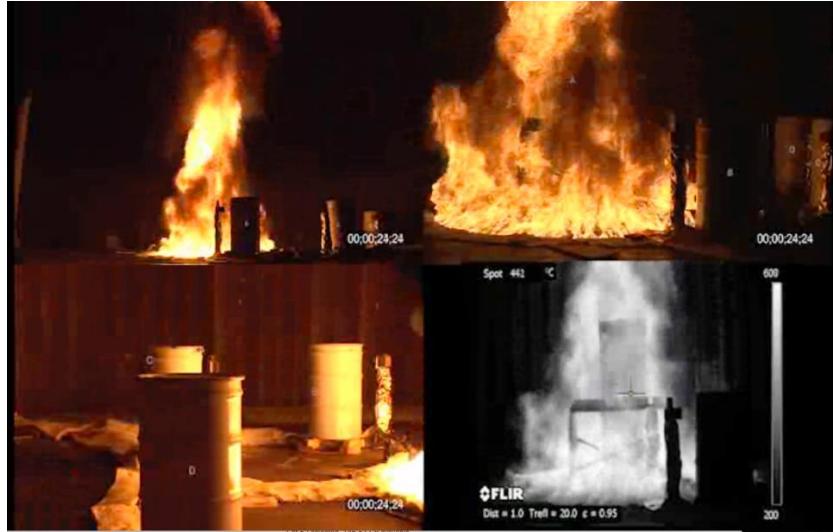
Figure 10. Camera views used in Phase I.

Beside the temperature response of POC components, one additional aspect of interest was the performance of the drum seal, drum filter, and drum lid. Does gas start to vent through the drum seal before the drum filter ruptures; does the drum lid open before the drum filter ruptures; if the lid opens, when does it open; etc.? To help answer some of these questions, three video cameras and one IR camera were deployed to monitor the tests in real time and for closer post-test examination of test events. Video cameras provided coverage of the entire flame region and of specific drums, and an infrared (IR) camera was used to observe the center POC through the flames. Figure 10 shows the four views taken with three video cameras and the one IR camera in Phase I. The top left image was taken with a camera set on the floor of the facility and looking up at the fire with a wide-angle view. This camera was located in the northwest quadrant of the facility, close to the IR camera. The top right image was also taken with a second camera in the northwest quadrant, but looking closer at the fire. The lower left image was taken with the camera located in the southeast quadrant. This camera was directed mostly at the drums outside of the fire, with the edge of the fire visible to the right. The last image was taken with an IR camera, and shows the center POC inside the fire.

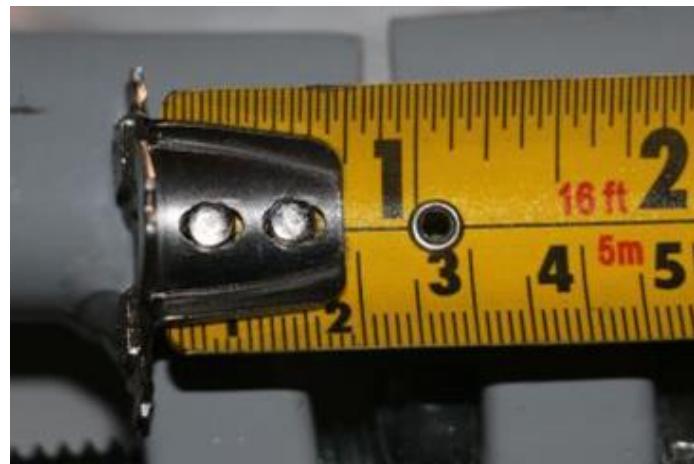
Figure 11. Gap that remains in the drum ring after torqueing to 60 ft-lb. Image taken from the first test in phase II.

As noted above, the main goal of the second phase of tests was to see how the POC and 7A drums would perform when the drum lid was torqued appropriately. To ensure this goal, staff from LANL were used during the second phase to demonstrate the procedure for tightening the drum lids in TA-55 at LANL. During that demonstration, it was learned that to achieve the required 60 ft-lb torque, the lid ring must be hammered with a mallet all around the drum ring every so often to readjust the lid gasket before continuing to tighten the lid to prevent damage to the drum ring or ring bolt. This procedure is repeated several times until the drum ring bolt is torqued to 60 ft-lb. To verify that the lid is properly torqued, at the end of the procedure when the 60 ft-lb torque has been reached, the spacing at the end of the ring should be checked to make sure it is about 3mm, as indicated in Figure 11. Although this was followed in earlier tests, the ring was not hammered with sufficient force to readjust the drum seal and drum ring, preventing torqueing to proceed until the 3mm gap was reached. That is, the torque specification is not sufficient to guarantee proper closure of the drum lid.

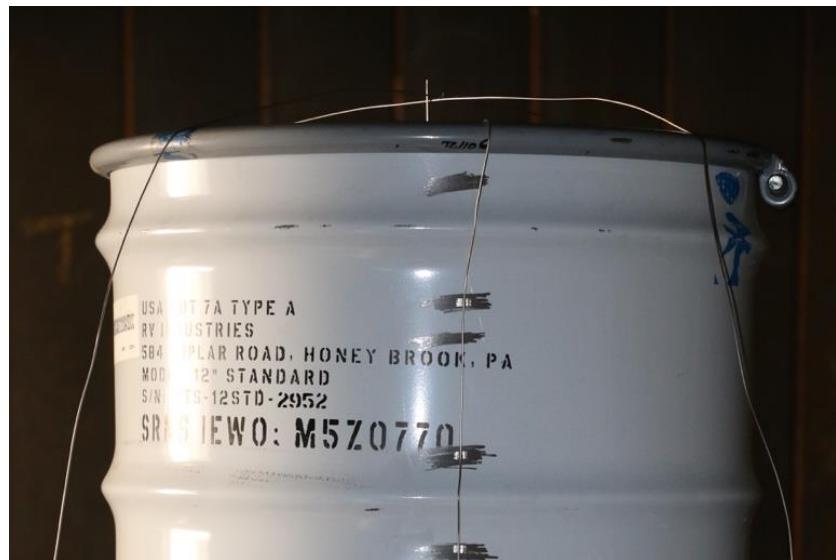
Figure 13. Sacrificial TCs routed through the top of the POC to detect the time when the lid popped open or was ejected.

In all tests, the POCs inside the fire were instrumented on the outside of the drum with four to five TCs (one TC on top and three to four TCs on the sides spaced equally apart) to assure fully engulfing conditions, as was done in the first phase. However, additional sacrificial TCs were added to the center drum in Phase II to detect the time when the lid popped open (see Figure 13). What was unique about the sacrificial TCs is that the metal cover (i.e., the sheath) was deliberately sliced at a location downstream from the top of the drum (just around the table top) to induce a mechanical failure when the lid either popped open but remained attached to the drum or was completely ejected. Some slack was left in the TC line to discount possible bulging of the lid, without opening or ejecting. During the test, these TCs recorded temperatures just before the lid popped open, at which time a sharp rise/drop would be noted in the temperature trace, indicating the time at which the lid came off.

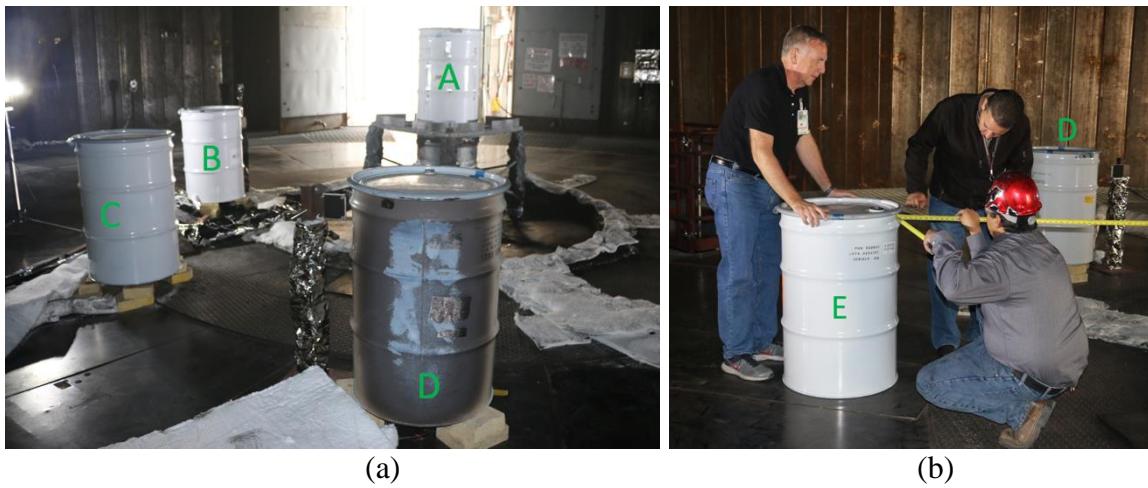
Figure 35. Images of test layout in Test #2: (a) looking northeast towards the entrance of the test cell and (b) looking southwest just to the left of the pool.

Figure 35 shows images taken before the second test. Figure 35(a) shows drums A through D in place, while Figure 35(b) shows drum E right as it was being added to the test cell. Drum D is seen further back in the image. Since damage to drum D had been limited in the first test, the same POC was used in the second test, this time with the damaged paint side of the drum facing away from the fire as observed in Figure 35(a). As in Test #1, the TCs lines from the center drum were routed through the bottom of the empty drum to the outside of the pool, where all TC lines, including those from the other drums, were routed out to MIDAS. Insulation to protect the TC lines was added just like in the first test. HFGs were aligned with the front edge of drums B, C, and D; there was no HFG on drum E, but since this drum was at the same radial distance from the fire as drum D, the heat flux should be the same.

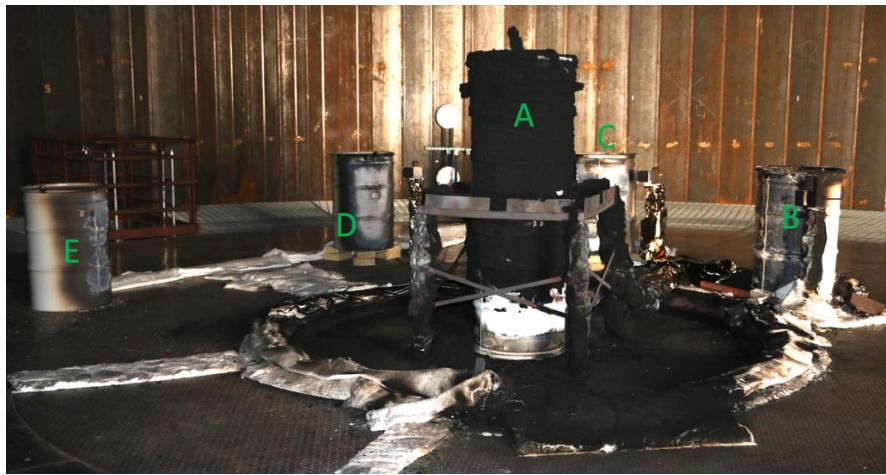
Figure 37(a) shows the state of all the drums after Test #2. As shown in Figure 37(b), drum A was heavily coated with soot; however, the lid did not appear to bulge significantly, as seen in Figure 37(c) after the soot was removed.

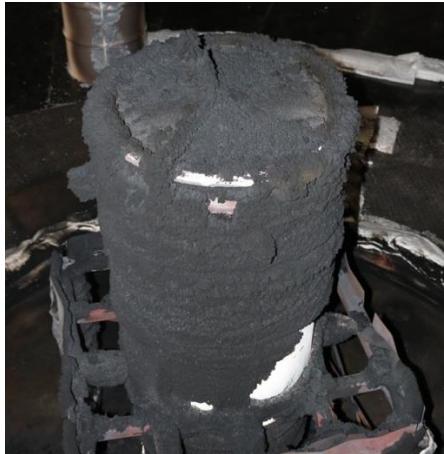
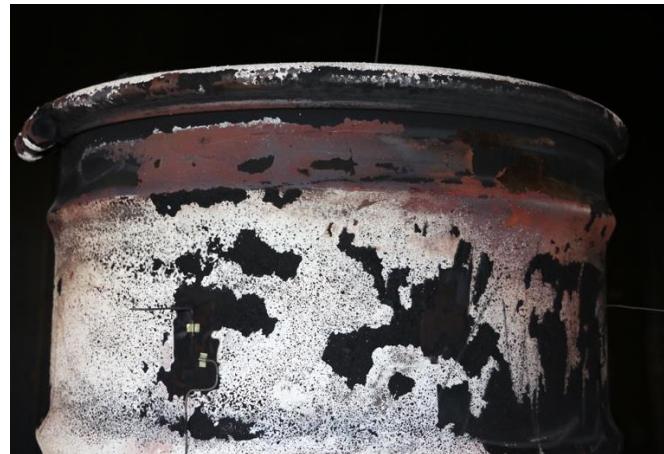
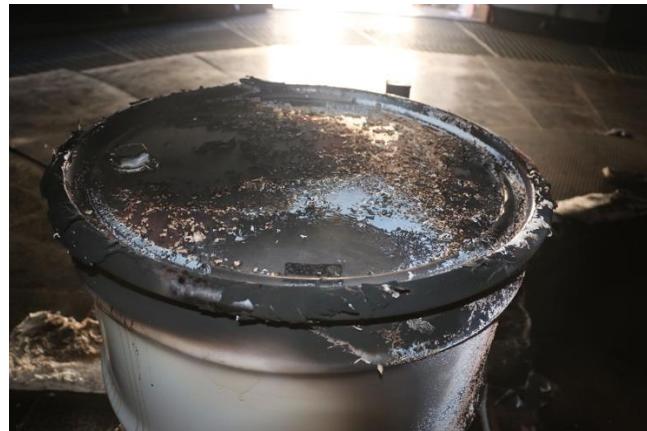
Figure 37. (a) All drums after Test #2, (b) and (c) close-ups of drum A, and (d) close up of drum B.

Outside the fire, drum B sustained the most damage, but it was significantly less than in the previous test (see Figure 37(d)). Particularly, the drum lid and the rest of the drum body did not

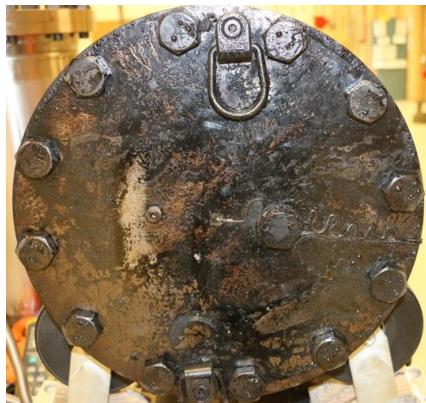
Figure 39. PC extracted from the center drum (A) after Test #2: (a) and (b) show black tar substance on the outer walls of the PC, (c) PC filter, and (d) PC O-ring.

Figure 39(c) and (d) show the PC filter and the PC flange O-ring that were extracted from the PC in drum A. Surprisingly the filter and the O-ring were found in good condition. Although hard to see in Figure 39(c), the carbon media is still in the vent housing. Typically, when the PC filter fails, the carbon media is displaced further down when the filter is placed upside down and not visible from the angle shown in this image, and in some cases when looked at straight down the center of the housing from the point of view of the side shown here, the carbon media shows signs of cracking on the surface. Other PC filters and the PC flange O-rings recovered from the other POCs outside the fire in this test and in Test #1 show similar conditions depicted in Figure 39(c) and (d).

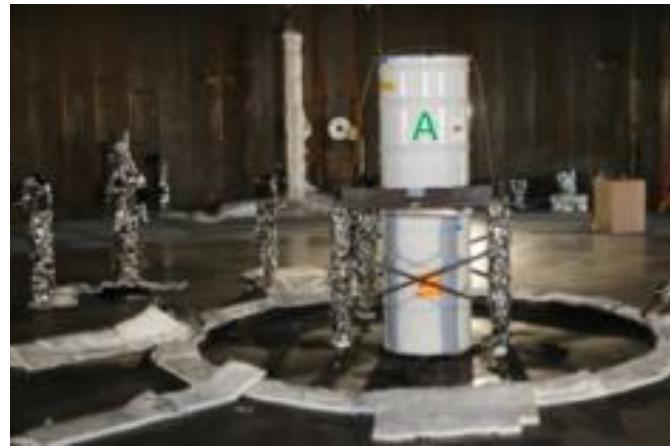
Figure 55. Test layout in Test #1 of Phase II.

The first test in Phase II was initially the only test planned in this phase. Since the purpose of the test was to see if the POC drum lid would get ejected from the center of the pool, only one POC was used. The POC was a standard POC with the drum lid on. There was no instrumentation inside it, but TCs were attached to the outside of the drum to monitor the temperature of the flames, which helped corroborate that the POC was getting heated evenly during the fire. HFGs were not required for this test, but were already in the facility. Thus, they were used to verify previous heat flux data. Figure 55 is an image taken prior to the test.

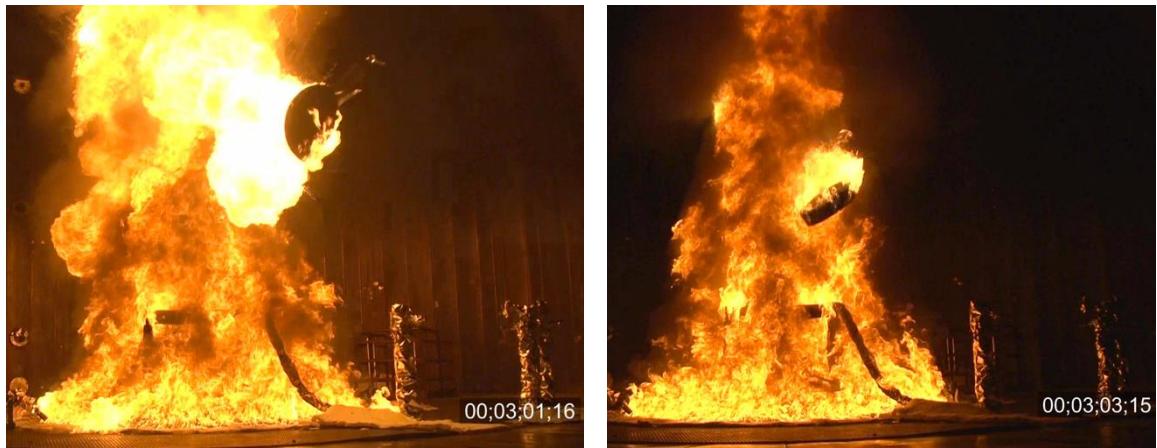
Figure 56. Videos screen captures of Phase II Test # 1 showing ejection of lid.

Figure 56 shows two images from this test. The test images are screen captures from videos taken just after the lid was ejected from the drum. In Test #1 of Phase II, the drum lid, the plastic liner, Celotex®, and wood board covers were ejected from the fully engulfed POC 3 minutes after the POC was fully engulfed. The time stamp shown on the bottom right corner of the images corresponds to the time elapsed since fully engulfing conditions were reached. The left image shows the lid in midair shortly after getting ejected from the drum, and the right image shows a section of burning Celotex® coming down on the pool after it had risen beyond the viewing area of the video camera. Note the difference in time in between images, which gives an indication of the time the Celotex® piece in the right image was airborne above the camera view. Although not shown in this figure, images obtained from IR video screen captures also showed the entire PC flange momentarily raised above the edge of the drum soon after the lid and the other components were ejected.

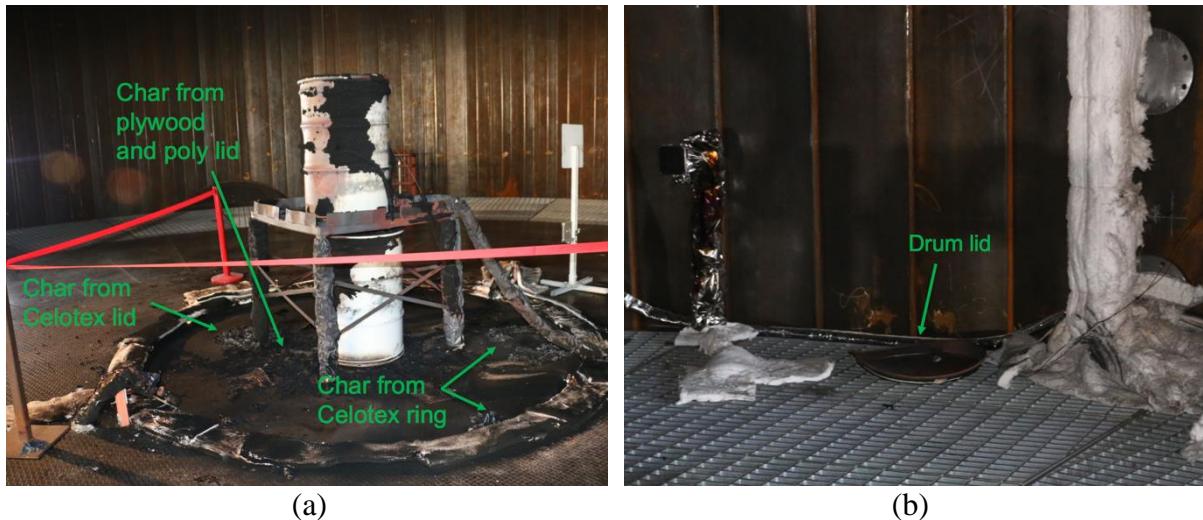
Figure 57. Test remains after Test #1 in Phase II. (a) center of the pool and (b) lid by the wall of the test cell.

Figure 57 shows the test area the day after the test. Figure 57(a) shows char remains of various Celotex® pieces inside the pool. The Celotex® lid is by the corner of the table and the Celotex® ring shown towards the bottom of the image (originally wrapped around the PC flange). The remains of the plywood and traces of molten plastic were observed near the table on the pool floor.

Figure 57(b) shows the final location of the drum lid; it's next to the HFG placed by the wall of the test cell, roughly 9 m away from the center of the pool. The lid was severely bowed and landed with the bottom side facing up. The ring was still attached to the drum with no signs of the seal, which had been completely consumed during the fire.

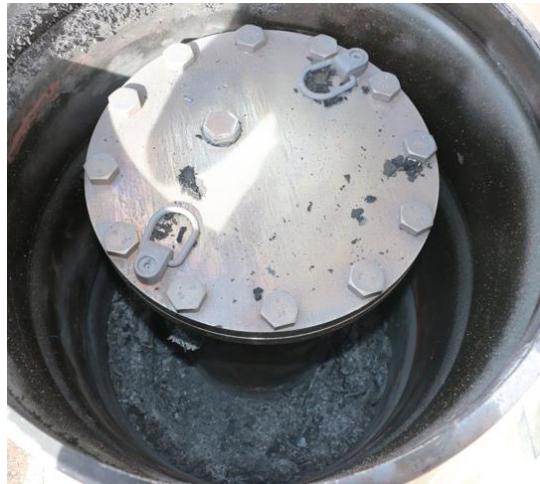
Figure 58. Remains of the POC in Test #1 of Phase II.

As in the first test of Phase I, all that remained inside the POC were the remains of burned Celotex® beneath and just to the side of the POC (see Figure 58(a)). The PC filter was examined in place (i.e., while attached to the lid) and the carbon material inside the vent housing was found pushed out from where it normally sits, with some evidence of gray discoloration on the sides of the carbon media (see Figure 58(b)). Without a leak test it's difficult to quantify the state of the filter. However, given the conditions observed and what was observed in the first phase, it's almost certain that the PC filter was compromised.

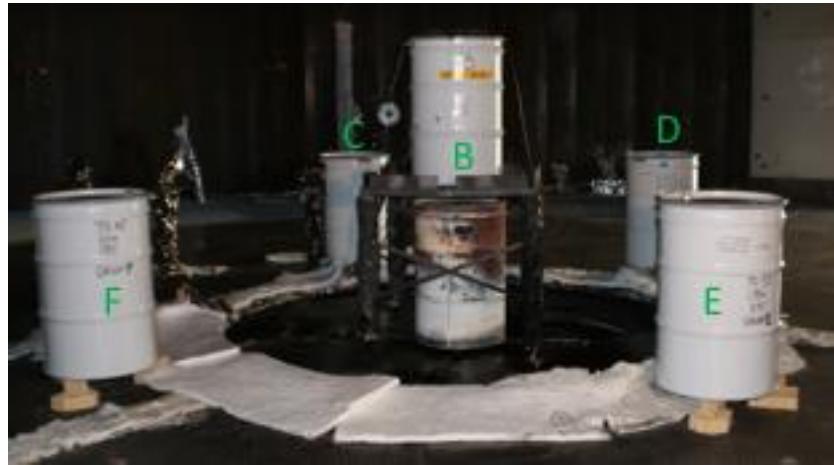
Figure 59. Image of the test layout in Test #2 of Phase II taken from the southeast corner of the facility.

Figure 59 shows an image of the test layout. One POC and one 7A were placed 1.7 m from the center of the pool and the other POC and 7A were placed 2.0 m from the fire, slightly closer to the fire than the POC in the Test #2 of Phase I. The POCs were located on the north and west side of the facility and the 7As on the opposite side as shown in Figure 12. As noted in that figure, the drum labeling scheme changed in this test but this had no special significance. In Figure 59, the 7As are the two closest drums (E and F), while the remaining drums shown towards the back are POCs.

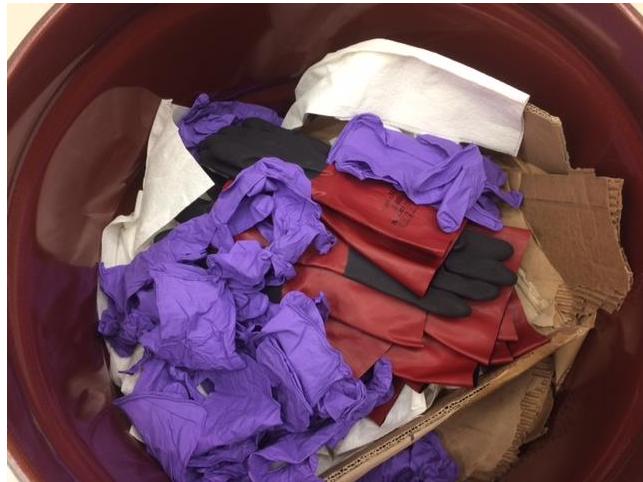
Figure 60. Typical contents of 7As in Test #2.

The PCs on the POCs were empty, but the 7As were filled with typical combustible materials (gloves, plastics, etc.) to the top (see Figure 60). Except for the center drum B, none of the other drums had TCs. The TCs on the center drum were all attached on the outside of the wall of the drum to make sure the drum was fully engulfed.

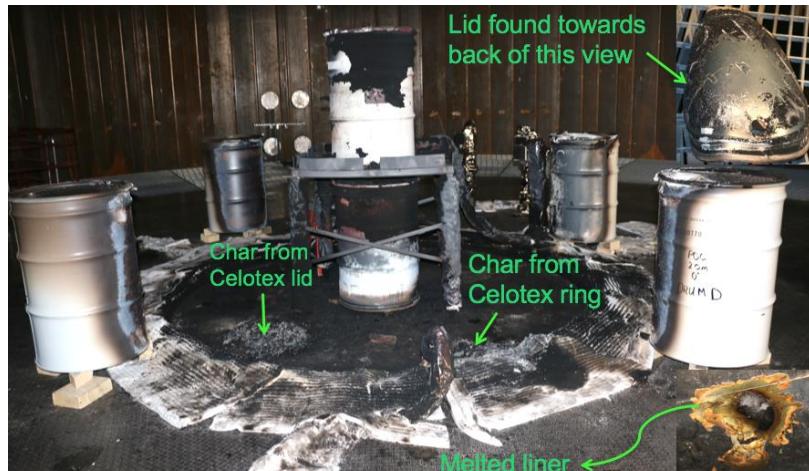
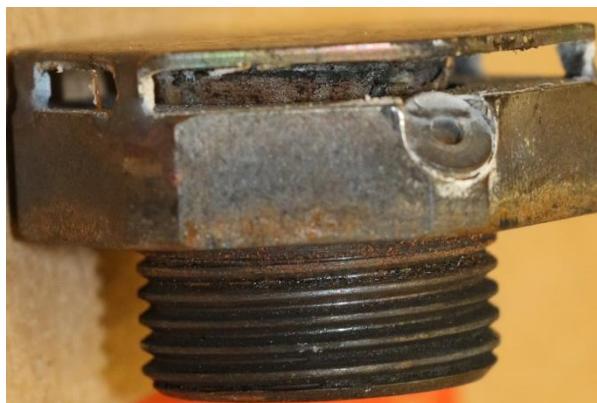
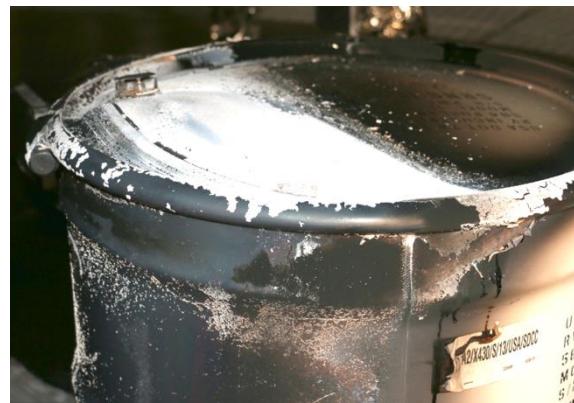
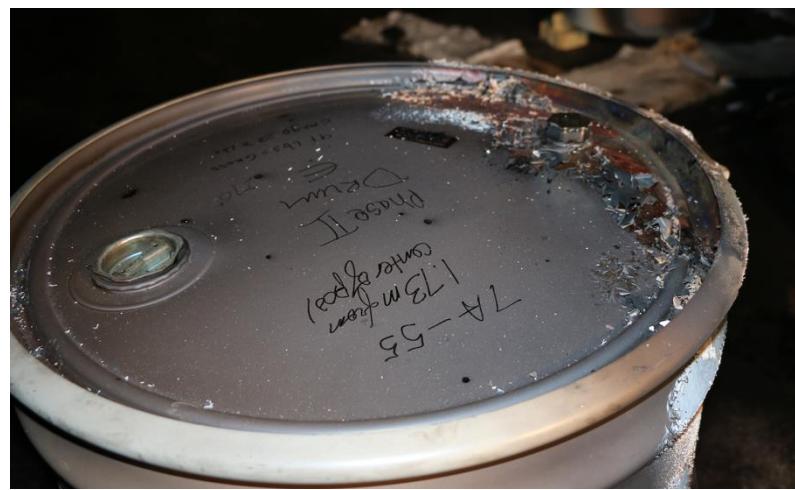
Figure 62. Conditions of the POC and 7As after completion of Test #2 in Phase II: (a) extent of damage to the center drum, (b) PC filter recovered from the center POC, and (c) and (d) damage on the lid of the POC and 7A drums closest to the fire.

Figure 62(a) shows the overall state of the POCs and 7As after the fire. As before, Celotex® material ejected from the center drum fell on the pool. The drum lid was found on the grid floor of the test cell towards the back of the setup (from the point of view of this image), as shown on the cutaway at the top right of this image. The lid was much more severely deformed than in the previous test. Molten plastic from the liner was also found, this time on the north side of the test cell, as observed on the cutaway image on the lower left of this figure. Figure 62(b) shows the PC filter recovered from the PC in drum A. Figure 62(c) and (d) show close-ups of the drum lids of the closest to the fire POC and 7A drum.

Overall, the 7A drum underwent very little damage; however, the POC drum shows significant bulging on the lid on the side facing the fire. Damage on the POC located at 2 m was less than shown in Figure 62(c), but more extensive than the damage observed on drum B in both the first and second test of Phase I. Based on these results, it appears that when the lid is torqued properly, bulging of the POC drum lids closest to the fire (<2.2m) is more severe. Still, both POC drum lids stayed on with no sizable gaps found between the lid and top edge of the drum. Damage to the 7A drum at 2m was less than that from the 7A that was closer to the fire.

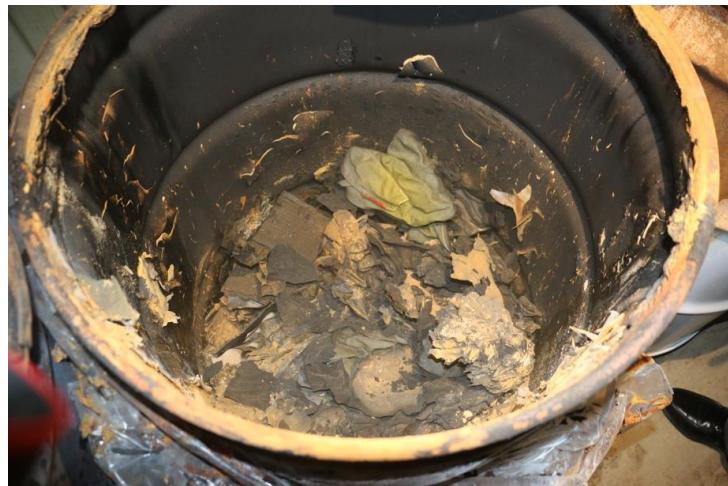
Figure 63. Left over material inside one of the 7As in Test #2 of Phase II.

Inside the POCs, the interior looked similar to the interior of drum B of the first and second test. Figure 63 shows an image of what was left inside one of the 7A drums. More than half the combustible material originally placed inside the drum was decomposed.
