CARBON FIBER EPOXY HAZARDS FROM FIRE ENVIRONMENT TESTING

A.L. Brown

Sandia National Labs/Fire Science and Technology Department
Albuquerque, New Mexico

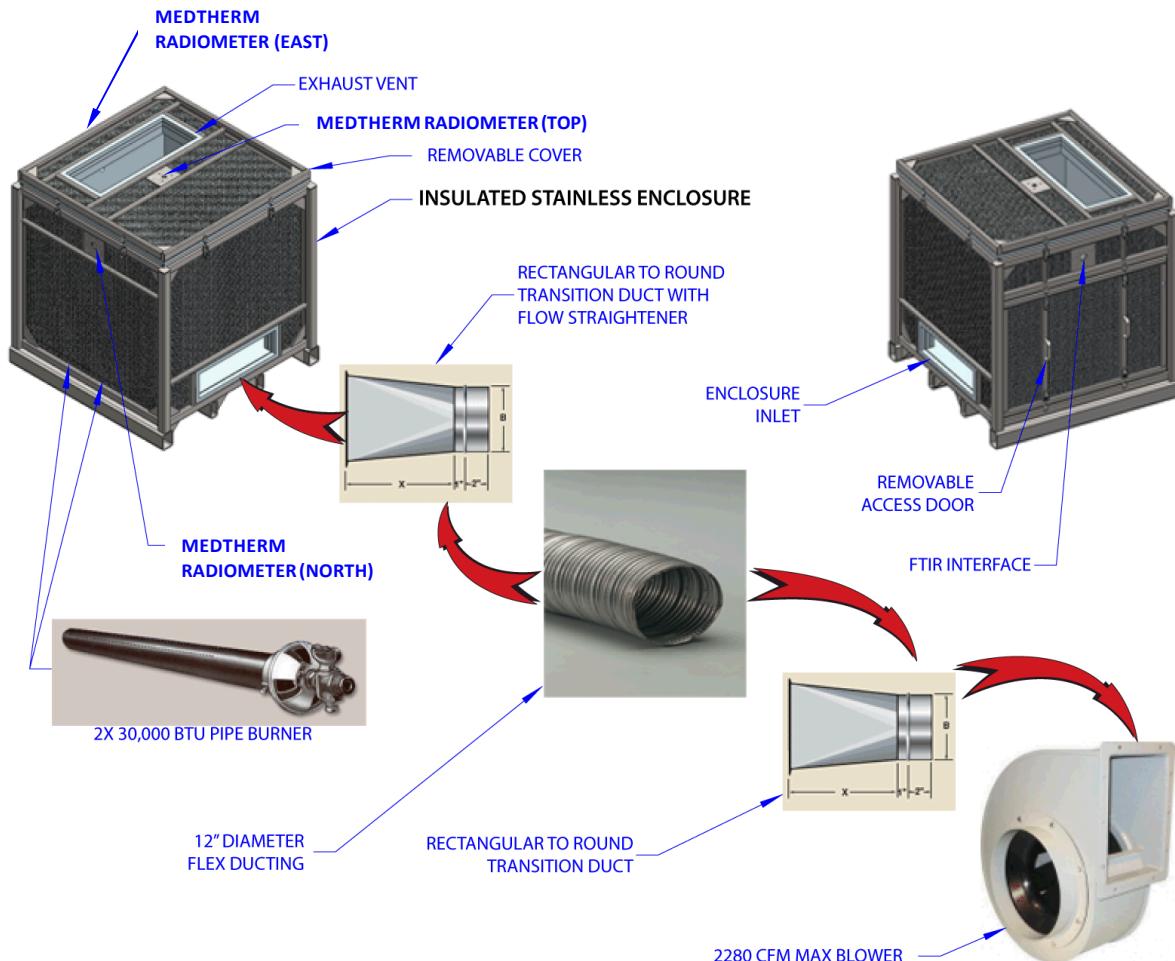
Figure 1. A schematic illustrating the test enclosure.

In what is being termed the enclosure fire tests, between 25-40 kg of material was placed in a 1 meter internal cube. The cube was insulated, with a controlled air inlet at the bottom and an exhaust at the top. Inside it was instrumented with heat flux gauges, thermocouples and a calorimeter. Other instrumentation existed external to the enclosure. The enclosure design is illustrated in Figure 1. Gas burners were used to ignite the carbon fiber composite epoxy material, only for the 1-5 minutes of the test. Other than mass variations, the most significant variations from test to test were the lay-out and shape of the composites and some minor air flow variations. Major findings include the following:

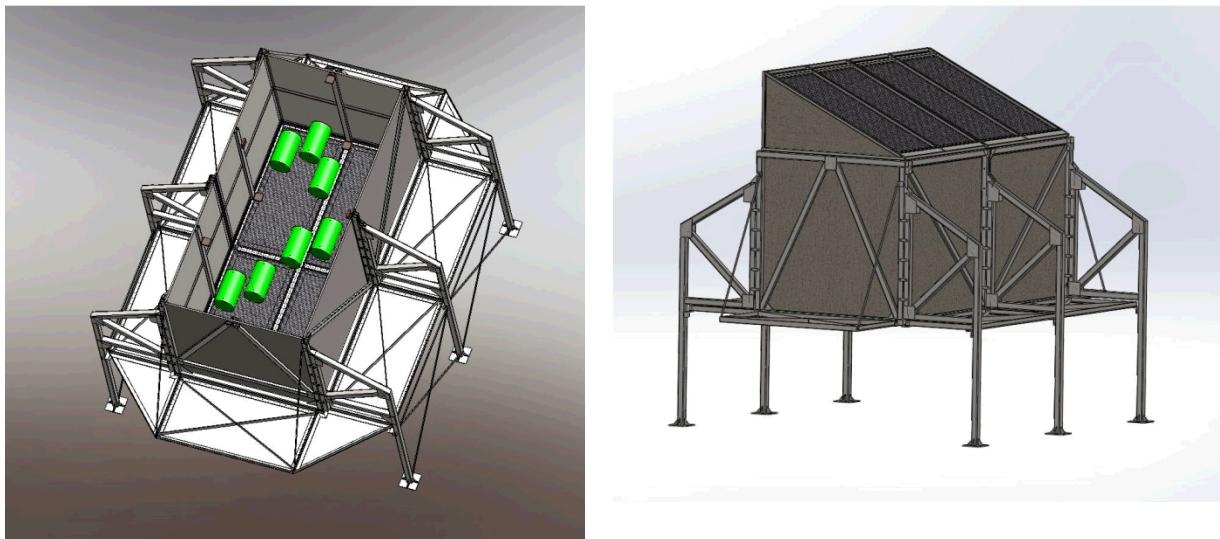
Figure 2 Two views of the mock aircraft design.

This test series involved a 2-meter diameter pan of jet fuel on the ground below a structure that was designed to simulate the geometry and construction of a B-2 bomb bay. The bay area consisted of two cubes, with the major cubic dimension being 2.44 meters. A triangular section on the top is used to represent the complexity of the actual aircraft in that area. The cavity is roughly to scale in height and width, but 2/3 scale in length. The assembly was raised on six legs such that the bottom surface of the mock fuselage was 1.83 meters above the floor. The top and bottom surfaces were made from carbon fiber epoxy, surfaces which were changed

out for each test. Calorimeters and heat flux gauges (green and red in Figure 2 respectively) were located throughout the enclosure and served to quantify the heat fluxes and fire environment in the enclosure during the test. The legs were water cooled, and the metal side-walls were insulated on the outside. Primary variables differentiating the two tests were the distribution and quantity of composite material, the wind speed imposed in the cross-wind test facility (XTF) wind tunnel during the test, the location of the fuel pan, and whether the lower bomb bay doors were open or not. Primary findings include:

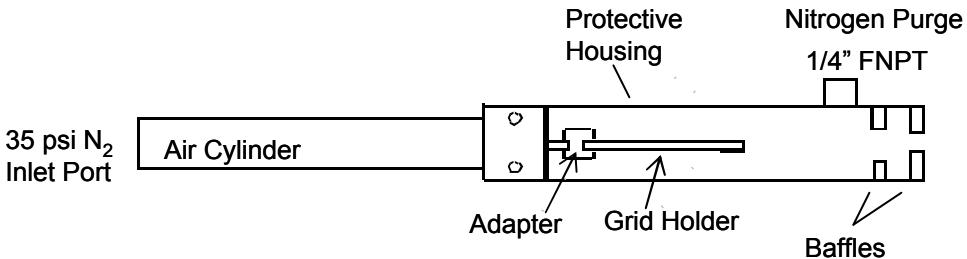
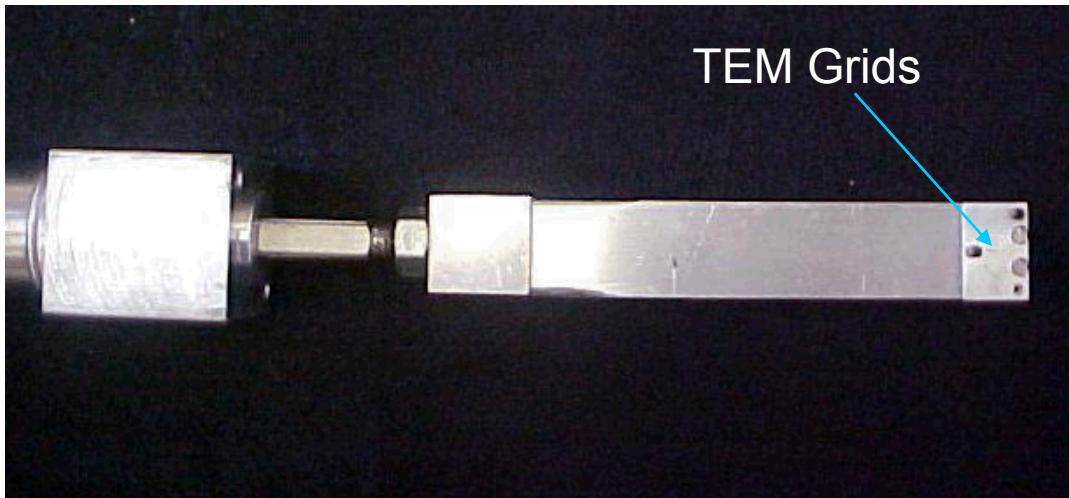
Figure 3. A schematic of the thermophoretic sampler for collecting soot from the flame, and photograph of the grid holder attached to the pneumatic cylinder (from [14]).

Several methods were employed to measure sooty emissions from the burns. In the enclosure test series, a pneumatically actuated, aspirated collection grid was located above the exhaust. During peak smoke emission (flaming combustion), the sampling system was actuated, exposing the collection grid through the baffles and into the smoky fire. Samples were otherwise maintained in an inert environment, cooled by a nitrogen flow. Particulate samples were recovered following the tests, and analyzed with a transmission electron microscope (TEM). A figure depicting the sampling instrument is found in Figure 3 (from Jensen et al., 2005 [18]).

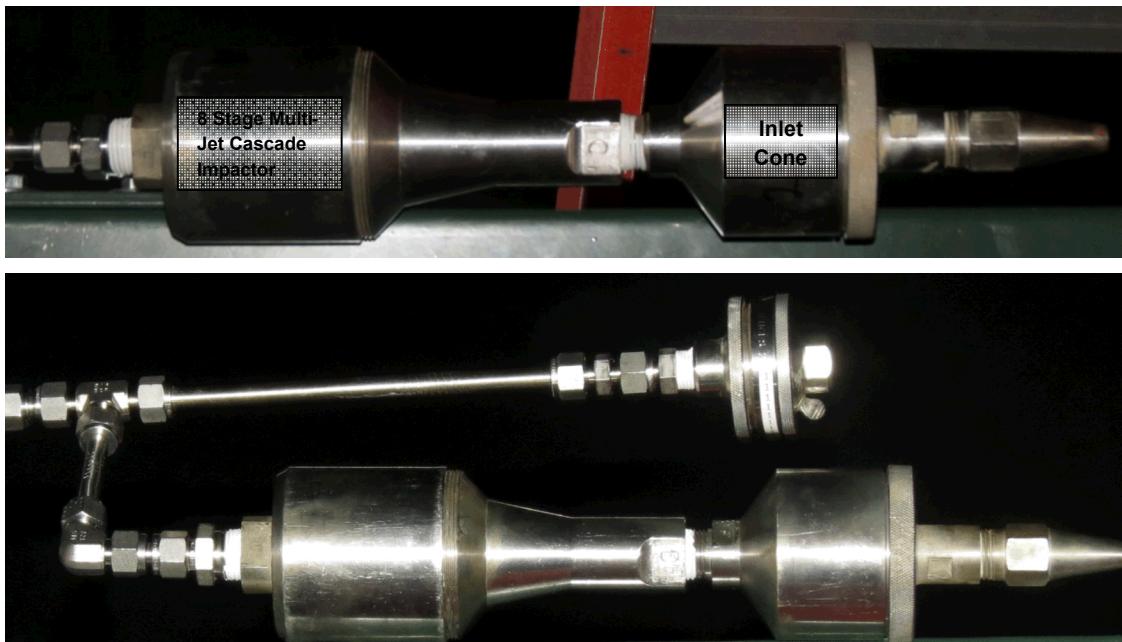
Figure 4. Photographs of Anderson Mark III Cascade Impactor used to measure aerodynamic particle size distribution

Two methods were employed for measuring soot from the mock B-2 tests. A cascade impactor was used to sample the product gases down-stream of the fire. Cascade impactors use a vacuum pump to draw effluent through a cascading series of collection filters. Aerodynamic separation results in a series of filter papers with deposits ranging by aerodynamic size. The filter papers can be pre- and post-weighed to quantify the mass of particulate matter in a given size range. A figure depicting the instrument is found in Figure 4. This instrument was located 3.66 m above the ground at 2.29 m from the north wall that constitutes the side of the XTF facility (about half-way to the center of the facility). The instrument was located about 18 m downwind from the last inlet screen to the facility, just up-wind of the make-up air grating, or 9 m downwind of the mock fuselage down-wind legs.

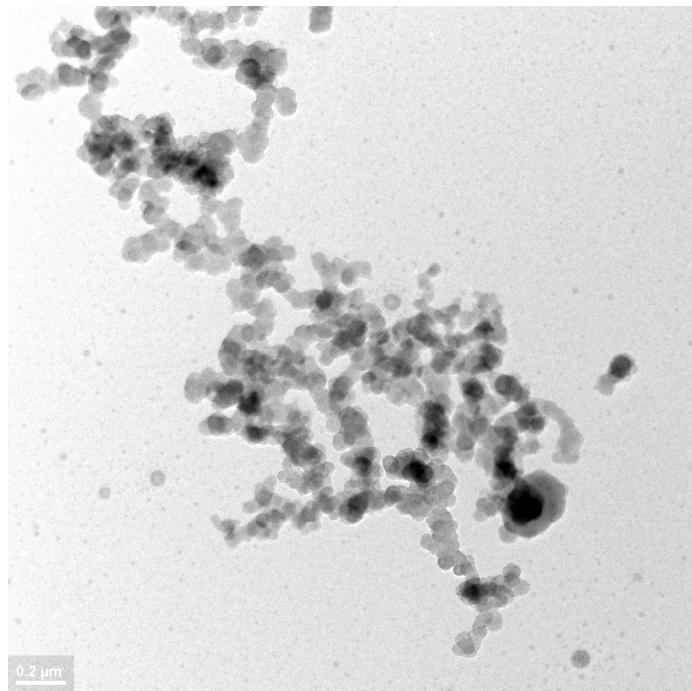
Figure 5. Test 5 TEM image of a soot agglomerate.

Nothing exceptional is noted with respect to the shape, size, or nature of the soot from the burning of epoxy. Extensive analysis of soot from JP-8 pool fires has been performed with the same instrumentation in the past, and many of the images found in Jensen et al., 2005 [18] can be compared to these. Imaging of the soot from epoxy combustion suggests it is comparable to soot from JP-8, or other fuels.

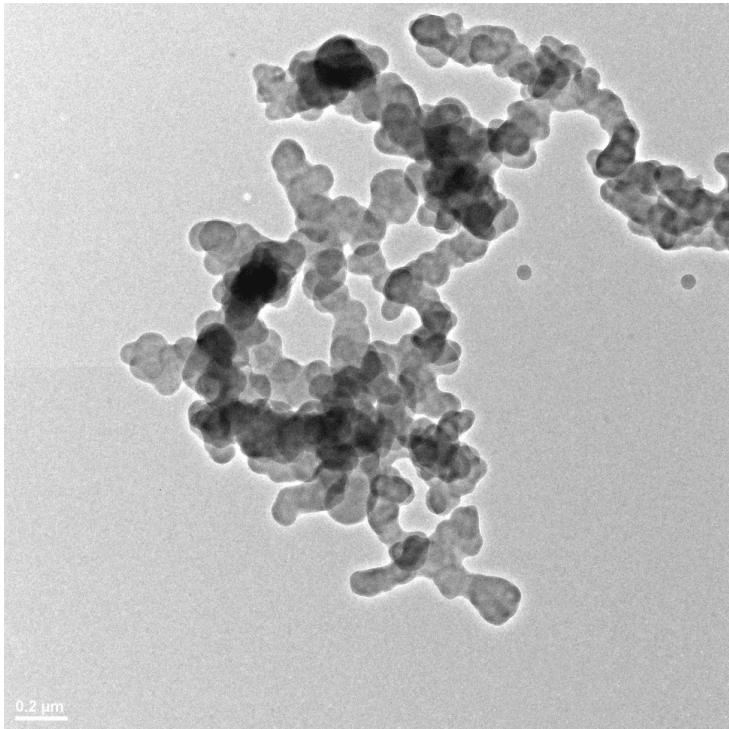
Figure 6. Test 6 TEM image of a soot agglomerate.

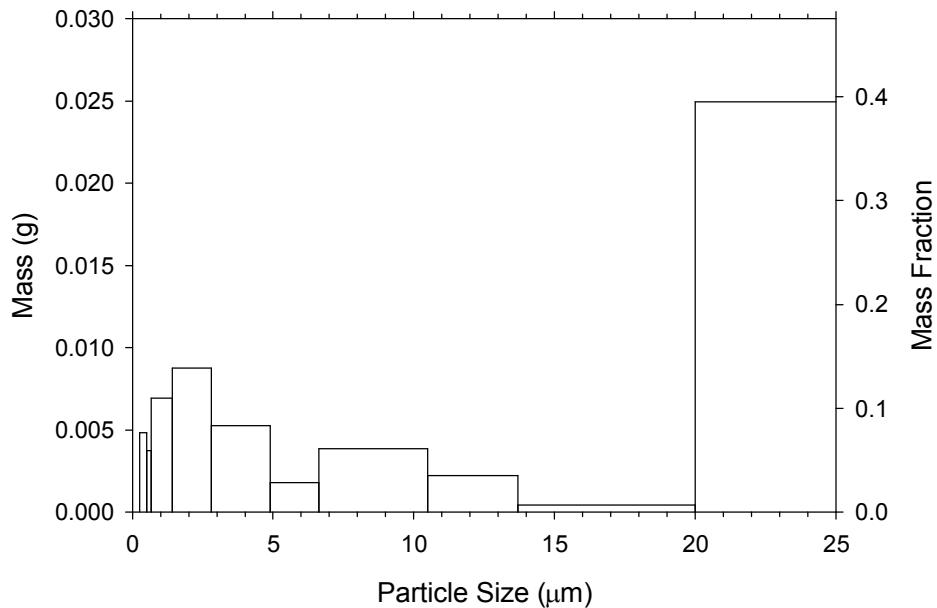
Figure 7. Mass of particles from the cascade impactor.

Test B from this test series was also instrumented with the cascade impactor. Particles were collected over a period of 11 minutes starting 10 minutes into the test. The duration was determined during the test, and the sampling was concluded when the flow rate was reduced by 10% from the starting value. Thus the flow rate varied between 72-65 lpm during the test. A total of 760 liters were sampled, and 38 mg were recovered from within the impactor. It is believed that the primary source for the soot is the JP-8 fuel, however the soot from the burning composite material is also believed to be a contributing factor. A similar set-up was located at half the elevation, but the filter paper did not collect significant product at that elevation. The particle distributions were based on custom collection size ranges, and are therefore binned according to the irregularly spaced bins corresponding to the instrument. Figure 7 shows the particle measurements based on the mass. In this and the next figure, the 20 μm bin is truncated for improved visibility of the lower-limit bins. It actually extends to 100 μm+, and was determined by sampling a total weight filter and subtracting the difference from that sampled in the impactor (63 mg versus 38 mg respectively). On a pure mass basis, the 20-100 μm range constituted nearly 40% of the mass. However, if the mass fraction data are normalized by the particle size range in μm, the distribution in Figure 8 shows that the peak of the mass distribution is closer to 0.5 μm. The distribution in Figure 8 suggests a relatively smooth distribution, much like expected from this class of data. The mean soot concentration based on the above data at the point of collection

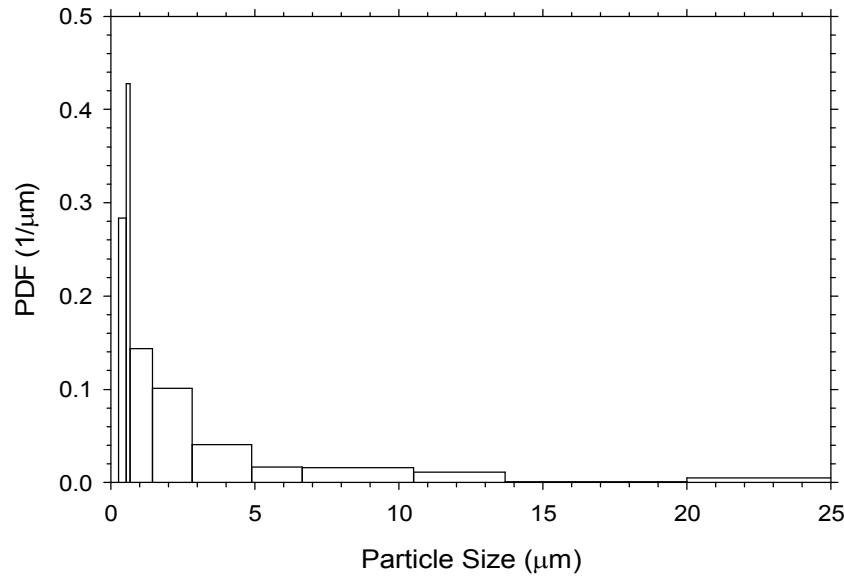
Figure 8. PDF of the particles collected in the cascade impactor.
