# **SANDIA REPORT**

SAND2017-8032X

## **Probability of Detection Study to Assess the Performance of Nondestructive Inspection Methods for Wind Turbine Blades**

**Dennis Roach**

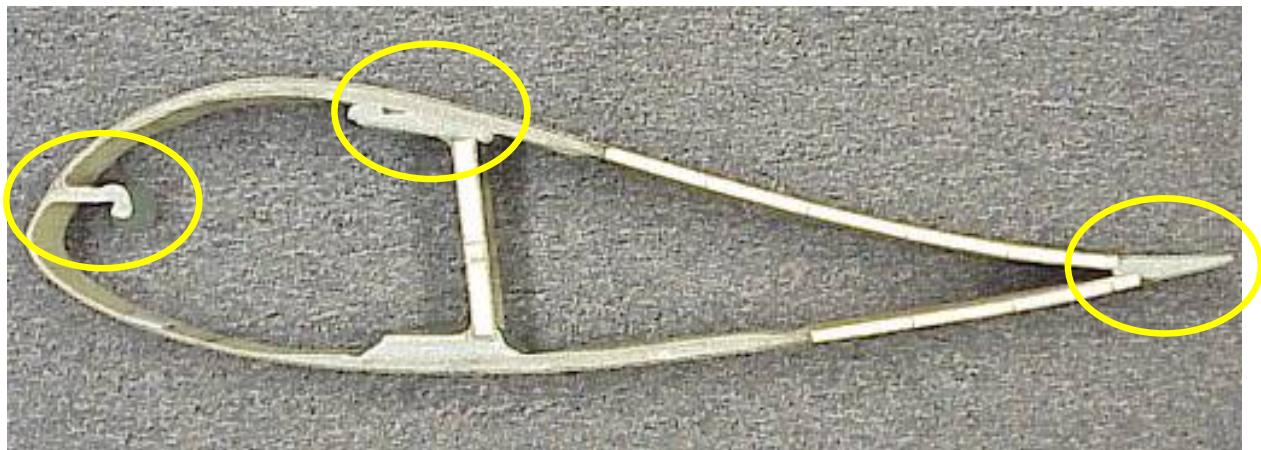
**Figure 2-1: Inspection Areas of Interest – 1) Leading Edge Bond, 2) Spar Cap, 3) Spar Cap-to-Shear Web Flange Bond Line and 4) Trailing Edge**

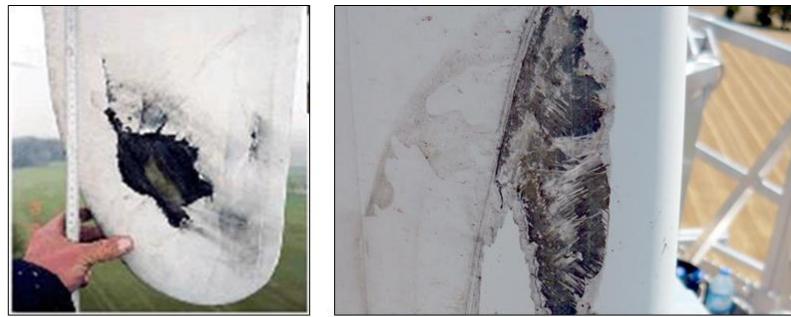
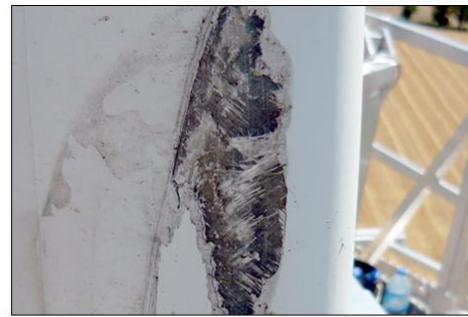
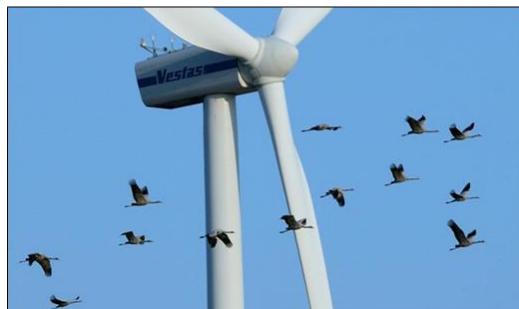
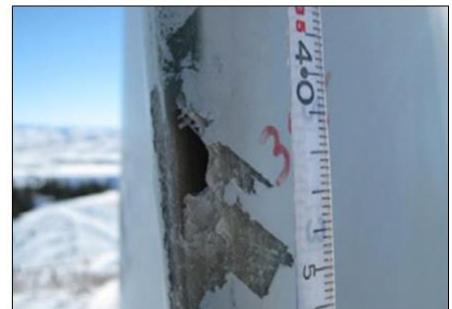
**Figure 2-6: Types of Damage to Wind Blades Experienced During Operation (1)**

Lightning Strike Damage

Impact Damage

**In-Service Blade Damage** - The most common operational damage is from surface impact and rain/dust erosion. Other damage stems from bird strikes, lightning strikes, other object strikes, the propagation of manufacturing anomalies and the origination of new damage stemming from normal fatigue stress loads, off-design overloads or other environmental conditions. Figure 2-6 to Figure 2-8 show various types of wind blade damage. Note that all photos feature damage that is extreme or that has propagated to the point of blade failure. The goal of this effort to conduct nondestructive inspections before minor damage can grow to levels of concern. Figure 2-9 shows several images of subsurface damage that can be detected via NDI methods.

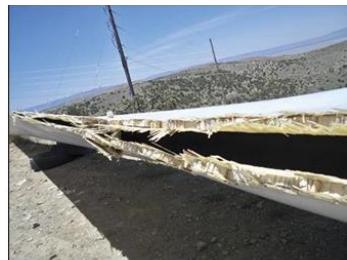
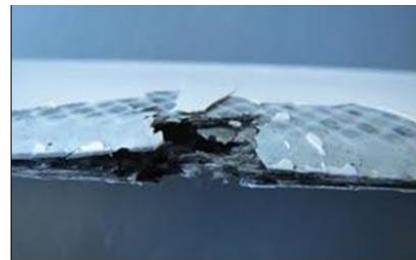
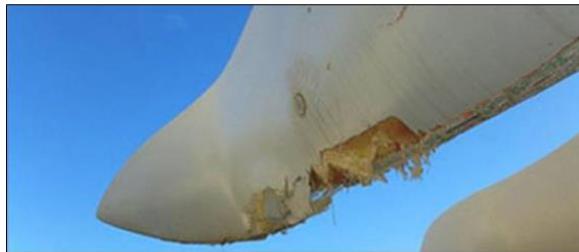
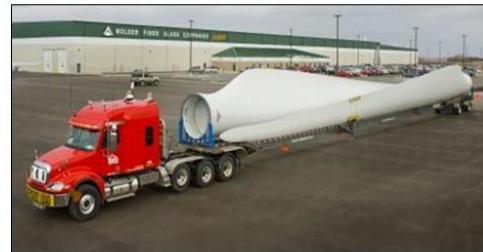
**Figure 2-7: Types of Damage to Wind Blades Experienced During Operation (2)**

Trailing Edge Disbond and Fracture Damage

Erosion and Impact Damage

Damage from Shipping and Installation Handling

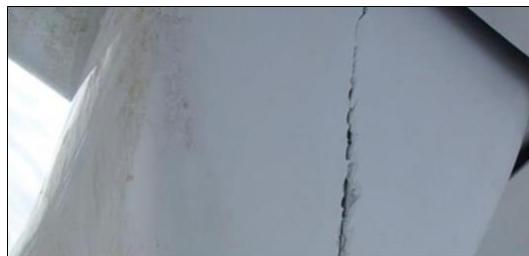
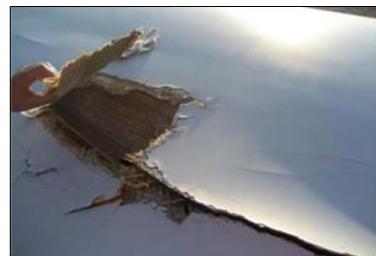
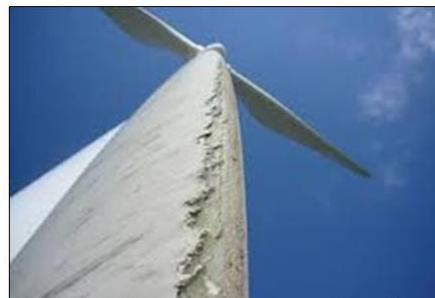
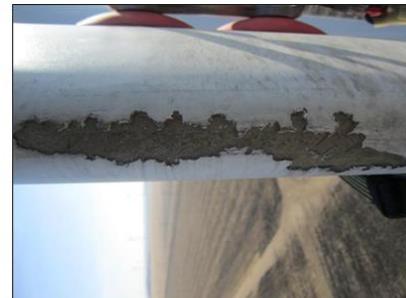
**Figure 2-8: Types of Damage to Wind Blades Experienced During Operation (3)**

Severe Growth of Fiber Fracture

Delamination and Subsequent  
Laminate Fracture

Erosion Damage

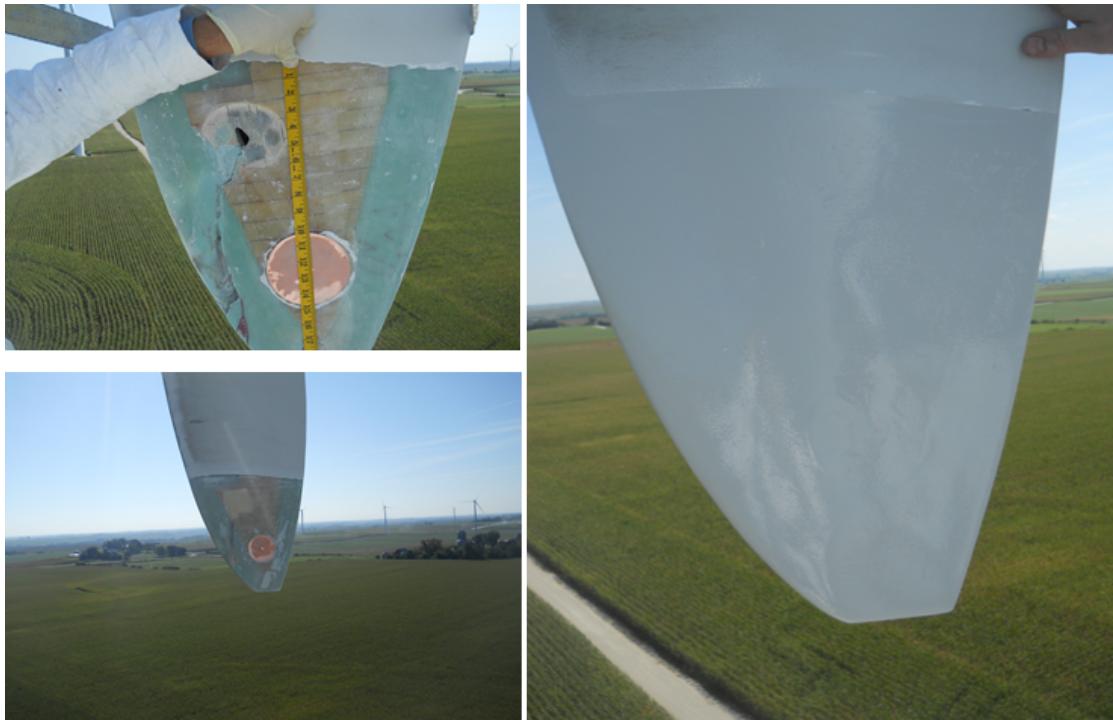
**Figure 2-12: Picture of a Lightning Strike Tip Repair**

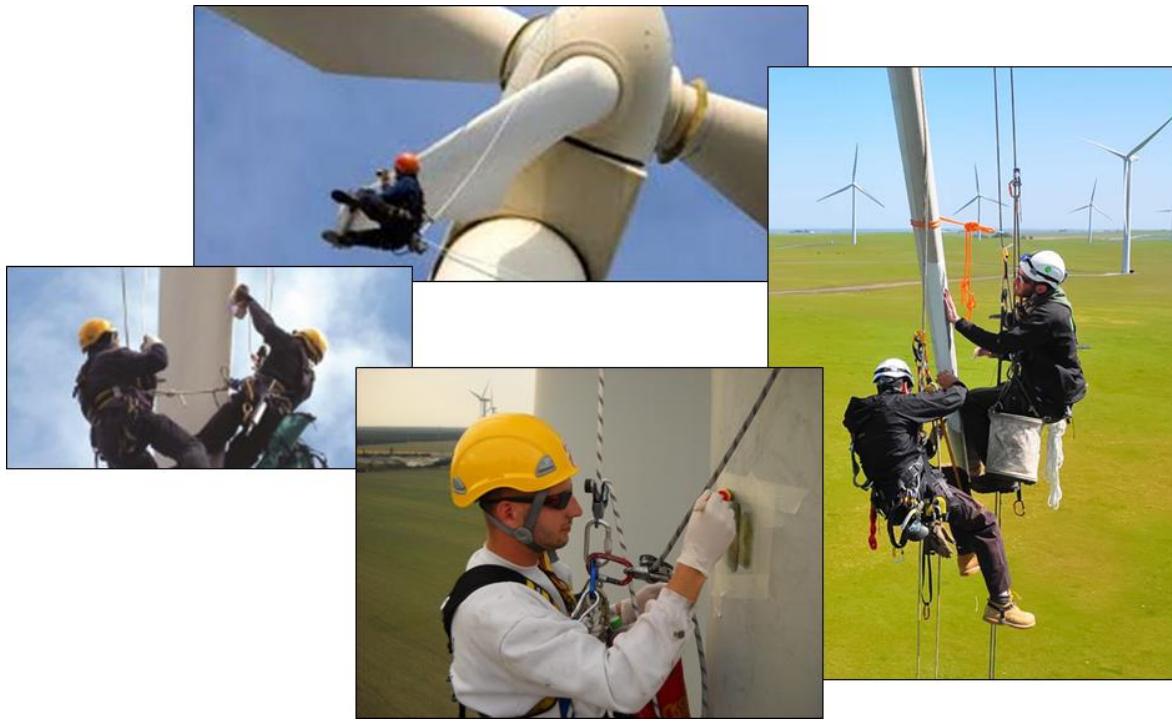
**Figure 2-13: Use of Skyworkers to Access Blades Via Climbing Ropes**

**Up-Tower Blade Access** - With a growing number of blades now in service - many well outside their warranty periods - rotor blade maintenance is becoming a major issue. One of the most challenging aspects of wind farm operations is the means to conduct periodic maintenance of the blades while they are still installed on the rotor hub (i.e. up-tower maintenance). Access to the blades and deployment of equipment severely hinders both the ability of workers to conduct their tasks but also limits the amount and type of work that can be carried out up-tower. Up until recently, the excellent reputation of composite materials for high durability has induced wind farm operators to defer general blade maintenance and oversight tasks. The increasing knowledge of wind blade aging issues has produced an increase in demand for blade inspection, maintenance and repair. In response, several wind service companies have been formed to supply a new breed of worker called skyworkers. These workers combine skills in the inspection and repair of wind blades with climbing skills. The technicians themselves are normally suspended from the rotor hub, working on the subject blade – which is stopped in the down position as shown in Figure 2-13. Anchor lines may be deployed to the tower or around the blade.

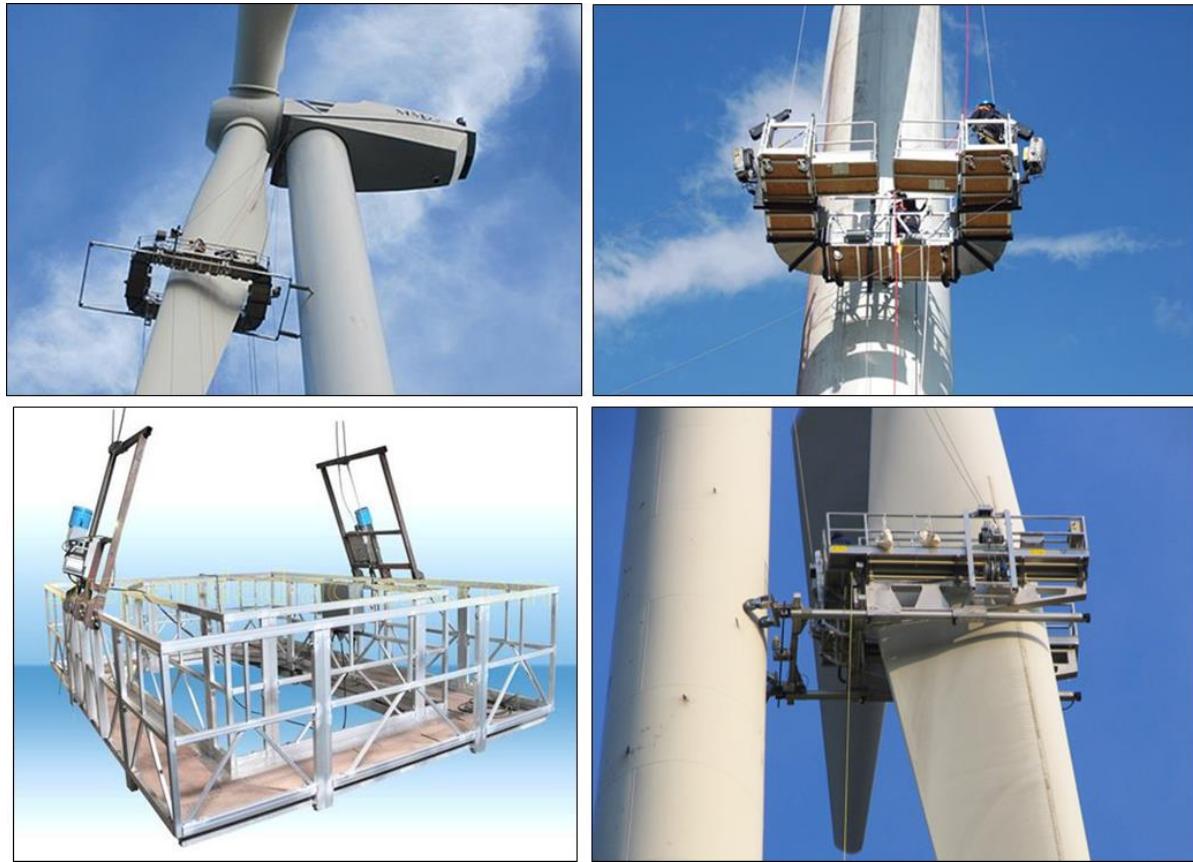
**Figure 2-14: Use of Adaptive Platforms to Provide Larger Work Space for Blade Maintenance Activities**

A variation on this theme involves the use of adaptive platforms to provide an enhanced work area with the ability to provide more controlled use of extensive equipment in an up-tower environment. Figure 2-14 shows several different types of work platforms that can accommodate more extensive blade maintenance activities.

**Deployment of NDI Methods** - The platforms highlighted in Figure 2-14 allow for the direct application of proven NDI methods (see Sandia report: Roach, D., Neidigk, S., Rice, T., Duvall, R., Paquette, J., “Blade Reliability Collaborative: Development and Evaluation of Nondestructive Inspection Methods for Wind Turbine Blades,” Sandia DOT Report, SAND2014-16965, September 2014). These could be deployed manually or in a scan mode. However, the use of these platforms is very rare at this time and quite expensive. Thus, there is a need for more frequent, rapid inspections means that other NDI deployment options should be pursued for use in the absence of such expensive work platform deployments.

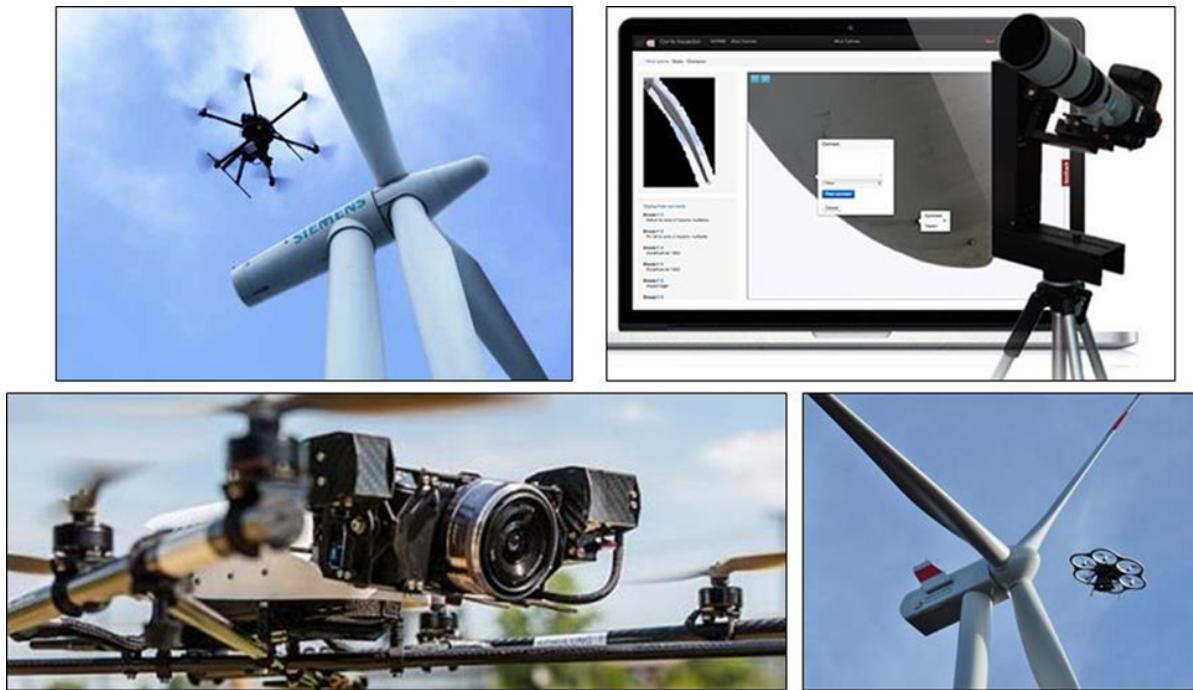
**Figure 2-15: Unmanned Aerial Systems and Ground-Based Devices Used to Conduct Visual Inspection of Wind Blades**

Remote Visual Inspections - The use of Unmanned Aerial Systems (UAS) or ground-based telescopic devices to inspect wind blades has received a lot of attention in the last 2-3 years. Such devices, such as the ones shown in Figure 2-15, utilize high resolution optics to produce excellent visual inspections of the surface of the blade. While these are quite useful for identifying surface-based damage such as erosion, these inspections are not useful for detecting the more extensive subsurface damage that can be present in wind blades. This damage, such as delaminations, disbonds and fracture in the composite fibers, represent damage that can reduce blade life and even result in catastrophic failure in-service. This critical damage must be

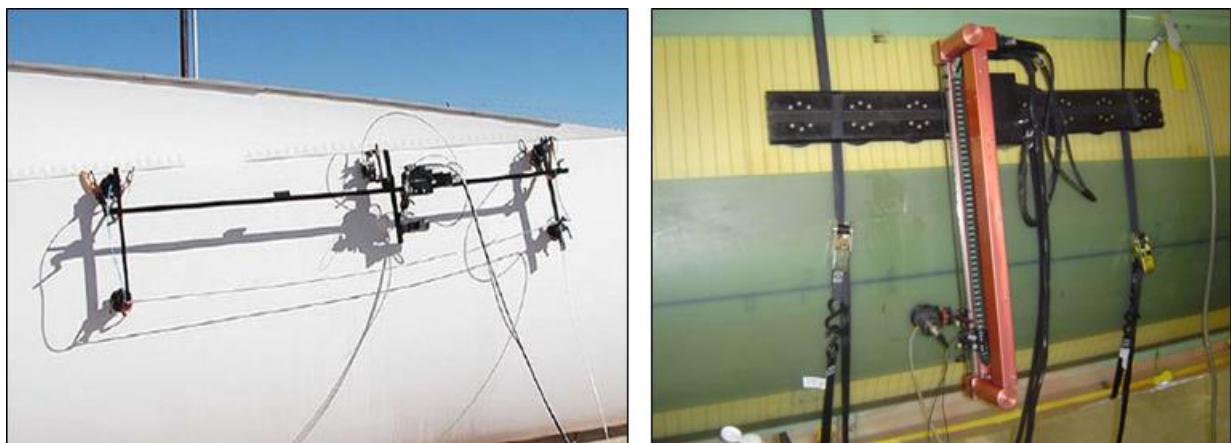
**Figure 2-16: X-Y Scanning Systems Can Temporarily Adhere to the Surface of Interest to Produce High-Quality, Through-Thickness Flaw Detection Images Over Wide Areas**

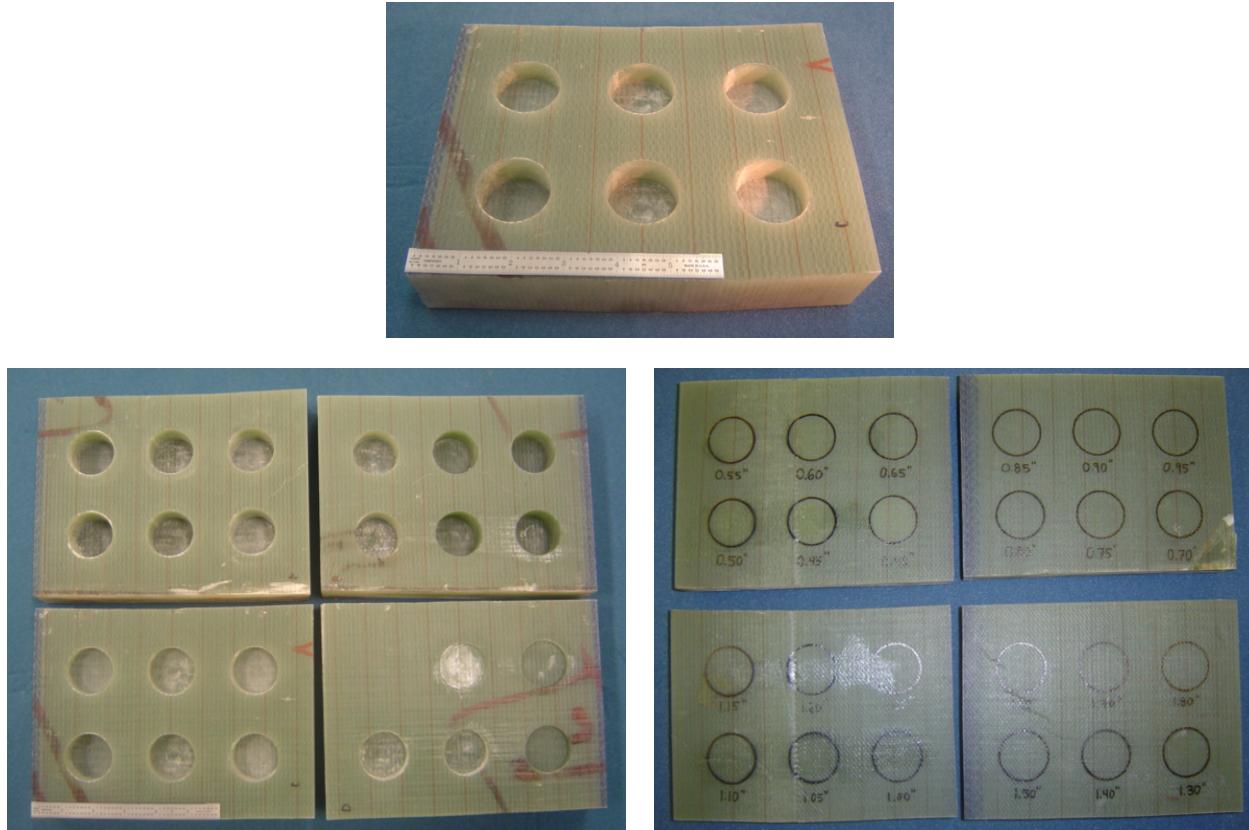
**Figure 3-12: Laminar Thickness NDI Feedback Specimens Made From a Retired Blade – Flat Bottom Holes Placed in Representative Laminate Section to Simulate Delaminations and Backside Disbonds**

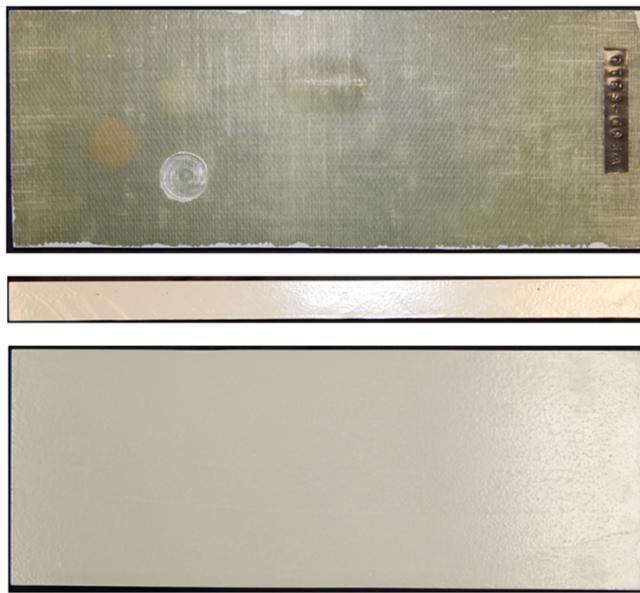
**Figure 3-23: Photos of NDI Feedback Specimen No. 10 (WPOD FB-10)**

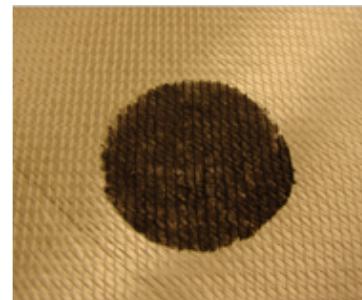
Grease

*Materials inserted into multiple layers to create flaws at different depths*

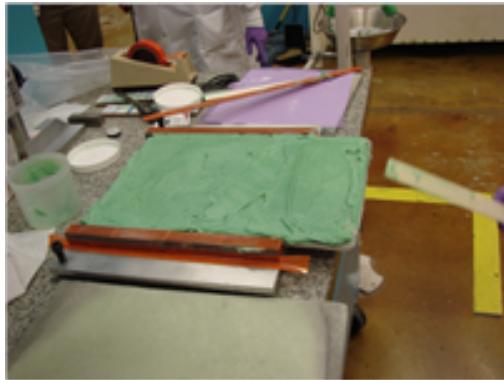
Adhesive layer applied over laminate

Figure 3-31: Fabrication of Trailing Edge Specimen - NDI Feedback Specimen No. 5

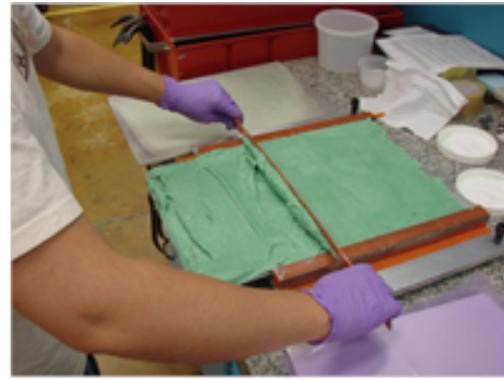
Screeding of adhesive to specific thickness

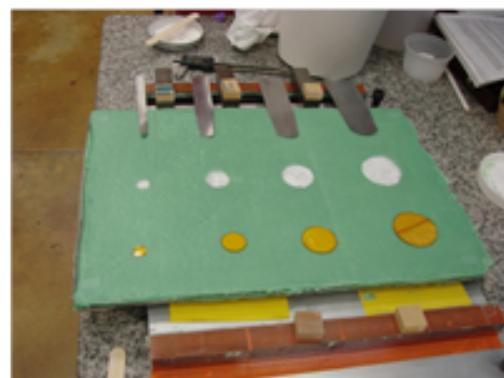
Final look before top laminate is put in place

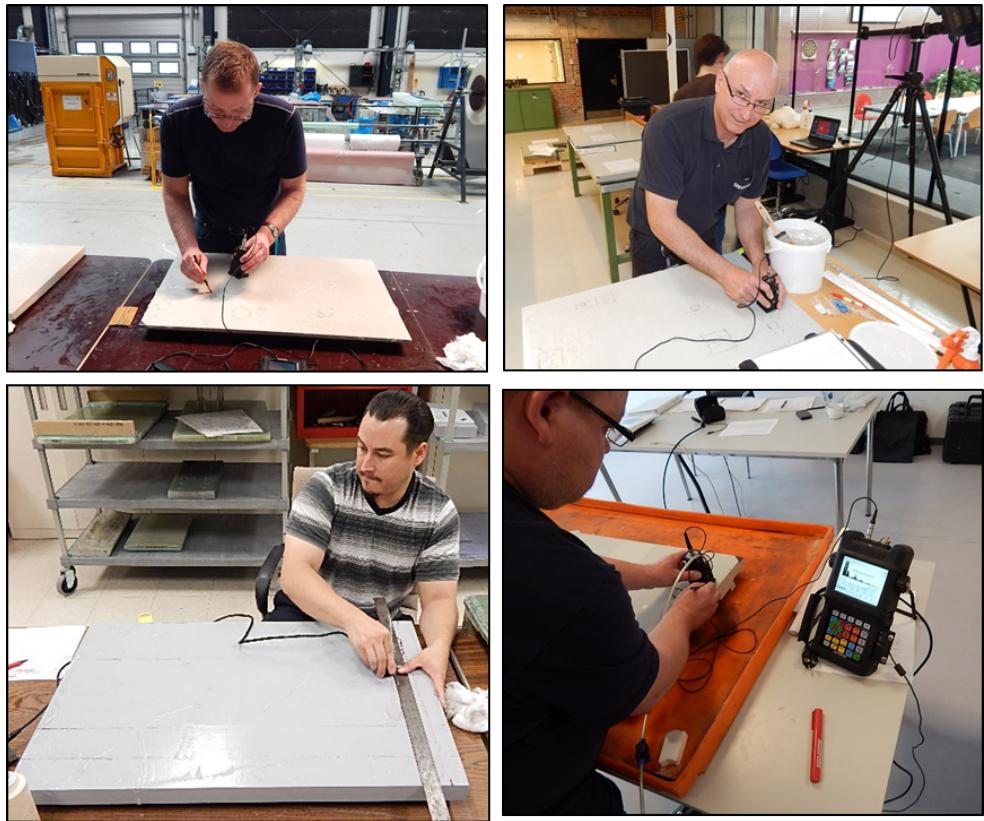
**Figure 4-2: Deployment of Wind Blade Flaw Detection Experiment**

probe type, and equipment used for inspection. The typical set-up for the experiment deployment is shown in Figure 4-2 where each inspector has a workstation to set-up their equipment and test specimens.

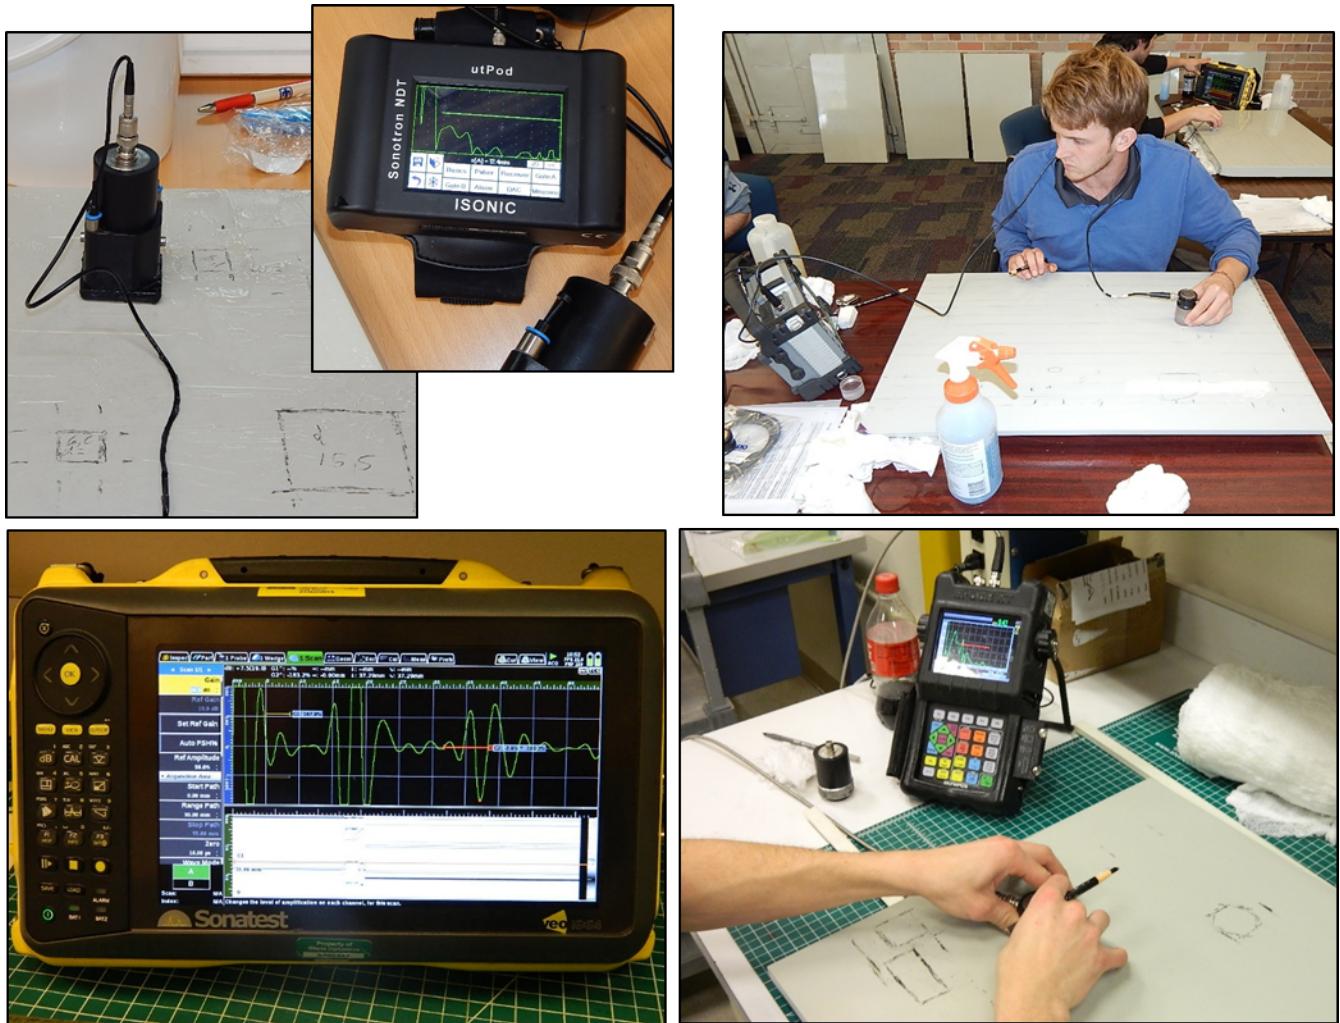
**Figure 4-3: Inspectors and Typical Equipment and Signals During the Wind Blade Flaw Detection Experiment**

The first day of each experiment started with the presentation of the Experimenter Briefing. Figure 4-1 shows one of the briefings being provided to inspectors while Figure 4-2 and Figure 4-3 show inspectors and their equipment while conducting the WBFDE inspections. The briefing explained the purpose of the experiment and the process the inspectors will use to indicate their flaw findings. The briefing was used at each facility to ensure a consistent presentation on the experiment goals and a thorough explanation of how the experiment will proceed. It also allowed the inspectors to ask questions. During the course of the NDI tests, the experiment monitors logged various observations along with the exact flaw calls provided by the inspectors.

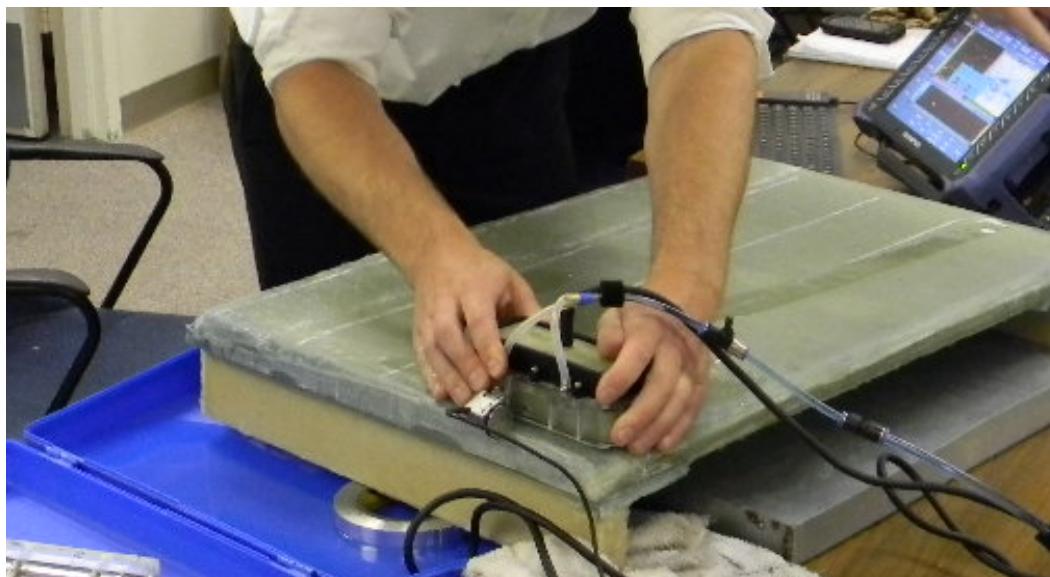
**Figure 5-11: Phased Array Ultrasonics Inspection with OmniScan System**

Figure 5-11 and Figure 5-12 show the OmniScan equipment set-up and deployment for phased array UT inspections of wind blade specimens while Figure 5-12 and Figure 5-13 highlight the various features of the UT transducers and the shoes or wedges used to optimize the NDI signals. Ultrasonic phased array technology, along with the widely adaptable range of probe housings and deployment options were shown to have strong flaw detection capabilities in multiple wind turbine blade structures. These include both thin and thick fiberglass spar cap laminates and bond line interfaces. Figure 5-14 and Figure 5-15 show sample results produced by the OmniScan from the inspection of carbon laminate test specimens that contain engineered flaws. Damage in the parts are shown in the photos and schematics while the accompanying C-scan images show the ability of the inspection method and equipment to detect the flaws.

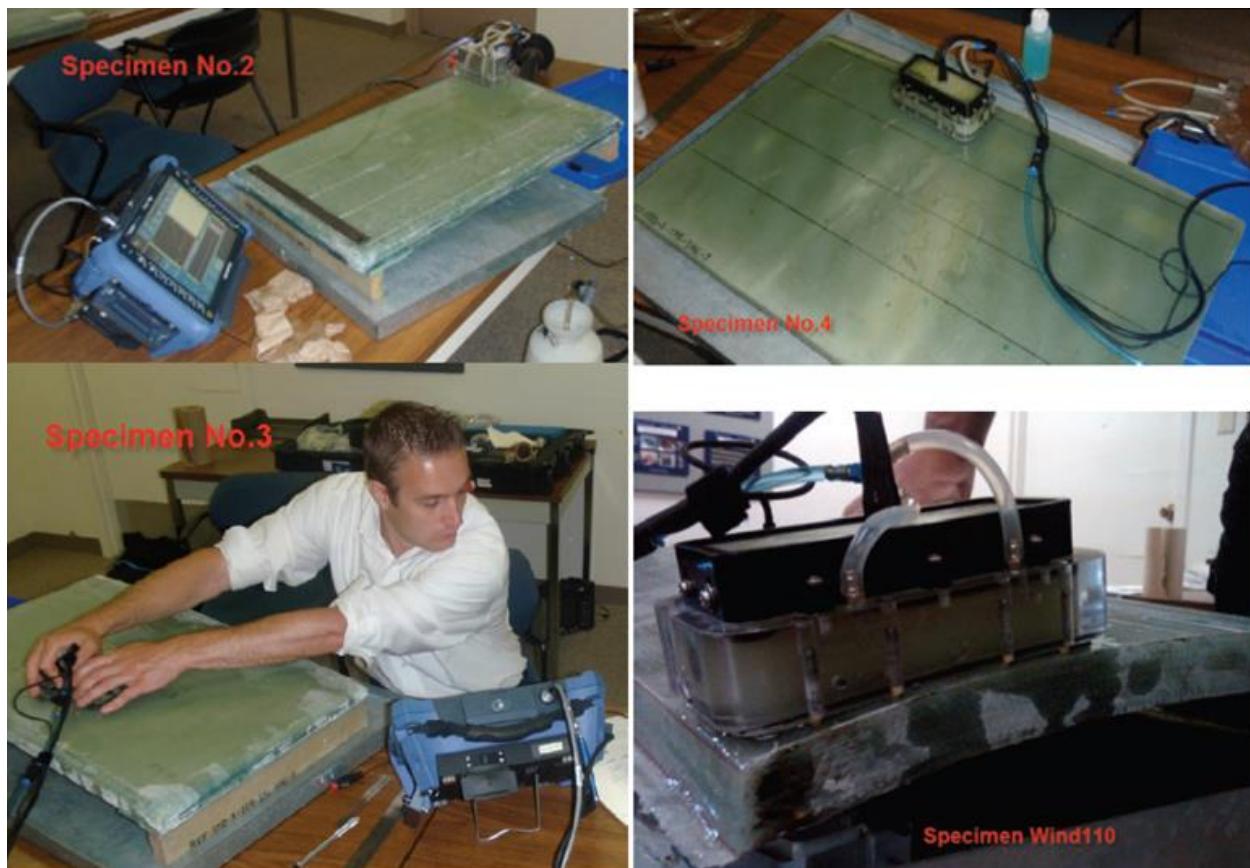
**Figure 5-12: Phased Array Probes and OmniScan Deployment on Wind Blade NDI Specimens**

Configuration 1 Large aperture	Configuration 2 Large Aperture	Configuration 3 Small Aperture
Probe	1.5L42 (XAAB-10011)	1.5L42 (XAAB-10118)	1.5L64-I4
Wedge	25mm water column (ABWX1875)	Contact wedge (ABWX1935)	Aqualene wedge (SNW1-0L-AQ25)
	Configuration 1	Configuration 2	Configuration 3
Probe Name	1.5L42	1.5L42	1.5L64-I4
Part #	XAAB-10118	XAAB-10011	1.5L64-I4
Housing	Custom	Custom	I4
Frequency	1.5MHz	1.5MHz	1.5MHz
Number of elements	42	42	64
Pitch	2.8mm	2.8mm	1mm
Elevation	26mm	26mm	7mm

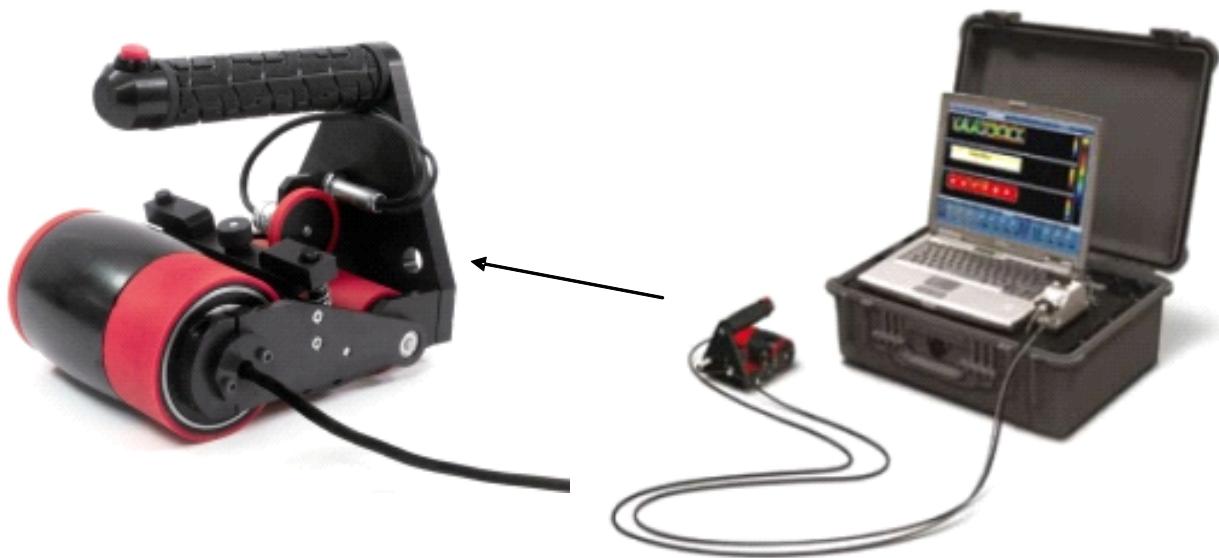
Sonatest RapidScan 2 - The RapidScan rolling array WheelProbe was developed by Sonatest and provides a capability for A, B and C-scan inspections. It uses a novel, rubber-coupled sensor array that provides rapid, wide area C-scan data in the field. Powerful gating and evaluation tools are used to ensure proper analysis of the ultrasonic signals. RapidScan 2, shown in Figure 5-27, operates in a pulse-echo mode suitable for inspecting medium to large areas. A water film coupling that can be sprayed onto the inspection surface is used to transmit the UT pulse and return signals from the rolling wheel and back to the linear array transducer housed within the wheel. Multiple scan strips can be assembled to produce images of entire structures such as the horizontal stabilizer image shown in Figure 5-28. The high resolution C-scans, such as those in the examples of Figure 5-29 through Figure 5-31, show time of flight and amplitude data. Both A and B-scans can be simultaneously displayed. The system includes a 128-channel multiplexing pulser/receiver module; data capture electronics and a standard PC laptop, housed in a low-profile plastic enclosure for easy portability. Array WheelProbes incorporate a 64 element linear array (50mm) or 128 element linear array (100mm) with 0.8mm resolution, and a high resolution position encoder. The array WheelProbe provides high quality, high resolution data. Current array probes are available in 1, 2, 5, and 10 MHz to provide a range of resolutions and depth of penetration in thick and highly-attenuative structures.

Figure 5-27: RapidScan UT Rolling Wheel Array Device

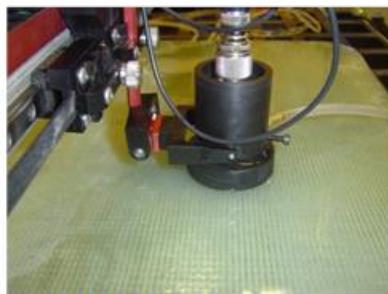
Flaw Depth =  
1.52"

1 MHZ 2" Focus Immersion  
Probe on MAUS V Pulse Echo  
UT Inspection

**Figure 5-40: Ultrasonic A-Scan Signals Highlighting Inspection Impediment Where Deeper Signals of Interest are Hidden Within Harmonics from Earlier Arriving Signals**

and enhanced signal strength at greater depths. The focused probe is normally used for immersion UT testing in a water tank. Thus, it had to be deployed in the “captured water column” shown in the Figure 5-39 schematic. It can be seen that the focused transducer is placed at some offset distance from the inspection surface. This is the height of the captured water column. In order to overcome the harmonics inspection impediment that is described above, a threaded housing was developed to allow the offset distance to be adjusted. The focused UT transducer can be moved within the housing to create the optimum offset distance that avoids placing signal harmonics on top of the true signals of interest. Figure 5-40 and Figure 5-41 show the threaded housing arrangement which allows for the operator to adjust the water column between the transducer and the inspection surface. Figure 5-40 also shows some sample A-scan signals from various depths within a test specimen. Peak return signals from the 1.4" and 1.52" depth flaws can be detected but the peak signal from the 1.65" depth flaw is hidden inside the signal harmonics (i.e. not detected).

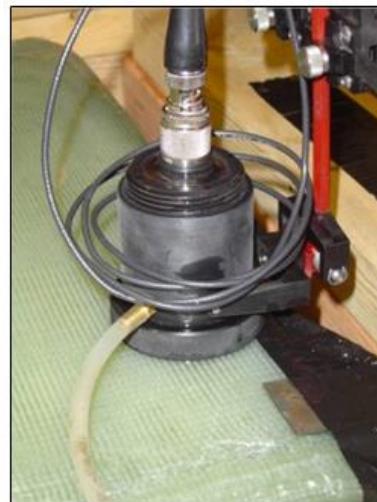
**Figure 5-41: Variation on Water Column Shoe that Includes a Threaded Housing to Allow for Adjusting the Length of the Water Path or Column Height (Patent Pending)**

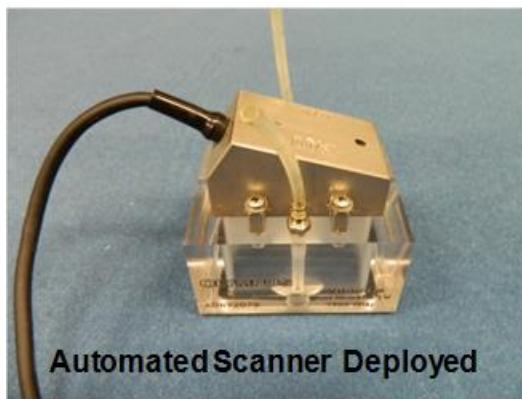
**Figure 5-48: PA-UT C-Scans of Fiberglass NDI Specimen Generated by Olympus 40mm Open Water Box 1.5L16 Probe on Automated Scanner**

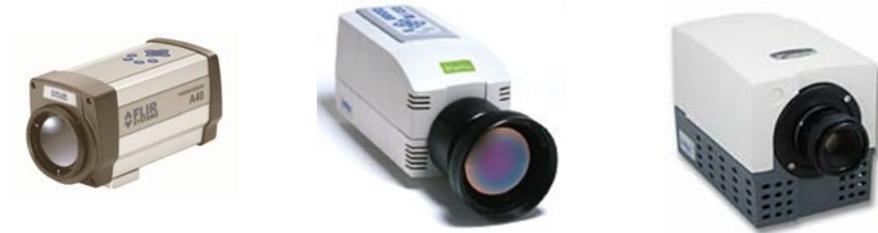
<u>A40</u>	<u>Merlin Mid</u>	<u>Phoenix</u>
<b>Detector Material:</b>	Vanadium Oxide (VOx)	Indium Antimonide (InSb)	Indium Antimonide (InSb)
<b>Detector Cooling:</b>	Uncooled Microbolometer	Integral Stirling or LN2	Integral Stirling or LN2
<b>Spectral Range:</b>	7.5-13 micron	3-5 micron	3-5 micron
<b>Thermal Sensitivity:</b>	0.08° C	0.025 °C	0.025 °C
<b>Focal Plane Array:</b>	320 x 240	320 x 256	640 x 512
<b>Frame Rate:</b>	60 Hz	60 Hz	30 Hz
<b>Weight:</b>	3.1 lbs	9 lbs	Camera: 7 lbs & RTIE: 6 lbs
<b>Size:</b>	8.2" x 4.3" x 3.6"	9.8" x 5.5" x 5.0"	Camera: 7.5" x 4.4" x 5.2"

**Figure 5-61: Comparison of Infrared Cameras for Thermography Inspection**

After presenting the thermography principles and equipment, it is worthwhile to discuss some specifics on the critical component: the infrared camera. An infrared camera is a non-contact device that detects infrared energy (heat) and converts it into an electronic signal, which is then processed to produce a thermal image on a video monitor and perform temperature calculations. Heat sensed by an infrared camera can be very precisely quantified, or measured to monitor thermal performance, as well as to identify and evaluate the relative severity of heat-related problems. Recent innovations, in particular detector technology, the incorporation of built-in visual imaging, automatic functionality, and infrared software development, deliver more cost-effective thermal analysis solutions. A brief comparison of some infrared cameras used for thermographic inspection systems is provided in Figure 5-61.

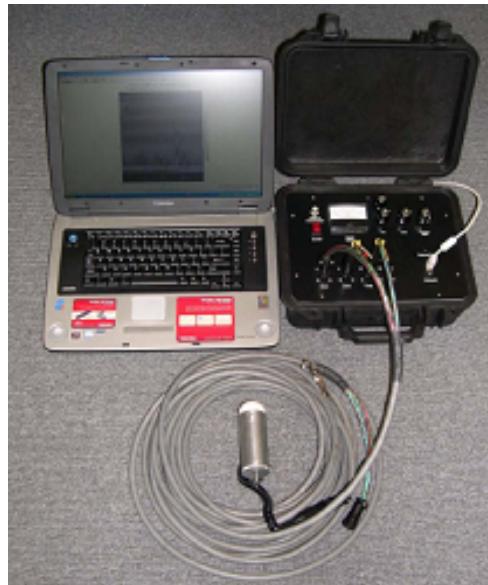
**Figure 5-68: Basic Equipment Set-up for Microwave Inspection**

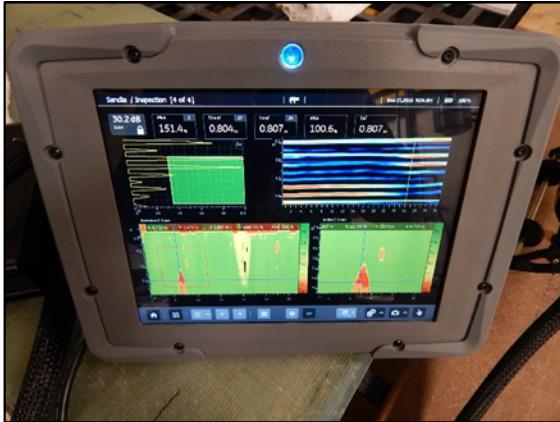
**GE Mentor UT System**

Figure 6-75 and Figure 6-76 show the GE RotoArray device, described in detail in Chapter 6, deployed on a wind NDI test specimen. Results contained here were obtained from the 1 MHz and 500 KHz RotoArray rolling wheel transducers connected to either the GE equipment shown in Figure 6-74 or the OmniScan pulser and data display device described earlier.

It should be noted that, at the time of this experiment, the Mentor UT System could only fire 32 elements. This is going to 128 elements GE indicates that around the publication date of this report, the Mentor UT control device will be able to control and properly take data from a 128 element UT array. Also, it was not possible for the GE equipment to complete the POD experiment at this time so only a preliminary evaluation could be completed on the GE PA-UT method deployed with a rolling wheel transducer.

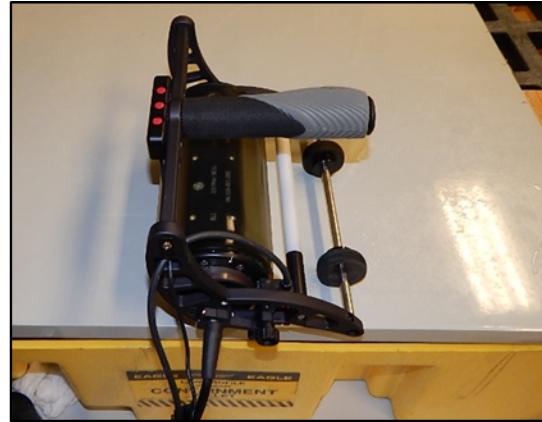
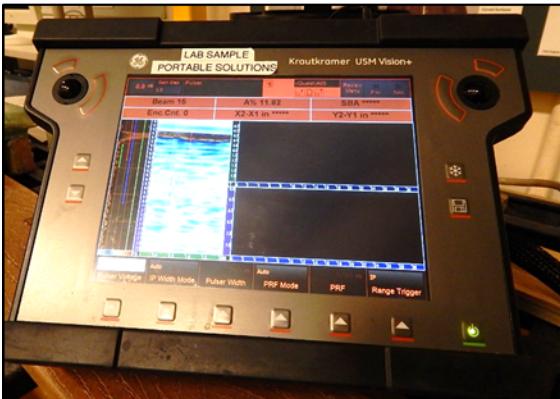
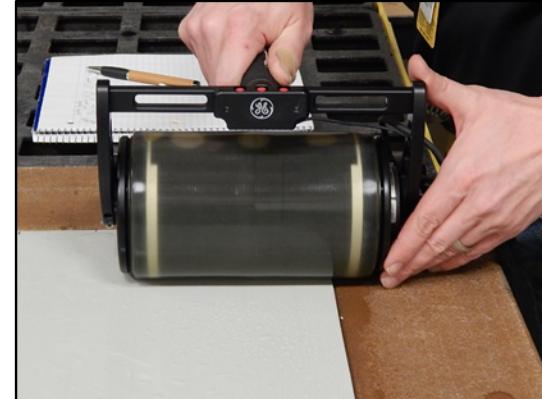
**Figure 6-74: GE RotoArray Rolling Wheel Phased Array Transducers and Associated UT Equipment Deployed in Trail Mode for Preliminary Evaluations**

**GE RotoArray  
(500KHz, 60 Elements)**

**GE USM Vision +**

**1 MHz GE RotoArray  
(1 MHz, 64 Elements)**

The GE RotoArray system was applied to several of the Sandia Labs Wind Test Specimen Library including the WBFDE POD panels. Figure 6-74

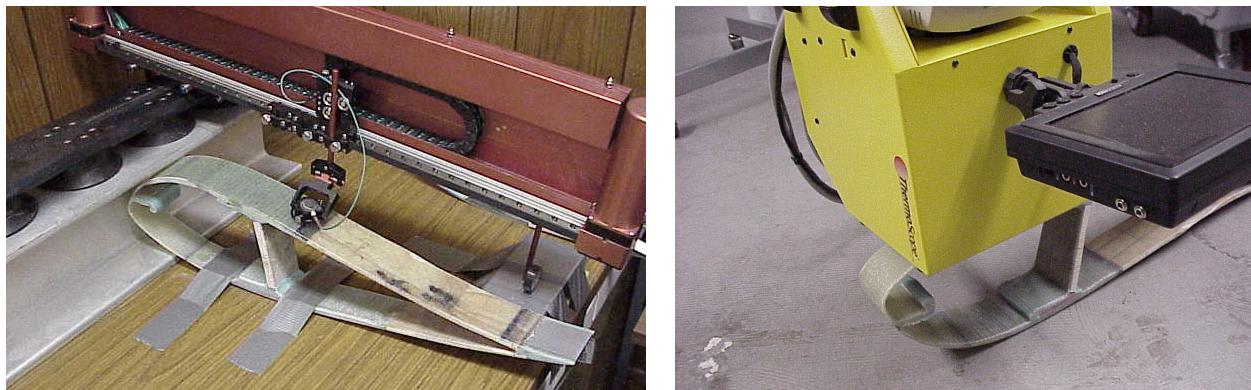
**Figure 6-82: Wind Blade Section Containing Engineered Damage and Pulsed Thermography System (right) Deployed on Blade for Inspection**

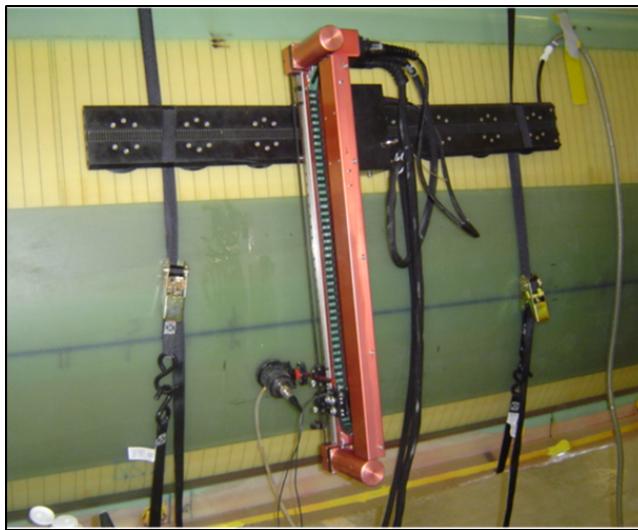
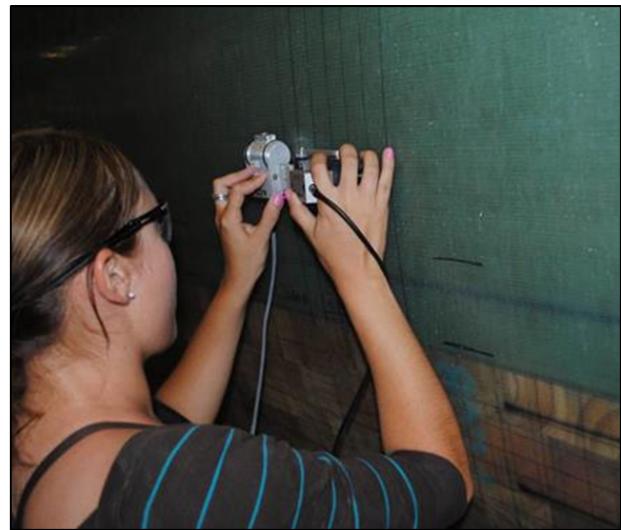
**Figure 6-116: Blade Inspections on Factory Floor - MAUS V Scanner Deploying UT Single Element Focused Probe (left) and Inspector Practicing a Shear Web Bond Line and Spar Cap Inspection Using Phased Array Transducer with Linear Position Encoder (right)**

Inspections were performed at the same time in the fabrication process as when the blades are typically inspected. The majority of inspection time was focused on inspecting the critical shear web to spar cap bonded joints on fully assembled blades. The scanner was set up and multiple gate settings were tested to obtain optimum scans. The width of the bond was determined using the adhesive “squeeze out” on each side of the bond line and was differentiated from the web bond interface itself as shown in Figure 6-117. The adhesive paste squeeze-out on either side of

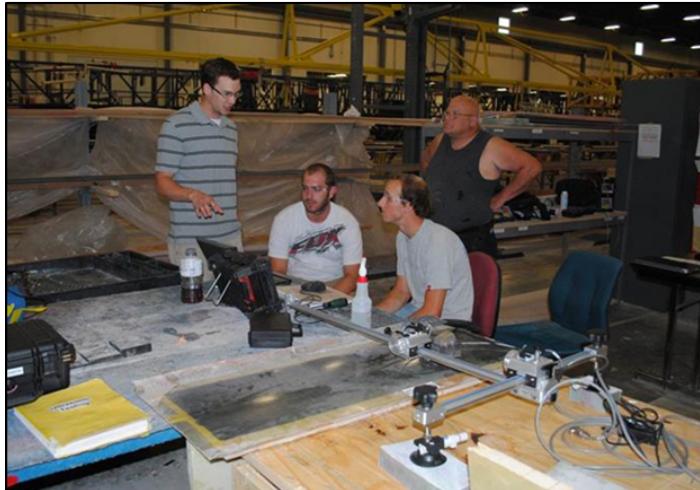
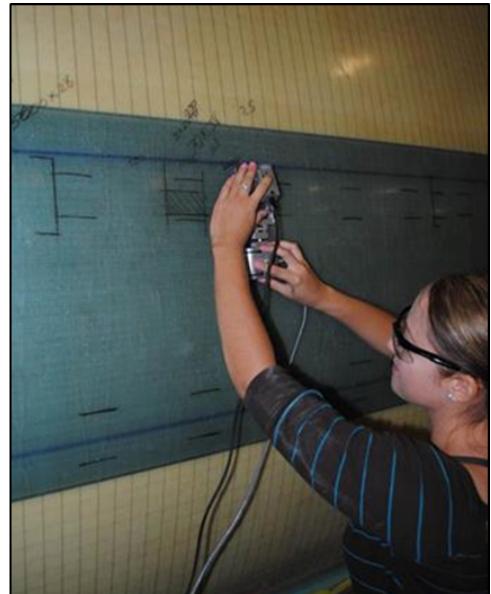
**Figure 6-120: Hands on Equipment Introduction Being Presented to Blade Inspectors and an Inspector Completing a Trial of Phased Array Inspection Process**

The second part of the inspector training was the hands-on portion where the inspectors were able to use the phased array hardware. This part of the training involved using the OmniScan with the phased array probe, linear encoder and custom designed sealed water box on various fiberglass and carbon samples. In this part of the training the inspectors were able to perform scans on actual wind blade parts and on blades during the manufacturing process. Figure 6-120 shows the hands on portion of the training being conducted with three inspectors and an inspector practicing using the phased array equipment on a fiberglass spar cap.
