Wellbore Seal Repair Using Nanocomposite Materials

Project Number DE-FE0009562

University of New Mexico

U.S. Department of Energy
National Energy Technology Laboratory
Carbon Storage & Oil & Natural Gas Technologies Review Meeting
August 16-18, 2016

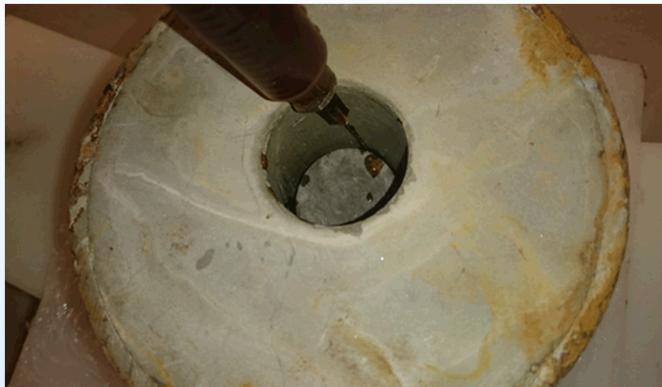
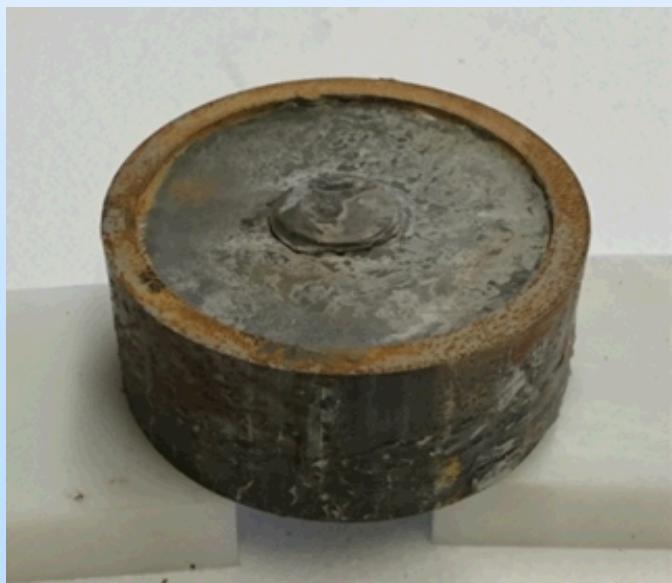
Push-out tests evaluated bond strength between shale and repaired shale-cement interfaces.

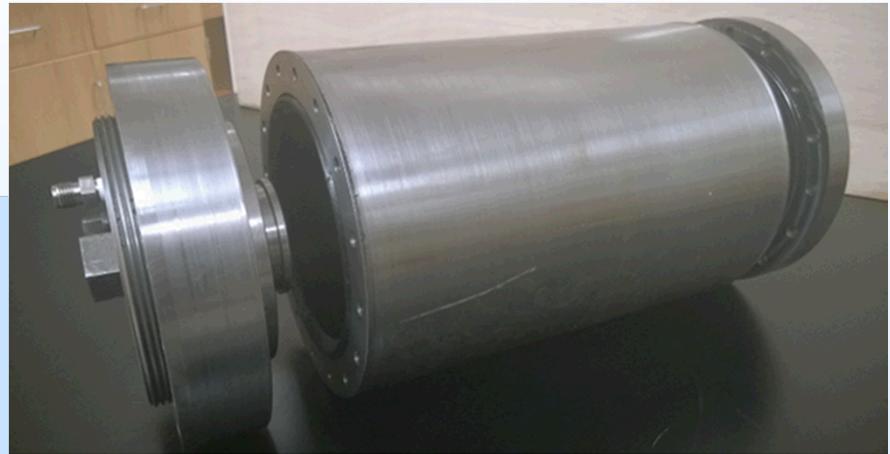
Pressure vessel

Independent control of
confining pressure to
30 MPa and casing
pressure to 20 MPa.

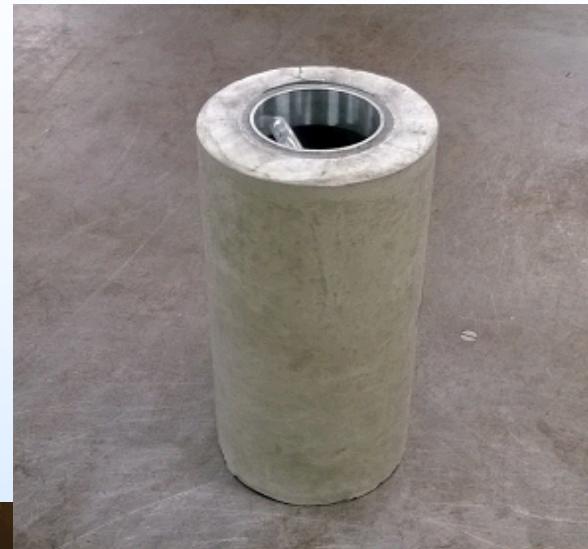
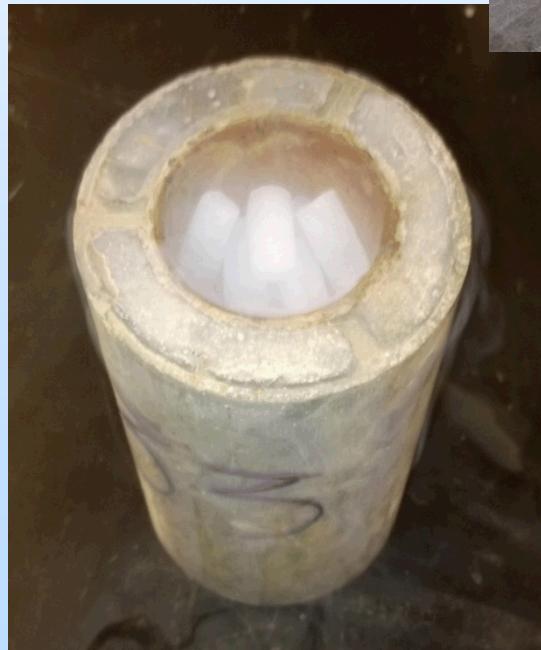
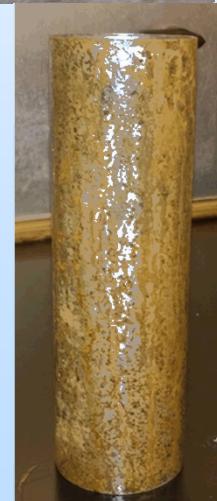
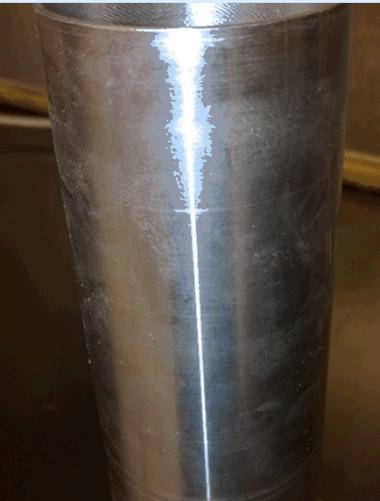
Specimen preparation

- Microannulus
 - Large
 - Small
- Cement fracture

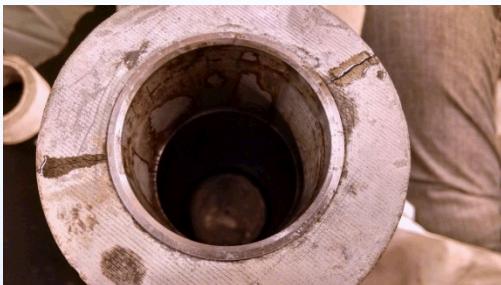
1. No pressure

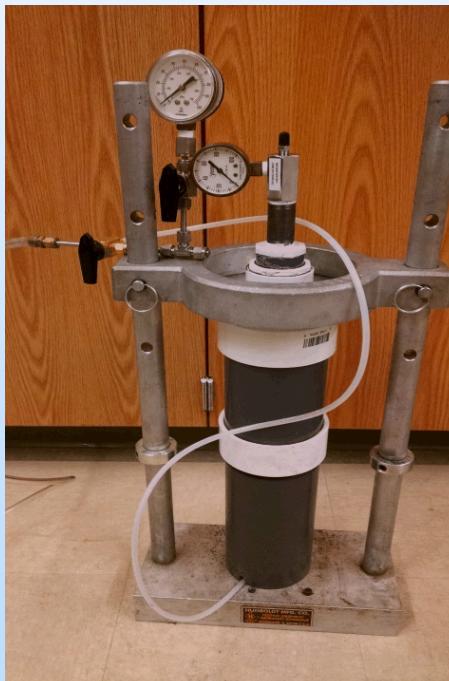
2. Separate pressurized system

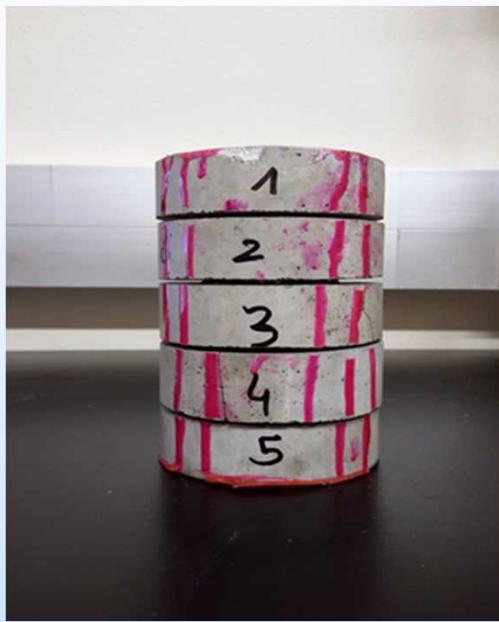
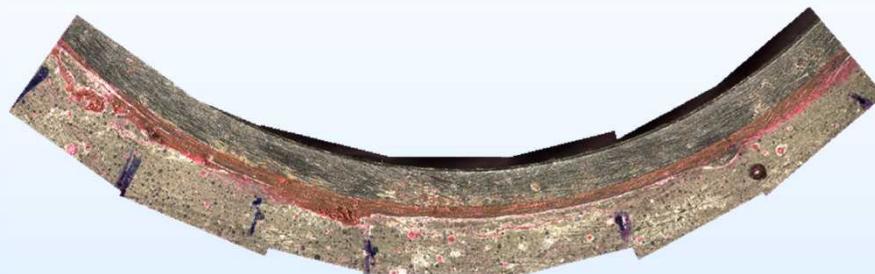
Image analysis of microphotographs to obtain microannulus aperture distribution.
