# Influence of corrosion on dynamic tensile properties of stainless steel

Eric Hicks

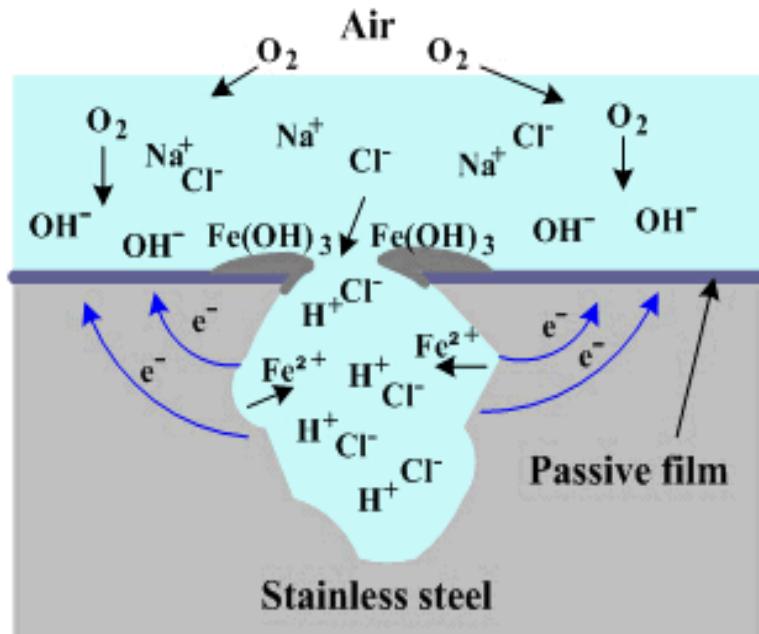
- Pitting is the most common
- Difficult to measure & detect
- Pit acts as anode
- Surface acts as cathode
- Causes material to fail much sooner
- Measured by mils/year corrosion rate
  - Speed at which a metal deteriorates in a specific environment.

## Pitting corrosion

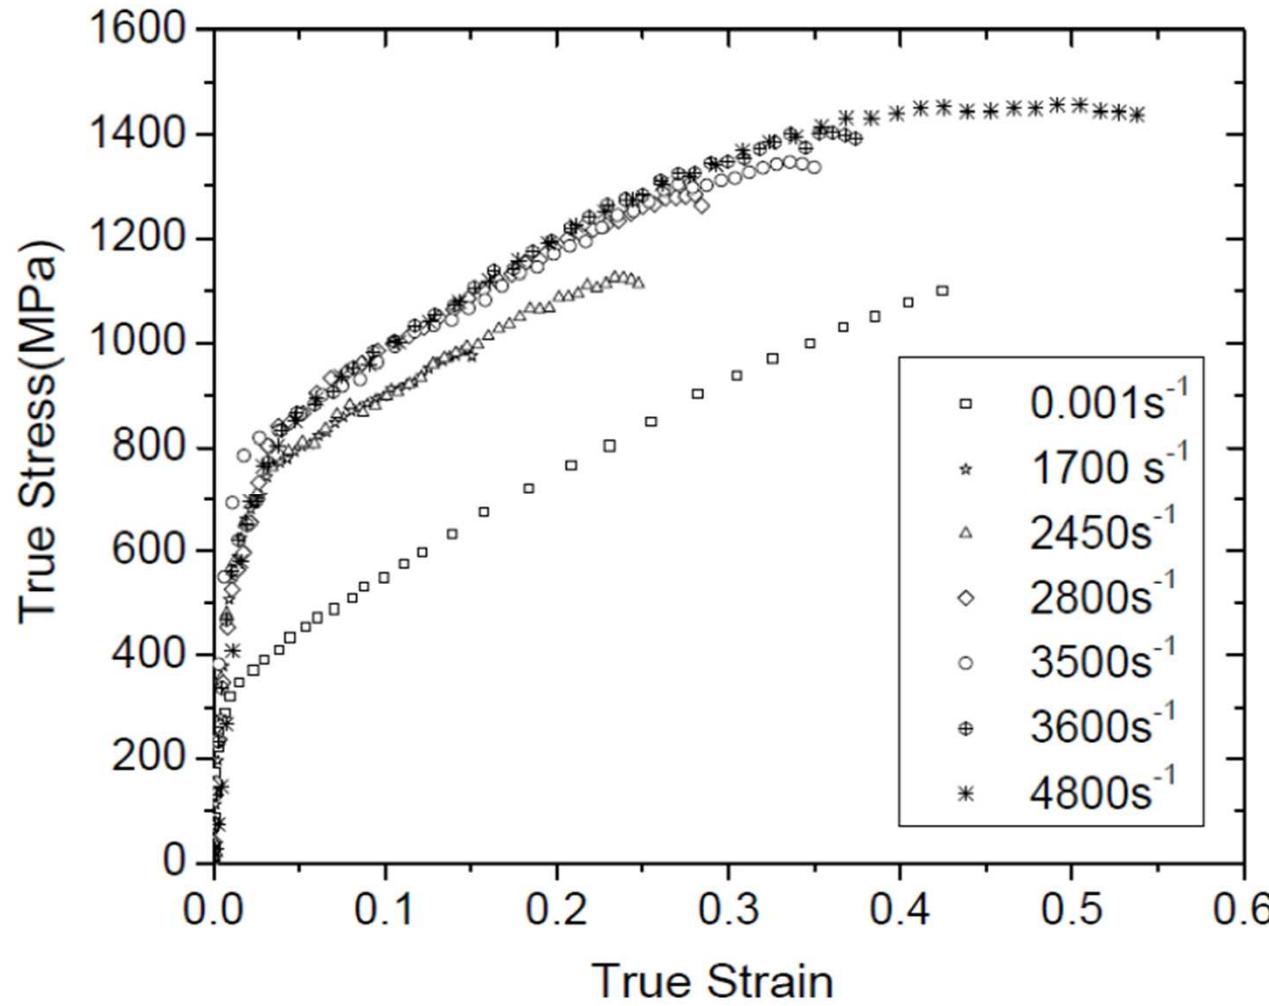
- Increased failure strength with increased strain rate

Mechanical Behavior of SS 304 LN at High Strain Rates in Compression, SEM (Sumit V Prasad, 2012)

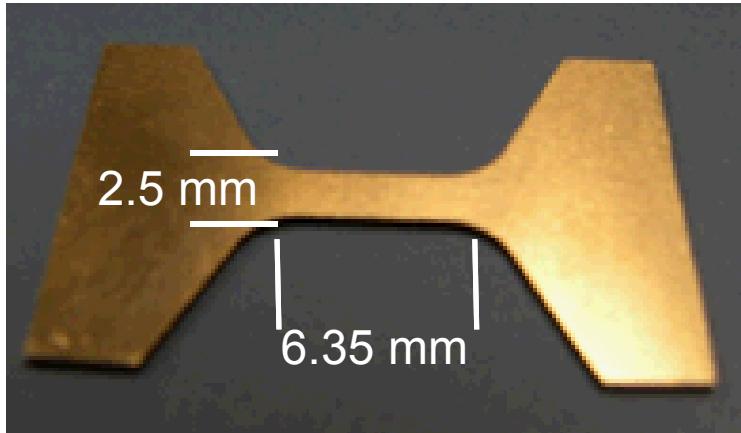
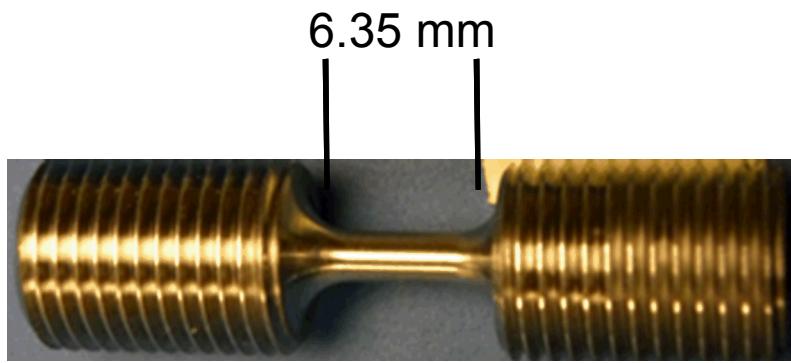
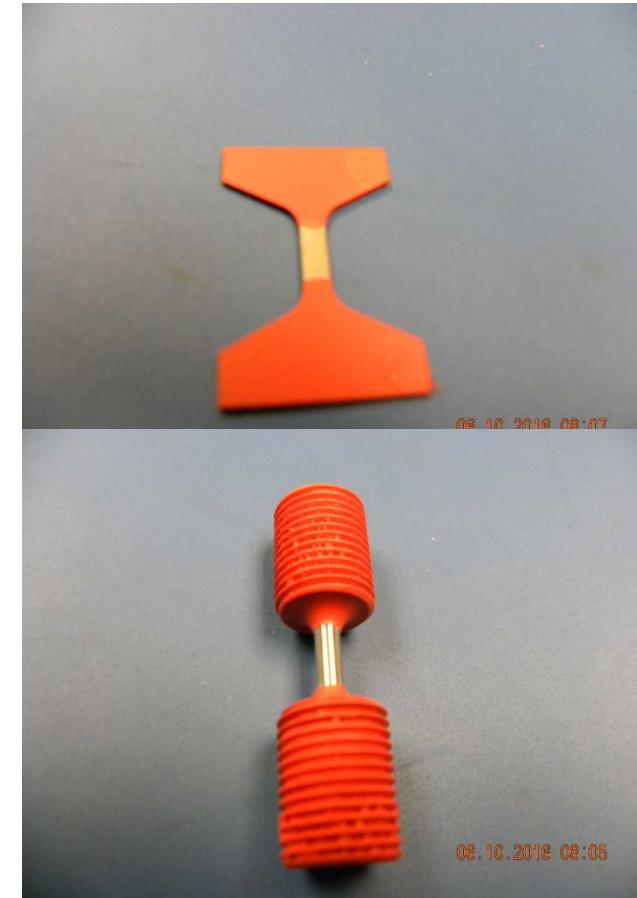
- 304 stainless steel flats??????
- 304L cylindrical specimens
- Rubber coating used to protect specimen ends

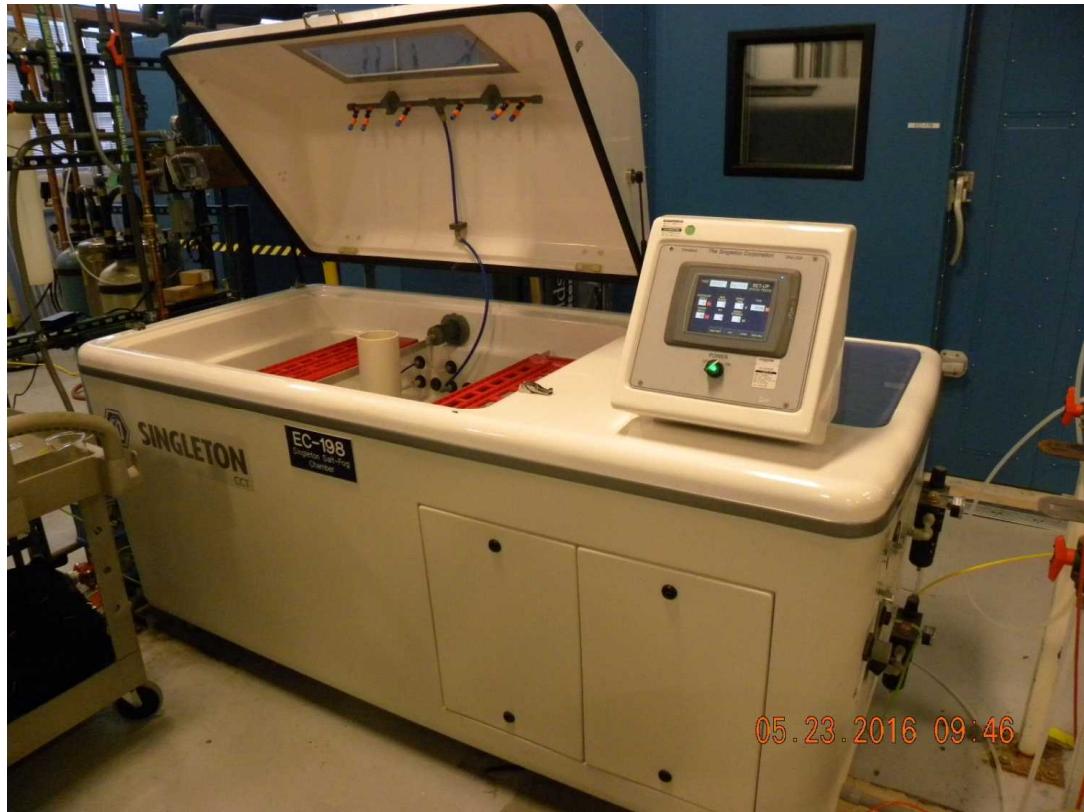
- Singleton Cyclic Chamber
- 5% solution salt-fog cycle
- ASTM B117 standard
- Constant exposure
- 7 & 14 day increments

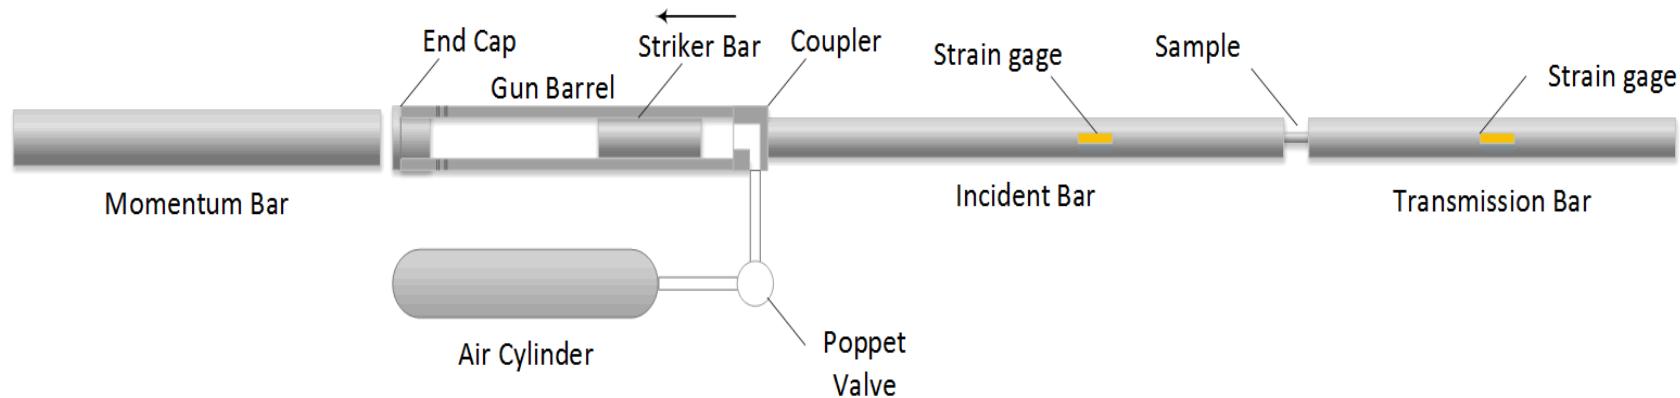
Momentum  
Trap

- Kolsky (Split-Hopkinson) bar
- Compression or tension
- Strain rates from 500 to 10,000 per second
- Developed in 1949

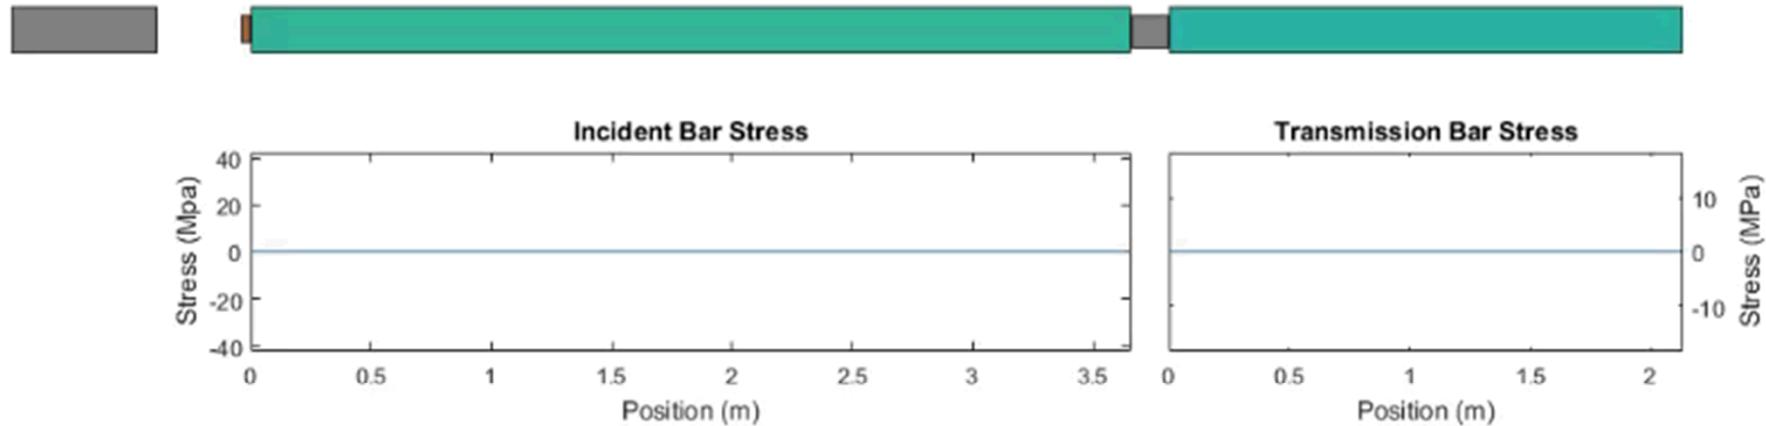
# Compression Test Example

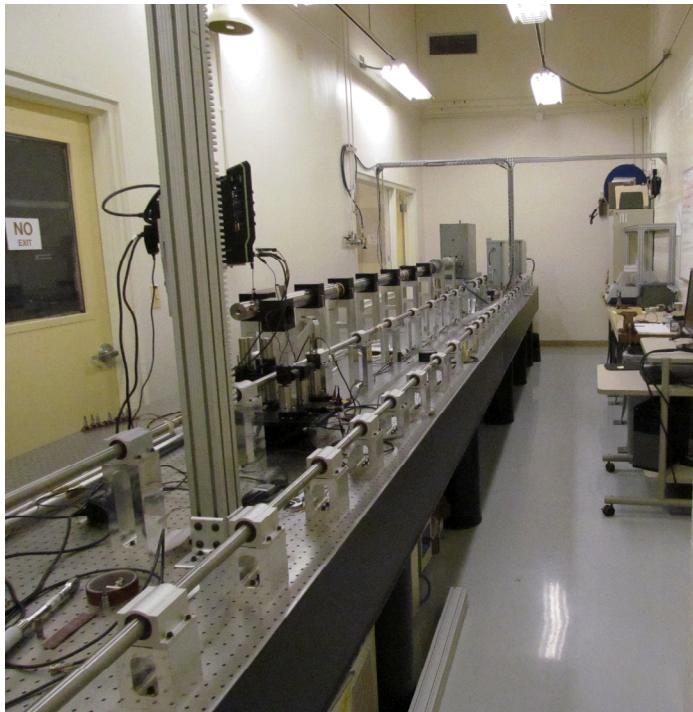
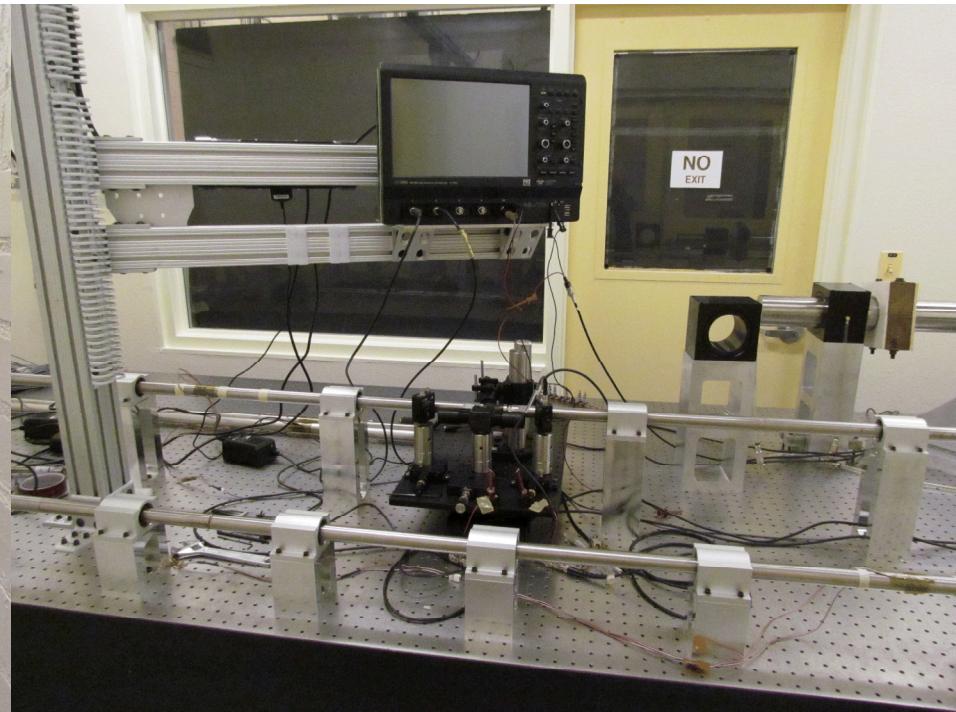
# Kolsky Bar Lab @ Sandia

- 1" Tension and compression bars
- 3" Compression bar

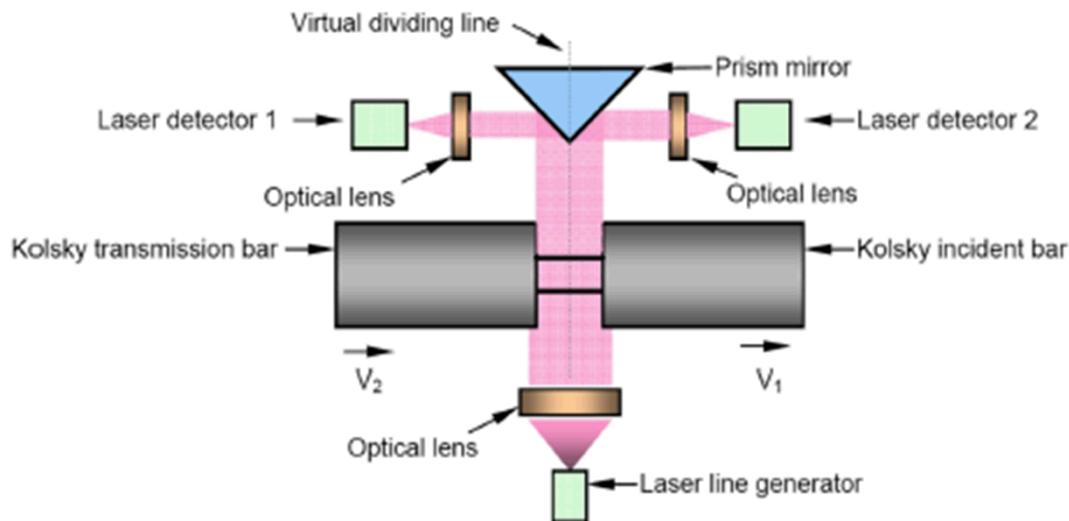
# Laser Based Strain Measurements

- Independent source of strain measurement
- Reflected wave strain measurement is not as accurate
- Calibration needed before ever session
- Correction factor needed

$$c' = \frac{\Delta L_s}{\Delta L + \Delta L_s} = 0.62$$

$$\varepsilon_s = c' \frac{L_1 - L_2}{\text{Gauge Length}}$$

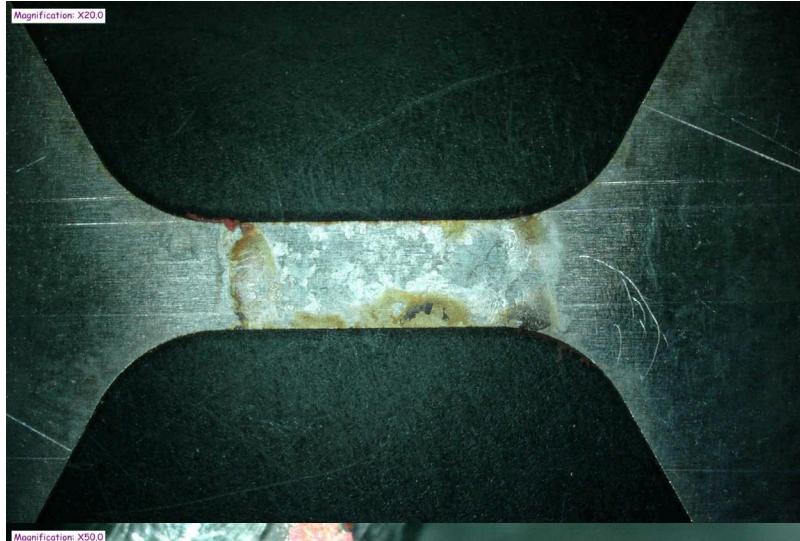
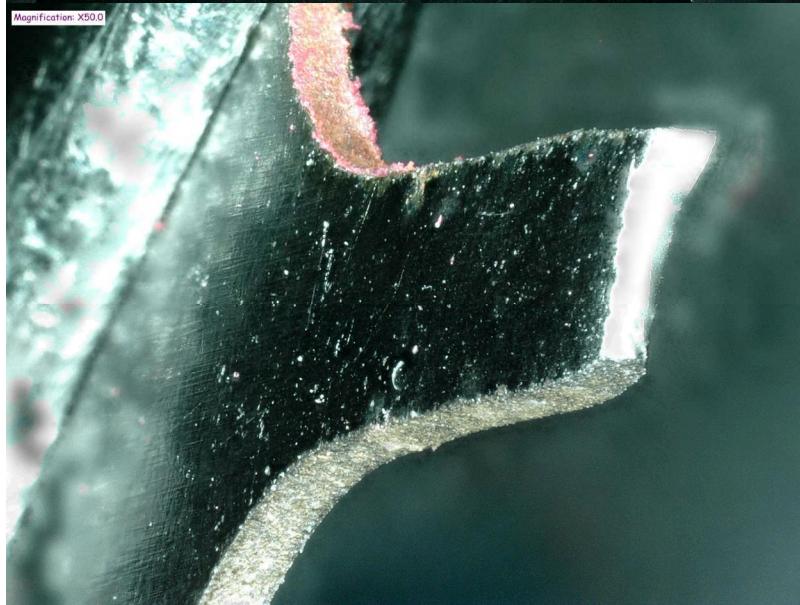
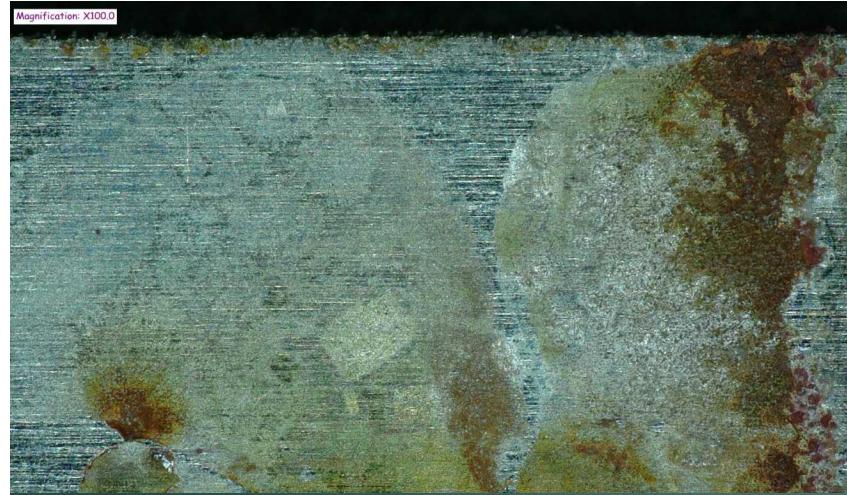
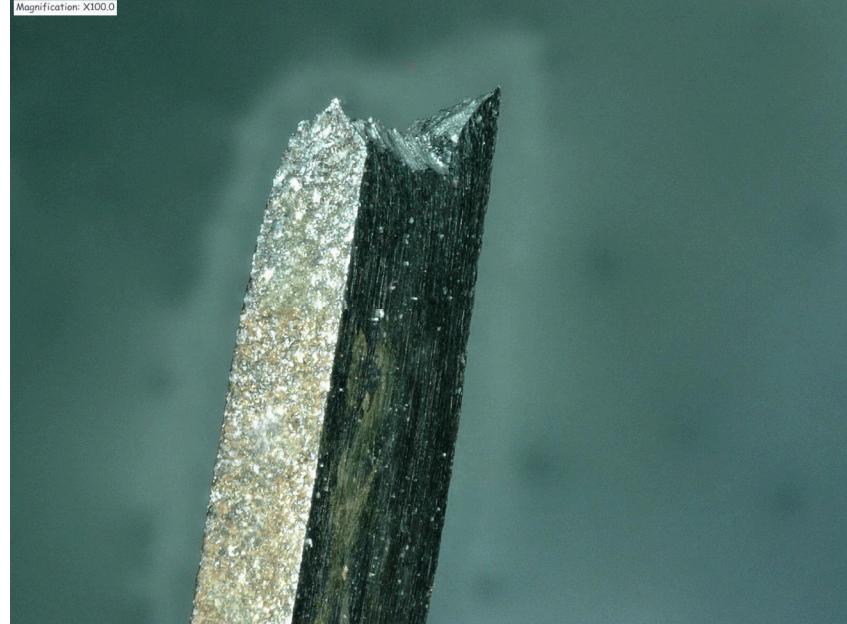
# Post Salt-Fog – 7 days

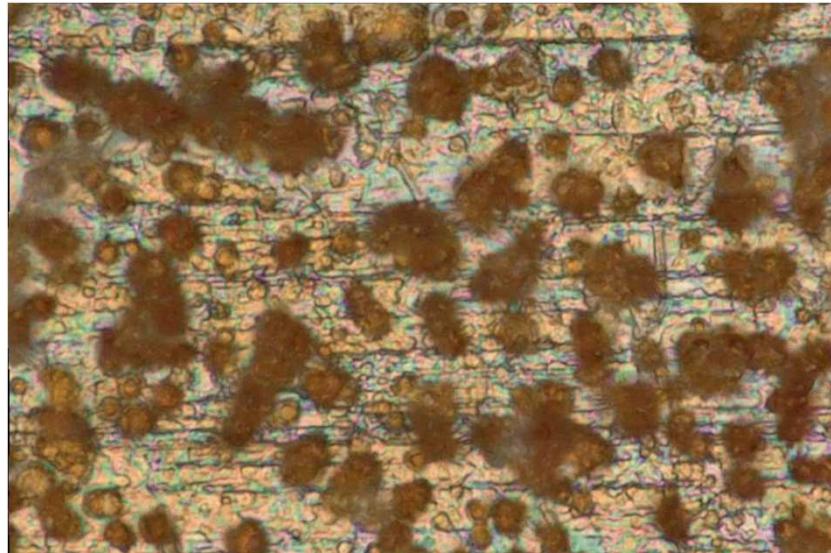
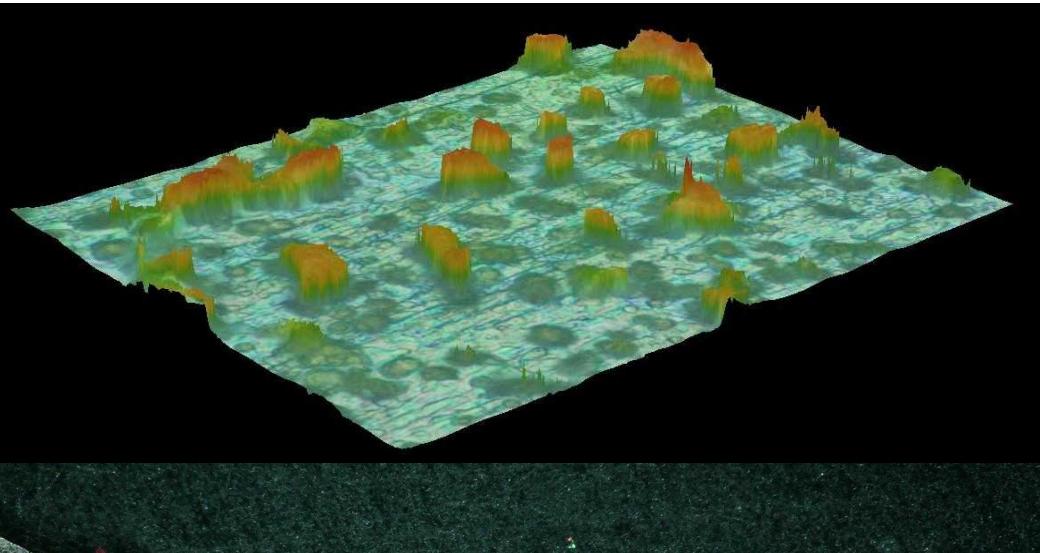
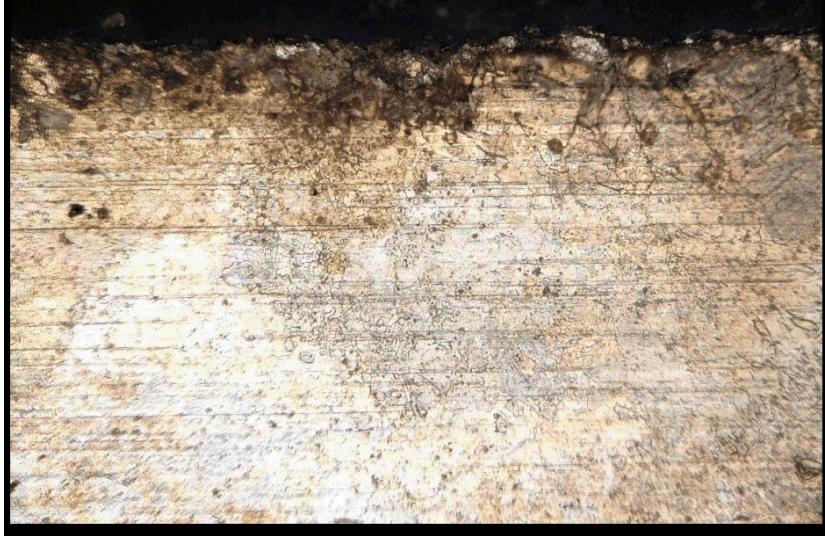
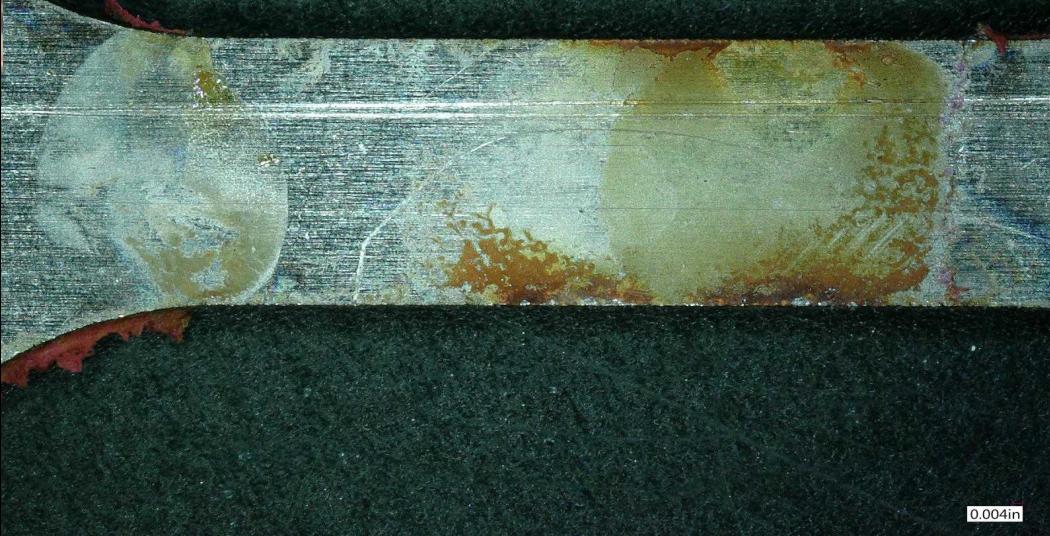
# Post Salt-Fog – 14 days

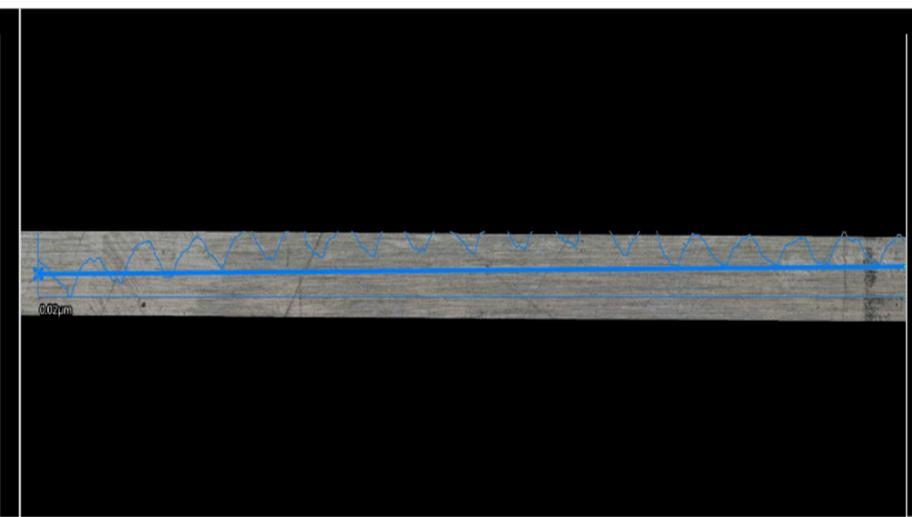
Surface profile (Pre salt-fog)

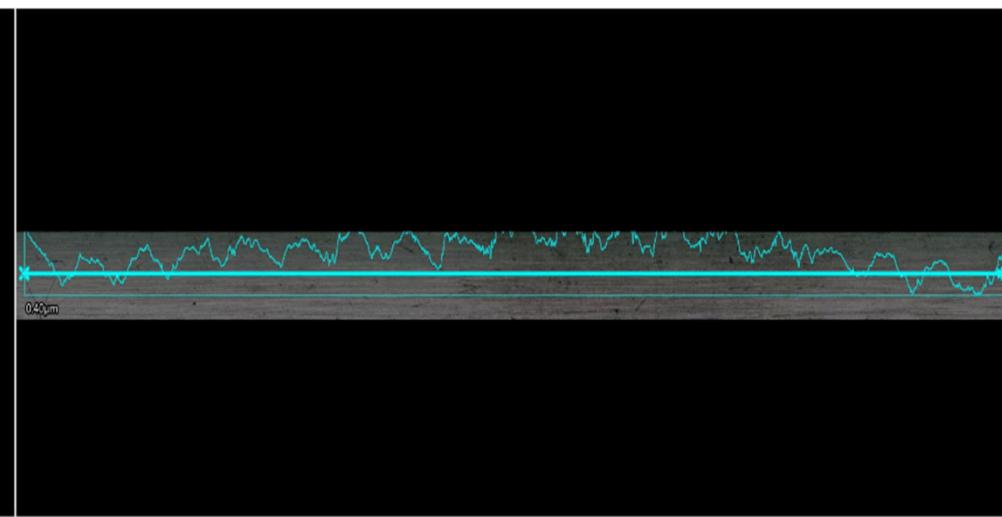
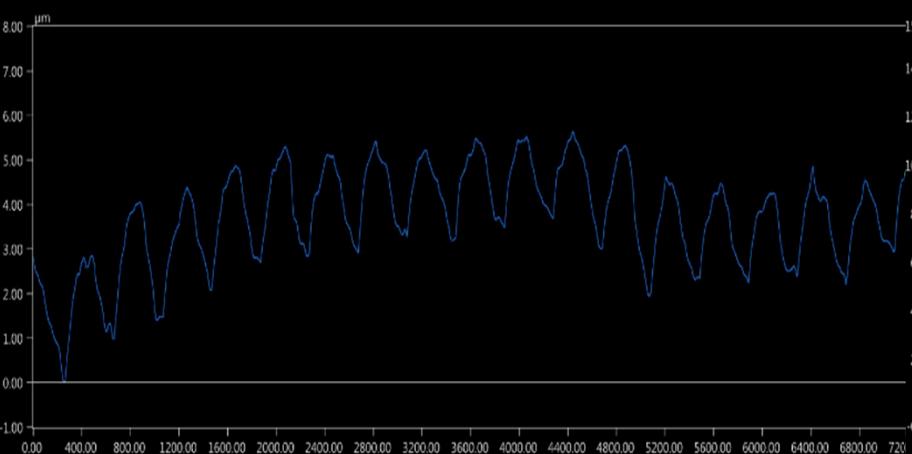
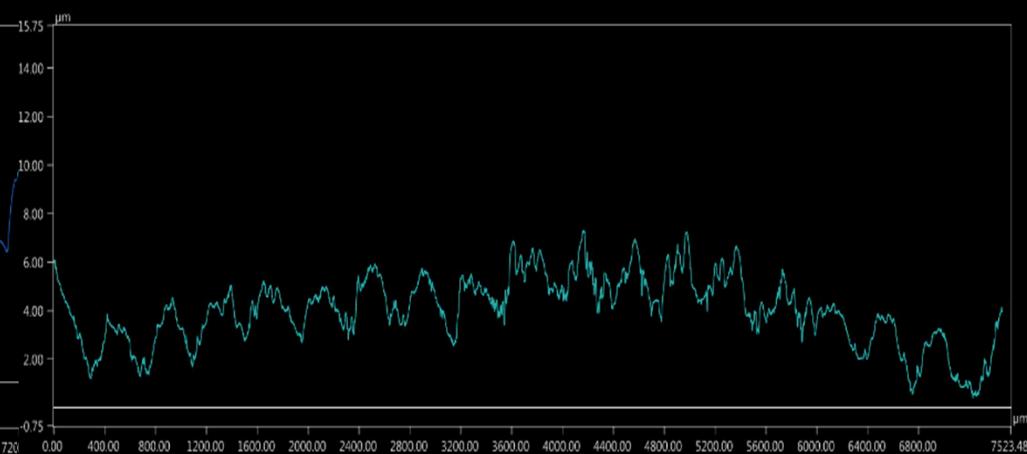
Surface profile (post 14 days of salt-fog)

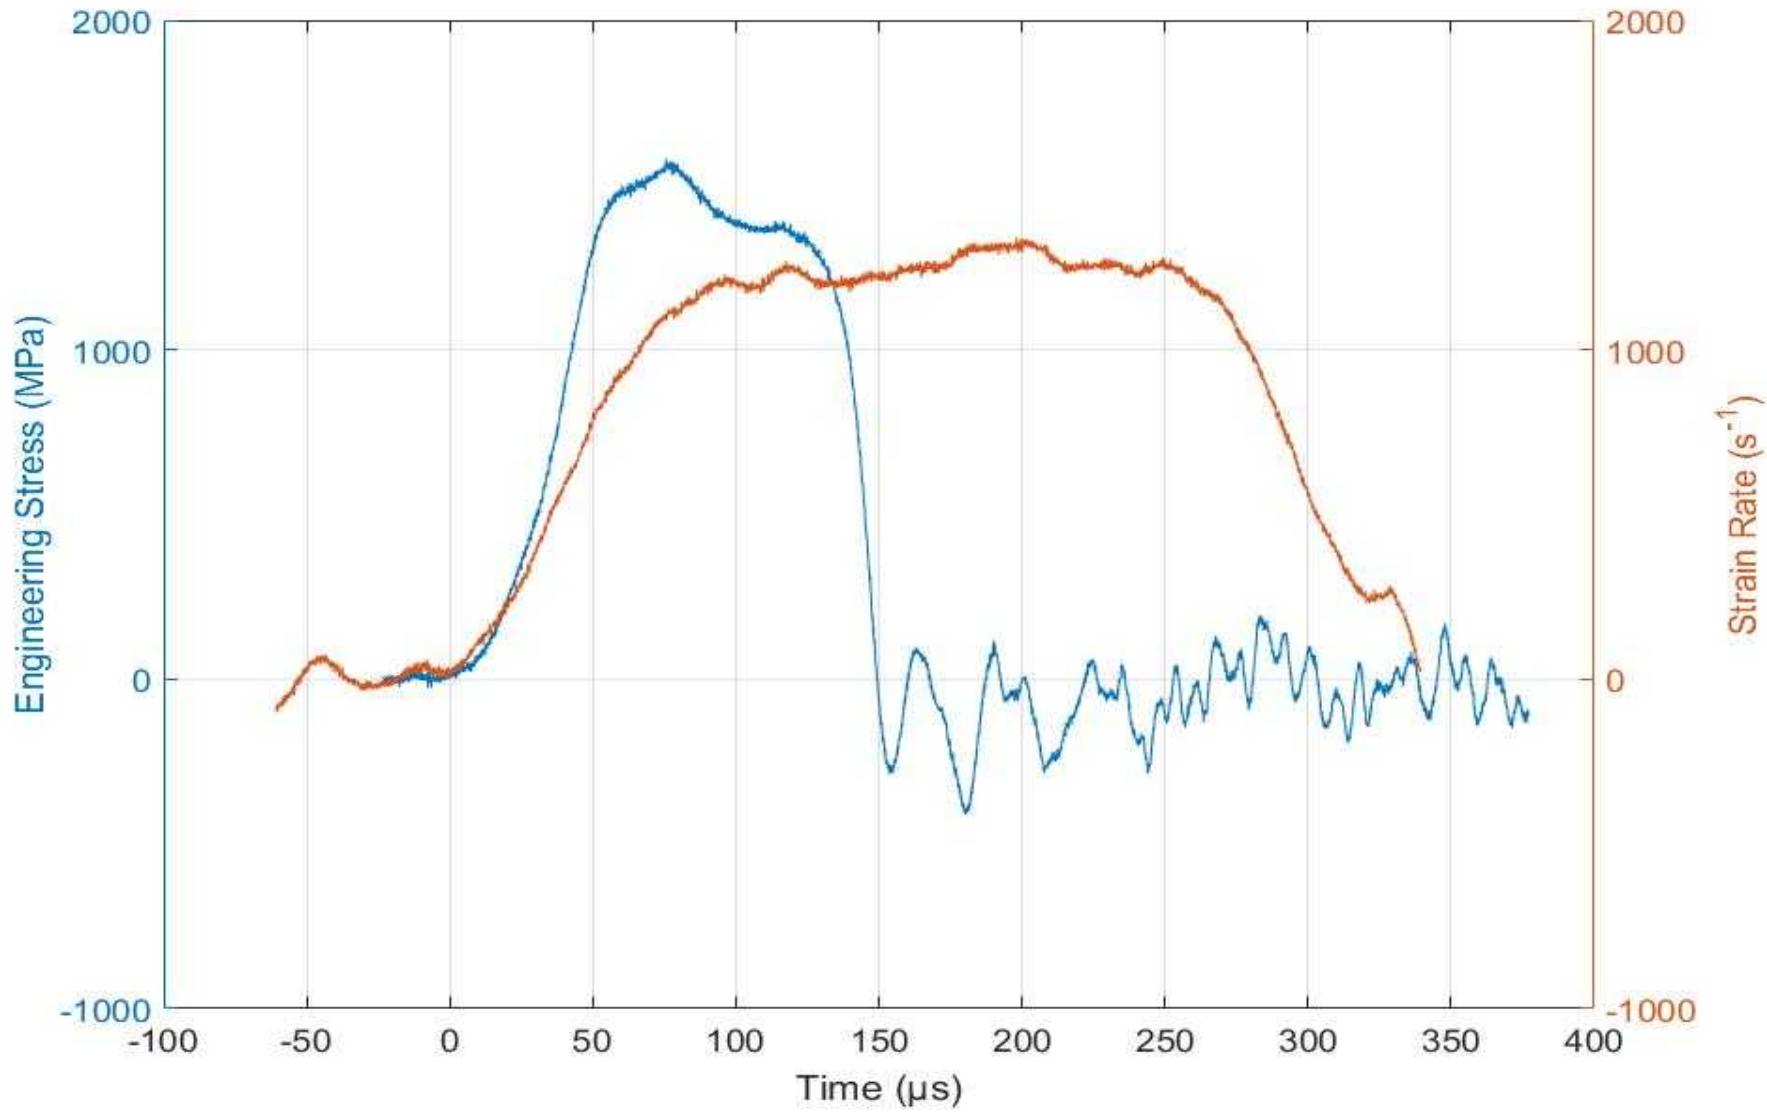
# Constant Strain Rate

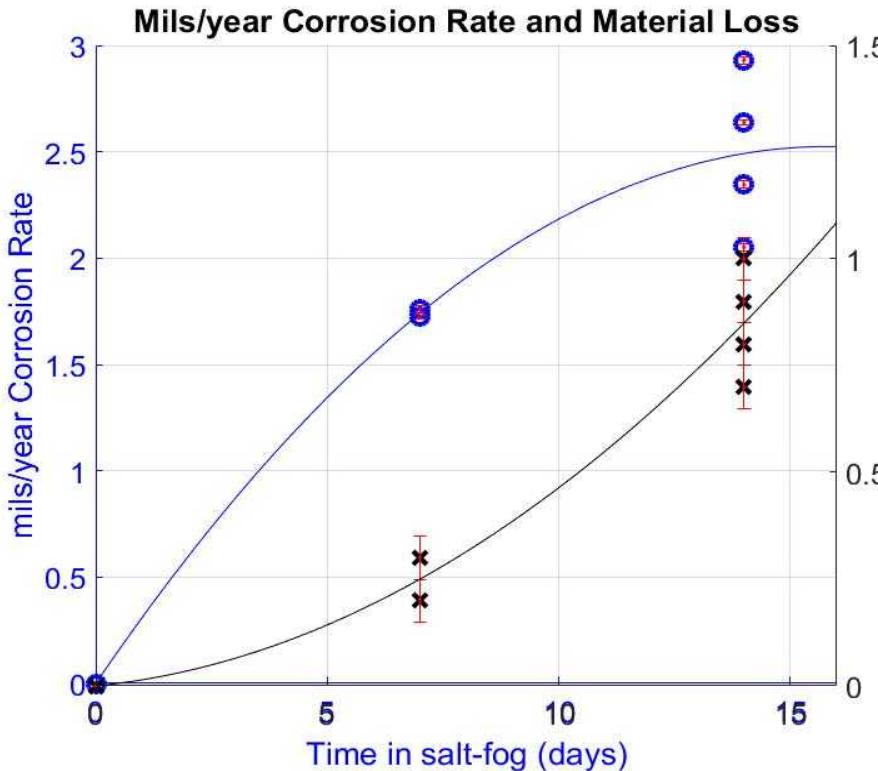
- Mass loss is consistent
- Longer time duration needed

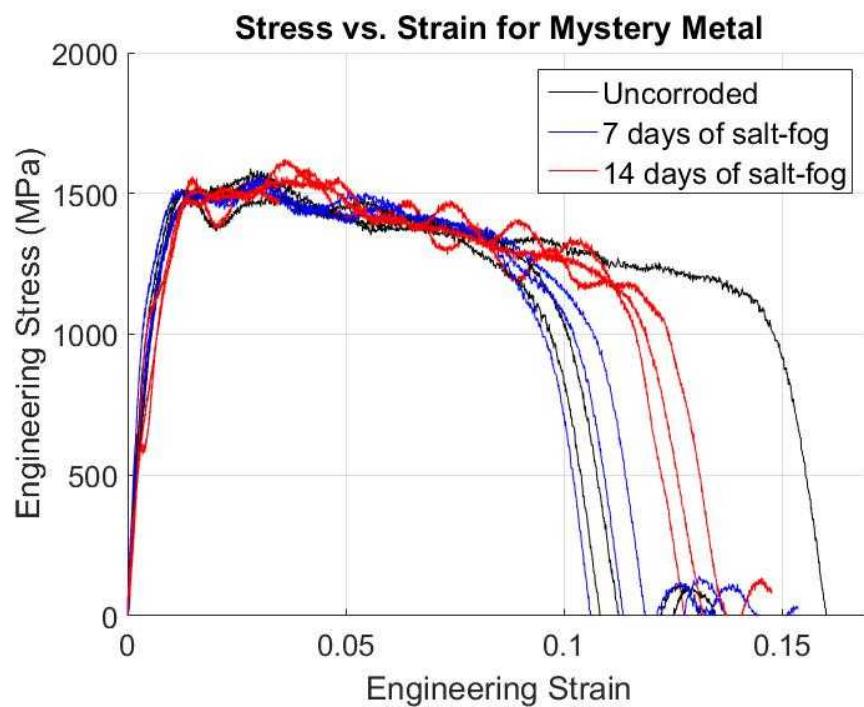
- Failure Strength = 1500 MPa
- Failure Strain = 10 – 15 %

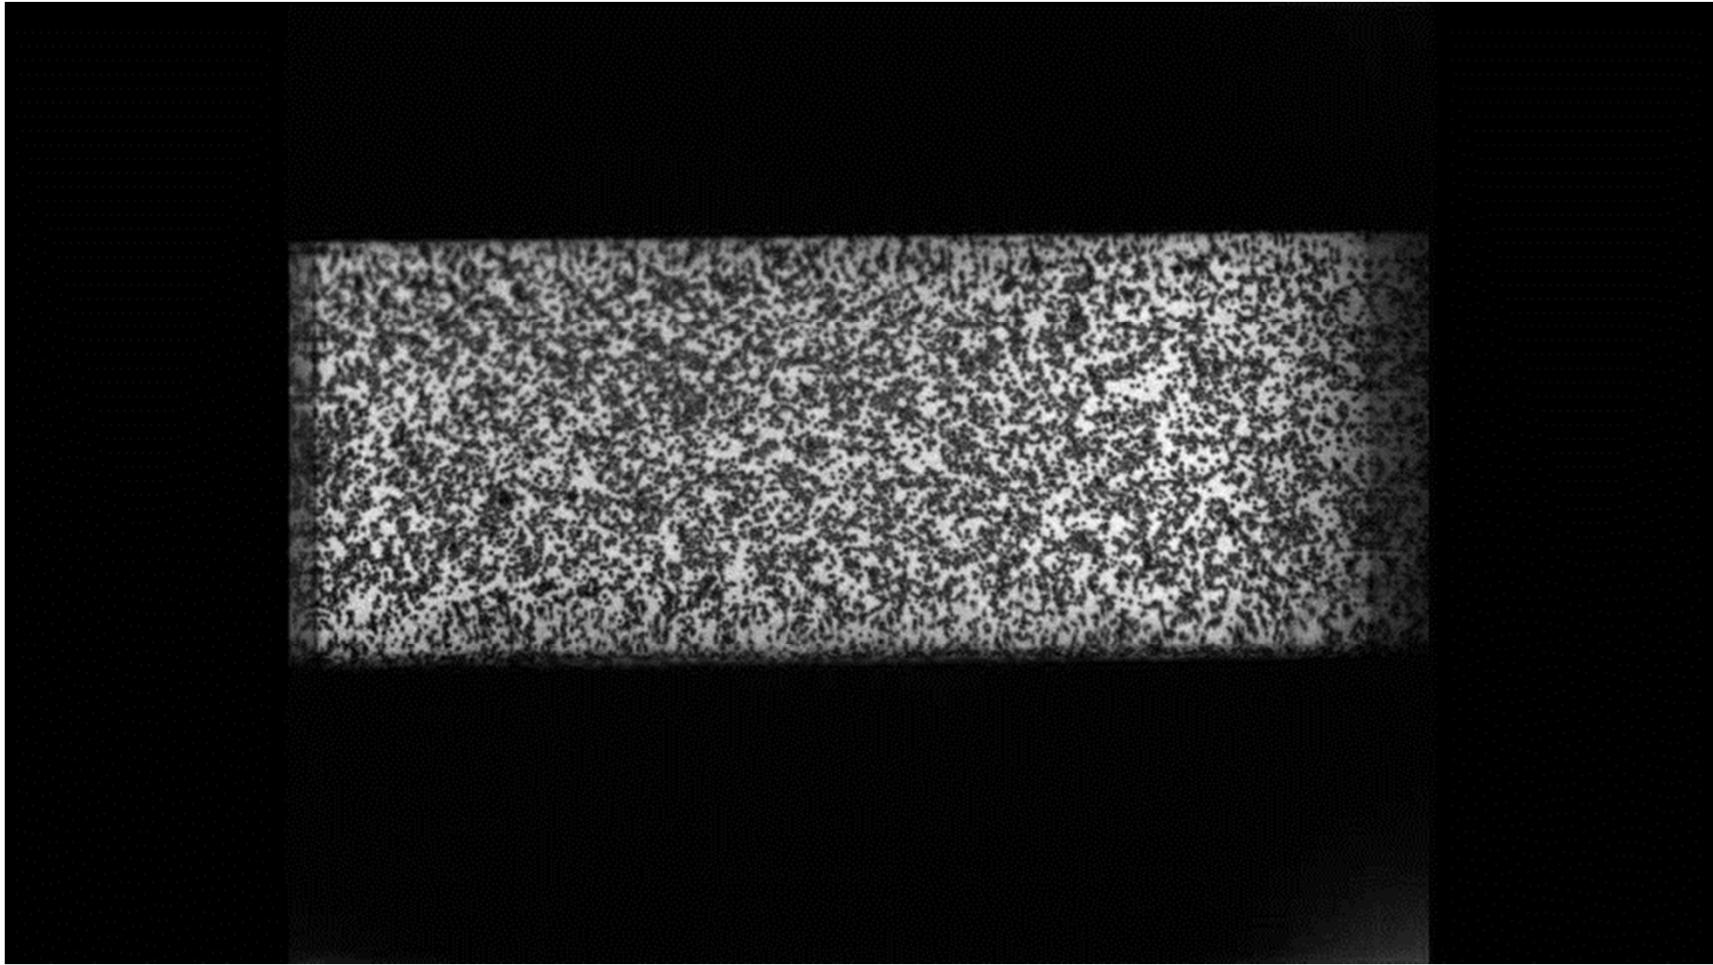
# Digital Image Correlation (DIC)

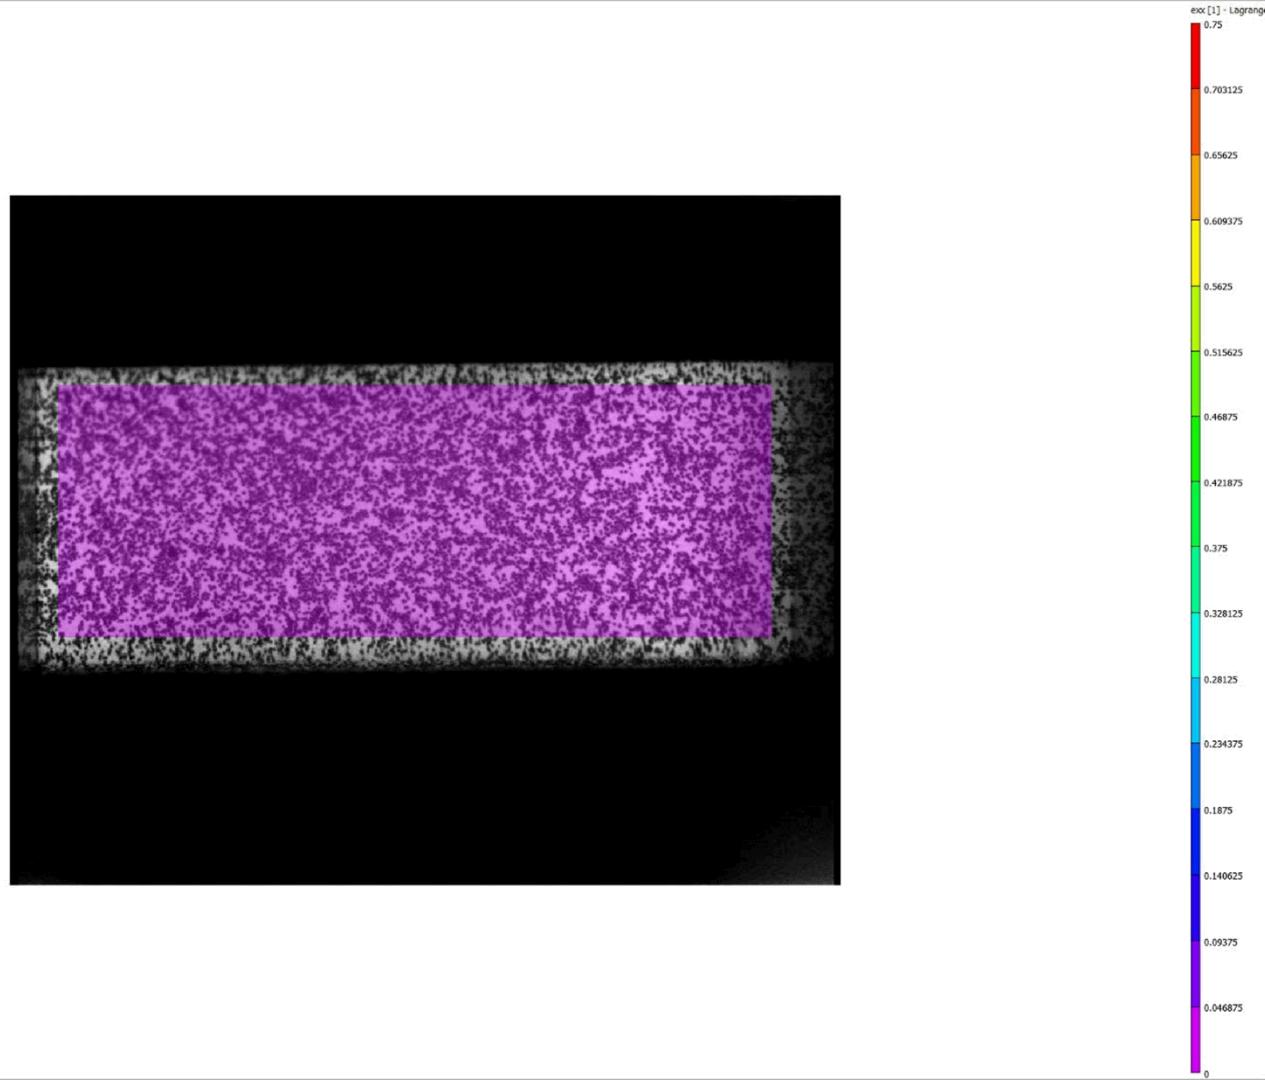
# Digital Image Correlation (DIC)

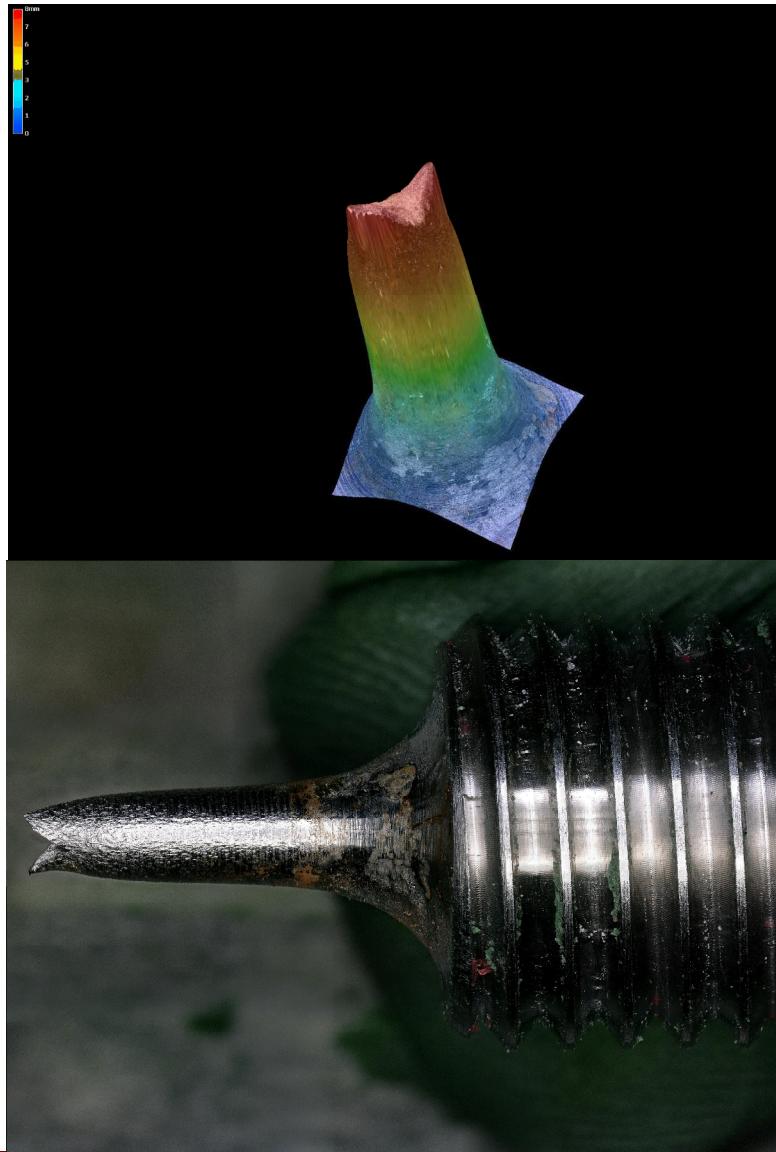
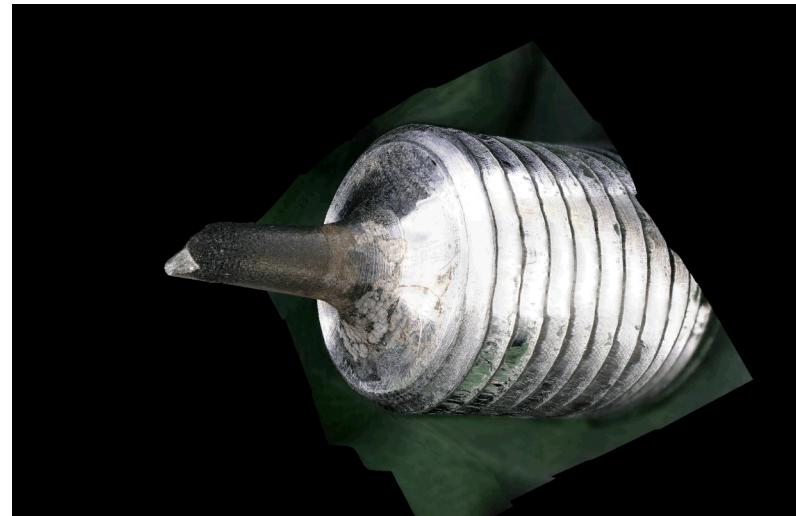
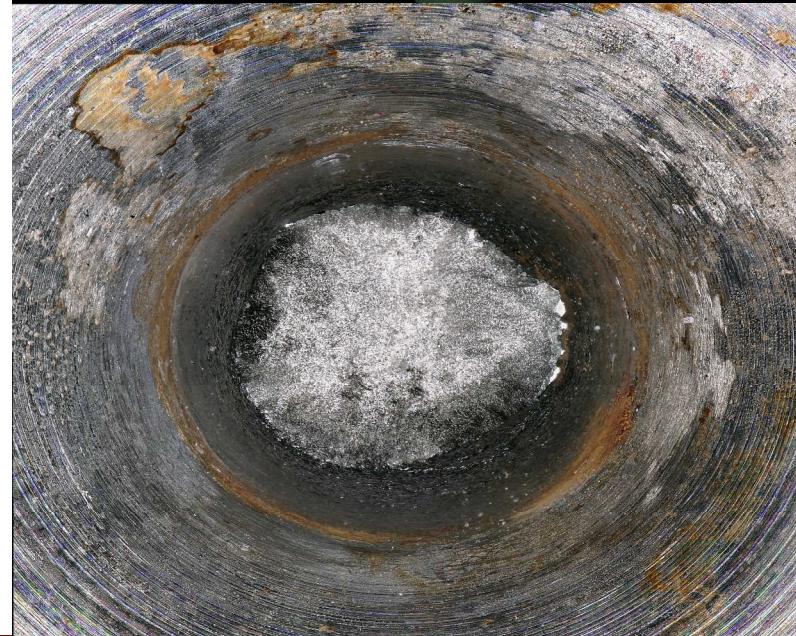
# Cylindrical Sample Post Salt-Fog

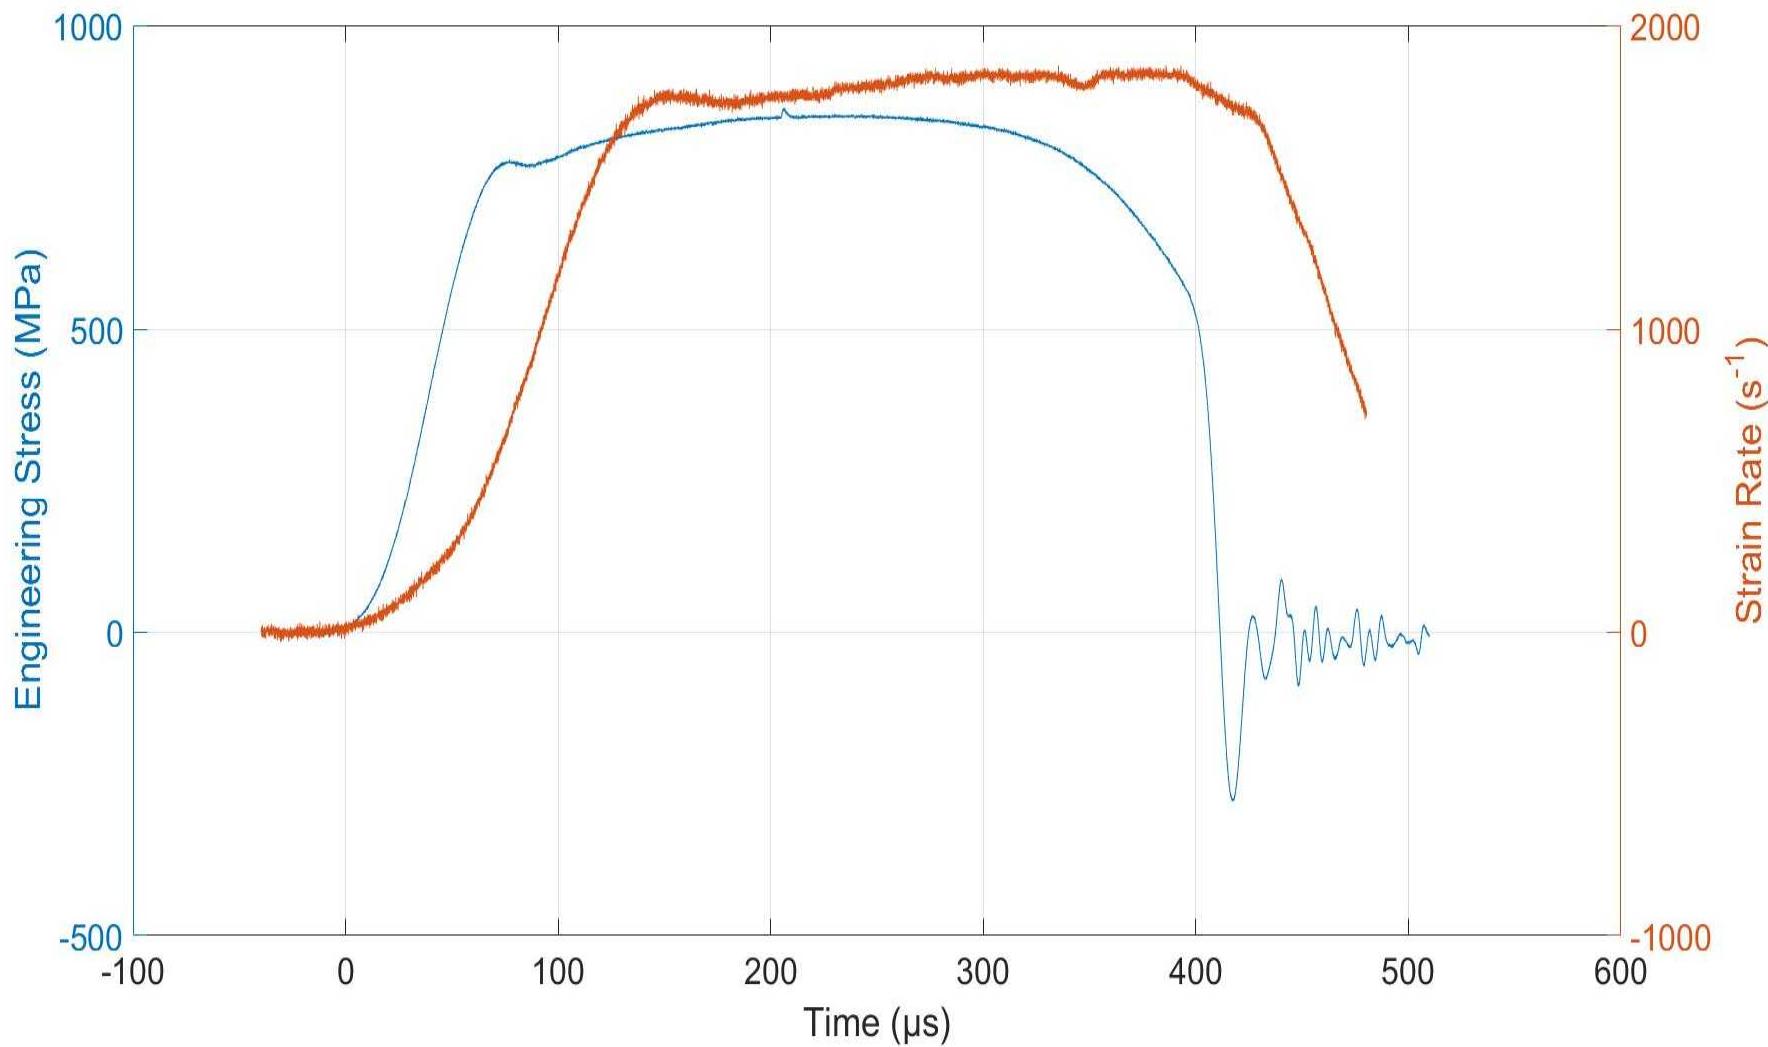
# Constant Strain Rate
