# Influence of corrosion on dynamic tensile properties of stainless steel

Eric Hicks

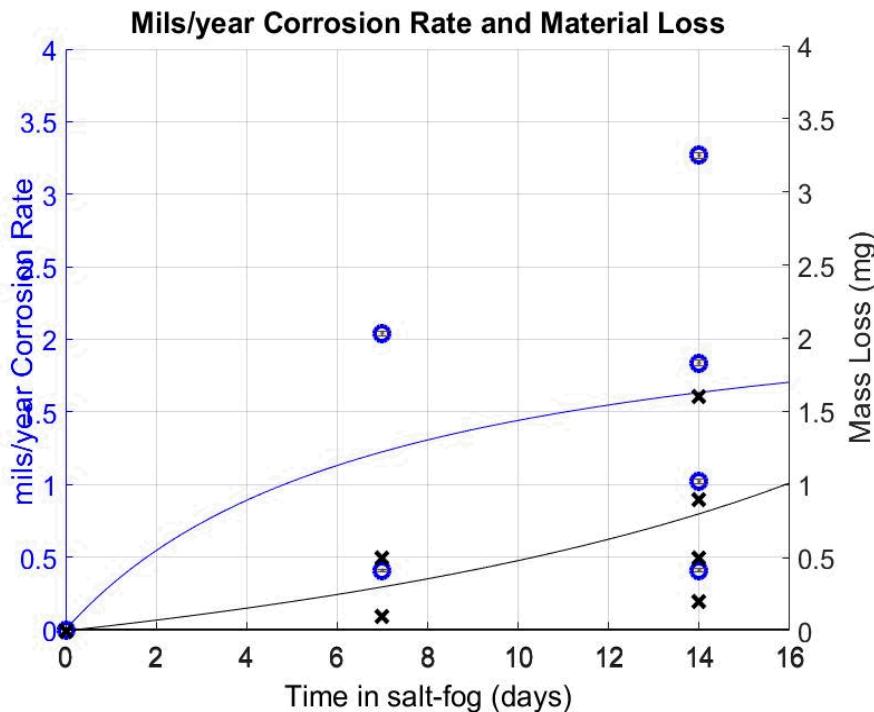
- Mass loss not as consistent
- Same trend as flat samples

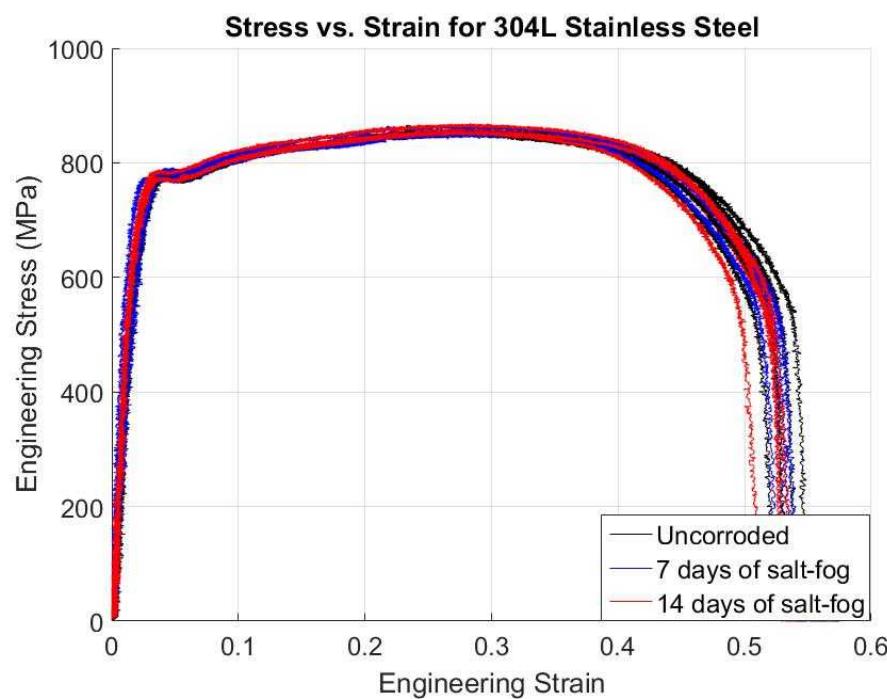
- Failure Strength = 1300 MPa
- Failure Strain = 40 – 45 %

- Flat samples were the wrong samples
  - Possibly 4140H
  - Same tensile failure, strain and hardness.
- No change in tensile failure strength for cylindrical samples
- Next study will have intervals of 2,3 and 4 weeks in salt-fog
