# **YUCCA MOUNTAIN SITE CHARACTERIZATION PROJECT**

## **The Nevada Railroad System: Physical, Operational, and Accident Characteristics**

**THE NEVADA RAILROAD SYSTEM:  
PHYSICAL, OPERATIONAL, AND ACCIDENT CHARACTERISTICS**

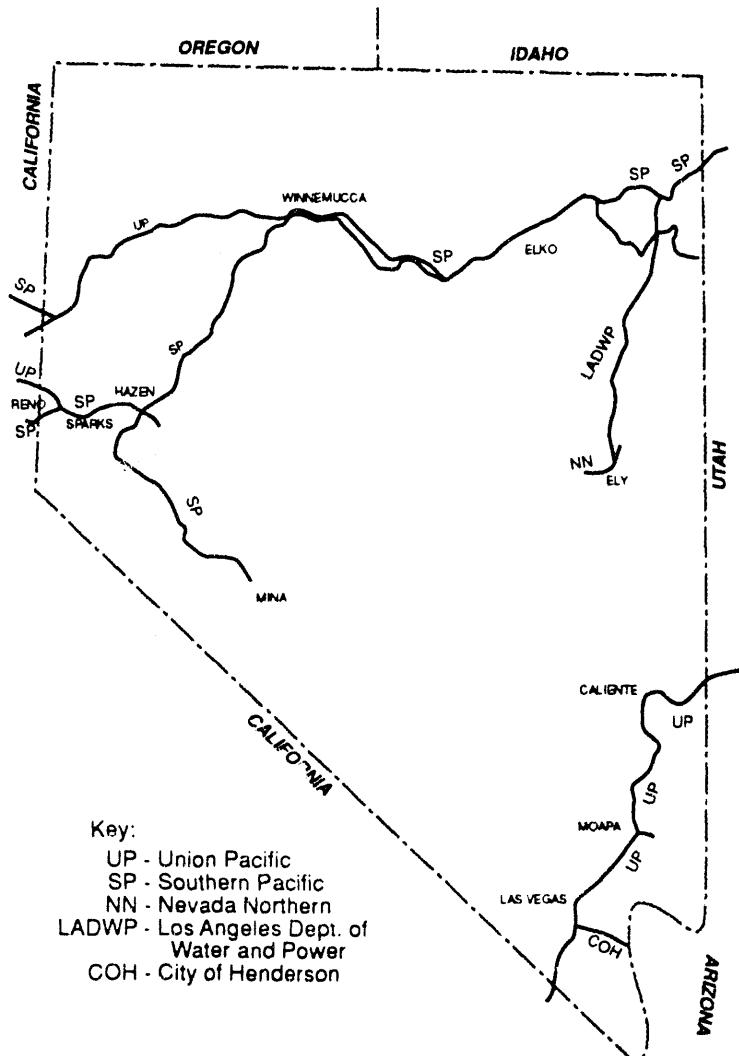
Figure 1 — Existing Nevada Rail System

In 1988, Class I railroads operated 1,440 route miles of track in Nevada, including trackage rights. This accounted for slightly over one percent of the total 139,856 U.S. route miles. Railroading does not appear to be a major employer in the state. As of March 12, 1989, the Class I carriers employed 823 Nevada residents out of a total of 258,023 railworkers nationwide. Figure 1 shows the Nevada rail network.

Although Nevada has a small portion of the nation's rail mileage, the routes operating through the state are important. Nevada has three mainline routes, one owned by the Southern Pacific Transportation Company (SP) and two owned by the Union Pacific Railroad (UP). Nevada's only remaining shortline railroad, the Nevada Northern, is currently inactive.

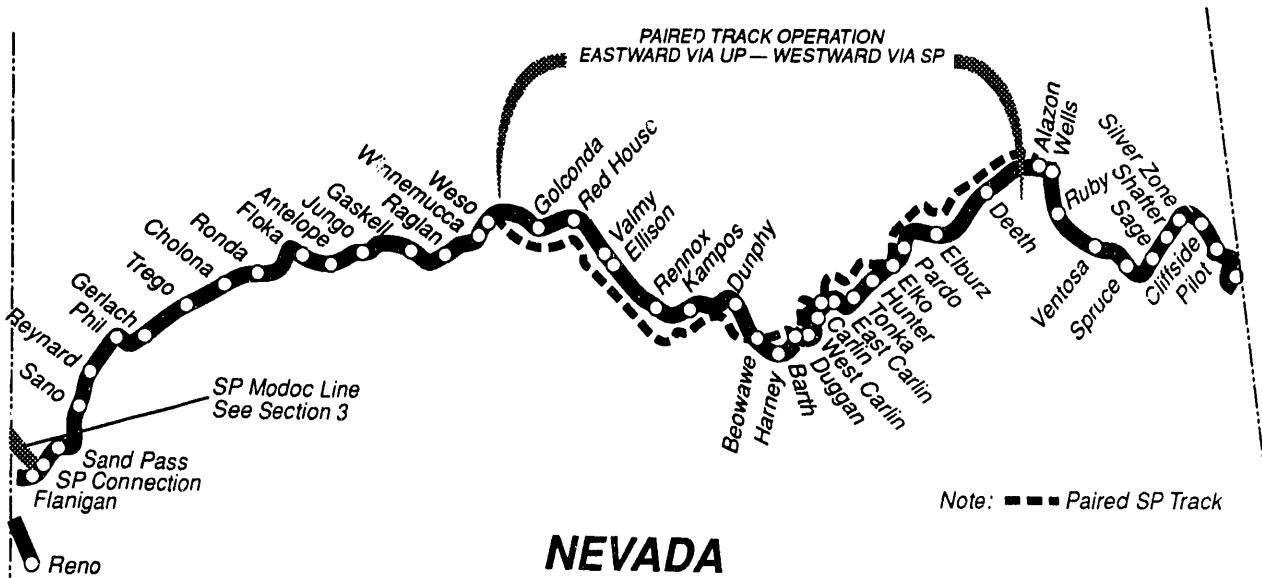
Figure 2 — Union Pacific Feather River Line and Reno Branch

The UP Feather River Line extends 928 miles between Oakland, California, and Salt Lake City, Utah. This track was the former Western Pacific Railway (WP). About 427 miles of track cross northern Nevada, extending in a roughly west-east direction between Herlong, California, and Wendover, Utah. A short branch extends from the mainline at Reno Junction, California, to serve Reno, where a connection is made with the SP Overland Route mainline. Twenty-two miles of the Reno Branch lie in Nevada. Figure 2 shows the Feather River Line's Nevada track.

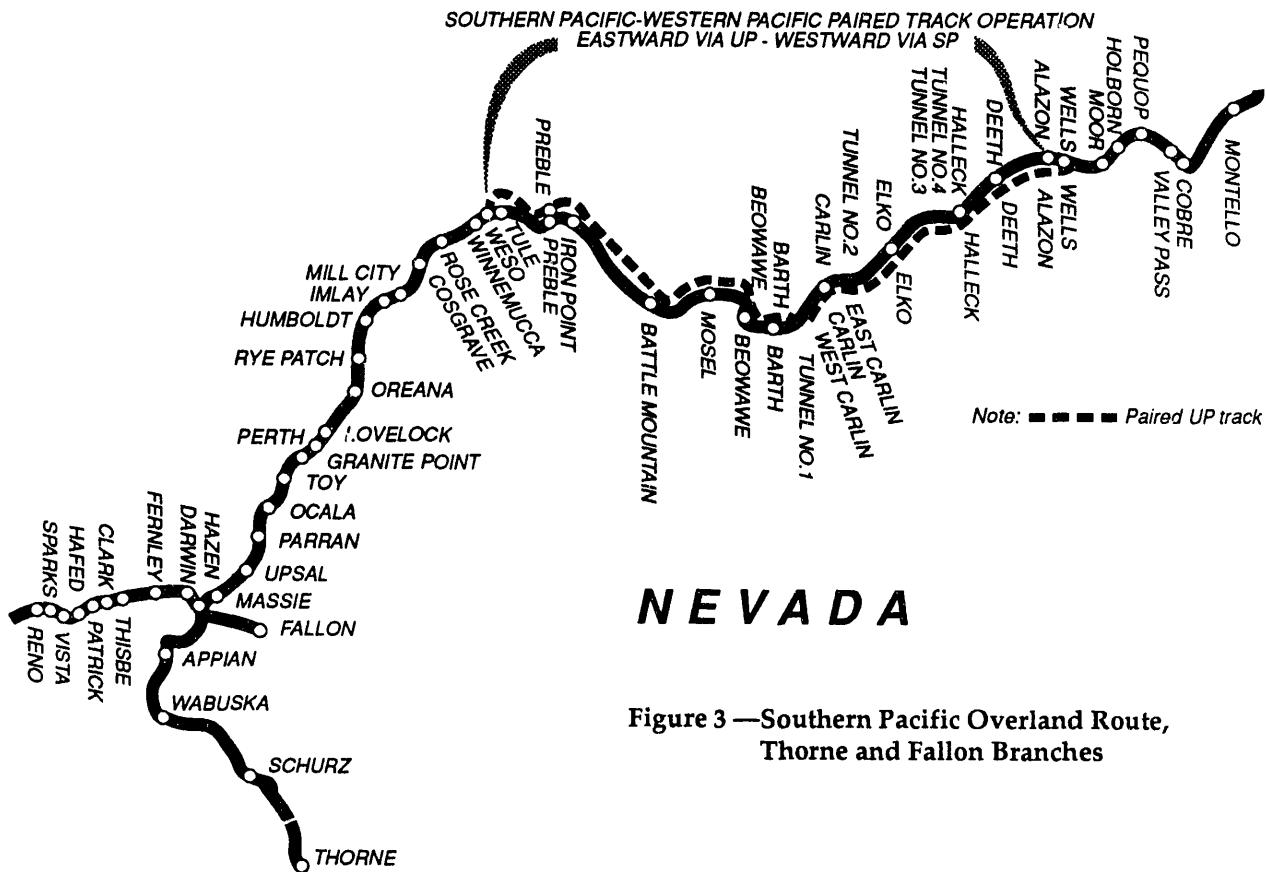
**Figure 3—Southern Pacific Overland Route, Thorne and Fallon Branches**

The SP Overland Route extends 779 miles between Oakland, California, and Ogden, Utah. About 440 miles of the line span northern Nevada, extending in a west-east direction roughly between Verdi, Nevada, and Lucin, Utah. Two branches extend from the mainline at Hazen, Nevada, to Thorne and Fallon. Figure 3 shows both the mainline and the two branches.

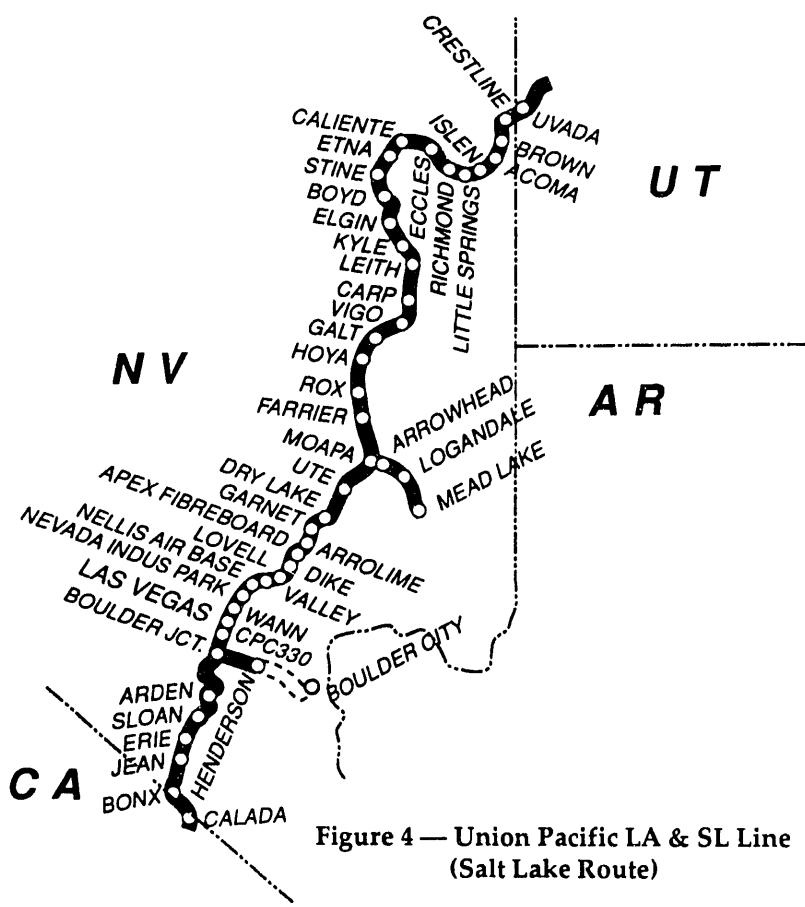
The LA & SL Line of the UP stretches 784 miles across Utah, Nevada, and California to connect its namesake cities. About 212 miles of the route lie in Nevada. Short branches extend in Nevada from the mainline to Henderson and Mead Lake. Spurs serve Nellis Air Force Base and a gypsum plant. Figure 4 shows the LA & SL Line's Nevada trackage.

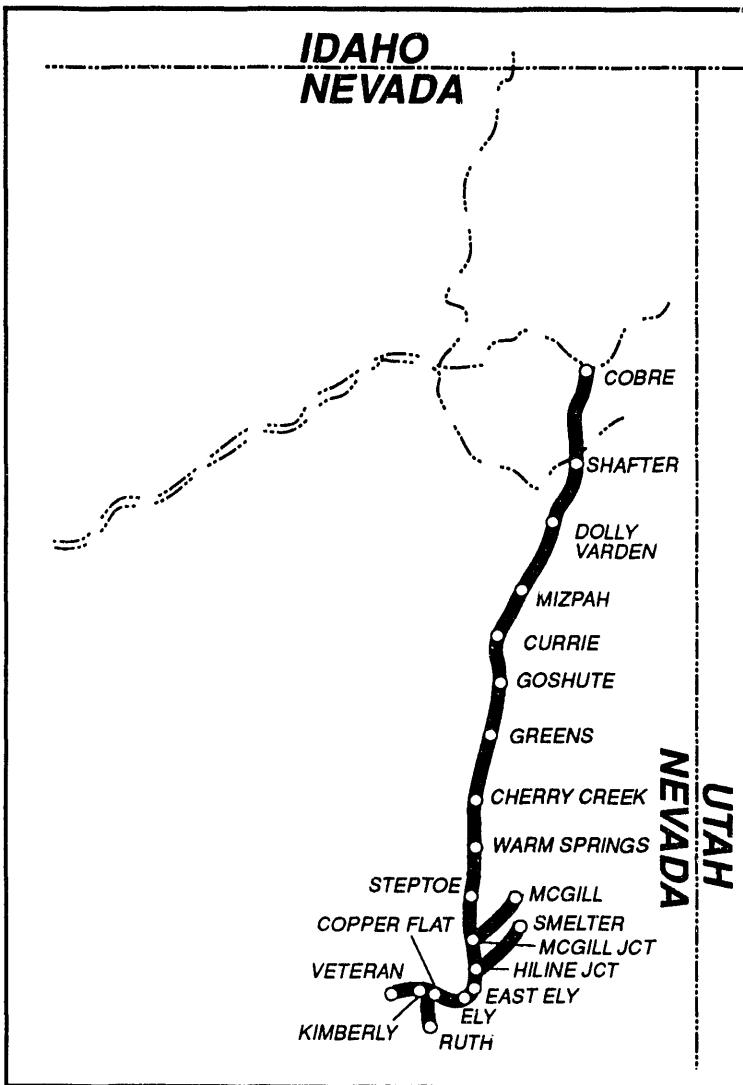
Figure 5 — Nevada Northern Railroad

The Nevada Northern Railroad (NN) is the last shortline railroad in Nevada. Currently shut down for common carrier operations, the line may be resurrected in the late 1990s to serve a proposed power project. Figure 5 shows the NN line.

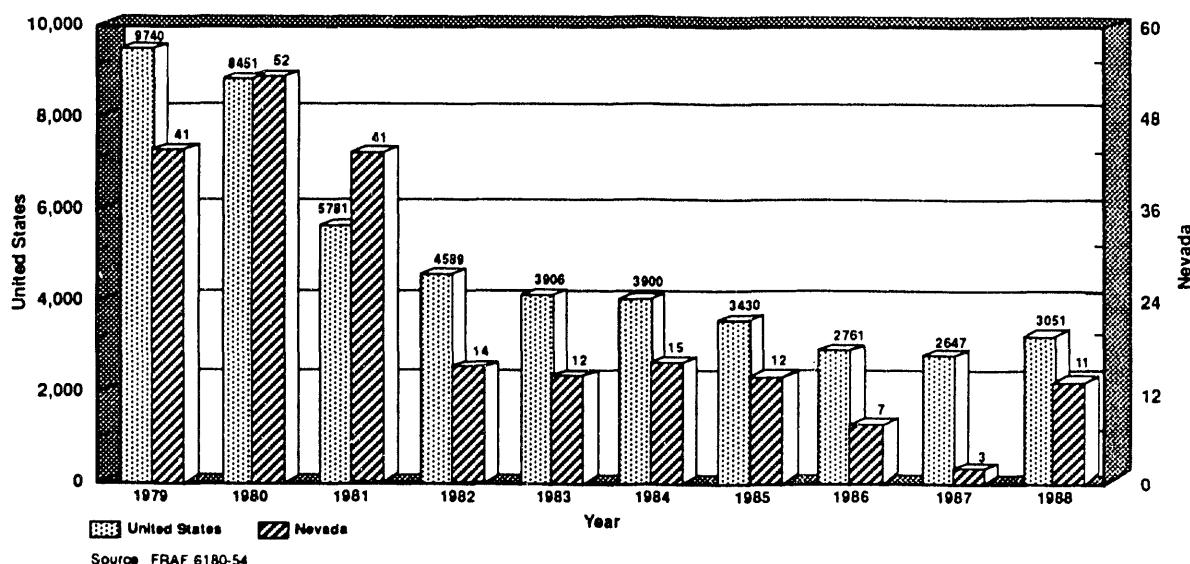
During the 10-year period from 1979 to 1988, the FRA Accident/Incident Data Base contained 208 rail accidents in Nevada and 48,256 for the entire United States. Figure 6 illustrates both a national and a Nevada trend toward fewer rail accidents. Only 23.1 percent of the reported Nevada rail accidents occurred during the last five years of the reporting period. In comparison, 44.7 percent of the Nevada

Figure 6 — Reported Rail Accidents in the United States and Nevada, 1979-1988

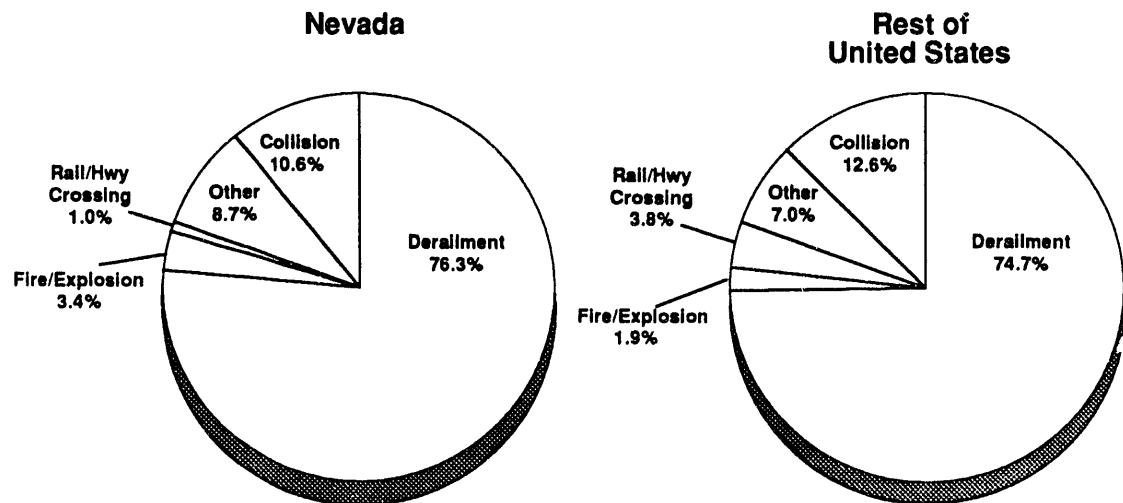
Figure 7 — Distribution of Rail Accidents by Types 1979-1988

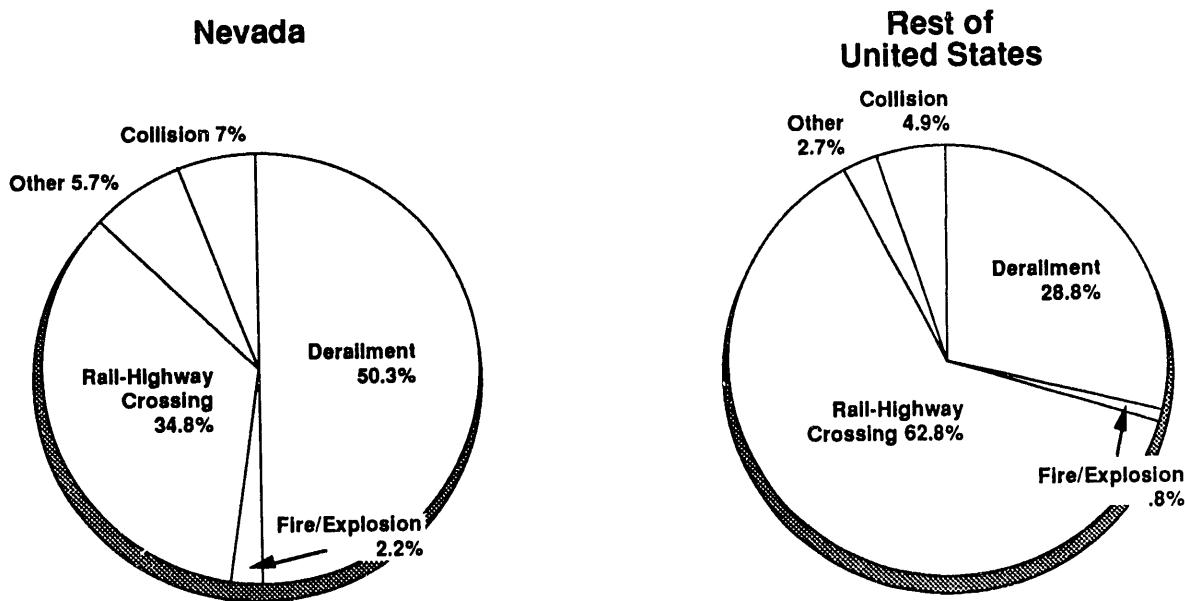
Combining FRA's Accident/Incident Data Base with the Rail-Highway Crossing Data Base provides an additional perspective on rail accidents in the State of Nevada and the United States. Figure 8 shows that nationally *rail-highway grade crossing* accidents are, by far, the most likely type of accident to occur, comprising 62.8 percent of all reported accidents. However, when Nevada is examined, *derailments* remain the most likely type of accident to occur (50.3 percent of all accidents). *Rail-highway grade crossing* accidents are second at 34.8 percent. Two points emerge when rail-highway grade crossings are considered: first, the relative importance of this type of accident when compared with all other types;

**Figure 8 — Distribution of All Rail Accidents by Type 1979-1988**

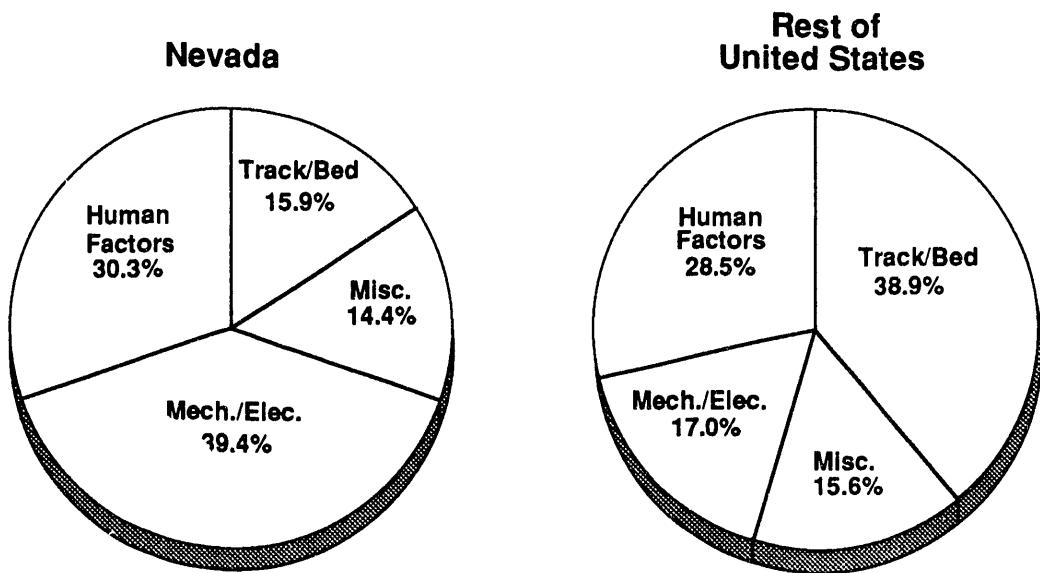
Figure 9 shows the proportion of accidents attributed to each category. The national and Nevada data differ in this classification. During the 10-year period being examined, the two most common causes of rail accidents in Nevada were *mechanical/electrical* and *human factors*, each of which accounted for 39.4 percent and 30.3 percent, respectively, of the total accidents. The other approximately one-third of the accidents were divided between *miscellaneous* (14.4 percent) and *track/roadbed* (15.9 percent). These data indicate that the most likely cause of a train accident in Nevada will be either a mechanical failure of some part of the train itself, or improper operation of the train.

Figure 9 — Causes of Rail Accidents Reported 1979-1988

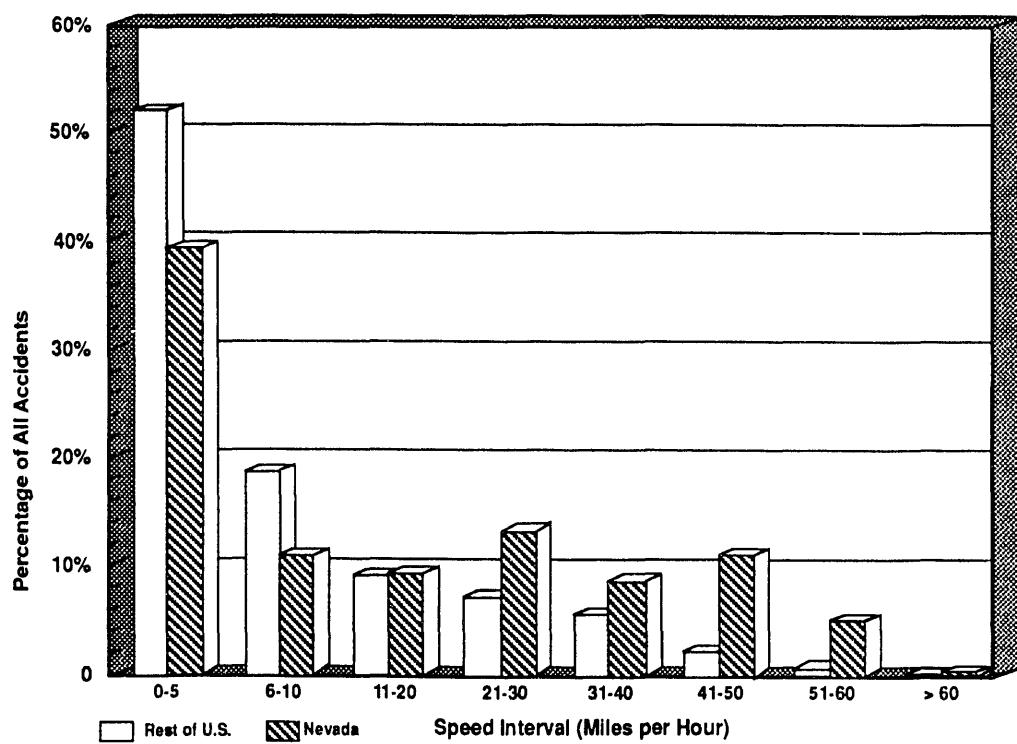
Most rail accidents happen at very low speeds. Figure 10 shows a breakdown of accident percentages by speed range. Almost half of all reported accidents in Nevada (49.7 percent) occurred at speeds of 10 mph or less, and 39.5 percent of all accidents in the state were at 5 mph or less. On a national basis, 72.5 percent of all accidents occur at 10 mph or less, and 52.8 percent of all rail accidents occur at 5 mph or less. These speeds are indicative of freight yard switching and branchline operations, where track is generally less well-maintained than on mainlines. Switching operations, with the coupling and uncoupling of cars, frequent changes in direction, and movement through turnouts, seem to offer higher potential for reportable accidents than do mainline train movements. These accidents may, however, be of lower severity than are accidents occurring in mainline operation.

The frequency of accidents in the higher speed ranges in Nevada is a little greater than in the rest of the United States. This difference is probably due to the larger proportions of open track in Nevada and the resulting higher average train speeds and lower number of switching activities. The severity of accidents increases at higher train speeds, especially when collisions occur.

Figure 10 — Percentage of Rail Accidents by Speed Interval 1979-1988  
Source: FRA F 6180-54

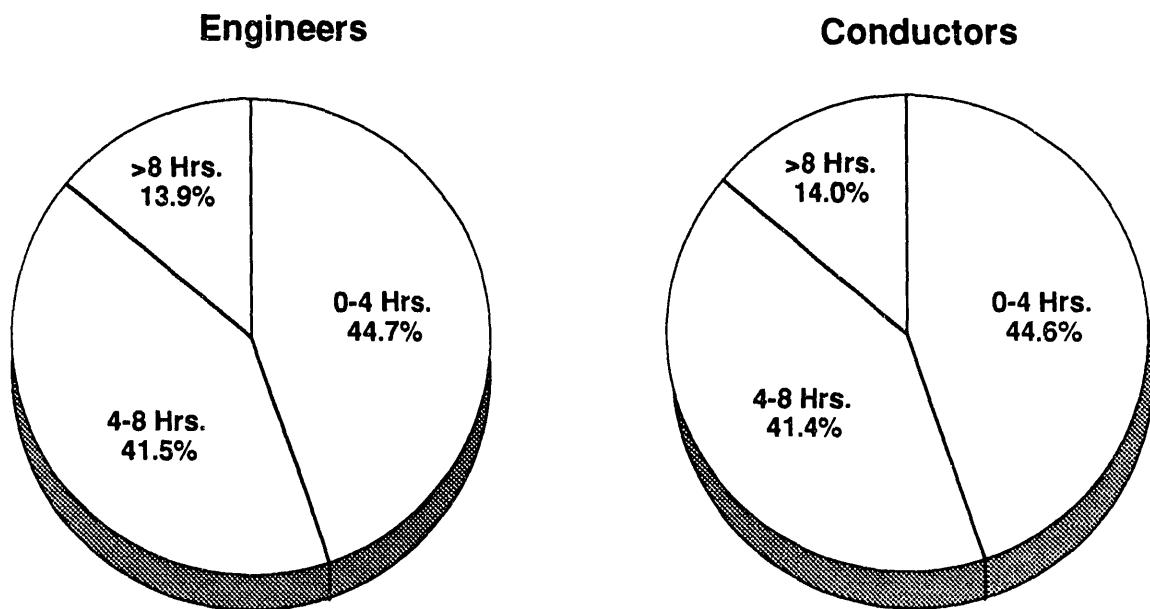
Figure 11 shows the distribution of time on duty for engineers and conductors involved in accidents. It might be expected that accidents would tend to be more prevalent when hours of service are high because of employee fatigue. The data seem to indicate, however, that elapsed time on duty follows no trends. Both occupations show similar figures; neither has a very dramatic change in accident rates. The charts show that about 45 percent of all accidents happen in the first 4 hours, about 41 percent happen between 4 and 8 hours, and about 14 percent happen after 8 hours. When human factors accidents are selected and analyzed (to test the hypothesis that accidents caused by human error will increase over time), the results are virtually identical.

Figure 11 — Time on Duty at Rail Accidents - United States 1979-1988  
Source: FRA F 6180-54

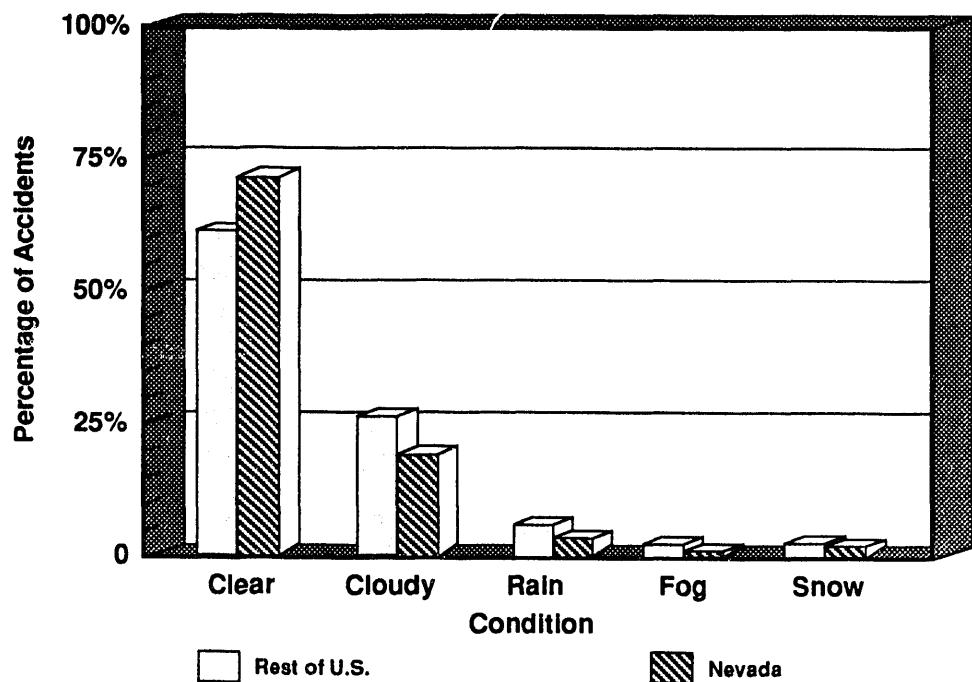
In Nevada, almost three-fourths (73.0 percent) of all accidents reported in the data occurred in clear weather, while 19.3 percent occurred in cloudy weather. Rain, fog, and snow account for lower proportions. Figure 12 shows the percentages. Generally, weather does not seem to be a major factor in rail accidents either in Nevada or the nation.

Figure 12 — Weather at Time of Rail Accidents - U.S. & Nevada  
 Source: FRA F 6180-54

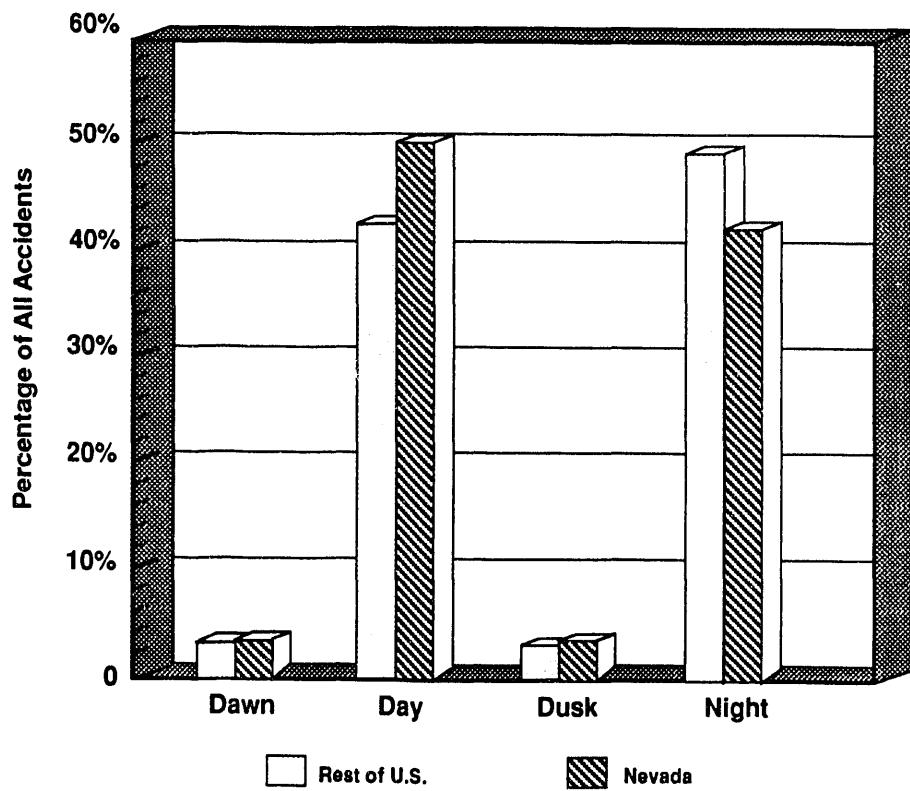
In Nevada, about half (49.2 percent) of all rail accidents occurred after dark. The day and night proportion is reversed for national data — 42.1 percent of all accidents occurred at night. Unlike highway operations, rail operations have no general temporal patterns; operations usually occur around the clock. Signalling practices and the presence of multiple crew members in the operating cab may tend to negate factors that lead to increased accident frequencies during nighttime highway operations. Figure 13 shows a breakdown of accident percentages by the general time of day.

Figure 13 — Time of Day of Rail Accidents 1979-1988  
 Source: FRA F 6180-54

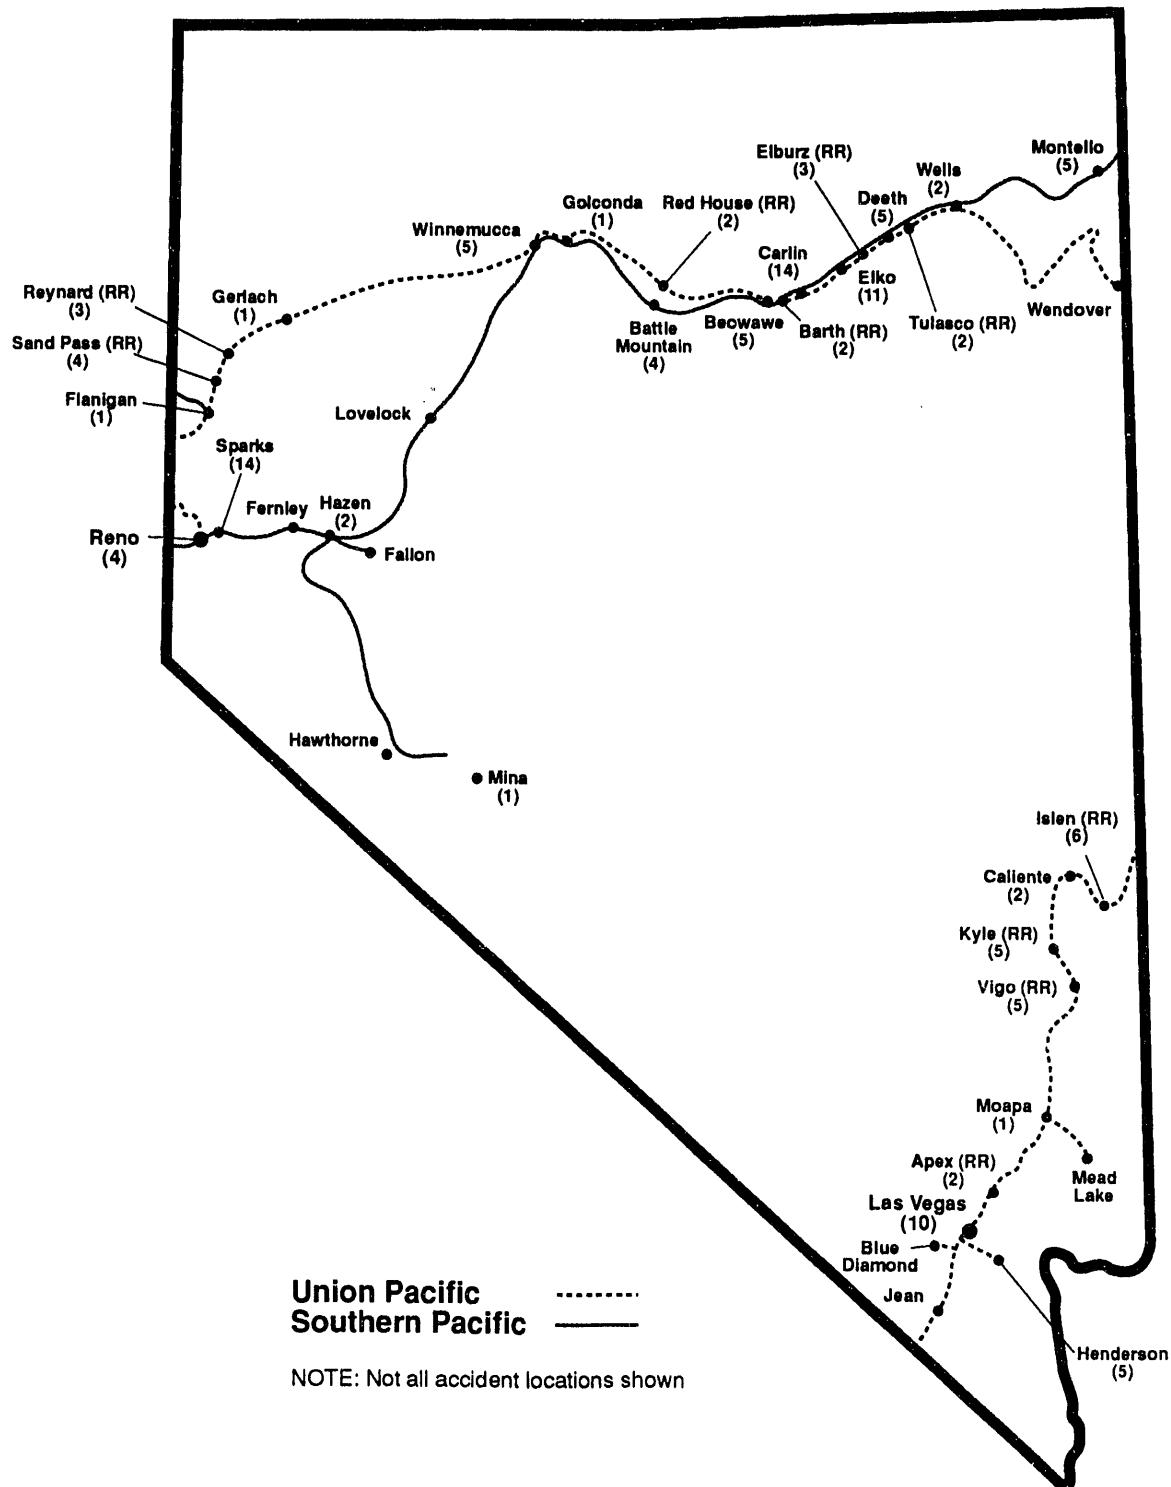
Figure 14 shows the stations most commonly listed as closest to reported rail accidents in FRA F 6180-54. The figure also gives the number of accidents (in parentheses) occurring near that location during the 1979-1988 reporting period. Not all accident locations are shown in the figure, but the most significant ones are. The most common stations listed as closest to an accident are Carlin and Sparks (14 accidents each), Elko (11 accidents), and Las Vegas (10 accidents). Sparks, Las Vegas, and Elko all have heavy switching activity. This seems to lend credence to the hypothesis that the frequency of accidents at low speeds correlates with switching movements. Carlin is a crew change point. Note that a number of locations (designated by RR) are railroad stations, not necessarily population centers.

**Figure 14 — Locations of Accidents**  
Source: FRA F 6180-54

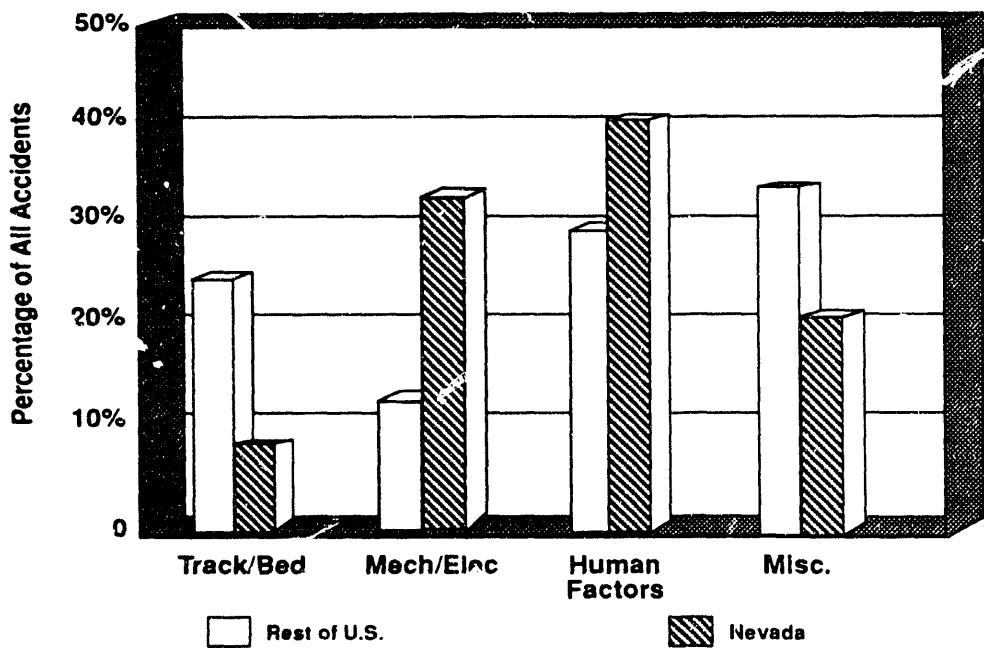
During the 1979-1988 period in Nevada, a total of 15 accidents in which 36 people were injured were reported to the FRA Accident/Incident Data Base (FRA F 6180-54). This is a rather small data set, so conclusions regarding injury-producing accidents in Nevada must be tentative. In the rest of the nation, 1,810 injury-producing accidents were reported during the same period. This size data set provides more validity for conclusions. Figure 15 shows a breakdown of these accidents by cause.

Figure 15 — Causes of Injury-Producing Rail Accidents 1979-1988

The causes of injury-producing accidents are fairly consistent with the causes of all accidents reported earlier in this section. As indicated in Figure 15, Nevada and the rest of the United States show a marked difference: human factors and mechanical/electrical problems caused 40 percent and 33 percent, respectively, of Nevada's injury-producing accidents. This is consistent with information presented in Section 8, which discussed the differences in Nevada and national rail accident causes.

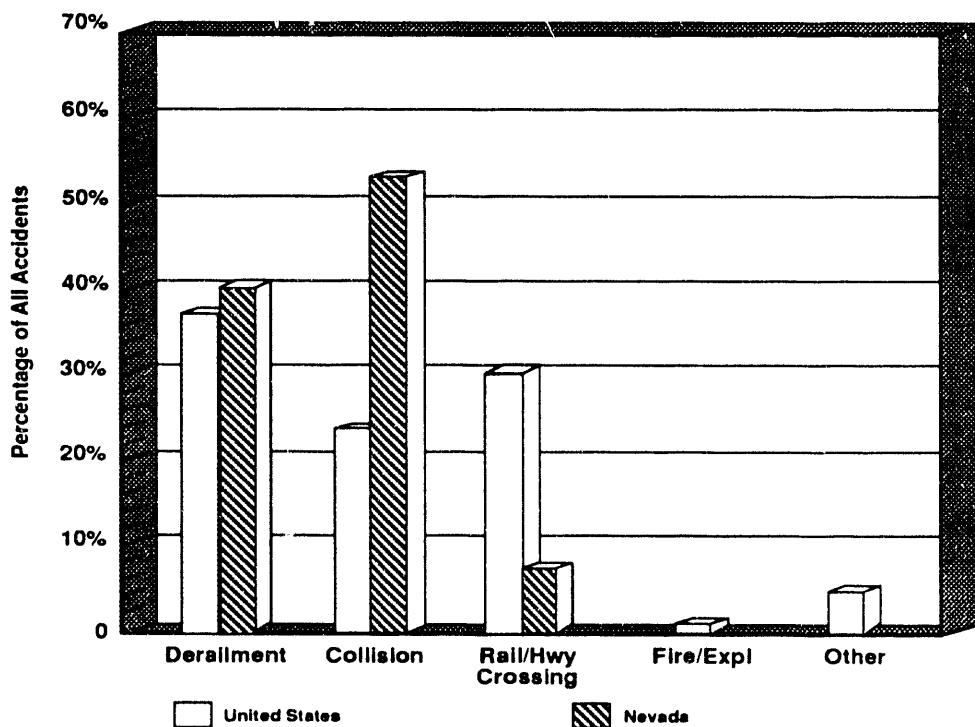
The types of injury-producing rail accidents (accidents classified as described on page II-4), shown in Figure 16, are somewhat different in Nevada than in the rest of the nation. In the rest of the United States, 36.2 percent of injury-producing accidents were derailments and 24.2 percent were collisions. In Nevada, the relative rankings are reversed — 40 percent derailment and 53.3 percent collision. Nationally, rail-highway crossings account for 30.7 percent of all injury-producing accidents, but such crossings account for only 6.7 percent of all injury-producing accidents. The differences could be related to the relatively small data set in Nevada, or they may be a result of the more open spaces in Nevada.

Figure 16 — Types of Injury-Producing Rail Accidents 1979-1988

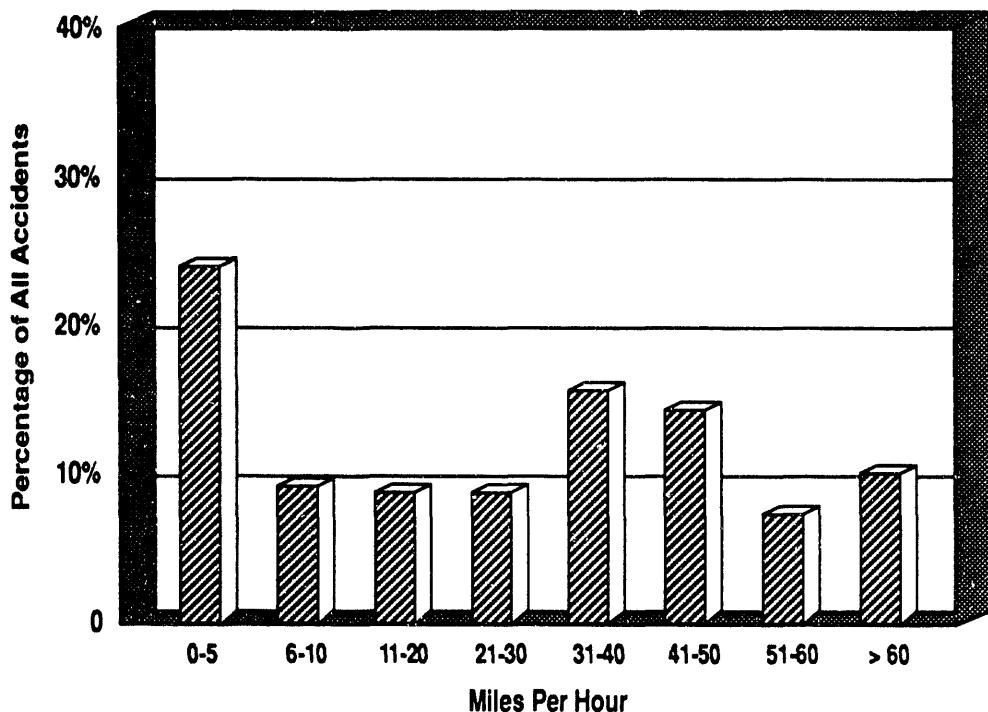
The national data report a total of 488 accidents in which one or more people were killed. This larger sample size bears some scrutiny. The statistics for fatal accidents related to speed are interesting. Figure 17 shows the proportion of fatal accidents occurring in each speed interval for the nation, but this is not a complete picture. Significantly fewer accidents occur at the higher speeds, but the chance that an accident, once it occurs, will produce a fatality increases dramatically as speed increases. By comparing the total number of accidents at each speed interval to the total number of fatal accidents at each speed interval, it becomes clear that an accident occurring above 60 mph is 31 times more likely to cause a fatality than an accident occurring at 5 mph or less. The odds of an accident causing a fatality increase steadily as speed at the time of the accident

**Figure 17 — Speeds During Fatal Rail Accidents - United States 1979-1988**

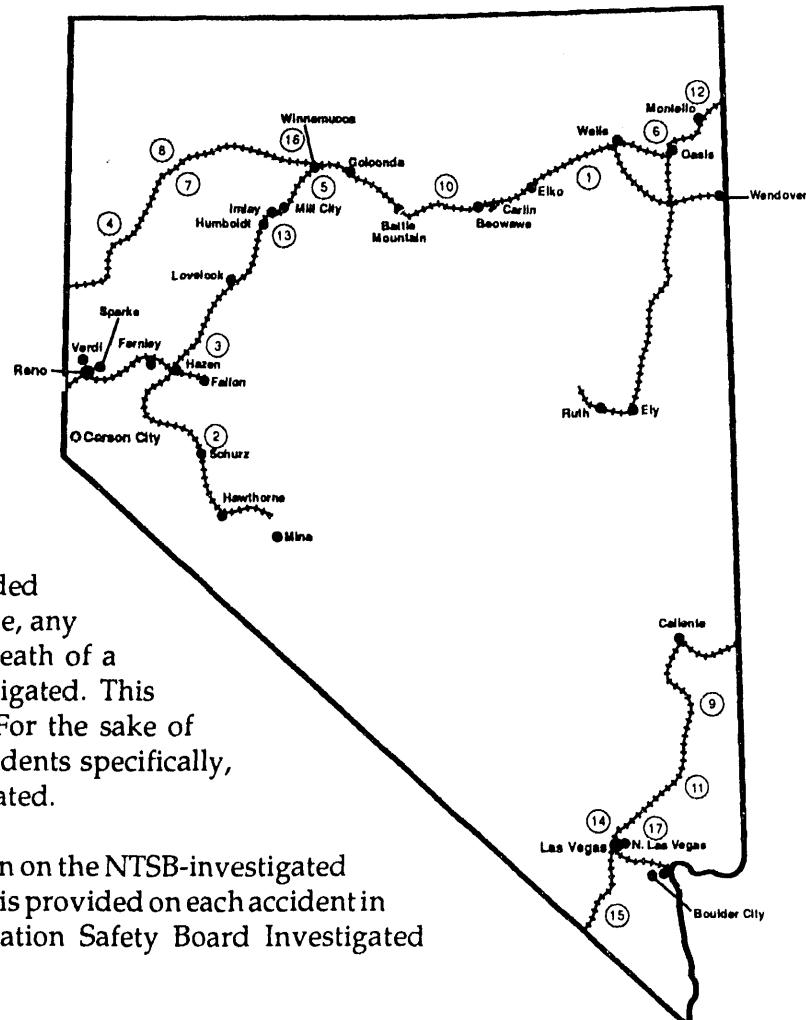
Numbers presented in the figure are keyed to the accident numbers in Appendix D. Examination of the figure indicates that the location of NTSB-investigated accidents are widely dispersed throughout the state. Some accidents that the NTSB investigated prior to 1982 are not included in this study because, before that time, any accident or incident involving the death of a trespasser on rail property was investigated. This requirement was dropped in 1981. For the sake of consistency, and to focus on rail accidents specifically, these pre-1982 incidents were eliminated.

Figure 18 — Locations of Accidents Investigated by the NTSB  
Note: Numbers refer to accident numbers in Appendix D
