Title: Stainless Steel Corrosion Studies Final Report: FY17 End of-Year

## **Stainless Steel Corrosion Studies**

### **Final Report: FY17 End of-Year**

**Test Substances:** MEK (methyl ethyl ketone), Neoprene (polychloroprene)

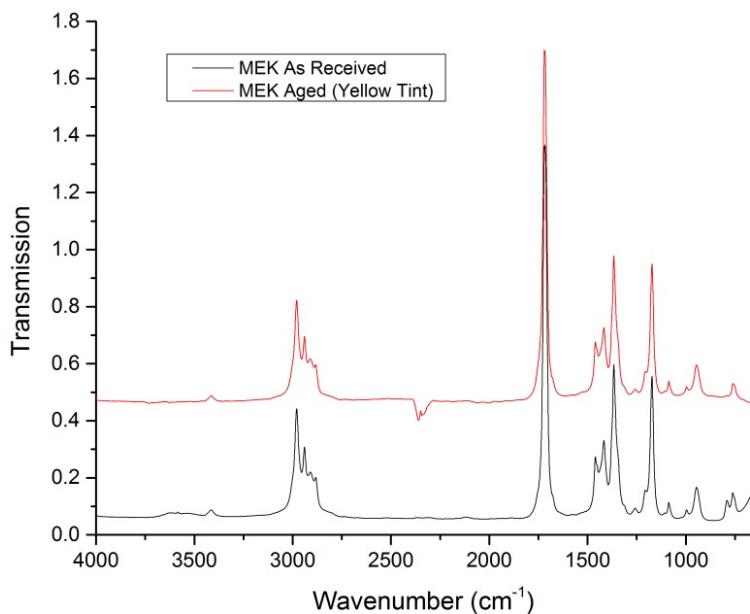
**Figure 6:** FT-IR of MEK as-received from the vendor vs. MEK that has been aged in contact with stainless steel at elevated temperature.

The MEK used in the corrosion study developed a yellow tint after nine months at elevated temperature. The MEK liquid in the submersion study as well as the MEK liquid sample without stainless steel contact both exhibited approximately the same degree of yellowing. MEK liquid used in the vapor study condensed in its container and the residue was a sticky yellowish substance. Colloquial lore indicates MEK can exhibit a translucent yellow tint as it ages. Figure 8 shows FTIR spectra of aged and as-received MEK. There is no chemical degradation of the MEK regardless of the yellow tint that is observed. [The negative peak at  $\sim 2350\text{ cm}^{-1}$  in the aged MEK sample of Figure 6 arises from ambient  $\text{CO}_2$ .] Figure 7 shows a photo of aged and as-received MEK.

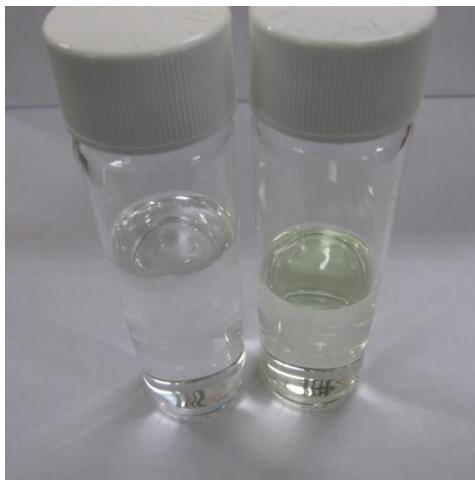
**Figure 7:** As-received MEK (left) and aged MEK after  $\sim 1$  year contact with stainless steel at elevated temperature (right).

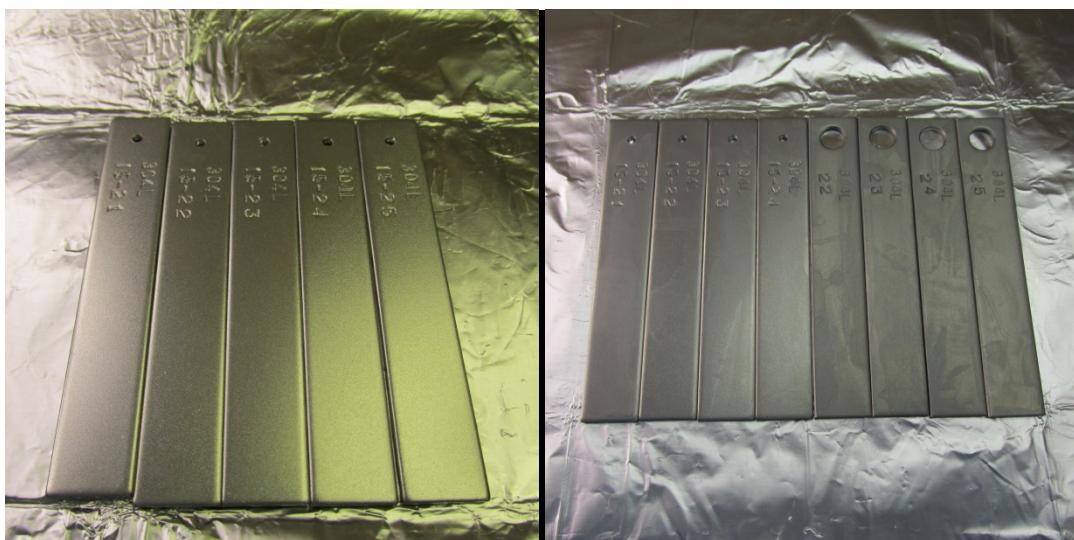
**Figure 8:** Stainless steel coupons before and during corrosion testing. Left: initial stainless steel coupons. Right: MEK vapor exposure  $\sim$  107 days.

Figure 8 shows stainless steel substrates before exposure and after submersion exposure to MEK. No corrosion is visually observed on any stainless steel substrates exposed to MEK. In the submersion study all substrates appeared clean during submersion. Substrates removed from MEK appeared to have a slight dullness after drying. In the vapor study the substrates removed from the MEK vapor appeared to have a dull surface or film after drying. This surface dullness and film are not observed in the absence of solvent exposure. We believe the film to be residue of dried solvent. This residue can be removed by wiping the substrate with a Kimwipe wetted with alcohol. The residue and underlying substrate surface were analyzed by XPS and no anomalies were found.

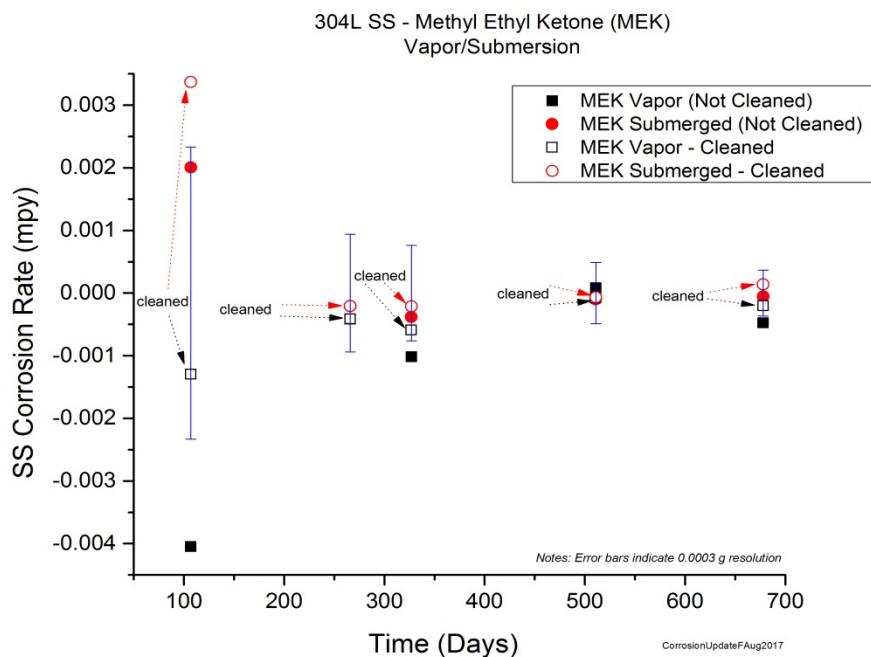
**Figure 9:** Corrosion rate (mpy) for stainless steel substrates submerged in MEK and exposed to MEK vapor, at 50 °C. Error bars represent the uncertainty of the corrosion rate based on an uncertainty of 0.3 mg in the substrate weight.

Figure 9 shows the corrosion rate (mpy) of stainless steel exposed to a MEK vapor and stainless steel submerged in MEK. Arrows indicate corrosion rates on substrates that have undergone ‘final’ cleaning (acid etching). Corrosion rates are well below 0.1 mpy, and are almost always within the error bars imposed by the uncertainty in the substrate weight measurement (0.3 mg). Corrosion rates are effectively zero over the course of this study.

Residue drying on substrate surfaces can lead to slight increases in substrate weight (translated as negative corrosion rates in the figures). In cases where stainless steel substrates underwent final cleaning (acid etching) corrosion rates were generally closer to zero than for uncleaned substrates, indicative of the removal of residue but no underlying substrate corrosion. This is denoted in Figure 9 with arrows indicating where selected substrates have been acid cleaned. At the end of 34 months the last of the stainless steel samples were ‘final’ cleaned and the results indicate no sign of significant corrosion for either the vapor exposed or the submerged samples for the full duration of the study.

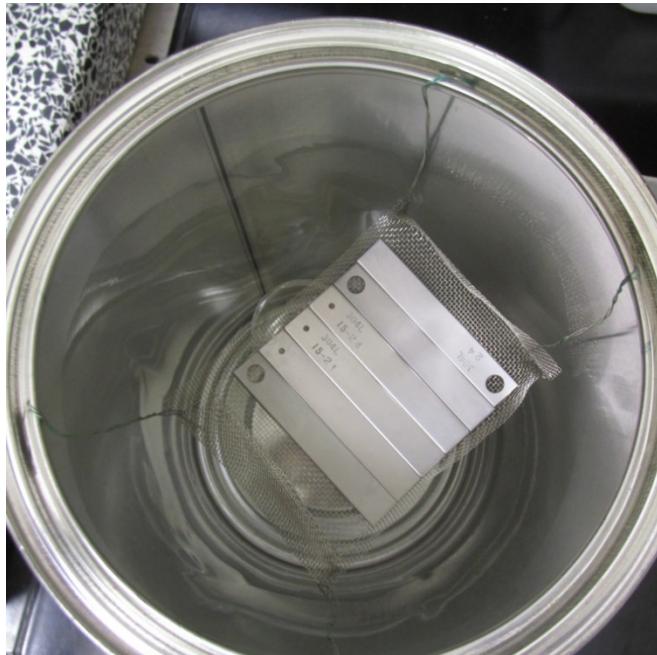
**Figure 10:** Vapor chamber used to suspend the stainless steel coupons. This is sealed with a tight lid and placed in an air filled oven at 50 °C.

Figure 10 shows stainless steel coupons in the vapor chamber sitting in a stainless steel wire mesh tray hanging above a beaker of MEK.

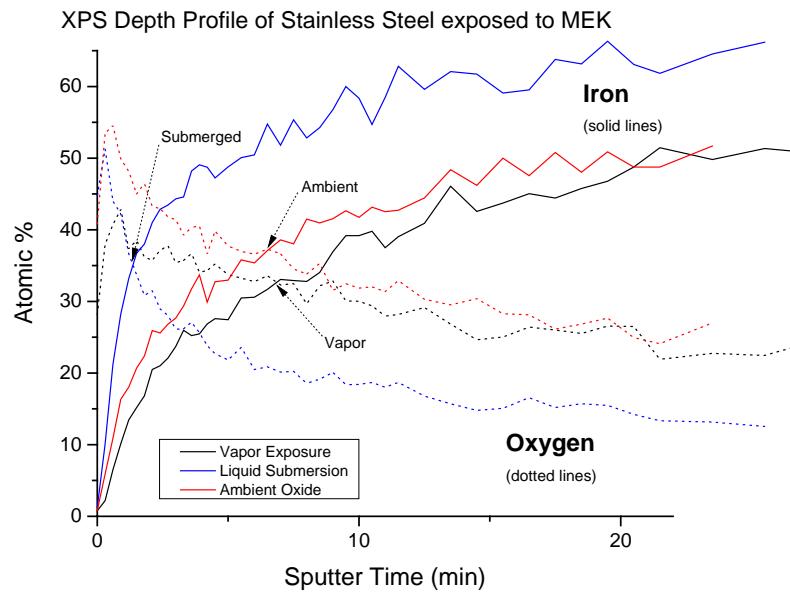
**Figure 11:** XPS elemental compositional comparison of oxygen and iron on stainless steel substrates, as a function of ion sputter time (depth into sample).

At ~ 10 months exposure of stainless steel to MEK liquid and vapor, XPS was used to examine substrates and compare them to a control sample that was not in contact with MEK. The essence of XPS depth profiling of a stainless steel corrosion layer is captured in Figure 11, which shows the atomic concentration of oxygen and iron as a function of ion sputter time on stainless steel substrate prior to nitric acid etching. As ion sputtering proceeds the underlying iron is revealed in increasing concentration. The crossover point between the iron and oxygen curves of the different substrates can be interpreted as a measurement of corrosion layer thickness. In Figure 11 longer times to the crossover point would indicate a thickening of the oxidation layer. The crossover points for ambient-exposed and MEK-vapor-exposed substrates

are approximately equal ( $\sim$  7 minutes); these substrates have comparable corrosion layer thicknesses. The cross-over point for the substrate submerged in MEK is significantly shorter ( $\sim$  2 minutes); the corrosion layer is thinner for this substrate. This indicates submersion in the MEK provides a slight deterrent to oxidation of the stainless steel substrate. XPS depth profiling results here can be compared qualitatively to previous XPS work, but due to changes in sputter parameters crossover times should not be directly compared<sup>4,5</sup>.

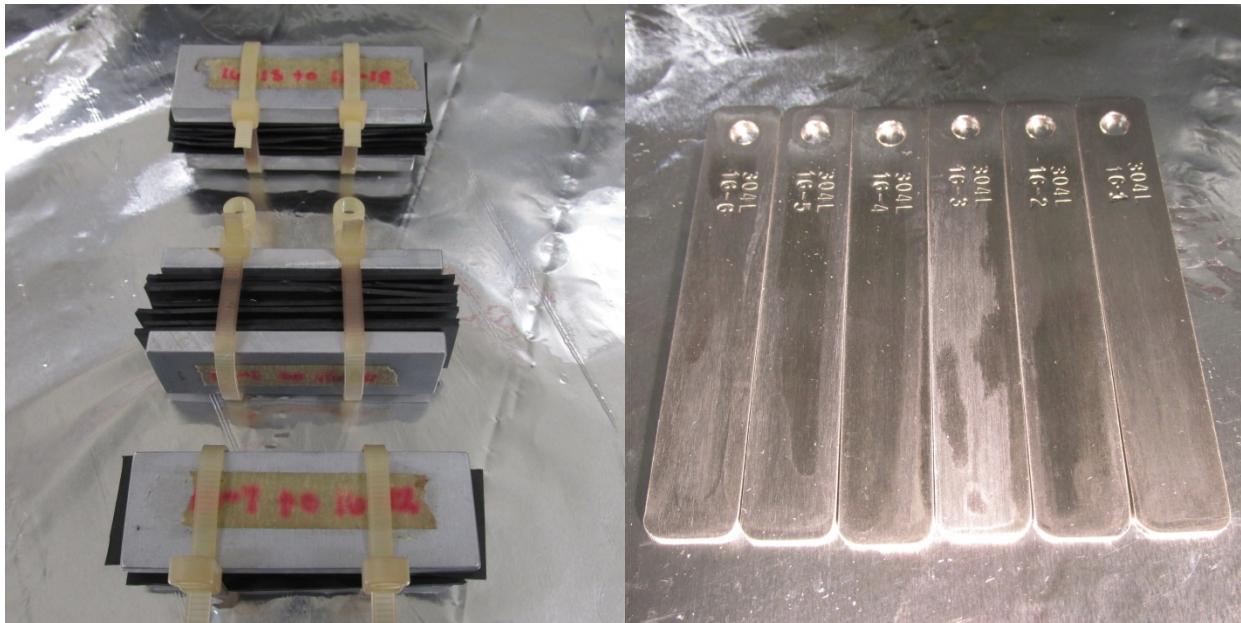
**Figure 12:** Left: polycarbonate zip ties used to clamp aluminum plates with stainless steel coupons alternating between neoprene strips. Right: coupons from a disassembled sandwich showing residue after one month.

visually inspected. It was noted that the steel clamps were showing signs of degradation, and they were switched out for polycarbonate zip ties. After one month the sandwiches were inspected. Figure 12 shows the sandwiched and disassembled stainless steel substrates. Residue is observed on the coupons.

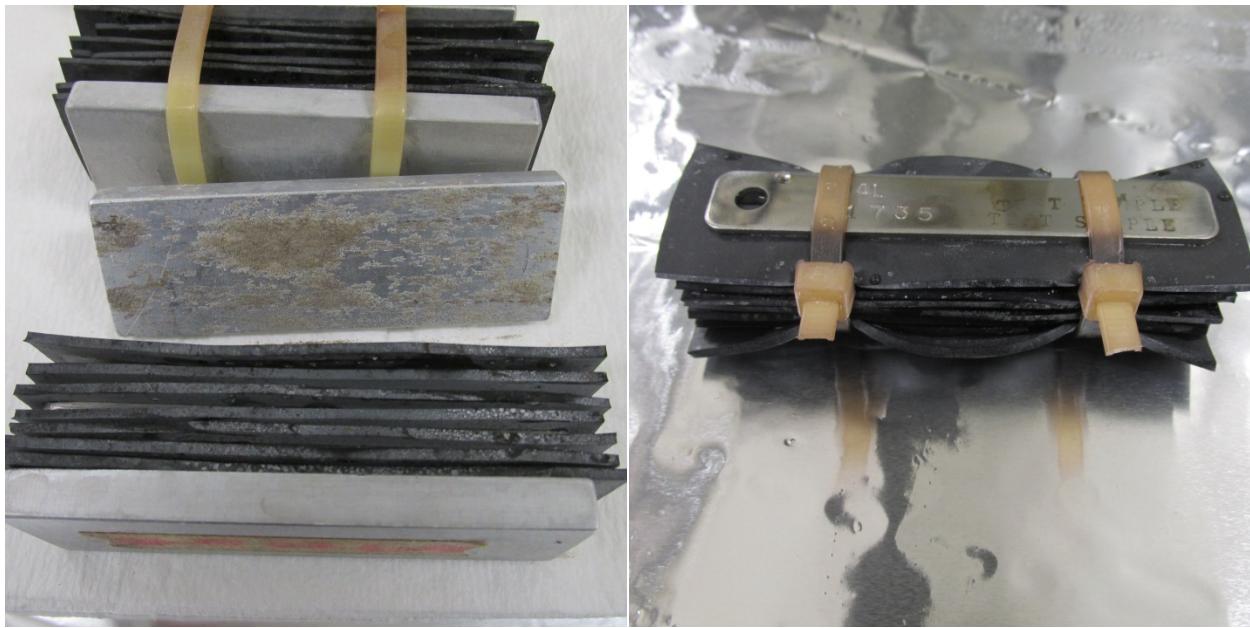
**Figure 13:** Left: degraded aluminum plates in contact with neoprene. Right: stainless steel end plates in sandwiches.

During inspection after two months it was discovered that the aluminum end plates were showed signs of degradation (Figure 13, left), and they were replaced by stainless steel endplates (Figure 13, right).

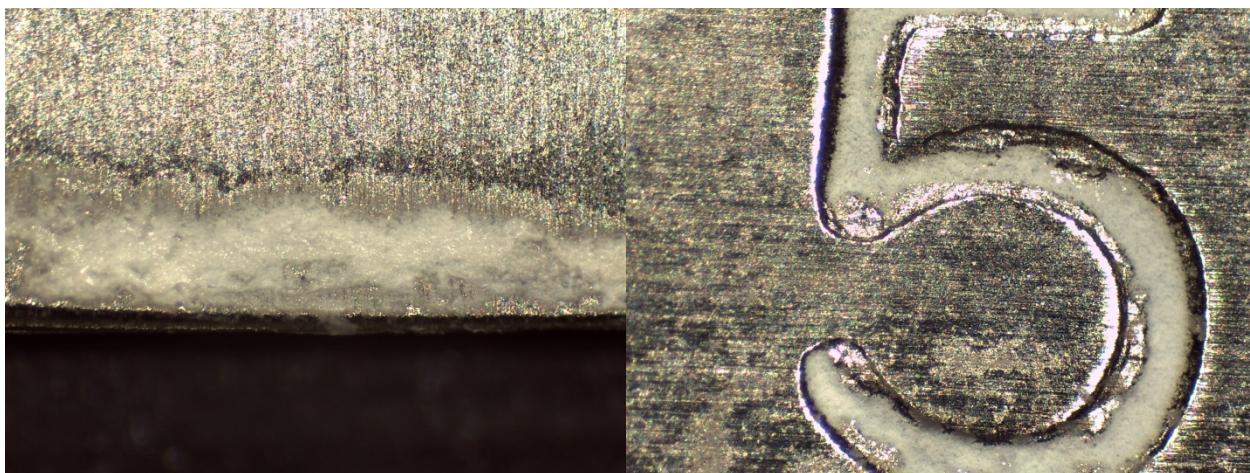
**Figure 14:** Left: debris at the bottom edge of a coupon. Right: white debris deposited in the crevice of the engraved ID of a coupon.

The degraded neoprene that had been in contact with the aluminum plates was replaced. At the three month inspection, white residue was observed to be adhered to the stainless steel coupons. The coupons looked cloudy and covered with white debris at some locations (Figure 14).

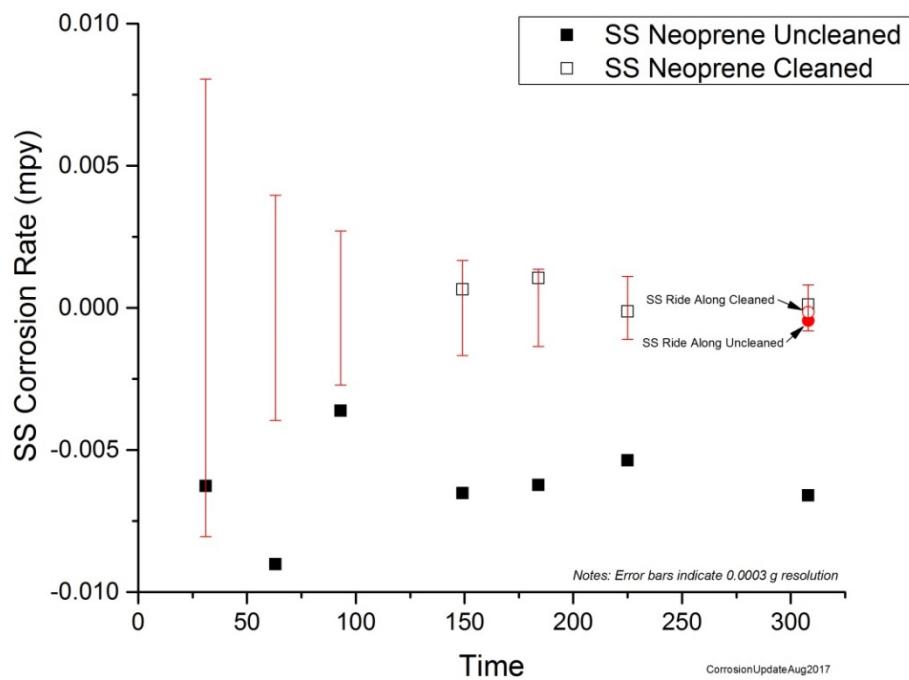
**Figure 15:** Corrosion rate (mpy) for stainless steel substrates pressed in contact with neoprene and exposed to humidity, at 60 °C. Error bars represent the uncertainty of the corrosion rate based on an uncertainty of 0.3 mg in the substrate weight. The ride-along samples were held in a glass jar in the same environment as the other samples, but not in direct contact with neoprene.

During each inspection selected coupons were weighed and then re-sandwiched for continued corrosion study. Throughout the study select coupons are acid-etched to determine precise corrosion rates. Figure 15 illustrates corrosion rates vs. time; acid cleaned coupons have a corrosion rate of effectively zero.

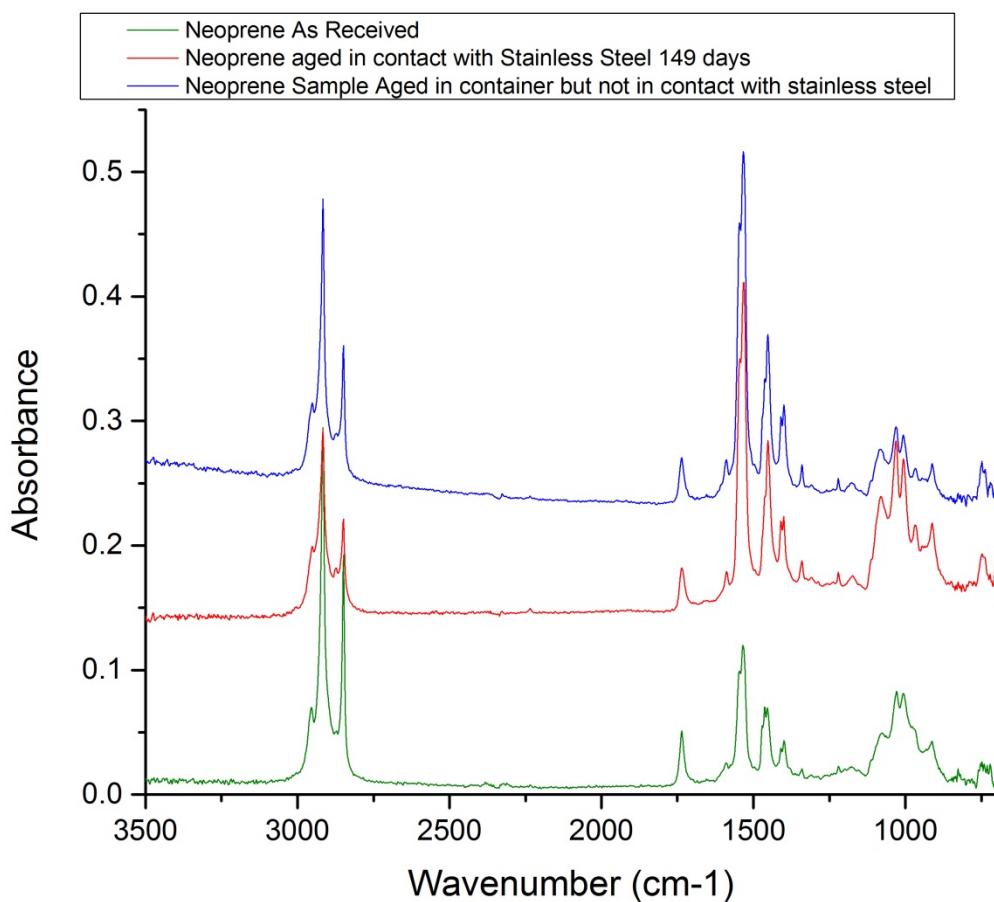
**Figure 16:** FTIR-ATR of neoprene. Green trace is fresh neoprene; red trace is neoprene after 149 days contact with stainless steel; blue trace is neoprene in aging container, but not in contact with stainless steel.

FTIR-ATR of aged neoprene were compared with fresh neoprene. A ride-along sample of neoprene (not in contact with stainless steel, but in the same container during corrosion testing) was also examined (Figure 16). FTIR of aged neoprene shows an increase in intensity at  $\sim 1200\text{-}1700\text{ cm}^{-1}$  as compared to fresh neoprene; this is true for both neoprene whether or

not in contact with stainless steel. In the aged neoprene, the increase in intensity at 1500-2000  $\text{cm}^{-1}$  could indicate polymer degradation and C=C formation.
