**U.S. Department of Energy
Energy Efficiency and Renewable Energy
Vehicle Technologies Program**

Award: DE-EE0006442

**CHRYSLER UPSET PROTRUSION JOINING TECHNIQUES
FOR JOINING DISSIMILAR METALS**

Final Report

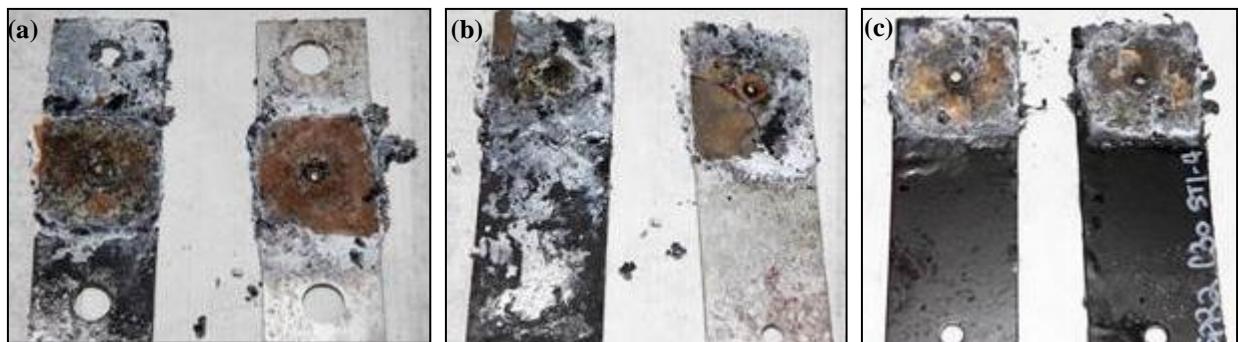
Figure 9: SPR1 cross tension (a) and shear tension (b), and SPR2 shear tension (c) joint failure after 8 weeks of accelerated corrosion exposure

Unexpectedly, many of the joined assemblies did not remain intact throughout the prescribed 12-wk accelerated corrosion test, and were removed from the test. Unfortunately, this left an insufficient number of intact samples to conduct all previously defined post-corrosion testing (especially fatigue testing, which typically requires many samples). However, a reduced fatigue test was conducted to allow for later comparison to the UPJ joint performance. Typical joint failure observed during this test after 6-wks of exposure, as shown below in Figures 7 and 8, occurred in the steel SPR rivet itself, not in the Mg or Al material as was expected, although there was clearly extensive corrosion occurring on the Mg and Al coupons as well. Similar failures occurred through 8-wks of exposure as shown in Figure 9, but none of the SPR1 or SPR2 samples remained intact after 8-wks.

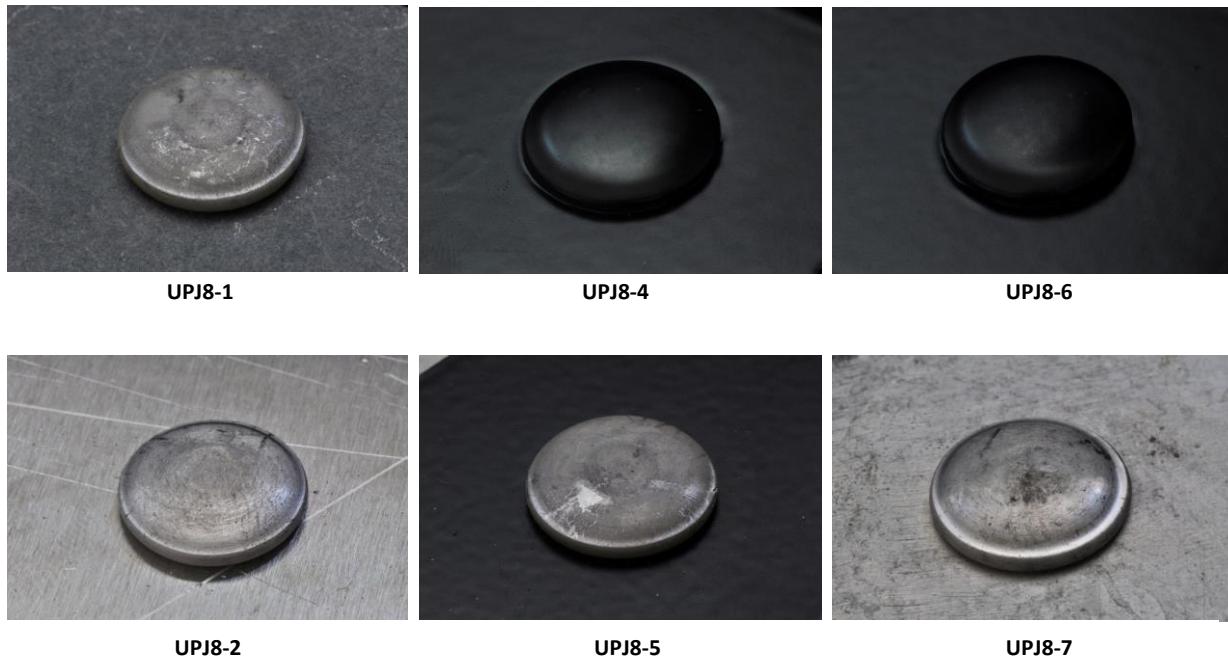
Figure 23: 8-mm round boss UPJ head formations

Figure 23 shows several head formations produced on 8-mm round boss Mg, Al, and steel top sheets in bare, pre-treated, and coated configurations. From these photos, it can be seen that well-formed, crack-free head formations were produced in desired material and coating configurations.

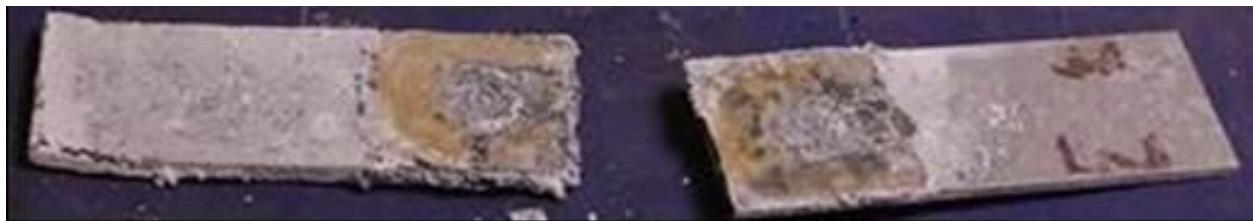
Figure 30: UPJ 8-2 Bare Mg to bare Al joint separation after 6 weeks

Over 250 8-mm diameter round boss UPJ joints were subjected to the FCA accelerated corrosion schedule. As in the case of the benchmark SPR joint evaluations, numerous samples of the bare Mg to bare Al UPJ joints (UPJ8-2) began separating after 6 to 8-wks exposure in the corrosion chamber and could not be evaluated for structural/mechanical performance. However, in the case of UPJ, the effect of galvanic corrosion between the Mg and Al coupons and exfoliation (delamination) corrosion of the Al was more obvious as opposed to fracture of the steel rivet seen in the SPR process. In the case of the Mg to Al6013 joint combination, even with the UPJ process, some level of coatings (e.g., UPJ8-4, UPJ8-5, and UPJ8-6) is required to protect against galvanic corrosion from this high copper containing aluminum alloy. This particular aluminum alloy is a high strength alloy with a higher level of copper than most 6xxx series Al alloys. The combination of high level of copper, acetic acid in the salt spray, and hydrogen given off by the Mg AM60B alloy during corrosion may have exacerbated the exfoliation corrosion of the Al coupons as there were a large number of joints showing this type of corrosion in the bare Mg to bare Al joint combinations.

Examples of separated bare Mg to bare Al (UPJ8-2) joints are shown in Figures 30 and 31. Close up views of the sample showing the extent of corrosion on both the Mg and Al coupons are shown in Figure 31. Note the delamination or “exfoliation” of the Al 6013 coupon in Figure 31(c).

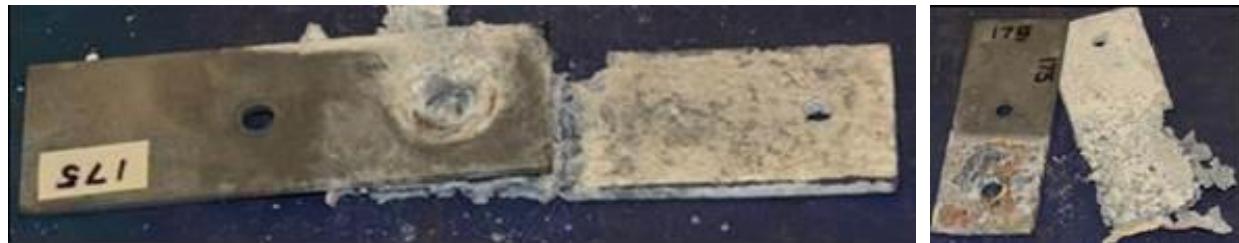
Figure 34: UPJ8-1 lap shear tension test coupons separated after 8-wks of accelerated corrosion

Additionally, none of the Mg-steel joint configurations (UPJ 8-1 and UPJ 8-3) were able to withstand the full prescribed 12-wk corrosion exposure testing. These particular configurations include a DP590 steel panel joined to a Mg die-casting. Even the combination of galvanizing, e-coating, sealed edges, etc., was not sufficient isolation to protect the Mg die-casting from the electro-galvanic corrosion activity incited by the coupling to steel in the aggressive accelerated corrosion environment after 6-wks. Examples of separated Mg to steel joints are shown in Figures 34 and 35 where the severe galvanic reaction between the two metals resulted in dissolution of the Mg casting in the areas of contact at the edge of the steel coupon.

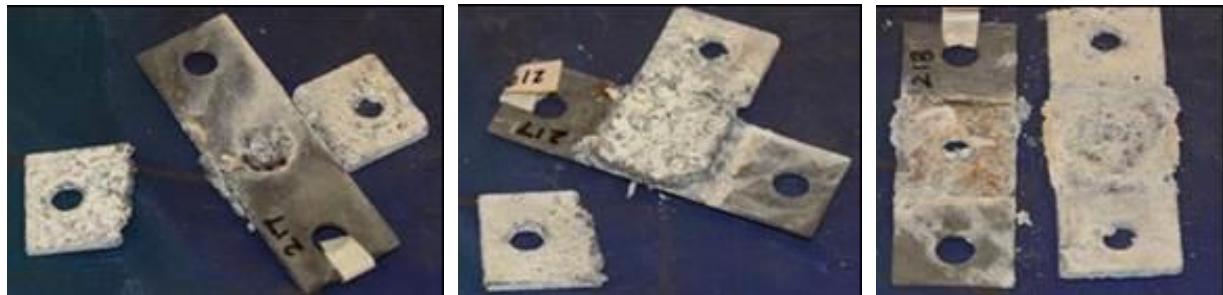
Figure 35: UPJ8-1 cross-tension test coupons separated after 8-wks of accelerated corrosion

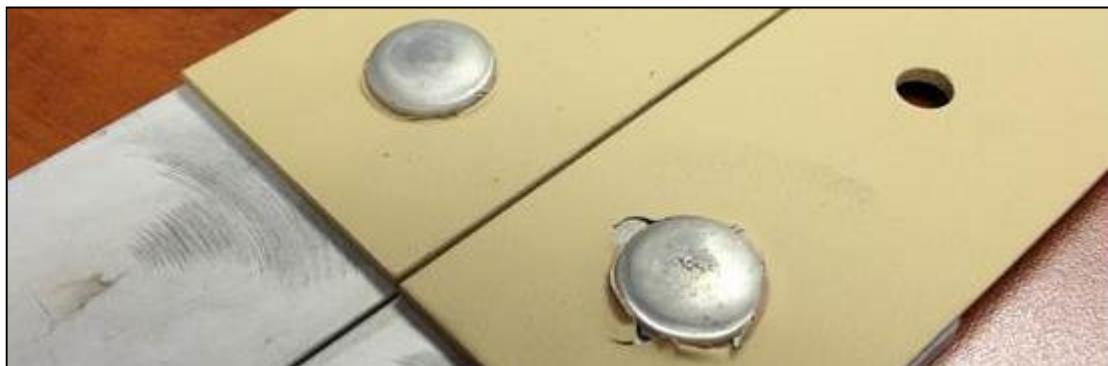
Figure 73: Photo of two joined lap-shear tension assemblies utilizing the CARC coating on the steel coupons

The United States Army Tank Automotive Research, Development and Engineering Center (TARDEC) provided 75 steel test coupons with the military spec Chemical Agent Resistant Coating (CARC) coating process to see if this coating could provide improved galvanic isolation between the steel and Mg samples compared to the previously evaluated conventional automotive coating processes. However, as can be seen in Figure 73, this coating was unable to withstand the UPJ process temperatures and forces. Due to the obvious extensive coating damage in the area of the UPJ joint, no corrosion testing was conducted.
