Sandia National Laboratories

Long-Term Stewardship

Sue Collins, Program Lead
10/25/2016

Sandia LTS Program

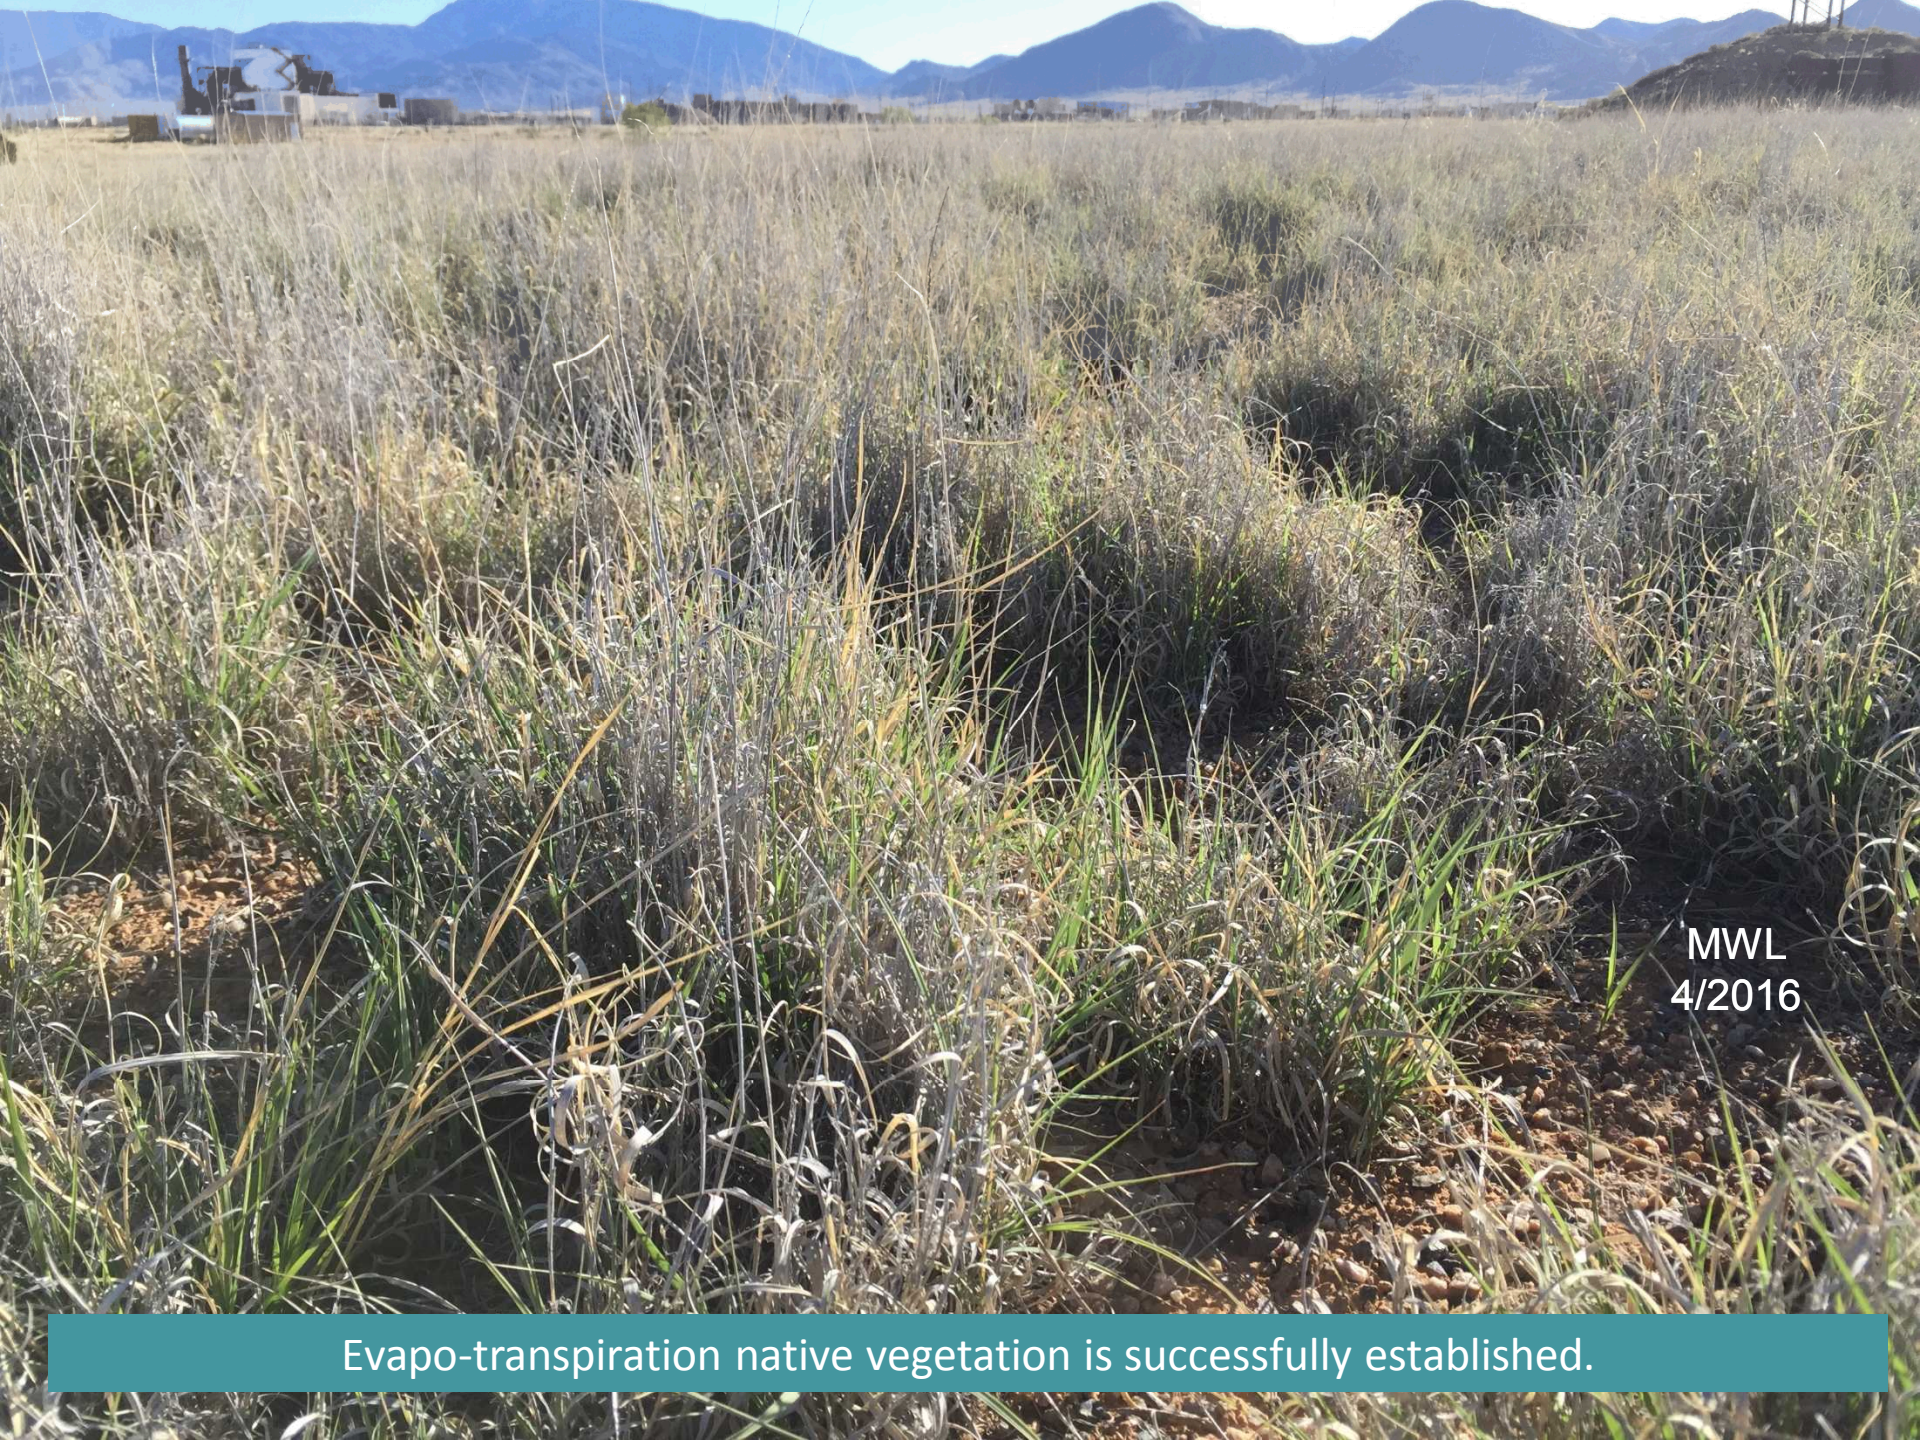
MWL
4/2016

Evapo-transpiration native vegetation is successfully established.

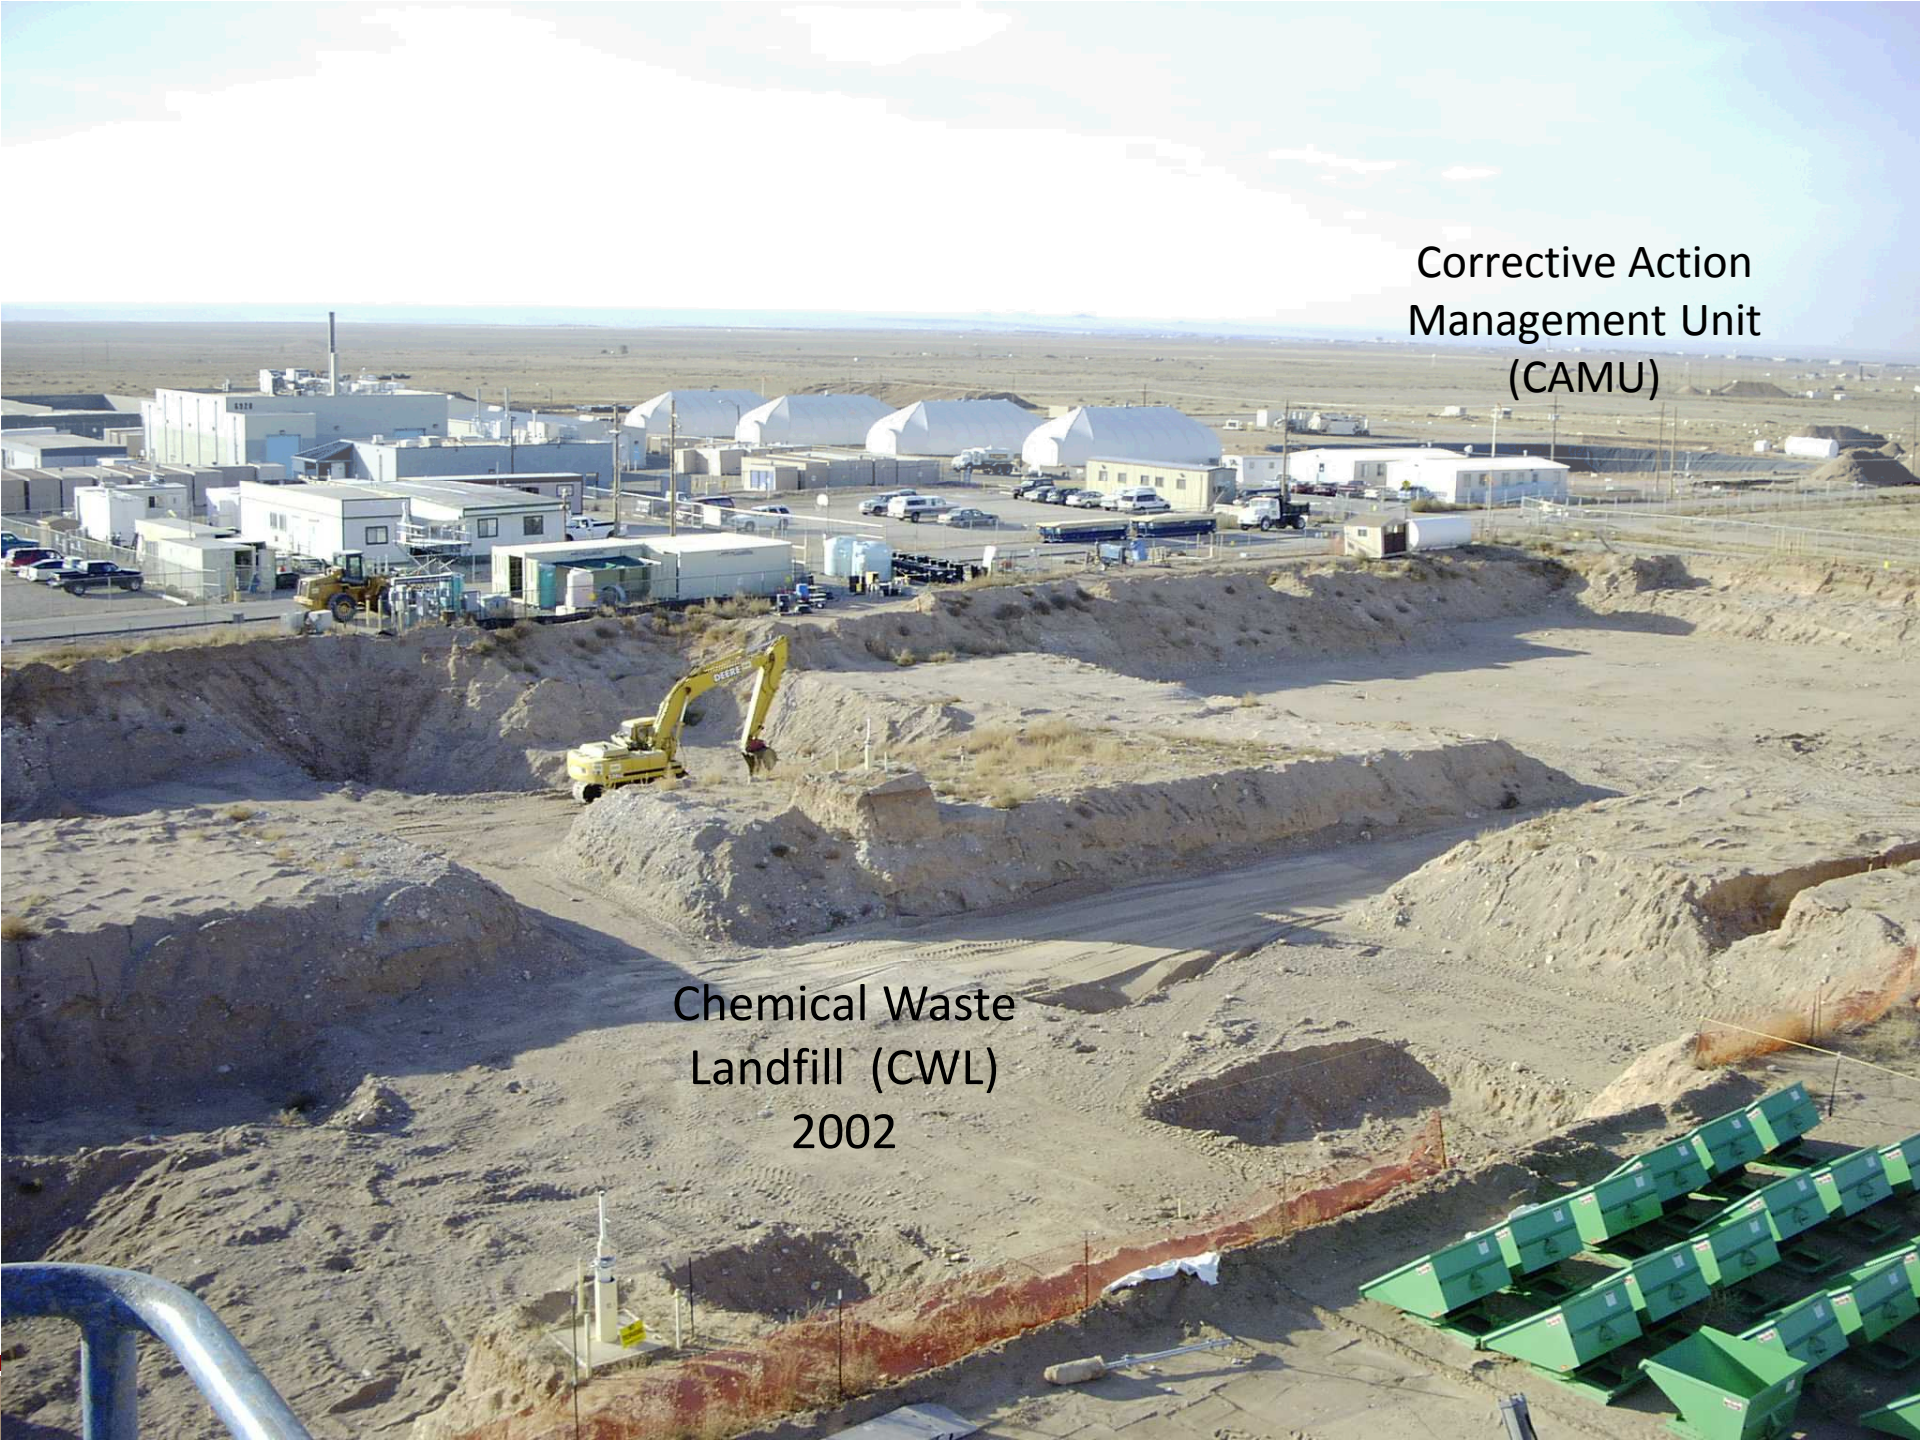
Chemical Waste Landfill today

4 groundwater wells
3 five-port vapor wells
2 three-port vapor wells

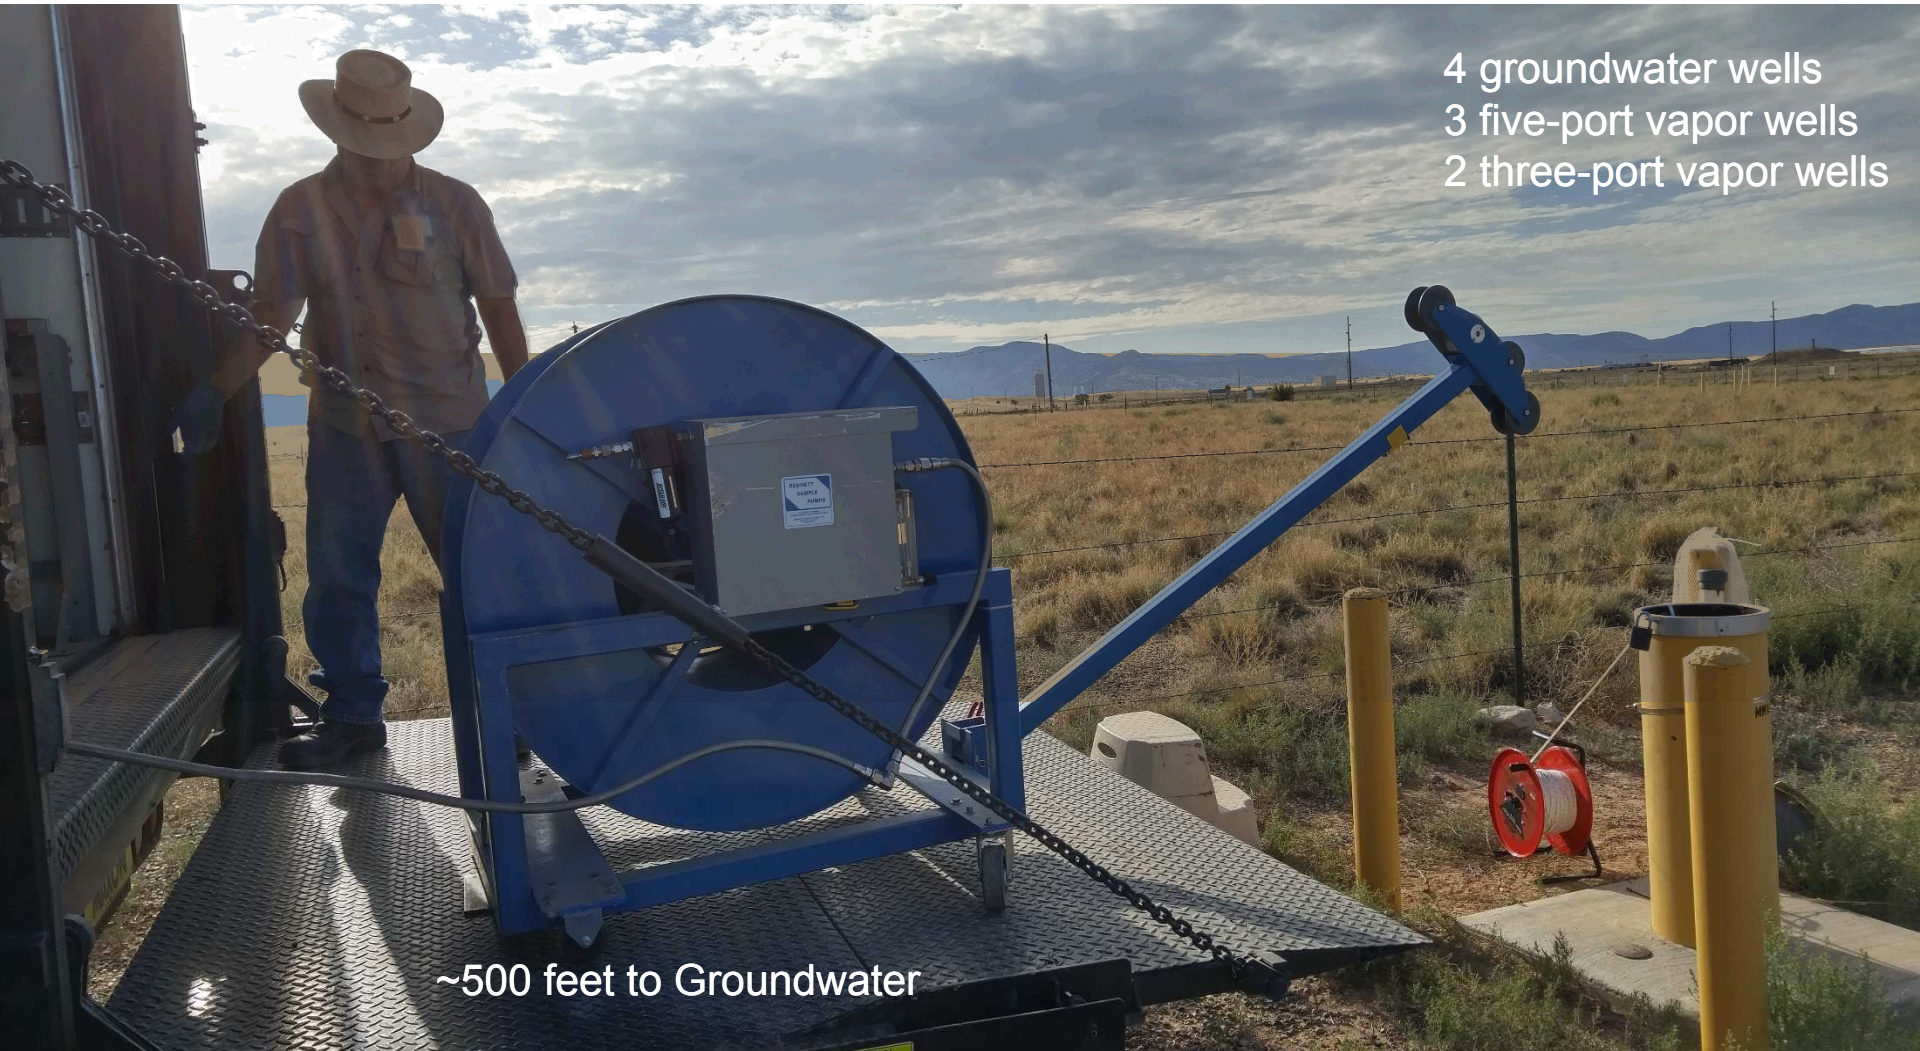
~500 feet to Groundwater

Groundwater Analyses
TCE, chromium, and nickel
Plus additional VOCs annually

Soil Vapor Analysis
VOCs

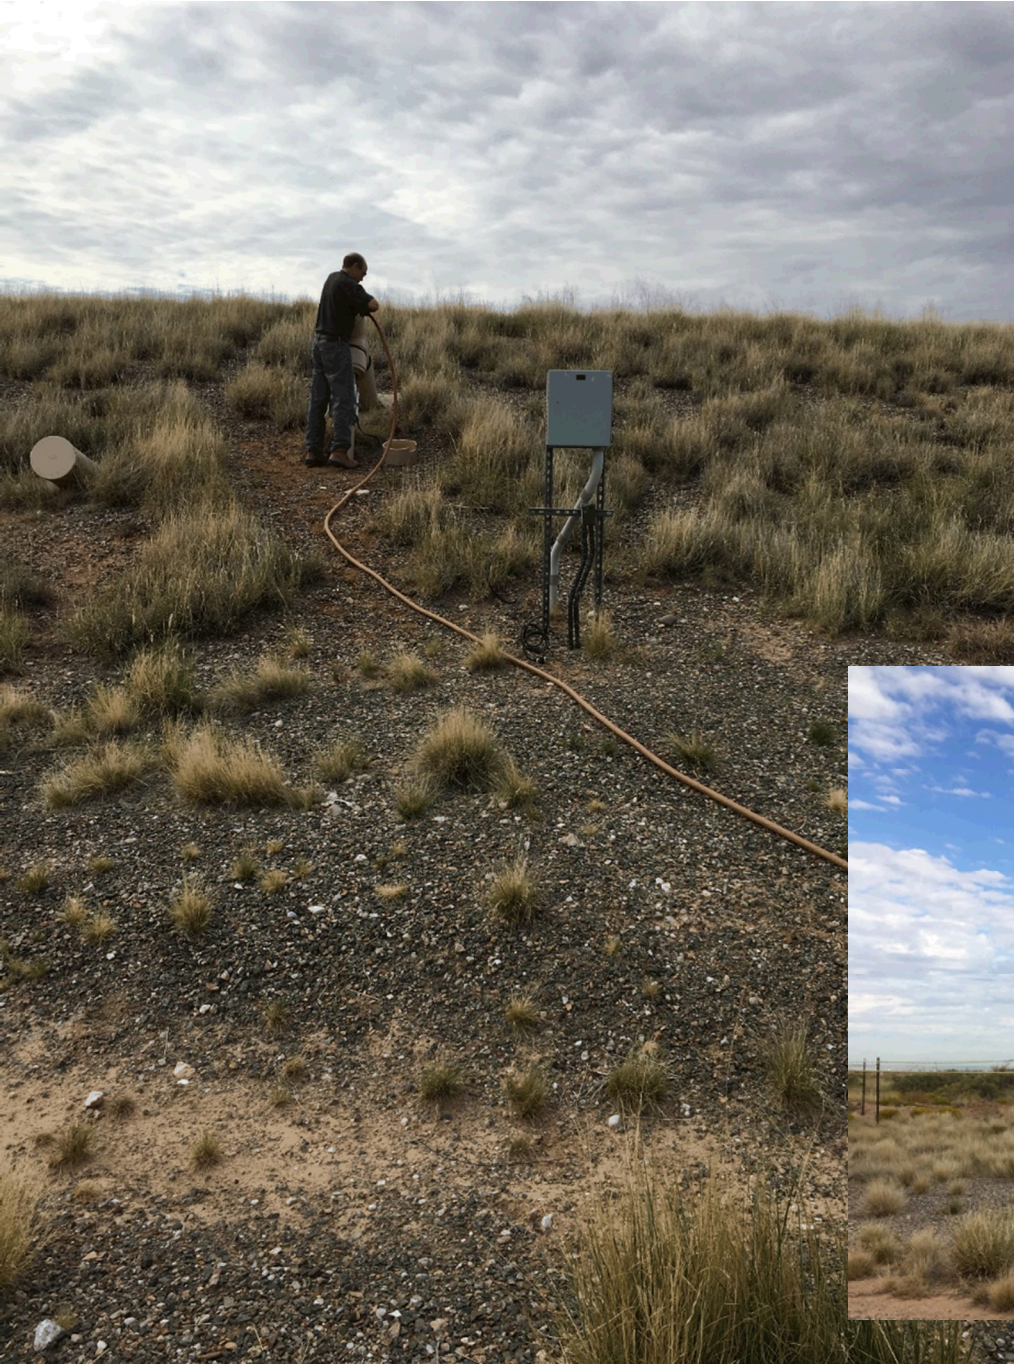
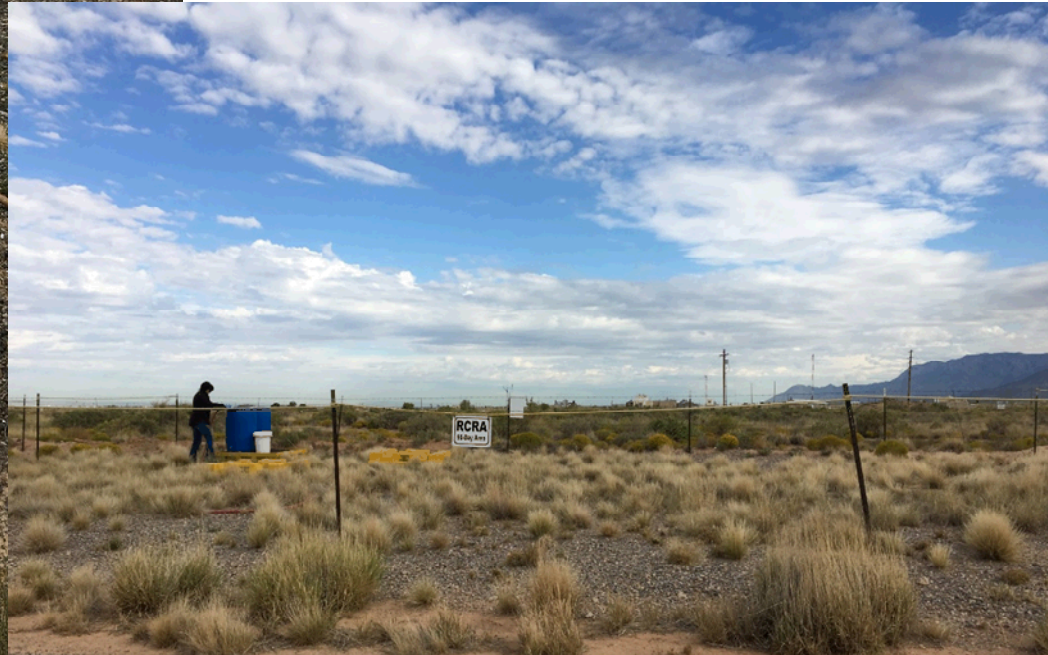
Leachate Collection and Removal System

<70 gallons per quarter today

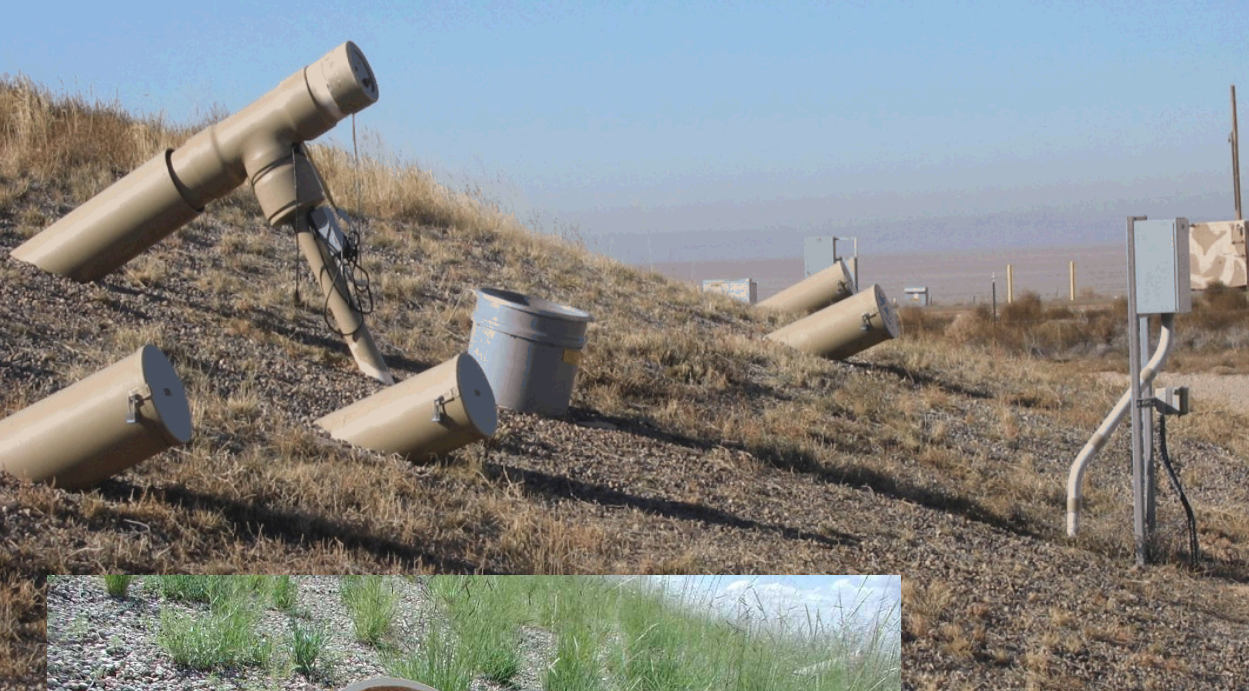
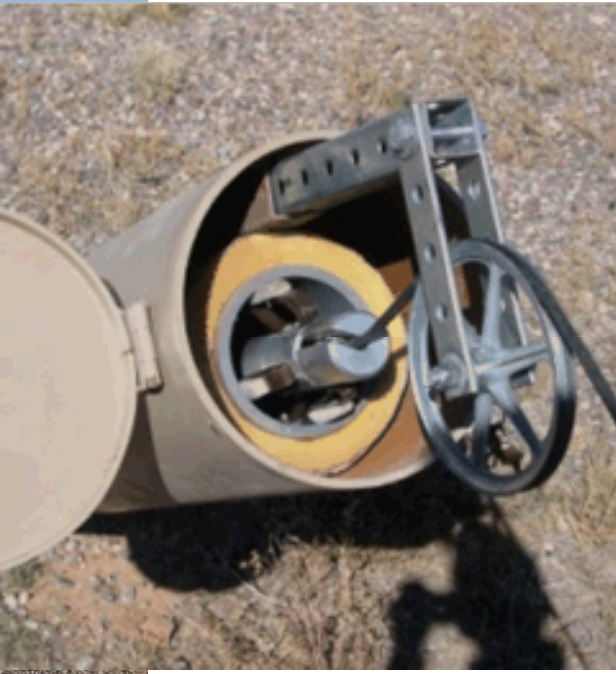
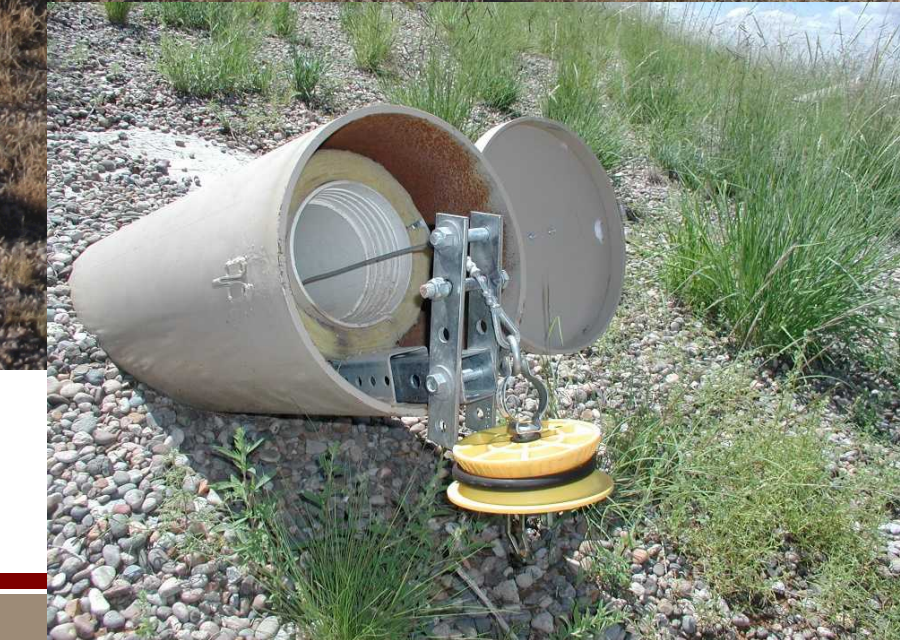
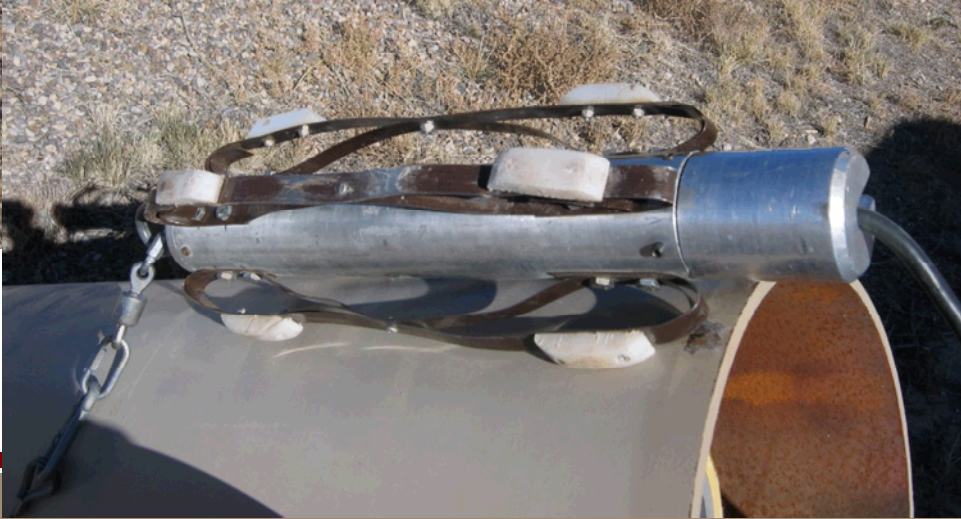
Primary Sub-liner Monitoring System

Vertical Sensor Array

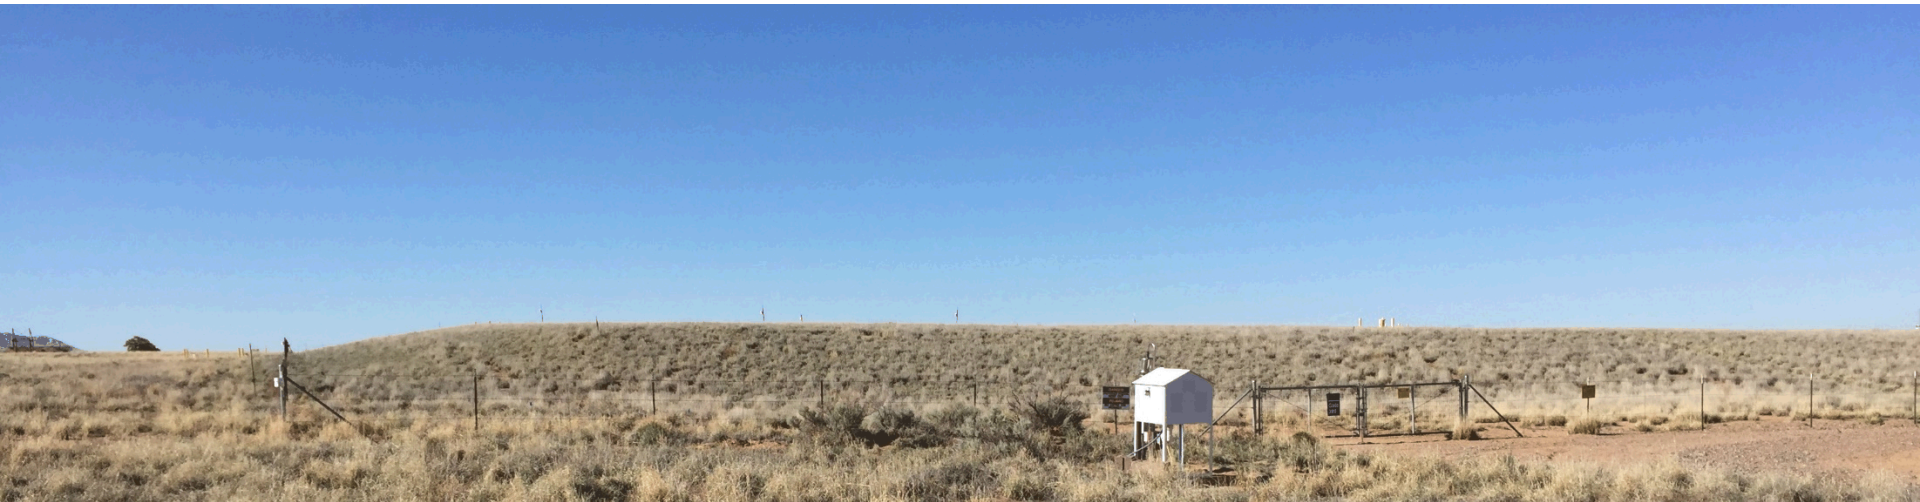
Cover design highlights:
Native grasses for evapo-transpiration
Rock bio-intrusion layer

The native community vegetation is successfully established.

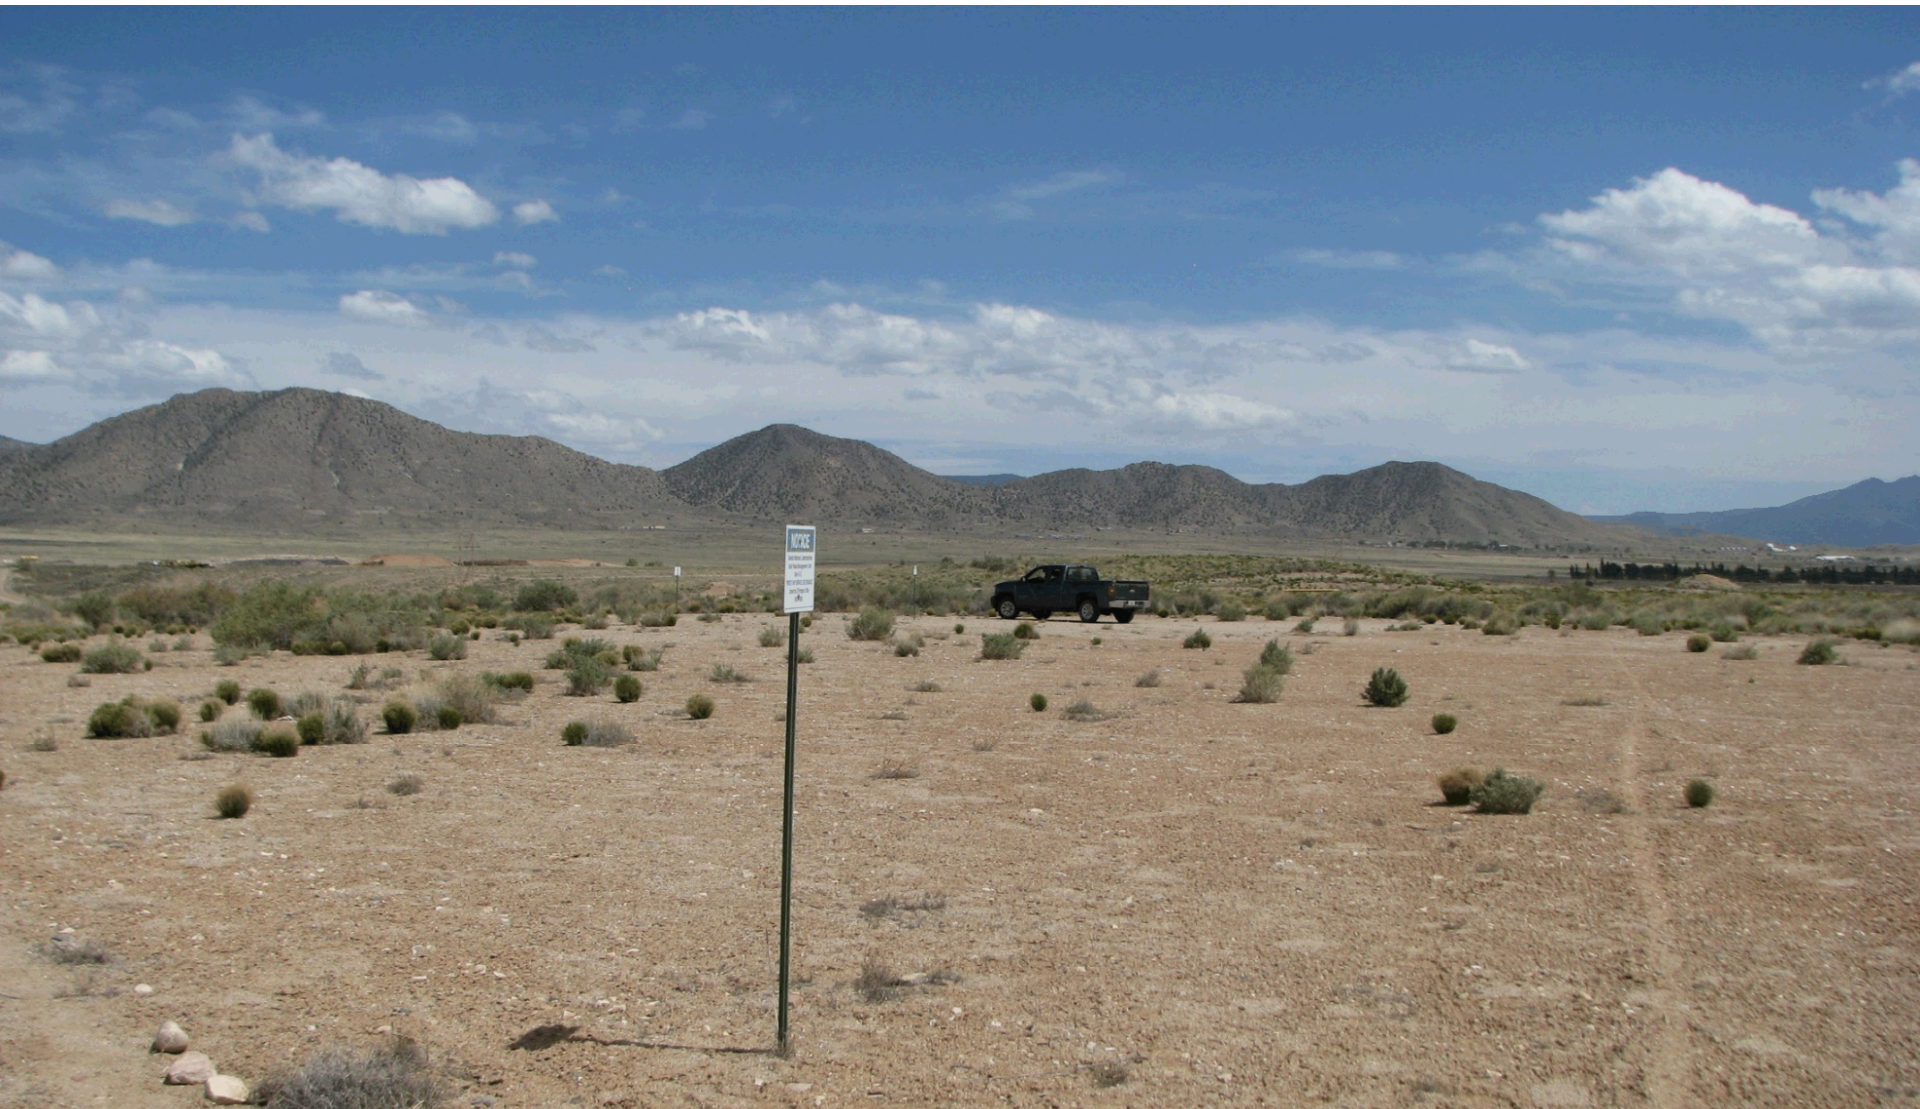
View from the hill east of Bldg. 9990. View to the west.

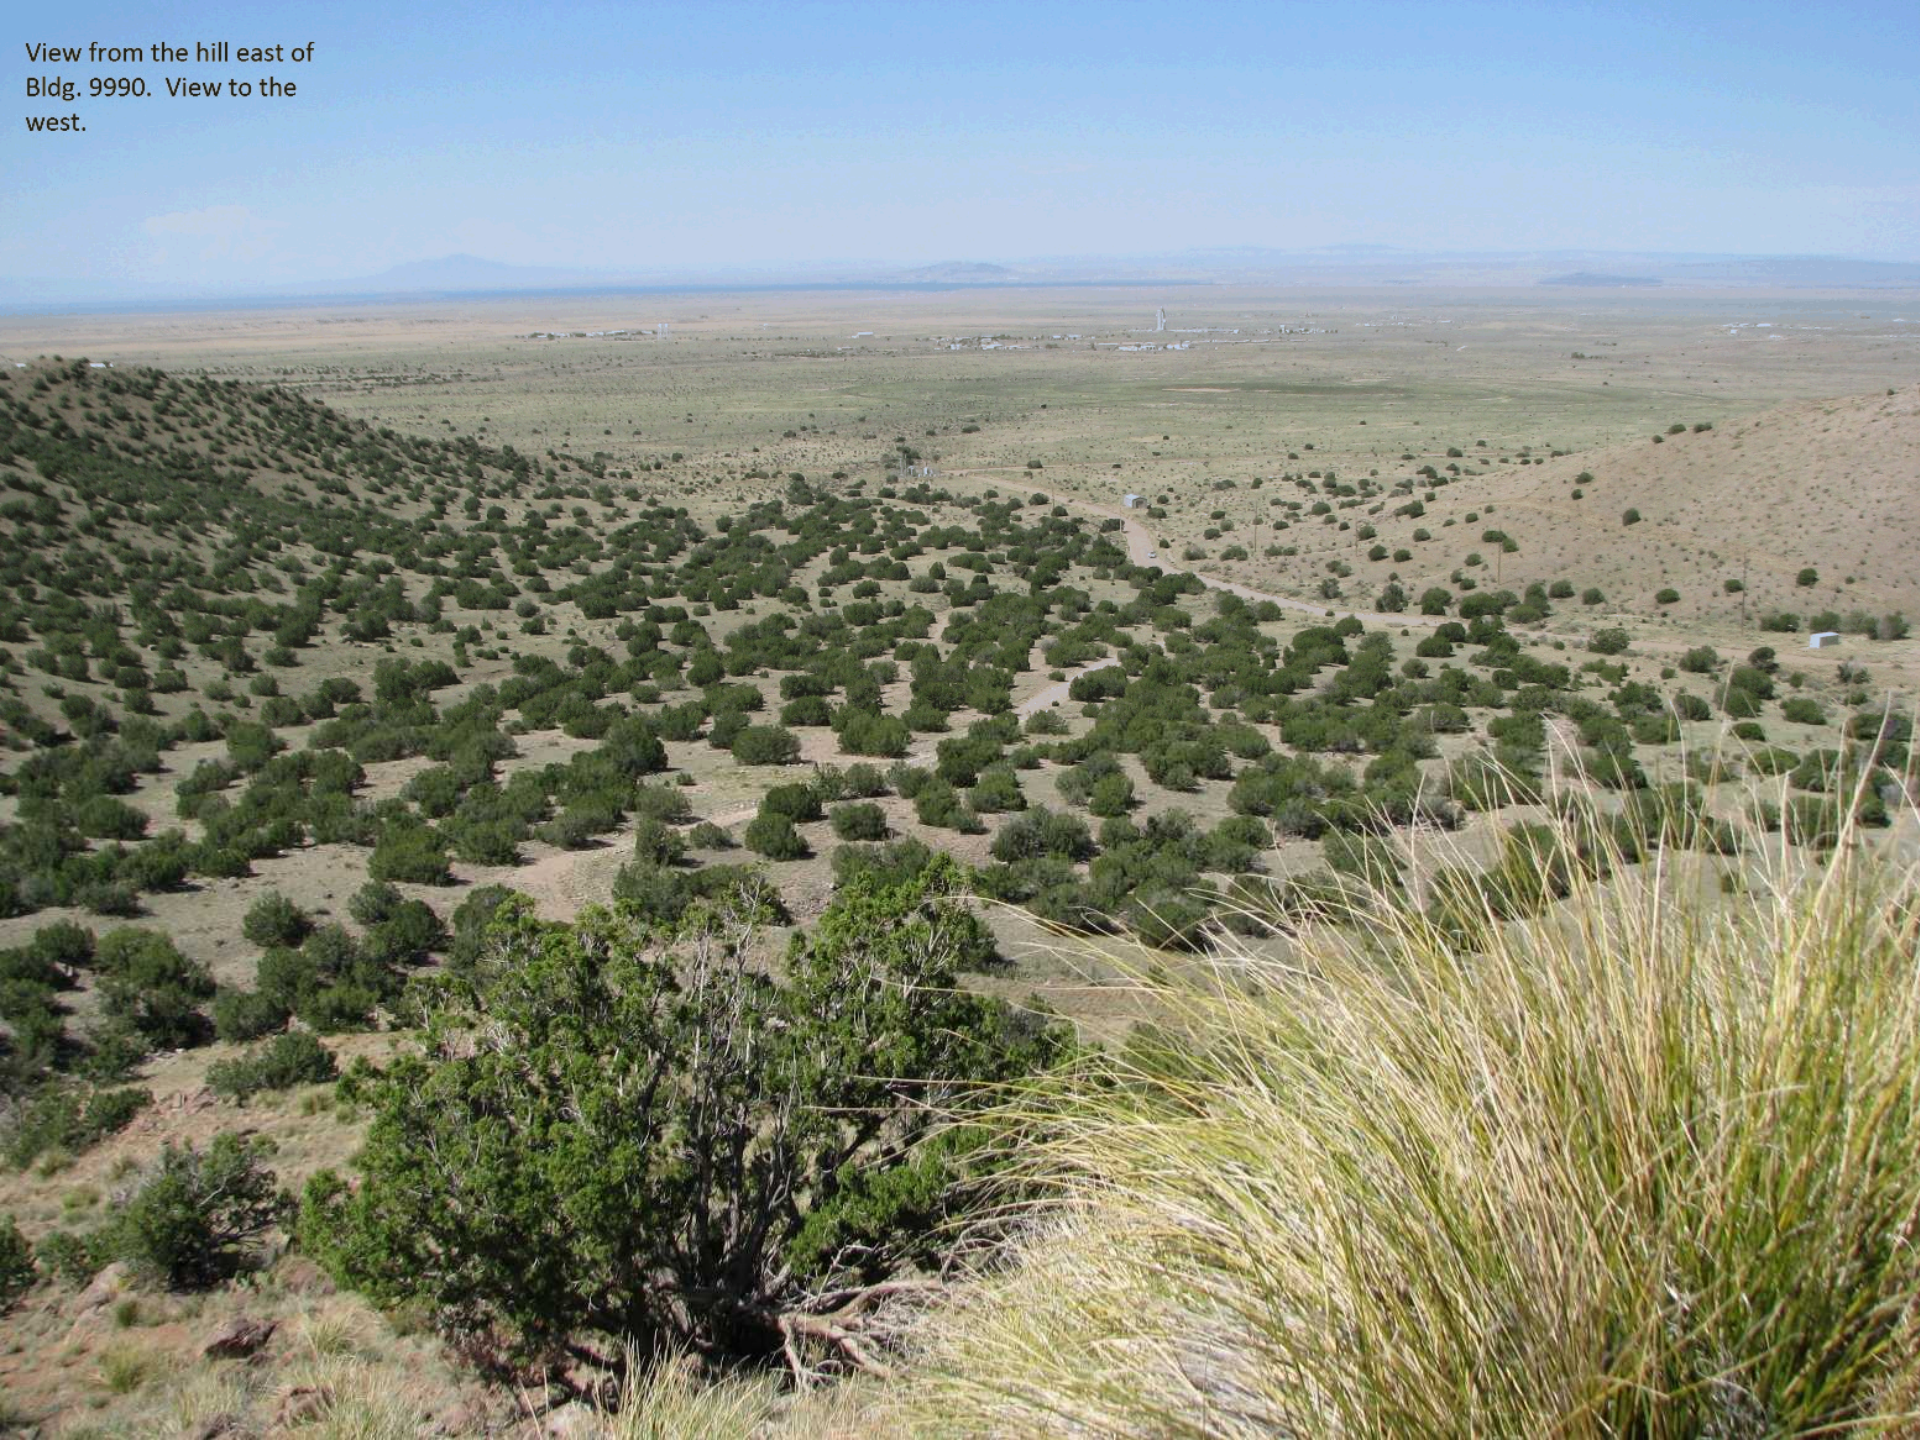
Photo 2. View from the same location as photo #1. View to the northwest.

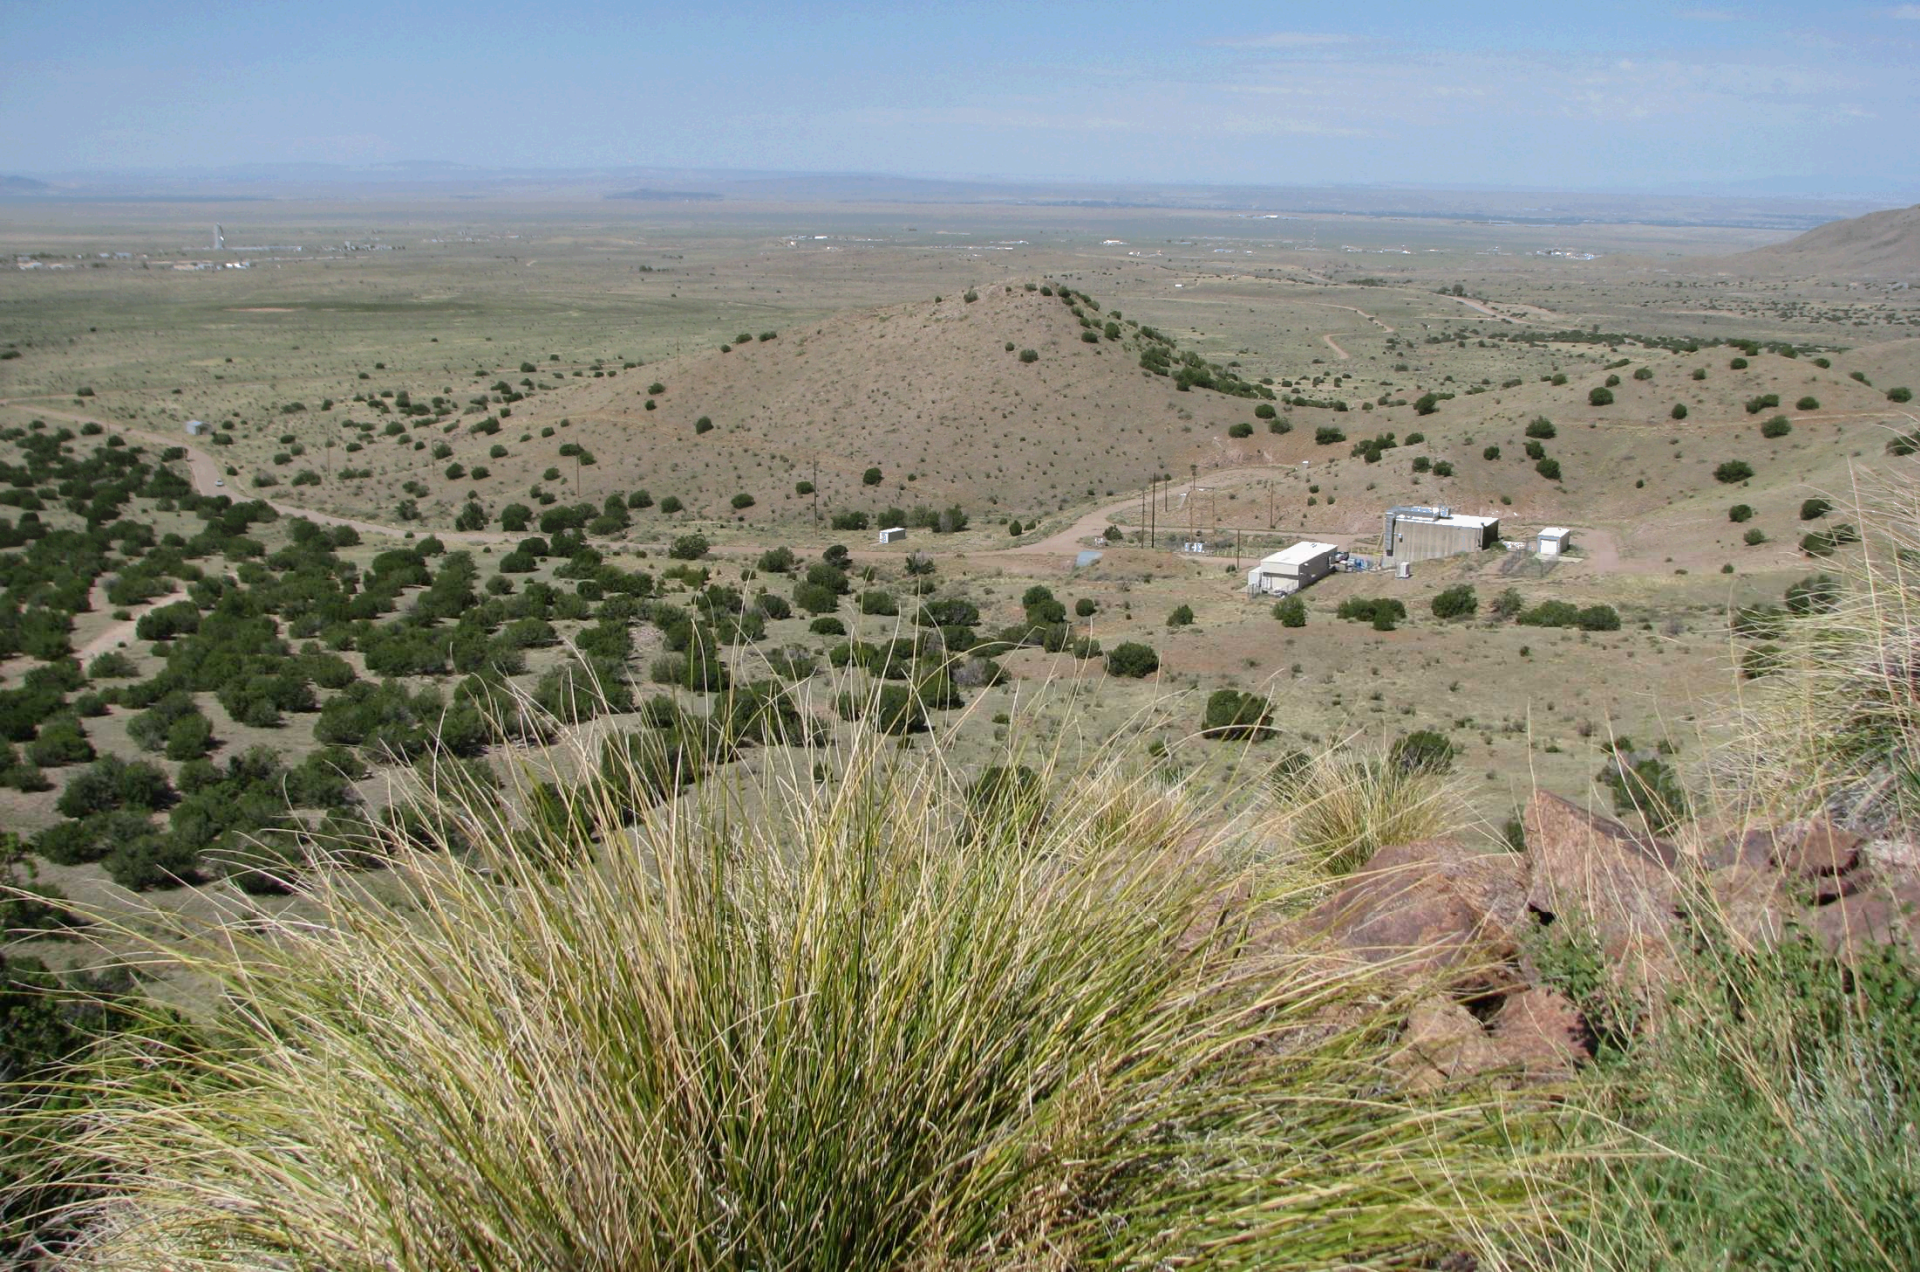
Photo 1. View to the east showing both signs. Signs are located on the perimeter of a circle formed by the signs.

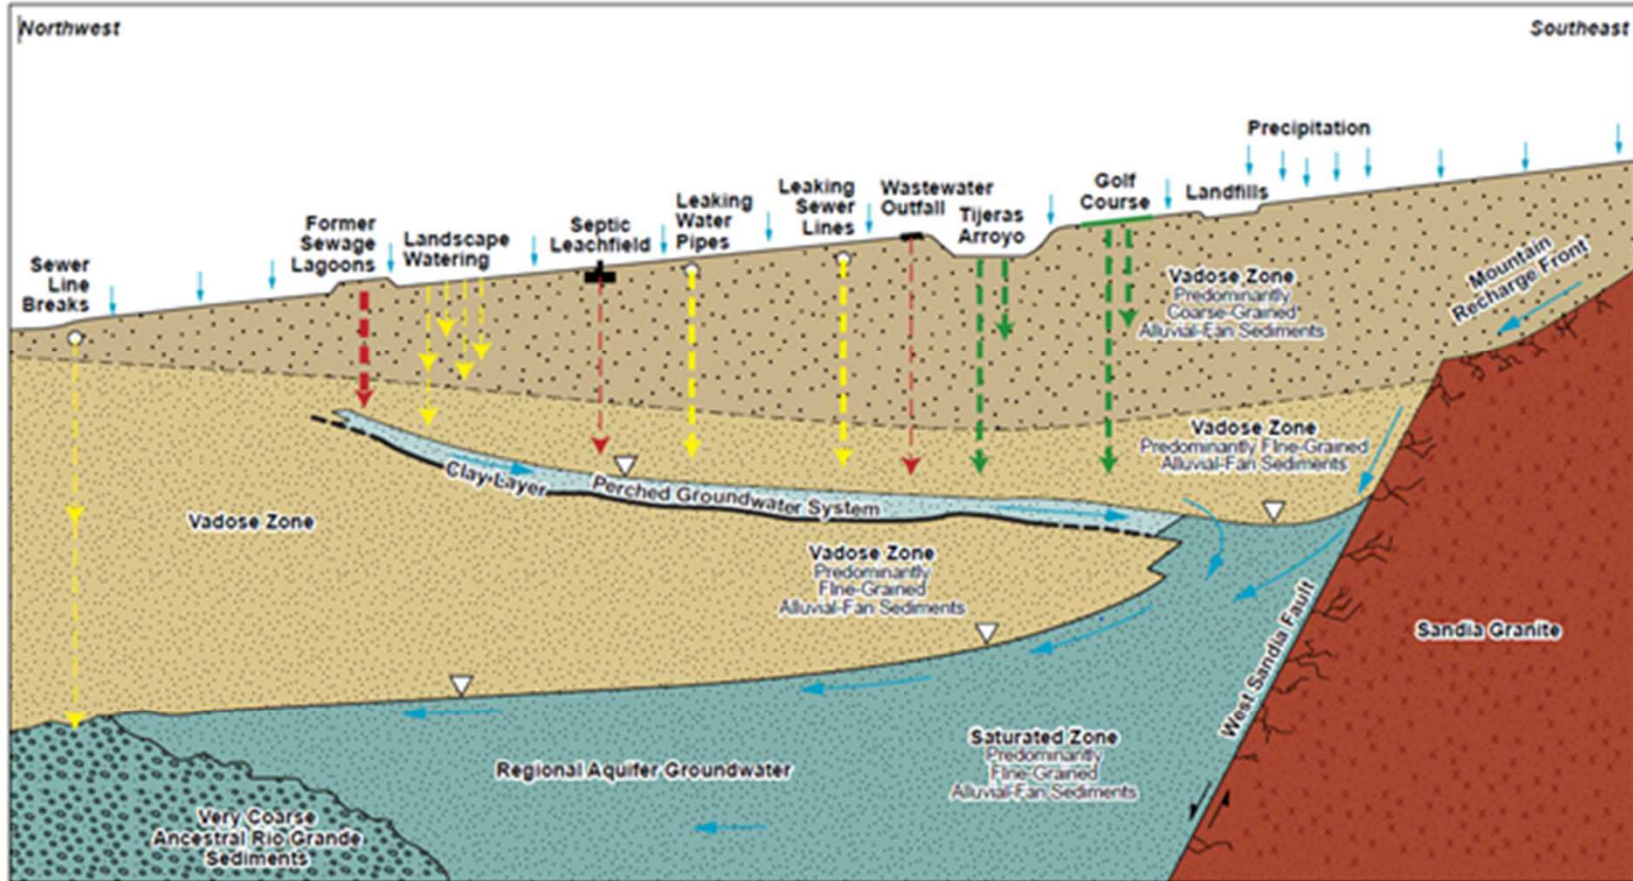
1462269_03015000_A3_TAG_SIMPLE

Groundwater Flow Model for TAG Area Showing Principal Recharge Features, View to Northeast, Not to Scale. Width of a recharge arrow signifies relative volume. Color signifies the duration: green arrow denotes ongoing recharge, yellow arrow denotes a reduced rate of discharge, red arrow signifies that recharge has stopped.
