# **Monitoring Potential Transport of Radioactive Contaminants in Shallow Ephemeral Channels: FY2015 and FY2016**

**Publication No. 45277**

Desert Research Institute  
Nevada System of Higher Education

October 2017

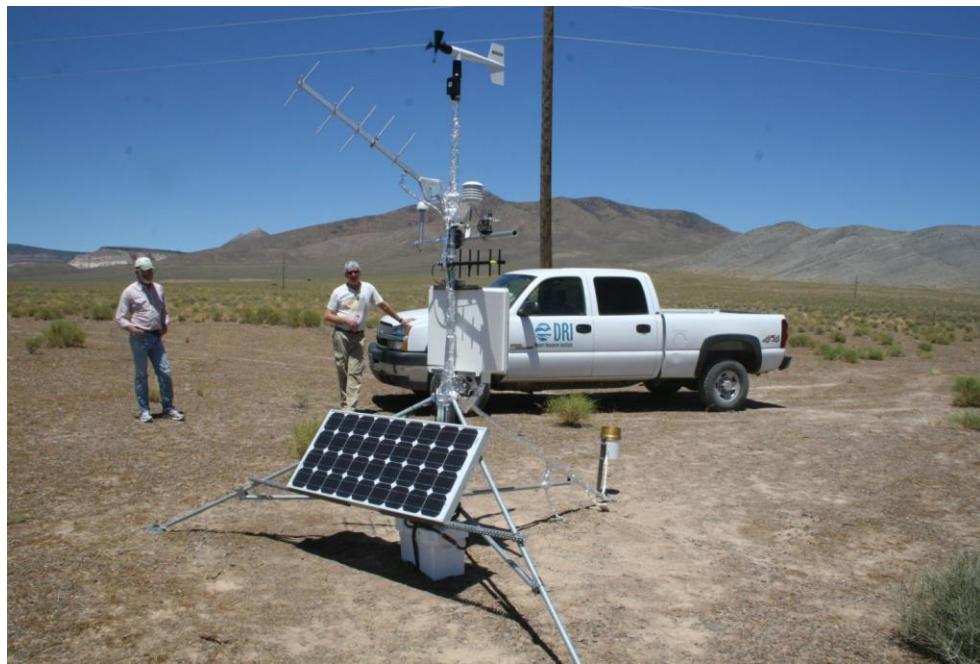
Figure 3. The Smoky CA meteorological station was installed to measure precipitation, wind, and other climate parameters.

The meteorological station—which has instrumentation to measure temperature, relative humidity, wind speed, wind direction, soil volumetric water content, soil temperature, solar radiation, barometric pressure, and precipitation—was installed in an uncontaminated area adjacent to the Smoky CA (Figure 3) on July 14 and 15, 2011. The coordinates of the meteorological station are  $37^{\circ} 10' 39.48''$  latitude and  $-116^{\circ} 4' 25.59''$  longitude. The meteorological station also includes Geostationary Operational Environmental Satellite (GOES) transmission equipment and equipment to receive radio frequency data transmissions from the flume instrumentation station (Figure 2). The accumulated meteorological data are transmitted daily to the Western Regional Climate Center (WRCC) at the DRI offices in Reno via GOES. At the WRCC, the data are uploaded to a restricted-access internet webpage that is available to project personnel.

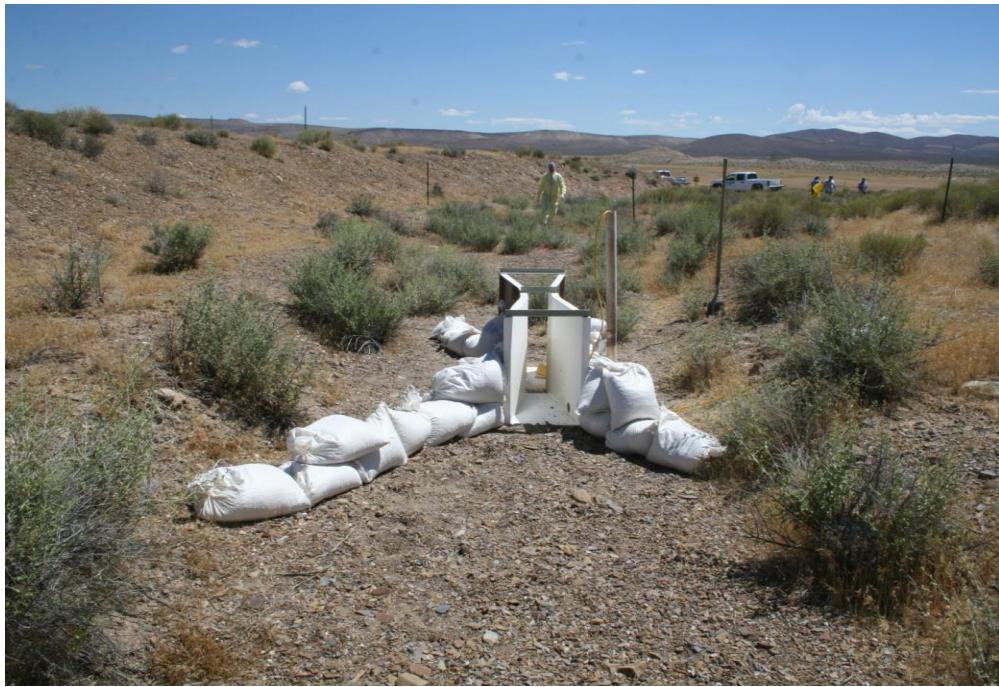
Figure 4. View looking downstream through the flume installed to measure runoff from the Smoky CA (prior to washout in July 2013).

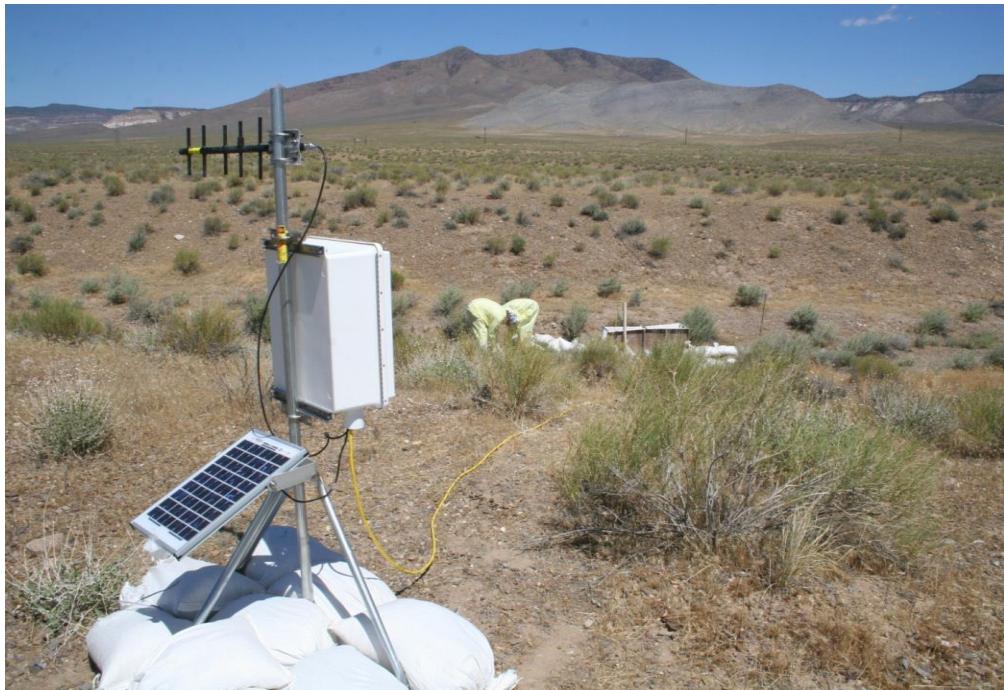
Figure 5. Runoff conditions in the flume are detected by the pressure transducer (yellow cable), recorded in the datalogger (white box), and relayed by radio (black antenna) to the meteorological station for transmission to the WRCC via the GOES.
