Correlating Defect Populations with Mechanical Performance in AM Tensile Samples of PH 17-4

O. Underwood¹, J. Madison¹, C. Finfrock², L. Swiler³,
B. Boyce¹, B. Jared⁴, J. Rodelas⁵, B. Salzbrenner¹

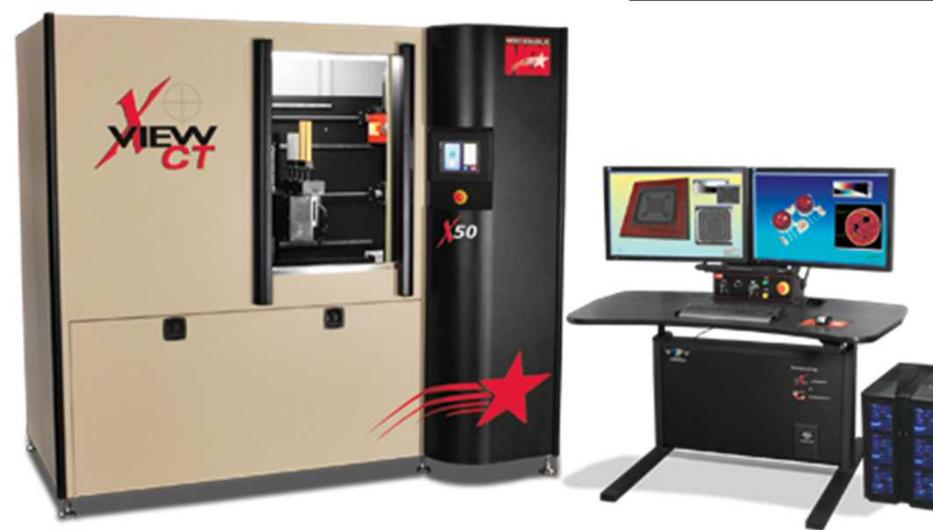
Using a North Star Imaging[®] Inc. X50 cabinet system and an Xray Works[®] 1500 uA table top system, both operating near 160kV, micro-computed tomography was performed on 100+ tensile bars from the Group 2, AM build. Effective pixel size for all samples ranged from 6.5 – 10.2 μ m per voxel edge.
