# Current Status of the Characterization of RPV Materials Harvested From the Decommissioned Zion Unit 1 Nuclear Power Plant

Conference Paper · July 2017

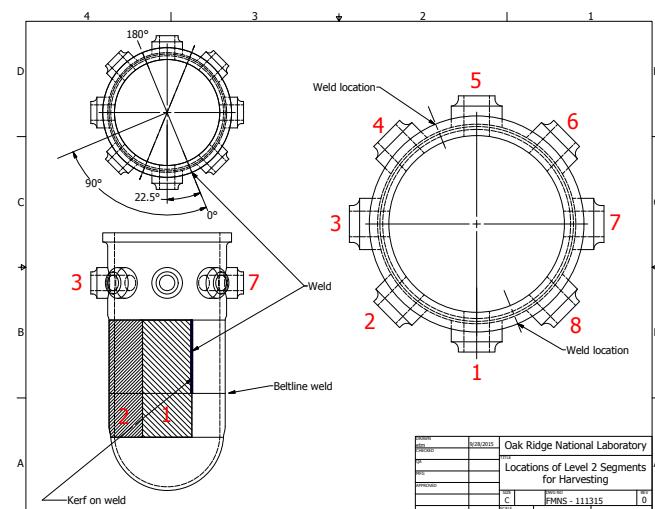
Fig. 1. Identification of Level 2 segments (1, 2, 5, and 6) collected as part of process to harvest Segment 1. Segment 1 contains the previously well-characterized base metal B7835-1 (intermediate shell) and WF-70 beltline weld [15].

The Zion Unit 1 RPV consisted of the head, three ring or shell sections composed of semicylindrical plates with two vertical welds, and a bottom plate as shown in a preliminary segmentation plan (Fig. 1). It had a height without the head plate of ~ 419 inches (1,064 cm). The vessel wall has an inner diameter of 173" (439 cm) and thickness of 8.8" (22.4 cm) over the beltline region. Including the cladding, the reactor vessel weighed about 700,000 lbs. (317,515 kg) and had a total activity of ~ 400 curies.

The Zion Unit 1 RPV was cut into 16 segments over three levels with horizontal cuts in the nozzle section just above the intermediate shell and midway into the lower shell above the bottom plate. Level 1, which includes the inlet and outlet nozzles, was cut into eight 45° segments of 157.5" (400 cm) in height. Level 2 was also cut into eight 45° segments of 157.5" (400 cm) in height and 72.9" (185.2 cm) in length as measured from end to end of the outer diameter (Fig.1).

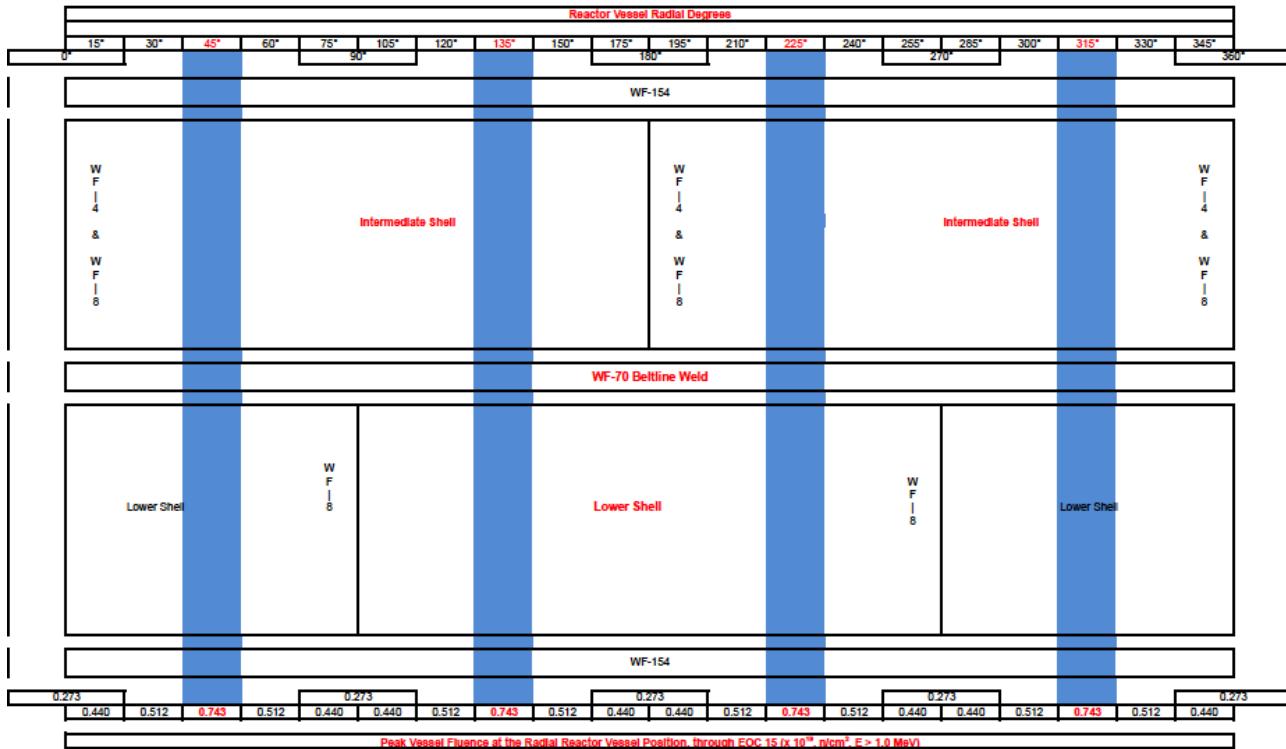
Fig. 2. Vessel fluence along the circumferential weld of the Zion Unit 1 RPV through End of Cycle (EOC) 13 ( $\times 10^{19}$  n/cm $^2$ , E > 1.0 MeV) is noted at the bottom of the diagram. Blue bands highlight the highest fluence regions [16].

An important consideration in the evaluation of which RPV segments to harvest is the circumferential fluence. As shown at the bottom of Fig. 2 and highlighted in blue, the peak circumferential fluence varies approximately by a factor of three over a 45° arc from the vertical weld positions to midway between the vertical weld positions. Based on this variation, the optimum region of beltline weld to harvest would be a section midway between the upper (intermediate shell) and lower (lower shell) vertical welds.

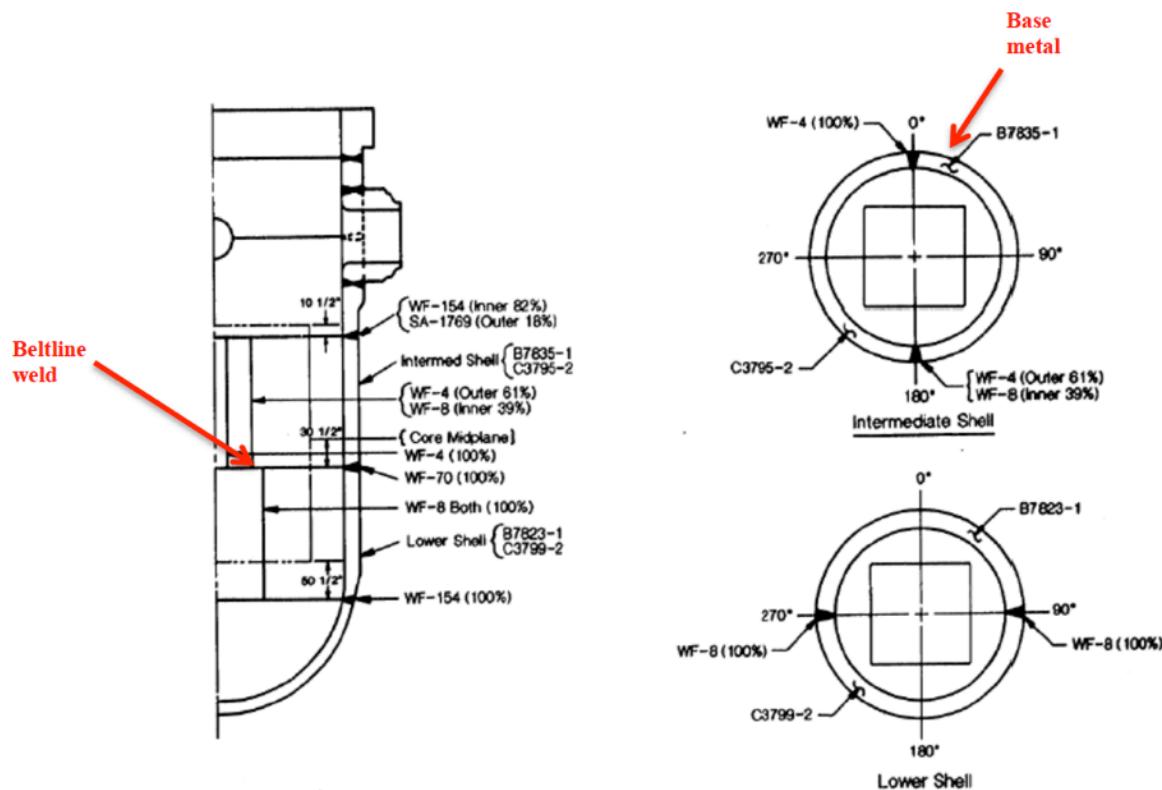
Fig. 3. Location of materials (beltline weld W-70 and base metal, B7835-1) used in the fabrication of the Zion Unit 1 beltline (intermediate shell to lower shell), two vertical welds above the beltline, and base metal heats [17].

Zion Unit 1 Beltline Weld Segment 1, with dimensions of 157.5" x 72.9" x 8.8" (400 x 185.2 x 22.4 cm) and containing the previously well-characterized WF-70 beltline weld and base metal heat B7835-1 (Fig. 3), was cut from just below the circumferential weld between the nozzle section and the intermediate shell to just above the circumferential weld between the lower shell and the bottom plate using an oxy-propane torch (Fig. 4). The right edge (as viewed from the outer wall of the RPV) begins at the  $0^\circ$  / WF-4 vertical weld (Figs. 2 and 3). Segment 1 was removed using a gripper crane and positioned on the "down-ender" frame (Fig. 5) to allow proper positioning in the steel-shipping box. Segment 5 was loaded face up and the matching segment (opposite side segment: Segment 1) was loaded face down (Figs. 6 and 7) to provide "clam-shell" shielding for shipment to the EnergySolutions Memphis Processing Facility (Figs. 8 & 9) for cutting the segment into specimen blocks [1].

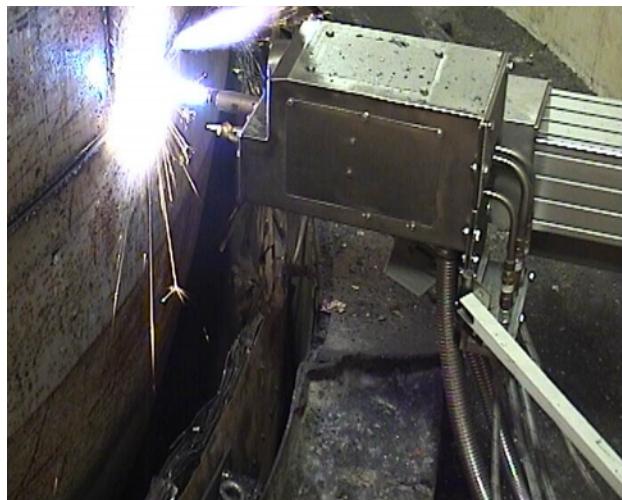
Fig. 4. Vertical cut using an oxy-propane torch of a Zion Unit 1 RPV Level 2 Segment [15].

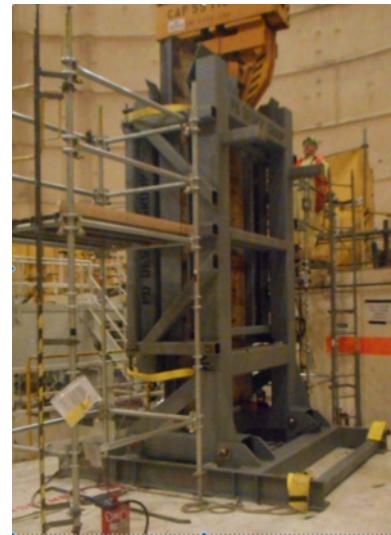
Fig. 5. Gripper crane and "down-ender" frame for repositioning segments into the shipment box [15].

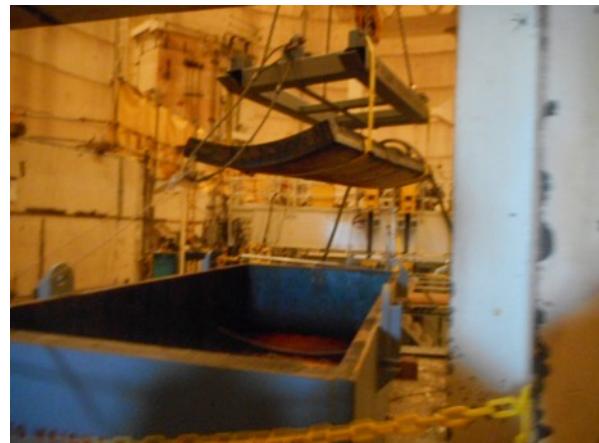
Fig. 6. Loading the matching segment (opposite side segment) face up into the shipping container box [15].

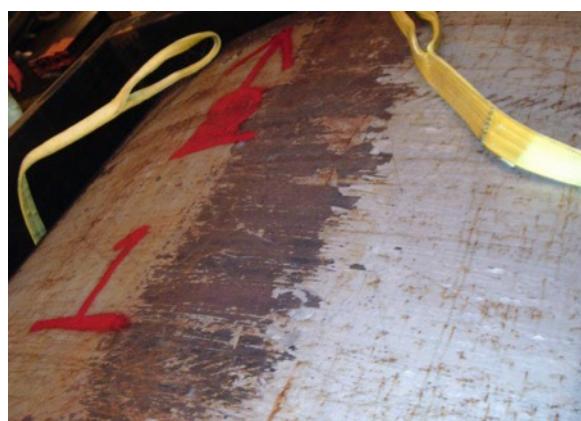
Fig. 7. Loading Segment 1 face down onto to Segment 5 (opposite side segment) into the shipping container box [15].

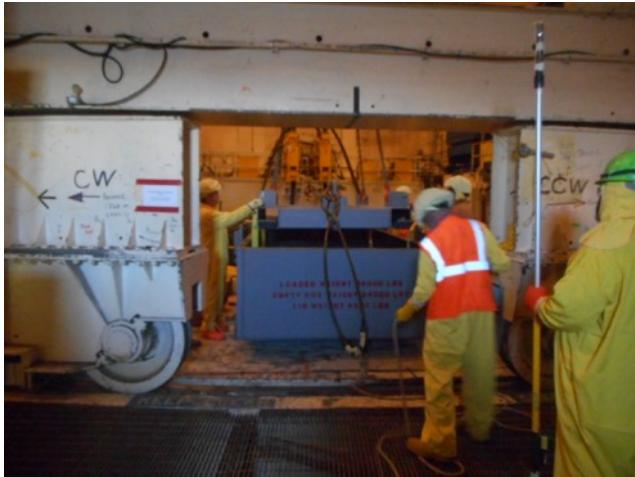
Fig. 8. Closing the steel box containing opposite side segment pairs for shielding and eventual loading into the rail car [15].

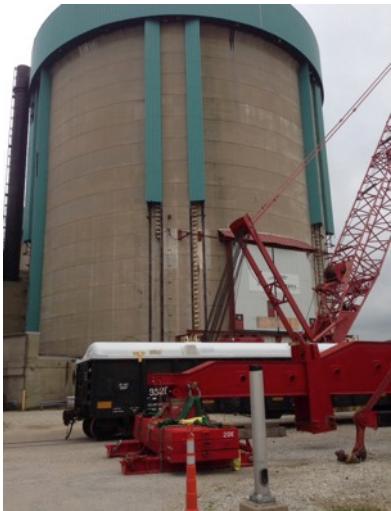
Fig. 9. Crane for loading 2 steel shipping boxes holding 2 pairs of Zion Unit 1 RPV segments into the railcar that was transported to the Memphis Processing Facility [15].

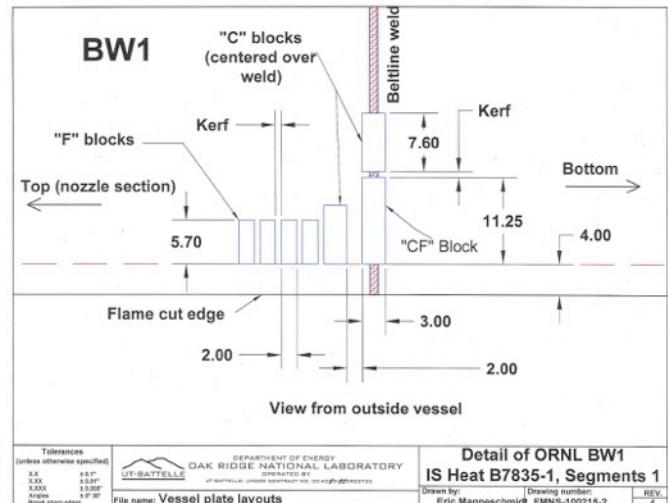
Fig. 10. Location of 5 base metal and 2 beltline blocks cut from Zion Unit 1 RPV Segment 1.

As shown in Figs. 10 and 11, plans to cut seven blocks, varying in length from approximately  $5.7 \times 2.0 \times 8.8$  inches ( $144.8 \times 50.8 \times 223.5$  mm) to  $7.6 \times 3.0 \times 8.8$  inches ( $193.0 \times 76.2 \times 223.5$  mm) to  $11.25 \times 3.0 \times 8.8$  inches ( $285.8 \times 76.2 \times 223.5$  mm) and designated "F," "C," and "CF," using a diamond wire saw were developed to obtain sufficient through-vessel mechanical test specimens from the beltline weld and base metal to assess radiation embrittlement models and for possible annealing and re-irradiation experiments. The block designations correspond to the type of samples to be machined. For example, "F" blocks for fracture toughness, "C" blocks for Charpy and tensile specimens, and the "CF" block for alternating rows of fracture toughness and Charpy specimens.

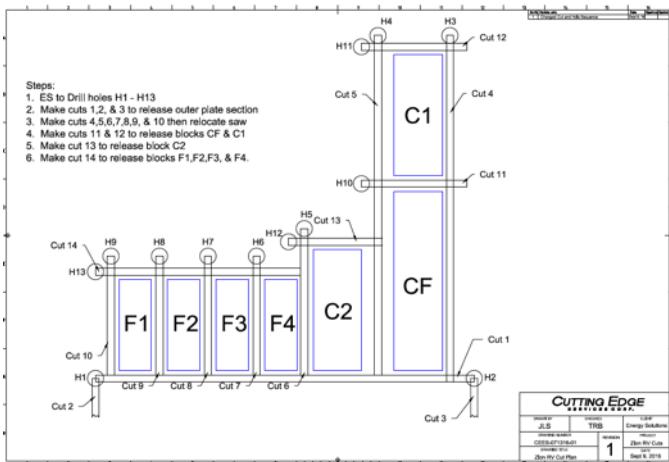
Fig. 11. Cut plan (based on Fig. 10) noting the blocks (blue outline), the wire saw access holes and cut [15].

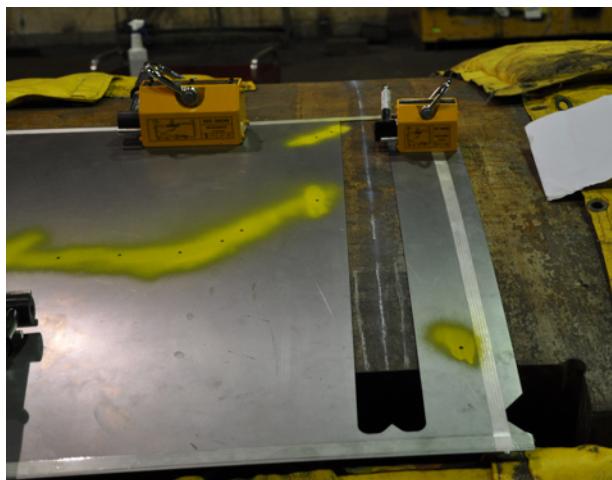
Fig. 12. A metal template was aligned with the beltline weld (chalk line) and holes for threading the diamond wire [15].

Once the position and slope of the weld were determined, a thin metal template was placed over the segment and aligned with the beltline weld (Fig. 12). The template was designed based on the location of the blocks relative to the beltline weld and base metal and the location of the 13 holes used to thread the wire to cut the blocks, including the kerf, along the lines as seen in Fig. 11. The holes were used for inserting the diamond wire to cut the 2 beltline weld and 5 base metal blocks from Segment 1 as shown in Fig. 13. With the completion of Cut 11 (Fig. 13), the CF block was removed from Segment 1 (Figs. 14 and 15) using a lift magnet. Similarly, the remaining blocks were successfully cut and lifted out from Segment 1.

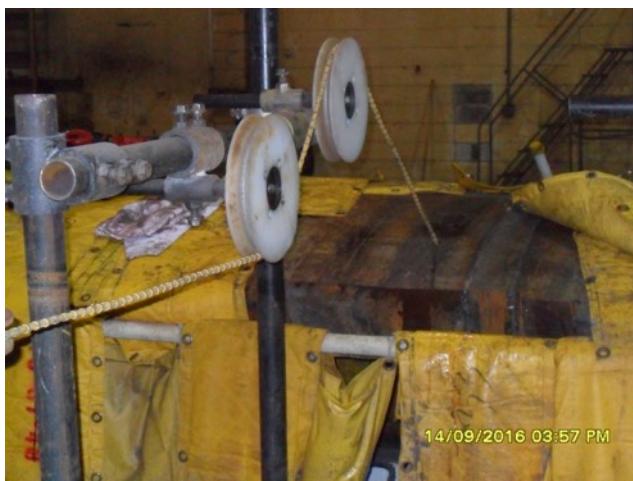
Fig. 13. Wire saw cutting parallel to the beltline weld [15].

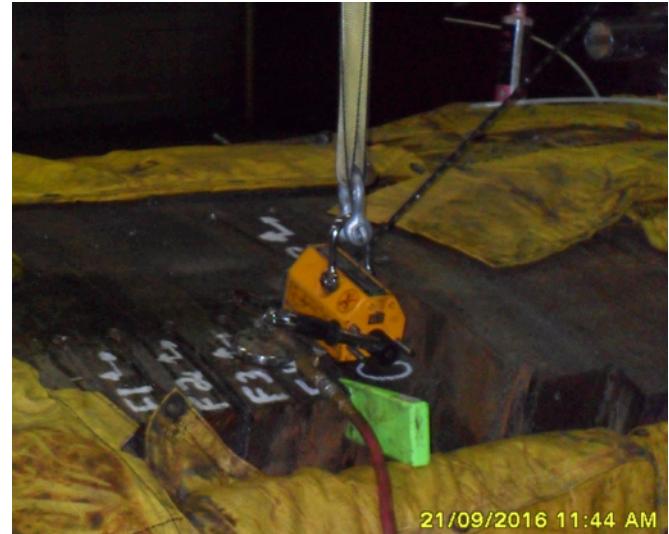
Fig 14. Lift magnet used to remove the cut blocks [15].

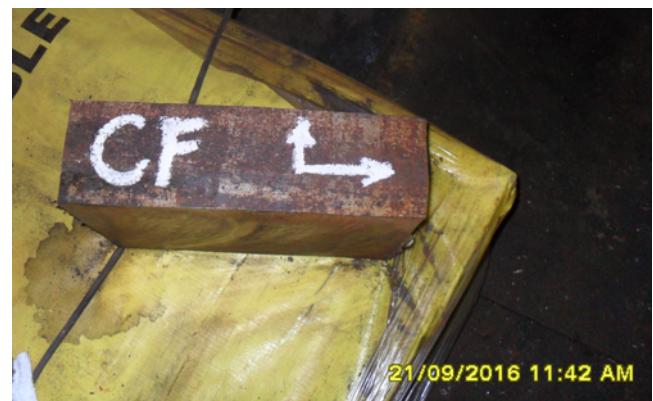
Fig. 15. CF block with orientation marked (Y axis is perpendicular to the beltline weld with the arrow pointing to the top of the segment and the X axis is parallel to the weld with the arrow pointing to the right of the segment) [15].

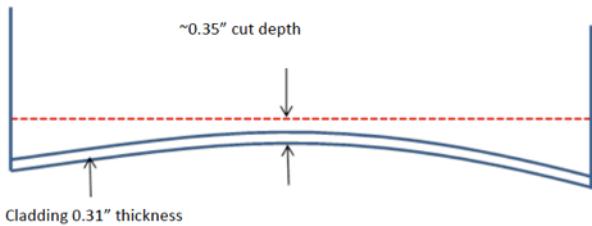
Fig. 16. Sketch of cladding cut off from Segment 1 blocks [18]

Following receipt of the Zion Unit 1 RPV sample blocks at BWXT the seven blocks were inspected and radiation levels verified, and the stainless steel cladding removed. This simple process was performed with an electrical discharge machining (EDM) using a 0.010" (.25 mm) diameter wire. The cut with the kerf created a straight ~0.1" (2.5mm) cut above the apex of the cladding and approximately 0.35" (8.9 mm) into the block from the outside of the cladding. The cladding thickness was measured manually to verify that no remnant pieces remained on the RPV steel block. A rough sketch of the cut is shown in Fig. 16.

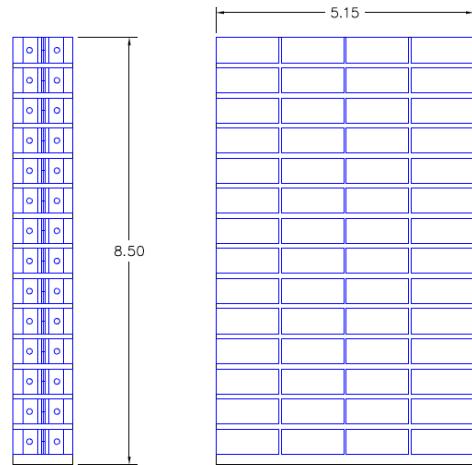
Fig. 17. Layout for machining compact tension specimens from "F" blocks from RPV Segment 1.

As shown in Fig. 17, a total of 56 compact tension specimens were machined from each of two F blocks. The base metal F block layout is such that 4, 0.5T C(T) specimens were machined from each row oriented along the circumferential direction of Segment 1 (parallel to the beltline weld) and 14 specimens were machined through the thickness of the vessel segment.

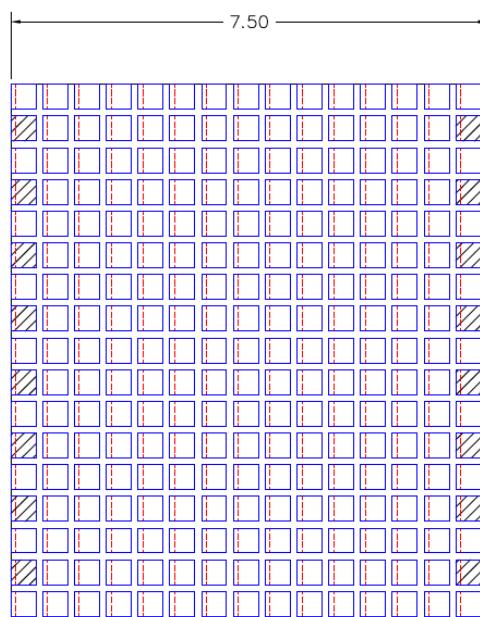
Fig. 18. Layout for machining Charpy and tensile specimens from the block C2. Hatched blocks were machined into SS3 tensile specimens and coupons.

As shown in Fig. 18, a total of 255 Charpy-size (10 x 10 x 55 mm) bars were machined from base metal block C2. Fifteen specimen bars were machined from each row oriented along the circumferential direction of the segment (parallel to the beltline weld) and 17 bars were machined through the thickness of the vessel segment. From those 255 Charpy-sized bars, 239 CVN specimens (10 x 10 x 55 mm) were machined. The remaining 16 Charpy-size bars were machined into 128 SS3 tensile specimens (25.4 x 5 x 0.76 mm) and 64 coupons (10 x 10 x 0.5 mm) for chemical and microstructural characterization (Fig. 19).

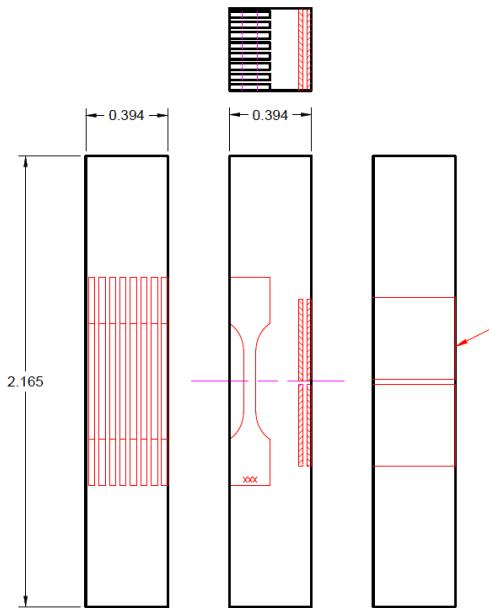
**Fig. 19.** Charpy-sized bar machined into 8 SS-3 tensile specimens and 4 chemical and microstructural coupons/

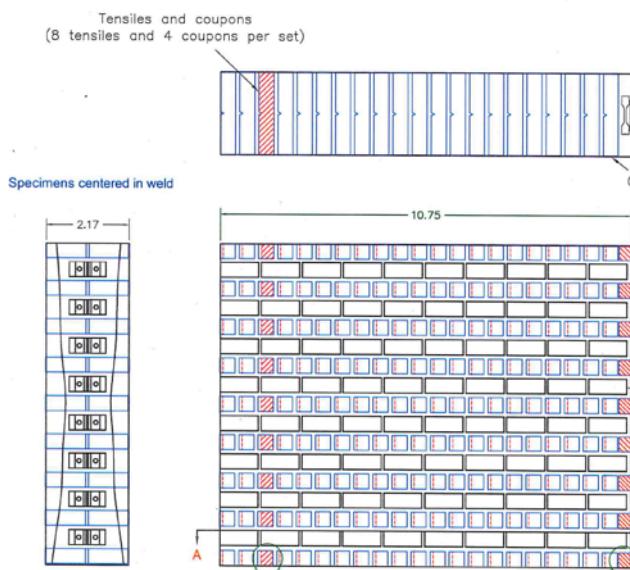
**Fig. 20.** Detailed CF block layout of alternating rows of 0.4T C(T) and Charpy specimen positioned over the WF-70 beltline. Hatched blocks were machined into SS3 tensile specimens and chemical and microstructural coupons.

Prior to machining the beltline weld CF block, chemical etching, using a 10% Nital solution, identified the centerline and cross-section of the weld. This was critical to insure that the V-notch of the Charpy specimen, the gauge section of the SS3 tensiles, and the 0.4T C(T) notches were centered on the beltline weld as shown in Figs. 20 and 21.

Following the etching, twenty-two specimen bars were machined from alternating rows oriented in the circumferential direction of the segment (aligned with the beltline weld) and 9 bars were machined through the thickness of the vessel segment. From those 198 Charpy-sized bars, 180 CVN specimens (10 x 10 x 55 mm) were machined. The remaining 18 Charpy-size bars were machined into 144 SS3 tensile specimens and 72 coupons (10 x 10 x 0.5 mm) for chemical and microstructural characterization. Finally, 80 compact tension specimens were machined from the CF block. Specifically, ten 0.4T C(T) specimens were machined from alternating rows oriented in the circumferential direction of Segment 1 (aligned with the beltline weld) and 8 specimens were machined through the thickness of the vessel segment.

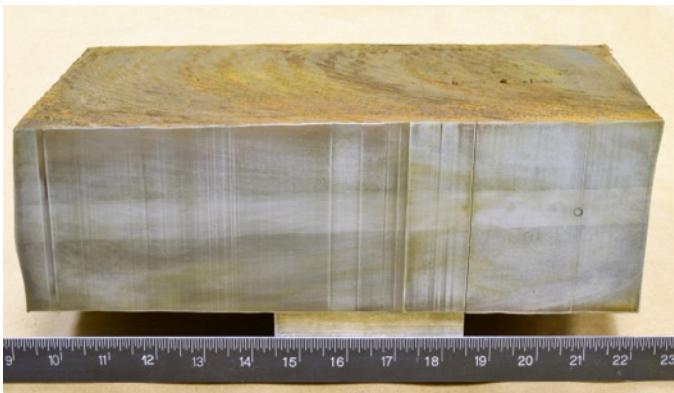
Fig. 21. WF-70 Beltline weld revealed after removing the cladding and etching block CF [18].
