Title: Residual Stresses in SAVY 4000 and Hagan Container Bodies

# Residual Stresses in SAVY 4000 and Hagan Container Bodies

## Abstract

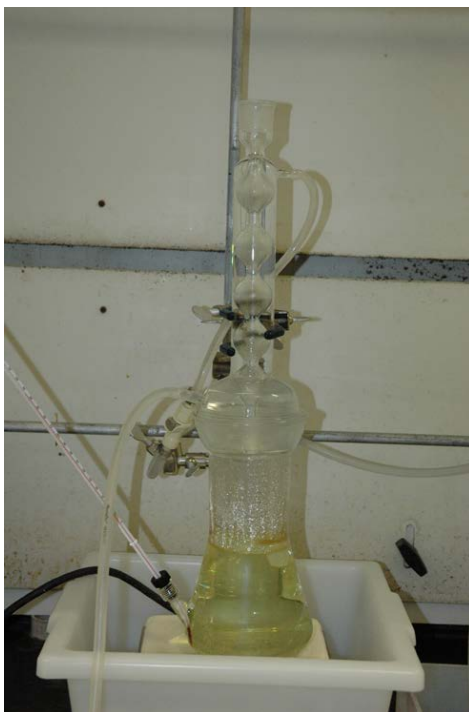
*Figure 4 Experimental set-up for the boiling  $MgCl_2$  experiment on container pieces.*

A quarter section of a 3013 SRS/Hanford inner container was also present in the flask during the experiment. All container sections were ultrasonically cleaned for five minutes in Alconox detergent, and subsequently rinsed with isopropyl alcohol. The test was in accordance with *ASTM standard G36: Evaluating resistance to SCC of metals and alloys in boiling  $MgCl_2$* <sup>2</sup> except that temperatures were lower than the 155° C stated in the standard. No boiling chips were used. Glassware and set-up (Figure 4) is described in ASTM G36.

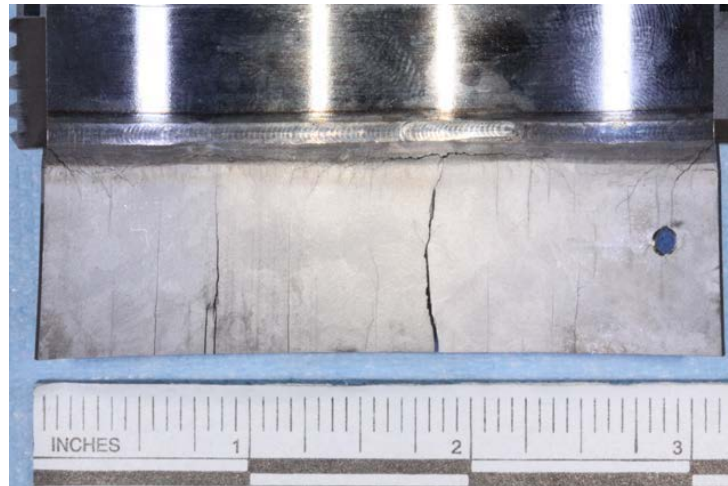
*Figure 6 Inner contour of the Hagan-1 section after 16 hours of exposure to boiling MgCl<sub>2</sub>.*

*Figure 7 Outer contour of the Hagan-1 section after 16 hours of exposure to boiling MgCl<sub>2</sub>.*

Extensive through wall cracking parallel and perpendicular to the weld was observed in the Hagan-1 section. Vertical through wall cracks propagated through the entire length of the wall piece.

Photographs of the Hagan-1 section after the 16 hour exposure are shown in Figures 6 and 7.

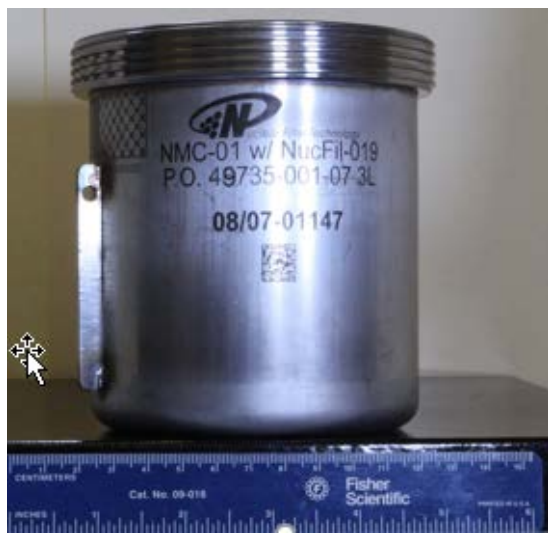
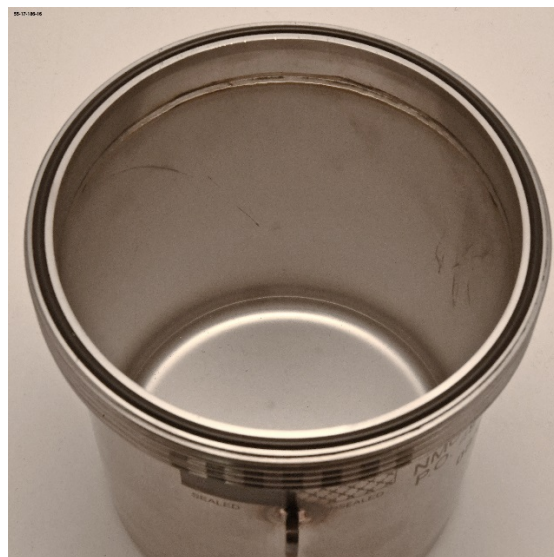
Figure 11 a) Exterior and b) interior of the one quart Hagan container prior to exposure to boiling  $MgCl_2$ .

Boiling  $MgCl_2$  tests were also conducted on the full container bodies per ASTM Standard G36. Photographs of the one quart Hagan body, S/N 08/07-01147, prior to exposure to the boiling  $MgCl_2$  are shown in Figure 11.

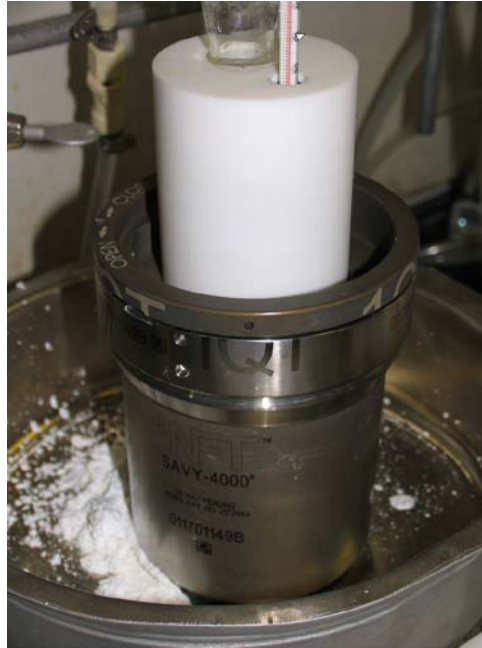
Figure 14 SAVY 4000 container after failure with  $MgCl_2$  in catch pan.

The SAVY 4000 container body was gradually filled with 1349 g of reagent grade  $MgCl_2 \cdot 6H_2O$  while being heated on a hotplate. The solution level was above the weld near the top of the container. No water or boiling chips added to the container. A specially designed Teflon lid with condenser and thermometer affixed was placed onto the body of the SAVY 4000 container. Boiling starting time was defined as the time solution reached  $154^\circ C$  and began to condense. After 44 hours no cracks were visible on the outer contour of the SAVY 4000 and no solution was observed in the catch pan. After 46 hours a great deal of  $MgCl_2$  was observed in the catch pan at the bottom of the SAVY 4000 container (Figure 14).

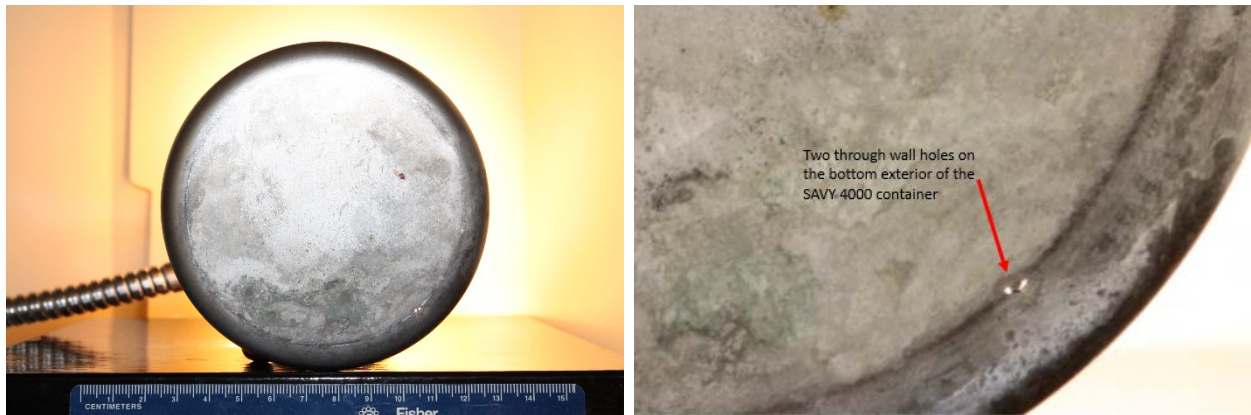
*Figure 16 Photographs of the bottom of the SAVY 4000 container after 47 hours of exposure to boiling  $MgCl_2$ .*

Two holes were clearly visible in the bottom of the container.

The boiling MgCl<sub>2</sub> testing on the SAVY 4000 body suggest that through wall pitting near the container bottom was the primary failure mechanism. The bottom is the thinnest region (0.6 mm) of the SAVY 4000 container. Pits, with depths up to 40 microns, have been observed in an In-Service Hagan container.<sup>4</sup> To date, no pitting has been observed in an In-Service SAVY 4000 container.

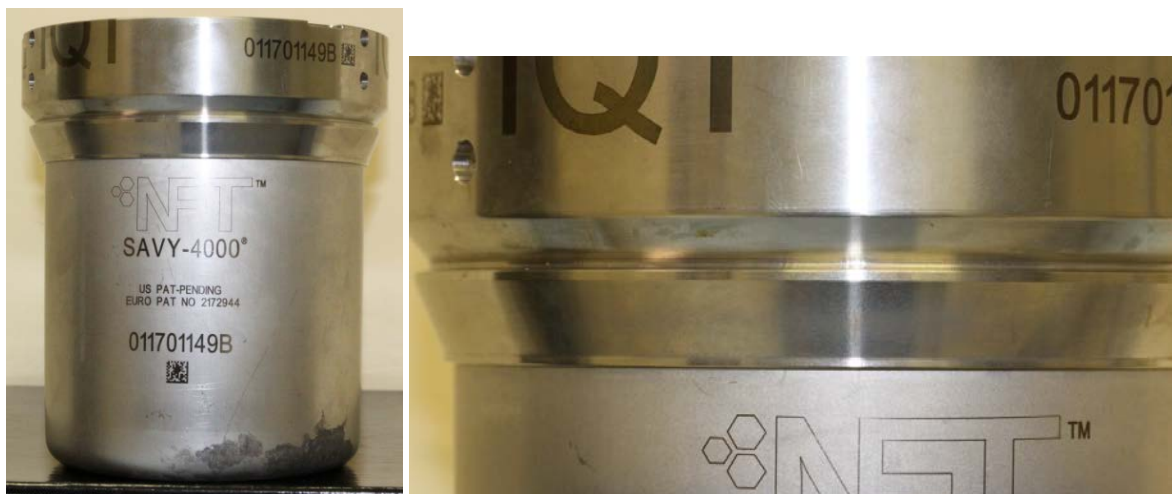
*Figure 17 Exterior of SAVY 4000 after 47 hours of exposure to boiling  $MgCl_2$ .*

No cracks were visible on the exterior of the SAVY 4000 container, however, the weld region is covered by the collar.

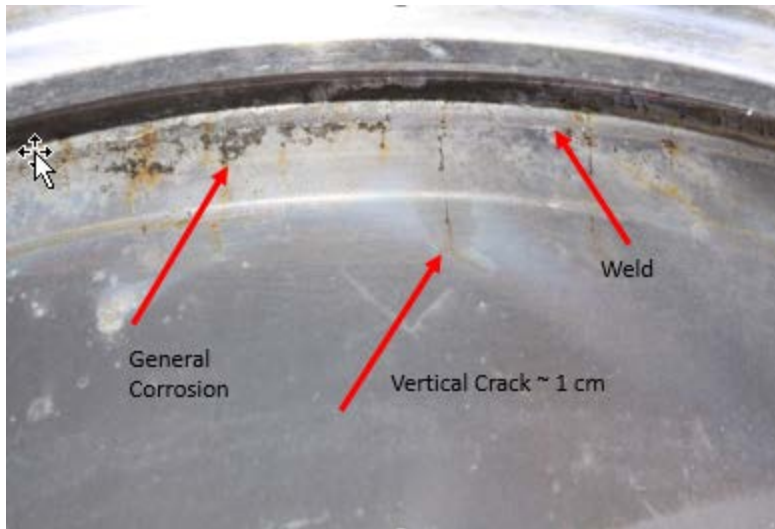
Figure 19 SAVY 4000 inner wall weld region after exposure to boiling  $MgCl_2$  showing vertical cracks and general corrosion.

Cracks perpendicular to the weld were observed on the inner contour up to 2 mm above the weld and cracks 1 cm in length were present below the weld. A band was visible approximately 6 mm below the weld, roughly corresponding to the bottom of the collar. Cracks propagated through the weld and the band. Cracks parallel to the band were also observed. General corrosion was also observed near the weld. (Figure 19).

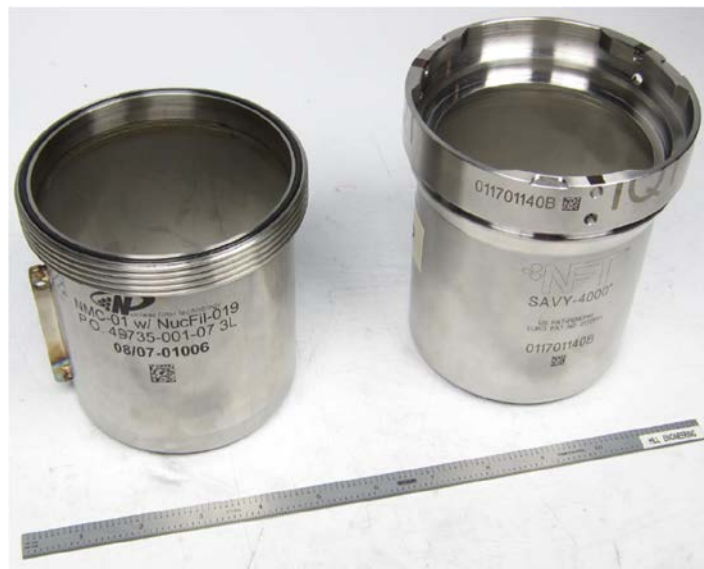
Hole drilling measurements were obtained on a 1 quart SAVY 4000 container and a 1 quart Hagan container shown in Figure 21.<sup>5</sup> Residual stress was determined from the measured strain versus depth data through an elastic inverse solution based on the principles of elasticity.

*Figure 21 Photograph of the SVY and Hagan containers used for hole drilling measurements*

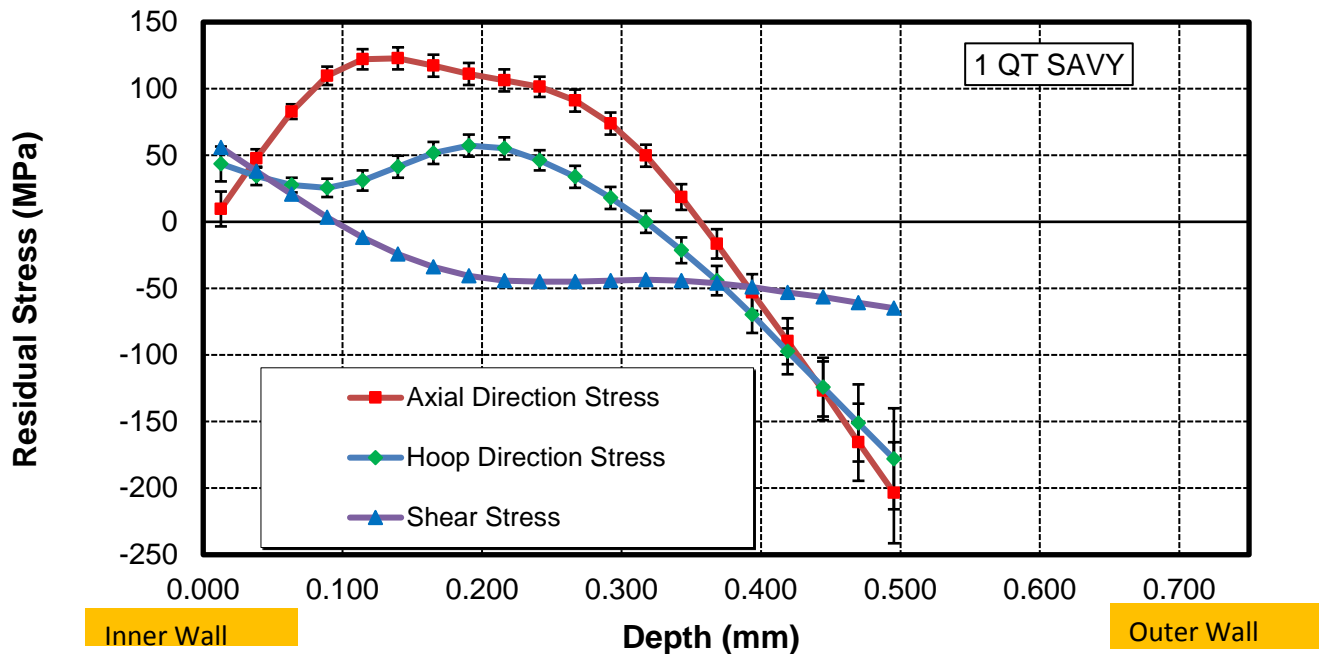
Figure 24 Line Plot of the residual stress versus distance from the inner wall for HD1.

At HD1, axial stresses were the largest magnitude stresses present in the SAVY 4000 container. Axial stresses of 10 MPa was present at the inner wall and increased to a maximum value of 123 MPa at 0.14 mm from the inner wall before steadily decreasing with increasing distance into the container. The hoop stress of 43 MPa present at the inner wall gradually increased to a maximum value of 57 MPa at 0.2 mm from the inner wall before gradually decreasing with

increasing distance into the container. Shear stress at the inner wall was 56 MPa and gradually decreased with increasing distance into the container. For all incremental hole drilling results, uncertainty increased with increasing hole depth.

A line plot of the measured residual stress versus depth for the SAVY 4000 container, HD1, is shown in Figure 24.

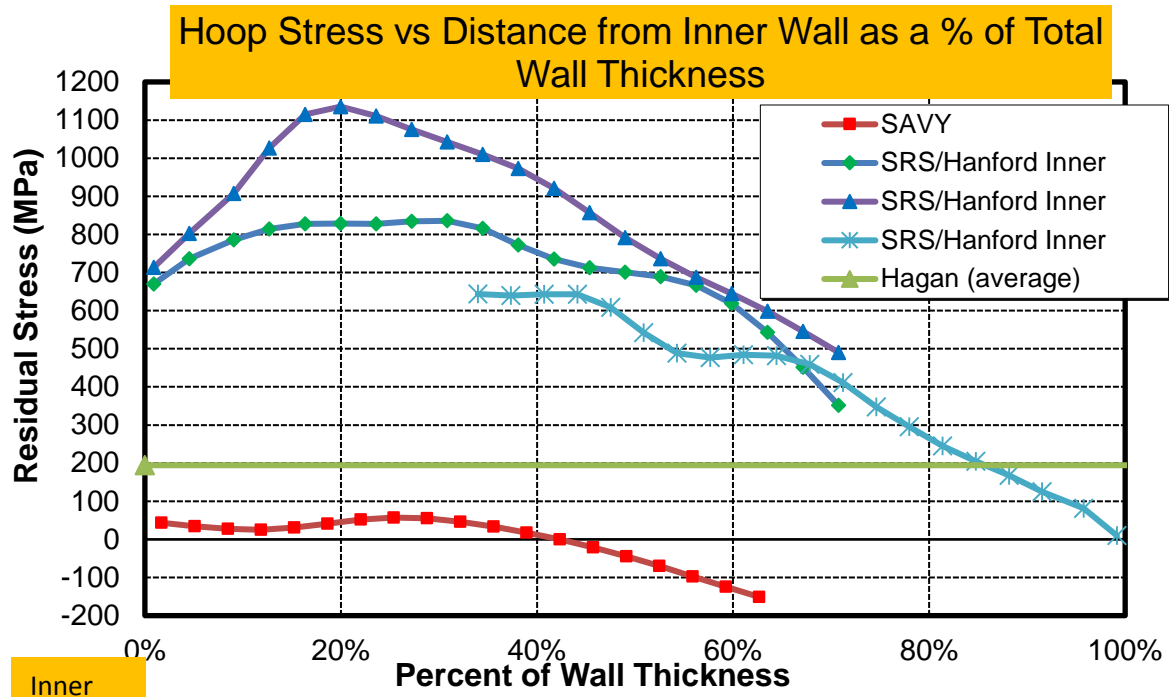
Figure 25 Comparison hole drilling hoop stresses near the weld in SAVY 4000, Hagan and SRS/Hanford Inner containers

The smallest “maximum” residual hoop stresses were measured in the SAVY 4000 container. Maximum measured hoop stress reported for the SAVY 4000 were approximately six times smaller than those reported in the 3013 outer container. Maximum measured hoop stresses reported for the SAVY 4000 were approximately 10 times smaller than those reported in the SRS/Hanford inner container. Maximum axial stresses in the SAVY 4000 are approximately 60% less than those in the 3013 outer container. Maximum axial stresses are approximately 25% or more less than those in the SRS/Hanford inner container. Figure 26 and 27 compare the hoop and axial stress versus distance from the inner wall as a % of the total wall thickness for the SAVY 4000, Hagan and 3013 inner container, obtained from incremental hole drilling.

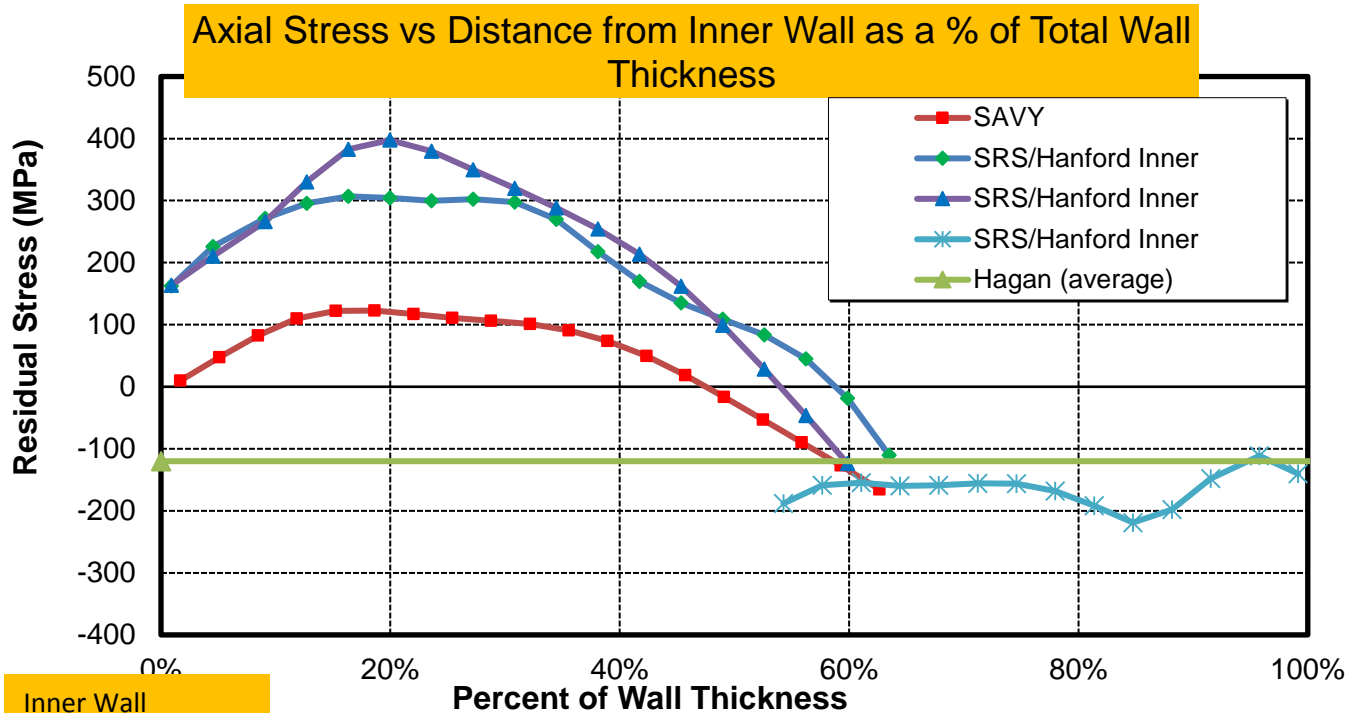
Figure 26 Comparison of hole drilling axial stresses near the weld in SAVY 4000, Hagan and SRS/Hanford Inner containers

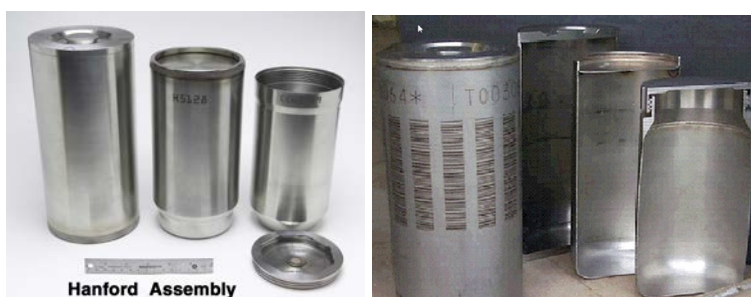
Surplus plutonium-bearing materials have been stored in nested 3013 containers at the Savannah River Site (SRS) for five to ten years. Figure 28 illustrates the container configuration, which includes a convenience can which is in direct contact with the material.

Figure 27. 3013 (BNFL designed) outer, inner, and convenience containers.
