SAND2017-12429xx

Analysis of Samples Collected from the Surface of Interim Storage Canisters at Calvert Cliffs in June, 2017: Revision 01

Analysis of Samples Collected from the Surface of Interim Storage Canisters at Calvert Cliffs in June, 2017

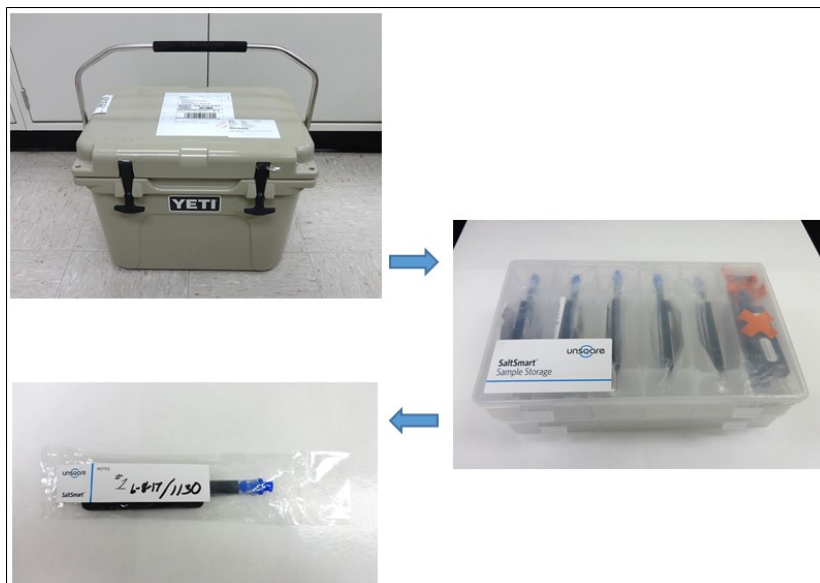
Following collection at Calvert Cliffs, the SaltSmart™ samples and the dry dust samples were prepared for shipping. Each Salt-Smart test strip was placed into a plastic sleeve and sealed, and then placed into a compartmentalized polypropylene box. Each steel sampling head used for the dry dust sampling, with the Scotch-Brite™ pad and the paper filter backing still attached, was treated similarly, sealed into a plastic sleeve and placed into a compartmentalized polypropylene box. The samples were then placed into a Yeti® ice cooler with a single Blue Ice pack and packing materials, and shipped via overnight express to Sandia. The packaging is shown in Figure 1.

Figure 1. Packaging of SaltSmart™ samples delivered to SNL. Dry dust sampling heads (not shown) were packaged in the same manner.

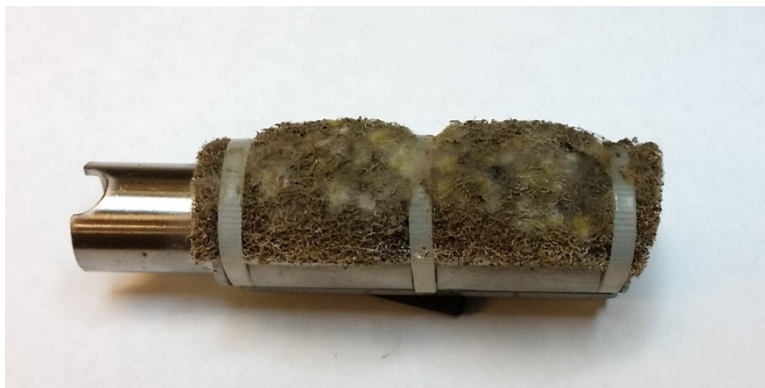
Upon receipt at SNL, the cooler was opened and the samples extracted. It was immediately noted that the “dry dust” sampling heads were no longer dry. Condensation had formed within the sealed plastic sleeves, in some cases in sufficient quantity to actually pool in the bottom of the bags. It was clear that any salts present would have been remobilized by the condensation. As the purpose of the “dry dust” samples was to evaluate the size, morphology, composition, and distribution of salts in the dust on the canister surface, the samples were no longer acceptable for their intended use. The Scotch-Brite™ pads also displayed a patchy discoloration, which initially was interpreted as moist dust adhering to the pad. In an effort to preserve the samples from further damage, the plastic sleeves were cut open and the samples were placed within a desiccator with Drierite™ desiccant (calcium sulfate). Although visible moisture was removed, after four days, the patchy discolorations had evolved

into heavy mold growth (Figure 2). At this point, the decision was made not to pursue further analysis of the Scotch-Brite™ samples.

Figure 2. Mold growing on one of the dry dust sampling heads, after four days in a desiccator.
