Title: Evaluating Corrosion in SAVY Containers using Non-Destructive Techniques

Intended for: Presentation for undergraduate class.

# Evaluating Corrosion in SAVY Containers using Non-Destructive Techniques

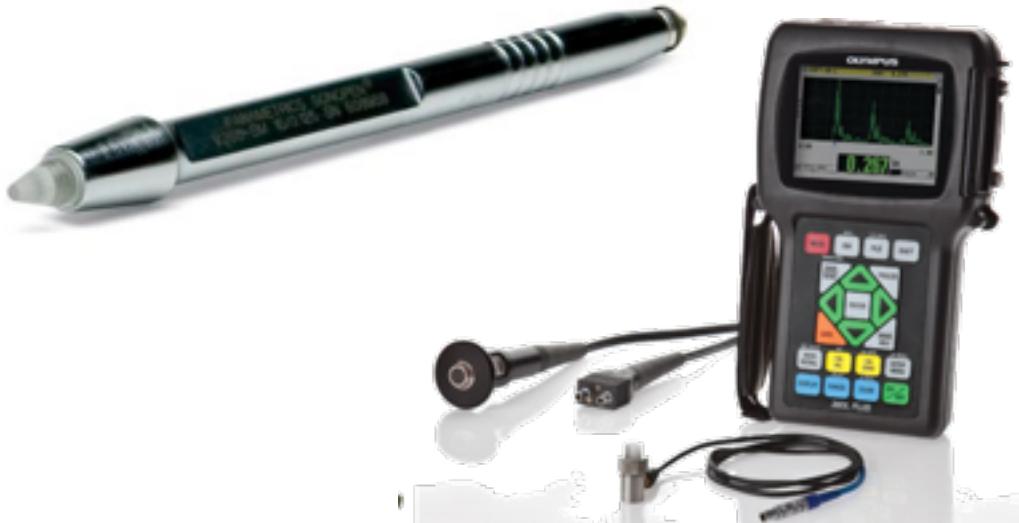
- Olympus 38DL Handheld System
  - Portable
  - One transducer
- Olympus 15 MHz Sonopen Ultrasonic Delay-line Transducer

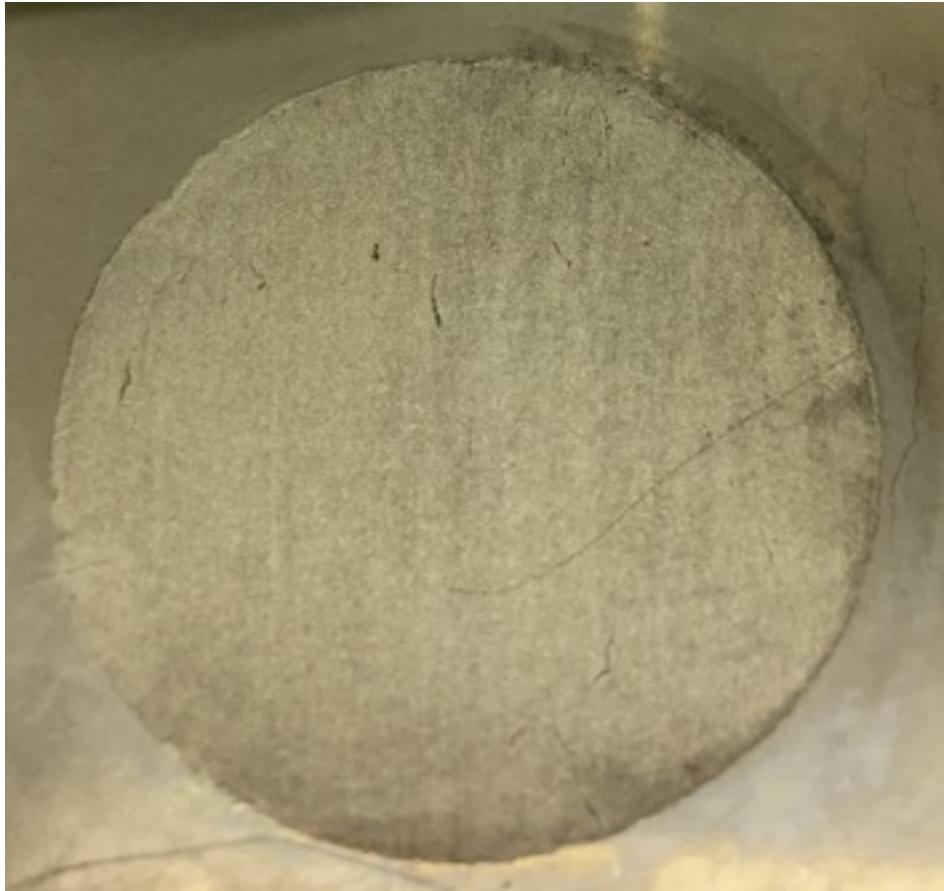
12M HCl Corroded for 7 days

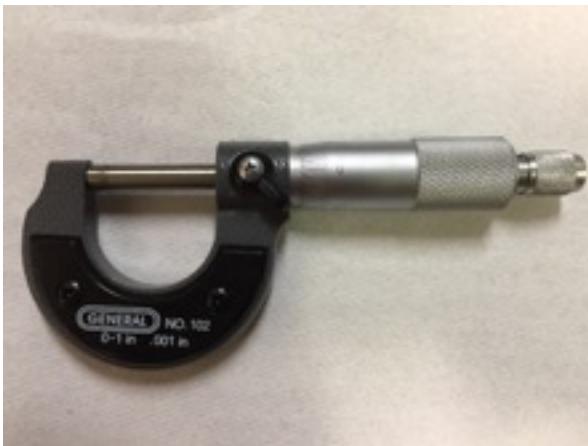
38 measurements verified with micrometer

[n]	Mean Error (in.) [ $\mu$ ]	Std. Dev. [ $\sigma$ ]
38	.00051	.00035

Therefore, with 99% confidence, average error is less than 0.0007 in.

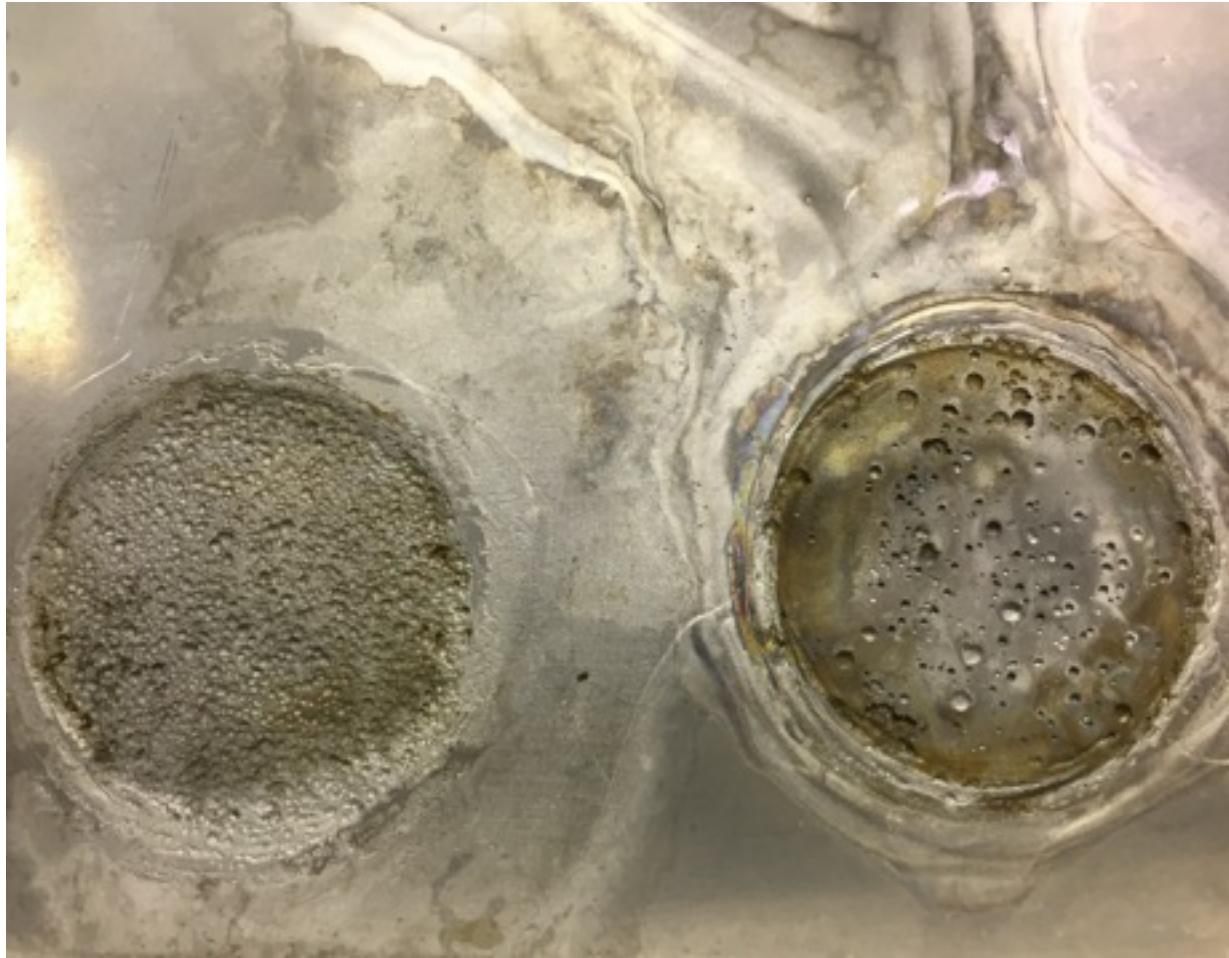
3M  $\text{FeCl}_3$  Hexahydrate (left) - 7 day immersion vs. 1.5 M Anhydrous  $\text{FeCl}_3$  (right) - 2.5 day immersion

- $\text{FeCl}_3$  Hexahydrate solution created small uniformly distributed pits
- Anhydrous  $\text{FeCl}_3$  solution created localized deep pits and crevice corrosion under o-ring
- 1.5 M Anhydrous  $\text{FeCl}_3$  solution perforated sample after 2.5 days immersion

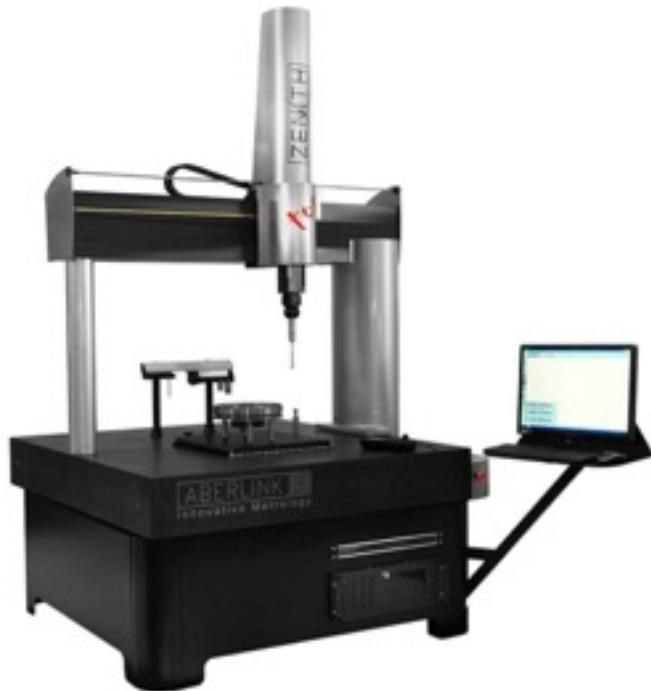
CMM  
Machine

- Two SAVY containers corroded with HCl and a control SAVY
- Max/min wall thickness measured by PF group using CMM
- Results replicated by NPI-2 using non-destructive (NDT) UT measurements
