LA-UR-17-24400 (Accepted Manuscript)

# Fatigue Performance of Ti-6Al-4V Additively Manufactured Specimens with Integrated Capillaries of an Embedded Structural Health Monitoring System

**To be published in:** Materials

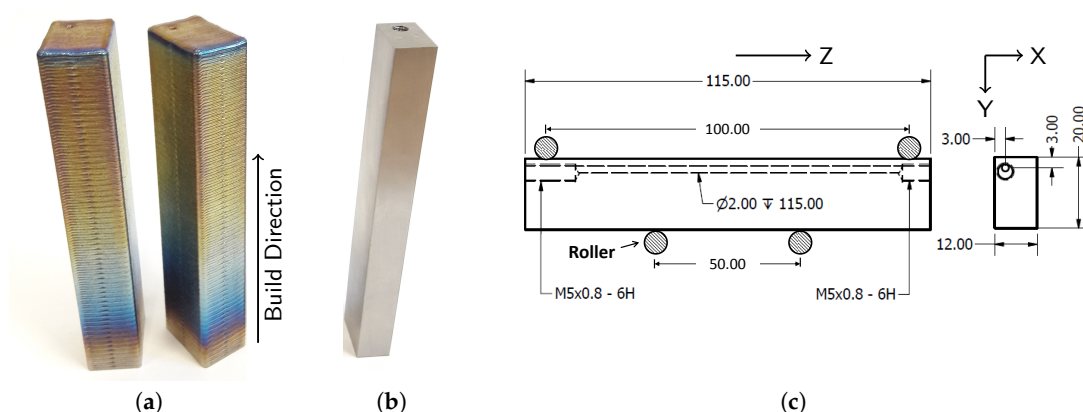
**Figure 1.** Additive manufactured Ti-6Al-4V specimen produced by laser based DED in as-built condition (a) before milling and (b) after milling according to the design presented in (c).

The wrought specimens were produced by conventional milling operations from a mill annealed Ti-6Al-4V plate. The capillaries were added according to the design presented in Figure 1c, using deep gun drilling with a drill diameter of 2 mm.

2.96 g/min Ti-6Al-4V particles into the melt pool. Specimens were built on Ti-6Al-4V flat plates with a thickness of 18 mm. The build direction was vertical (indicated on Figure 1a) and the scanning direction of successive layers was rotated by an angle of 90°. In one layer, the contours were first scanned before a bidirectional scanning pattern with a scan offset of 0.3 mm was applied. Figure 1a shows two laser based DED samples in as-built condition. AM processes, such as laser based DED, can introduce high thermal stresses inside the specimen. After the specimens were removed from the base plate, a heat treatment was applied in order to obtain stress relieved conditions. While additively manufactured Specimens 11–13 were subjected to a standard heat treatment often used for conventional Ti-6Al-4V (4 h at 650 °C), Specimens 7–10 were subjected to a heat treatment at lower temperatures in order not to alter the microstructure (2 h at 530 °C). The specimens were then milled to the final dimensions of 115 mm × 20 mm × 12 mm. The corners of the specimens were not rounded. Although the capillaries were designed to have a diameter of 2 mm, the printed capillaries in Specimens 9–13 turned out to have variable diameters varying between 1.4–1.8 mm due to the geometrical inaccuracy of the laser based DED process. In order to improve the capillary surface roughness, the printed capillaries of Specimens 11–13 were drilled through using deep gun drilling with a drill of 2 mm diameter.

The location of the capillary is crucial in terms of fatigue crack detection by the eSHM system and fatigue performance of the specimen. A trade-off is to be made. A closer location of the capillary near the tensile stressed surface of the specimen allows earlier detection of growing cracks, but increases the chances of crack initiation at the capillary surface. A capillary topology study was performed by Strantza et al. on specimens produced by laser based DED. It was found that, for both capillaries with their center located at 3 mm and 4 mm from the bottom and side of the specimen, the crack initiated at imperfections on the surface of the printed capillary. It was concluded first that other parameters such as residual stresses and capillary surface roughness have to be eliminated before detailed capillary topology studies can be started [23]. The current work therefore investigates the effect of the capillary surface roughness in stress relieved specimens. Corresponding to the designs used in the work of Strantza et al. [23], the capillaries were positioned such that their center was located at 3 mm from both the side and bottom of the specimen, as shown in Figure 1c. As such, one corner of the specimen is more influenced by the presence of the capillary than the other. Two M5 threaded connections were then foreseen at the ends of the straight capillary. Figure 1b shows a specimen with capillaries after milling. The specimens with integrated capillaries of the eSHM were all produced according to the design presented in Figure 1c.

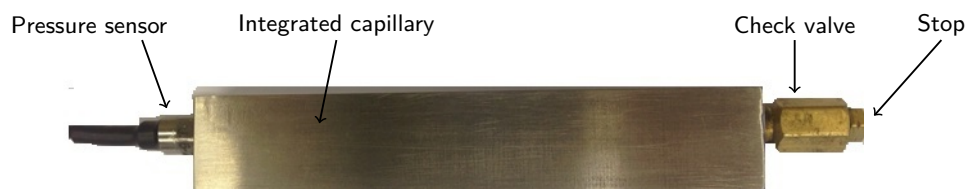
**Figure 2.** Fully equipped Ti-6Al-4V specimen with installed pressure sensor at one side and check valve and stop at the other side. The eSHM system is active.

The specimens were equipped with a Kulite XTL-123BEG-190M-1.7 bara pressure sensor (Kulite Semiconductor Products Inc., Leonia, NJ, USA) at one side and a Clippard MCV-1-M5 check valve (Clippard Instrument Laboratory Inc., Cincinnati, OH, USA) on the other side. In order to properly seal the connections, a Loctite 577 thread sealant (Henkel, Düsseldorf, Germany) was applied to the M5 threads. The anaerobic thread sealant remains liquid until being isolated from oxygen in the presence of the metal ions of the thread. When cured, they form a durable seal by filling up the gaps between the threads. The specimen were then placed in a vacuum oven and the pressure inside the capillary was reduced to approximately 0.4 bara. The check valve prevented the capillary pressure to rise when taken out from the vacuum oven. In order to prevent occasional leaking through the check valve, an additional Clippard 11755-M5-PKG stop (Clippard Instrument Laboratory Inc., Cincinnati, OH, USA) was screwed onto the check valve end. Figure 2 shows the Ti-6Al-4V specimen with the installed eSHM system, just before testing.

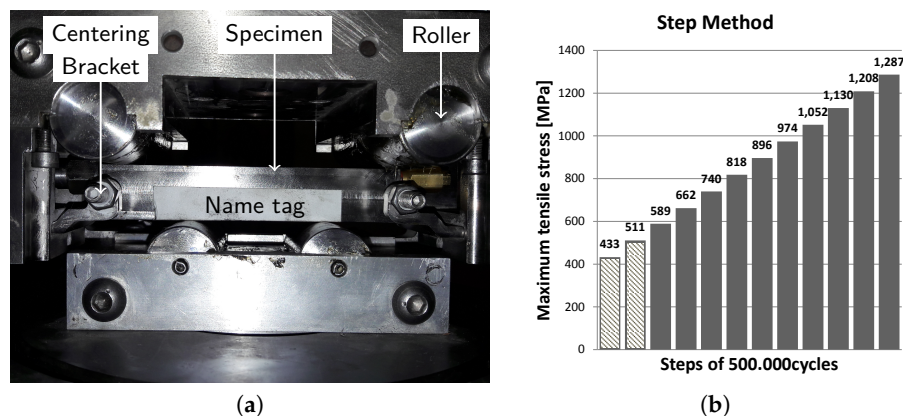
**Figure 3.** All specimens were subjected to four-point bending fatigue tests according to the step method. (a) specimen installed in the four-point bending test setup and (b) the maximum tensile stress levels in each load step.

All specimens were subjected to a cyclic fatigue loading in a four-point bending test setup. Figure 3a shows the specimen installed in the test bench. In between the two inner rollers, a region of maximum and constant stresses is present in the specimen. The fatigue cracks are expected to nucleate and grow in this region, on the tension side of the specimen. The specimen was placed in the set-up with the capillary in the tensional stress area, such that the eSHM system could detect the fatigue cracks as early as possible. The centering brackets held the specimen in place during testing.

In this particular study, each step consisted of 500,000 cycles of a sinusoidal load with a stress ratio (R ratio) equal to 0.1 and a testing frequency of 15 Hz. The initial load level must be considered below the expected fatigue strength of the specimen. From the literature [22], indications of the failure level of wrought Ti-6Al-4V under the same testing configurations were found to be equal to 820 MPa. The initial stress level was chosen to be 589 MPa. Then, every step, the stress level in the section with maximum stress levels was increased by approximately 76 MPa such that failure of the reference samples is expected in the fourth step. However, when a specimen failed in the first step, all specimens with the same configuration were started at a lower initial stress level with a minimum of 433 MPa. The different loading steps during the four-point bending tests are depicted in Figure 3b. The initial stress levels that were used can be found in the summarization Table 1.

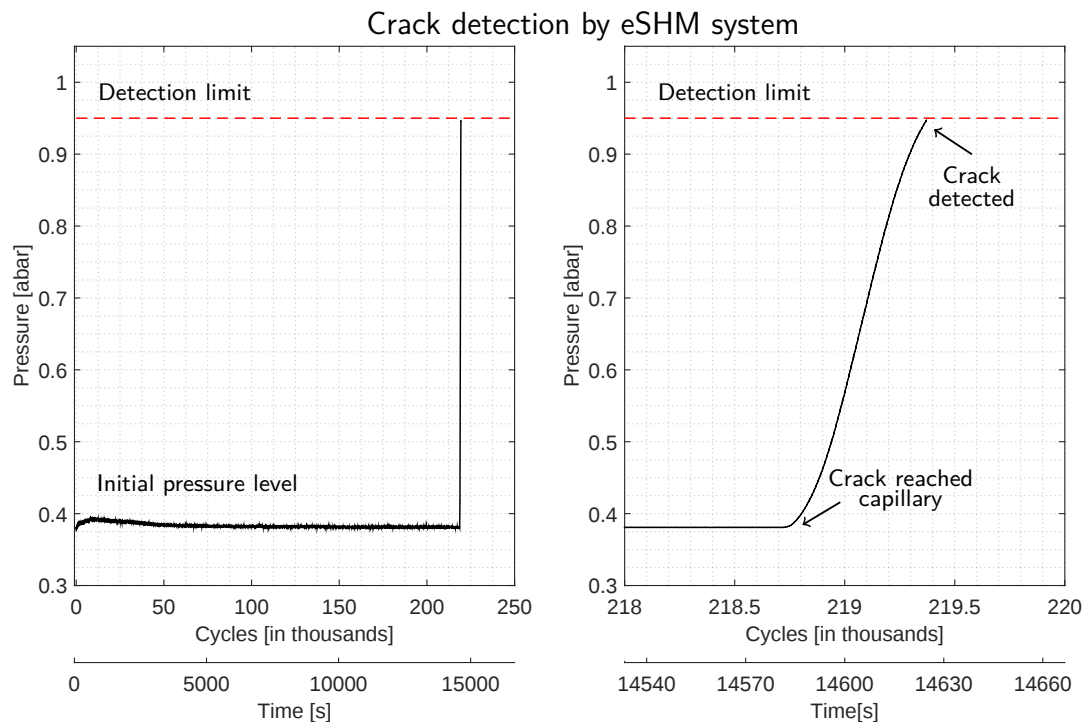
**Figure 4.** Crack detection by eSHM system for Specimen 13. Capillary pressure output during the entire test (**left**) and a detailed view on crack detection (**right**).

On the contrary, the test procedure of specimens with integrated eSHM systems was stopped at crack detection by the eSHM system. Figure 4 shows the pressure output of the eSHM system during the entire test (left) and a detailed view on the last cycles of the test (right). Initially put under vacuum conditions, the capillary became very sensitive to leaks. During initial testing, no crack was present in the test specimen and the internal capillary pressure remained unchanged and equal to the initial pressure level of approximately 0.4 bara (see Figure 4 (left)). However, a fatigue crack initiated at the specimen's outer surface and grew inward towards the capillary. When the crack finally breached the capillary, the crack formed a leak connection between the capillary and the ambient conditions outside the specimen. The resulting leak flow increases the pressure level inside the capillary towards the ambient pressure level. According to Figure 4 (right), this happened after about 218,750 cycles or 14,585 s of testing for Specimen 13. In the following period, the pressure sensor installed at the capillary end registers a rapid pressure increase towards ambient pressure conditions. The test procedure was stopped when the capillary pressure exceeded the pre-set limit of 0.95 bara. Figure 4 (right) indicates that, according to this methodology, Specimen 13 failed after 219,377 cycles. All test specimens were successfully stopped by the eSHM system. The specimen still withstood the loading and was not ruptured. In order to be able to inspect the fracture surface, the specimens were loaded further at the load level of the last step until final rupture of the specimen occurred.

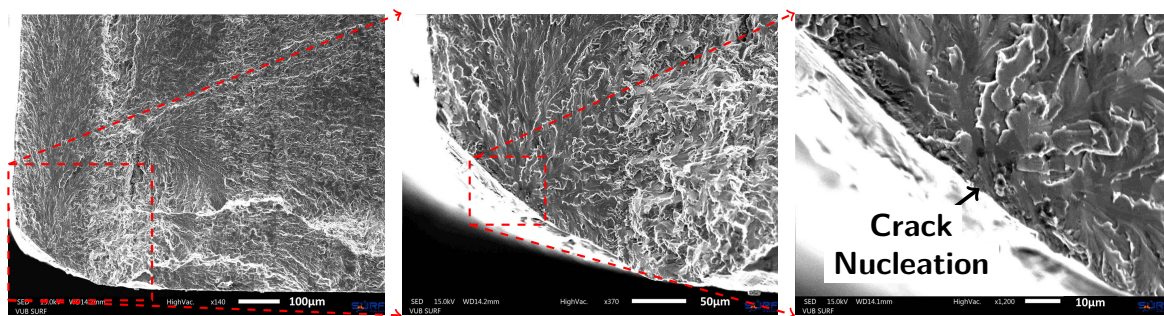
**Figure 5.** SEM images of the fracture surface of Specimen 1 (wrought material without capillaries). The fatigue crack initiated from the bottom left corner of the specimen.

The three first specimens, manufactured from conventional Ti-6Al-4V, without capillary failed between 820 and 896 MPa. Initially loaded at 589 MPa, the first two specimens survived three steps and failed in the fourth step at a load level of 818 MPa. The third reference specimen survived even the fourth step and had a fatigue strength of 896 MPa. The presented fatigue strengths are in very good correspondence with the literature considering the same test set-up and procedure. Strantza et al. reported three specimens that failed at a stress level of 820 MPa [22]. Figure 5 presents the SEM micrographs taken from the fracture surface of Specimen 1. The fatigue crack nucleations are located at the bottom left corner of the specimen. Similarly, Specimen 2 failed due to an internal defect also located in the beam corner. Specimen 3 failed due to the presence of an internal defect in the bulk material, as shown in Figure 6.

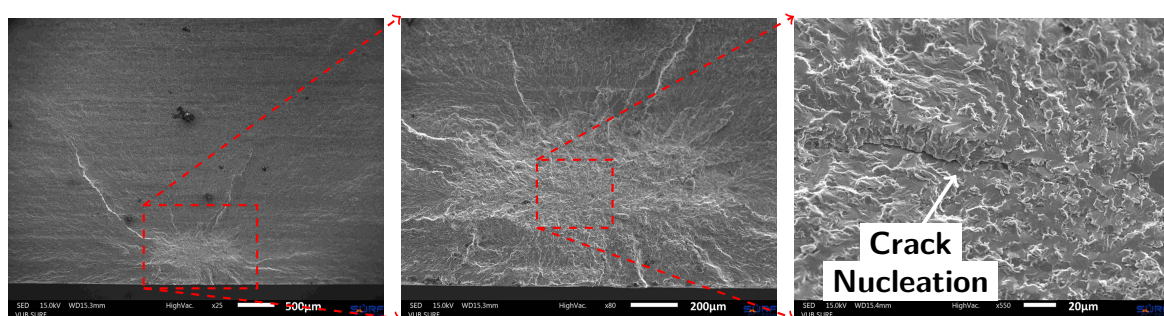
**Figure 6.** SEM images of the fracture surface of Specimen 3 (wrought material without capillaries). The fatigue crack initiated from an internal defect near the bottom of the specimen.

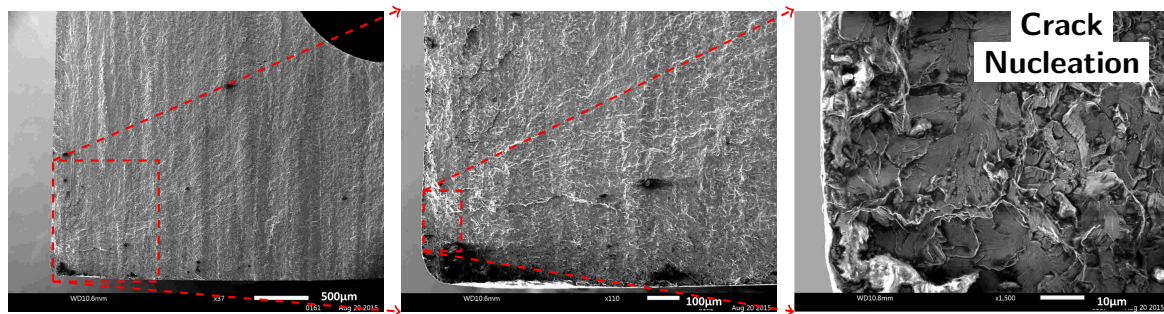
**Figure 7.** SEM images of the fracture surface of Specimen 4 (wrought material with capillary). The fatigue crack initiated from the bottom left corner of the beam.

Three other specimens, also produced from wrought Ti-6Al-4V, but with integrated capillaries, showed both better and worse fatigue properties than the specimens without capillaries. Specimen 4 failed only at a load level of 976 MPa, while Specimens 5 and 6 failed at 662 MPa. Specimen 5 did not fail in between the inner rollers of the test set-up, but at the contact point with an outer roller, close to the M5 connection with the pressure sensor. The stress concentration around the roller led to premature failure of the specimen. Although having a considerable lower hardness (341 HV) as compared to all other specimens, the actual fatigue strength of the specimen could have been higher than 662 MPa since 459,360 cycles already survived. In order to overcome the issue of stress concentrations around the rollers, the threaded M5 connections have to be redesigned for future tests in order to maximize the distance between the M5 thread zone and the load insertion by the roller. Fractographic analysis revealed that Specimens 4 and 6 with integrated capillary failed due to a fatigue crack that initiated from the beam corner that was located closest to the capillary. Figure 7 presents the fracture surface of Specimen 4. The fractographic analysis of Specimen 6 is not shown in the current paper since it is very similar to that of Specimen 4. The fatigue crack did not initiate at the capillary surface, likely because of the lower stress levels around the capillary and the low capillary surface roughness ( $0.55 \mu\text{m} \leq R_a \leq 0.65 \mu\text{m}$ ).

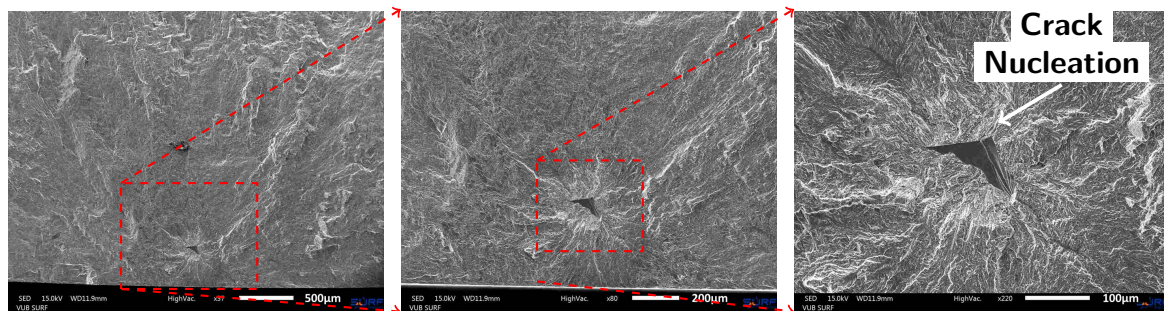
**Figure 8.** SEM images of the fracture surface of Specimen 7 (AM material without capillary). The fatigue crack initiated from an internal defect near the bottom of the sample.

In contrast with the predictions from the literature, the stress level at failure of the additively manufactured specimen without capillaries were considerably higher than the reference specimens produced from wrought Ti-6Al-4V. Based on previous testing experience on a Ti-6Al-4V specimen produced by laser based DED (but without stress relief and therefore not included in this study), which failed at a load level of 1293 MPa, it was decided to increase the initial load level to reduce testing time. Starting at initial load levels of 896 and 974 MPa, respectively, Specimen 7 and Specimen 8 only failed in the fourth step at a load level of 1208 MPa. As opposed to Specimen 7, Specimen 8 was subjected to a higher initial load level but with smaller load increments, but both specimens failed at the same load level of 1208 MPa. At these load levels, a considerable part of the specimen is already stressed beyond the yield limit of the material. Since further increasing the stress level would not have led to interpretable results, Specimen 8 that survived 500,000 cycles at 1208 MPa was subjected to the same loading until it finally failed. As compared to the reference samples from wrought Ti-6Al-4V, the AM specimens resisted more than two million more cycles at increasing load levels beyond the failure level of the wrought Ti-6Al-4V. These observations are in line with the higher hardness (370–390 HV) of the specimens as compared to the wrought Ti-6Al-4V specimens (340–356 HV), expecting higher tensile strength and improved fatigue performance for the harder specimens. Figure 8 shows the micrographs of the fracture surface of Specimen 7. The rivermarks that are present in the micrograph on the right in Figure 8 indicate that the crack was nucleated due to a triangular shaped void located in the bulk material.

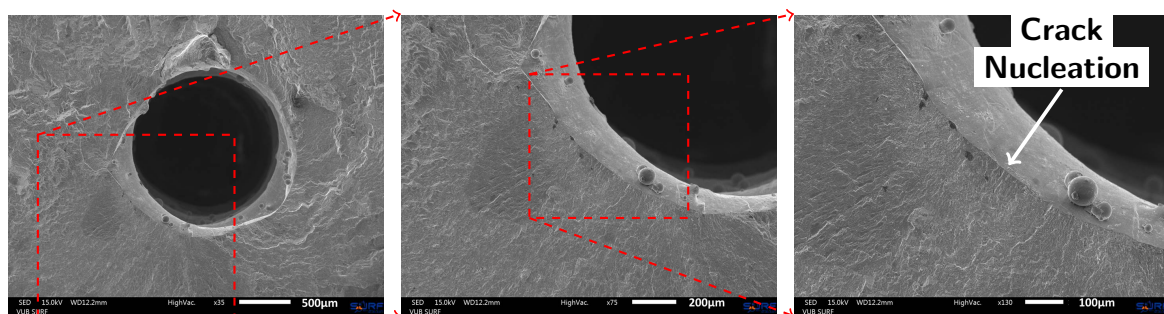
**Figure 9.** SEM images of the fracture surface of Specimen 9 (AM material with printed capillary) reveal that the fatigue crack initiated from a notch formed by the severe surface roughness at the capillary.

The capillary surface roughness deteriorated the fatigue performance of Specimen 9 and Specimen 10. Fatigue cracks have initiated at the capillary surface at stress levels (589 and 662 MPa) well below those obtained for the additively manufactured specimens without capillaries. The fracture surface of Specimen 9 is shown in Figure 9. In addition, Specimen 10 failed due to a fatigue crack that initiated from the capillary surface. The layerwise addition of contours around the capillary in the vertical build direction has introduced roughness in the capillary surface. The stress concentrations that result thereof lead to premature failure of the specimen. The surface roughness  $R_a$  of a capillary produced by laser based DED is found to be 10 times higher than that of a drilled capillary.

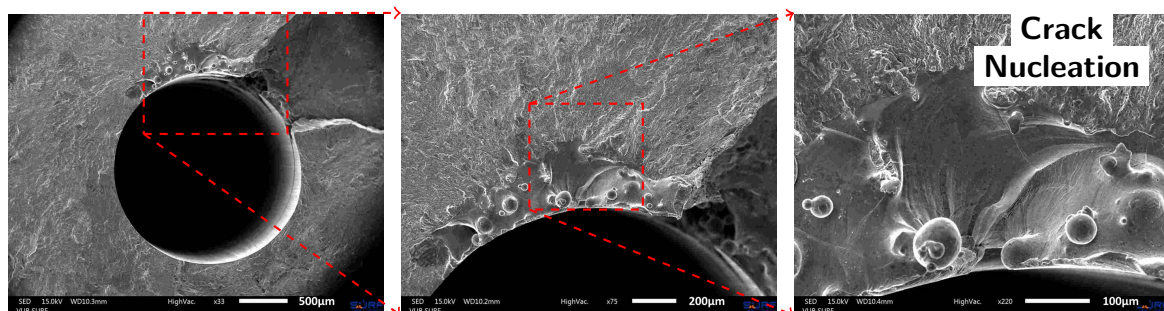
**Figure 10.** SEM images of the fracture surface of Specimen 13 (AM material with printed capillary after drilling operation). The drilling operation did not sufficiently remove the surface roughness of the printed capillaries and therefore did not solve the initiation issue around the capillary.

Because of the latter conclusions from the fractographic analysis, three more specimens (with initial printed capillaries with a diameter of 1.4–1.8 mm) were drilled afterwards with a drill of 2 mm diameter, in an attempt to reduce the capillary surface roughness. Initially loaded at stress levels similar to previous specimens with printed capillaries, the specimen already failed in the initial load step. The specimen failed at load levels of 433 MPa and 589 MPa. As is clear from the fracture surface of Specimen 13 in Figure 10, the drilling operation did not remove all traces of the additive building process prior to the drilling operation. Fractographic analysis revealed that the remaining “notches” initiated the fatigue crack. Specimen 11 failed due to the presence of a gas inclusion of approximately 200  $\mu\text{m}$  by 500  $\mu\text{m}$ . Specimen 12 failed at the roller contact. The M5-thread connection for the pressure sensor is found to be located too close to the load insertion points (the rollers). New test specimens will be designed differently such that the M5-thread is located in a stress-less zone.

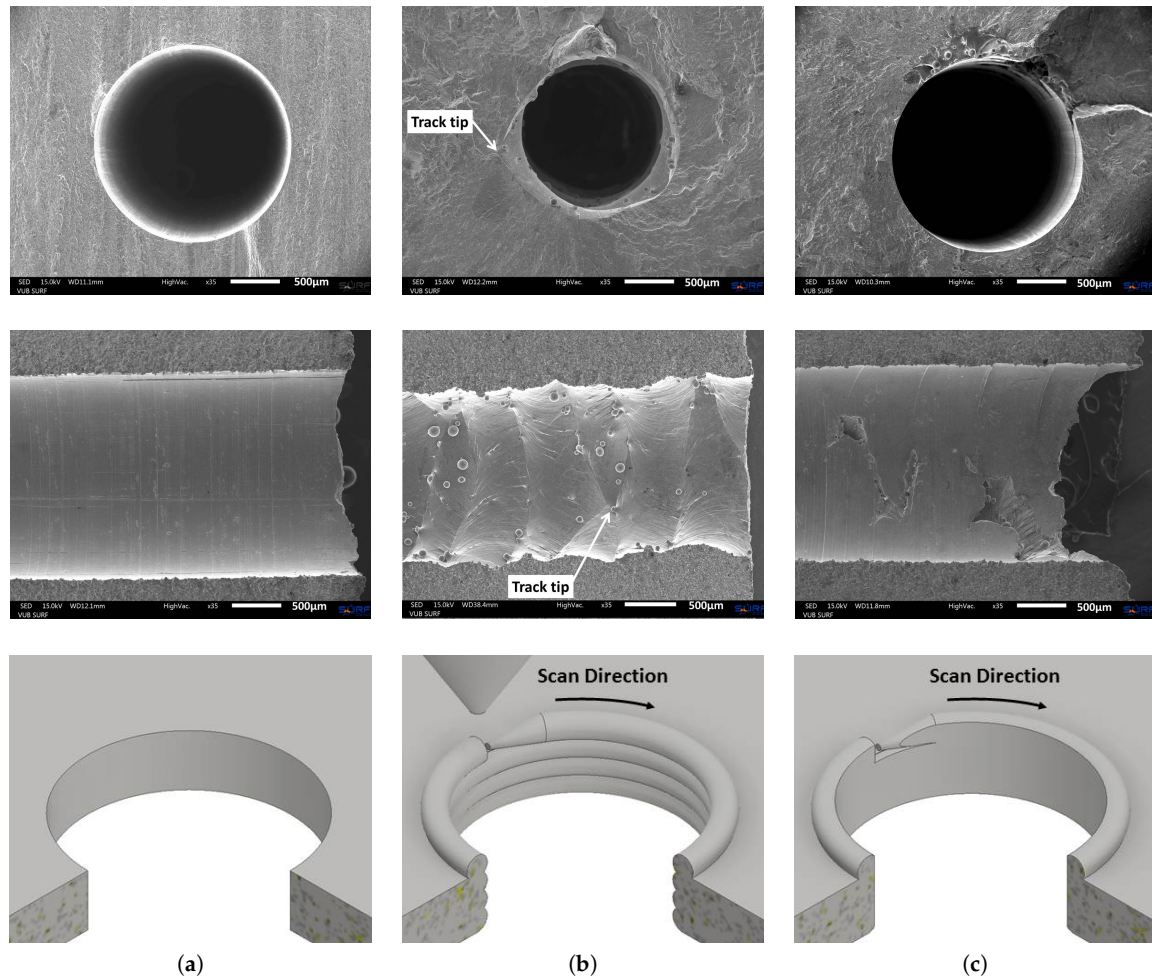
**Figure 11.** Cross sectional view (top), longitudinal view (middle) and CAD representation of the production process (bottom) of a (a) drilled capillary in wrought Ti-6Al-4V (Specimen 6), (b) vertically built capillary by laser based DED (Specimen 9) and (c) vertically built capillary by laser based DED (Specimen 9) with additional deep gun drilling (Specimen 13). The fracture surface is on the right for the middle figures.

Figure 11 allows comparing the capillary surface finish of a drilled capillary in wrought Ti-6Al-4V material (a), the additively manufactured capillaries using the laser based DED process (b) and the additively manufactured capillaries that were drilled through to reduce the capillary surface roughness (c). Figure 11b,c especially deserve some more attention. As is clear from the middle figure in column (b), the tracks that are clearly visible as vertical lines on the capillary surface, are not all exactly parallel to each other. This is because of the lack of proper process control by the use of continuous laser power (500 W) and constant linear scan speed (1000 mm/min). With the start of each contour around the capillary, the laser is switched on and the nozzle moves at a constant speed. In the very early beginning of the deposition, the material is not sufficiently heated and the melt pool did not grow to its full size before the nozzle moved away, giving rise to a very small track tip. Gradually heating up the substrate, the melt pool reached its intended size and with it also the track became wider. Each such start location of a track is seen as a narrowed track, as indicated on Figure 11b. These locations are regions of larger capillary diameters and are thus locations of deeper notches. Even with the drilling operation, some of these deep notches remained present, as depicted in Figure 11c. A proper closed loop process control system should increase the initial laser power such that the melt pool gains its intended width before moving the nozzle [28,29].

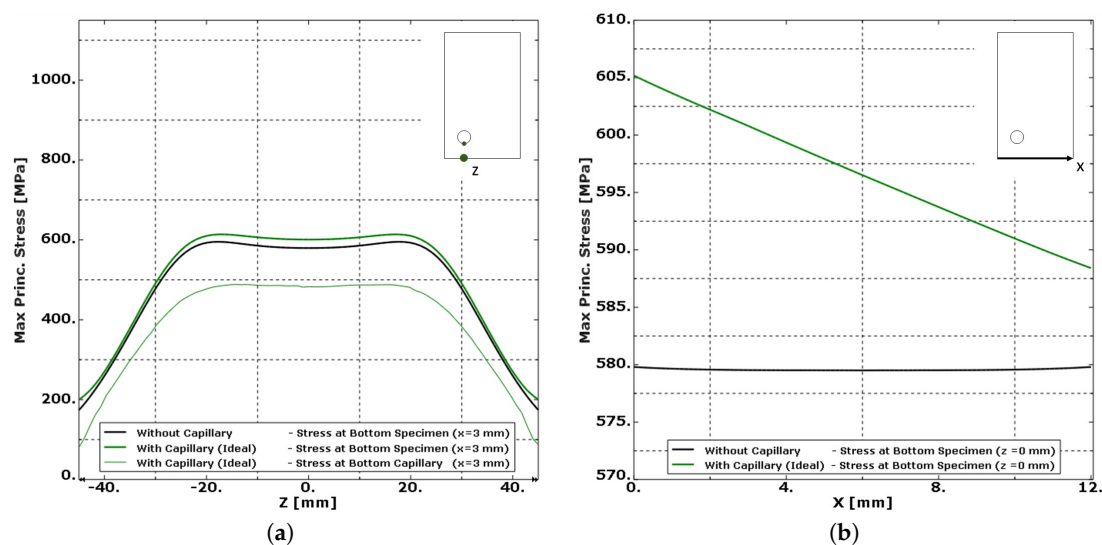
**Figure 12.** The maximum principal stress level plotted in function of (a) the longitudinal Z-direction at the bottom of the specimen and bottom of the capillary and (b) the X-direction at the bottom of specimen. The integration of a capillary slightly increases (+3%) the overall stress level in the specimen. The stress level at the capillary is significantly lower than that at the bottom of the specimen. The stress level increases linearly by 3% from the corner without capillary to the corner with capillary.

A comparison of the modelling results presented in Figure 12 shows the effect of the integration of a capillary. According to Figure 12a, the addition of the capillary slightly increases (+3%) all stress levels inside the specimen. The stress levels at the capillary remain well below the stress levels found at the bottom of the specimen. It is therefore expected that for materials without defects, fatigue cracks will not initiate at the capillary location. Fractographic analysis of specimens with drilled capillaries in wrought Ti-6Al-4V indeed revealed that the fatigue cracks did not initiate at the capillary surface.

When considering the stress pattern along the X-direction in Figure 12b, the proximity of the capillary near one corner slightly increases the stress level in that corner. Although the difference of the stress level from one corner to the other is limited to only 3%, it is possibly the reason why fatigue cracks seem to prefer this corner as fatigue initiation location as found during the fractographic analysis of Specimens 4 and 6. The addition of a capillary could alter the fatigue performance of the component; however, further studies will be needed to analyse this effect.

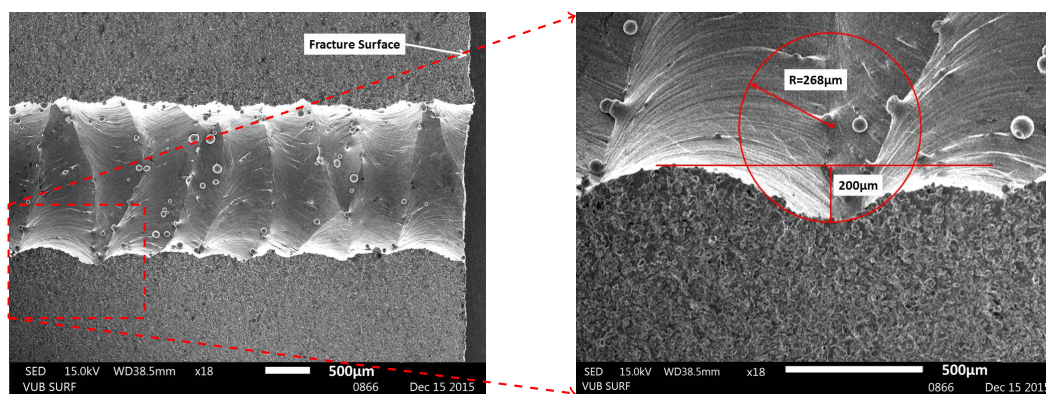
**Figure 13.** Longitudinal cut view of the surface roughness of the printed capillary of Specimen 9: (a) a general overview and (b) a detailed view with derived dimensions as input for the simulations.

Although the integration of an “Ideal Capillary” did not alter the fatigue initiation location, the roughness of the additively manufactured capillary leads to fatigue initiation at the capillary surface. In an attempt to estimate the severity of the stress concentrations introduced by the surface roughness, simulations were performed. The geometry of the simulated “notch” was derived from a longitudinal cut view of Specimen 9, provided in Figure 13. Only one notch is considered in the simulations and is modelled as a torus with a minor radius of 268  $\mu\text{m}$  and a major radius of 932  $\mu\text{m}$  such that the indentation with respect to the minimal capillary diameter of 2 mm equals 200  $\mu\text{m}$ . The notch is located in the middle of the beam, between the inner rollers where tensional stresses are the highest. The same load of 37.7/2 kN per roller, the load level at which Specimen 9 failed, was again applied to the specimen.

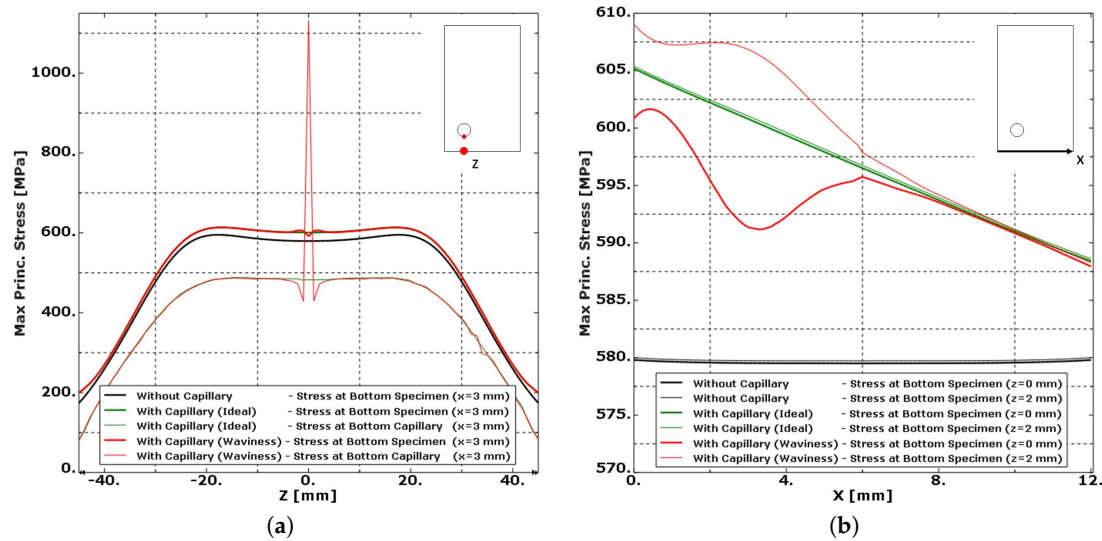
**Figure 14.** The stress level is plotted in a function of (a) the longitudinal Z-direction at the bottom of the specimen and bottom of the capillary and (b) at the bottom of the specimen along the X-direction for  $z = 0$  mm and  $z = 2$  mm. The stress concentration caused by the roughness of the capillary surpasses all stress levels of the specimen with smooth capillaries. The capillary becomes the place where fatigue initiation can be expected.

It is clear from the simulation results presented in Figure 14 that the surface roughness of the laser based DED process induced stress concentrations that surpass all stress levels expected in a specimen with an “Ideal Capillary”. The roughness on the capillary makes the capillary surface a preferred location for crack initiation. On top of this capillary roughness, the presence of unmelted particles furthermore increased the capillary surface roughness and can cause crack nucleation. Figure 14b presents the results of the same simulations along the X-direction at the outer surface of the specimen, where only small influences are noted. The highest stress levels at the outer surface of the specimen are not found just below the “notch” ( $z = 0 \text{ mm}$ ), but at  $z = 2 \text{ mm}$ .
