# **SiC Composite for Fuel Structure Applications**

DOE-EPRI-0000539

Final Report, December 22, 2017

Extensive evaluation was performed to determine the suitability of using SiC composite as a boiling water reactor (BWR) fuel channel material. A thin walled SiC composite box, 10 cm in dimension by approximately 1.5 mm wall thickness was fabricated using chemical vapor deposition (CVD) for testing. Mechanical test results and performance evaluations indicate the material could meet BWR channel mechanical design requirement. However, large mass loss of up to 21% was measured in in-pile corrosion test under BWR-like conditions in under 3 months of irradiation. A fresh sister sample irradiated in a follow-up cycle under PWR conditions showed no measureable weight loss and thus supports the hypothesis that the oxidizing condition of the BWR-like coolant chemistry was responsible for the high corrosion rate. A thermodynamic evaluation showed SiC is not stable and the material may oxidize to form  $\text{SiO}_2$  and  $\text{CO}_2$ . Silica has demonstrated stability in high temperature steam environment and form a protective oxide layer under severe accident conditions. However, it do

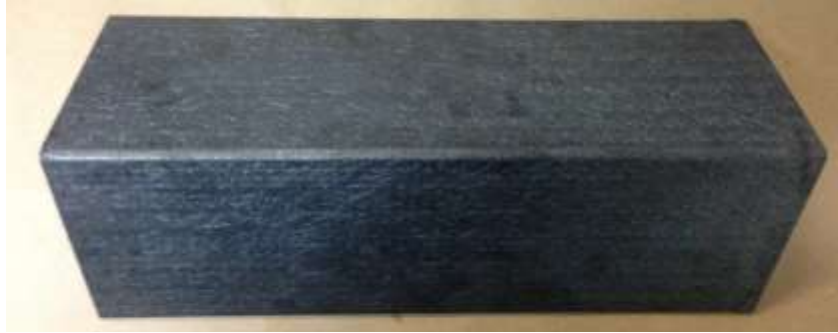
Figure 1-2 A section of test sample.

The test article had a 10 cm squared cross-section and with a wall thickness of approximately 1.5 mm. A 50 cm long section was used in an impact test.

The composite SiC<sub>m</sub>-SiC<sub>f</sub> channel box was produced with near stoichiometric Hi-Nicalon Type S SiC fiber in a SiC matrix produced by chemical vapor infiltration (CVI). A thin pyrolytic carbon (0.10+/-0.05 microns) was applied to the fiber prior to matrix densification. This composite construction has been previously shown to be radiation stable. The fiber preform was constructed of four layers of Hi-Nicalon Type S totaling 0.06-inch thickness. The innermost and outermost layers were constructed of triaxial braids formed continuously around a mandrel with the geometry of the channel box inner mold line. The two layers between the braided layers were formed from high areal weight Hi-Nicalon Type S fabric (8 harness satin construction at 360 g/m<sup>2</sup>) with an overlap joint such that the expected axial strength was >30 ksi. After preforming, a pyrolytic carbon fiber coating was applied by the thermal decomposition of hydrocarbons at elevated temperature and reduced pressure. SiC matrix densification was performed by CVI using the thermal reduction of methyltrichlorosilane to beta phase silicon carbide. CVI processing with uniform deposition on all preform surfaces was continued until ~10% residual porosity remained. A photograph of a section of the channel is shown in Figure 1-2.

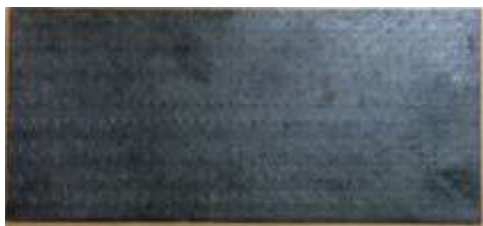
Figure 2-1 – Test coupon

Test samples were sectioned from the channel box fabricated per section 1.1.2.1 to dimensions tabulated in Table 2-1. A photograph of a typical sample is shown in Figure 2-1.

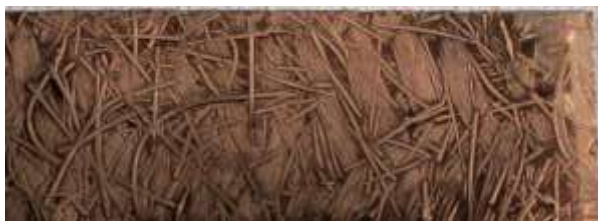
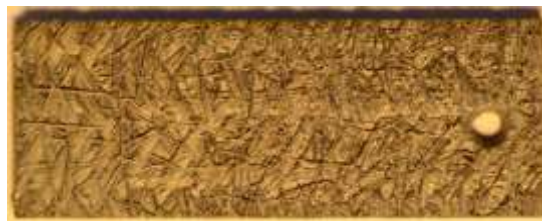
**Figure 2-24 Representative coated samples, (a) TiSiC 1:1 Ti:Si ratio and (b) Zr doped SiC with 2-5% atomic Zr content.**

Precursor gas for the formation of SiC was trimethylsilane. Hydrogen gas was used as a carrier gas and to control the thermodynamic conditions within the reaction chamber to facilitate SiC formation.  $\text{TiCl}_4$  or  $\text{ZrCl}_4$  were precursor gases for the deposition of TiC or ZrC, respectively. The flow rates of Ar,  $\text{H}_2$  and TMS gases were precisely controlled and measured. However, the flow rates of titanium or zirconium chlorides could not be precisely controlled or measured. Deposition was conducted at  $1100^\circ\text{C}$ . Precursor feed rates were adjusted trial by error to target the desired composition of 1:1 Ti/Zr:Si atomic ratio. The desired composition was achieved with TiSiC but not with ZrSiC. The deposition of ZrC is more favorable at higher temperatures relative to SiC. Representative photographs of test coupons are shown in Figure 2-24. Coating details and sample characterization were provided in reference 10.

The coated coupons were corrosion tested in a refreshed and oxygenated autoclave [11]. The dissolved oxygen concentration in the water was controlled at 1 ppm. Test samples were weighted at 7, 14 and 28 days of exposure. A few samples showed a rate change after 7 days of exposure but the rate did not continue to decrease after 14 days, indicating the failure to form a protective layer. After 28 days of exposure the test samples were examined in detail.

Visual examination of the test samples confirmed the weight measurements. The coating on most of the samples had corroded away. One of the coupons had a local patch of  $\text{Ti}_2\text{SiC}$  composition also corroded away. Minor residue still remain on some of the samples and an example is shown in Figure 2-25. X-ray analysis of the residue indicates the presence of some titanium but it is far from the  $\text{TiSiO}_4$  composition. High magnification image of the residue indicate a corrosion product of Ti-Si-O was formed, but it appears to be porous and not stable.
