**Paper No. 2065**

## **Thermal Testing of Waste Packages for a Storage Environment**

**Carlos Lopez, Victor Figueroa,  
Walter Gill, and Douglas Ammerman**  
Sandia National Laboratories  
Albuquerque, New Mexico, USA

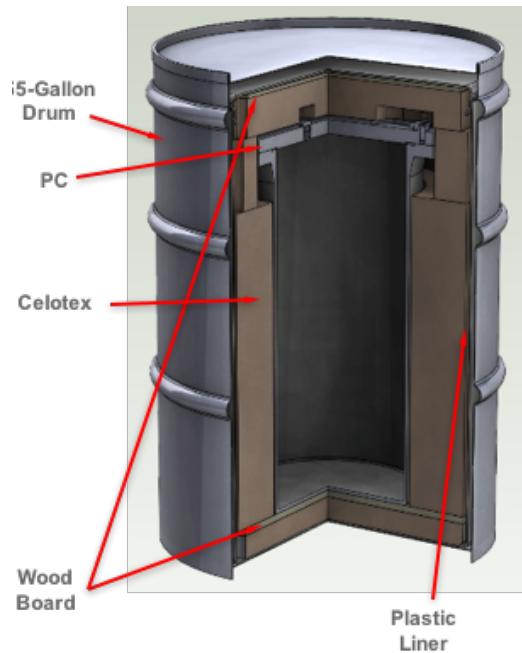
**Figure 1: Components of the Pipe Overpack Container (POC). As shown, the inner metal container is called the Pipe Container (PC).**

was not known. The POC has many design features that are similar to Type B packages that do provide protection from engulfing fires. Figure 1 shows the design features of the POC.

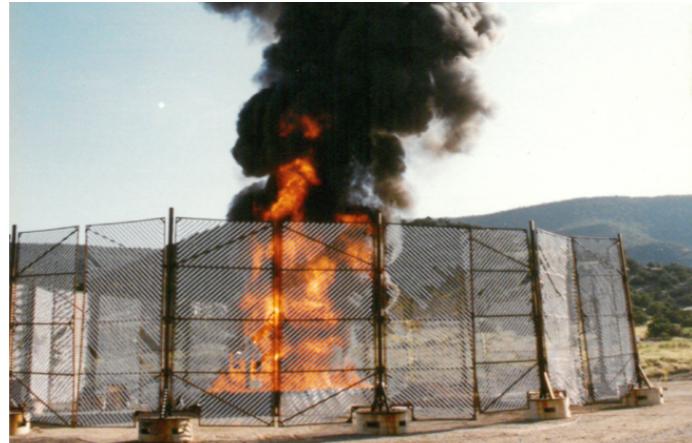
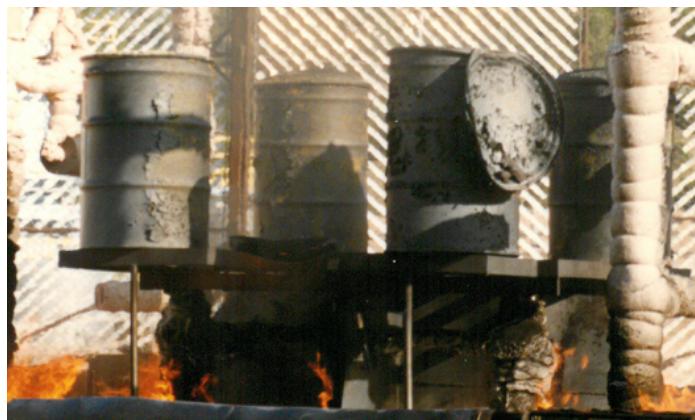
**Figure 2: (a) Engulfing pool fire and (b) damage to the POCs.**

Radioactive waste storage operators would like to be able to claim some level of protection is provided by the POC for thermal assaults that could occur within storage facilities. The tests performed during the 1990s at SNL showed that it was possible for a long duration fire to cause over-pressurization of the outer 7A drum and ejection of the drum lid. Figure 2(a) shows the engulfing pool fire that contained 4 POCs and Figure 3(b) shows the damaged state of these POCs after the fire. Note that one POC lid is rotated off the top of the drum and that the two other lids are severely bowed outward.

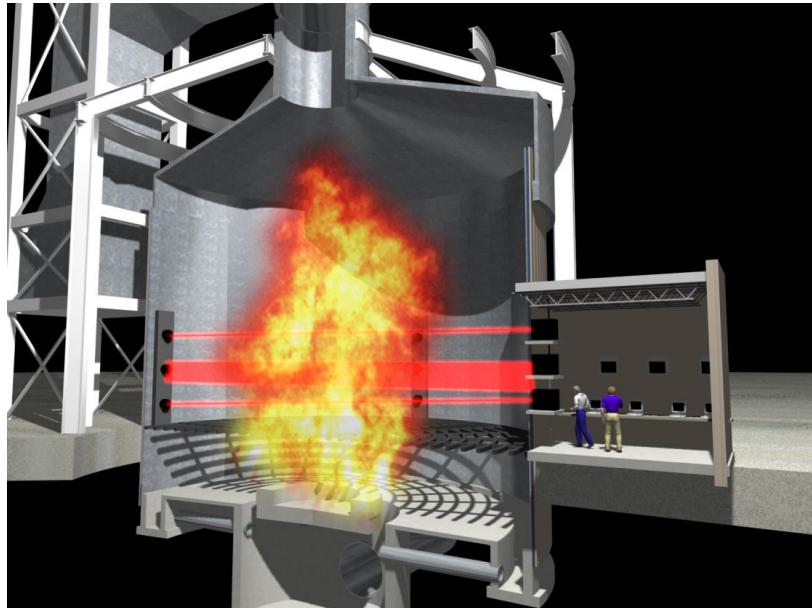
Figure 3. Conceptual drawing of the FLAME facility.

Testing during the first phase was conducted inside SNL's Fire Laboratory for Accreditation of Models and Experiments (FLAME) facility (see Figure 4). The FLAME facility has an 18.3 m in inner diameter with a height around the perimeter of 12.2 m. Figure 4 and Figure 5 show a typical test layout. The 3-m circular pool shown at the center of these figures was initially filled with Jet-A fuel. A remote refueling system adds fuel to the pool in discrete amounts during tests to keep the POC fully engulfed (see Figure 6). To limit the fire to the desired time (i.e., to 30 min or 60 min), the pool has a drain system that dumps all remaining fuel, almost immediately terminating the fire.

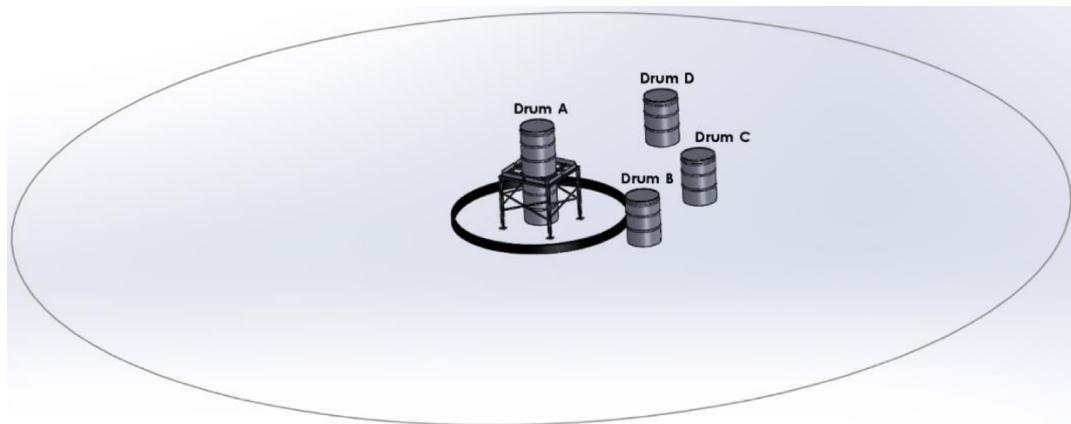
Figure 4. Layout of indoor POC tests in the FLAME facility. The inner circular wall marks the edge of the pool; the outer circular line marks the edge of the floor in the FLAME facility.

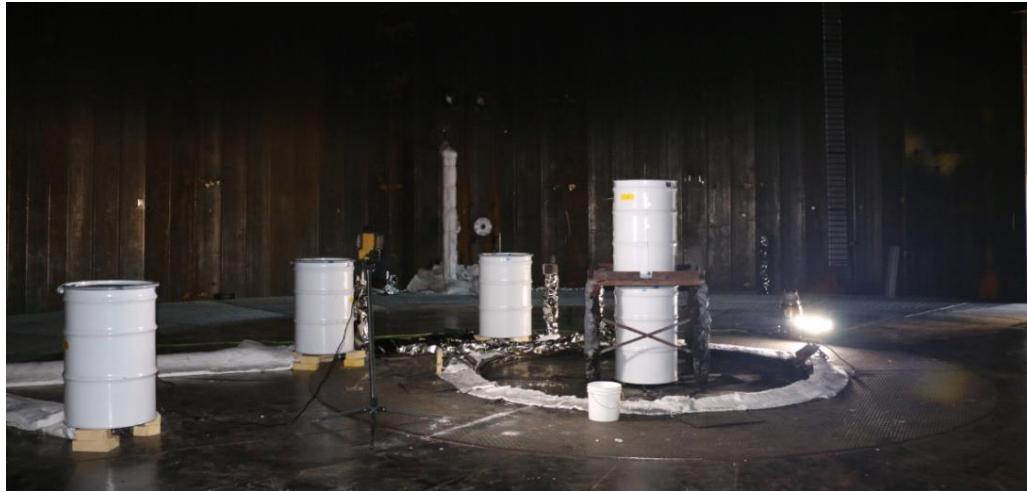
**Figure 5. View of POC drums in a typical test layout.**

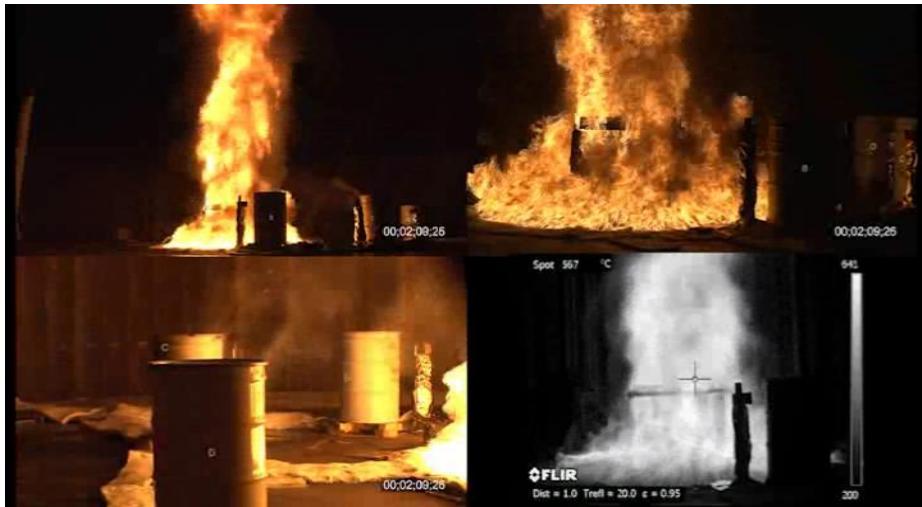
**Figure 6. Image of an indoor POC fire test showing fully engulfing conditions of the center POC drum, and showing the surrounding POC drums (bottom left).**

The initial location of the fully engulfed drum was at the center of the fuel pool, and just above an empty 55-gallon drum. This vertical drum arrangement is typical of what is seen in storage facilities, where two drums are stacked on top of each other typically in a two level, four-drum- array packed arrangement. The reason for choosing the top drum as the instrumented drum is that this is likely the drum that will experience the highest temperatures in a typical storage fire should there be a fuel pool accumulated at the base of the bottom drum. The rest of the drums were located at varying distances ranging from 1.75 to 4.5 m from the center of the fuel pool, and spaced at an angular distance of approximately 45-degrees from each other. Each drum had a HFG adjacent to it. Additional standalone HFGs were placed further back from the center of the pool.

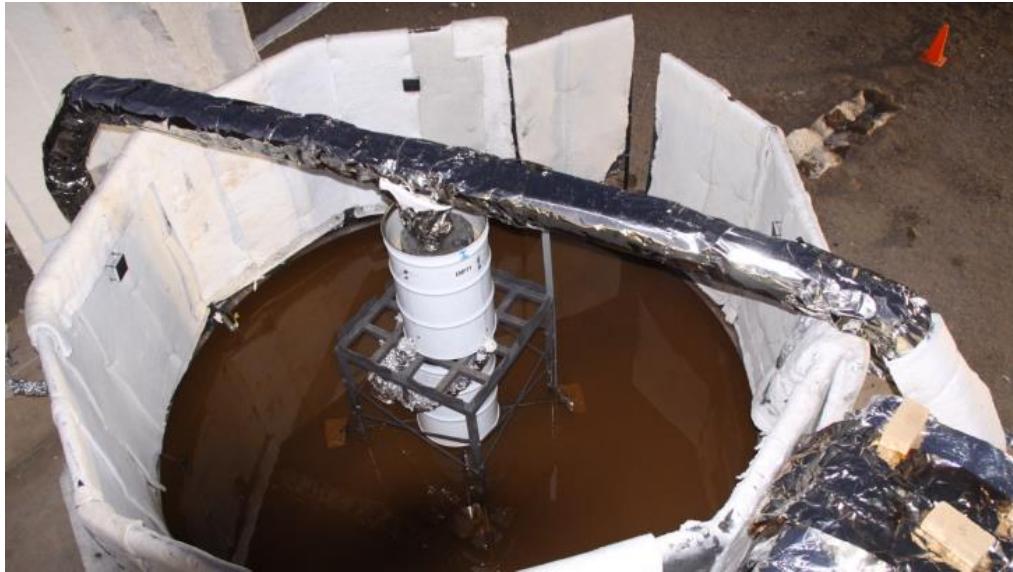
**Figure 7. Image of the POC drum inside the outdoor test cell. Note that there is no drum lid, and plastic liner, Celotex, and wood board cover in the top drum.**

Figure 7 shows an image of the drum inside the outdoor test cell, and taken at about 45-degree angle from the top surface of the pool. As in the first test phase, the instrumented drum is above an empty 7A drum. The fuel pool in this case was approximately 4m in diameter, but also filled with Jet-A fuel. The entire pool is enclosed inside an insulated fence extending about one or two inches just past the lid of the top drum.

As shown in Figure 7, in this test phase the drum lid and the top plastic liner, wood board, and Celotex covers were missing. The reason for this change in configuration is that the first phase tests showed these components are ejected early in the test (less than 3min) in the case of the fully engulfed POC drum. Although not by intention, this change allowed for simplifications in the design/installation of the aerosol collection system.

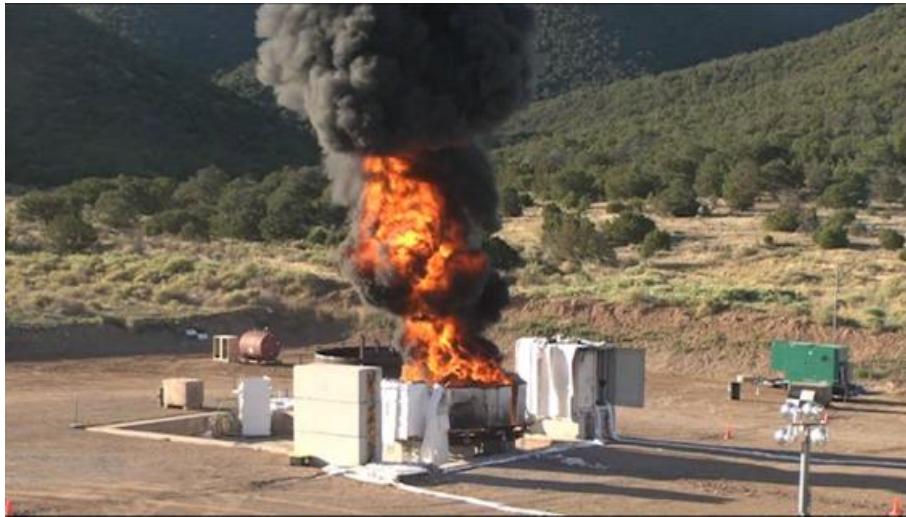
**Figure 8. Image of the fire showing fully engulfing conditions.**

As in the first phase, a remote refueling system was added to keep the fire going past 30-minutes. A drain system was also employed to dump the fuel and stop the fire at the desired time (30-minutes). The fence was added to shield the pool and the drums from incoming wind, guaranteeing the fire flames fully engulf the instrumented POC drum (see Figure 8).

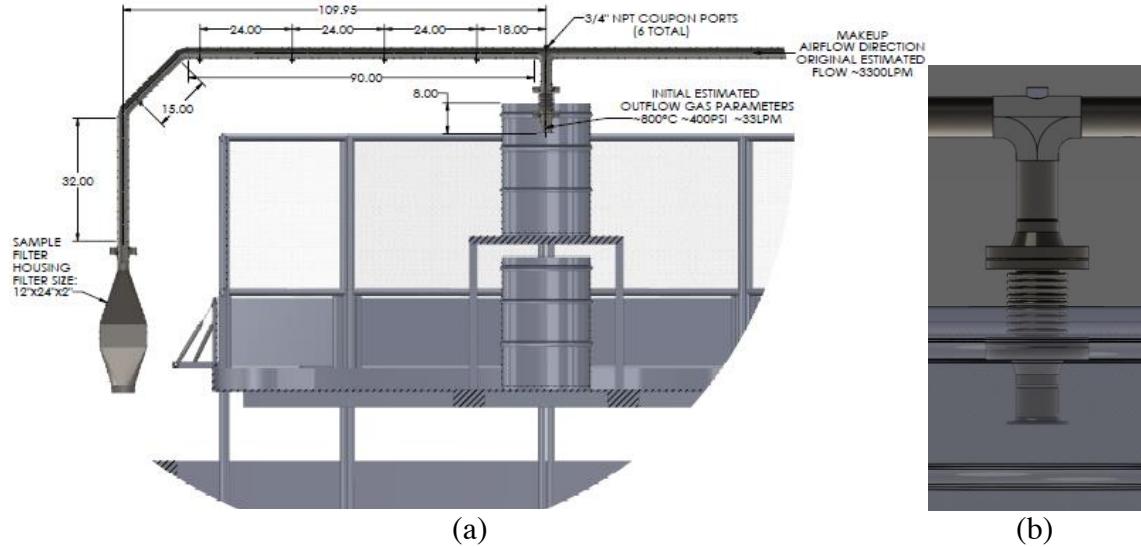
**Figure 9. (a) Schematics of the aerosol system showing the outlet HEPA filter and the location of the coupons. Not shown is the inlet end of the U-shaped pipe which mirrors the outlet end shown. (b) Close-up of the vertical section of the pipe. Contents of the POC drum are not shown. All length units are in inches.**

Prior to this test, this event had not been confirmed via previous tests in this series. A detailed diagram of the aerosol collection system is shown in Figure 9.

The aerosol collection system consisted of (1) three vertical pipes: the bottom welded to the PC lid, the top welded to a horizontal section of pipe, and middle one consisting of a bellows; and (2) a long, downward-facing U-shaped pipe. The vertical pipes were concentric with the PC filter and joined to each other using bolted flanges. Due to the flow path through the PC filter, it was expected that most of the mass escaping the PC would be collected in the lower section of the vertical pipe immediately adjacent to the filter. In principle, additional aerosol released through the PC filter not trapped in this section of the pipe wall, and presumably floating in the hot gas, would eventually rise through the vertical section of the pipe with the aid of buoyancy forces.

To collect loose aerosol at the T-junction, cold air was drawn through an upstream HEPA filter at one end of the U-shape section of the pipe (not shown in Figure 9) to clean incoming air. At the other end of the U-shape section, an additional HEPA filter was designed to collect the sizes of aerosol particles of interest. Cold air was necessary to keep the HEPA filter below its maximum operating temperature. The length of the U-shaped section of the pipe and the air flow rate were also based on this requirement. To catch any aerosol deposited on the U-shaped pipe, coupons were strategically placed at various locations along this pipe. Together, the samples collected in the section of the pipe near the filter, on the coupons, and the HEPA filter would give an indication if any aerosol of interest was released.

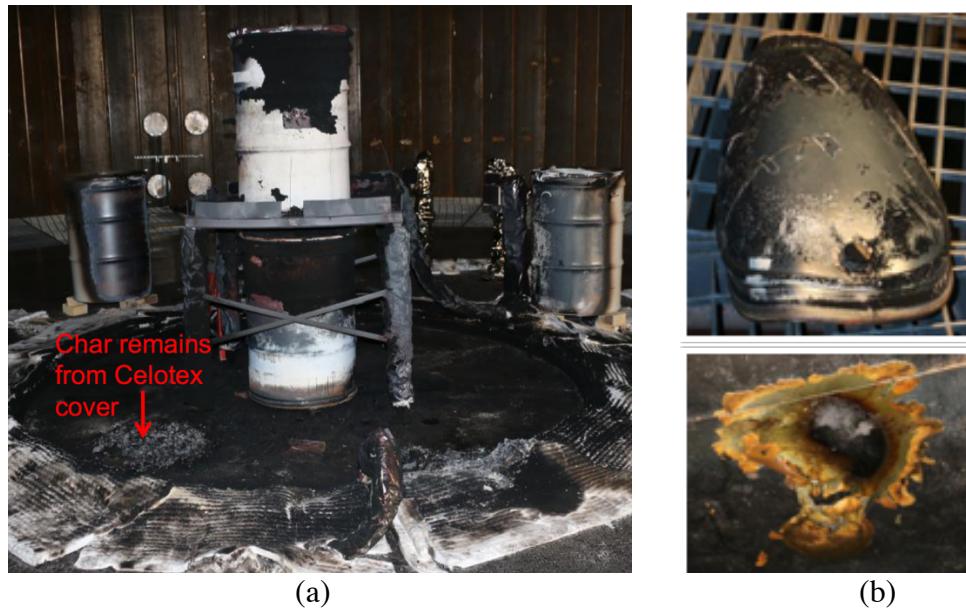
**Figure 10. (a) View of center drum after the fire. Also showing are the remains of top Celotex cover ash remains inside the fuel pool. (b) Close-up view of the ejected lid (top) and the remains of the plastic liner cover (bottom) on the test cell floor.**

Figure 10 shows an image of what the drums looked like after the 30-minute test, and some of the remains of what was ejected from the POC drum. Component ejection occurred less than 3 minutes into the test. Inside the fire, and like the 1997 SNL tests, the lid of the engulfed drum failed, and led to ejection of the top plastic liner, Celotex, and wood board covers under the increased pressure caused by expansion of hot gases inside the POC drum. Post-test visual examination of the fully engulfed drum showed no remains of the plastic liner and some ash remains of the Celotex material inside the drums. The PC was still standing at the bottom of the drum with the help of some of the intact remains of the bottom wood board.

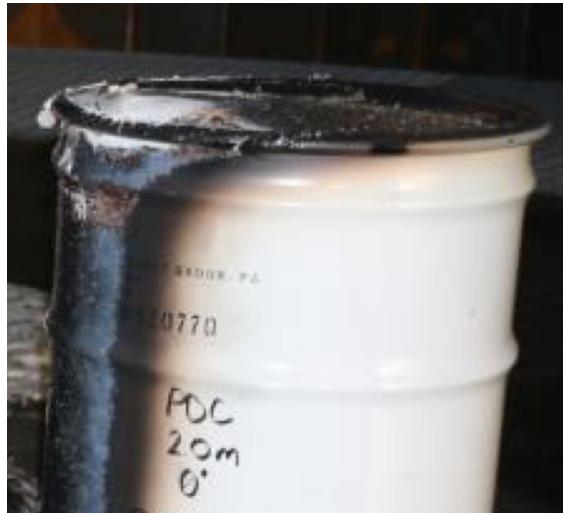
**Figure 11. Bulging of the 7A drum lid on a POC at 2m from the center of the fire.**

Based on video recordings during the test, and as confirmed by post-test examination of the drums, outside the fire none of the drum lids experienced gross failure; though, adjacent to the edge of the flame (2m or less, or  $\sim 45\text{kW/m}^2$  equivalent distance or higher), lid bulging occurred on the side facing the flame (see Figure 11). Internally, some degradation of the plastic liner and the Celotex was observed. Overall the bulk of the Celotex remained intact.

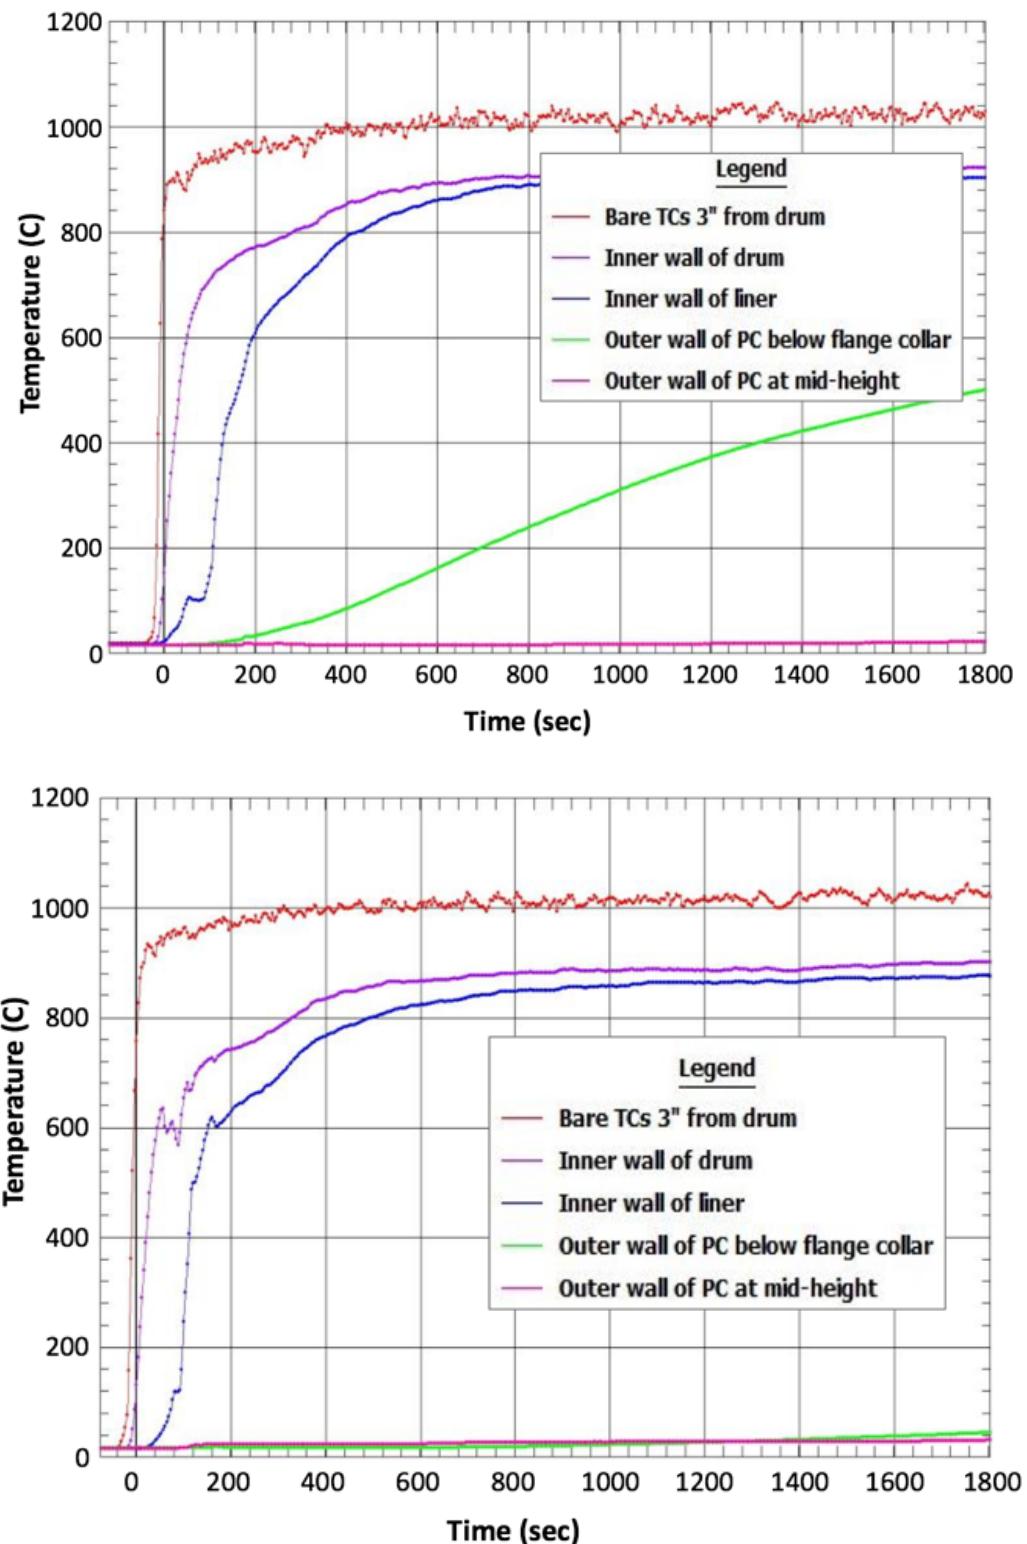
**Figure 12. Temperature response at various locations in the POC: upper graph without the drum lid, and plastic liner, Celotex, and wood board covers, and lower graph with standard components.**

Figure 12 shows typical temperature response of components inside the fully engulfed POC drum, including the PC, for the 60-minute test, without and with the lid. A significantly difference temperature profile is observed in the flange area, suggesting that the effect of ejecting these components is significant.

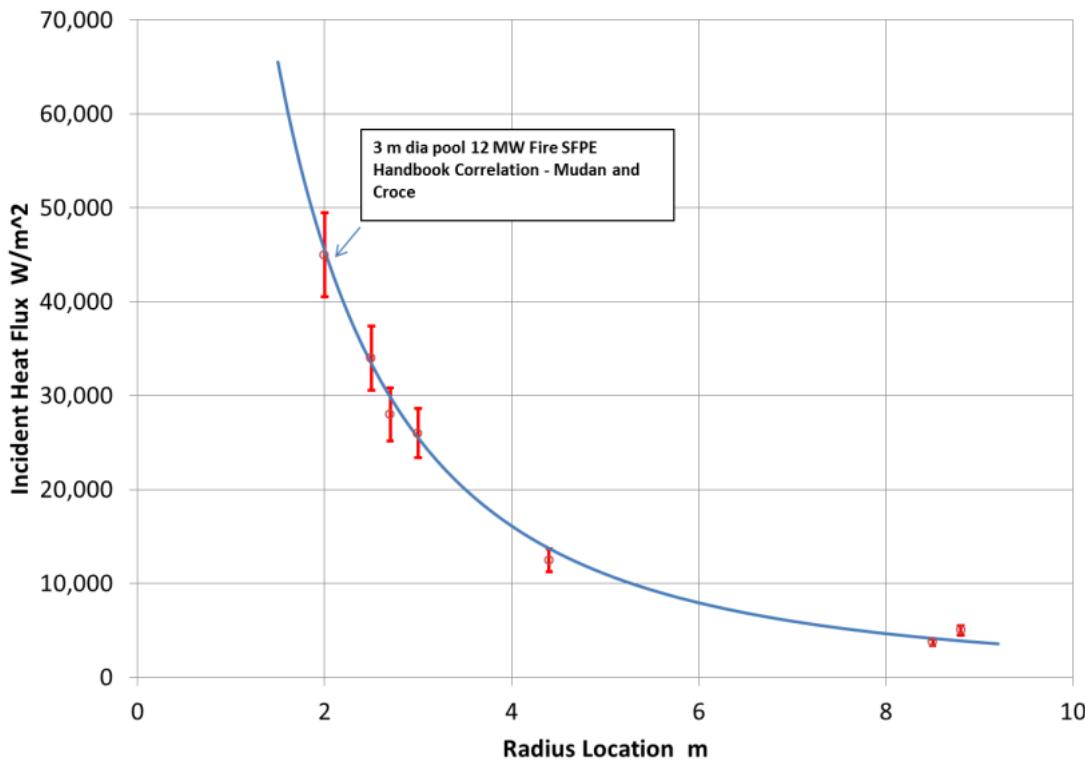
**Figure 13. Incident heat fluxes (red) recorded with HFGs for various test and at various distances. Superimposed on the data are correlation results for typical incident radiation from a fire plume as a function of distance.**

Figure 13 shows some of the incident heat fluxes recorded with HFGs at various locations in the FLAME test cell. Data for distances less that 4.5m give an indication of the incident heat fluxes on the hot side of the drums located outside the fuel pool. The solid line drawn in the plot, which aligns well with the measured heat fluxes, represents predicted incident heat fluxes taken with a correlation obtained from [1]. As noted in this plot, the relationship between incident heat flux and distance is inversely proportional to the square of the distance from the fire, as expected.

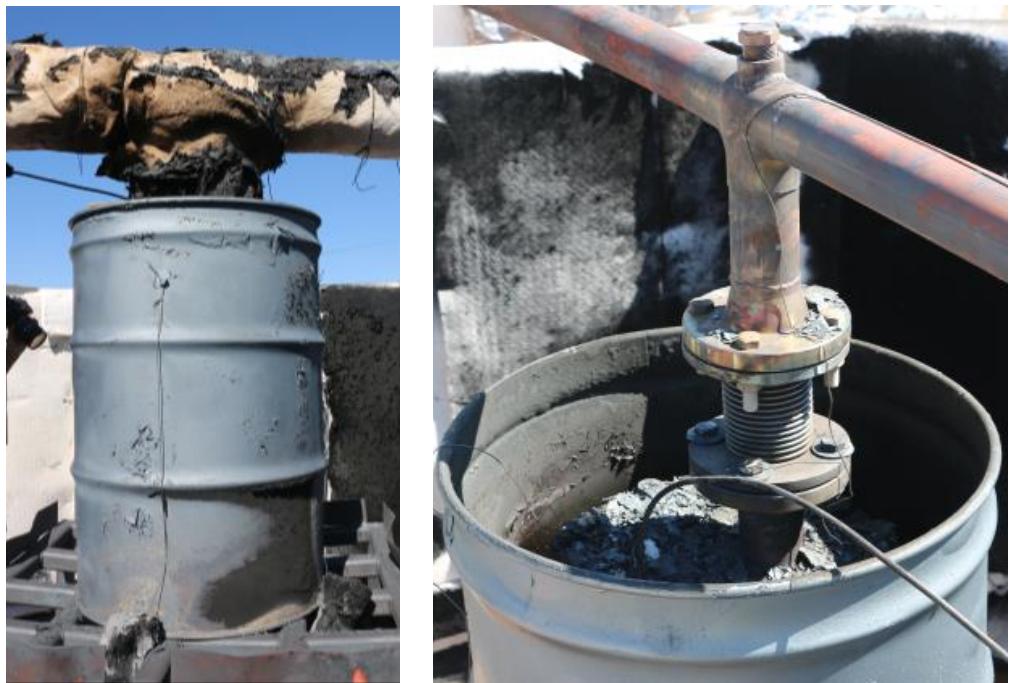
**Figure 14.** POC drum without a lid after the 30-minute engulfing fire. The right image shows a close-up of the vertical section of the pipe after the test when the insulation was removed. The bellows portion of the vertical pipe was added to allow for unobstructed deformation of the PC lid due to thermal stresses.

Figure 14 shows an image of what the drums looked like after the outdoor fire test. As expected, post-test visual examination of the drum showed no remains of the plastic liner and some ash remains of the Celotex material. The internals of the drum look very similar to those of the center drum in the first phase tests.

One significant finding from this test, as evidence by these images, is that the pressure build-up inside a PC with combustible material is not sufficient to rupture the PC. This finding allows future test to be conducted indoors under more controlled conditions.

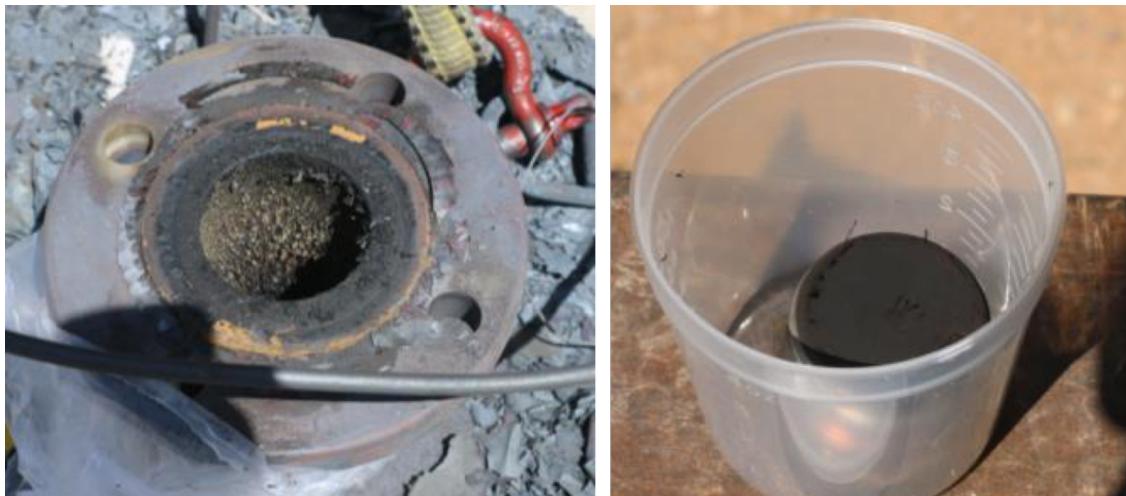
**Figure 15.** Material collected on the first section of the vertical pipe (left) and on one of the sample coupons on the horizontal section of the U-shaped pipe (right).

Figure 15 shows material that escaped through the filter and condensed on the side of the lower section of the vertical pipe immediately outside the PC filter, and a coupon with soot extracted from the aerosol collection system on the horizontal section of the pipe. As expected, accumulation of material was heavy in this region. This material seemed to be a black tar-like substance likely from condensation of gases and soot from the plastic material and burned Kimwipes. Material accumulation was mesh less on the second vertical section of the pipe and was made up primarily of soot particles. A soot like material was collected from the sample coupons and from the HEPA filter.
