Electrical Behavior of Mechano-Chemical Deposits on Sliding Contacts

M.T. Dugger, B.L. Nation and R.S. Colbert

2016 STLE Annual Meeting, 16-19 May, Las Vegas, NV

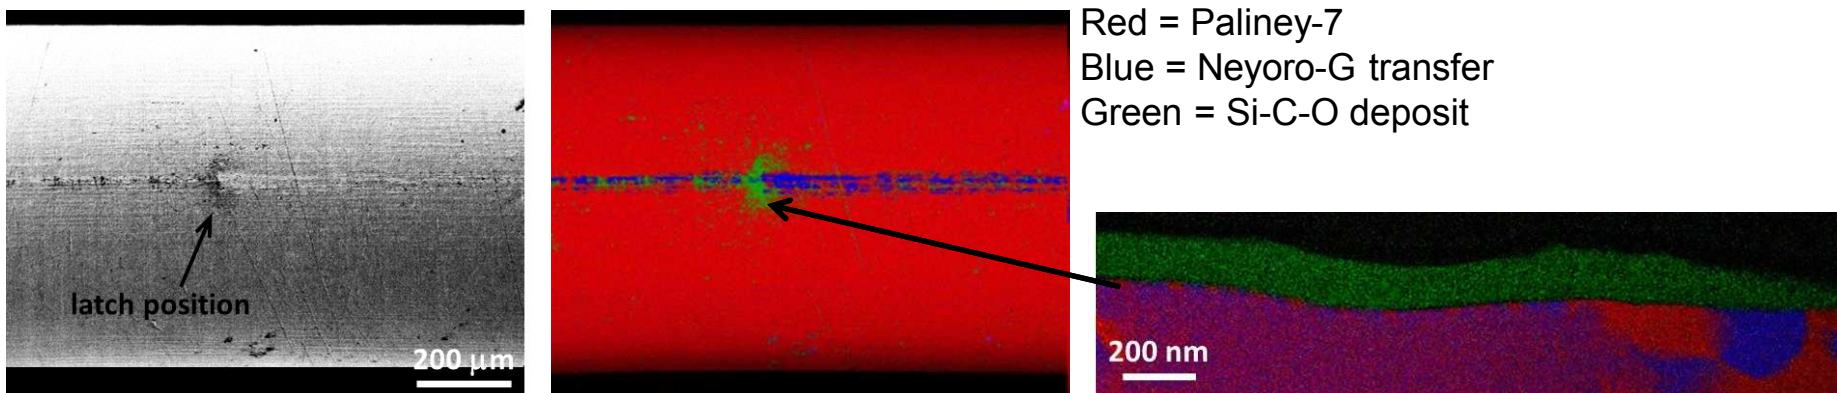
A fluid-damped accelerometer exhibits increased electrical contact resistance (ECR) after storage

- contacts are precipitation hardened Pd-Ag-Cu and Au-Cu-Pt electrical contact alloys (Deringer-Ney)
- the device is filled with 20 cSt PDMS (siloxane) fluid

EDS/AXSIA image of a focused Ion Beam (FIB) cross section through deposit

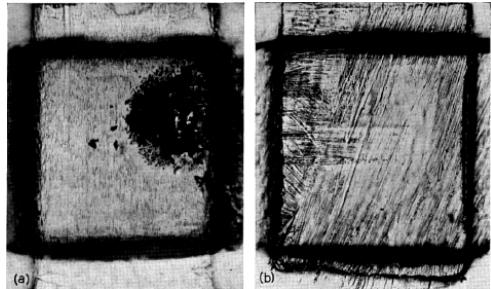
When taking plastic replicas of fielded contacts, organic deposit trapped on replica

Fig. 1 — (a) Vinylite replica of a palladium relay contact, showing organic deposit formed from vapors of organic structural parts after 10^8 closures; (b) replica of a silver relay contact after 10^8 closures, showing complete absence of organic deposit. (Both magnified 75 times.)

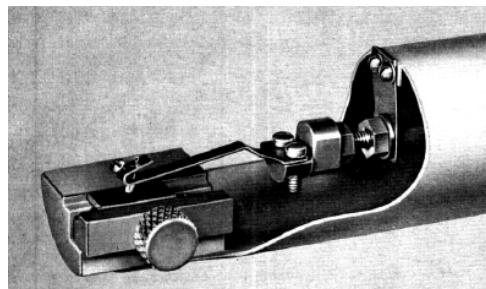
Developed high frequency oscillatory tribometer to produce deposit by sliding

- estimated conversion of 1 ML per pass of adsorbed benzene into polymer
- thermal decomposition ruled out; invoked "...straining and deformation of the molecules..." to cause reactions

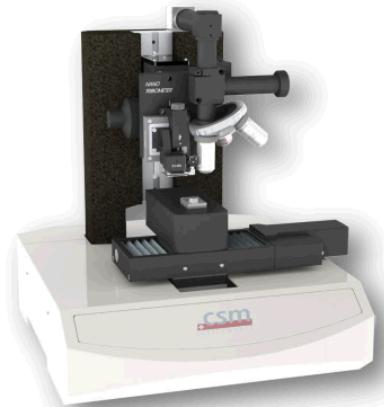
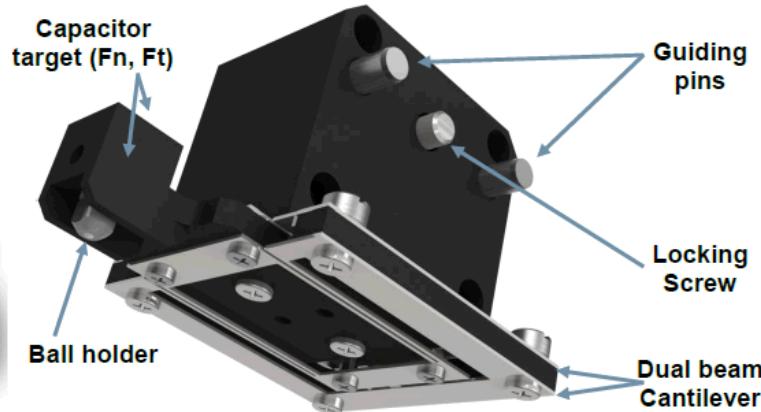
Nanotribometer modified for 4-wire ECR measurement

- $N = 50 \text{ mN}$
- pin radius = 1.6 mm
- track length = 1 to 2 mm
- fluid volume = 5 mL
- $i = 10 \text{ mA}, 1 \text{ V open circuit}$

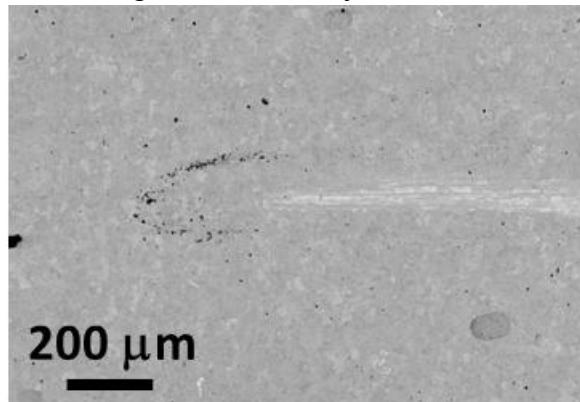
current + no vibration

thermal decomposition

- current alone produced gold transfer, but very little deposit
- suspected make-break arcs during movement, leading to thermal decomposition of silicone

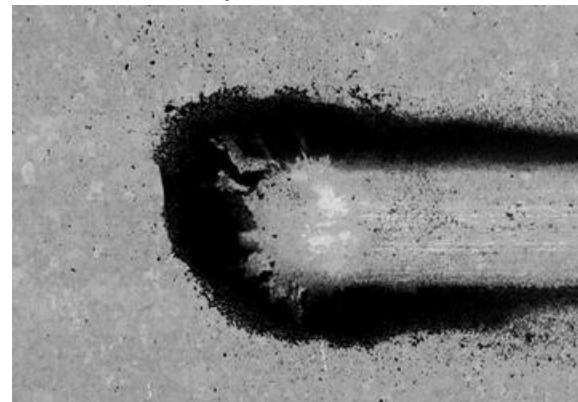
current + vibration

Deposit is created during mechanical contact of the metals, with little or no influence of current

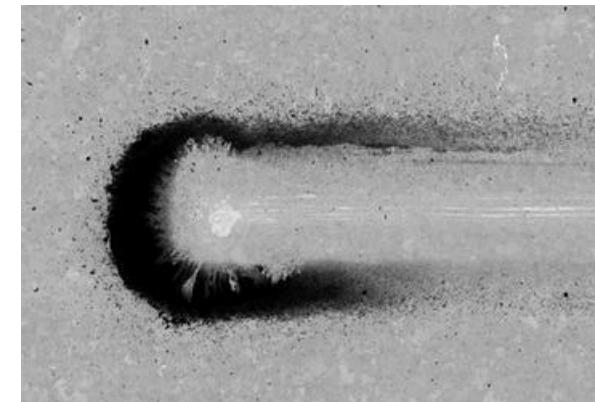
no current + vibration

- related to the creation of freshly-exposed metal surface by sliding

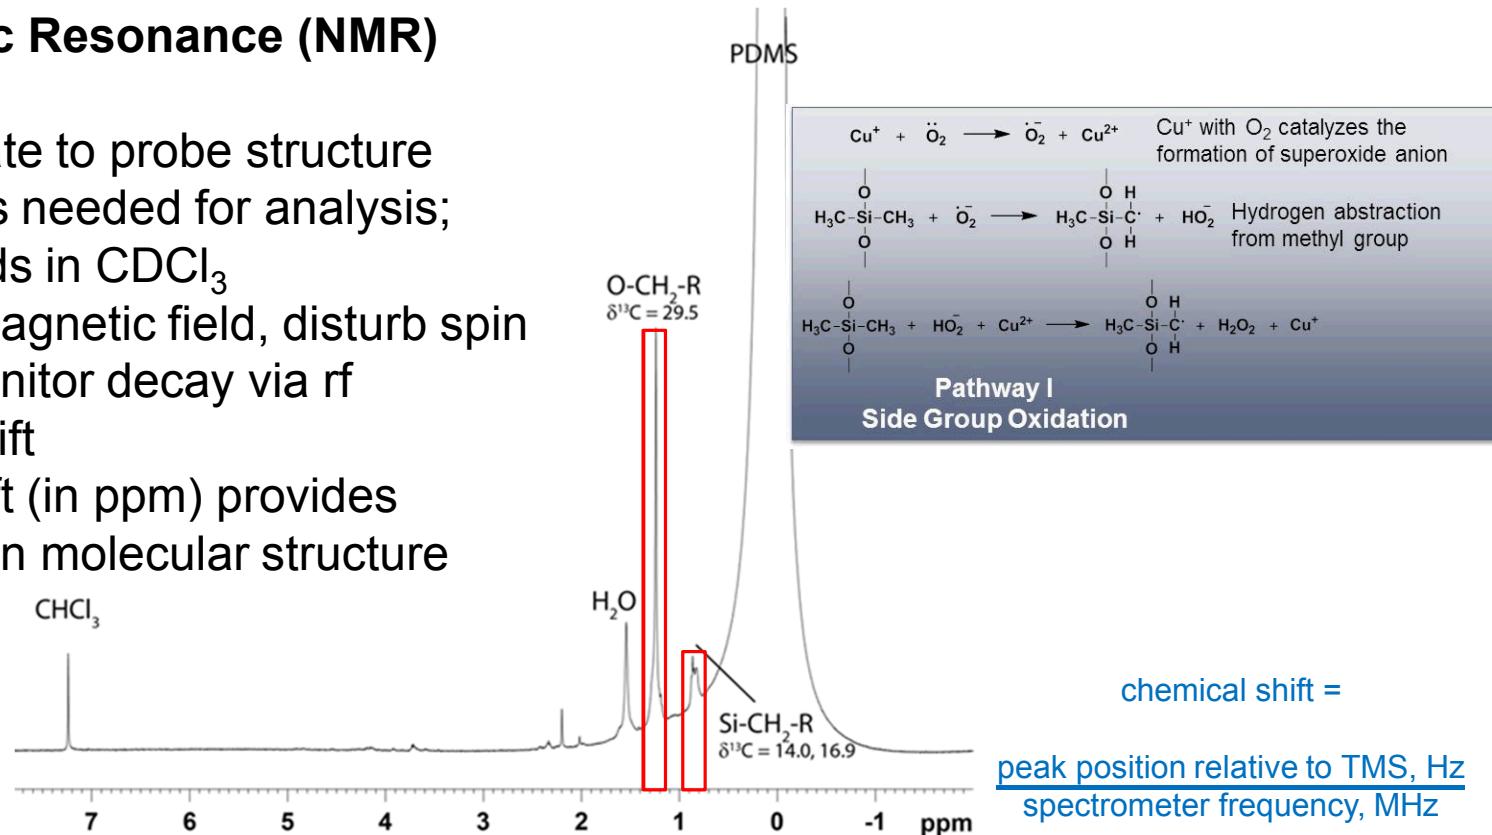
- uses spin state to probe structure
- mg quantities needed for analysis; dissolve solids in CDCl_3
- in a strong magnetic field, disturb spin state and monitor decay via rf frequency shift
- chemical shift (in ppm) provides information on molecular structure

- Product consistent with alkyl radical formation by metal catalysis
- Methyl side group oxidation, and free radical condensation is the dominant degradation pathway

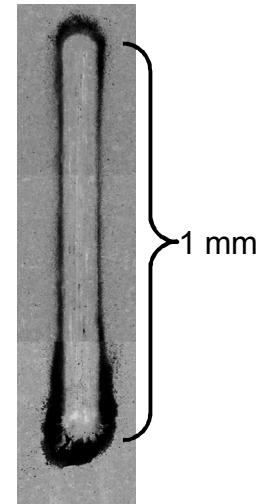
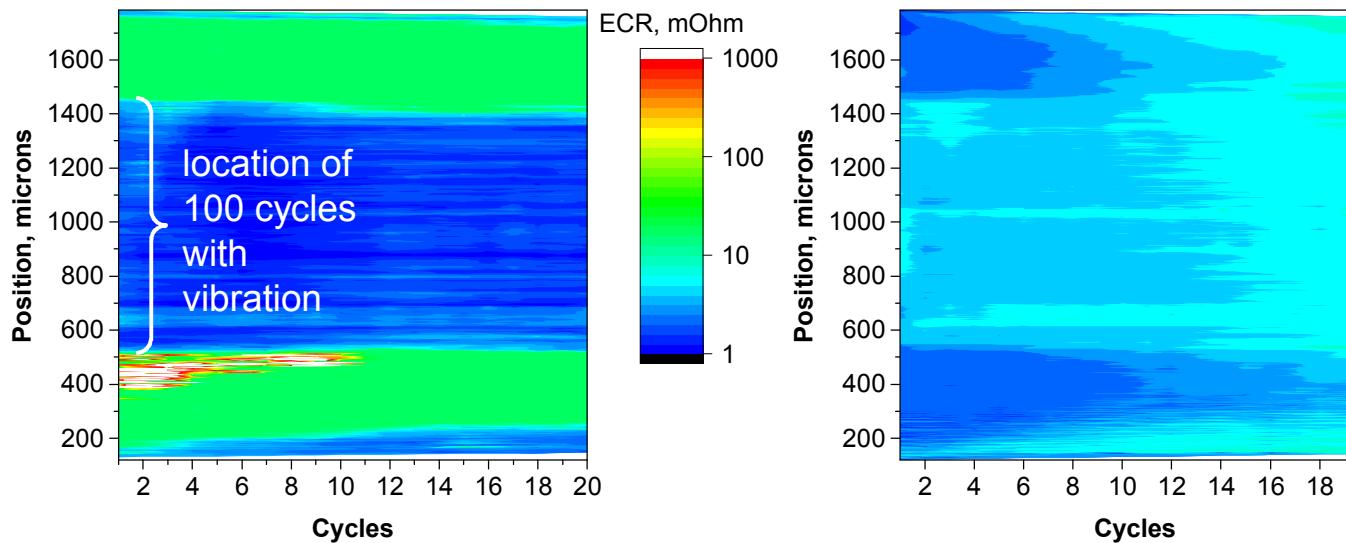
initial wear track
with vibration

Increased ECR is observed when pin slides over deposit

1. Measure CoF and ECR along 2 mm track for 3 cycles with no vibration
 - a. 88 mN (9 gf) contact force
 - b. 20 mA DC current, with 1.1 V open circuit limit
2. Perform 100 cycles sliding with vibration on central 1 mm
 - a. 50 μm displacement amplitude orthogonal to sliding direction, 100 Hz
3. Measure CoF and ECR along 2 mm track for 20 cycles with no vibration

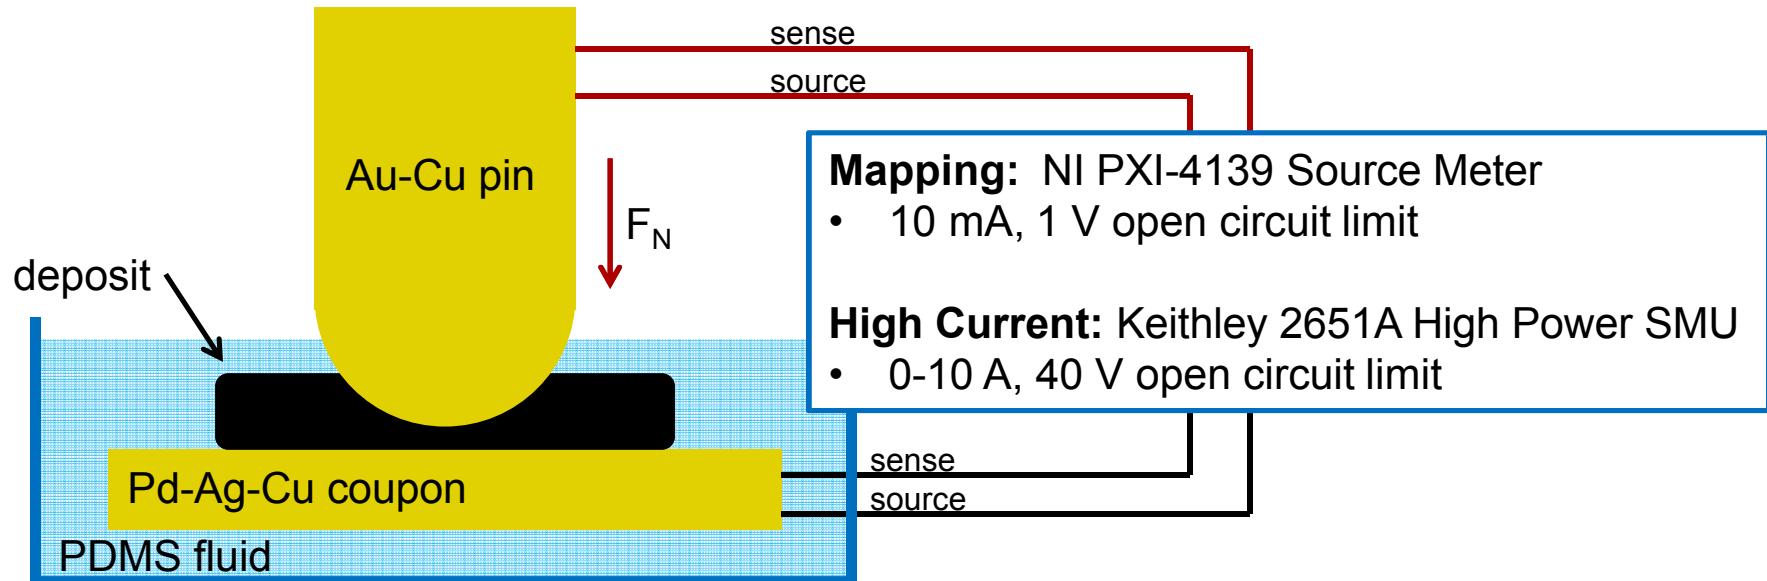
- map ECR near deposit using low probe current
- select location, deliver current pulses or ramps
- determine ECR versus force by ramping load on pin

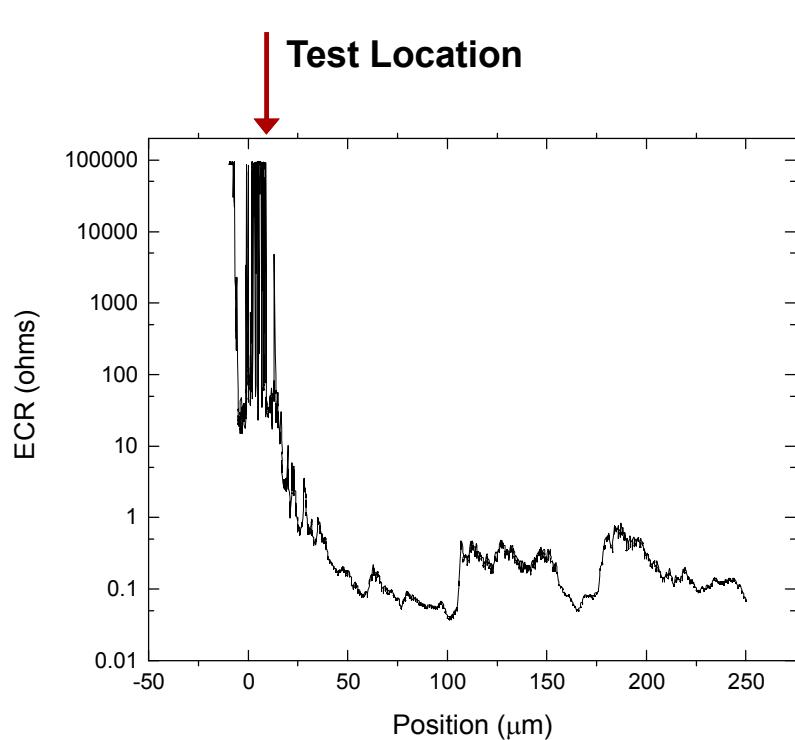
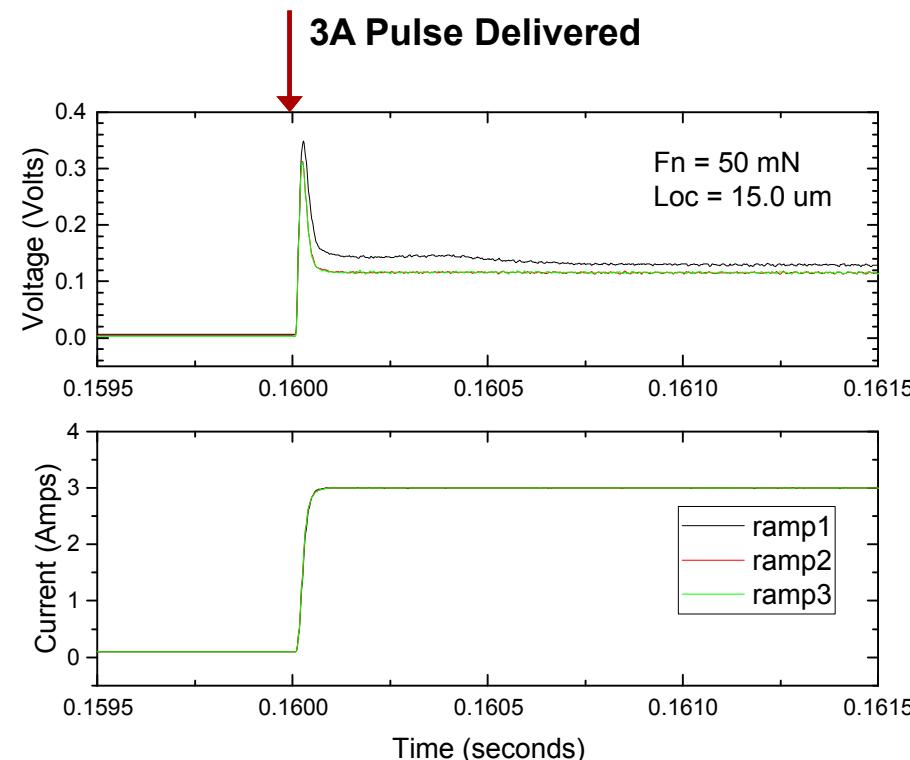
- initial voltage spike $\sim 350 \text{ mV}$ as current rises
- ECR stabilizes at $\sim 50 \text{ m}\Omega$

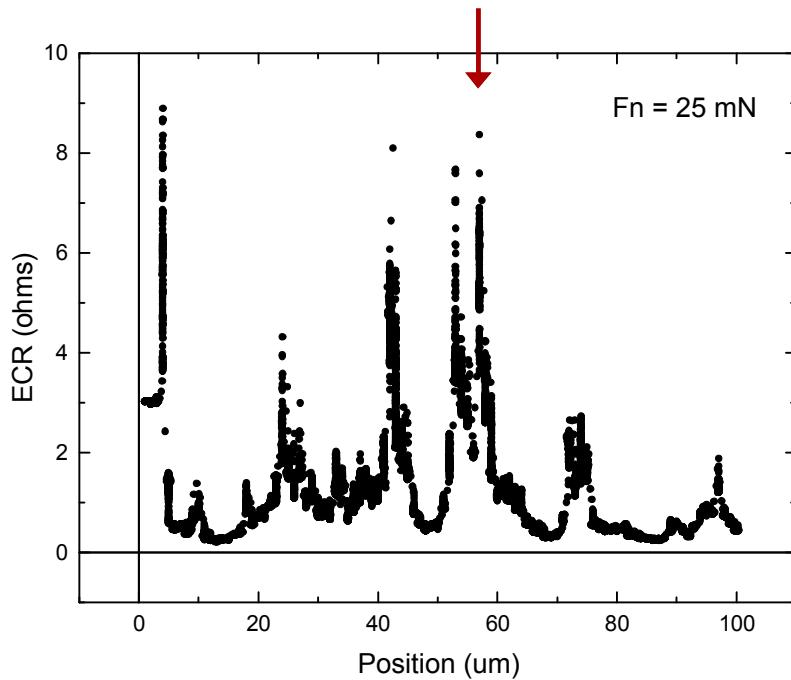
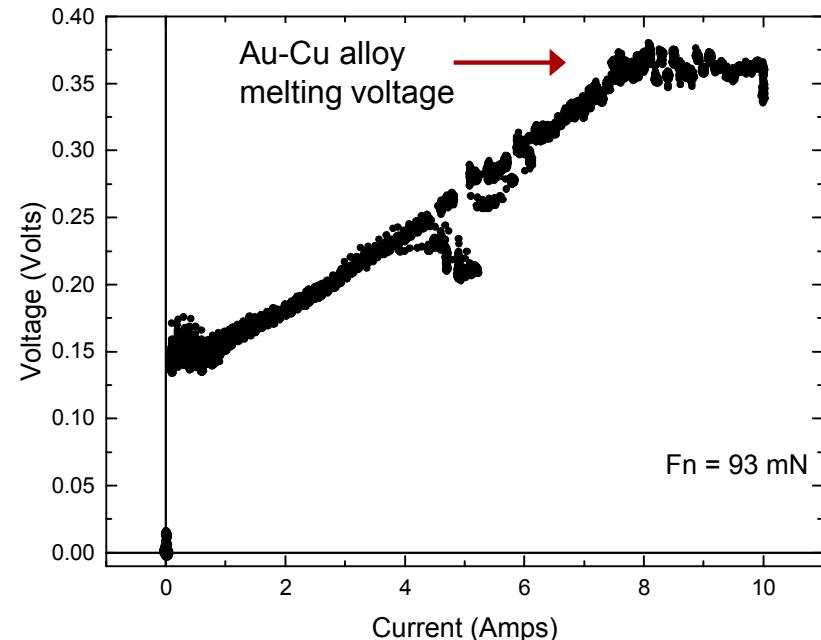
- slower current sweeps reveal an abrupt turn-on of current
- dielectric breakdown of deposit

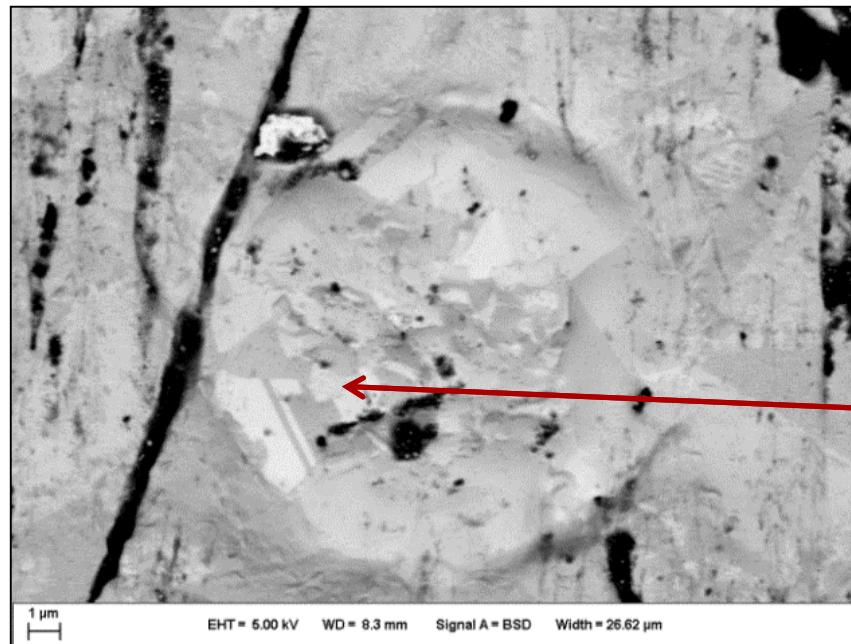
Backscattered electron channeling contrast image of Pd-Ag-Cu alloy after high current exposure

evidence for local
recrystallization

Local heating induces microstructural changes in the electrical contact alloy

- dielectric breakdown of deposit
- localized softening/melting of contact materials

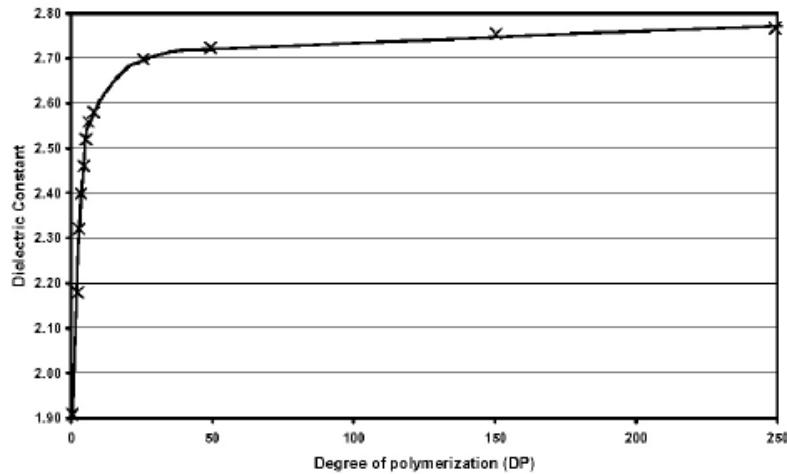
- dielectric strength rapidly saturates with increased polymerization (viscosity) to 158 kV/cm
- suggests ~10 nm deposit thickness
- consistent with TEM observations

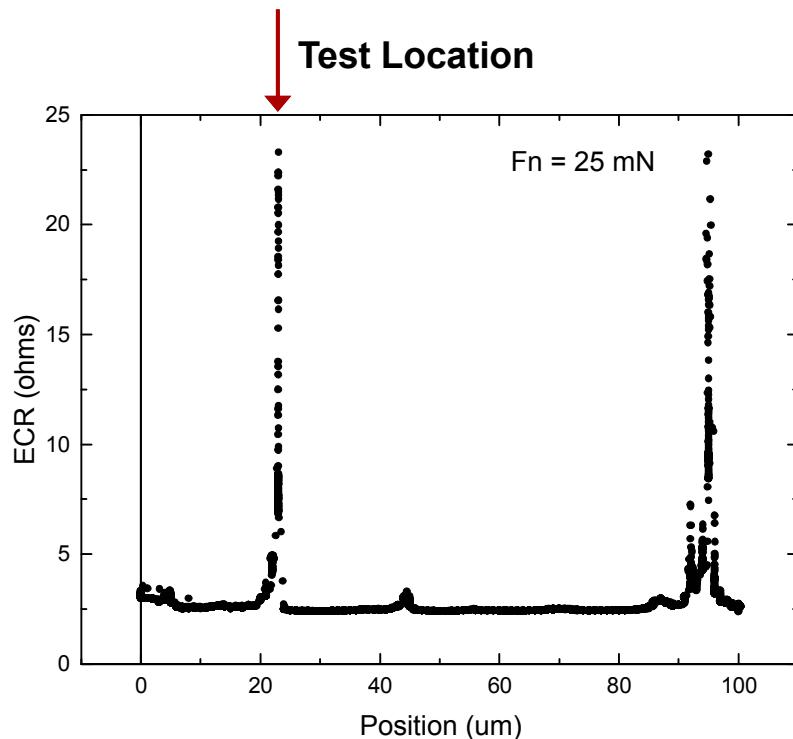
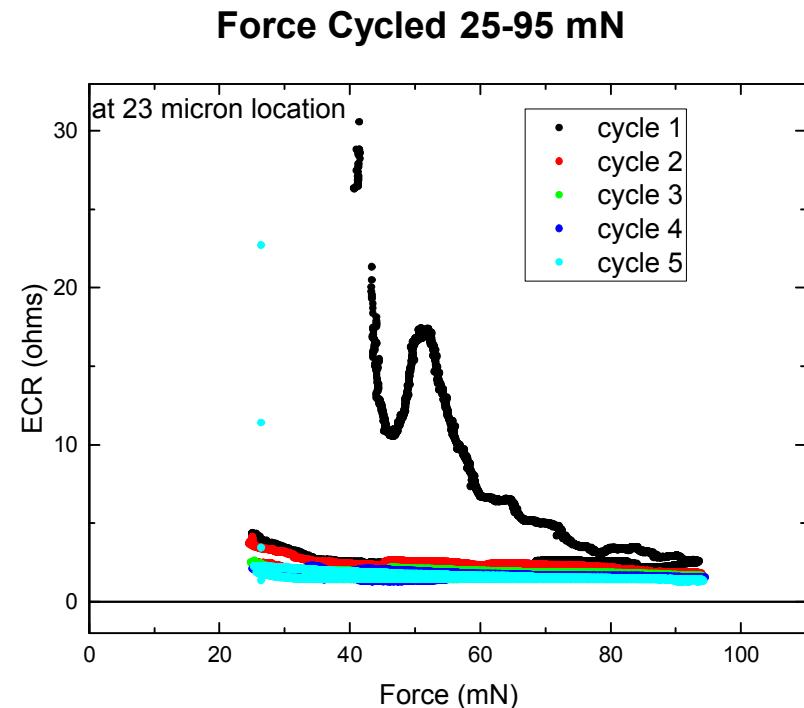
- first force cycle exhibits elevated ECR at low contact force
- subsequent cycles exhibit reduced ECR, indicative of mechanical displacement of deposit
