# **SANDIA REPORT**

SAND2018-1425

# **Pipe Overpack Container Fire Testing: Phase I, II, & III**

Victor G. Figueroa, Douglas J. Ammerman, Carlos Lopez, and Walter Gill

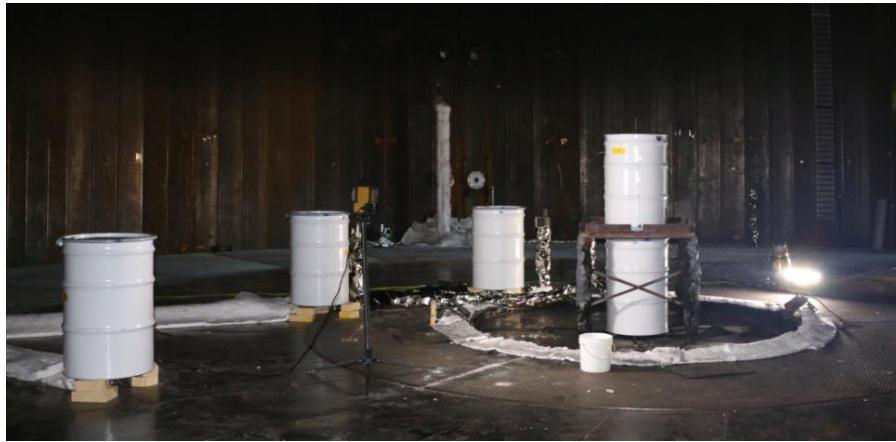
**Figure 3. Typical fuel-pool/drum layout inside of FLAME.**

Figure 3 shows the typical test layout inside the FLAME facility for the first four tests. The 3-m circular pool shown at the center of the facility was initially filled with Jet-A fuel in all tests. Jet-A fuel fires behave similar to a diesel fire. Little difference in heat flux to objects inside and outside of the fire are expected between these two fuel fires. A remote refueling system added fuel to the pool in discrete amounts during tests to keep the fire going. To limit the fire to the desired time, the pool has a drain system that dumped all remaining fuel at the end of the test, almost immediately terminating the fire. The typical fuel consumption rate for these tests was 0.3 kg/sec. All tests in this series consisted of one POC placed at the center of the pool, with additional drums placed on the grid floor outside of the fuel pan at various distances, as depicted in Figure 3. The POC at the center of the pool was always resting on a square-grid table, 1 m above the fuel pool surface and directly above an empty 55-gallon drum. This vertical configuration is typical of what is seen in storage facilities, where drums are stacked on top of each other, typically in a drum-array arrangement within a single drum level, as seen in Figure 4. In these tests, there were no drums adjacent to other drums as depicted in Figure 4 and the stack was only two-drums high. This test configuration (without a third drum stacked above the POC drum or adjacent stacked POC drums) exposes the POC drum to higher thermal loads than would be experienced in the typical drum-array storage arrangement, where the energy released from the fire would be shared with additional drums.

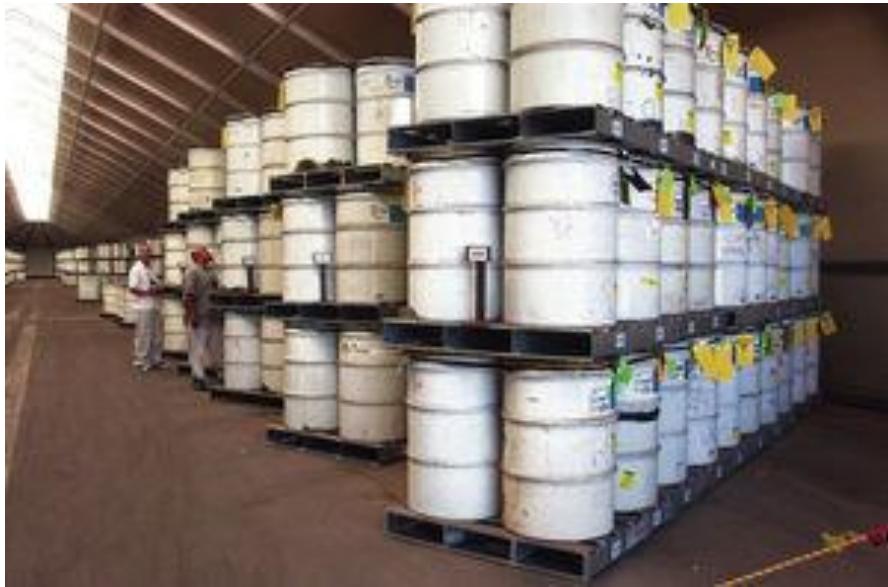
**Figure 4. Drums in a typical storage configuration at LANL**

In all indoor tests, the top center drum was instrumented with at least four thermocouples (TCs), while the lower empty drum was never instrumented. The empty drum was used to block the flames and to partially insulate the top POC, as it occurs in an actual stacked-drum configuration. The lower drum was also used in some tests to route TC lines from outside the fire to the interior of the top POC. The reason for loading and instrumenting just the upper drum is that this is the drum that will experience the highest heat fluxes in a typical storage fire should there be a fuel pool accumulated at the base of the bottom drum. One additional drum stacked above this top drum would shield this drum from the top flames.

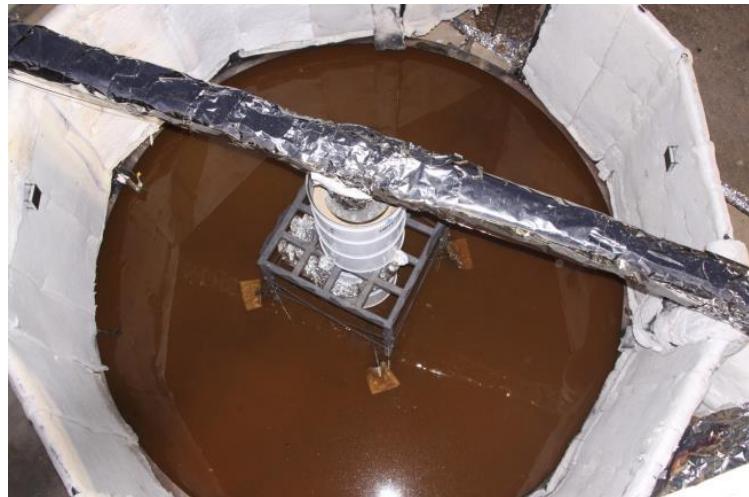
**Figure 5. Outdoor fire test cell with the POC drum.**

Figure 5 shows the test layout for the outdoor fire test. The 4.2-m circular pool was initially filled with Jet-A fuel. As in previous tests, a POC rested on a table with an empty 55-gallon drum placed underneath it. The table is the same one used in the indoor tests. The bottom of the POC was 1-m above the top of the fuel surface. The drum lid of the POC and all POC components above the PC lid were removed since they were assumed already ejected from the

POC. The drum lid and these components were ejected around 3 minutes in the fire when the POC was at the center of the fire in the indoor test. As shown in this Figure 5, an aerosol collection system was placed over the top of the drum, and consisted of an T-shape pipe system with the bottom of the vertical pipe covering the PC vent. The system was designed to collect material released through the PC vent. Samples of released material were analyzed for the presence of surrogate aerosol material. Details of the aerosol collection system are provided in the next section.

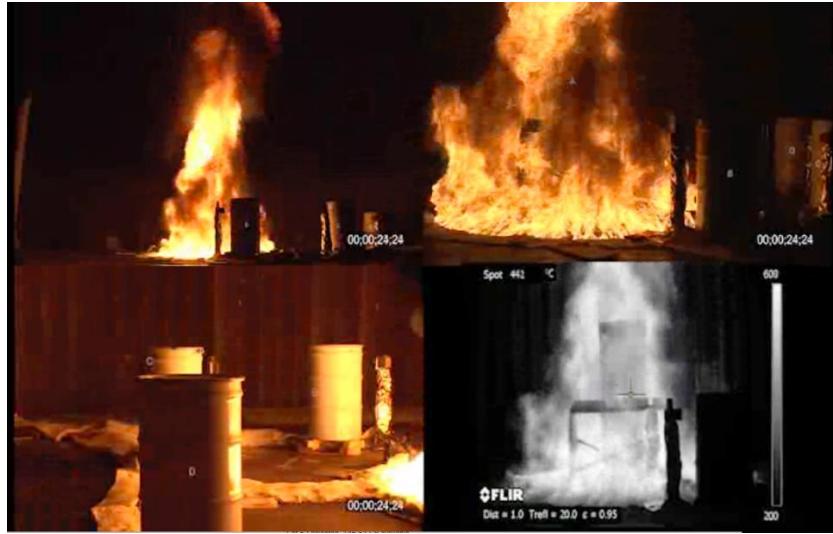
**Figure 11. Camera views used in Phase I.**

Beside the temperature response of POC components, one additional aspect of interest was the performance of the drum seal, drum filter, and drum lid. Does gas start to vent through the drum seal before the drum filter ruptures; does the drum lid open before the drum filter ruptures; if the lid opens, when does it open; etc.? To help answer some of these questions, three video cameras and one IR camera were deployed to monitor the tests in real time and for closer post-test examination of test events. Video cameras provided coverage of the entire flame region and of specific drums, and an infrared (IR) camera was used to observe the center POC through the flames. Figure 11 shows the four views taken with three video cameras and the one IR camera in Phase I. The top left image was taken with a camera set on the floor of the facility and looking up at the fire with a wide-angle view. This camera was located in the northwest quadrant of the facility, close to the IR camera. The top right image was also taken with a second camera in the northwest quadrant, but looking closer at the fire. The lower left image was taken with the camera located in the southeast quadrant. This camera was directed mostly at the drums outside of the fire, with the edge of the fire visible to the right. The last image was taken with an IR camera, and shows the center POC inside the fire.

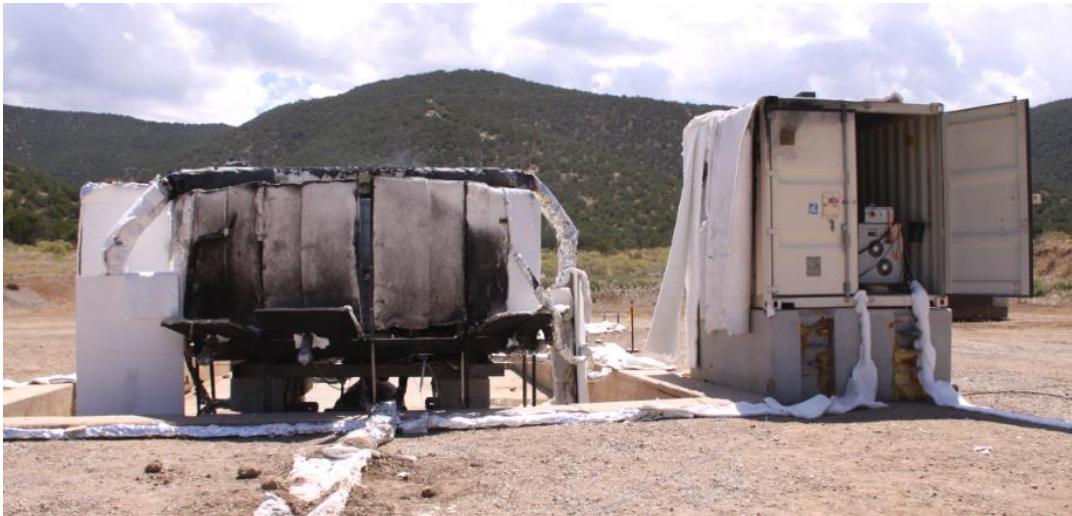
**Figure 21. Fuel pool with X-ray trailer adjacent to the pool.**

In addition to the video taken during the test, an X-ray system was deployed to look at the top of the PC in-situ, in the flange region, to see if there was any deformation of the PC lid or the bolts during the test and/or to see if the aerosol collection system was compromised near the PC lid during the test. The X-ray was able to see details of the PC flange clearly, but it was not possible to see the combustibles inside the PC as clearly due to the low density of these materials and the viewing area. Figure 21 shows an image of the setup looking into the entrance to the test cell (taken from the west end of the burn site facility). The trailer to the right provided a secure area to store the X-ray generation equipment, preventing damage from the flames. The trailer was

placed on top of large concrete blocks to raise the X-ray machine sufficiently high to see the top of the PC. The charge-coupled device (CCD) used for detecting the X-rays was located to the left of the test cell, between a large concrete wall and the test cell fence (not visible in this image). The concrete wall was required to attenuate X-rays passing beyond the CCD.

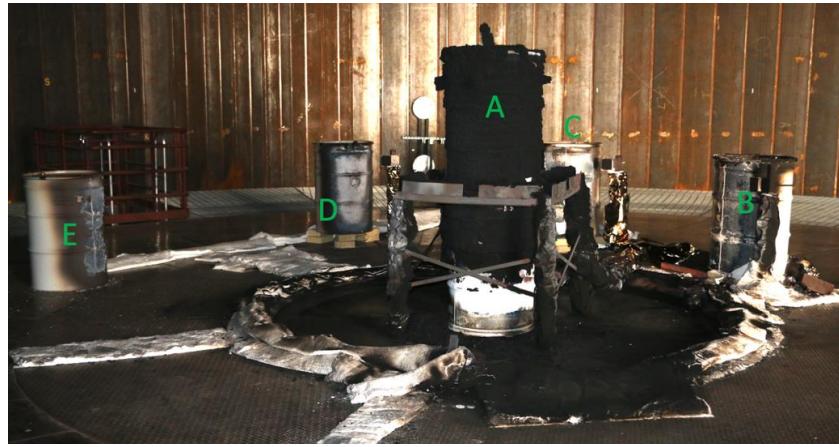
**Figure 45. (a) All drums after Test #2, (b) and (c) close-ups of drum A, and (d) close up of drum B.**

Figure 45(a) shows the state of all the drums after Test #2. As shown in Figure 45(b), drum A was heavily coated with soot; however, the lid did not appear to bulge significantly, as seen in Figure 45(c) after the soot was removed.

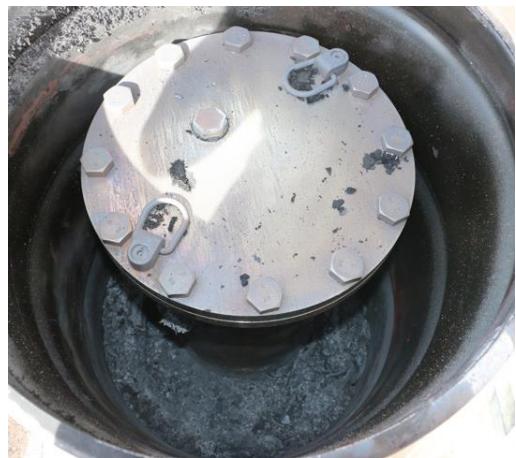
(a)

**Figure 66. Remains of the POC in Test #1 of Phase II.**

As in the first test of Phase I, all that remained inside the POC were the remains of burned Celotex® beneath and just to the side of the POC (see Figure 66(a)). The PC filter was examined

in place (i.e., while attached to the lid) and the carbon material inside the vent housing was found pushed out from where it normally sits, with some evidence of gray discoloration on the sides of the carbon media (see Figure 66(b)). Without a leak test it's difficult to quantify the state of the filter. However, given the conditions observed and what was observed in the first phase, it's almost certain that the PC filter was compromised.

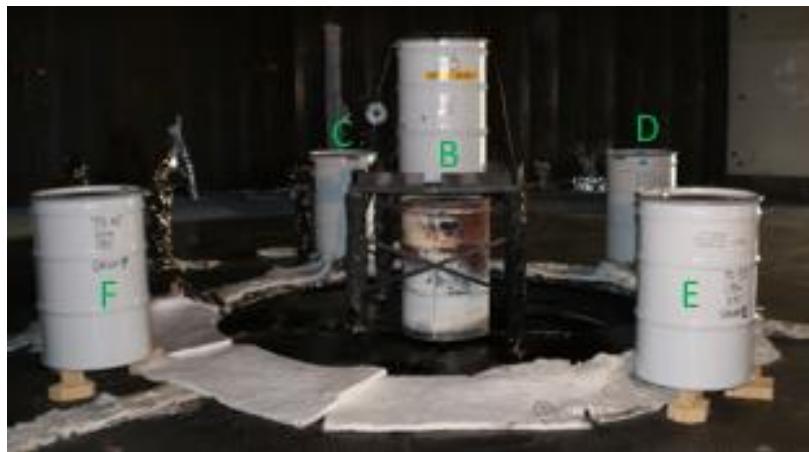
**Figure 67. Image of the test layout in Test #2 of Phase II taken from the southeast corner of the facility.**

Figure 67 shows an image of the test layout. One POC and one 7A were placed 1.7 m from the center of the pool and the other POC and 7A were placed 2.0 m from the fire, slightly closer to the fire than the POC in the Test #2 of Phase I. The POCs were located on the north and west side of the facility and the 7As on the opposite side as shown in Figure 13. As noted in that figure, the drum labeling scheme changed in this test but this had no special significance. In

Figure 67, the 7As are the two closest drums (E and F), while the remaining drums shown towards the back are POCs.

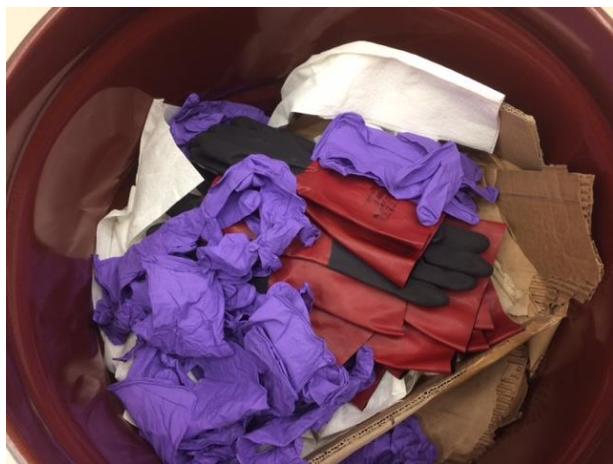
**Figure 68. Typical contents of 7As in Test #2.**

The PCs on the POCs were empty, but the 7As were filled with typical combustible materials (gloves, plastics, etc.) to the top (see Figure 68). Except for the center drum B, none of the other drums had TCs. The TCs on the center drum were all attached on the outside of the wall of the drum to make sure the drum was fully engulfed.

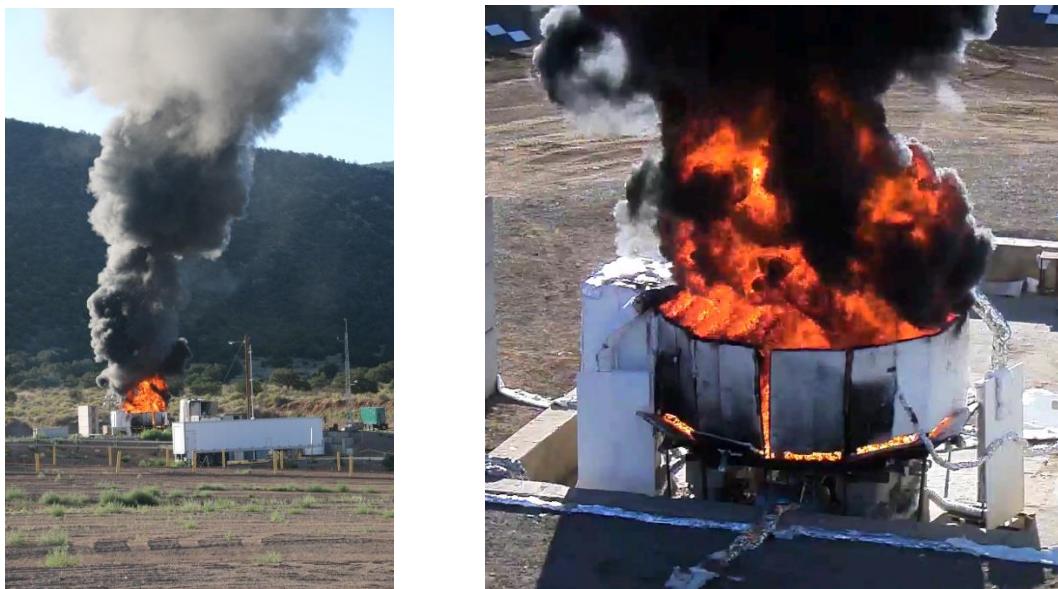
**Figure 72. Phase III, Test 1 fully engulfing fire**

Figure 72 shows a long distance and close-up images of the fire taken during the test. The POC was fully engulfed for the duration of the 30-minute fire. As expected, wind fences kept the POC fully engulfed through the 30-minute test. Conditions during the test were mostly calm and with some exceptions, the plume was vertical for most of the test.

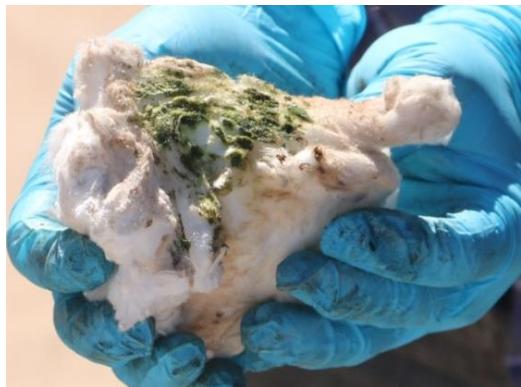
**Figure 81. (a) Sample of liquid collected on a piece of insulation laying beneath the outlet filter housing, (b) inner side of one of the coupons placed along the aerosol collection system horizontal pipe, and (c) view of the top of the POC drum after the test (Char flakes are observed on top of the PC.)**

Figure 81(a) shows liquid collected in the insulation just below the inlet filter housing and Figure 81(b) shows the inner side of one of the coupon full of soot. Also shown is the top of the POC drum, after the insulation was removed. As in Phase I, Test 1, and Phase 2 tests, most of the volume between POC drum and the PC was empty; mostly small chunks of char and ash remained beneath the PC. Some debris remained on top of the lid as observed in Figure 81(c).
