# SNS Cryogenic Test Facility Kinney Vacuum Pump Commissioning and Operation at 2 K

**Abstract.** The Spallation Neutron Source (SNS) at Oak Ridge National Laboratory (ORNL) has built and commissioned an independent Cryogenic Test Facility (CTF) in support of testing in the Radio-frequency Test Facility (RFTF). Superconducting Radio-frequency Cavity (SRF) testing was initially conducted with the CTF cold box at 4.5 K. A Kinney vacuum pump skid consisting of a roots blower with a liquid ring backing pump was recently added to the CTF system to provide testing capabilities at 2 K. System design, pump refurbishment and installation of the Kinney pump will be presented. During the commissioning and initial testing period with the Kinney pump, several barriers to achieve reliable operation were experienced. Details of these lessons learned and improvements to skid operations will be presented. Pump capacity data will also be presented.

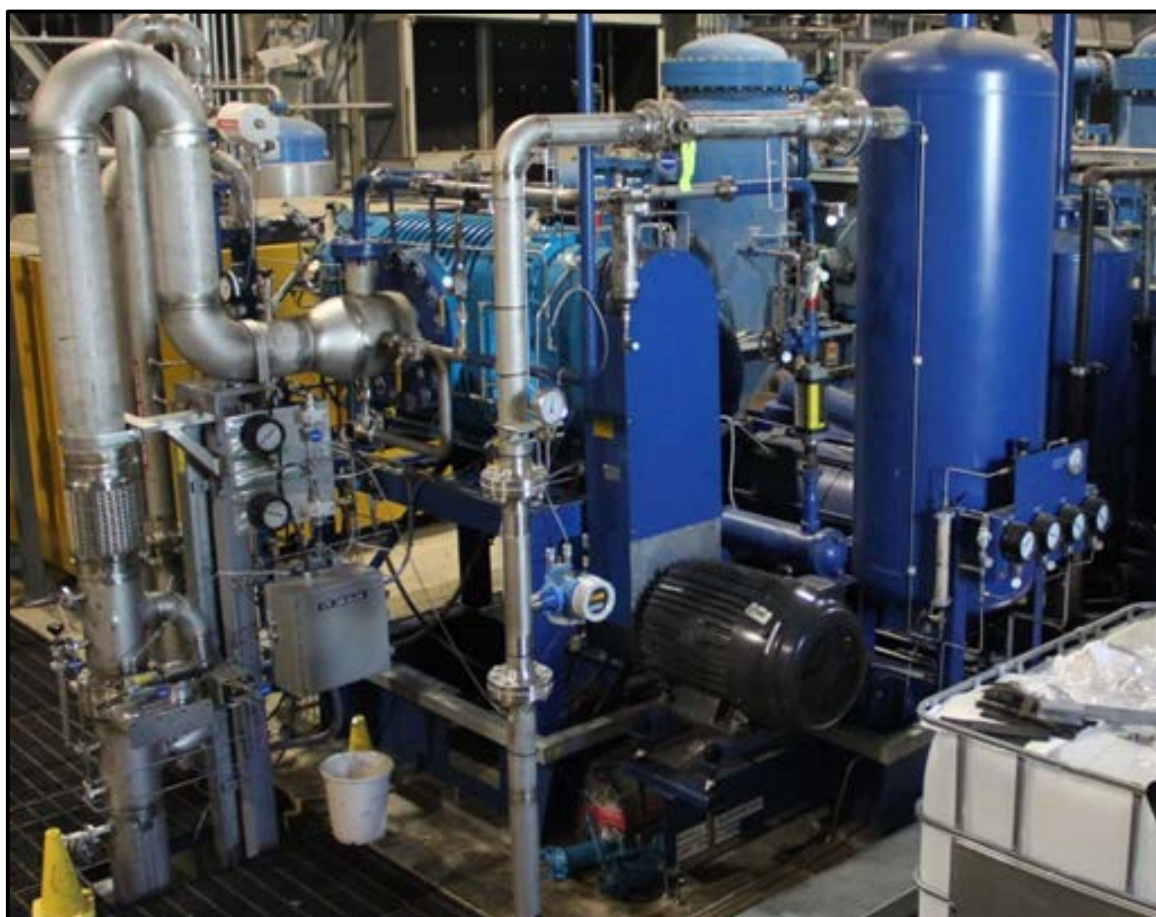
The skid is installed at SNS in the CHL compressor building allowing use of the trench surrounding the CHL compressors to route all the process piping to and from the Kinney skid. A large 8-inch diameter pipe connects the skid suction to the common pumping manifold of the RFTF test cave and the VTA. 2-inch piping allows the skid to discharge into the suction of two CHL recovery compressors. Figure 1 shows the Kinney skid connected to the CTF piping utilizing the CHL trench.

**Figure 1.** Operational Kinney pump skid connected to CTF piping

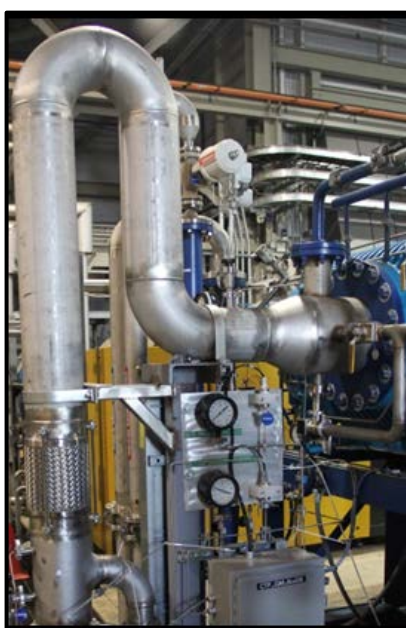
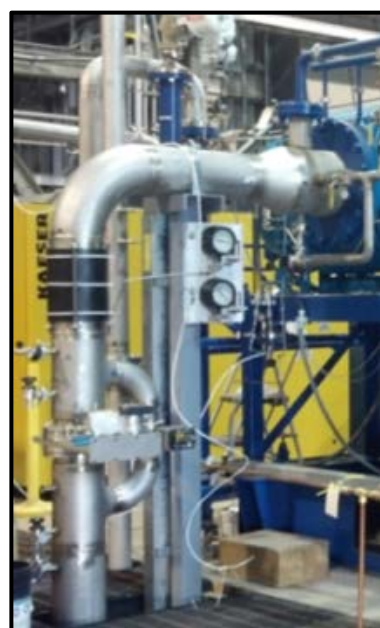
The initial turn on and commissioning of the Kinney skid went very well. The liquid ring pump was started first and successfully established a stable suction pressure of 0.04 atm (30 torr). After the first several hours of blower operation with stable suction pressure less than 0.002 atm (1 torr), the skid oil level in the bulk oil separator was observed to have dropped significantly. Upon investigation it was discovered that oil injected into the inlet of the blower was migrating to the vertical section of the suction piping and pooling on the top of the inlet valve matrix.

**Figure 3.** Kinney inlet piping after addition of u-bend

**Figure 4.** Kinney inlet piping during initial commissioning

This oil injection into the inlet of the blower is necessary to decrease the operating temperature through removing the heat of compression of the helium gas. It was then necessary to modify the inlet piping so that oil could not migrate backwards into the suction piping. A 2-foot vertical section of pipe was added to create a u-bend section. After this modification, no further oil was observed on the inlet valve assembly. Figures 3 and 4 show before and after images of this change to the inlet piping.

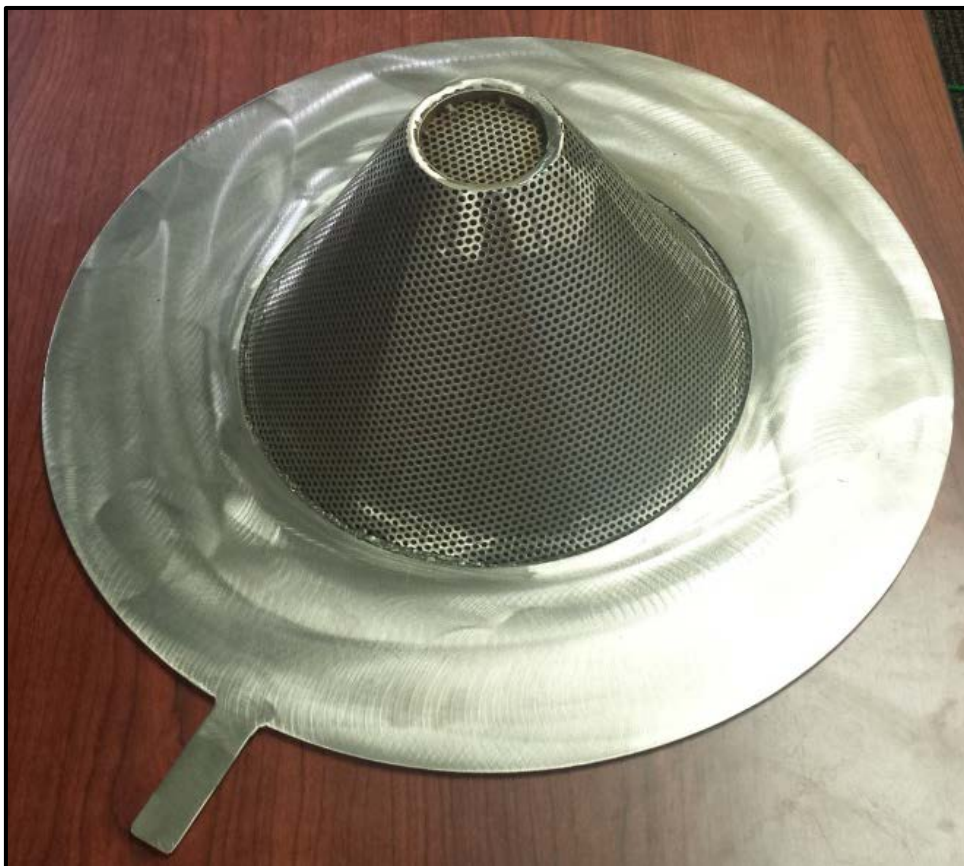
During the repair, two discoveries were made. First there was a small section of scarring on both sides of the blower lobes that may represent a particulate from the suction piping. This represents the likely cause of the rotors seizing. The source of the particulate is still unknown, however it is suspected to be a spur leftover from the inlet piping repair. In spite of significant effort being placed into the cleanup of the piping after the repair, a single piece was enough to lock the rotors.

**Figure 5.** Screen installed at the inlet of the Kinney blower

In order to address the issue of further process contaminants from the suction piping affecting the reliable operation of the Kinney blower, a screen was added inside the suction piping right in front of the blower inlet. The screen is a cone shape with 1/8-inch holes. The geometry allows for 80 percent of the effective cross sectional area to be available. The screen was placed inside the sealing o-ring between the blower suction and the flange on the suction piping. Tack welds were used to hold the ring centered in the suction piping. Operation with the screen had shown no appreciable pressure drop leading to a decrease in pump capacity. Figure 5 shows the screen before installation into the Kinney suction piping.

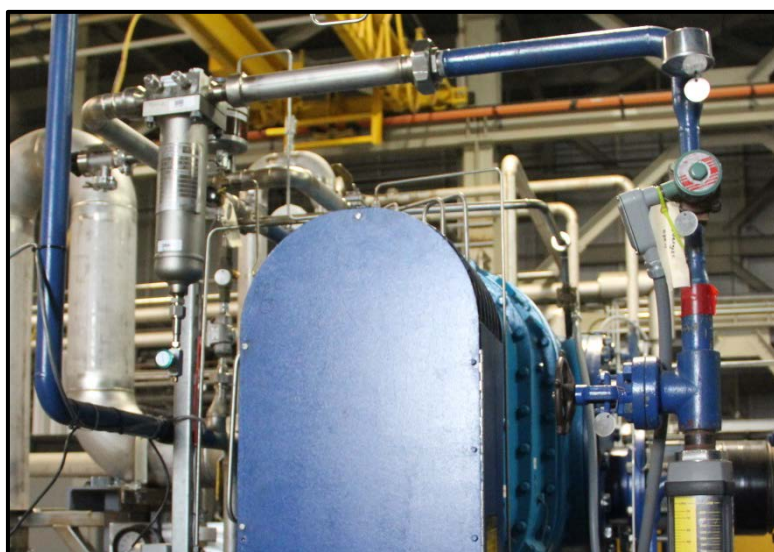
**Figure 8.** New filter element added to the Kinney blower oil injection line

To ensure that particulates from the skid oil circuit could not disrupt future blower operations, a small filter housing was installed on the Kinney blower oil injection circuit. Initially, the housing was installed with a 5 micron filter. Initial operation on this filter element lasted less than 10 minutes before it plugged. Oil samples sent out for analysis revealed a significant presence of particulates up to 100 microns. Additional filter elements of 25 and 50 microns were installed and the oil circuit was cleaned over the course of several weeks. There is suspicion that a source exists on the skid generating these particles, as the bulk oil transferred to the skid was clean when transferred. Figure 8 shows the addition of the filter element housing.
