Innovative, Efficient and Effective Methods to Address Wind Blade Production and In-Service Inspection Needs

SAND2017-12079C

Dennis Roach, Tom Rice, Ray Ely, Josh Paquette
Wind Blade Reliability Center
Sandia National Labs

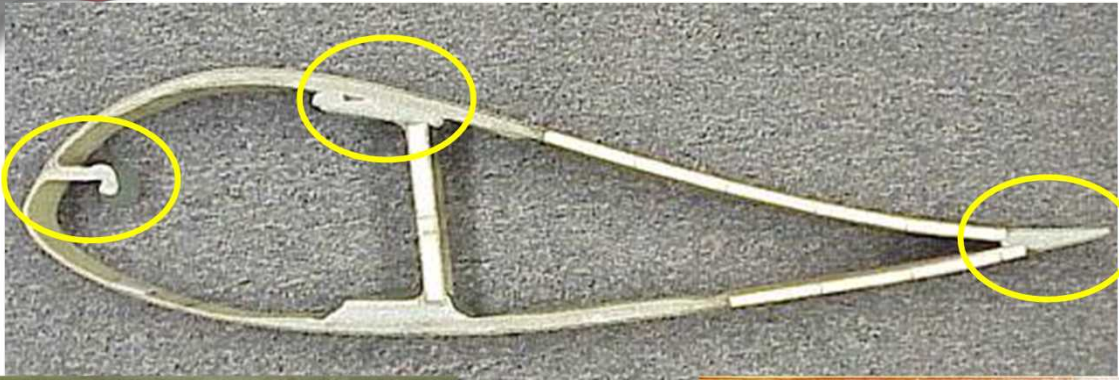
Inspection Areas and Flaw Types of Interest

Flaws include: Ply Waves
Delaminations, Adhesive
Voids, Joint Disbonds,
Snowflaking and Porosity

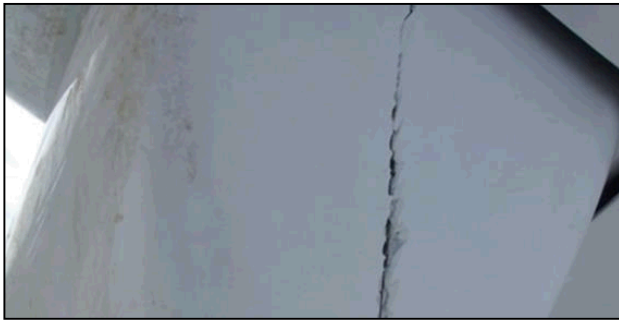
Severe Growth of Fiber Fracture

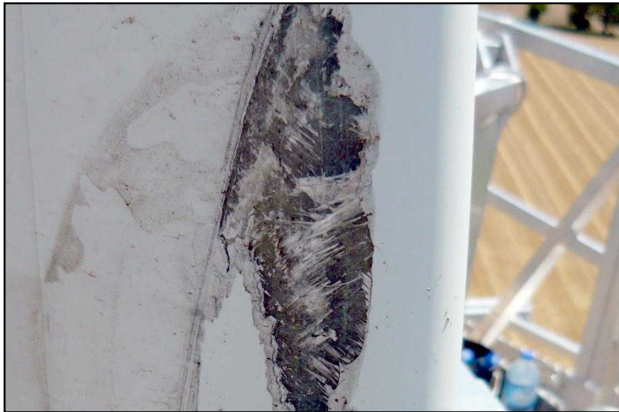
Lightning Strike Damage

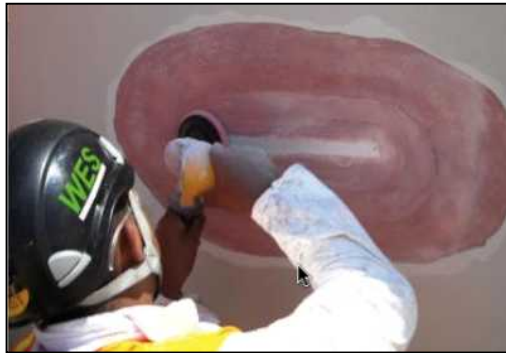
Scarfed
Blade Repair
Process

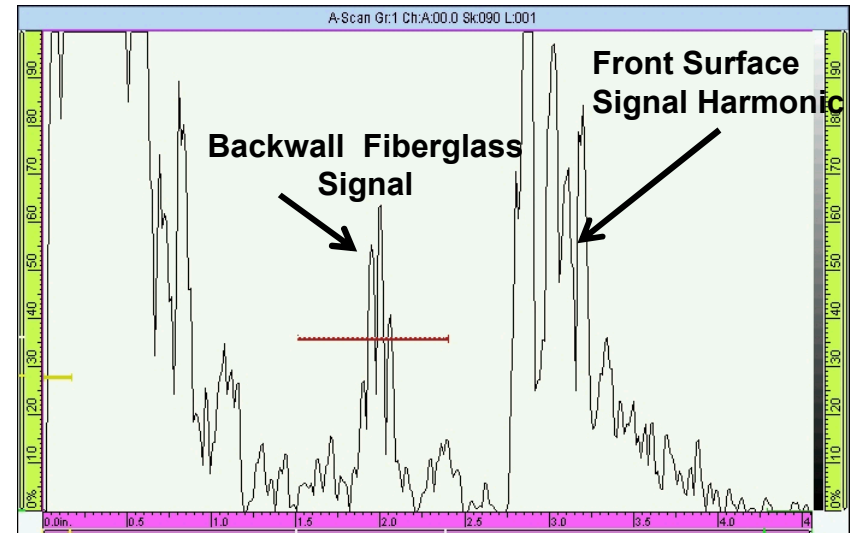
**Water Box Signal Analysis - 25mm compared to 40mm;
Moves harmonic return signal outside area of interest.**

40mm Delay

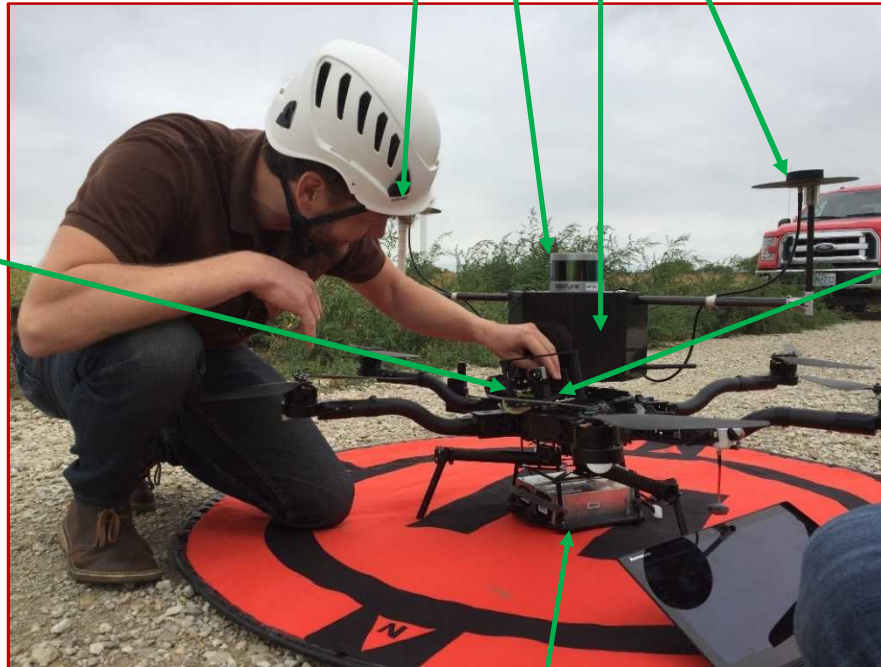
Thermography Inspection of Subsurface Flaws

Flir IR Camera (15 g)

LiDAR and GPS Sensors &
Computer for Automated
Drone Controls

LiPo Batteries (2.3 Kg)

Digital Camera (450 g)

Drone Empty Weight = 10 lbs. (4.5 Kg)
Max Payload = 20 lbs. (9 Kg)

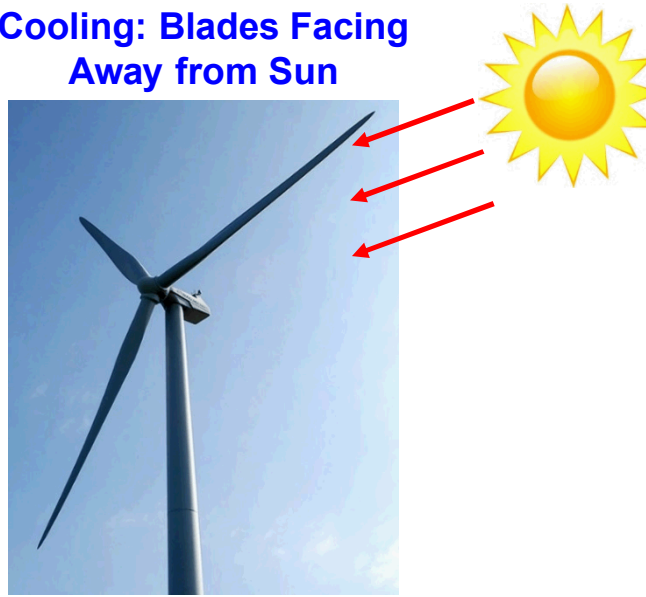
Cooling: Blades Facing
Away from Sun

.330\" Deep
Flaws Clearly
Visible

.660\" Deep
Flaws Barely
Visible

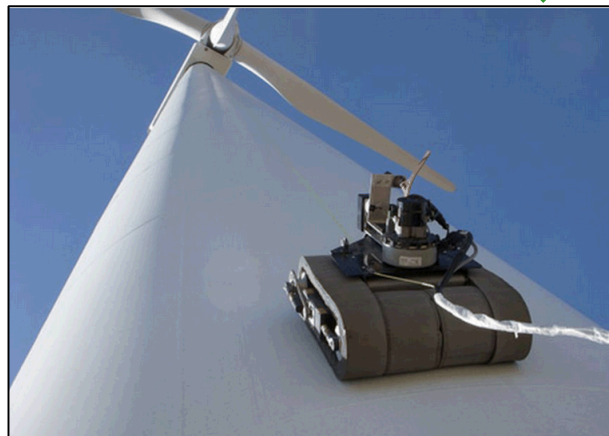
**Robot with On-Board NDI
System and Camera(s) for
Real-Time Assessments**

- Automated, remotely-controlled with wireless data transfer to ground station
- Includes Phased Array Ultrasonics for full-penetration damage detection
- Combined with high-fidelity visual inspection using deployed camera
- Real-time health assessment – allows for immediate repairs during a single maintenance stop and rapid return-to-service
- Benefits are escalated for off-shore applications
- Avoid more extensive repairs and even catastrophic blade failures (replacement)
