DOE/NV--1591

Post-Closure Inspection Report for the Tonopah Test Range, Nevada

For Calendar Year 2017

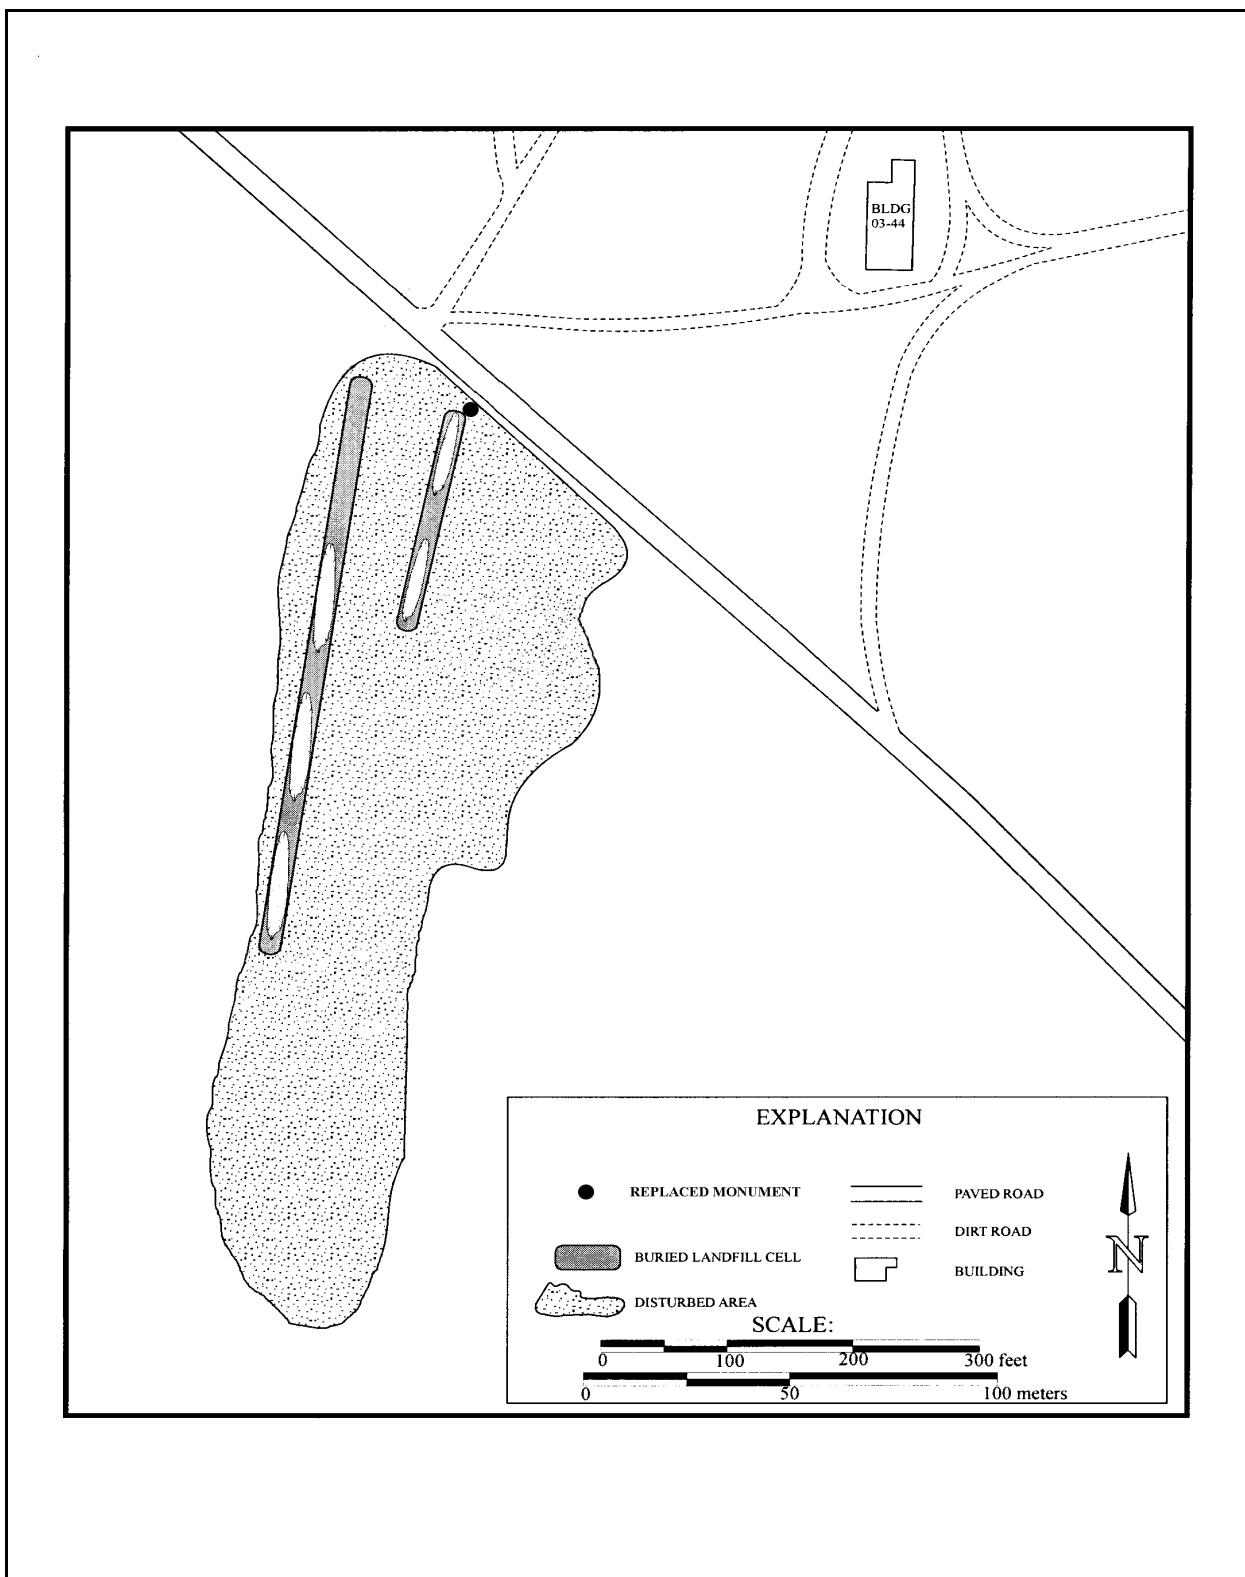
Figure A-5
CAU 424 Location of Replaced Monument at Landfill A3-4

Landfill Cell A3-4 (CAS 03-08-002-A304): A permanent northeast corner monument was noted as missing in the Calendar Year 2015 Post-Closure Inspection Report [NNSA/NFO, 2016] and a temporary marker was noted in the Calendar Year 2016 Post-Closure Inspection Report [NNSA/NFO, 2017]. Also noted in the Calendar Year 2016 Post-Closure Inspection Report [NNSA/NFO, 2017] was a corrective action to place a permanent concrete monument. During the May 23, 2017 inspection the northeast temporary monument was observed. The temporary northeast corner monument was removed and a permanent monument was installed on January 9, 2018. During the monument installation, an area of subsidence was noted and the subsided area was backfilled to grade with site borrow material on January 9, 2018. No additional problems were identified. Annual visual inspections should continue as scheduled.

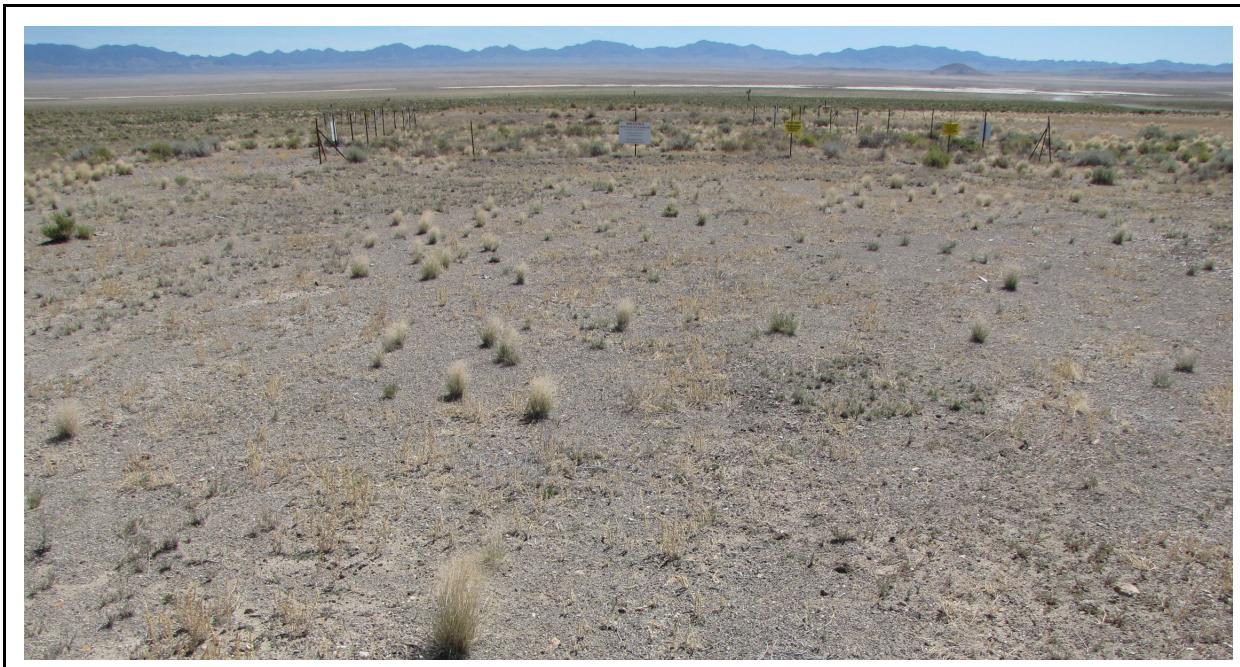
The annual visual inspection was conducted on May 23, 2017. The cover near the northeast corner and along the south facing slope was disturbed by animal burrowing activities. The cover was repaired on January 9, 2018. It was noted that two additional animal burrows were identified during

cover repair activities. The additional animal burrows were filled in. Vegetation status appeared to be similar to the vegetation status in the surrounding area. Annual visual inspections should continue as scheduled.

Figure E-1
Photograph 1: CAU 407, Facing East, Overview (05/23/2017)

An animal burrow requiring repair was identified during the May 23, 2017, inspection. At the time of repair (January 9, 2018), two additional animal burrows were identified and filled in. Annual visual inspections should continue as scheduled.

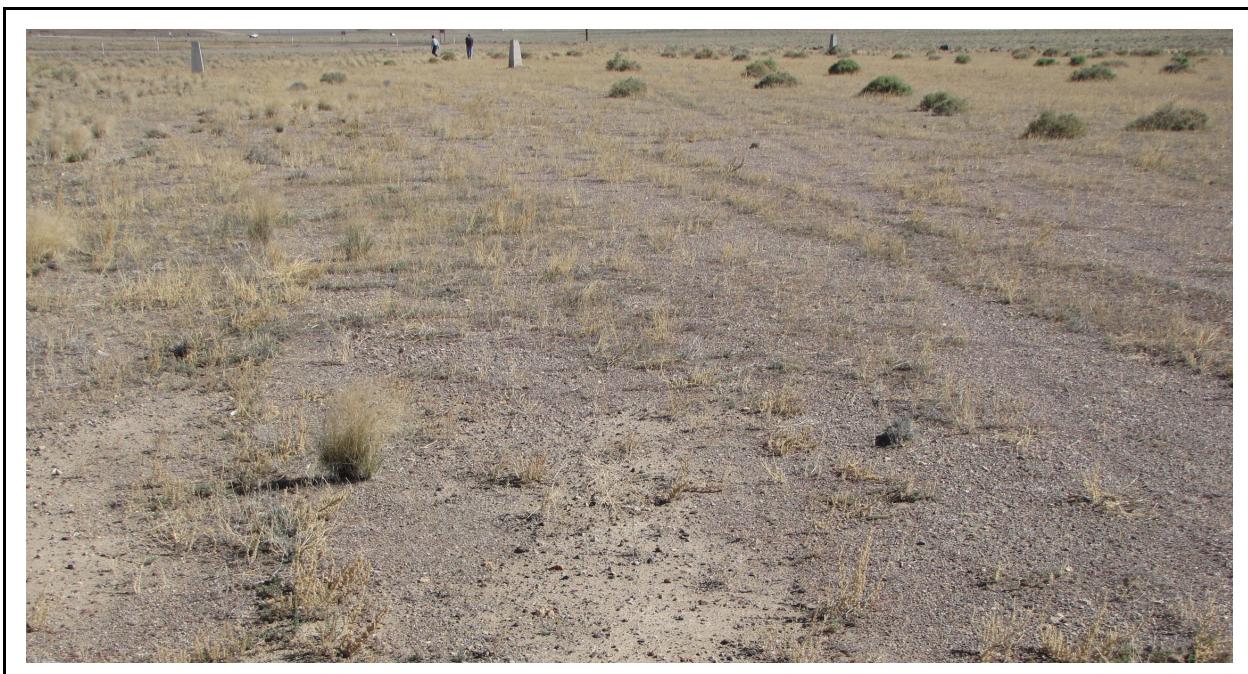
Landfill Cell A3-1 (CAS 03-08-001-A301): No problems were identified, and no maintenance or repairs were required. Annual visual inspections should continue as scheduled.

Figure E-2
Photograph 2: CAU 424, Landfill Cell A3-1, Facing North (05/23/2017)

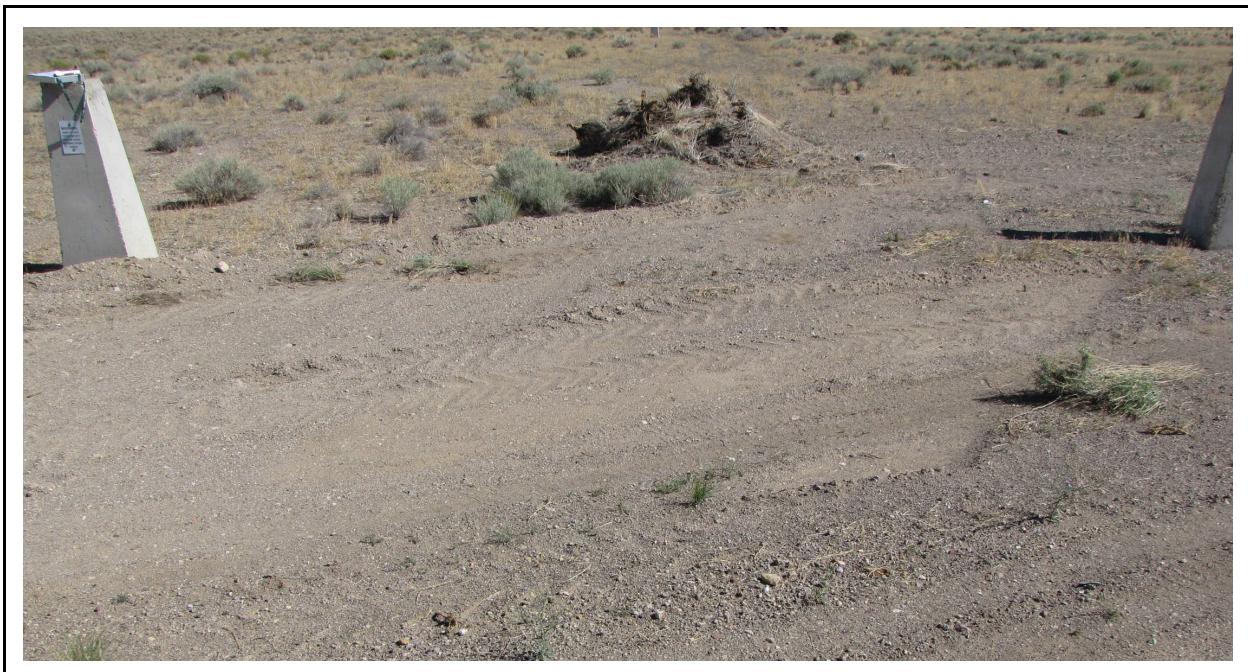
Landfill Cell A3-2 (CAS 03-08-002-A302): No problems were identified, and no maintenance or repairs were required. Annual visual inspections should continue as scheduled.

Figure E-3
Photograph 3: CAU 424, Landfill Cell A3-2, Facing North (05/23/2017)

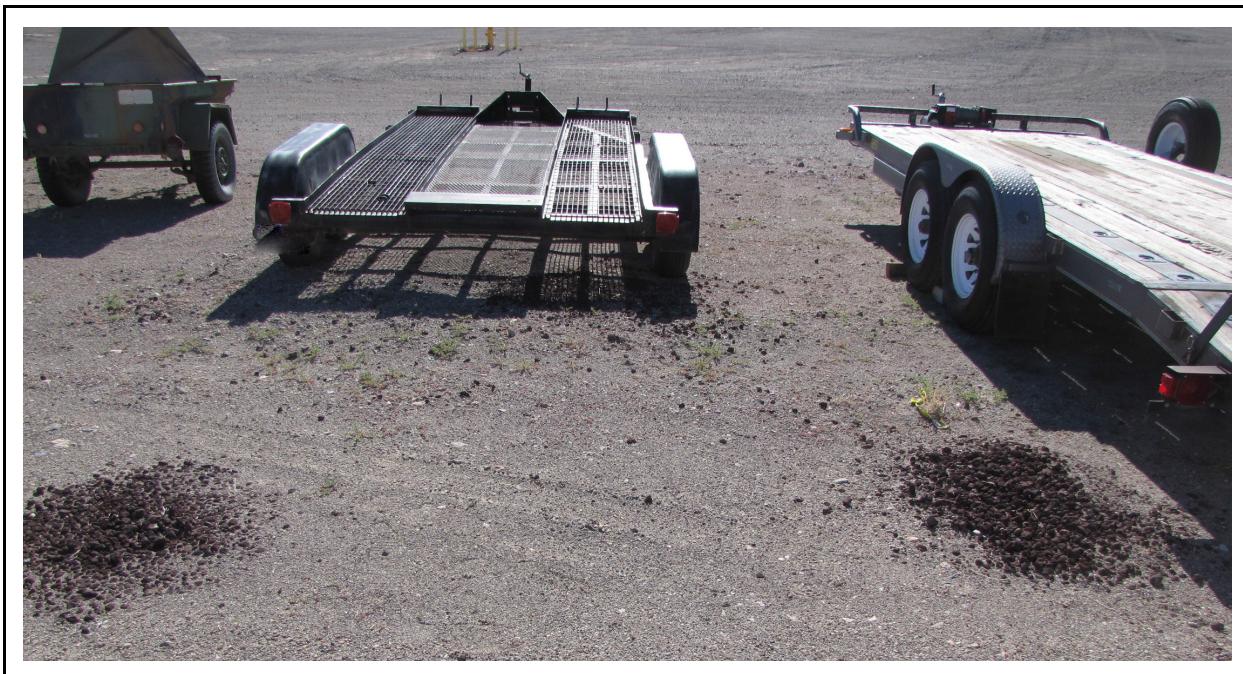
Landfill Cell A3-3 (CAS 03-08-002-A303): No problems were identified, and no maintenance or repairs were required. Annual visual inspections should continue as scheduled.

Figure E-4
Photograph 4: CAU 424, Landfill Cell A3-3, East Cell, Facing Ground (05/23/2017)

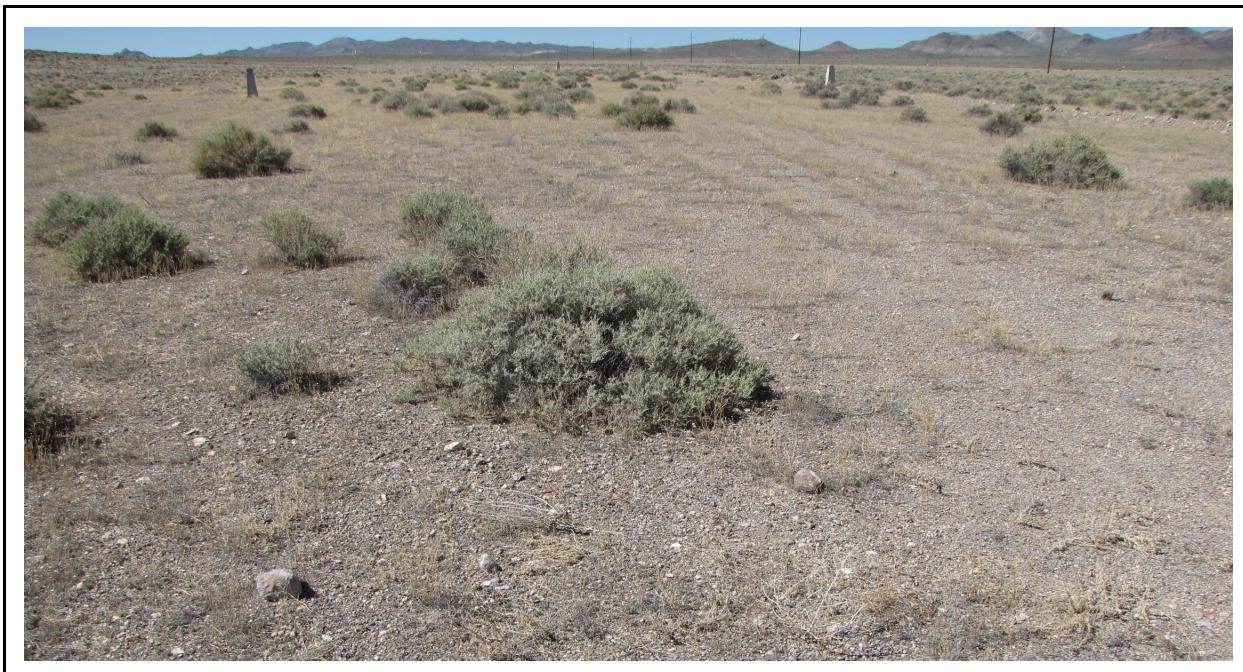
Figure E-5
Photograph 5: CAU 424, Landfill Cell A3-4, Facing South (05/23/2017)

The temporary northeast corner monument in Landfill Cell A3-4 (CAS 03-08-002-A304) was observed; and a very small amount of lava rock cover for the northeast and southeast monuments at Landfill Cell A3-8 (CAS 03-08-002-A308) was observed. Repairs to the site were made on January 9, 2018 and included: Installation of a permanent northeast corner monument at Landfill Cell A3-4 (CAS 03-08-002-A304); and the placement of additional lava rock on the northeast and southeast monuments of Landfill Cell A3-8 (CAS 03-08-002-A308). During the installation of the monument, an area of subsidence was identified and backfilled in Landfill Cell A3-4 (CAS 03-08-002-A304). Annual visual inspections should continue as scheduled.

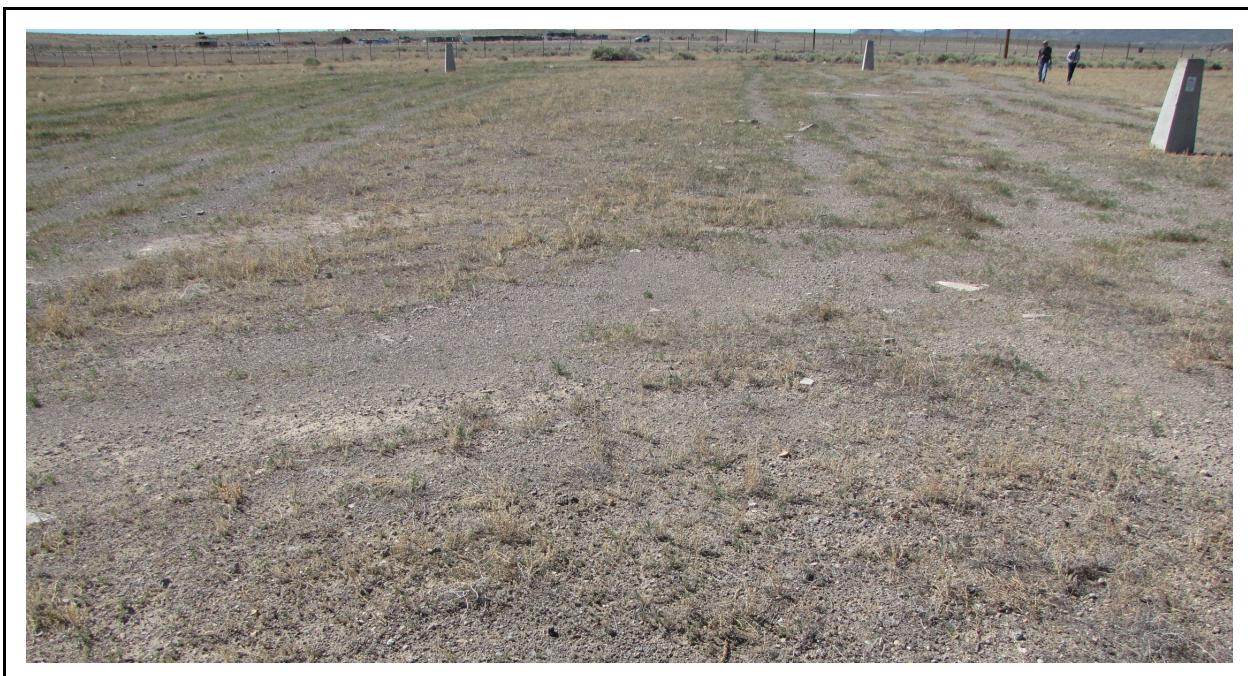
Landfill Cell A3-5 (CAS 03-08-002-A305): No problems were identified, and no maintenance or repairs were required. Annual visual inspections should continue as scheduled.

Figure E-6
Photograph 6: CAU 424, Landfill Cell A3-5, Facing North (05/23/2017)

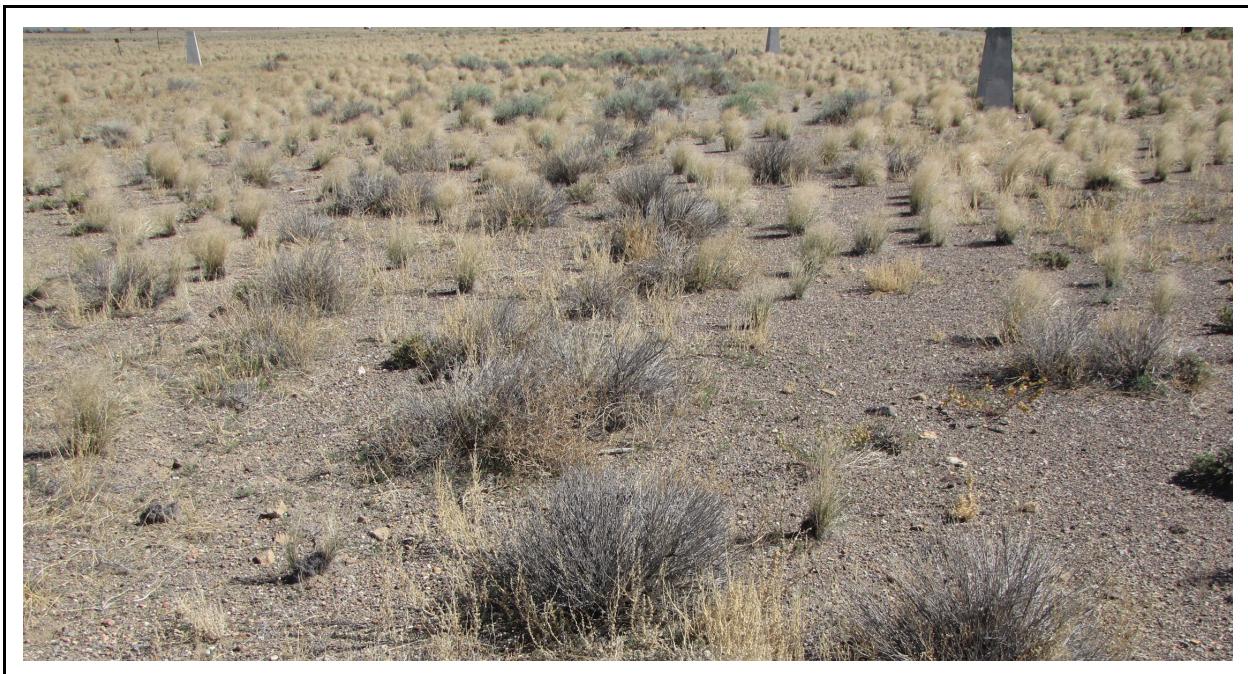
Landfill Cell A3-6 (CAS 03-08-002-A306): No problems were identified, and no maintenance or repairs were required. Annual visual inspections should continue as scheduled.

Figure E-7
Photograph 7: CAU 424, Landfill Cell A3-6, Facing North (05/23/2017)

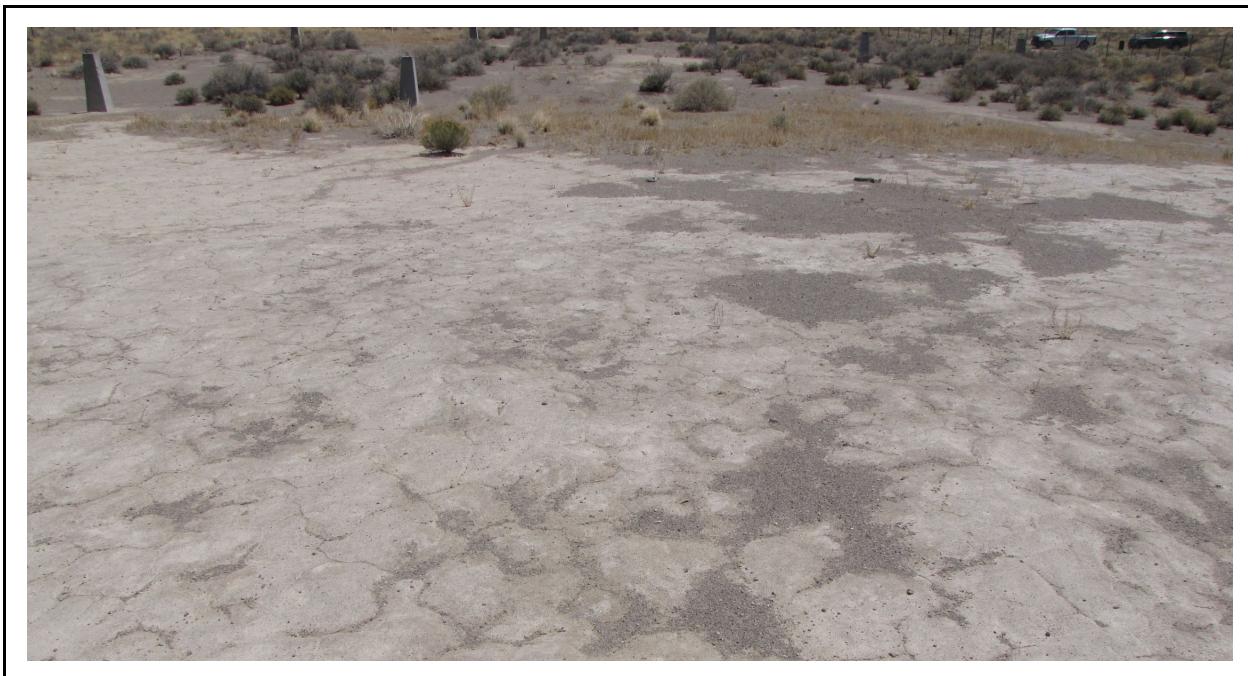
Visual inspections are conducted according to the post-closure requirements for CAU 453, Area 9 UXO Landfill (TTR), CAS 09-55-001-0952, Area 9 Landfill, as described in the CR (DOE/NV, 1999b) and subsequent correspondence. The site is shown in [Figure A-6](#) of [Appendix A](#). The annual inspection was conducted on May 23, 2017. The cover was found disturbed by animal burrowing activities. Five burrows were found in the east-central portion of the cover. The cover was repaired on January 9, 2018. During the repair action, eight additional animal burrows were identified and filled in. No other issues or concerns were identified, and no additional maintenance or repairs were required. Annual visual inspections should continue as scheduled.

Figure E-8
Photograph 8: CAU 453, Facing East, Overview (05/23/2017)

Five animal burrows requiring repair were identified during the May 23, 2017, inspection. At the time of repair (January 9, 2018), eight additional animal burrows were identified and filled in. Annual visual inspections should continue as scheduled.

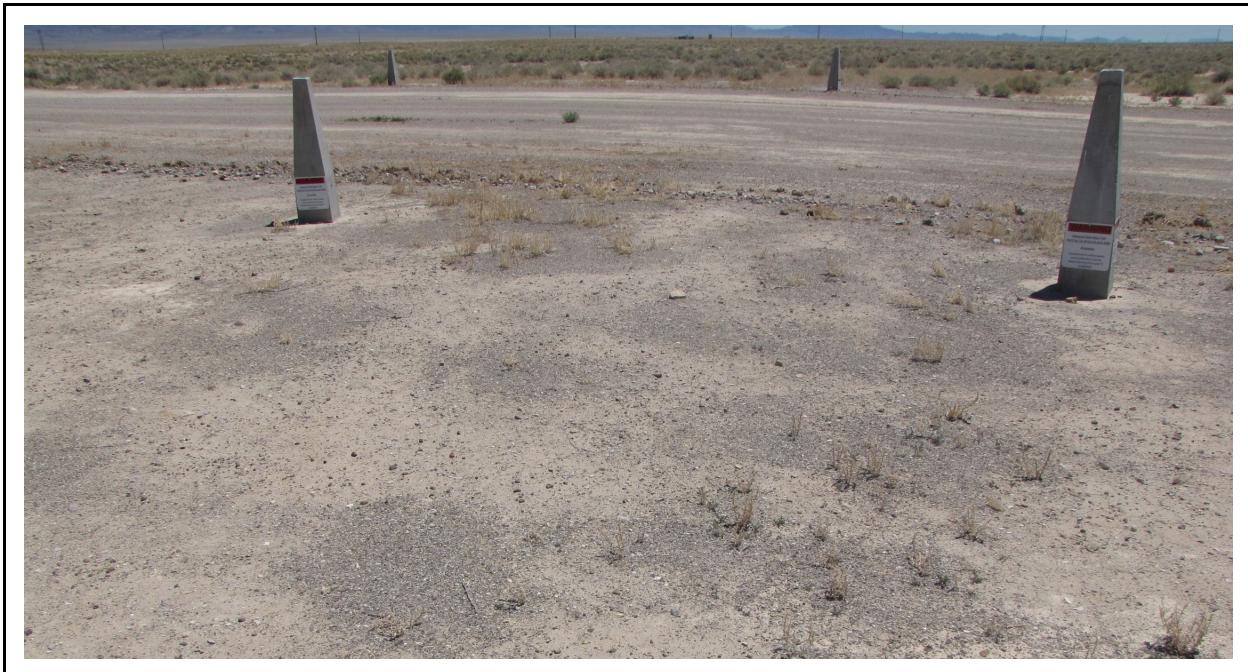
Inspections are conducted according to the post-closure requirements for CAU 487, Thunderwell Site (TTR), CAS RG-26-001-RGRV, Thunderwell Site, as described in the Corrective Action Decision Document (CADD)/CR (NNSA/NV, 2001b), Record of Technical Change (ROTC) No. 2 (NNSA/NSO, 2004), and subsequent correspondence. The site is shown in [Figure A-7](#) of [Appendix A](#). The annual inspection was conducted on May 23, 2017. No problems were identified, and no maintenance or repairs were required. The burrowing owl's nest that was observed during the 2016 inspection appears to be abandoned. Annual visual inspections should continue as scheduled.

Figure E-9
Photograph 9: CAU 487, A-8 Anomaly, Facing East (05/23/2017)

No problems were identified, and no maintenance or repairs were required. The burrowing owl's nest, noted during the 2016 inspection, appears to be abandoned. Annual visual inspections should continue as scheduled.

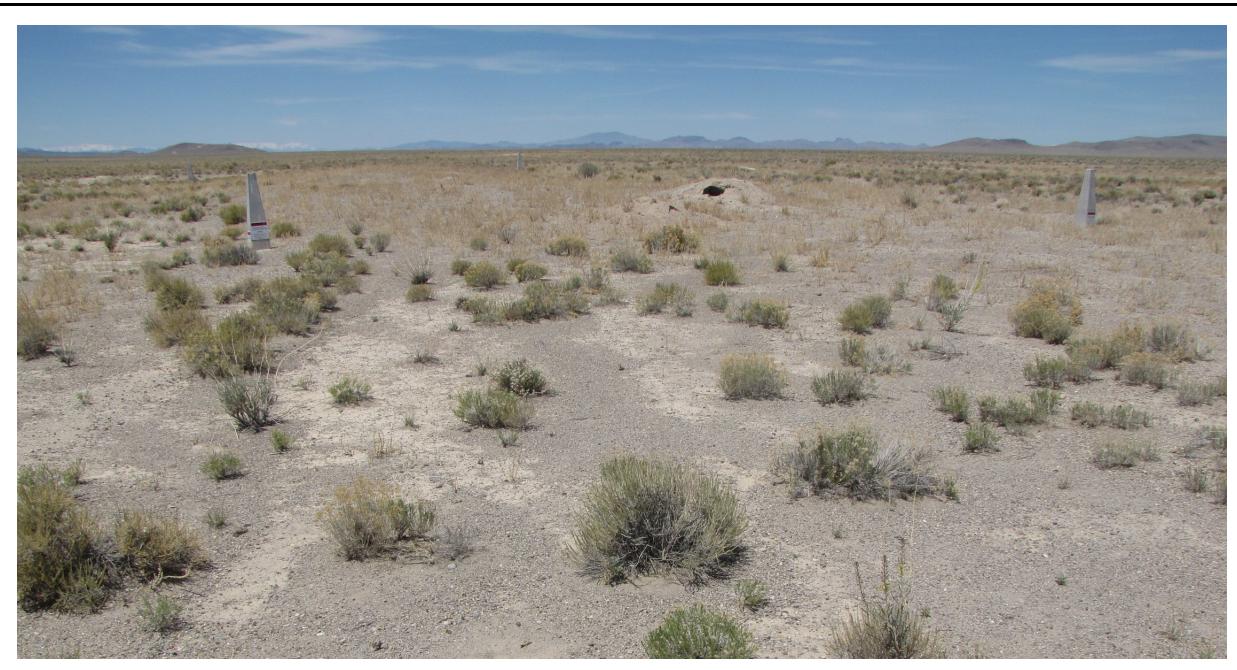
Figure E-10
Photograph 10: CAU 487, A-17 Anomaly, Facing West (05/23/2017)
