Fracture and Fatigue Behavior of Additively Manufactured Austenitic Stainless Steel

Chris San Marchi, Josh Sugar, Mike Maguire and Dorian Balch
Sandia National Laboratories, Livermore CA

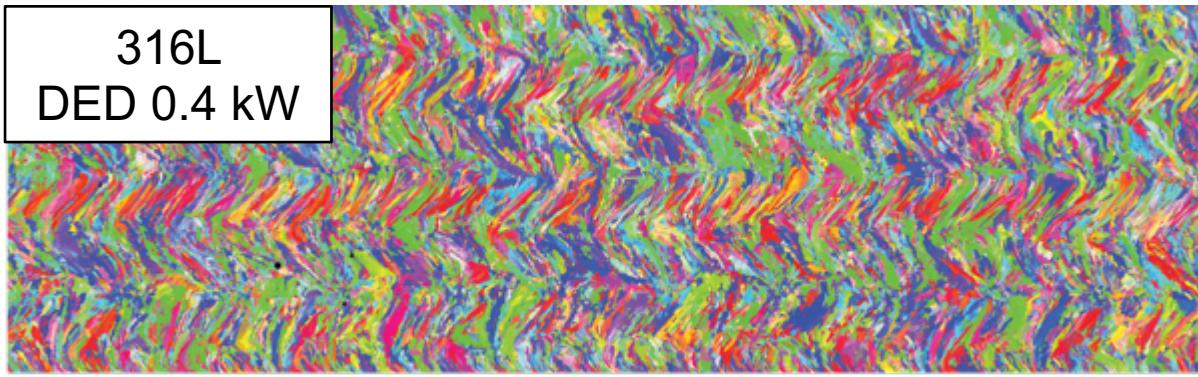
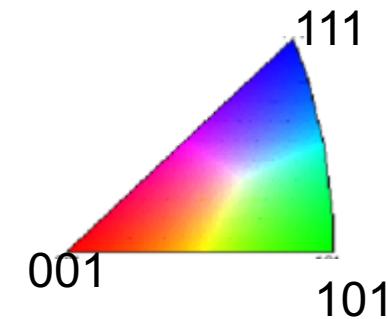
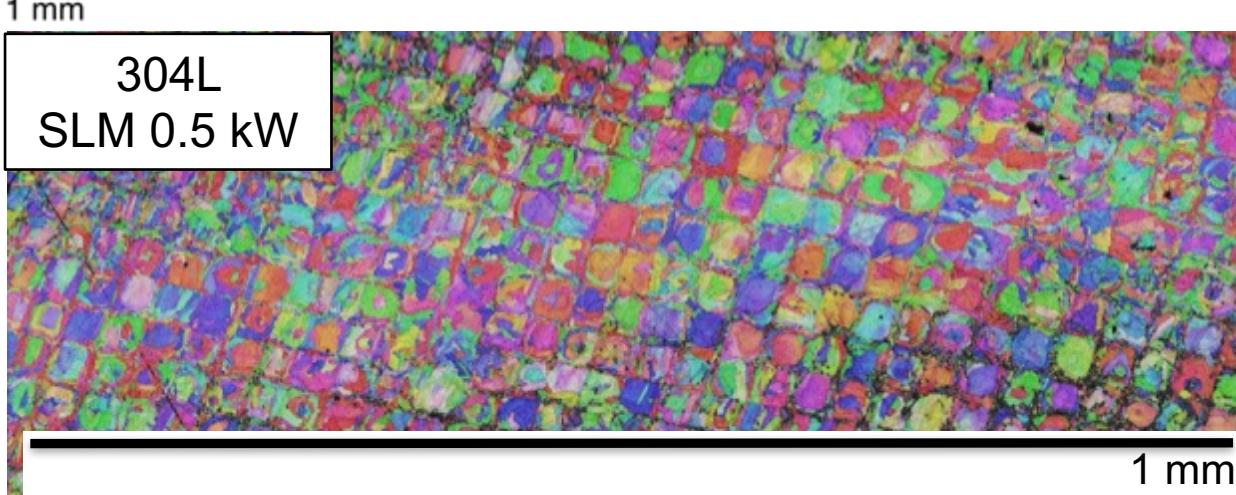
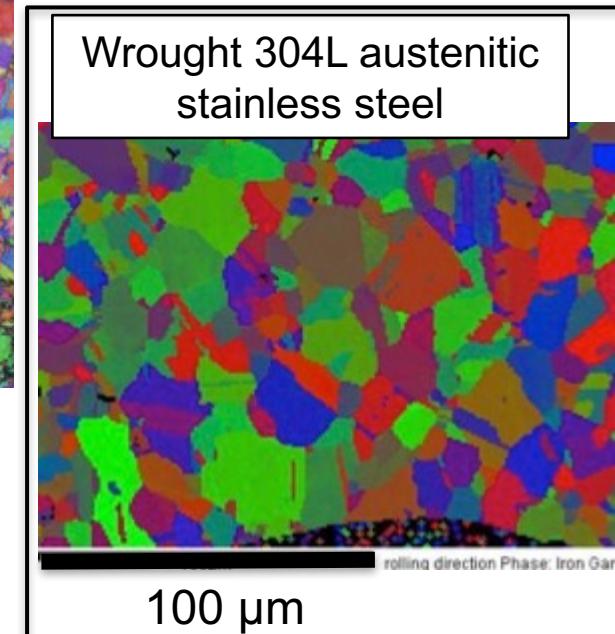
Grain structure is distinct from wrought materials, similar in some aspects to weld microstructure

- AM microstructures depend on processing conditions
- ***What is the effect on structural properties?***

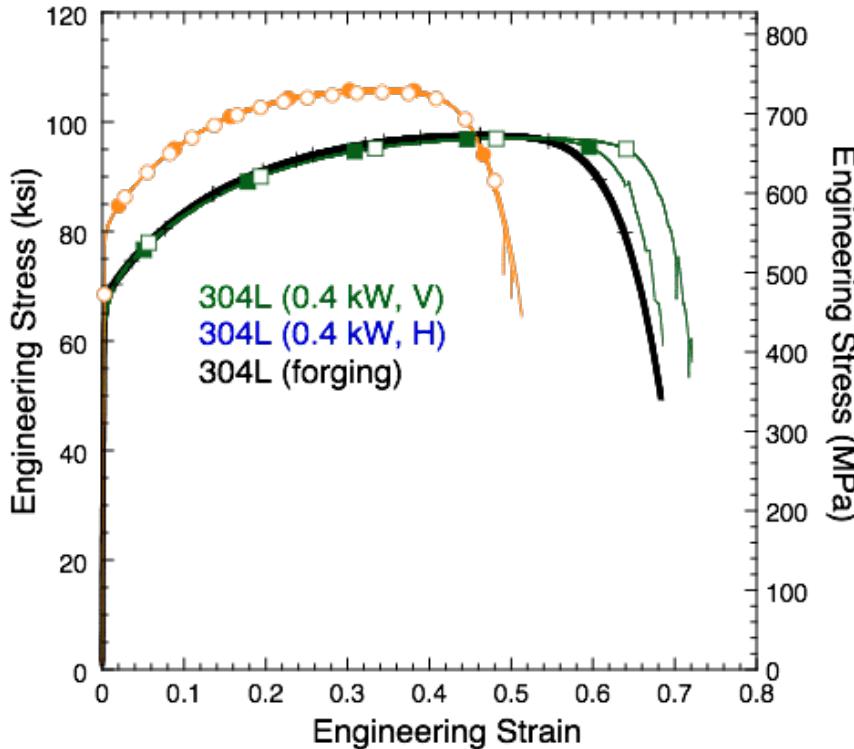
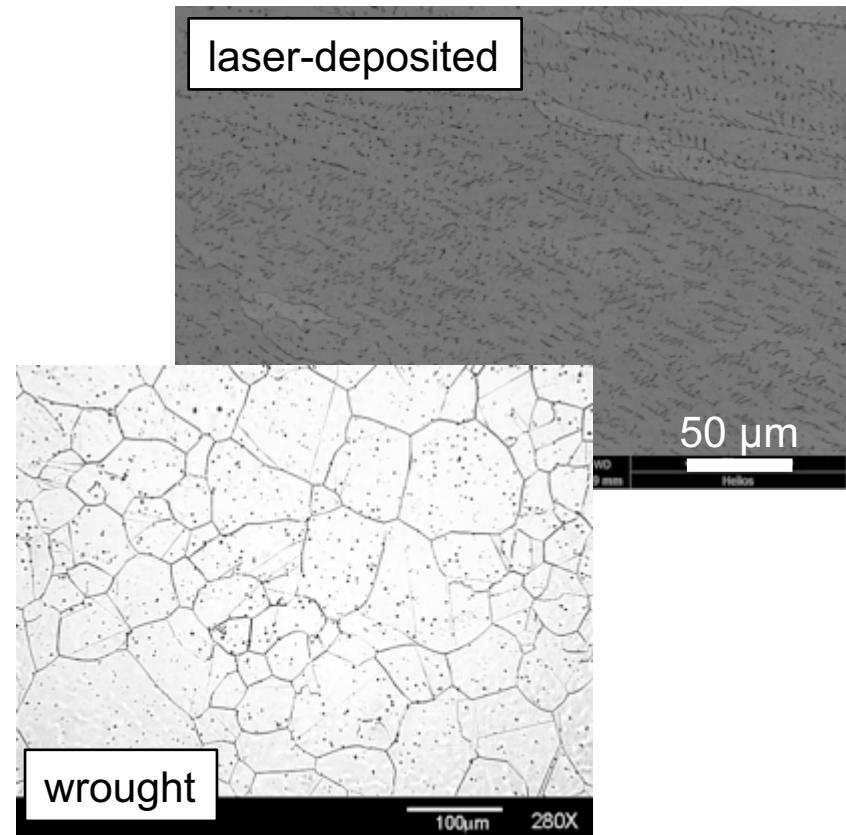
Tensile response can compare favorably to wrought materials

- Laser-deposited and wrought materials show similar tensile strength and ductility despite very different microstructures
- *How does the fracture response compare?*

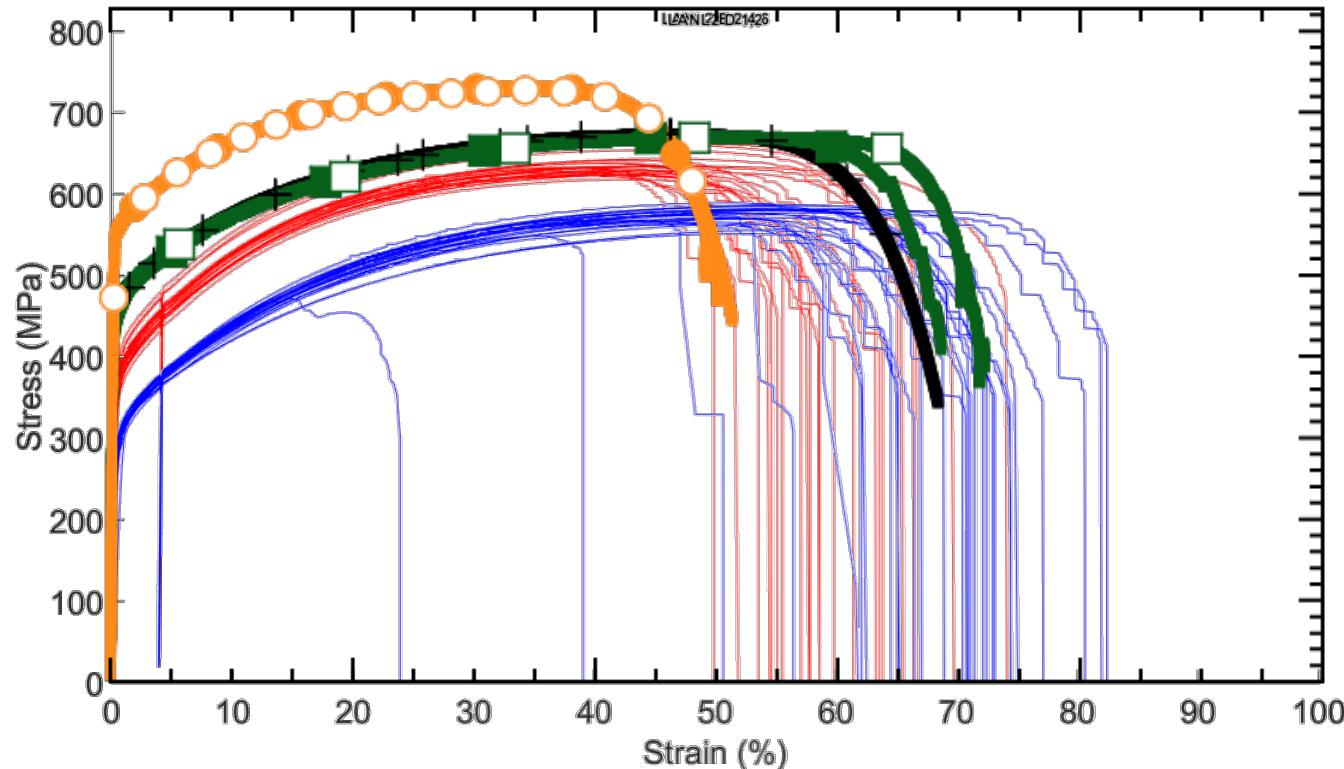
Comparison of DED 304L materials with different pedigree

- Strengthening in AM austenitic stainless steel is not well understood
 - Strength will likely impact fracture resistance

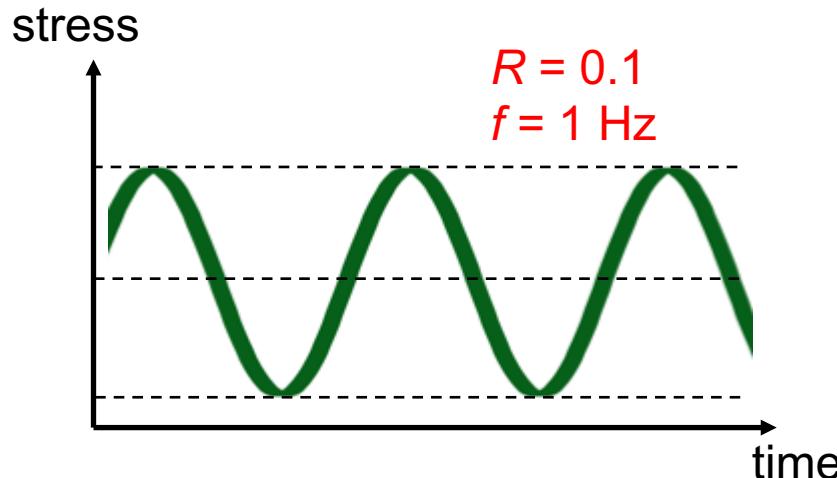
- Fatigue crack growth: da/dN
 - ASTM E647, constant load amplitude
- Fracture resistance: J_{IC}
 - ASTM E1820, elastic-plastic analysis using J-R curve determination

- **Compact tension geometry**

- $B \sim 13 \text{ mm}$
(thickness)
- $W \sim 26 \text{ mm}$
(width)

Fatigue test, then fracture test performed on same sample

- **3-point bend geometry**

- $B \sim 6.3 \text{ mm}$ (thickness)
- $W \sim 13 \text{ mm}$ (width)
- $S \sim 50 \text{ mm}$ (span)

- Direct current potential difference (DCPD) method for in-situ monitoring of crack position

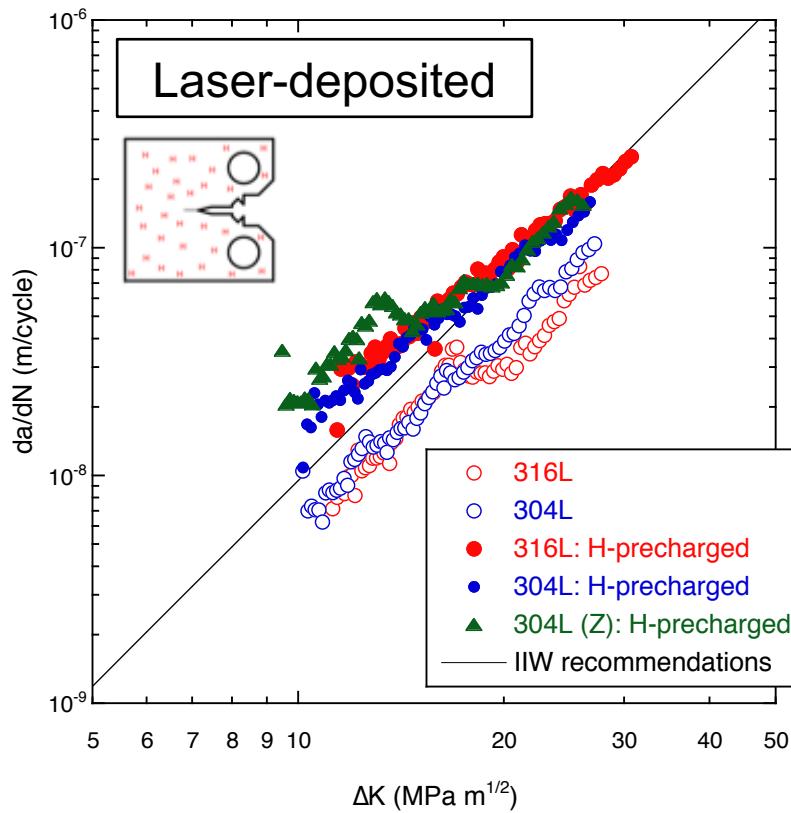
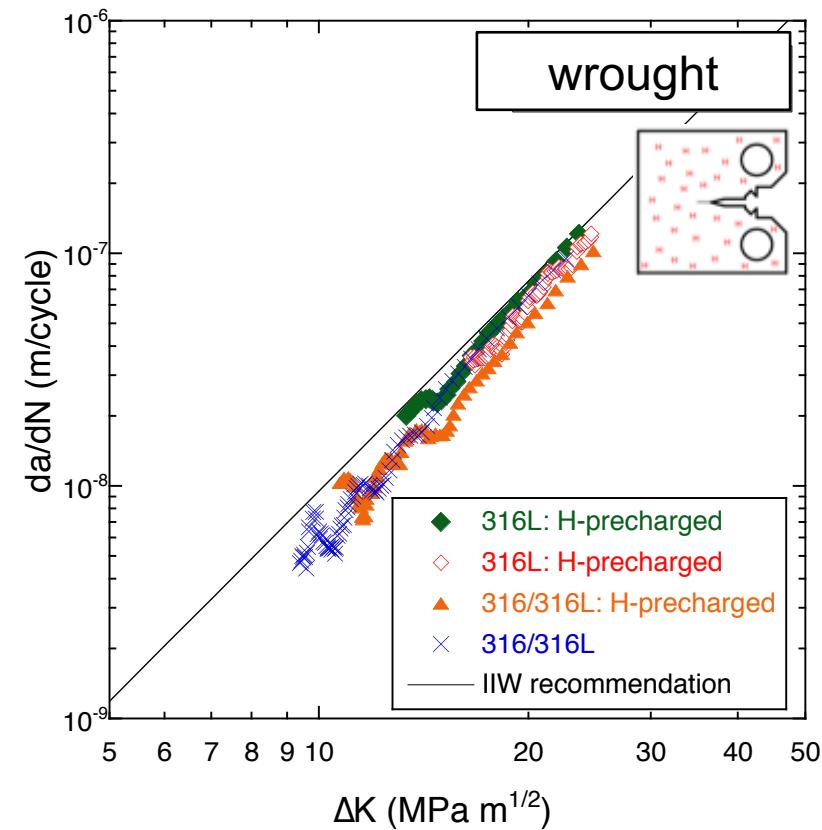
Fatigue crack growth measurements

- Fatigue crack growth rates of laser-deposited type 304L & 316L are consistent with wrought steels
- Hydrogen accelerates fatigue crack growth in laser-deposited materials, unlike wrought materials

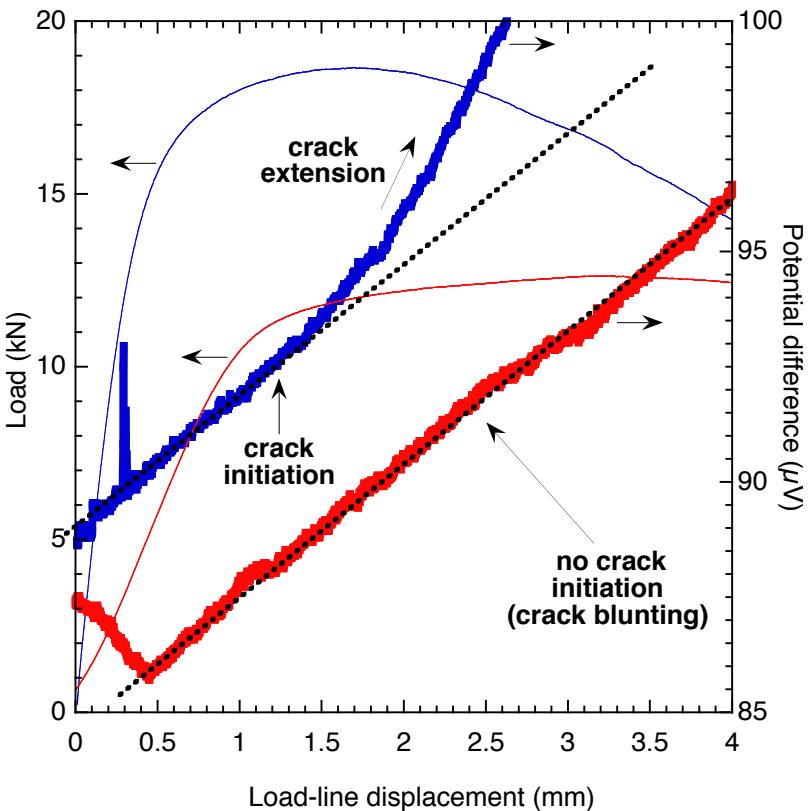
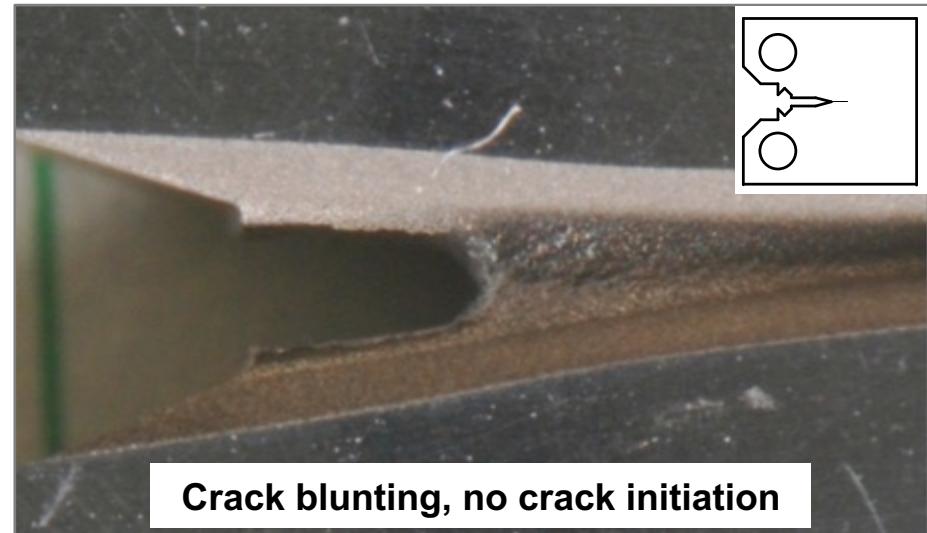
Laser-deposited materials display crack blunting

Crack blunting implies very high fracture toughness: $>200 \text{ MPa m}^{1/2}$

Crack initiation and extension:
not observed in laser-deposited materials

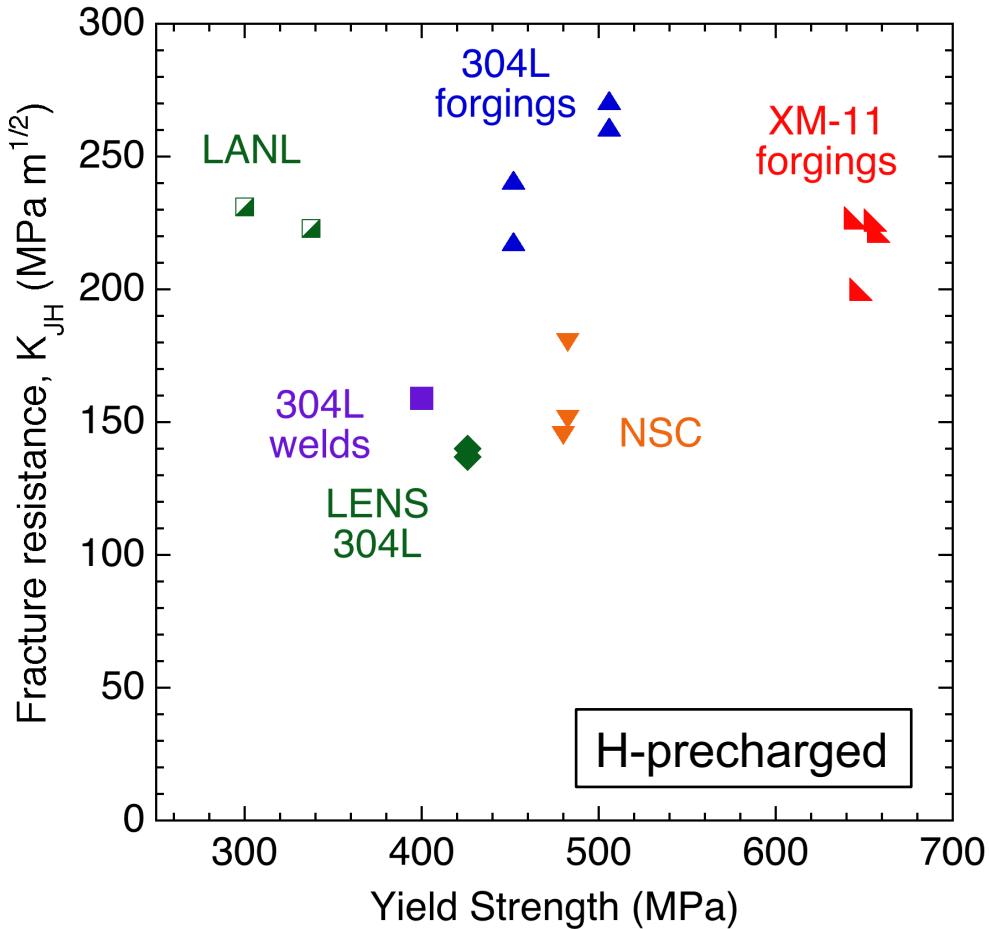
Fracture measurements

- Fracture resistance of H-precharged AM 304L is:
 - *similar to response of austenitic stainless steels welds*
- Lower fracture resistance compared to forgings is consistent with accelerated fatigue crack growth
- Lower strength results in higher fracture resistance (as expected)

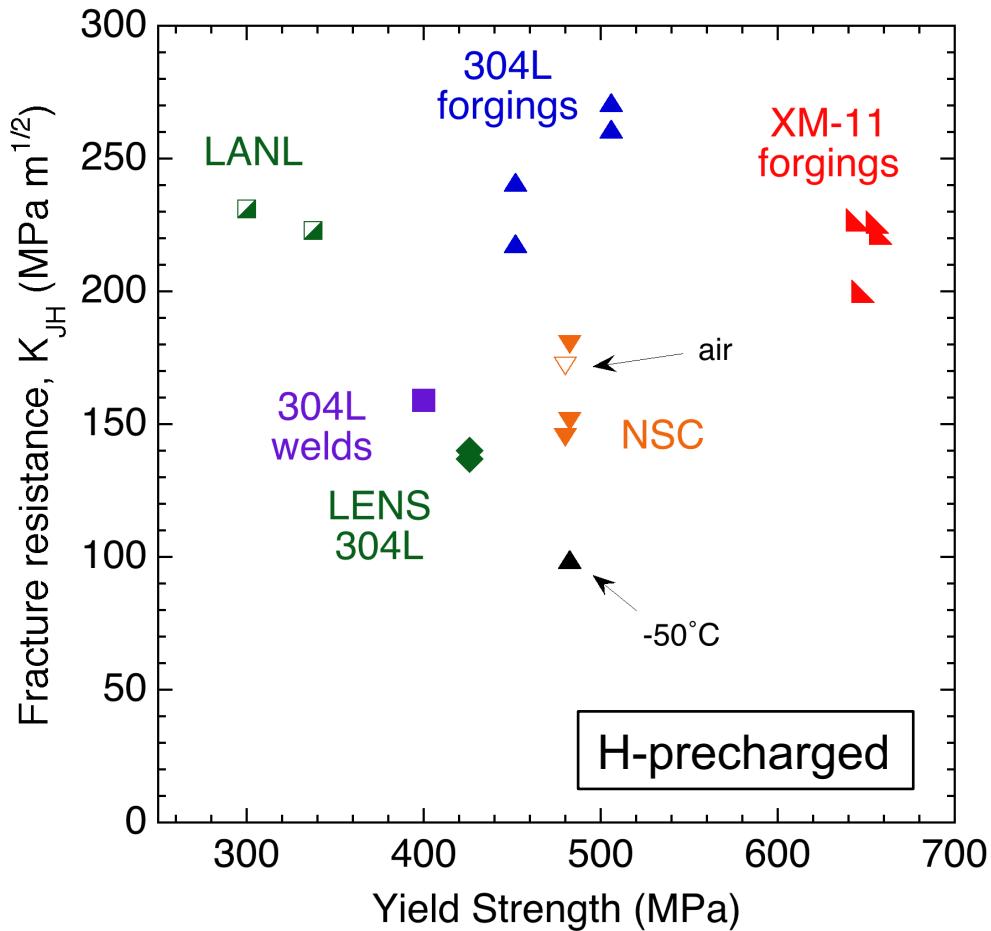
Fracture measurements

- Fracture resistance in air can be significantly lower than H-precharged forgings
- But generally, fracture resistance in air is high (not shown $>200 \text{ MPa m}^{1/2}$)
- Low temperature appears to significantly reduce fracture resistance
 - Work is under way to substantiate
 - Probably related to unique microstructures

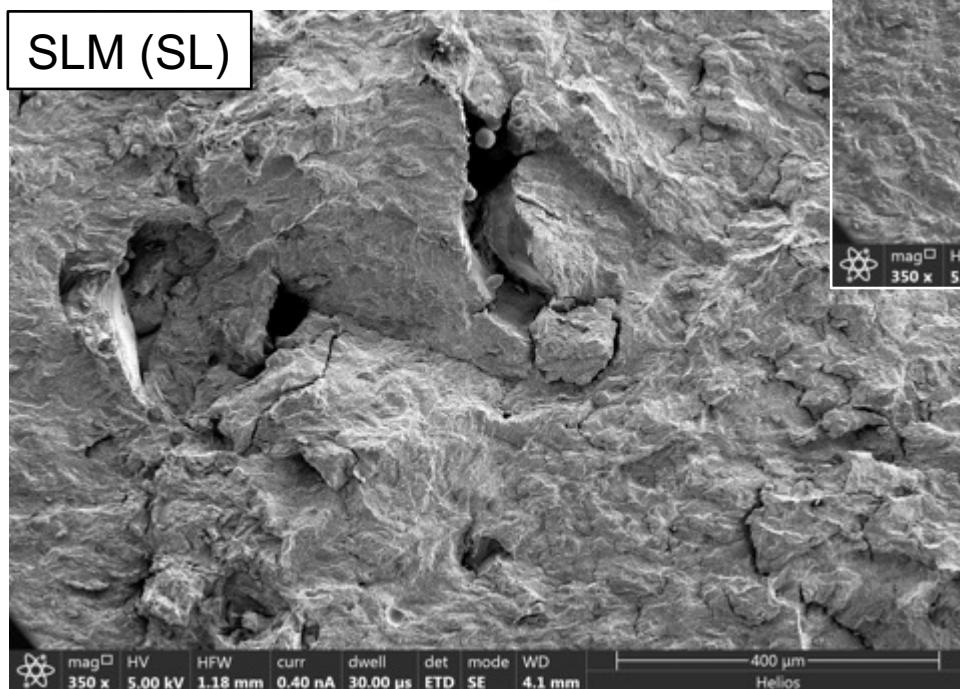
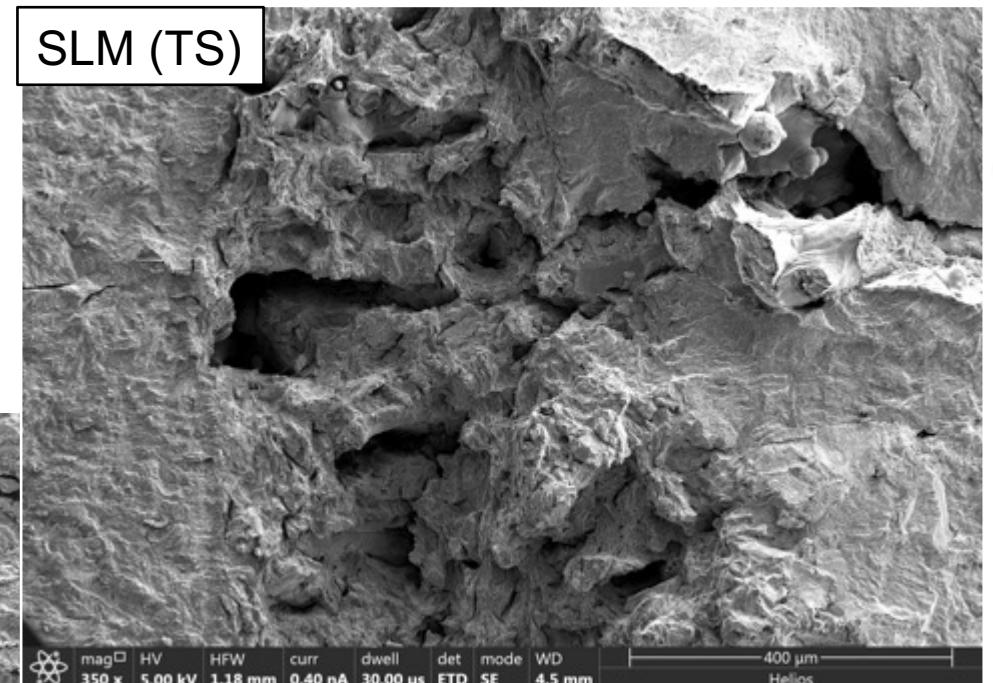
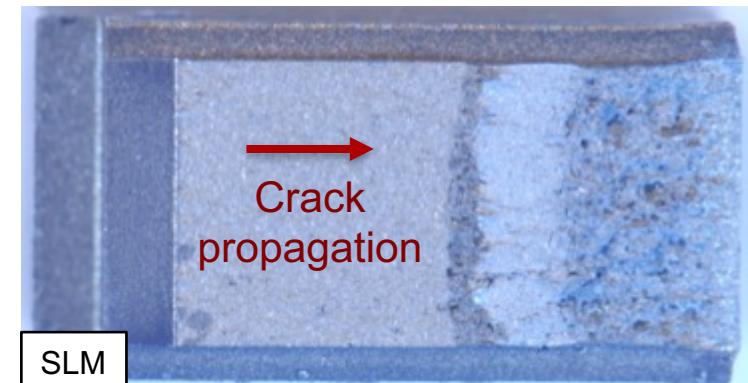
Fractography illuminates defect structure

- Macroscopic defects are associated with interlayers of build (when H-precharged)

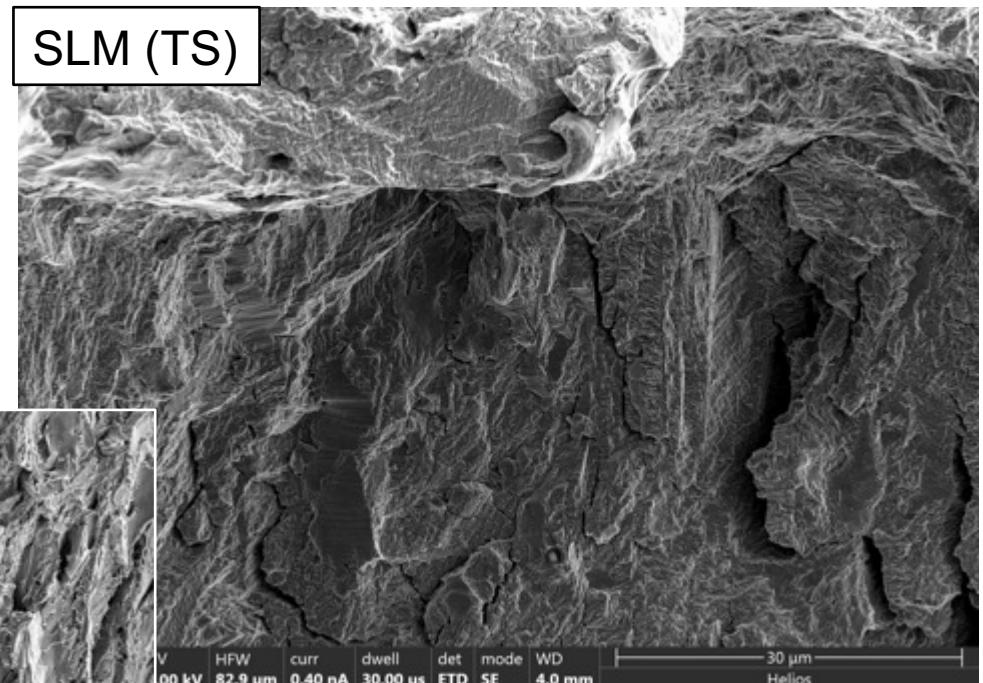
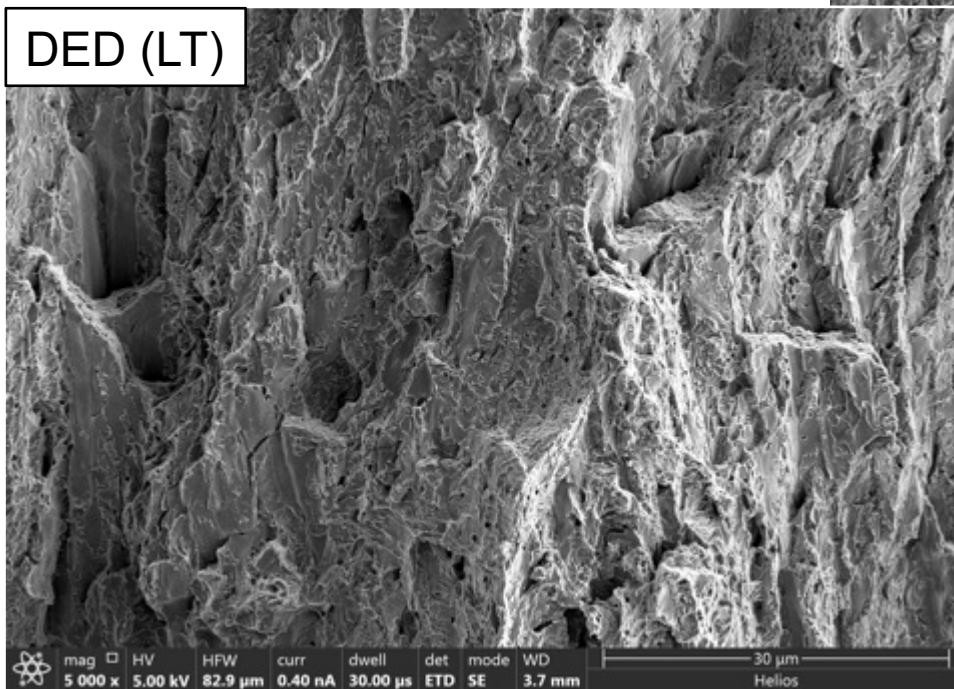
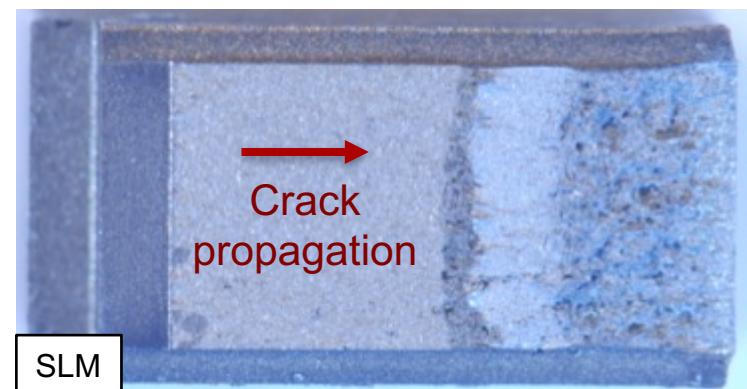
Fine fracture features consistent with H-assisted fracture and microstructure

- Hydrogen induces boundary fracture

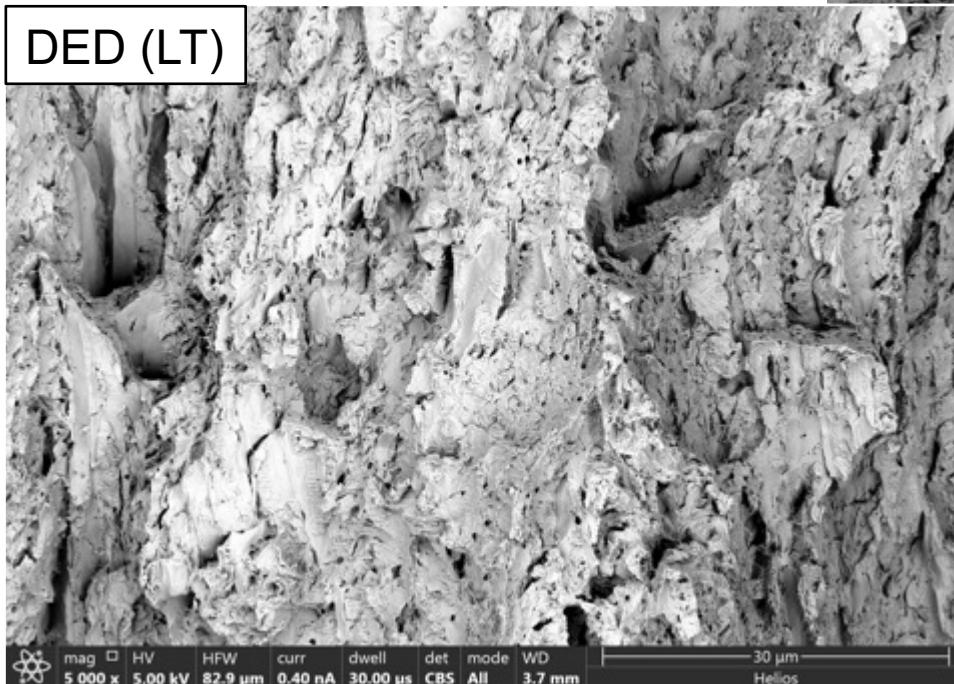
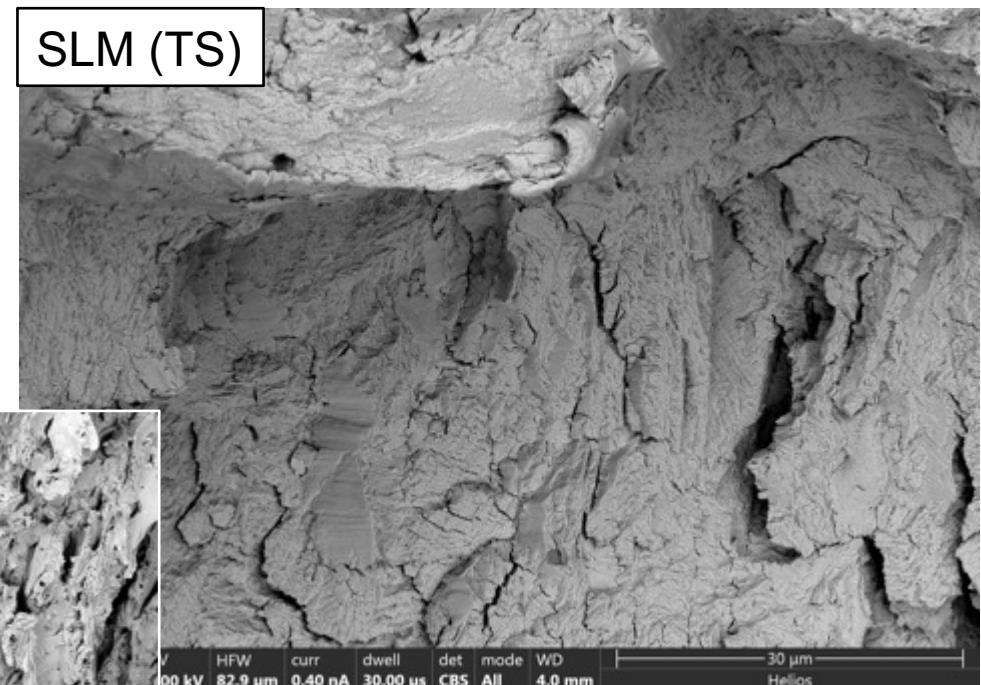
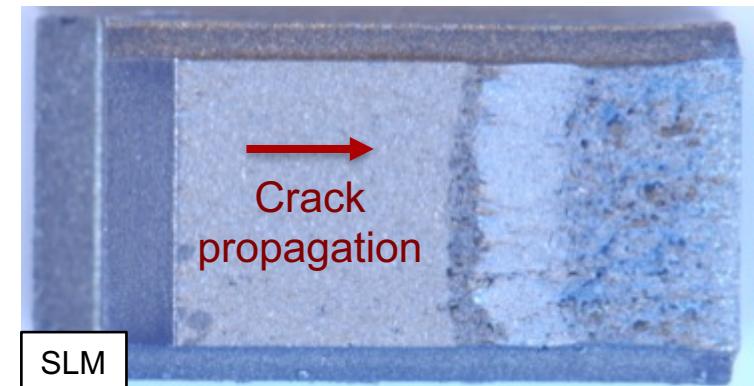
Fine fracture features consistent with H-assisted fracture and microstructure

- Macroscopic defects associated with interlayers of build

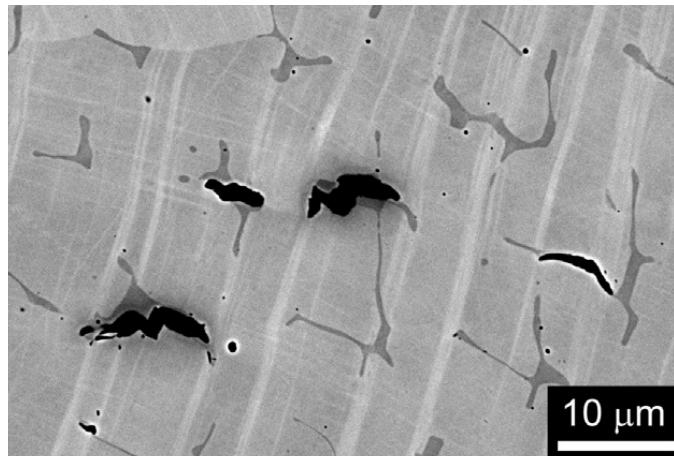
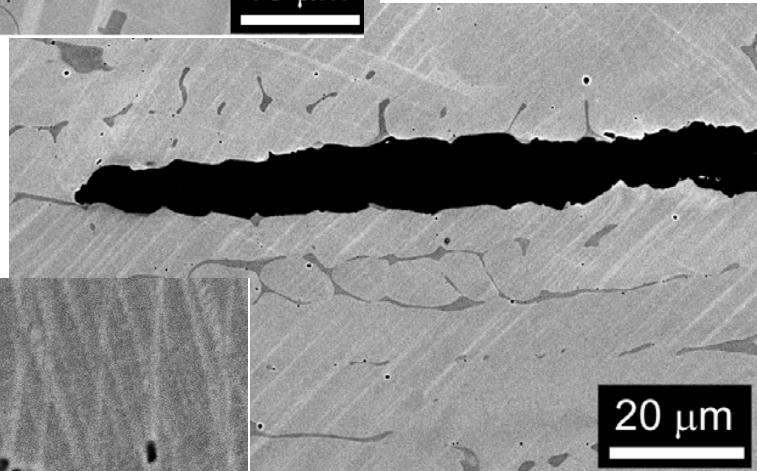
Cross sections just below the fracture surface from fracture tests of H-precharged 304L/308L welds show:

- Fracture of ferrite
- Fracture at γ/δ boundaries
- Void nucleation at ferrite boundaries

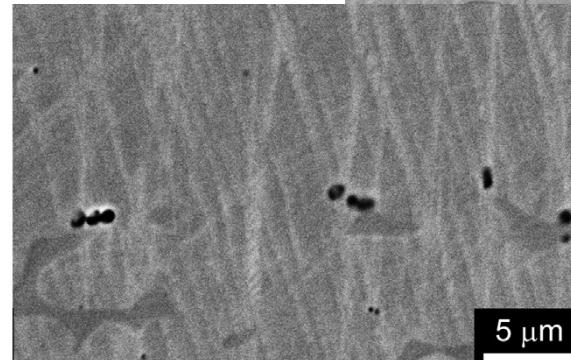
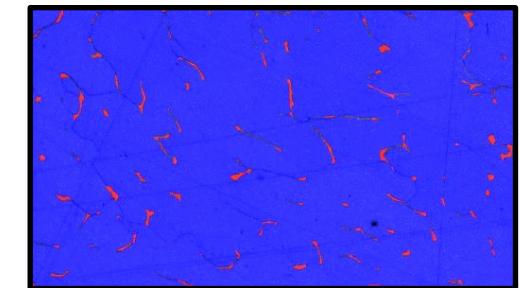
Laser-deposited 304L

Hydrogen-induced damage in *welded austenitic stainless steels* has been reported to be associated with the *ferrite phase*
