# **SANDIA REPORT**

SAND2018-6570

# **Pipe Overpack Container Fire Testing: Phase II-A**

## **Abstract**

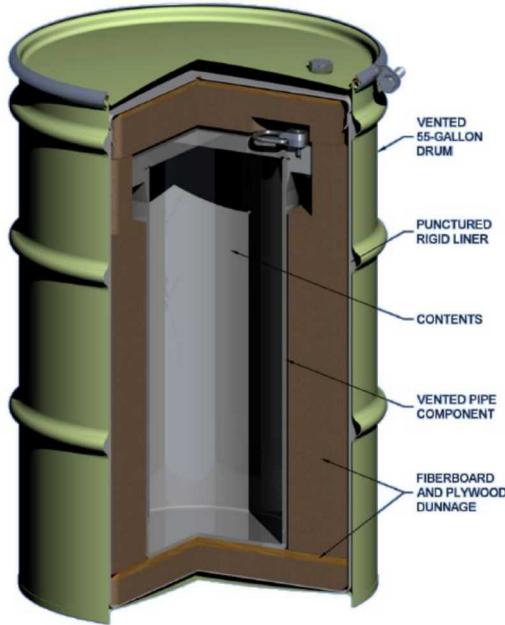
**Figure 1. POC Assembly.**

The Pipe Overpack Container (POC) was developed at Rocky Flats to transport plutonium residues, which contain higher levels of plutonium than standard TRU waste, to the Waste Isolation Pilot Plant (WIPP) for disposal. The POCs consist of an inner Pipe Container (PC) surrounded by fiberboard (Celotex®) and plywood dunnage inside of a 7A drum (see Figure 1). The PC was designed to maintain separation of fissile material and to provide shielding from radiation. In 1996 Sandia National Laboratories (SNL) conducted a series of tests to determine the degree of protection POCs provide during storage accident events. These tests were conducted to support use of POCs by Rocky Flats Plant (RFP) to package and ship plutonium residues. The POCs used in these tests were fitted with the all-metal filter (NUCFIL019DS) on the drum lid as is currently being used on POCs at storage sites. One of these tests exposed four of the POCs to a 30-minute engulfing pool fire, resulting in one of the drums (fitted with the metal filter) generating sufficient internal pressure to pop off its lid and expose the top of the PC to the fire environment. The PC contents in this test were inert materials that would not generate significant pressures within the PC. Even if the O-rings and filter failed, only a small fraction of the radioactive material contained within the PC was predicted to be released. These test results were reported in 1997 for the RFP (Ammerman, Bobbe, Arviso, & Bronowski, 1997) and are also available in DOE STD-5506-2007 (DOE, 2007).

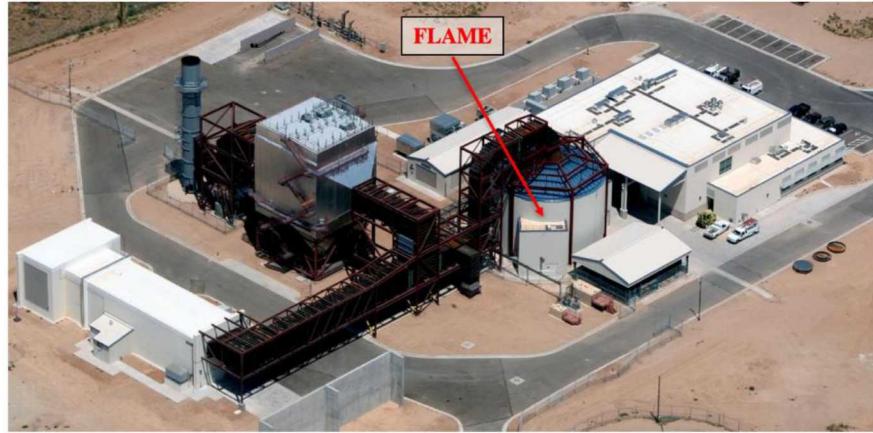
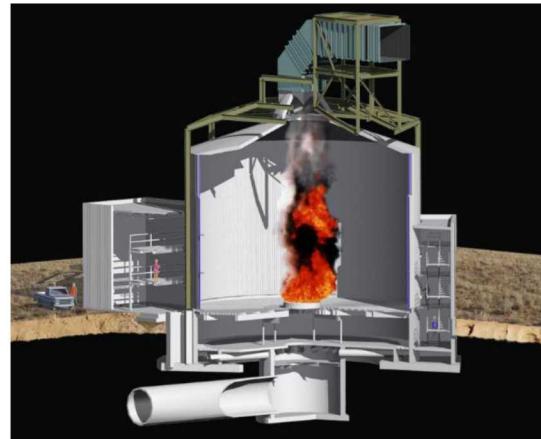
**Figure 2. (a) Location of FLAME within the TTC and (b) interior of the FLAME facility.**

A total of four tests were performed at SNL as part of this test phase. All tests were conducted inside the Fire Laboratory for Accreditation of Models and Experiments (FLAME) test cell located in SNL's Thermal Test Complex (TTC), shown in Figure 2. FLAME is a vertical wind tunnel design for conducting pool fire tests under calm conditions. The test cell has an inner diameter of 18.3 m and is 12.2 m tall along its perimeter walls. The walls are made of steel channel sections and are filled with water to keep the perimeter of the facility cool. At the top of these walls, the ceiling slopes upwards ( $\sim 18^\circ$ ) from the end of the walls to a height of 15 m over the center of the facility. A round hole 4.9 m in diameter at the top of the test cell transitions to a chimney duct, allowing fumes to escape the test cell.

Most of the test cell floor is made up of metal grid panels. At the center of the grid floor of the test cell is a fuel pan or gas burner. FLAME works with either a 3 m diameter gas burner (H<sub>2</sub>, CH<sub>4</sub>, etc.) or a liquid fuel pool (JP8, Jet-A, methanol, etc.). For this test, only the liquid fuel pool was used. Air channeled vertically through the grid floor, via a vent ring several feet below the floor and adjacent to the perimeter walls, allows air to be entrained naturally into the fire, as it would be in an outdoor fire.

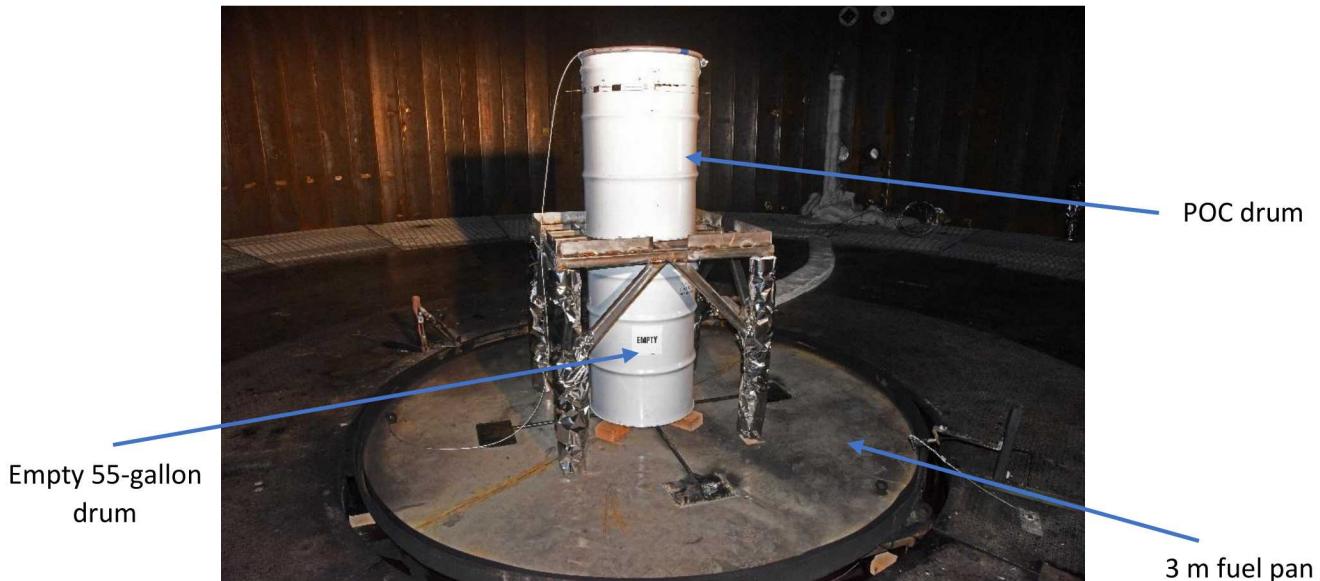
**Figure 3. Typical fuel-pool/drum layout for Tests #1 and #3 inside of FLAME.**

Figure 3 shows the typical test layout for Tests #1 and #3 of this phase. Starting from the bottom up, the test layout consisted of: a 3 m circular fuel pan used to create the fuel pool, an empty 55-gallon drum with a hole on the lid to prevent pressure buildup, and a filled POC drum which is concentrically placed above the empty drum but on top of a table. The configuration for Tests #2 and #4 varied slightly from Tests #1 and #3, as shown in Figure 4. For Test #2, the setup of Tests #1 and #3 was used, but a 7A drum filled with typical combustibles was added on the grid floor outside of the fuel pan. Test #4 did not include any POCs and instead used a 7A drum filled with

In all tests, the 3 m circular fuel pan shown at the center was initially filled with Jet-A fuel. The pool was ignited with a torch that was started remotely. To maintain the drum of interest fully engulfed throughout the test, a remote refueling system intermittently added fuel to the pool in discrete amounts throughout the tests to maintain a steady pool depth. To limit the fire duration to 30 minutes, the pool has a drain system that dumped all remaining fuel at the end of the test, almost immediately terminating the fire at the point of dumping. Typical fuel consumption rate for these tests was about 0.3 kg/sec.

While a variety of configurations exist for stacking POC drums, the vertical configurations shown in Figure 3 and Figure 4 are based on what is typically seen in storage facilities. These test configurations intended to mimic how drums are typically stacked on top of each other, in a drum-array arrangement within a single drum level, as shown by the storage arrangements exemplified in Figure 5. For drums at the center of the pool in all tests of this phase, only the top drum was loaded and instrumented. The reason for only loading and instrumenting the upper drum was because that drum would be the one to observe the highest flame temperatures in a typical storage fire should there be a fuel pool accumulated at the base of the bottom drum. This hotter region in the top drum occurs because pool fires typically consist of a relatively cold plume adjacent to the surface of the pool called the vapor dome which is caused by the evaporating fuel. Near the edge of the base of a quiescent pool fire, where the plume diameter is largest, air entrainment deep into the plume at this height is limited. Thus, combustion is efficient only near the edges of the fire where the air can effectively mix with fuel vapor. The lack of air inside the vapor dome prevents efficient combustion and thus results in a cooler region. Further up from the fuel pool, air entrains more readily further into the plume and therefore creating hotter regions deeper into the fire as a result of more efficient combustion. The height of the cold region is greatest at the center of the fuel pool and decreases towards the edge of the pool. Thus, the shape of the cooler region resembles a dome. Objects submerged within this vapor dome, as is the bottom drum in all test configurations of this phase, experience lower heat fluxes than other objects outside of this region within the fire. Consequently, drums stacked one meter above the fuel pool observe the most conservative conditions, which is why the upper drums are selected as the test subjects (Gritzo, Nicolette, Murray, & Moya, 1995).

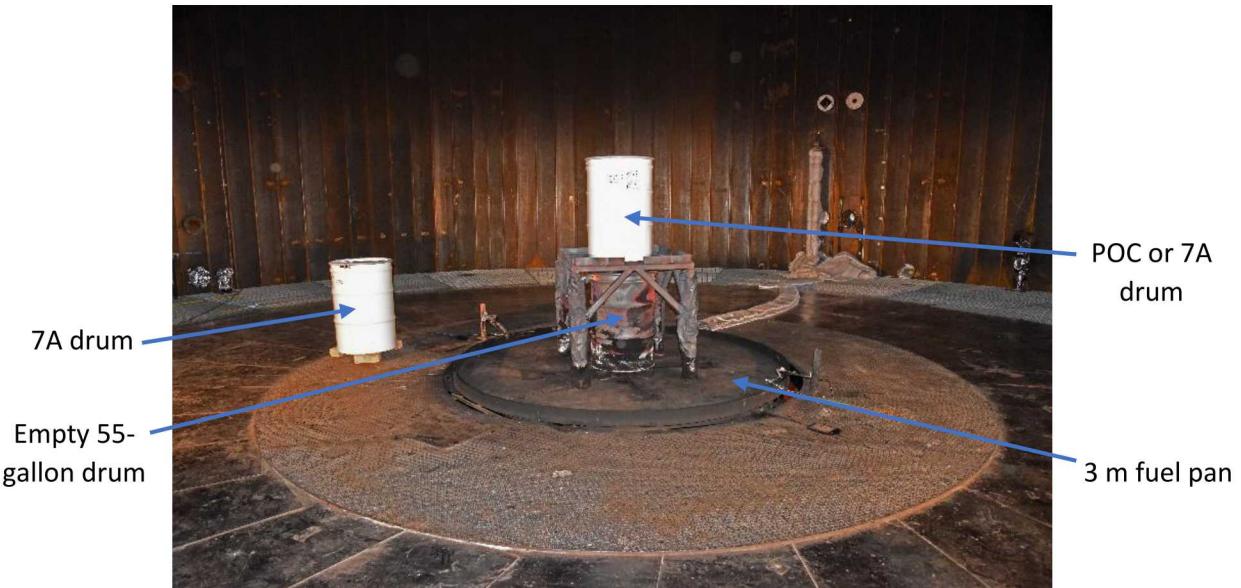
**Figure 4. Typical fuel-pool/drum layout for Test #2 and Test #4 inside of FLAME.**

typical combustibles on top of the empty drum at the center of the pool. Furthermore, a 7A drum was also added on the grid floor outside of the fuel pan for Test #4.

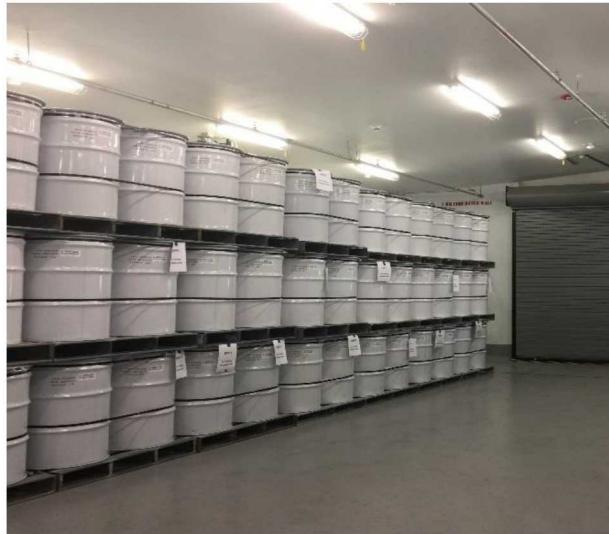
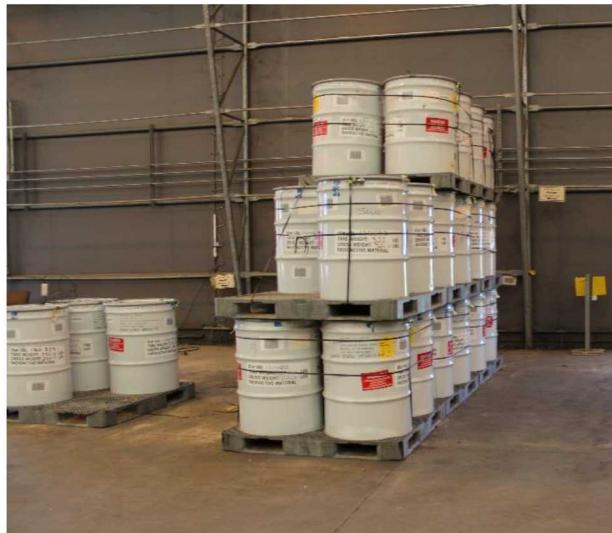
**Figure 5. Examples of drums in typical storage configuration. (a) is at LANL, (b) is at Savannah River Site (SRS).**

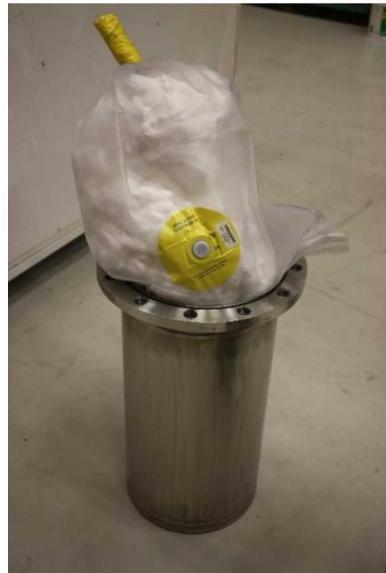
**Figure 6 . POC with filled bag-out-bag.**

In all tests, the POCs and 7A drums were loaded with typical combustibles used in each respective drum. For POCs, “typical” implied cellulose and plastic materials, which is the most prevalent content inside POCs based on TA-55 inventory. Pete Carson, a POC-inventory/POC-content SME from TA-55 in Los Alamos National Laboratories, further specified “typical” loading conditions for the PC as having a plastic bag-out-bag filled with cheesecloth, which is what is used for the PCs in this test phase. Figure 6 shows an example of one of the PCs with the filled bag-out-bag

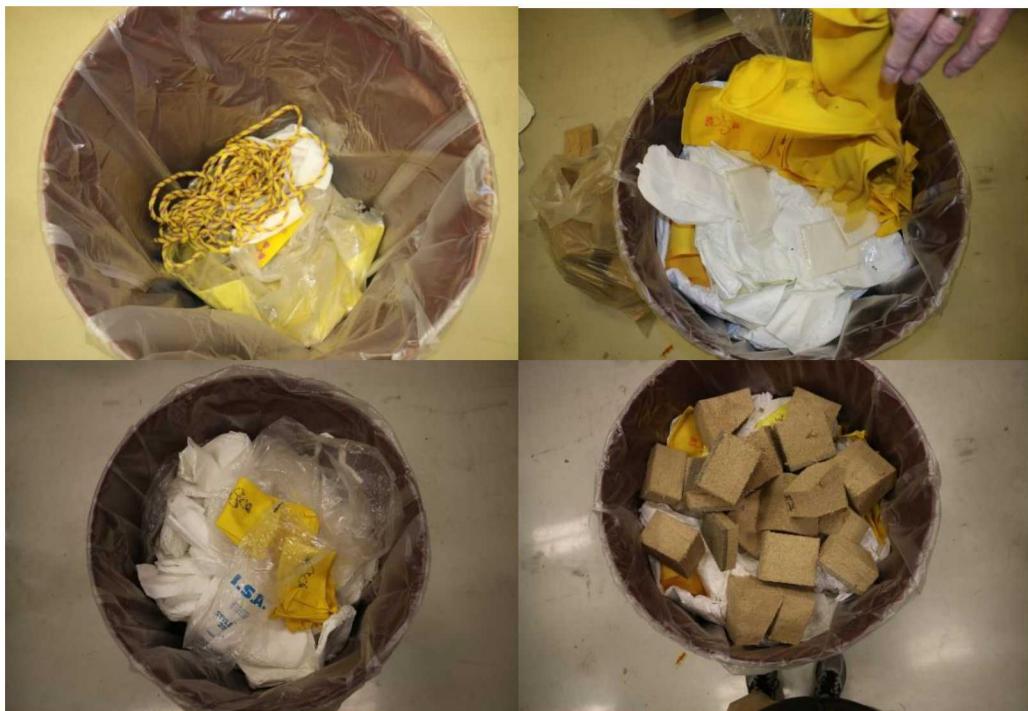
**Figure 7. Typical contents of 7A drums.**

laying on top, just before placing it inside the PC. For the 7A drums, contents were of mixed items that consisted of approximately 50% cellulose and 50% plastics by volume. The mixed items were selected based on what can typically go in these types of drums, and Figure 7 shows an example of the contents used in the 7A drums for Test #4.

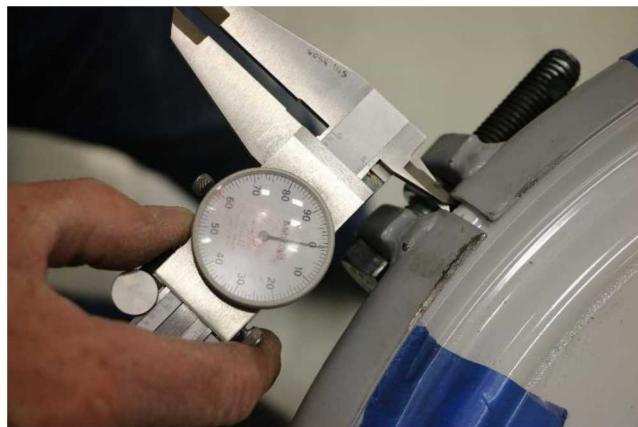
**Figure 8. Measurement of lock ring gap.**

Previous fire testing demonstrated the importance of correct drum-closure procedures, therefore, staff from LANL and WIPP monitored the procedure for tightening the drum lid rings for these tests. The specifications required a 55 ft-lb torque on the lock ring bolt (plus the tool uncertainty, which was  $\pm 2.5$  ft-lbs for the tool used in these tests) when a 5 mm lock ring gap was attained. To prevent damage to the lock ring and bolt when trying to achieve the 5mm gap as the lock ring was tightened, the lock ring was hammered with a mallet around the drum ring several times throughout the tightening process allowing the lid gasket to adjust. Figure 8 shows how calipers were used to ensure the 5 mm gap on the lock ring, and Figure 9 shows how the lock ring bolt was torqued to 57.5 ft-lbs once the 5 mm gap was attained. This procedure was followed on all POC and 7A drums.

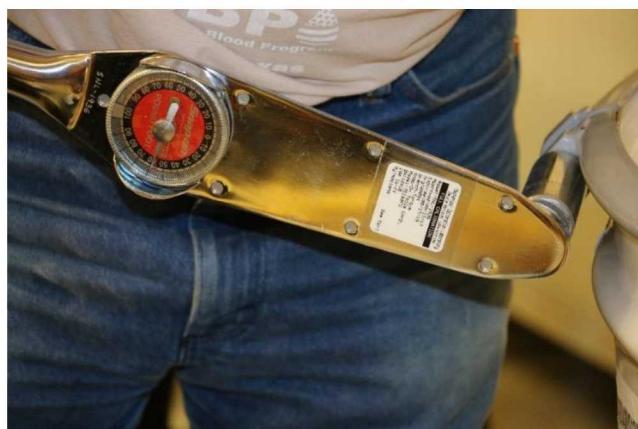
**Figure 9. Lock ring torque.**

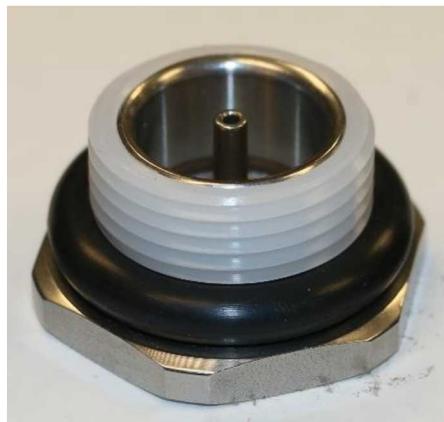
Figure 10. UT9424S drum lid filter.

As mentioned at the beginning of this report, previous tests have shown that, when engulfed in a pool fire, the current all-metal filter used on POC drum lids results in lid ejection due to the pressure buildup resulting from pyrolysis gases generated inside the POC. This is undesirable. The UT9424S drum lid filter, shown in Figure 10, has been proposed as a viable POC lid filter alternative given that it is based upon the UT9424 filter that is already approved for use in TRU waste drums at storage sites. Of particular interest for this test phase, the UT9424S filter further has design features that allow it to relieve gas pressure that can build inside the drum during a fire accident. The bolt-like housing of this filter has a unique design in that it is attached to a plastic bushing which gets bolted to the drum lid. The expectation is that the melting of this plastic bushing early on in a pool fire test would allow a sufficient outflow of gases from inside the drum to prevent lid ejection. Therefore, the focus of this study was to investigate the performance of a POC in a 30-minute pool fire using this UT9424S POC drum lid filter.

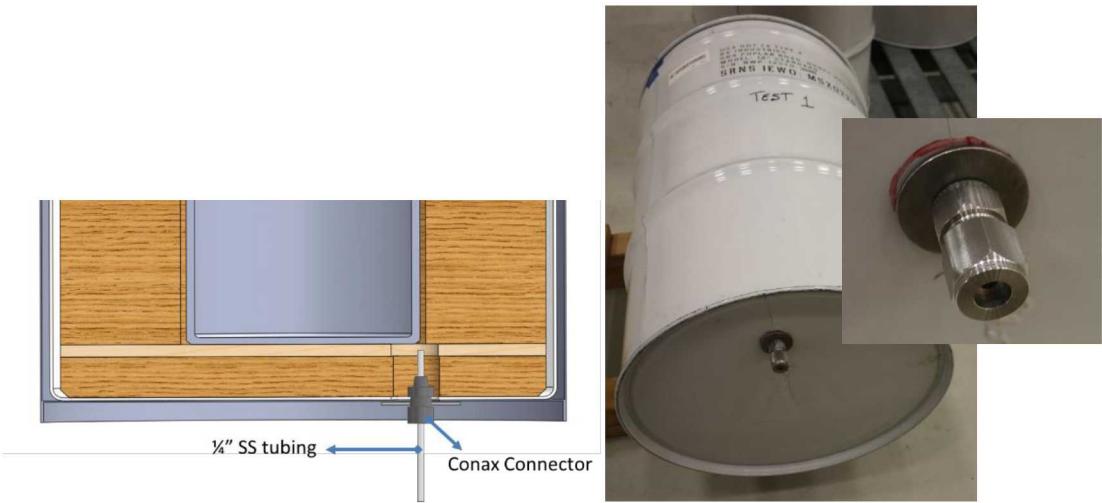
**Figure 11. Lower portion of POC showing location of pressure port on the POC drum.**

The POC drums for Test #1 and Test #2 were instrumented with a pressure port as shown in Figure 11. The pressure port was connected to a remote pressure transducer (Endevco® 8530B-200) using a Conax® connector and  $\frac{1}{4}$  inch stainless steel (SS) tubing attached to the bottom of the POC drum. The reason the pressure transducer was located remotely inside FLAME, away from the fire, was to prevent any drift (i.e., bias) that could be caused by exposure to the high temperature of the fire. To further prevent pressure drift resulting from temperature changes in the transducer's piezoresistive circuit, an aluminum block was used as a heat sink to maintain the temperature of the pressure transducer relatively constant. The aluminum block had one through-hole to fit the  $\frac{1}{4}$ " drum input pressure line on one side, and the 8530B-200 transducer on the opposite side. A second hole perpendicular and connected to the through hole just described was used to fit a  $\frac{1}{4}$ " tube that went to an OM-CP-PR140 data logger.

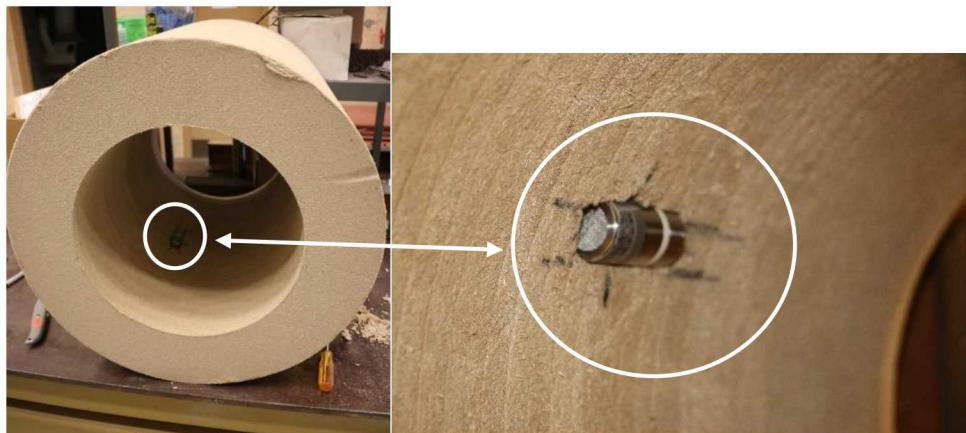
**Figure 12. Pressure data logger installed outside the PC in Celotex® cylinder for Test #3.**

For Test #3, the pressure port was covered and unused. In this test, however, wireless data loggers were successfully used to measure the pressure inside the POC. A total of two data loggers were used inside the POC; one inside the PC, and one outside the PC. As shown in Figure 12, the data logger outside the PC was inserted in a cutout made to the Celotex® cylinder surrounding the PC. The depth of this insertion was minimized (based on the results of the previous tests) to not affect the results of this test. The second pressure data logger was secured to the bag-out-bag inside the PC as shown in Figure 13.

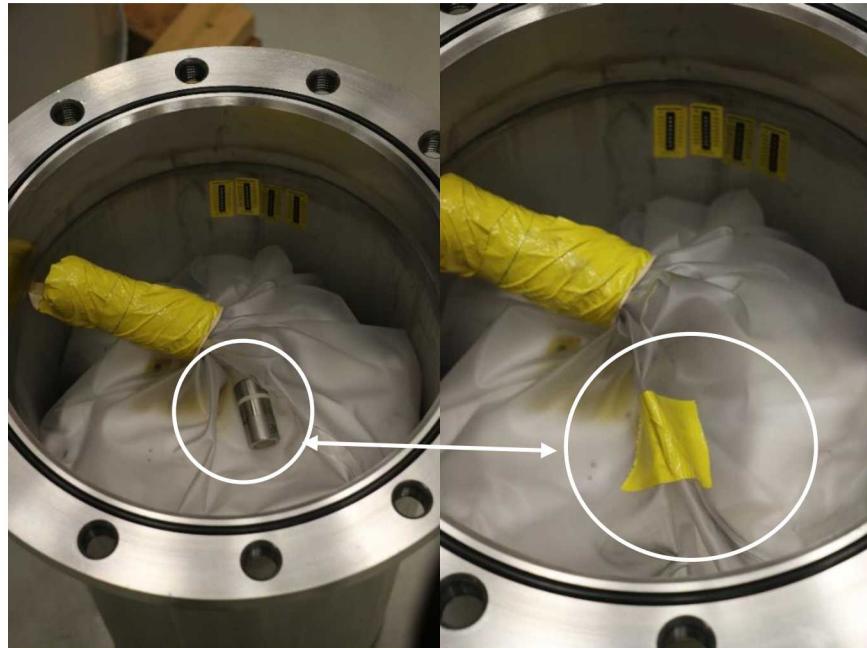
**Figure 13. Pressure data loggers secured inside PC for Test #3.**

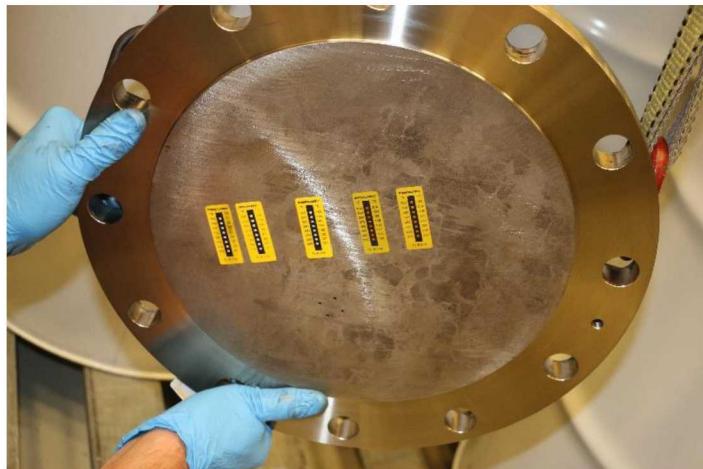
**Figure 14. Example of temperature label set used on underside of PC lid.**

Real time temperature data on the interior of the POC was not recorded. Instead, only peak temperatures inside the PC were monitored using Omega® irreversible temperature labels. Figure 14 shows how temperature labels TL-E-105, TL-E-170, TL-E-250, TL-E-330, TL-E-410 were used as a set to record any peak temperature reached between 77 °C and 260 °C.

1. On the underside and center of the PC lid.
2. On the side wall of the PC, approximately 2-inches from the bottom.
3. On the side wall of the PC, approximately 10-inches from the bottom.
4. On the side wall of the PC, approximately 20-inches from the bottom.
5. On the inside and bottom of the bag-out-bag.
6. On the inside and top of the bag-out-bag combustibles.
7. On the inside and mid-section of the bag-out-bag.

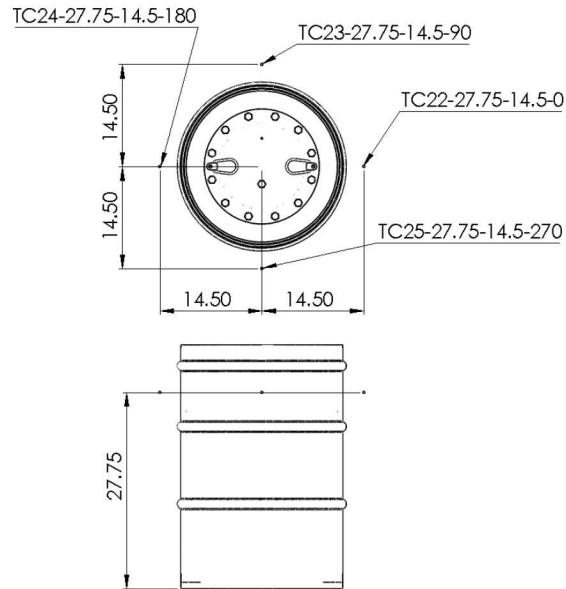
**Figure 15. Location of thermocouples outside the POC drums.**

For Tests #1 and #2, real time temperature data was obtained using mineral insulated 1/16" type K thermocouples at six different locations on the exterior of the POC:

1. On the UT9424S filter on the POC lid.
2. At 90° intervals around the perimeter of the drum, 4 inches away from the drum wall, and at a height of 27.5 inches measured from the base of the drum. The drum seam was used to mark the 0° point to identify all four angular locations as shown in Figure 15.
3. On the bottom drum lid, at the same radius as the filter location on that lid.

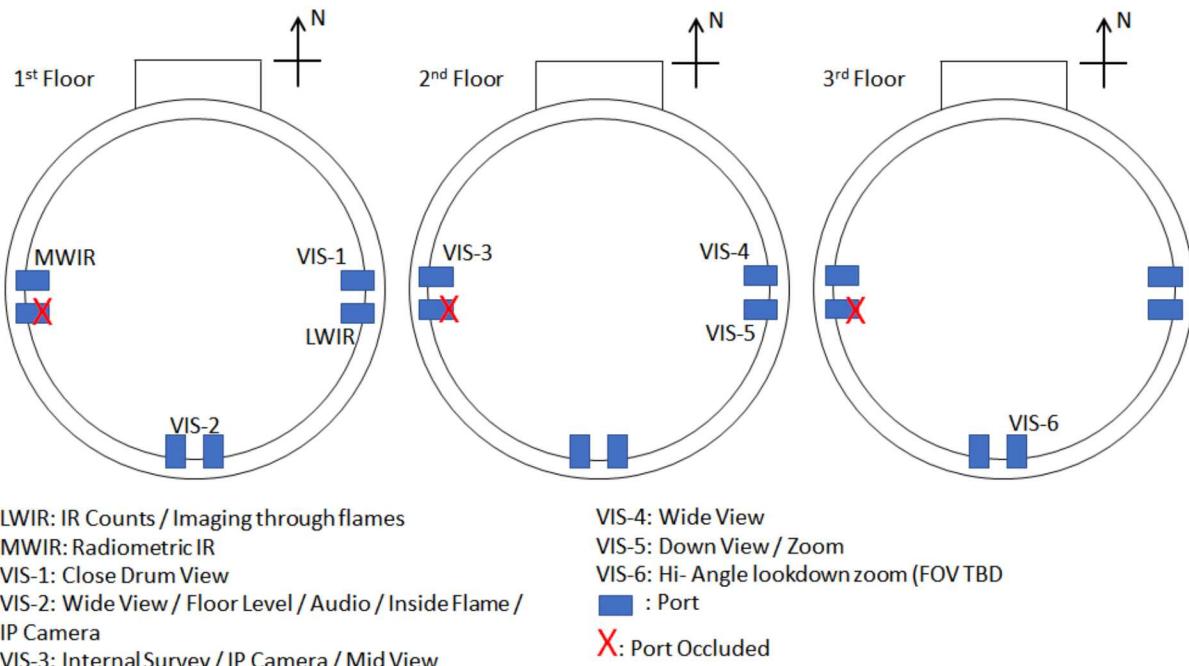
**Figure 16. Camera locations.**

The entire duration of the test was recorded on real-time digital video from two orthogonal directions, while the engulfed package was filmed with mid-wave (MWIR) and long-wave (LWIR) infrared cameras. Figure 16 below illustrates the location of these cameras.

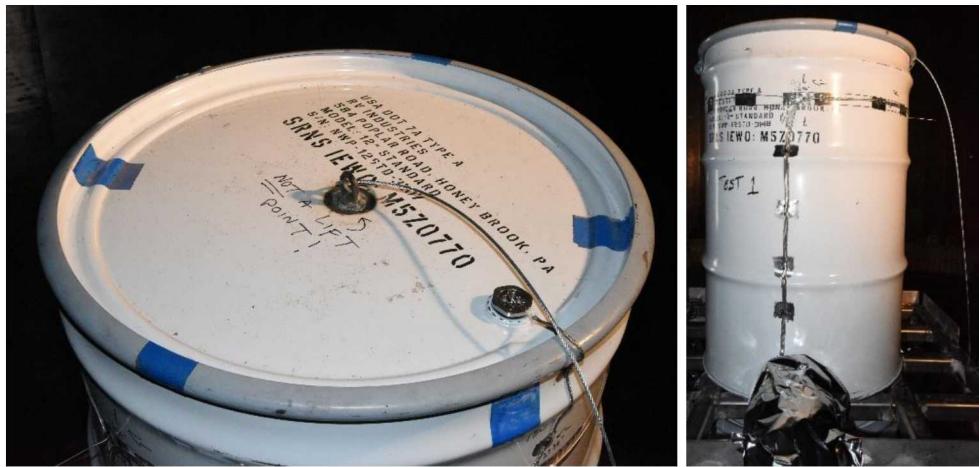
**Figure 17. Tether attachment on lid of POC drum in Test #1.**

The outcome of the first test determined how the remaining tests would be performed. Due to the uncertainty of what could happen in the test, a tether was attached to the lid of the POC drum on Test #1, as shown in Figure 17. In case the POC drum lid ejected with a large force, this tether was attached to prevent the lid from flying out and damaging the FLAME facility. However, the success of this test rendered the tether unnecessary for subsequent tests.

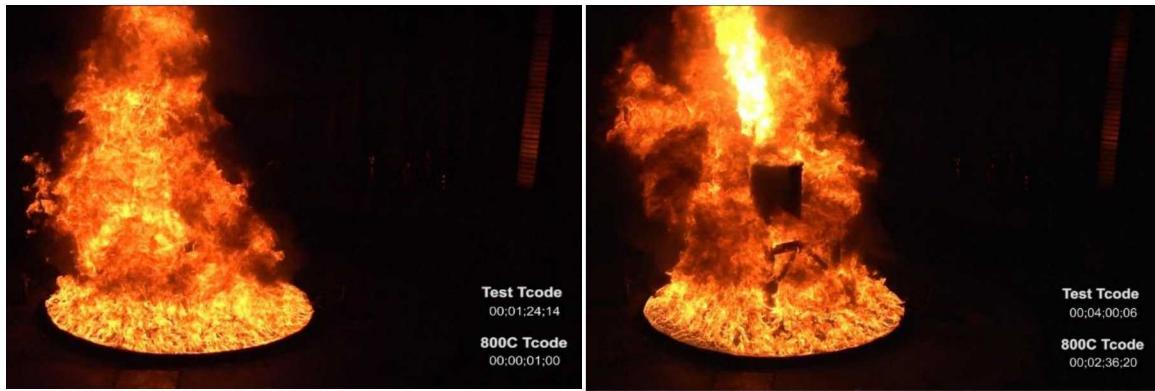
**Figure 18. POC under fully engulfed fire conditions: (a) Before filter ejection and (b) after filter ejection.**

For Test #1 and all subsequent tests, the fire was considered fully engulfed when the thermocouples around the top drum reached 800 °C. Figure 18 below exemplifies the POC in the fully engulfed pool fire before and after the filter ejection. In Figure 18(a), the fire is shown just as it becomes fully engulfed but with the lid filter still in place. Once the filter popped off, approximately two minutes after reaching fully engulfed conditions, two notable phenomena were observed: (1) liquified polyethylene was ejected from the POC drum due to the melted interior drum liner, as shown in Figure 19, and (2) a flame jet resulting from the pyrolyzed gases being ejected as the pool fire burned, as shown in Figure 18(b). The spilling of the liquified polyethylene persisted for about 15 seconds after it started, which was at approximately two minutes and 30 seconds after reaching fully engulfed fire conditions. The jet created from the pyrolysis gases persisted throughout the test and stopped about two minutes after the 30-minute marker, the point at which the fuel supply had recessed to extinguish the pool fire.

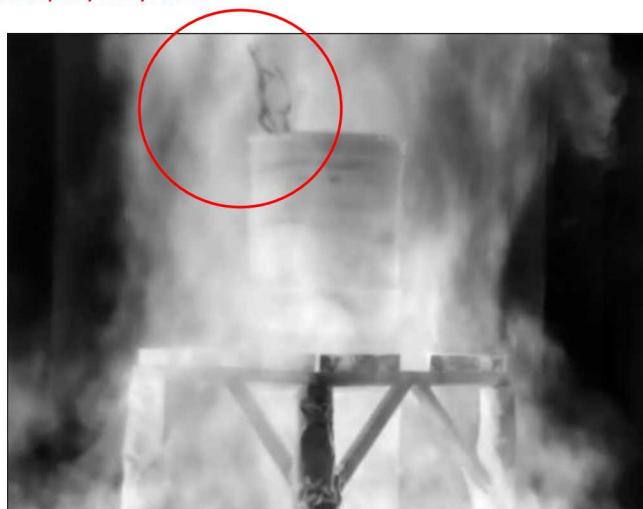
Liquified polyethylene

**Figure 19. IR image of POC under fully engulfed fire conditions after filter ejection.**

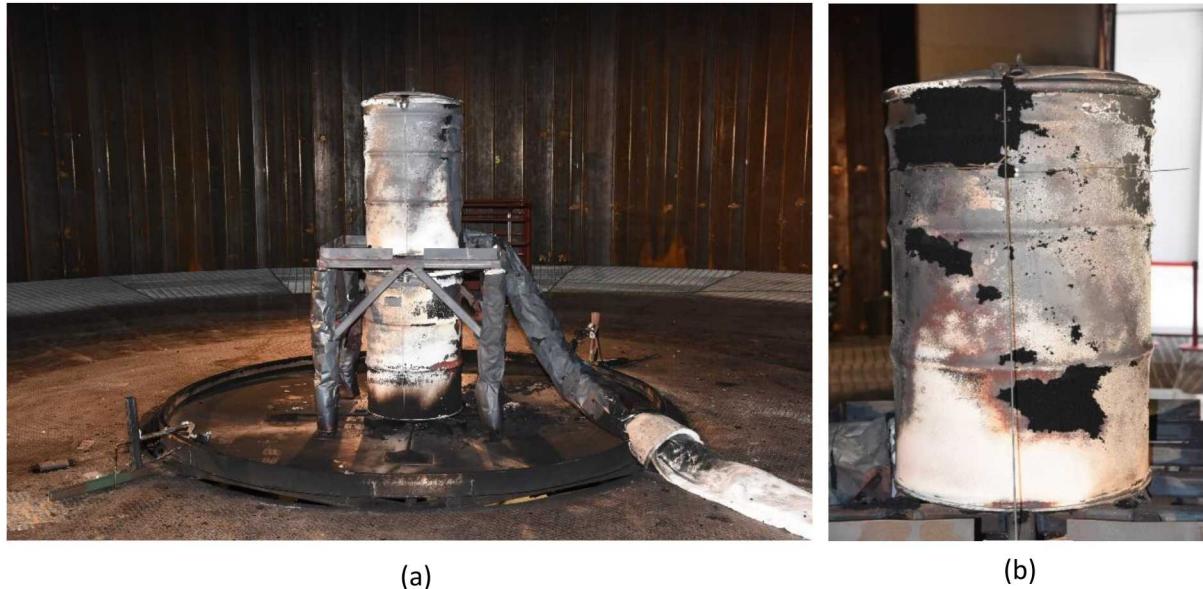
**Figure 20. Remains of Test #1. (a) Full setup and (b) POC only.**

The remains of this test were allowed to cool overnight, and Figure 20 below shows the conditions of these remains. In this figure, it is apparent that there was no lid ejection. Therefore, attachment of a tether became unnecessary for subsequent tests performed under the same conditions. However, even though there was no lid ejection, there was still significant bulging of the lid in this test resulting from the pressure buildup caused by the pyrolysis gases. The bulging of the lid along with the ejected filter are captured in Figure 21, where it can be seen how the peak of the bulge reached just over two inches above the edge of the lock ring. When comparing the tested filter with a new one, Figure 22 shows how the plastic bushing around the

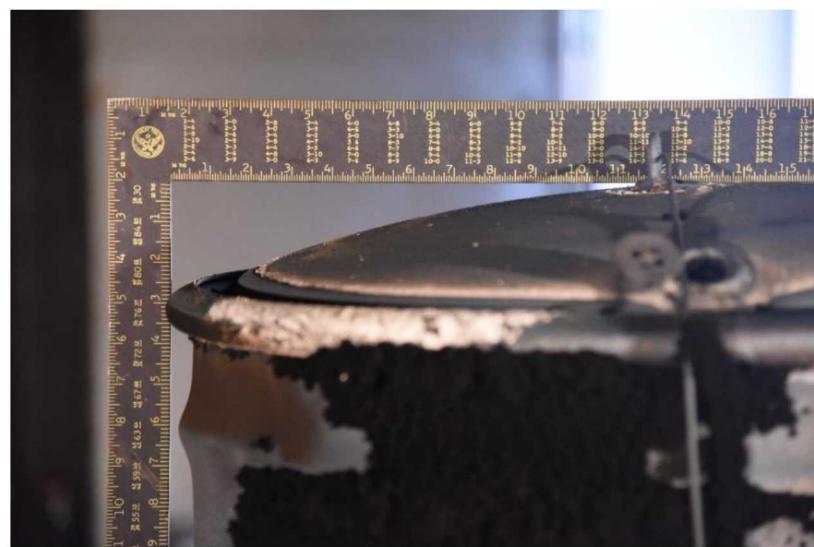
**Figure 21. Bulging of POC drum in Test #1.**

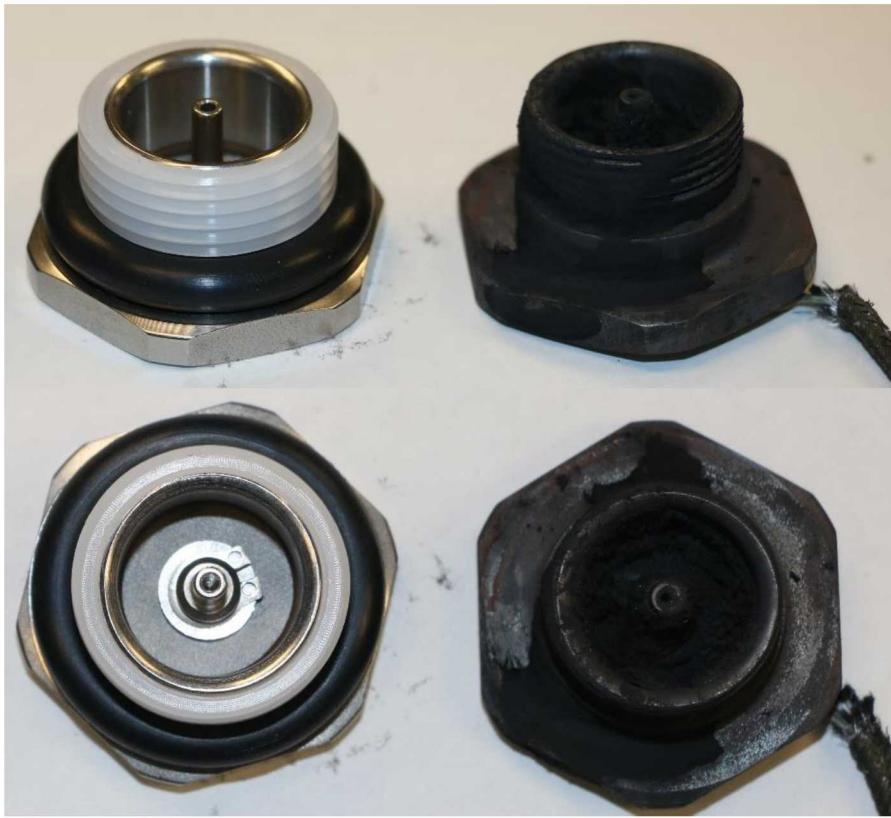
**Figure 22. Comparison of new filter vs tested filter from Test #1.**

tested filter indeed melted during the fire, thus allowing the filter to eject from the POC lid. However, it is noted that the bushing probably finished melting off after the filter ejection.

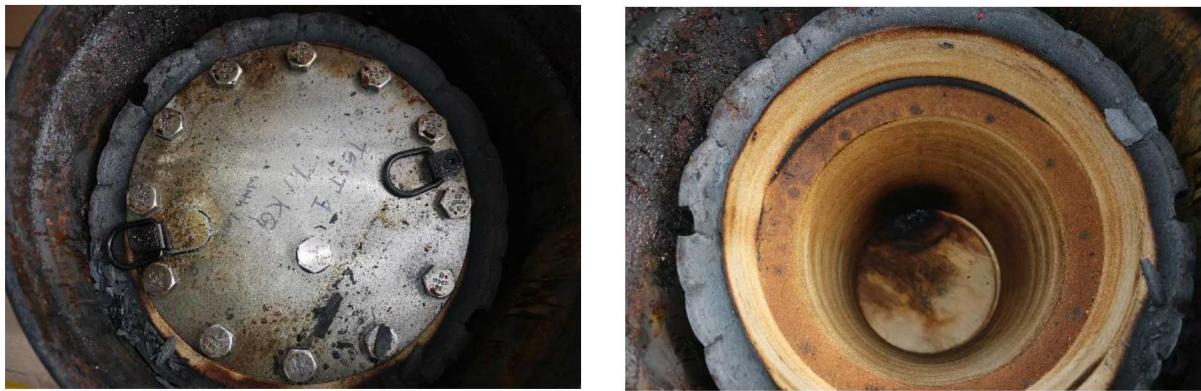
**Figure 23. Internal conditions of POC from Test #1 after test completion when Celotex® top is removed.**

In Figure 23, it can be seen how the internal contents of the POC were affected and how the Celotex® burned about two inches inward in the radial direction. When removing the PC, it is also noticeable how there was additional charring near the pressure port on the Celotex® inside the POC. In the close-up view of Figure 24, the residue on both the Celotex® and the PC near the pressure port are highlighted. This residue was not analyzed but is probably due to a local hot spot resulting as a consequence of the hole created on the Celotex® to install the pressure port. Specifically, the void created for the pressure port could have also created enough space to allow melted polyethylene to rise to these spots, thus leaving this tar-like substance as the melted polyethylene cooled. In addition to the residue on the PC and Celotex, Figure 25 shows how the bag-out-bag also partially melted near this same spot as it reached a temperature of 160 °C near that region, which directly caused the 0.7% mass loss noted in Table 2 for the PC. However, after inspecting other temperature labels within the PC but away from the alleged hotspot, no other label showed such a high temperature was reached. Instead, these other temperature labels located at a similar height (but 180° away from as the hotspot inside the PC) only showed 82 °C as the highest temperature reached. Based on these observations and conjectures from Test #1, it was concluded that insulation should be placed around the pressure port to substitute for the missing Celotex® in subsequent tests. Therefore, insulation was placed in the pressure port voids of Tests #2 and #3.

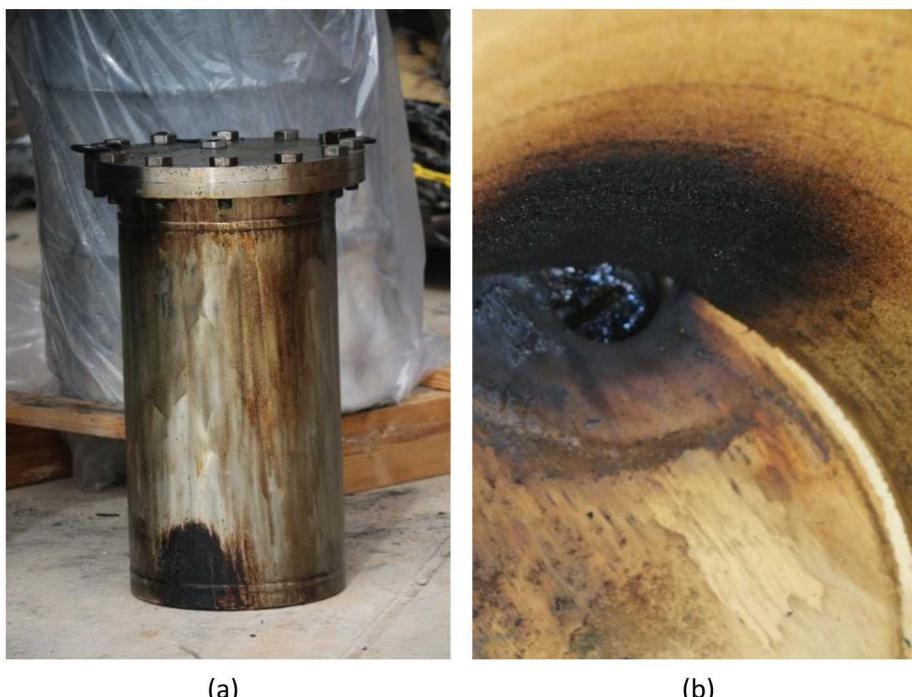
**Figure 24. Residue near the pressure port on (a) the PC and on (b) Celotex®.**

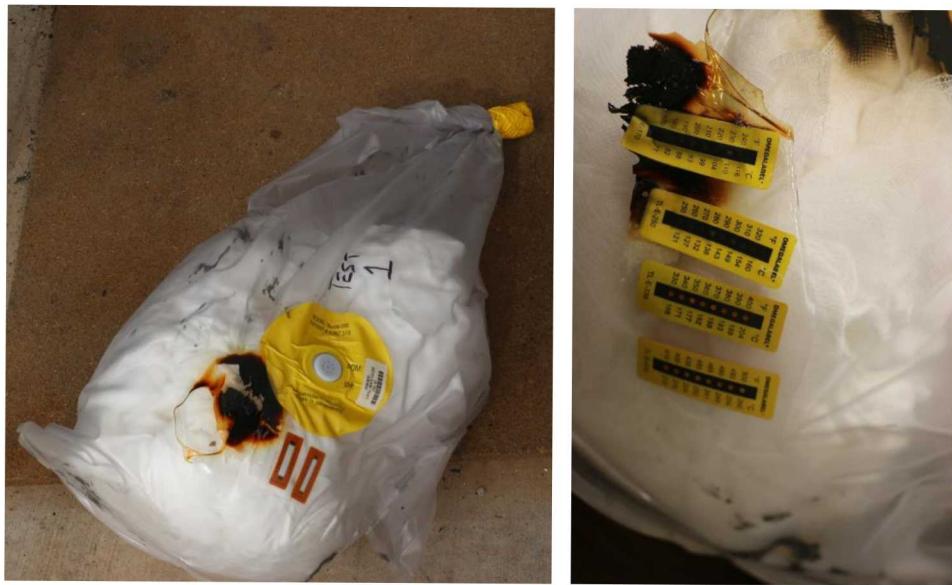
Figure 25. Bag-out-bag after completion of Test #1.

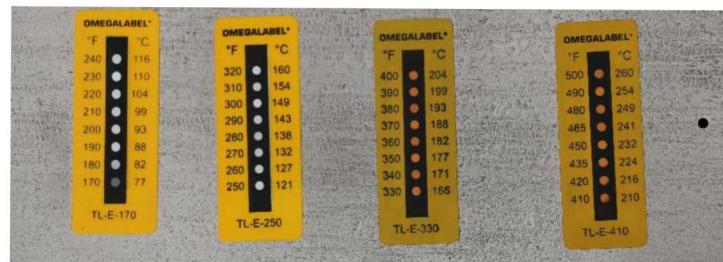
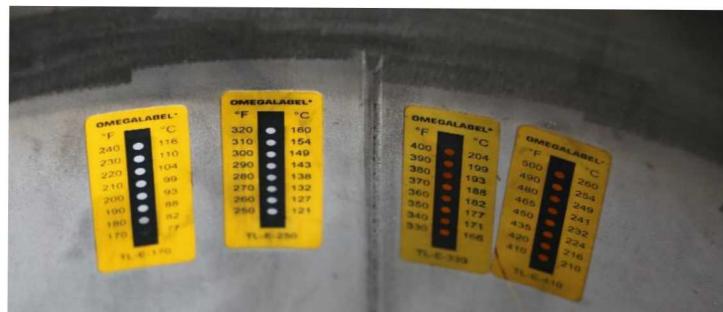
Figure 26. Temperature labels on (a) interior of PC lid and (b) inside the PC along its wall (note that in both images only the bottom dot on the left-most label has changed color, indicating a peak temperature below 82 °C).

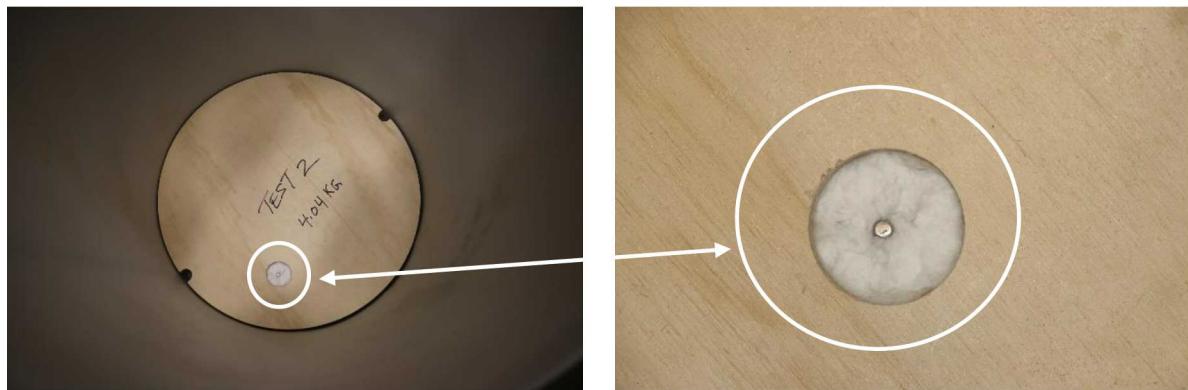
**Figure 27. Pressure port void filled with insulation.**

Tests #2 and #3 had outcomes similar to that of Test #1 with a few differences. As mentioned previously, due to the fact that the fire conditions and configuration were the same for Tests #2 and #3 as in Test #1, the tether shown in Figure 17 was not installed on the POC drum lid for these other two POC tests. Secondly, as shown in Figure 27, the void space around the pressure port was filled with insulation in an effort to mitigate the effects seen in Test #1 near that void space by minimizing the direct heat transfer from the fire to that region of the PC.

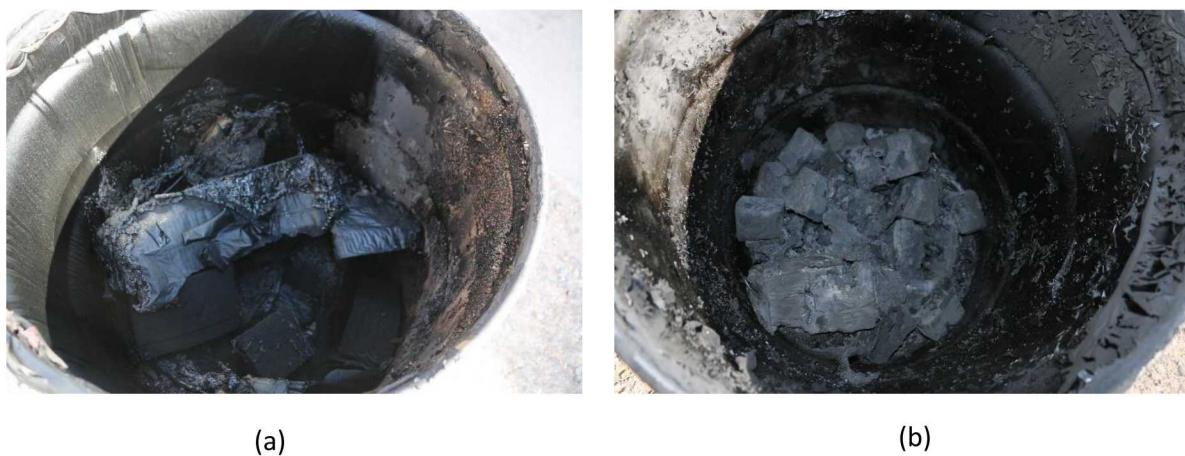
**Figure 28. Remains of 7A drums for Test #4. (a) drum placed at the  $35 \text{ kW/m}^2$  distance, and (b) drum placed in center of pool fire.**

Test #4 did not involve any POCs. Instead, as mentioned in section 3.1 above, the 7A drums were filled with mixed items that comprised approximately 50% cellulose and 50% plastics by volume. However, the same UT9424S filter was used on the drum lids as was used in the POC drum lids. For the 7A drum fully engulfed at the center of the fire, the UT9424S filter ejected from the drum lid early on in the test, which in turn allowed a pressure relief and prevented lid ejection, similar to the POC drums used in Tests #1 - #3. Once the filter was ejected from this drum, pyrolysis gases emitted through the filter orifice resulted in a flame jet above the drum, similar to Tests #1 - #3. The pyrolysis reactions of the internal contents in this drum ended up causing the 27.3% mass loss shown in Table 2. For the drum placed at  $35 \text{ kW/m}^2$ , while the UT9424S filter did eject, no flame jet was observed and negligible mass loss was experienced by this drum. Figure 28 shows how the remains of the two 7A drums in this test varied, where the drum in the center of the pool shows significant degradation when compared to the drum placed outside the pool. In contrast with Tests #1 - #3, no temperature or pressure instrumentation was installed on or in either of the 7A drums.

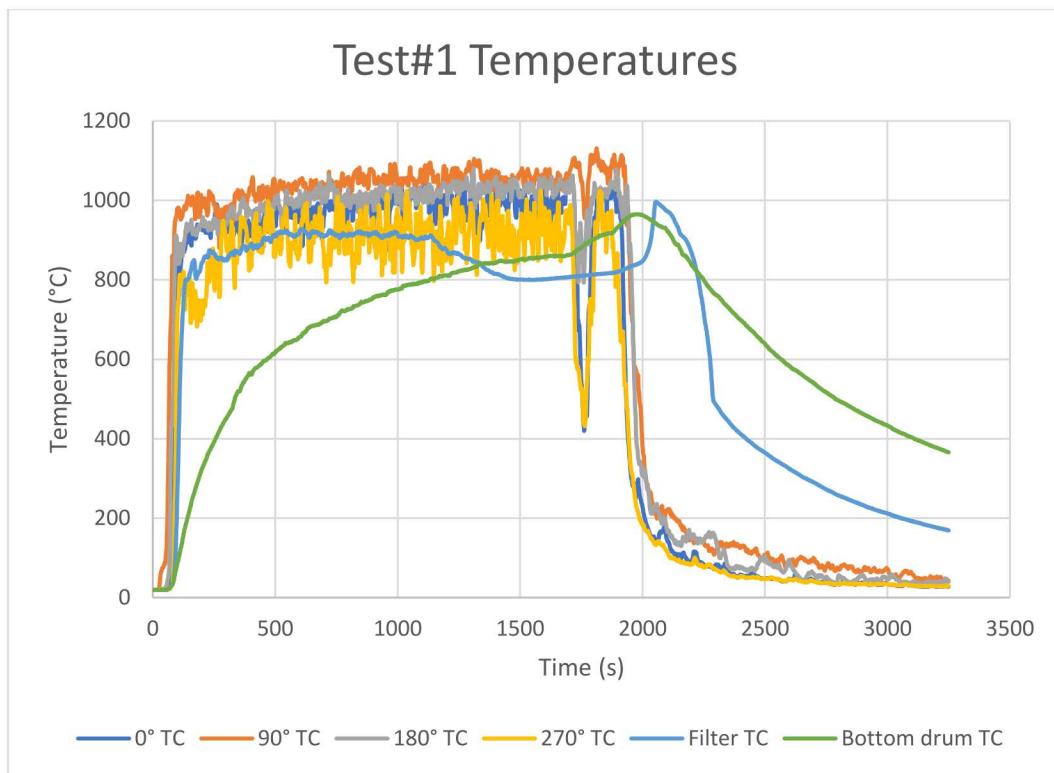
**Figure 29. Test #1 measured temperatures.**

In Figure 29, the temperature evolution of the six main thermocouples used for Test #1 are shown. The four thermocouples with angular labels are the ones on the POC drum wall used to measure the flame temperature around the POC which were described earlier in Figure 15. The other two thermocouples were on the filter and bottom drum lid. According to the thermocouples around the POC drum wall, Figure 29 shows how the flame temperature around the POC had some slight variation from one thermocouple to the other. It is speculated that this is a direct result of two phenomena: (1) The flame's natural tendency to lean towards one side as seen in Figure 18(a), and (2) when the filter popped off, the pyrolysis gases exiting the POC drum created a flame jet that potentially changed the fire dynamics and could have further provided additional localized heat near that region, as was shown in Figure 18(b). Nonetheless, the four thermocouples showed comparable temperatures around the POC lid, and they all reached the fully engulfed zoned (marked by a temperature of 800 °C) within 90 seconds of ignition. The thermocouple on the filter reached its peak temperature after the end of the fire when the jet of pyrolysis gases has more oxygen available to sustain combustion and the region of combustion lowers to near the drum lid surface. For the bottom drum, Figure 29 shows how it experienced a slower response time with lower temperatures and smoother profile. The slower response time and cooler temperatures are a result of the vapor dome described in section 2.2. This temperature response on the lower drum directly supports the argument that the top drum is within the hottest region of the pool fire and is therefore in a more conservative location for the test. Even for this cooler drum, the temperature at the filter location rises above the melting temperature of the plastic filter bushing within about 100 seconds from the time the fire becomes fully engulfing. This indicates that this drum filter will also be ejected well before there is sufficient build-up of pressure within a bottom drum to eject its lid.

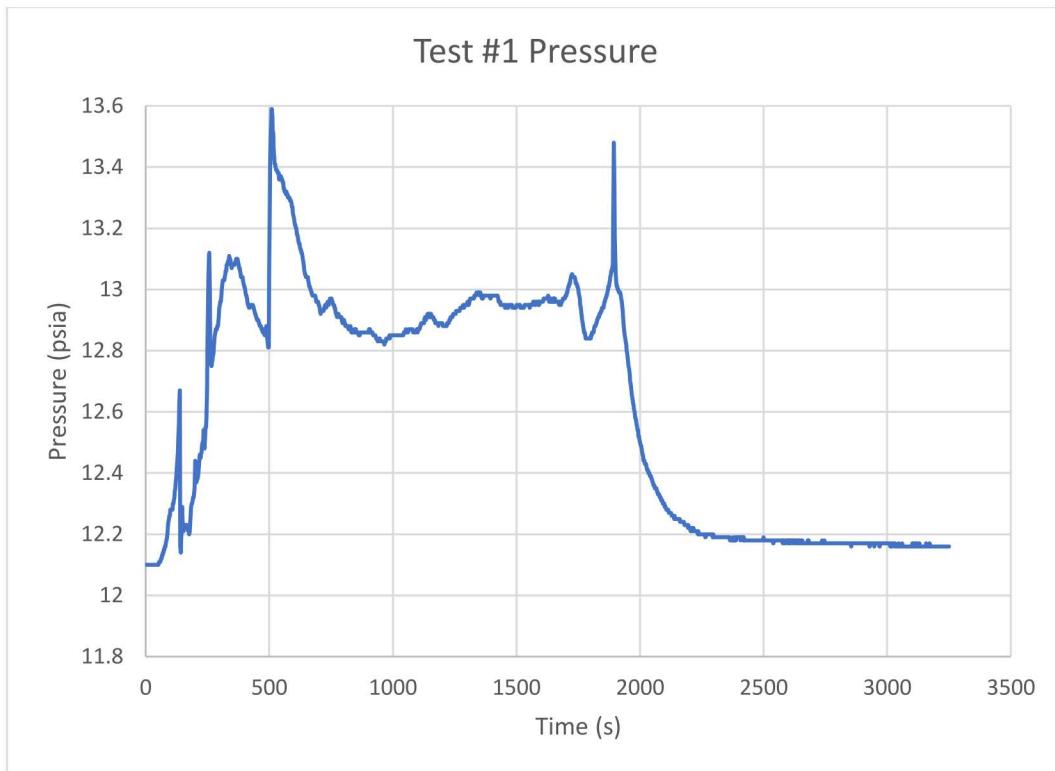
**Figure 30. Test #1 measured POC pressure.**

The pressure measured inside the drum with the pressure port instrumentation for this test is shown in Figure 30. From this plot, it is not easy to distinguish exactly what is occurring based on the pressure profile alone. However, it is noticeable that, early on in the test a little after 2 minutes from ignition, the drum lost pressure due to the ejection of the POC filter. It is speculated that the system subsequently continues to build pressure as the polyethylene liner thermally decomposes. The pressure drop starting near 250 seconds is attributed to the transition of polyethylene pyrolysis gases to Celotex® pyrolysis gases being generated as the fire heated the POC from the outside in. Lastly, it is also speculated that other random peaks throughout the pressure profile could have resulted from the pressure port having become temporarily obstructed for brief periods of time throughout the burn.
