# **SANDIA REPORT**

SAND2018-6570

# **Pipe Overpack Container Fire Testing: Phase II-A**

## **Abstract**

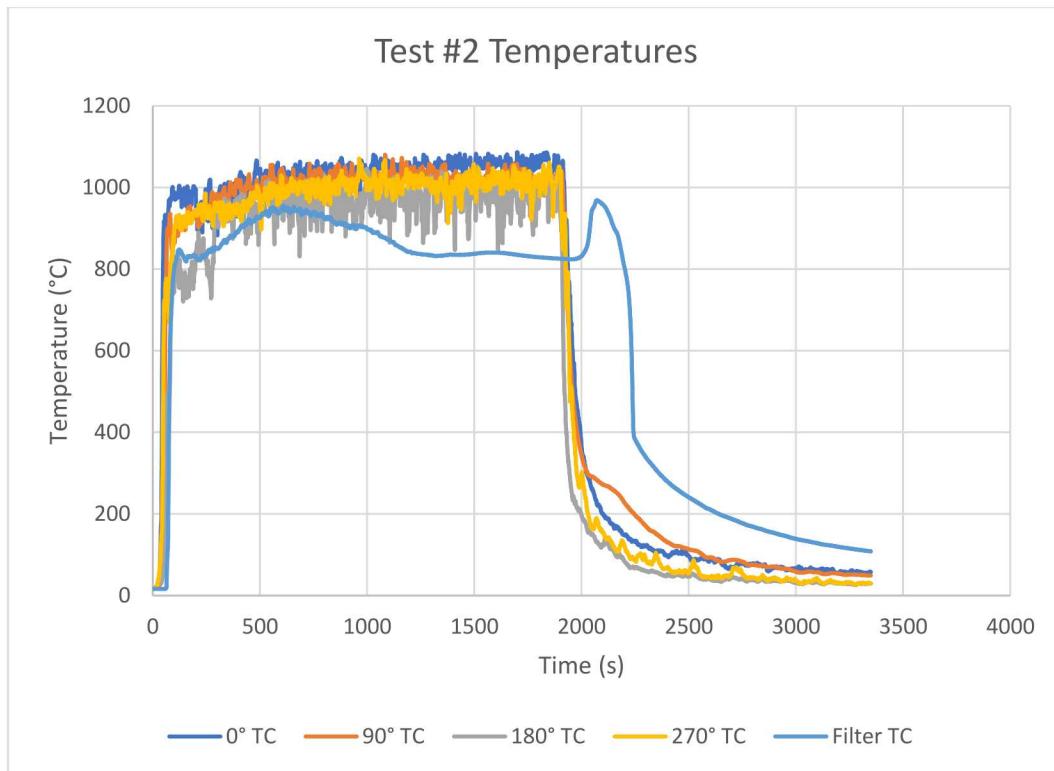
**Figure 31. Test #2 measured temperatures.**

The instrumentation for Test #2 was very similar to Test #1. In Test #2, the only difference was that the temperature of the bottom drum was not measured. The temperature results for Test #2 were very comparable to those of Test #1, and Figure 31 shows how similar patterns were observed throughout the test. Specifically, all four thermocouples around the POC reached the fully engulfed 800 °C temperature within 90 seconds and sustained temperatures above that for the 30-minute duration of the fire. The slight variations from one thermocouple to another were also observed in Test #2 as was observed in Test #1 as caused by the leaning of the fire.

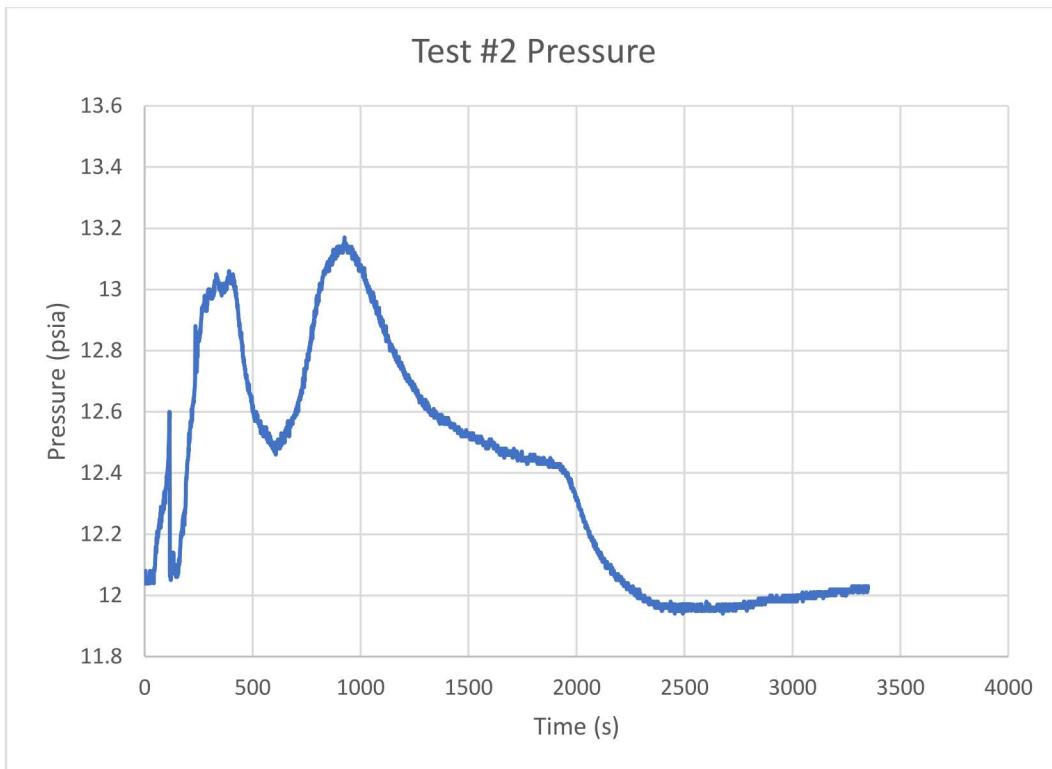
**Figure 32. Test #2 measured POC pressure.**

In Figure 32, the pressure profile observed in the POC drum of Test #2 is shown. This profile has some variations when compared to that of Test #1. The overall differences are attributed to the pressure port temporarily being obstructed for brief periods throughout the burn resulting in random pressure buildups. However, the first pressure-drop observed at the beginning of the burn occurs in both tests at similar times (within two minutes from the beginning of the test). For both tests, even though the profile for Test #1 indicates that it saw slightly higher pressures, the pressure stayed relatively low (below 14 psia) throughout the entire period of both tests. Considering that the atmospheric pressure at the test location is approximately 12.2 psi, the pressure results indicate that neither drum ever experienced more than 2 psi of pressure buildup. Lastly, both pressure profiles also show a significant decline in pressure right after the 30-minute marker for the end of the test, as would be expected due to the fuel being recessed from the pool.

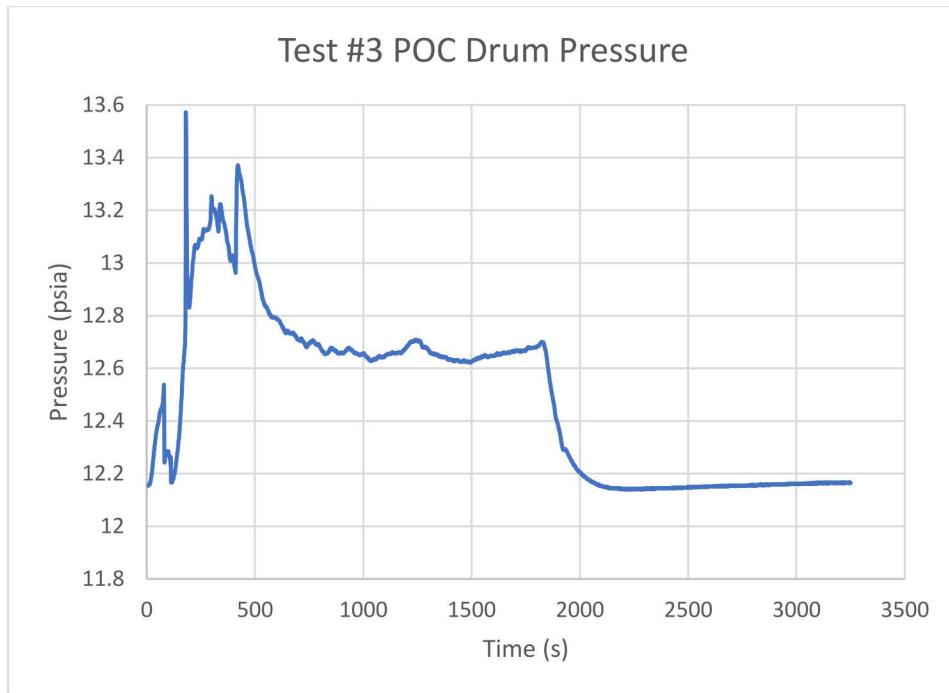
**Figure 33. Test #3 POC drum pressure measured using data loggers.**

For Test #3, there were no temperature measurements, and no pressure measurements were performed using the pressure port either. Instead, pressure measurements were taken inside the drum and inside the PC using remote data loggers as described in section 3.4. The results for the measured pressures are shown in Figure 33 and Figure 34 for pressure inside the drum and inside the PC, respectively. As seen in the measurements from Tests #1 and #2 when using the pressure port on the drum, the first drop in pressure occurred within the first 2 minutes for the drum in Test #3 (at approximately 80 seconds). Furthermore, it was observed that, for Tests #1, #2, and #3, the drum pressure reached at the point just before this first pressure drop is about  $12.6 \pm 0.1$  psia. This agreement throughout the three different tests, combined with the observations in the videos corresponding to the tests, reaffirms that this first sudden drop in pressure is in fact attributed to the UT9424S drum lid filter ejecting. As discussed for Test #1, the subsequent peak occurring near 180 seconds is speculated to be a result of the production of polyethylene pyrolysis gases followed by a transition to Celotex® pyrolysis gases. In Figure 33, around 500 seconds into the test, it is seen how the pressure stabilized as the pyrolysis gases were suspected to be produced mainly from the Celotex® inside the drum. The last pressure drop observed, just before 2000 seconds, results from the pool fire being extinguished at the 30-minute mark. For the pressure observed inside the PC, Figure 34 shows how, in general, it exhibited similar behavior to that shown for the POC drum in Figure 33. The PC pressure profile, however, is much smoother. This smoother profile observed inside the PC was attributed to the fact that many of the random pressure

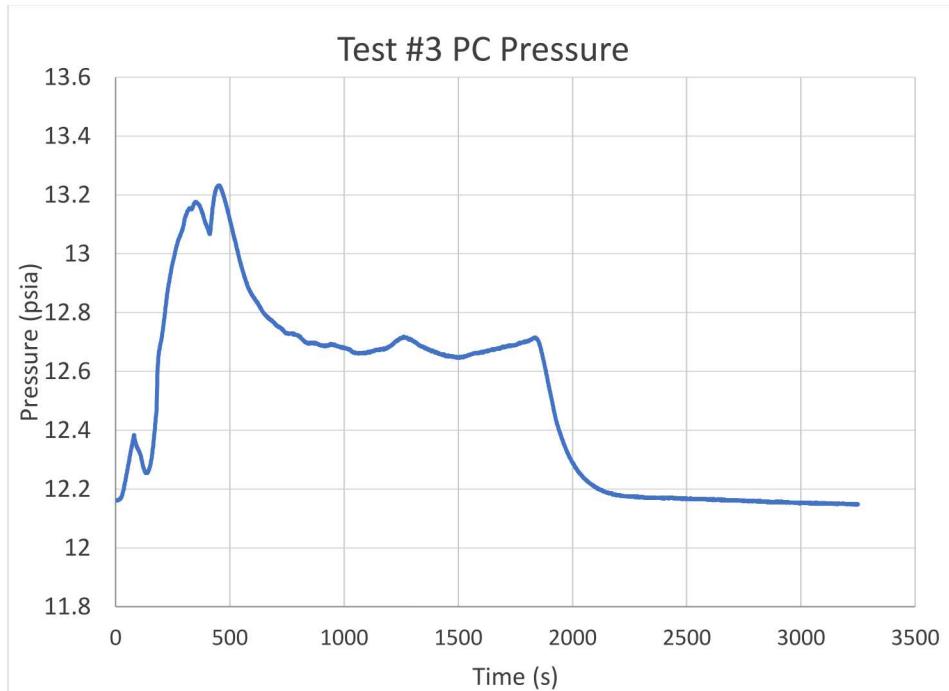
**Figure 34. Test #3 PC pressure measured using data loggers.**

fluctuations experienced by the drum were attenuated by the PC. For Test #4, as mentioned in sections 3.4 and 3.5, temperature and pressure data were not recorded.
