“Ion” b-dot results located inside the cathode knob of the self magnetic pinch (SMP) diode

Michael G. Mazarakis, Michael E. Cuneo,
Mark L. Kiefer, Joshua J. Leckbee,
Dan S. Nielsen, and Derek Ziska

Radiographic Integrated Test Stand: RITS-6

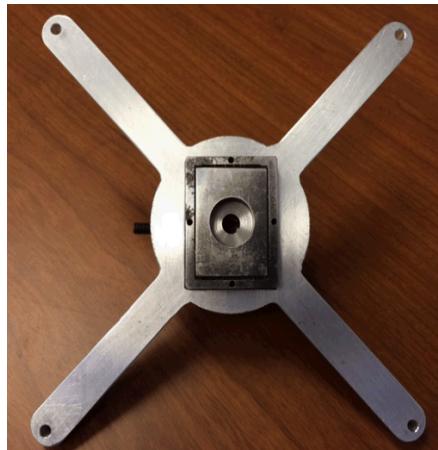
Faraday cup back

Faraday cup front
