# Damage Evolution in 304L Stainless Steel Partial Penetration Laser Welds

*Sharlotte Kramer, Amanda Jones,  
John Emery, Kyle Karlson, and Jay Foulk*  
SEM Annual Conference  
13 June 2017

# Fundamental understanding of **damage evolution of laser welds** is crucial to predicting their behavior.

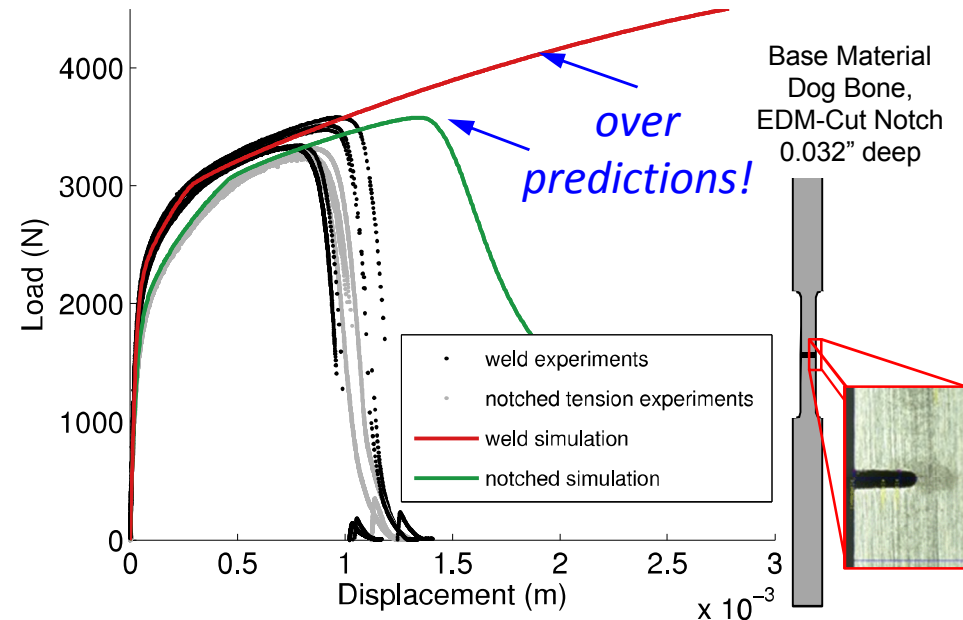
**notched & welded** specimen predictions  
(rate and temperature dependent)

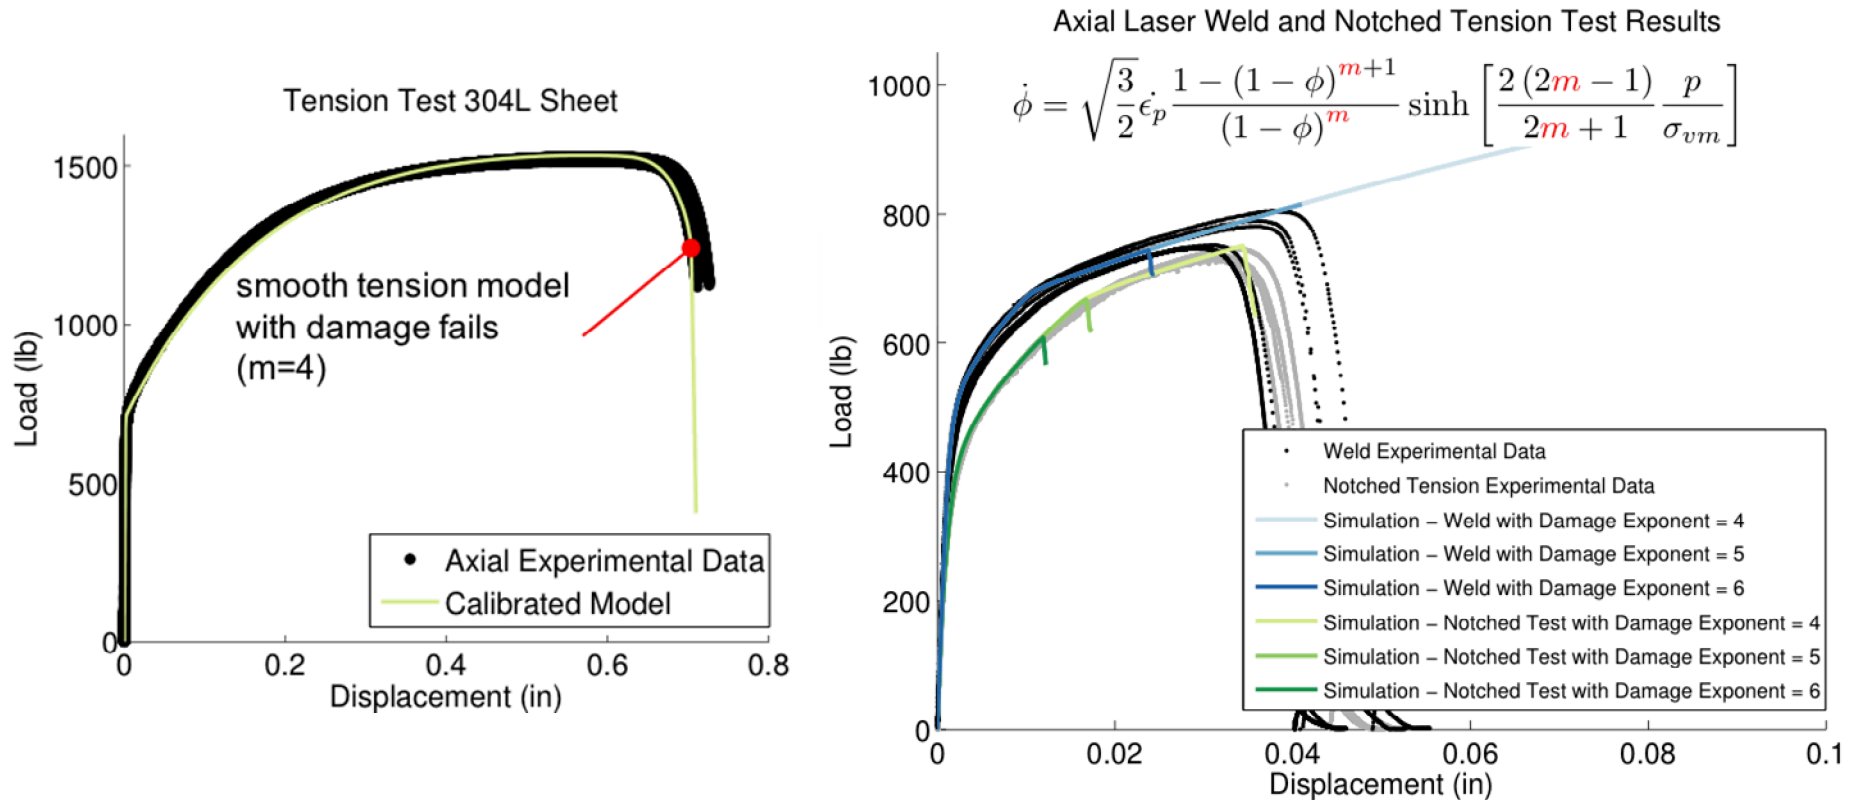
**Inclusion of a damage model improves the prediction of the EDM-notched and laser-welded tensile behavior, but experimental evidence is needed to know how the damage evolves to develop the appropriate computational model.**
