# Mechanical Property Variation in Metal Lattice Structures

Amber Dressler, Dr. Carolyn Seepersad  
Department of Mechanical Engineering  
The University of Texas at Austin

Improve the understanding of how defects impact mechanical properties to enhance designers' ability to manufacture metal lattice structures reliably.

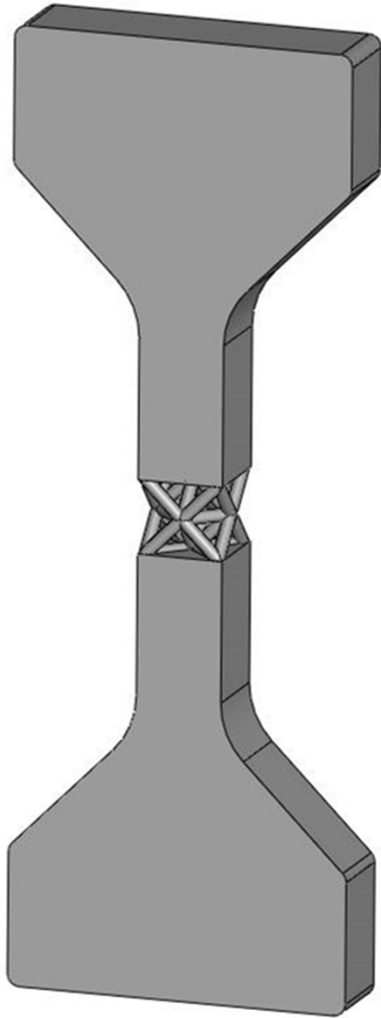
# Single Unit Cell Builds

- Individual strut behavior is difficult to analyze in the full lattice structure
- Data depicting how defects impact these small features is important in understanding lattice behavior
- Concerned about struts bending due to limited boundary conditions

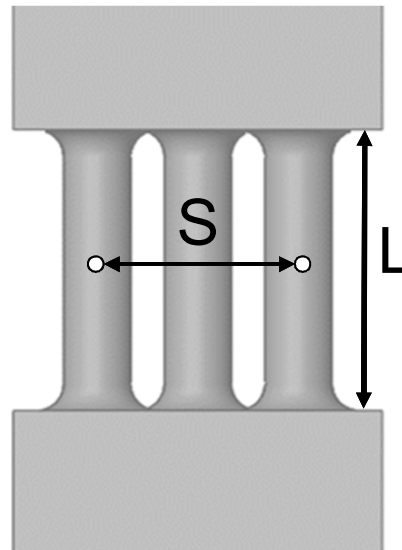
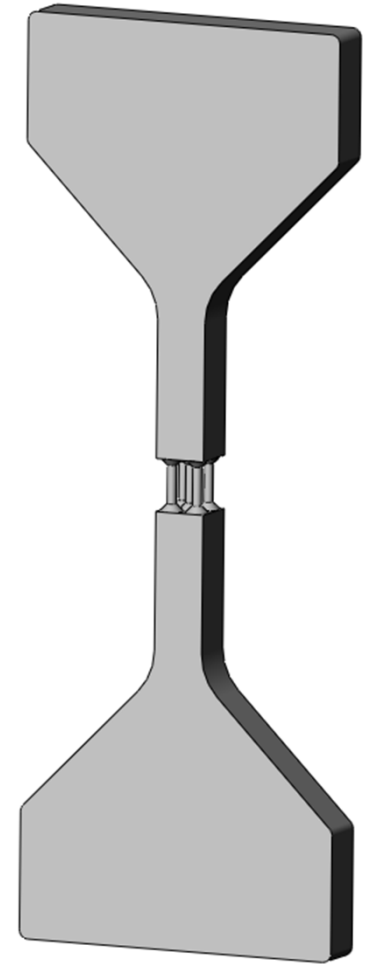
# Vertical Strut Builds

- Spacing based on the octet truss design
- Horizontal and vertical copies
- Three different sizes (representing 3, 4, and 5 mm unit cells)

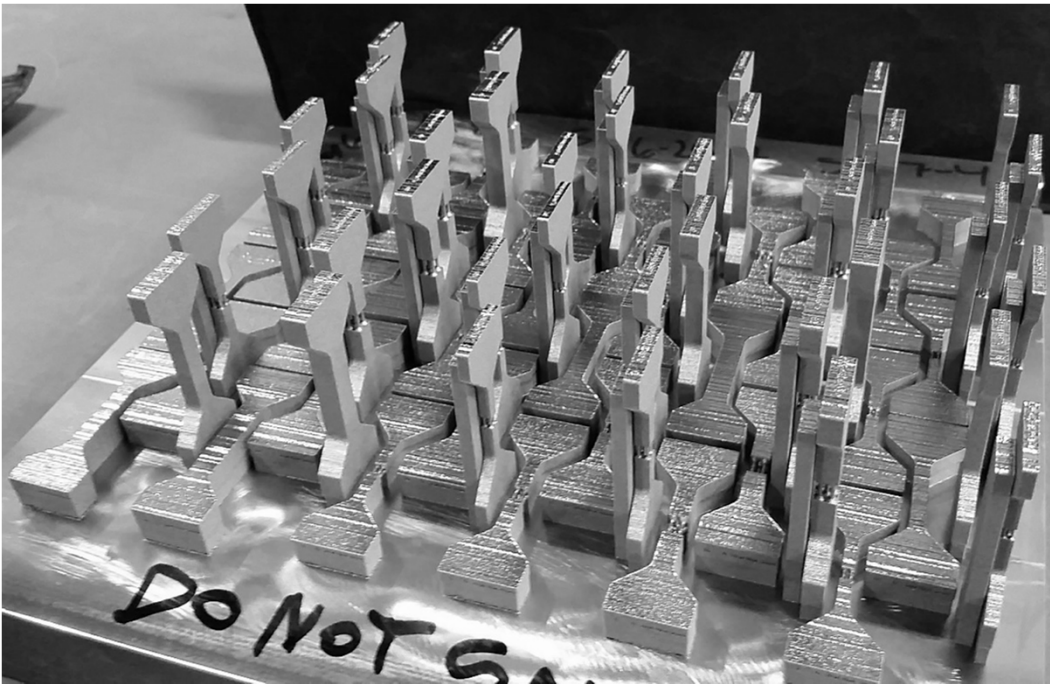
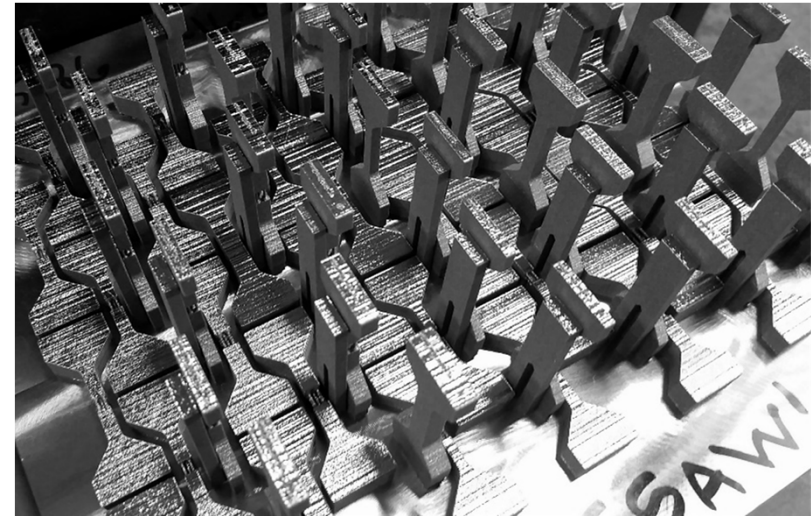
# Rebuild Results

Unfortunately, horizontal bars were broken during removal from the build platform.

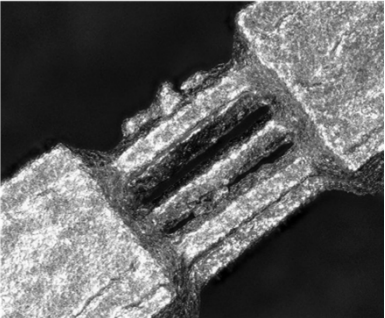
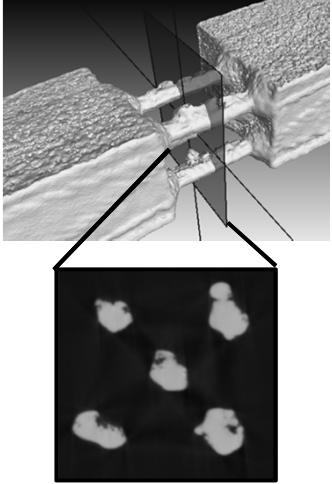
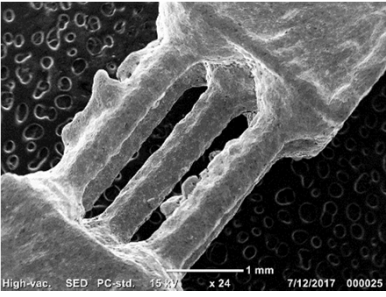
Visual Inspection	Microscope	CT Scan	SEM
3 mm Horizontal Bar

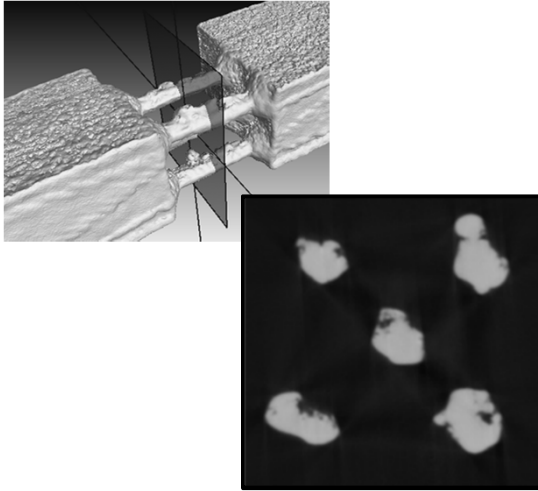
<p>This panel shows a 3D model of a horizontal bar with three 3 mm diameter bars. The CT slice below shows four bright spots in a square arrangement, indicating the presence of the bars.</p>

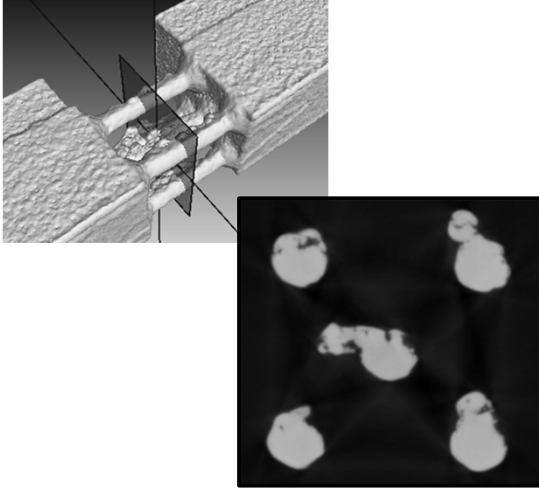
<p>This panel shows a 3D model of a horizontal bar with four 4 mm diameter bars. The CT slice below shows four bright spots in a square arrangement, indicating the presence of the bars.</p>

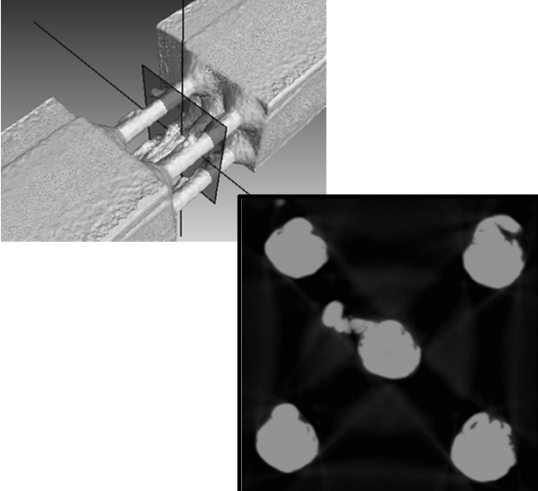
<p>This panel shows a 3D model of a horizontal bar with five 5 mm diameter bars. The CT slice below shows four bright spots in a square arrangement, indicating the presence of the bars.</p>
Vertical Bar

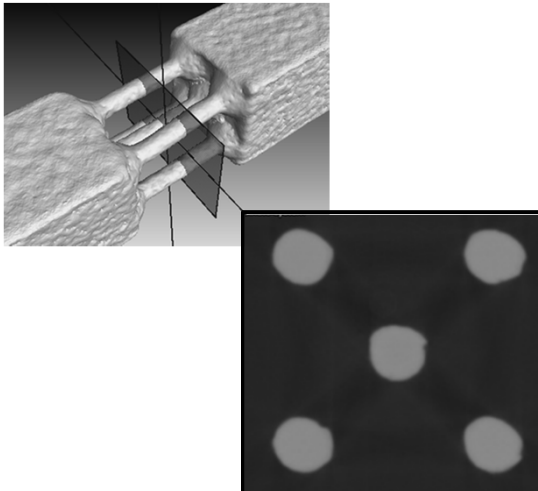
<p>This panel shows a 3D model of a vertical bar with three 3 mm diameter bars. The CT slice below shows four bright spots in a square arrangement, indicating the presence of the bars.</p>

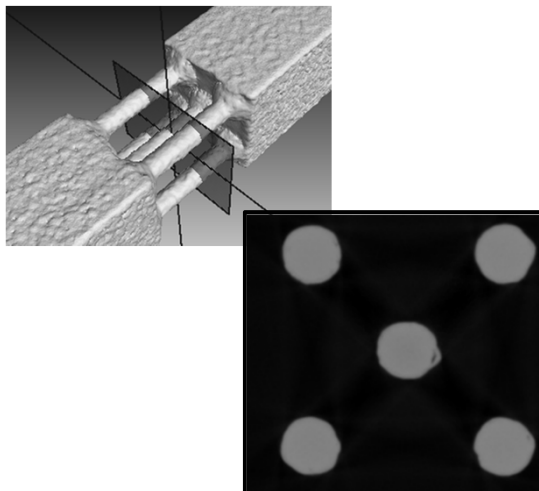
<p>This panel shows a 3D model of a vertical bar with four 4 mm diameter bars. The CT slice below shows four bright spots in a square arrangement, indicating the presence of the bars.</p>

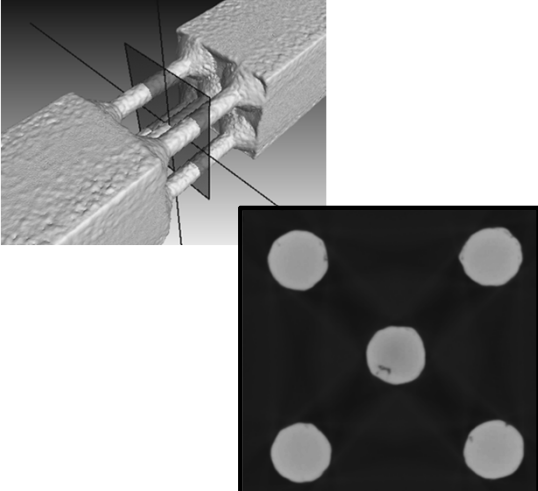
<p>This panel shows a 3D model of a vertical bar with five 5 mm diameter bars. The CT slice below shows four bright spots in a square arrangement, indicating the presence of the bars.</p>

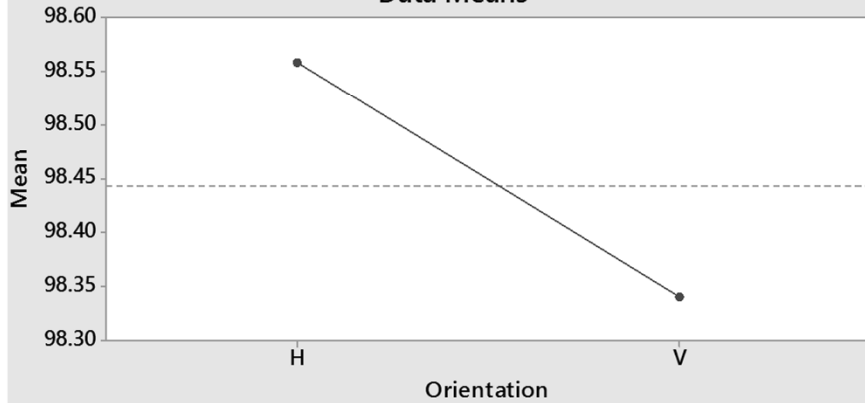
Main Effects Plot for Percent Dense  
Data Means
