## Critical Defect Signatures and Impacts on Material Performance for Metal Laser Powder Bed Fusion

Bradley Jared, Brad Boyce, Jon Madison, Jake Ostien, Jeff Rodelas, Brad Salzbrenner, Laura Swiler, Olivia Underwood, David Saiz, Kevin Webb

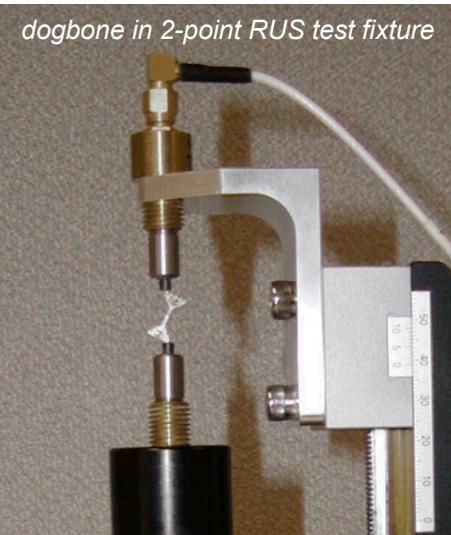
dogbone in 2-point RUS test fixture

- Archimedes density
- Resonant Ultrasound Spectroscopy
  - swept sine wave input from 2-point transducer (74.2 kHz - 1.6 MHz)
  - 19 resonance peaks
- Surface finish
- No significant trends observed

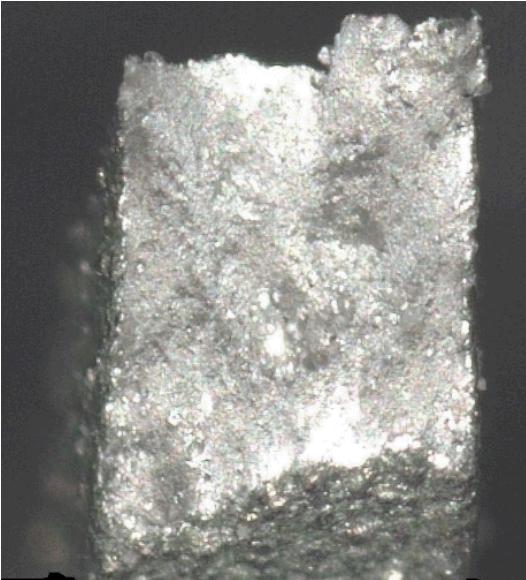
B2, fracture surface optical image by structured light scanning

- Defect dominated failure observed
- Increasing data fidelity & integration
  - overlay fracture surface w/porosity map using DREAM.3D
  - roughness inhibits registration accuracy
  - fracture surface may correlate to large pore
