Surrogate Spent Nuclear Fuel International Multi-Modal Transportation Test

Joint Tour of Transportation Technology Center, Inc. (TTCI) – Pueblo, Colorado

August 24, 2017

Sylvia J. Saltzstein*, Ken Sorenson*, Paul McConnell*, Steve Ross**

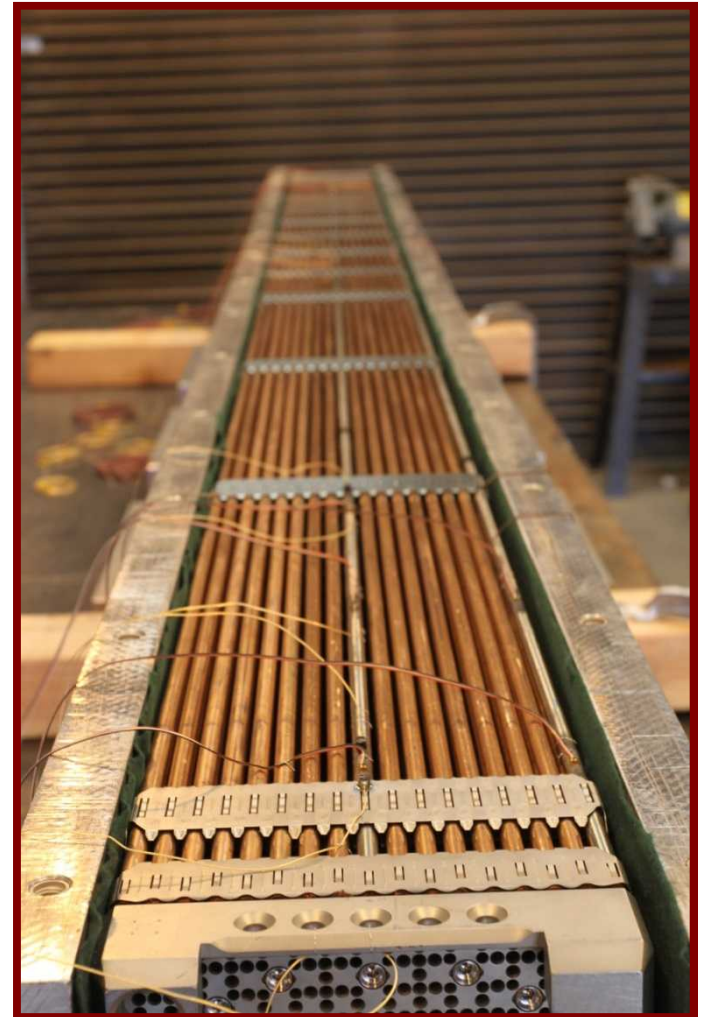
Getting Data Directly from the Fuel Rods.

A surrogate PWR assembly was assembled and instrumented at Sandia to measure strain and accelerations during Normal Conditions of Transport.

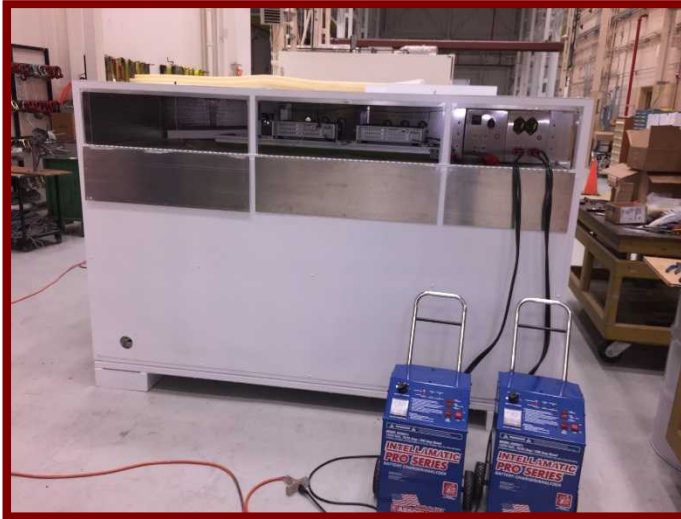
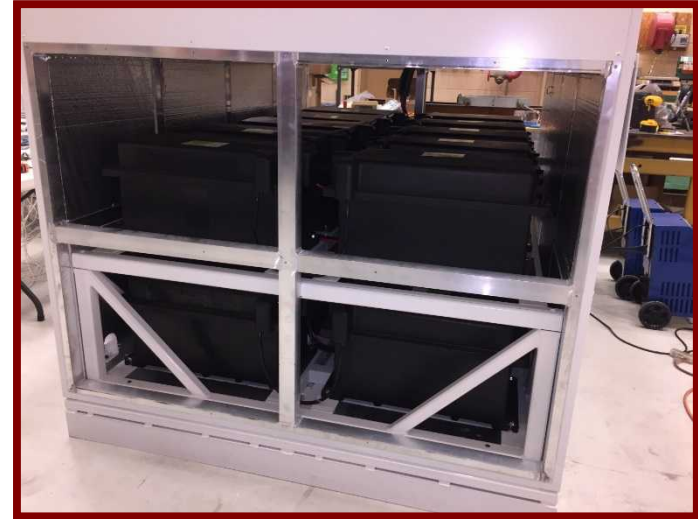
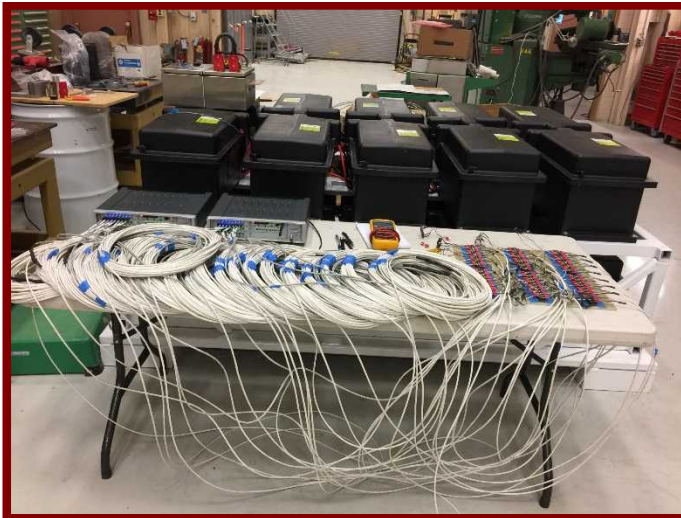
Instrumentation/Battery Box

Two 40-channel data acquisition systems, 20 batteries, 6160 feet (1.17 miles) of cable

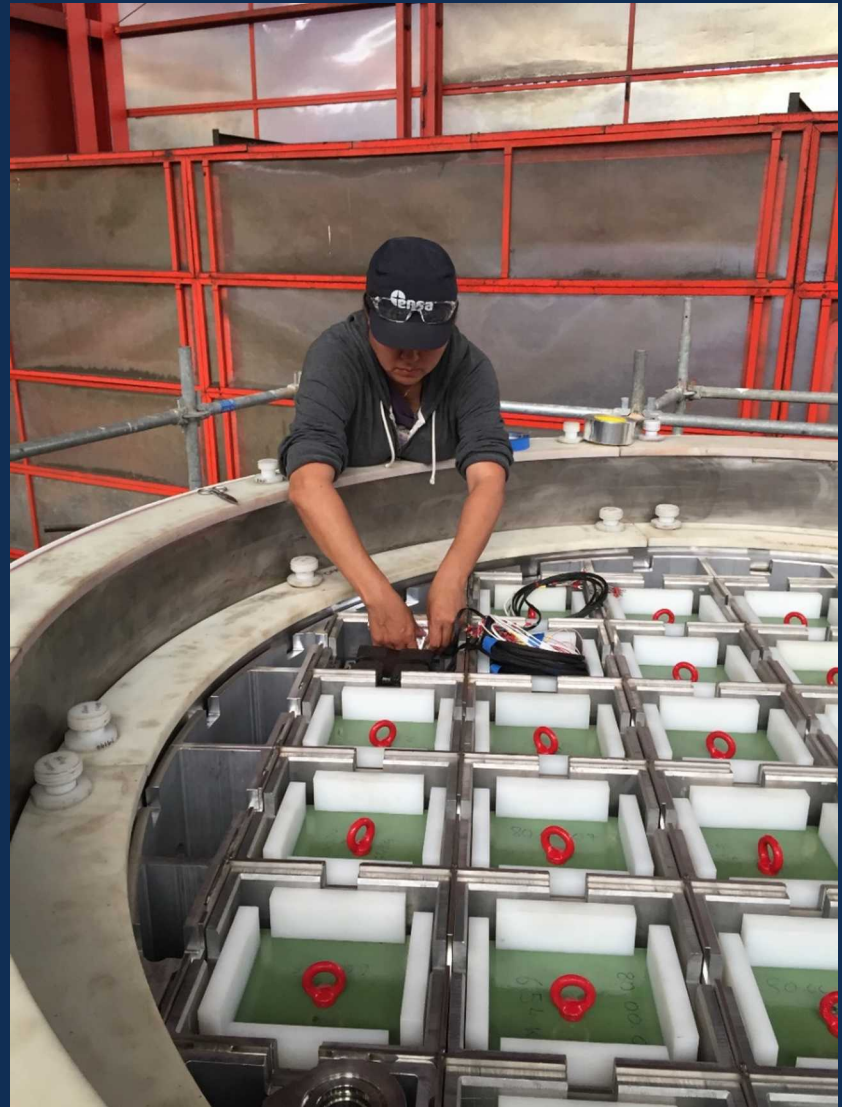
The ENUN 32P holds 32 assemblies. We loaded it with three surrogate assemblies and 29 concrete masses. Carissa is adding the accelerometers to the baskets.

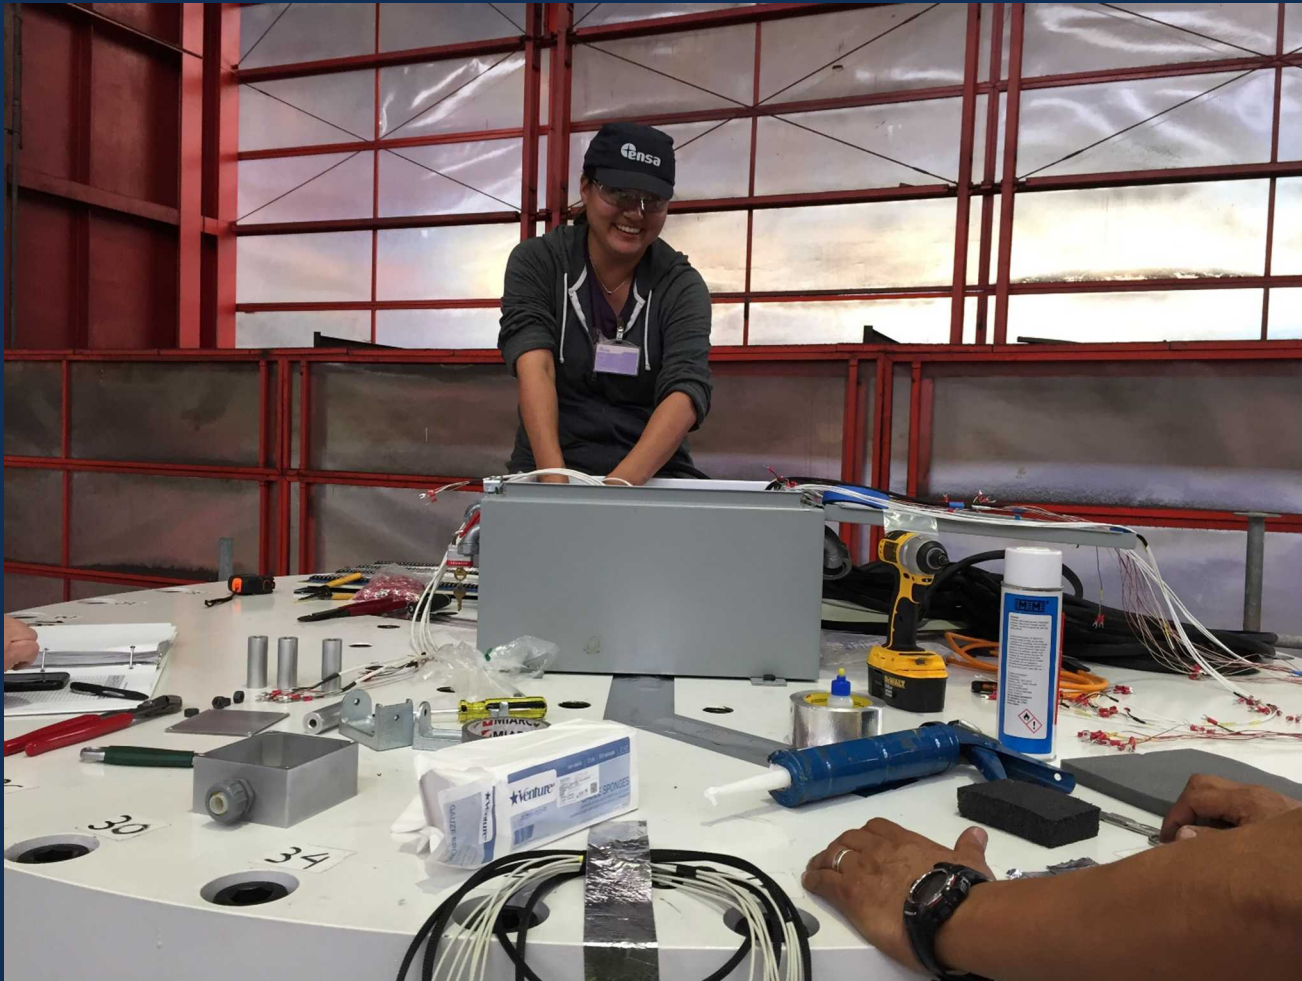
*All instrumentation leads connect into this box.
It is very precise work.*

The instrumentation box (the Hoffman Box) is the nexus for all the instrumentation leads and is mounted to the side of the cask.

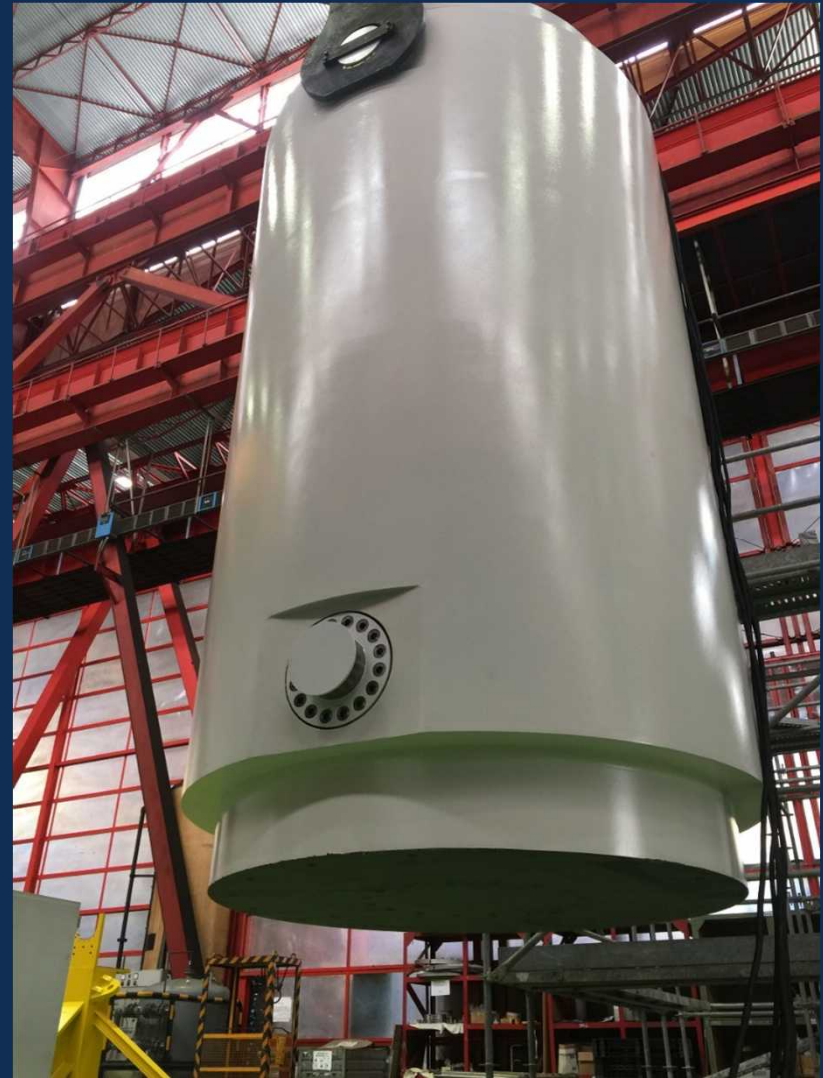
The cask was then placed on the cradle.

You can see one of the two cask accelerometers on the left side of the cask.

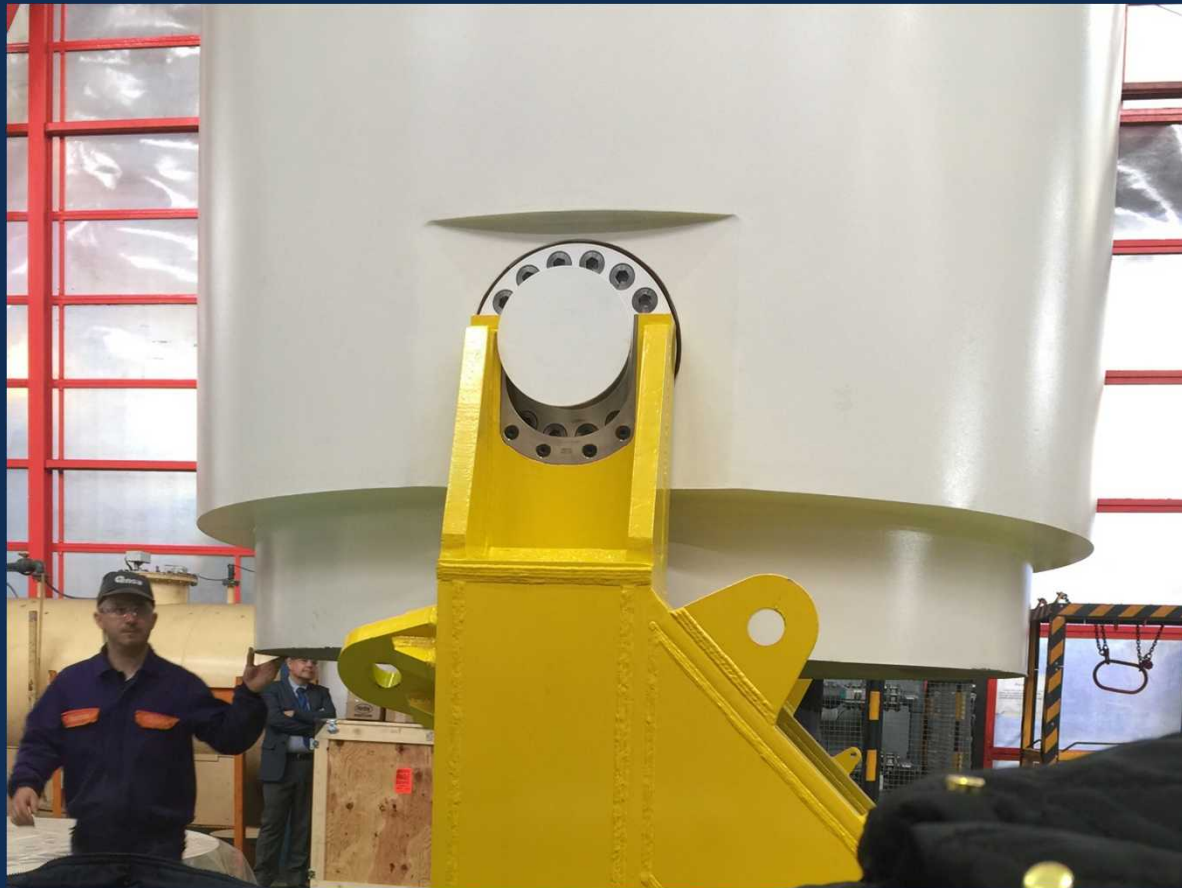
*The trunnion was centered carefully in the cradle.
Data was collected during this entire placement.*

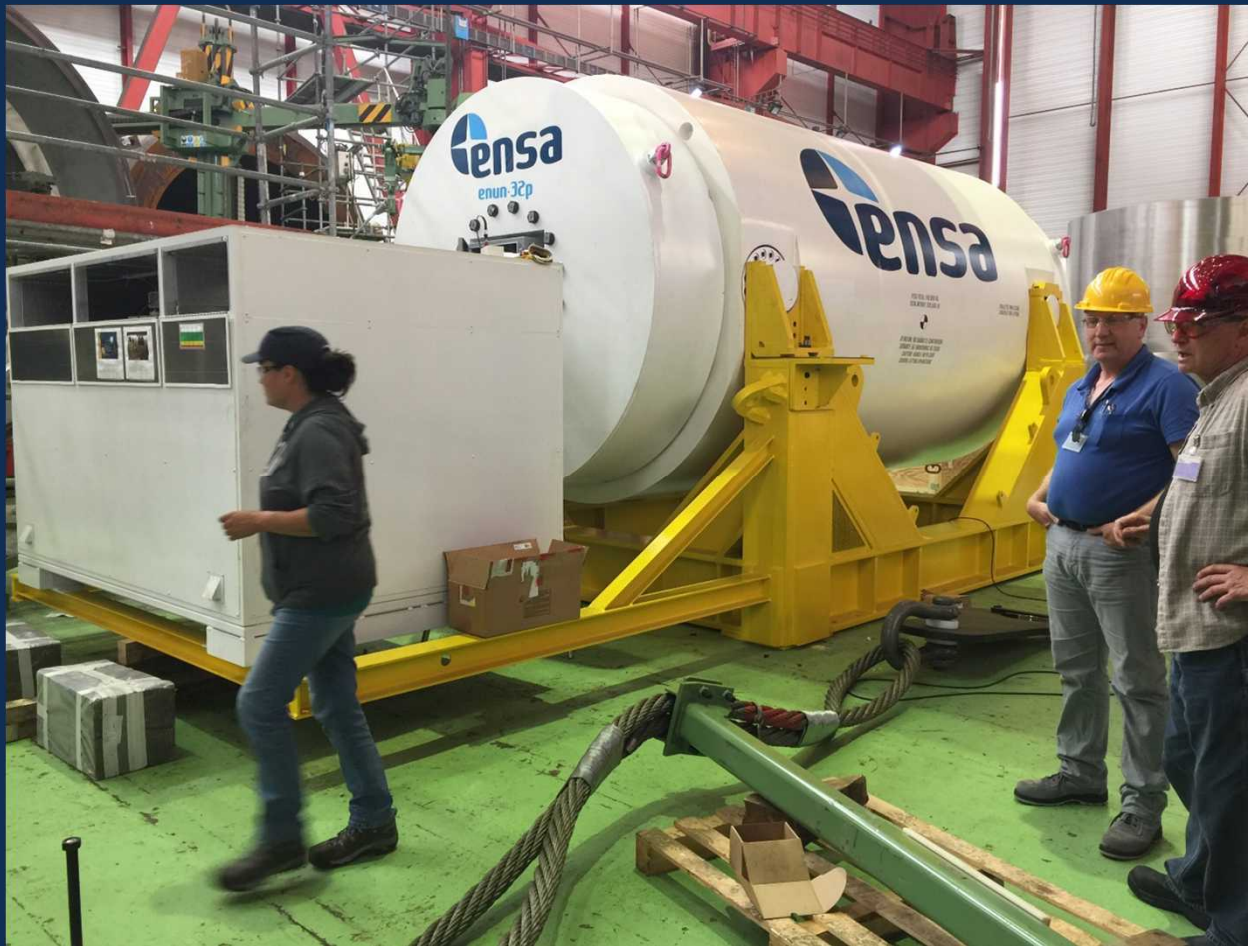
The short cables are now attached to the data acquisition box. Cables are run through waterproof conduit called "Liquid-tight."

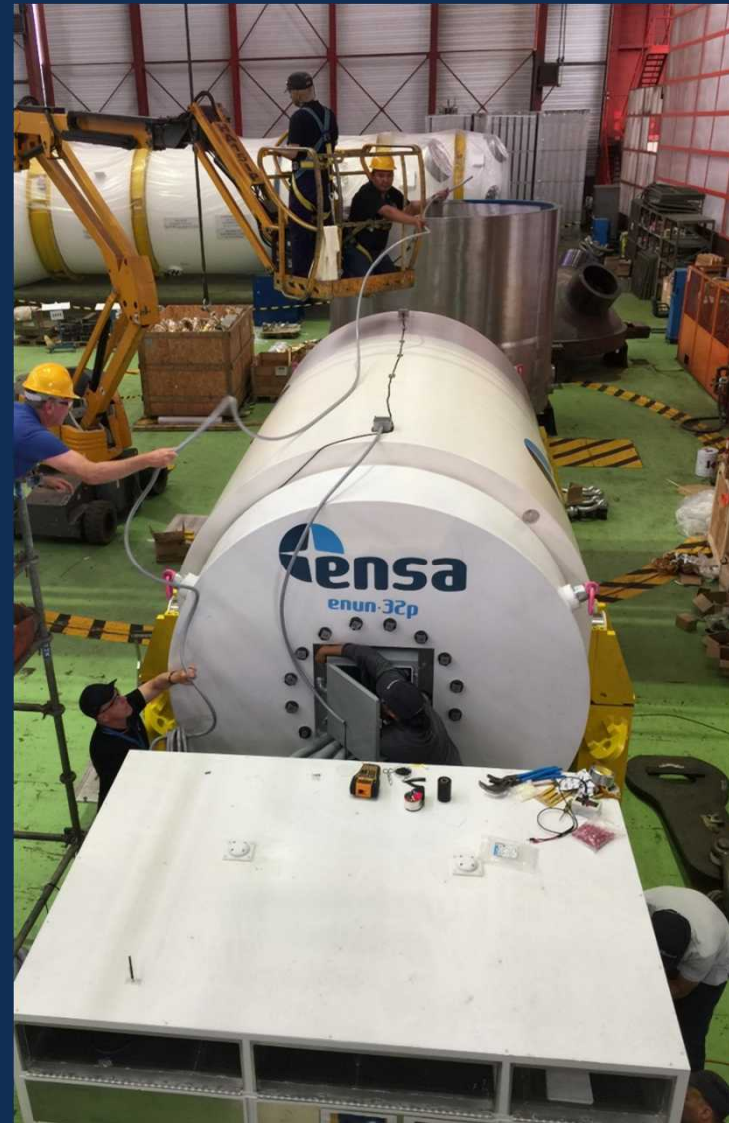
*Cask
accelerometers
cables are
connected to
the Hoffman
Box.*

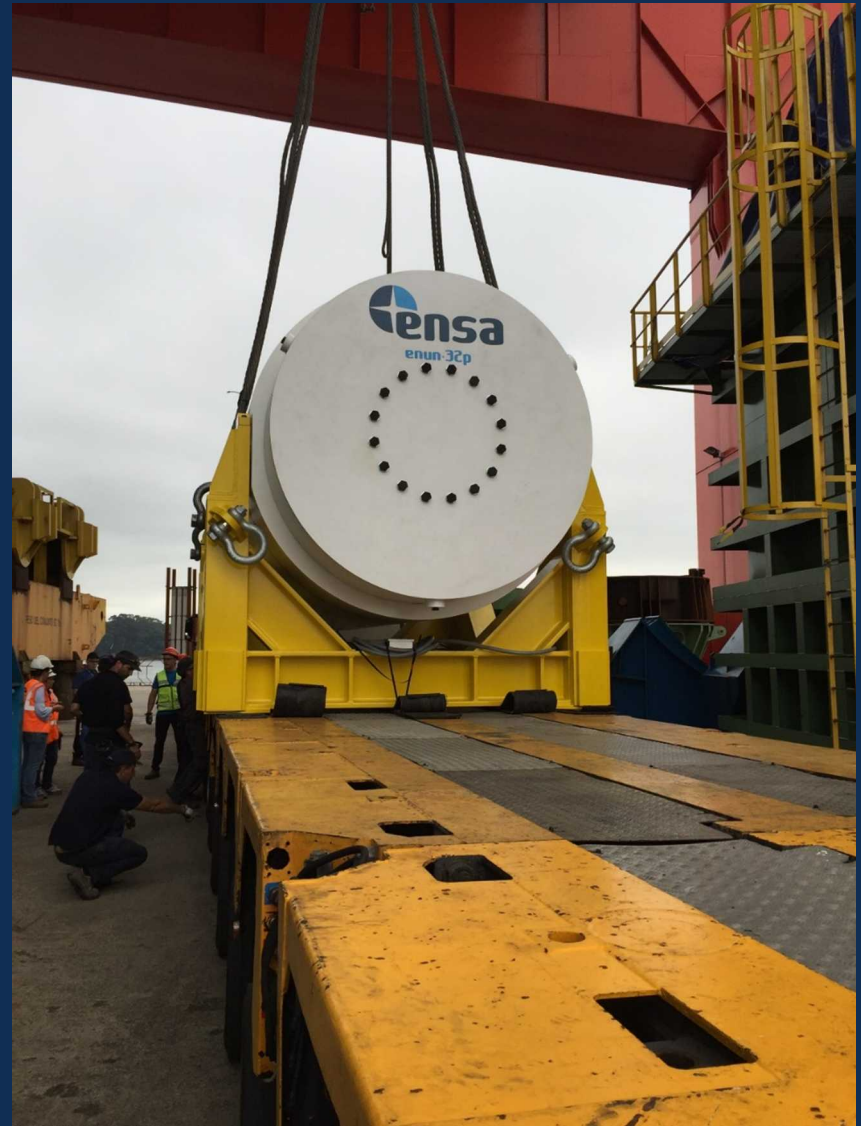
Loading on the 16-axle, 110 foot-long truck. The truck had 3 sets of tri-axial accelerometers on the bed.

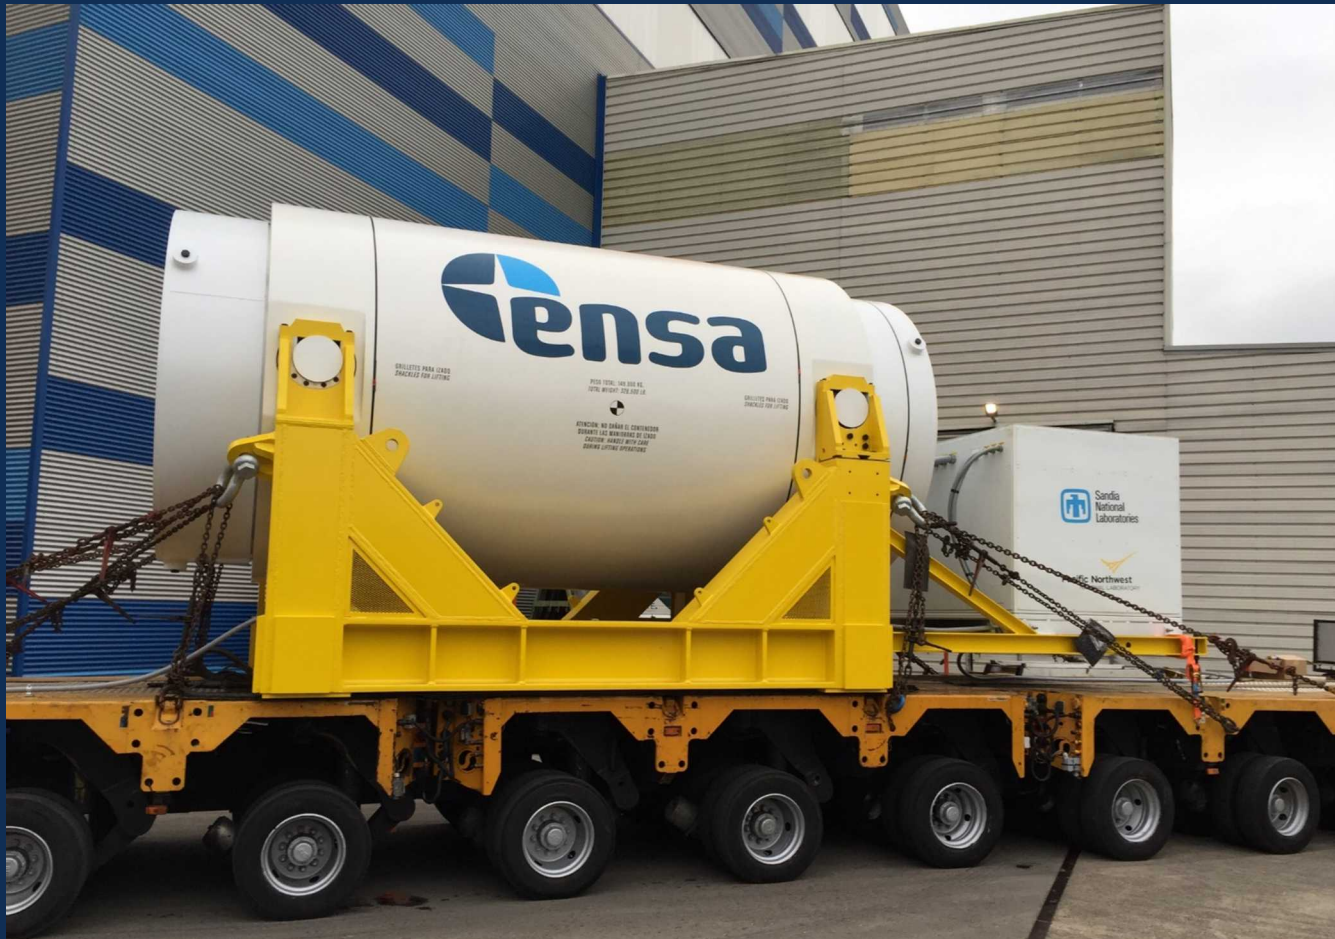
The cradle is chained to the truck bed at 12 places.

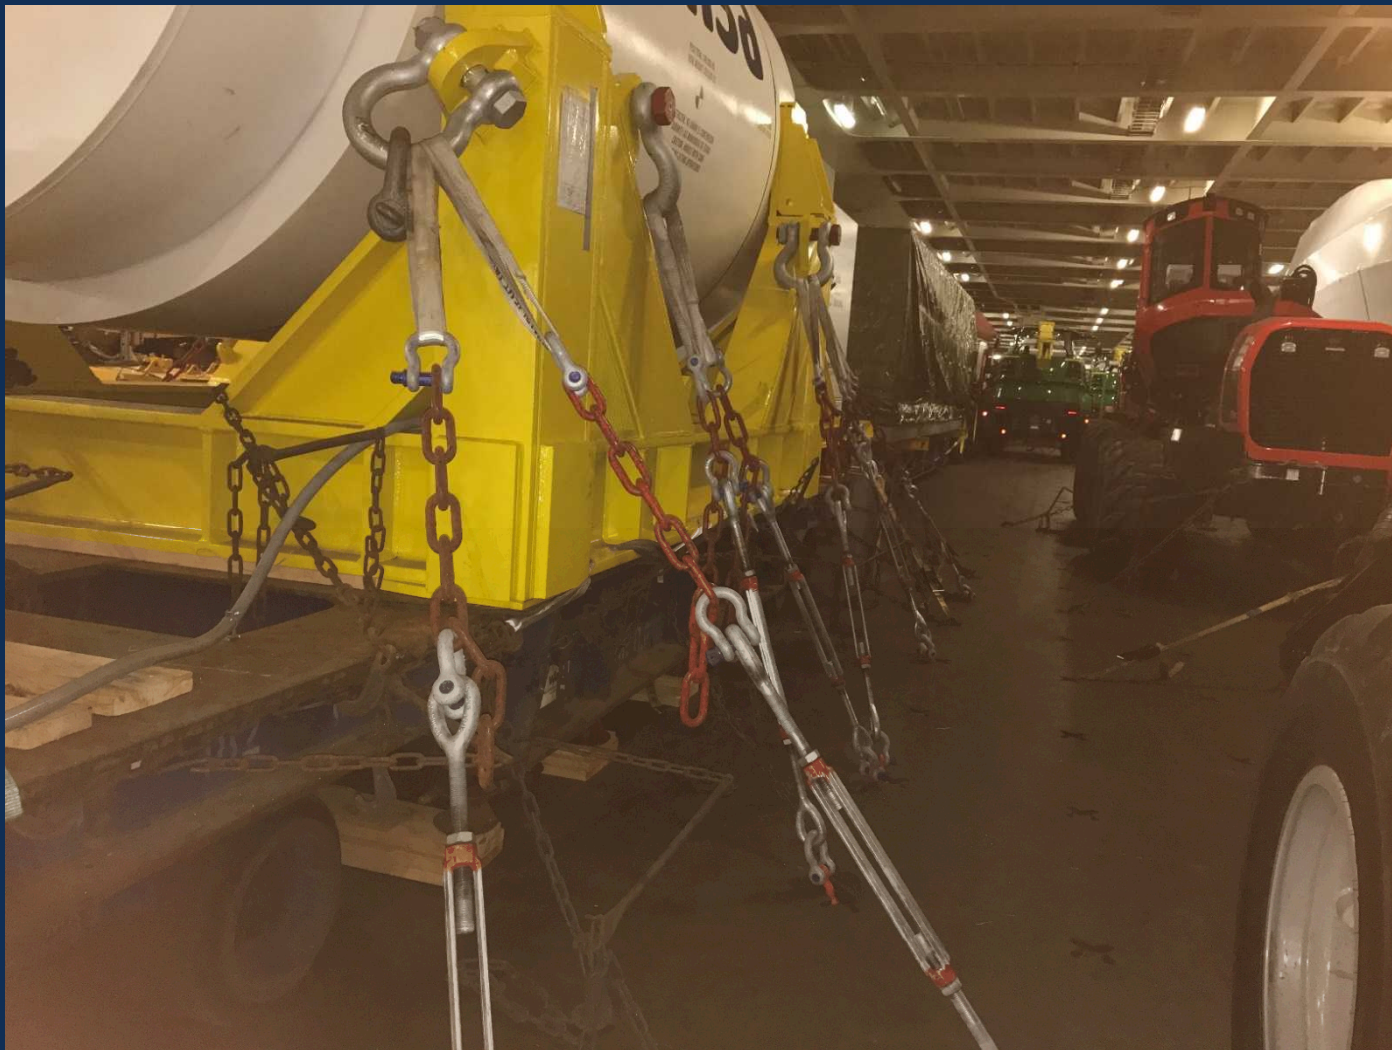
Lashing of the ENSA cask onto the Samson trailer and onto the deck of the ship in Zeebrugge on the TARAGO.

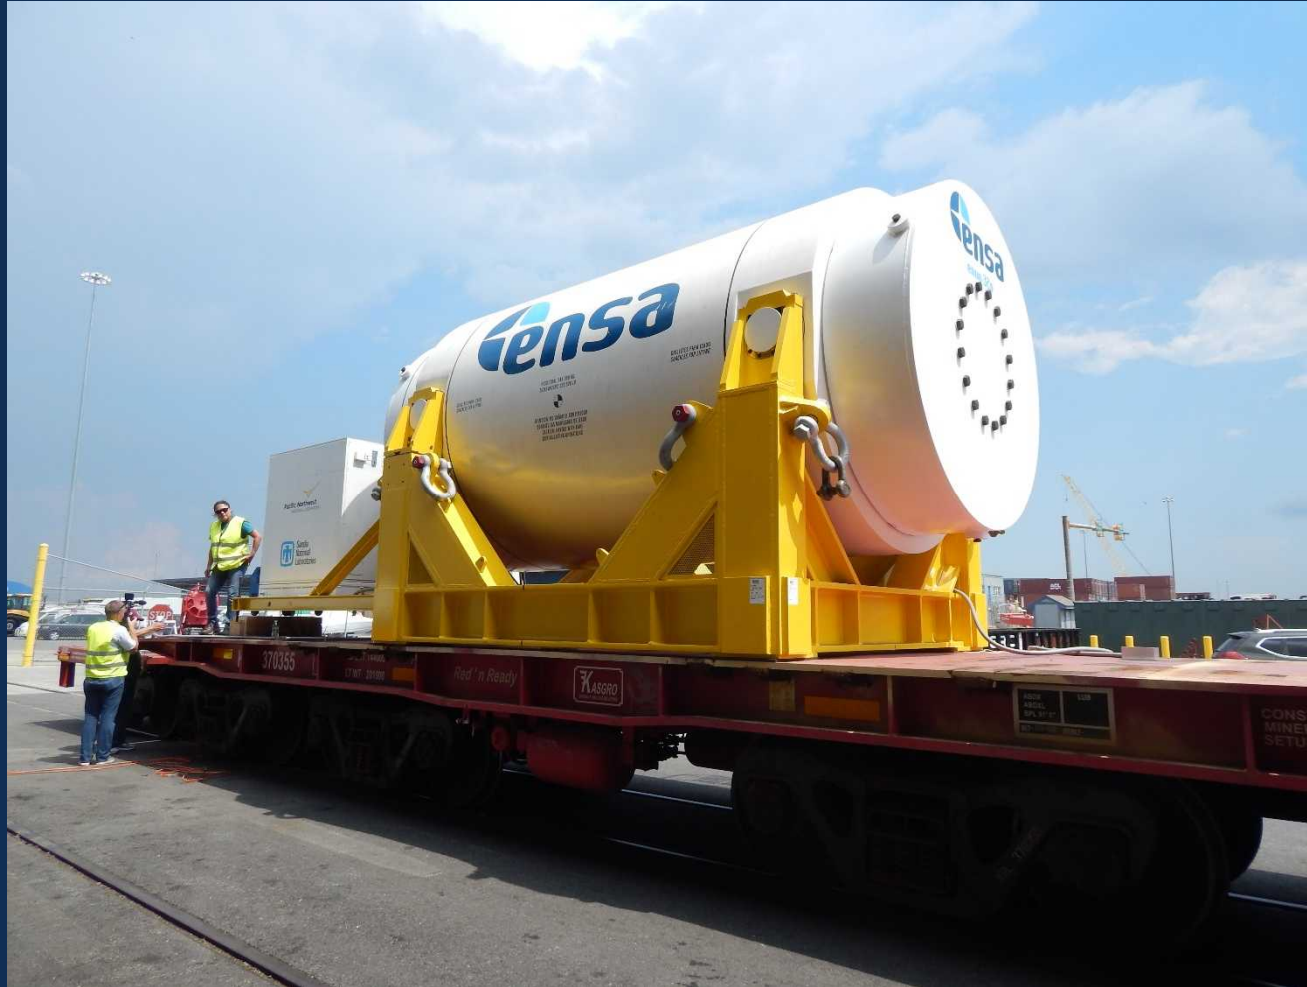
ENSA Cask after being transferred by crane from Samson trailer to Kasgro 12-axle railcar. This picture is prior to lashing (welding) and reconnection of instrumentation system.
