Title: What REALLY Happened at WIPP? The Tale of Two Fires Course 43441

What REALLY Happened at WIPP?

The Tale of Two Fires

Course 43441

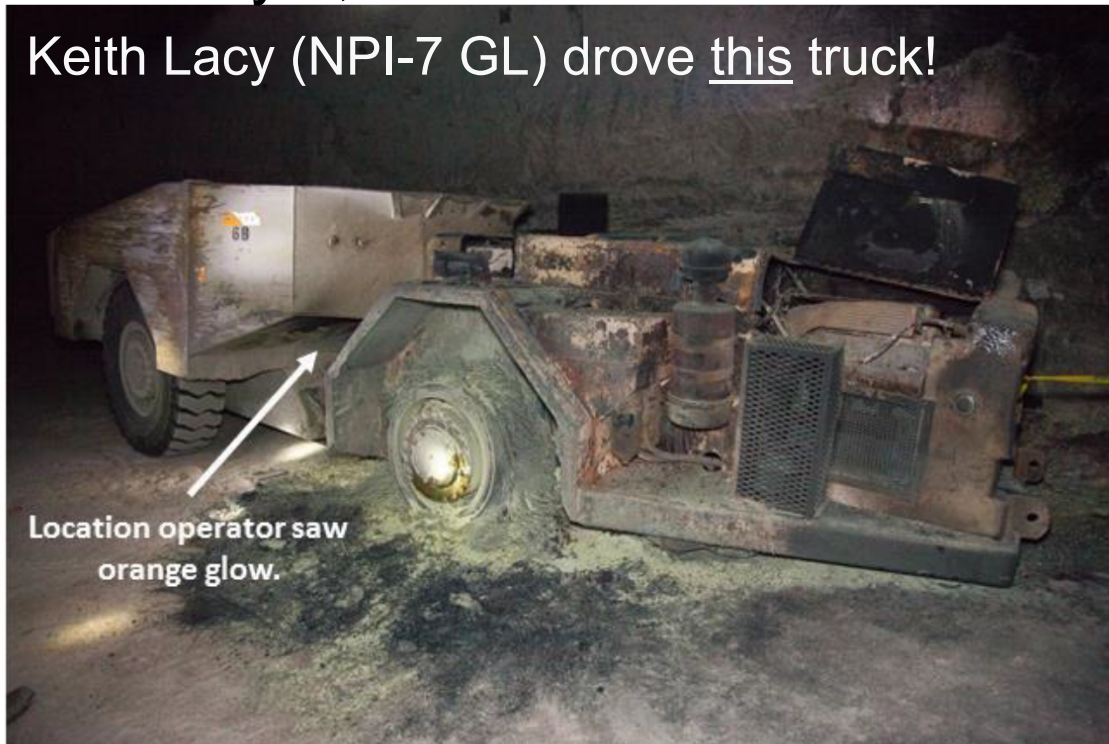
Salt Haul Truck Fire

February 5, 2014 10:45 am

Location operator saw orange glow.

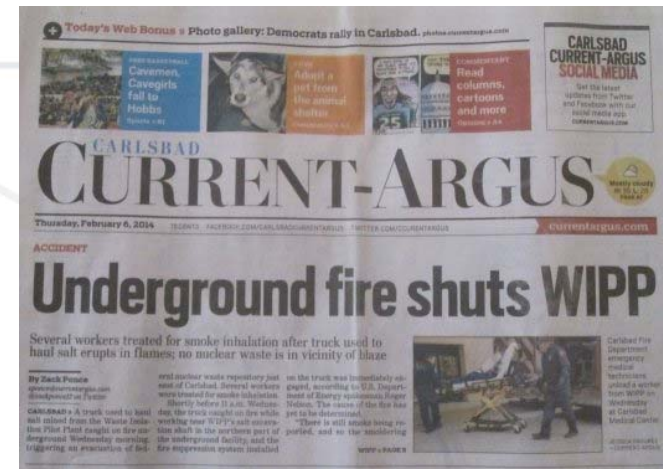
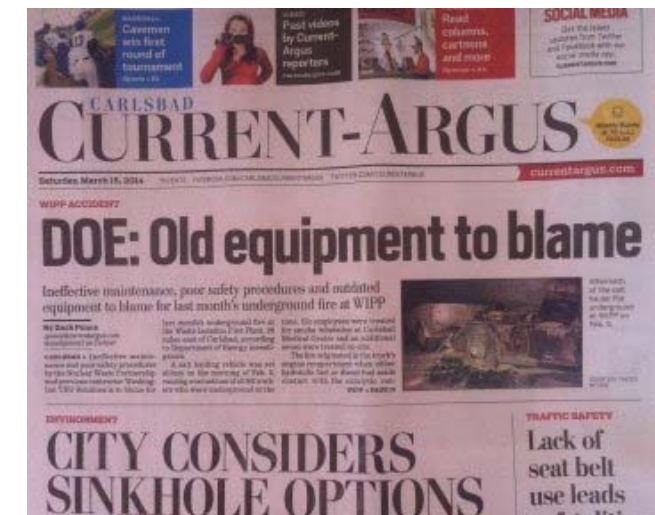
86 people in the mine
6 treated for smoke inhalation
7 more treated on-site

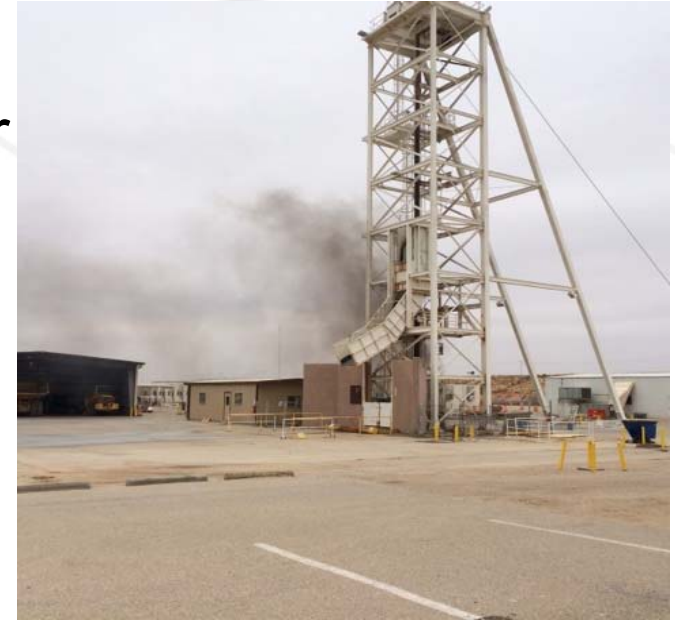
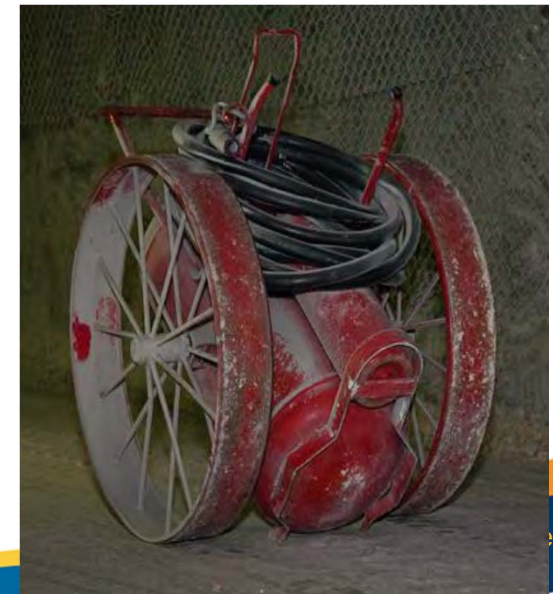
- Unreasonable expectations/uncertain capabilities of the Facility Shift Manager (FSM) to manage all aspects of an emergency or abnormal event.
 - 10:58 am: Switch the ventilation system from normal to filtration mode believing this would reduce fire and smoke in underground. This resulted in the flow of smoke into areas of the underground which workers expected to have good air
- Inadequate Fire Hazard Analysis, Training and Drills
 - Hadn't run fire drills and poor visibility (smoke)
 - Ineffective fire suppression system on truck
 - 300 lb fire extinguisher – ineffective
 - Workers said they couldn't hear the evacuation announcement

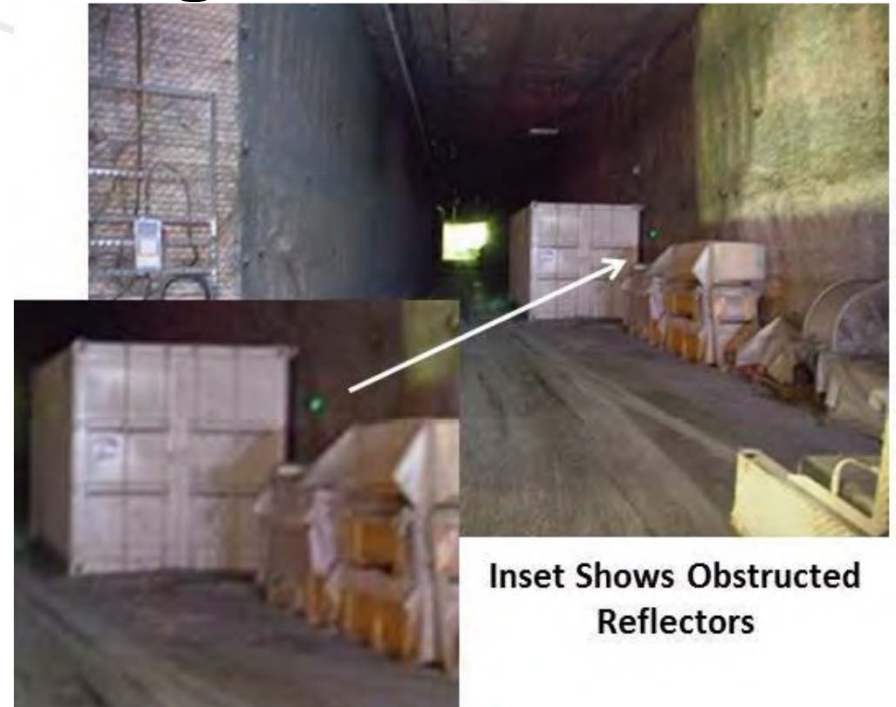
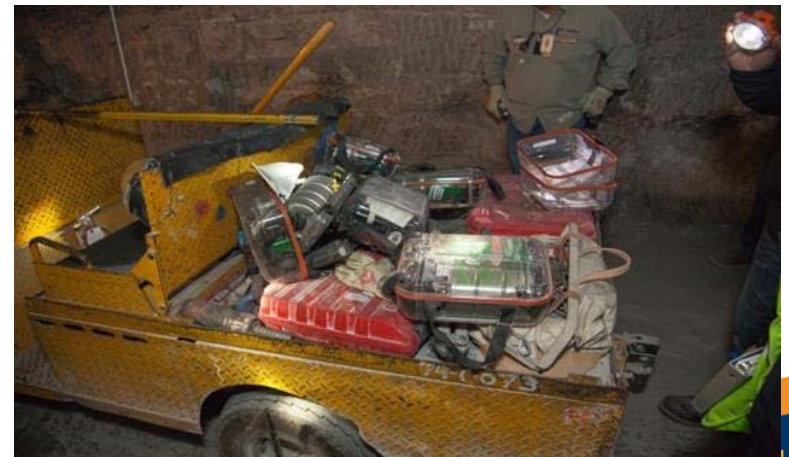
Inset Shows Obstructed Reflectors

- Inadequate combustible loading program in the underground.
 - Obscured evacuation route reflectors
- Emergency Operating Center (EOC) Ineffective as an Incident Command System (ICS)
 - Forgot to activate evacuation strobe lights
 - 11:03 am EOC did not classify event as emergency and did not contact DOE Headquarters
- Inadequate Operability and recognition of impaired critical safety equipment
 - Workers had difficulty opening and donning self rescuers

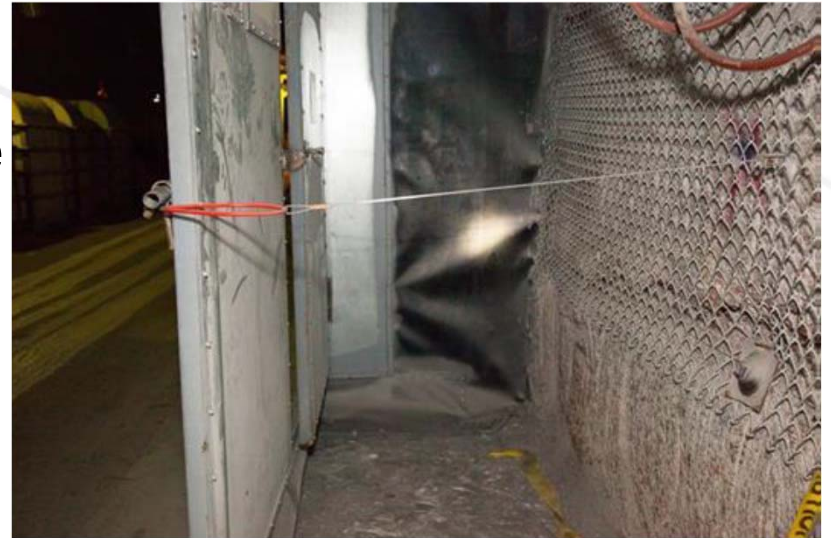
Air Lock Doors Wired Open

- Maintenance program = ineffective
- Fire protection program = less than adequate
- Evaluation and protective actions = less than adequate
- Maintenance of waste vs. mining vehicles

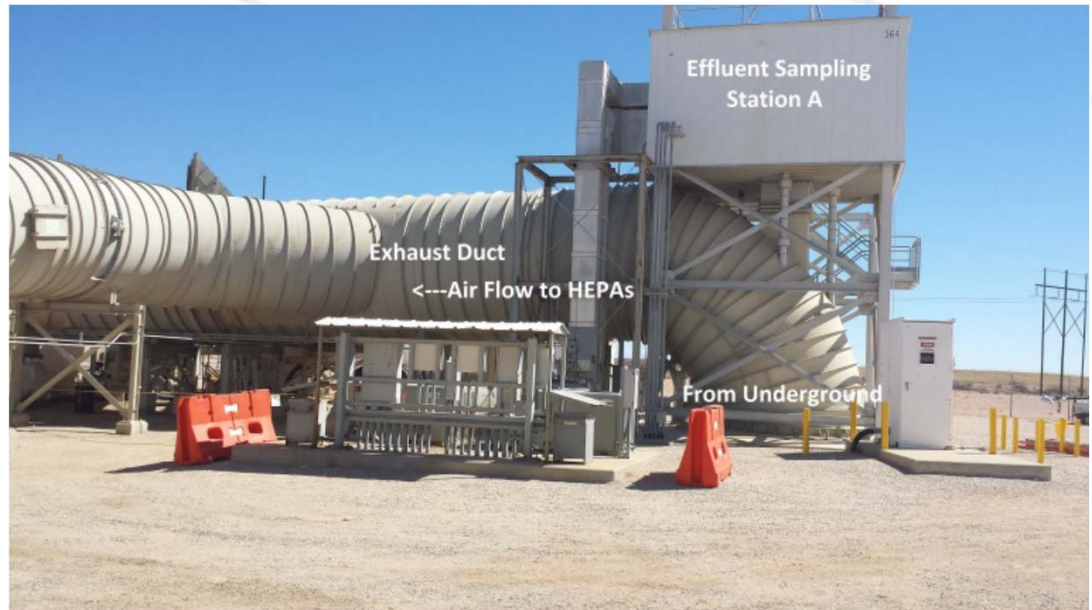
SRNL Preliminary Summary Report for WIPP Samples

- A high radiation alarm was received in the Central Monitoring Room
- Response: Underground Ventilation System initiated the switch to a HEPA Filtration mode.
- Exhaust Duct Dampers did not fully seal
- February 15th 2014 (7:15 am): 4.4 million dpm alpha contamination on filters upstream of HEPAs

Tested Fixed Air Samples and CAM Filters (some filters were black, one CAM had no filter): Am-241, followed by Pu-239, Am-243/Np-239, and Np-237/Pa-233.

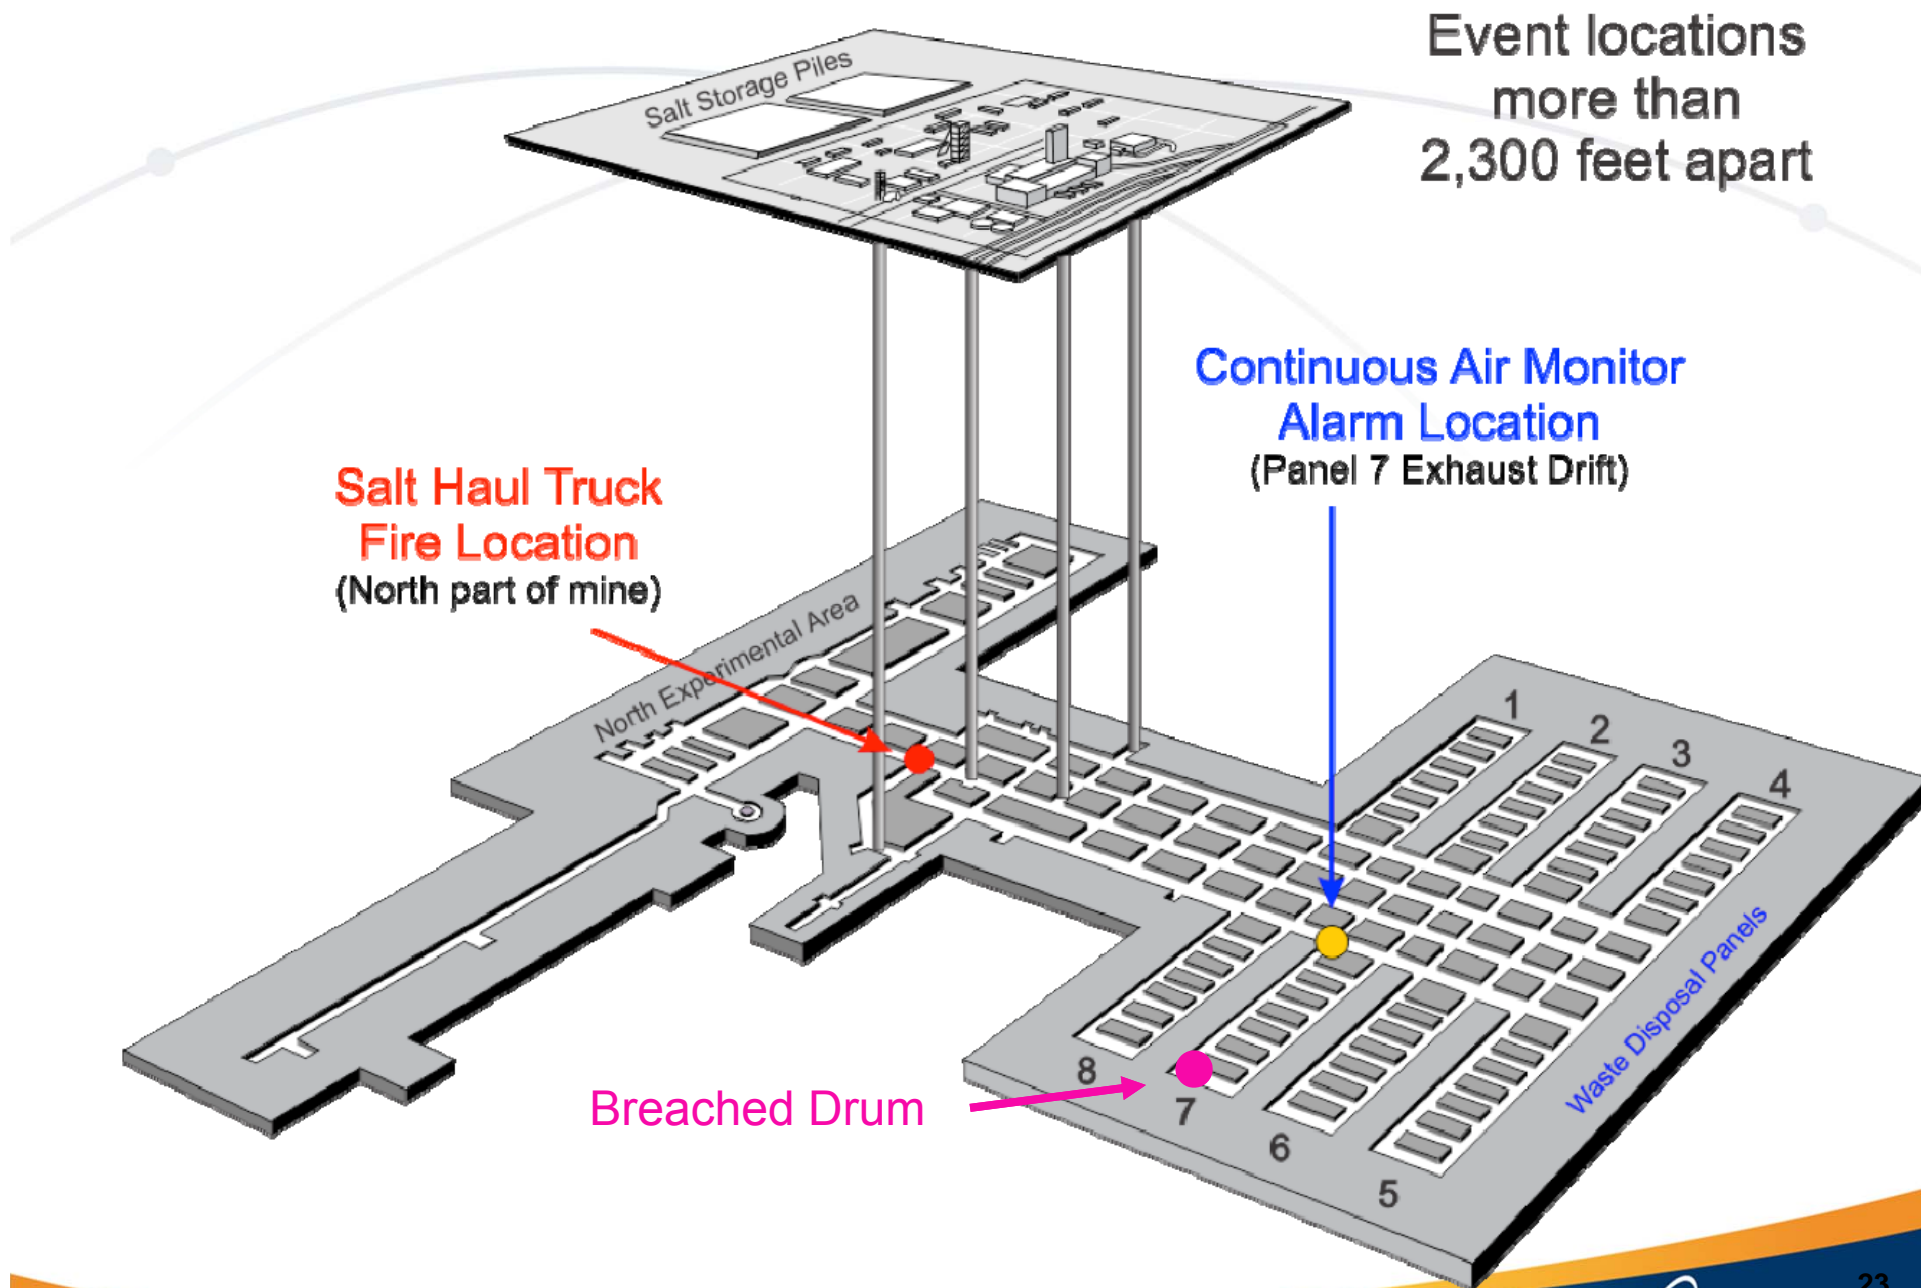
WASTE DISPOSAL PANELS

Salt Truck Fire 2/5/14

24 rows of CH waste in Room 7 of Panel 7

CAM Alarm Location (Panel 7 Exhaust Drift)

- Panels 1-5 filled and sealed
- Panel 6 filled and sealing in process
- CH waste emplacement in Room 7
- RH waste emplacement in Room 6
- Active mining Panel 8

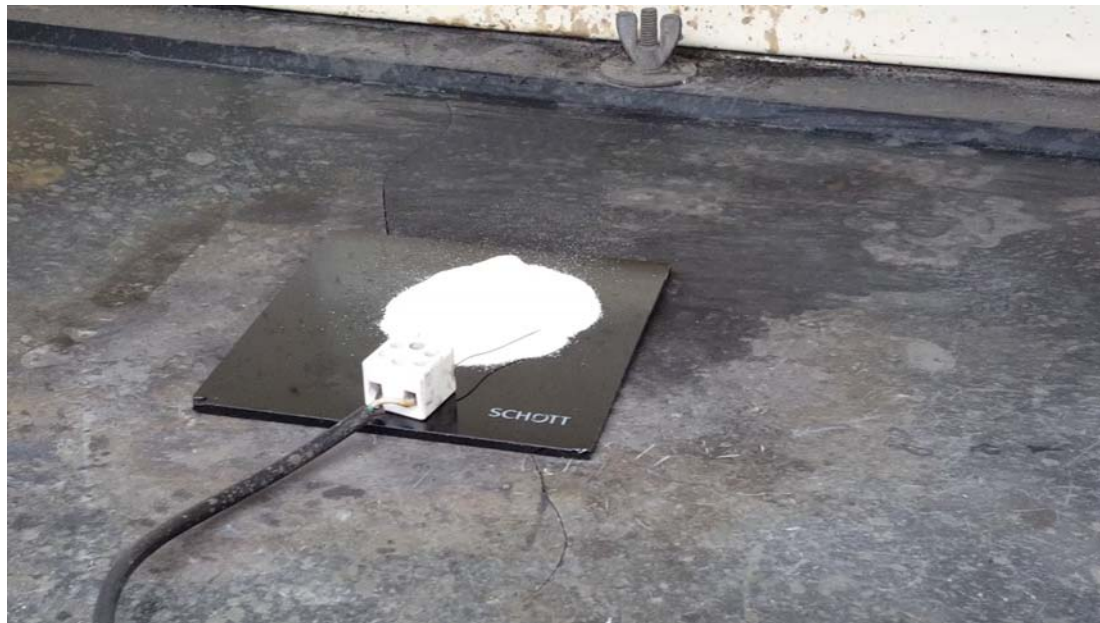
- Identified “absorbents” and oxidizers (77) in all waste streams being shipped to WIPP
- Scoping Studies 2015: EPA 846 Method 1040 Test Method for Oxidizing Solids
- Bounding Conditions: fastest burning oxidizer and absorbent
- Potassium Nitrite (KNO_2) and Quik Solid (polyacrylate polymer)

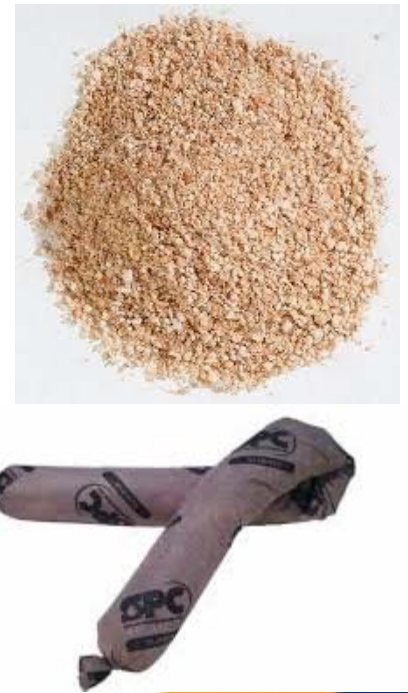
- Absorb with a listed inorganic sorbent zeolite type of clay
- NoChar, WasteLock and Quik Solid <30 weight percent oxidizer - no remediation required
 - Anything greater needs to be remediated with 50 weight percent zeolite
- Slikwik, sWheat Scoop (cellulose-based sorbents) absorbed with any amount oxidizer will require remediation of 70 weight percent zeolite

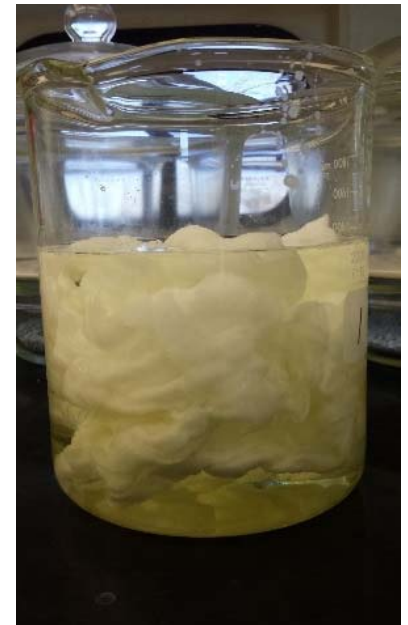
- LANL-CO performed three tests on saturated cheesecloth (with saturated solution of potassium nitrite (75 wt. %))
- The cheesecloth was wrung out until no dripping was observed
 - **1st test:** the saturated cheesecloth was soaked in 1 liter of deionized water for 1.33 minutes
 - **2nd test:** the saturated cheesecloth was soaked in 1 liter of deionized water for 30 minutes
 - **3rd test:** the saturated cheesecloth was soaked in 3 liters of deionized water for 2 minutes
- In all three scenarios, the direct burn tests resulted in an oxidizer

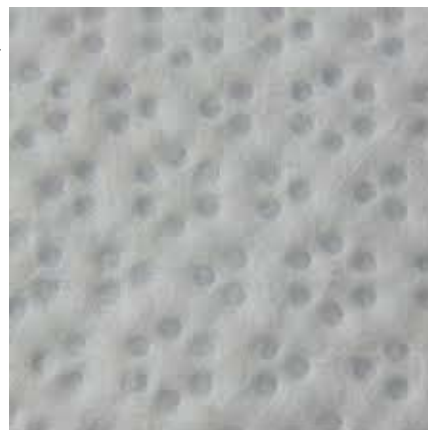
- Hazmat Sorbent Wipes and Kimtech Pure W4 Wipers

- 100% Polypropylene
- Passed with non-oxidizer results saturated with 75 wt. % potassium nitrite solution
