# *Nanocrystalline Alloys: Impervious to Fatigue Failure?*

Brad L. Boyce

Sandia National Laboratories, Albuquerque, NM

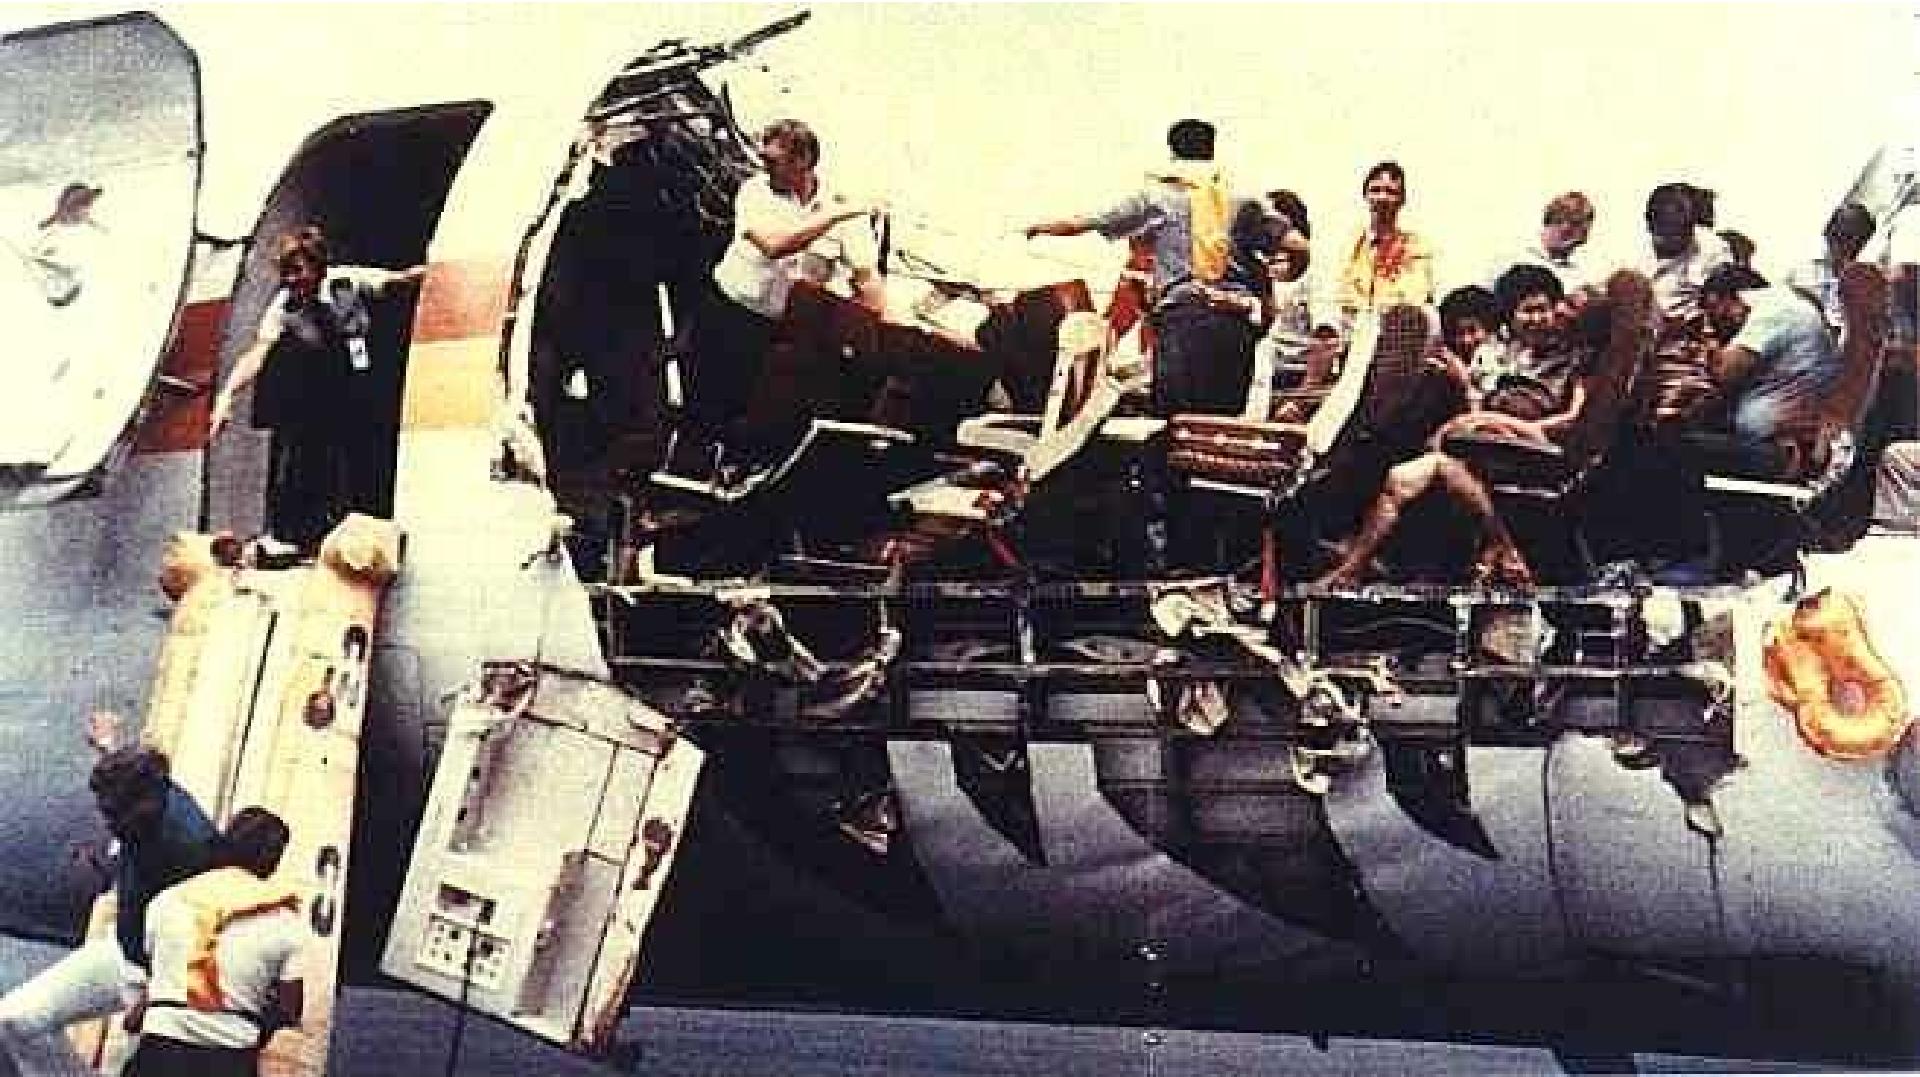
4-28-1988 After 89,090 flight cycles on a 737-200, metal fatigue lets the top go in flight.

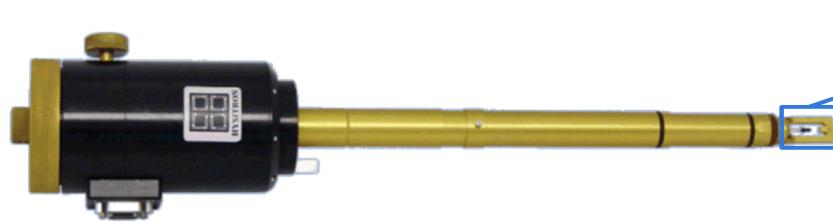
Hysitron PI95 *In Situ* Nanoindentation TEM Holder

- Sub nanometer displacement resolution
- Quantitative force information with  $\mu\text{N}$  resolution
- Concurrent real-time imaging by TEM

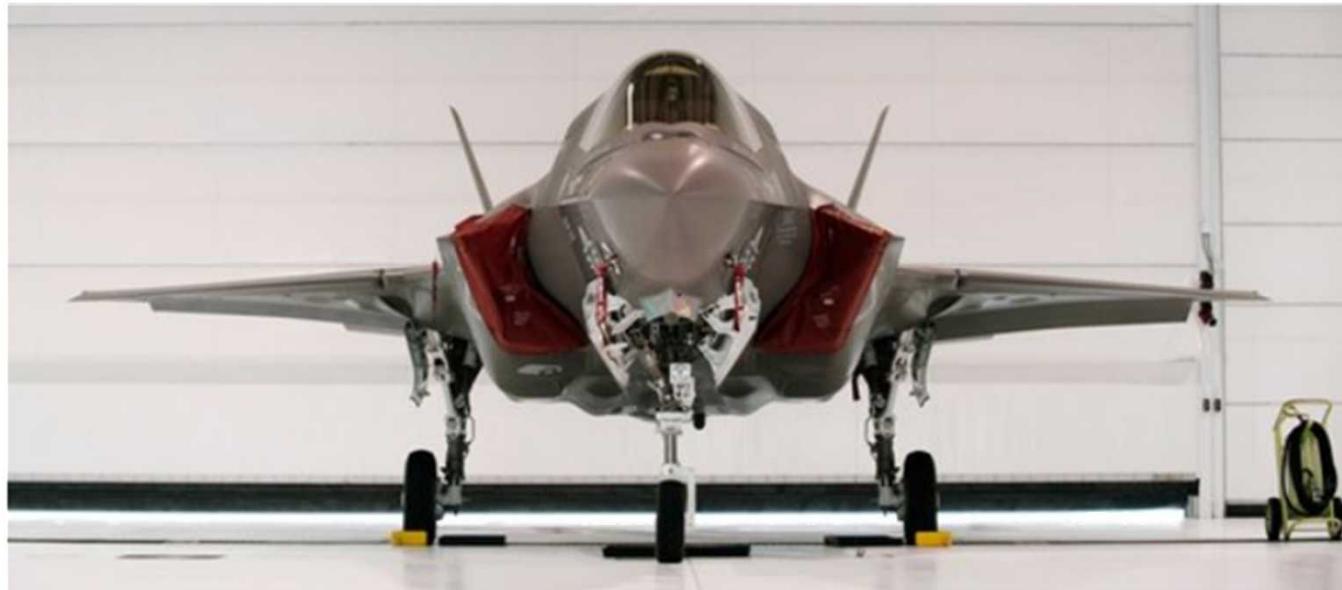
An inspection found a crack in a turbine blade in the engine of one of the planes.

The Pentagon said on Friday that it had grounded all of its stealthy new [F-35](#) fighter jets after an inspection found a crack in a turbine blade in the engine of one of the planes.

The Pentagon office that runs the program said the [crack in the turbine blade](#) was discovered on Tuesday in a routine inspection. The crack occurred on a test plane at Edwards Air Force Base in California. The blade is being shipped to a plant in Connecticut, where the engine manufacturer, Pratt & Whitney, will inspect it and look for the problem's cause.

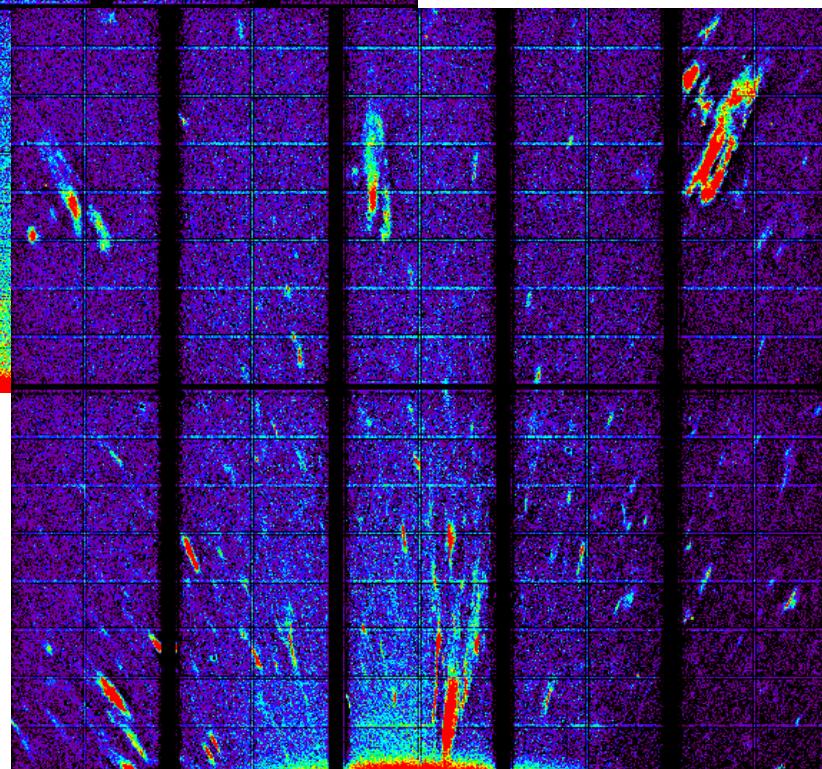
# Polychromatic Microdiffraction (Advanced Light Source)

Nanocrystalline  
region (no  
grain growth)

Grain Growth  
Region  
(only 4  $\mu\text{m}$  away!)
