Development of a propagating battery failure test

Joshua Lamb, Leigh Anna M. Steele, Chris Grosso, Jerry Quintana, Loraine Torres-Castro, June Stanley

Sandia National Laboratories

The Battery Show

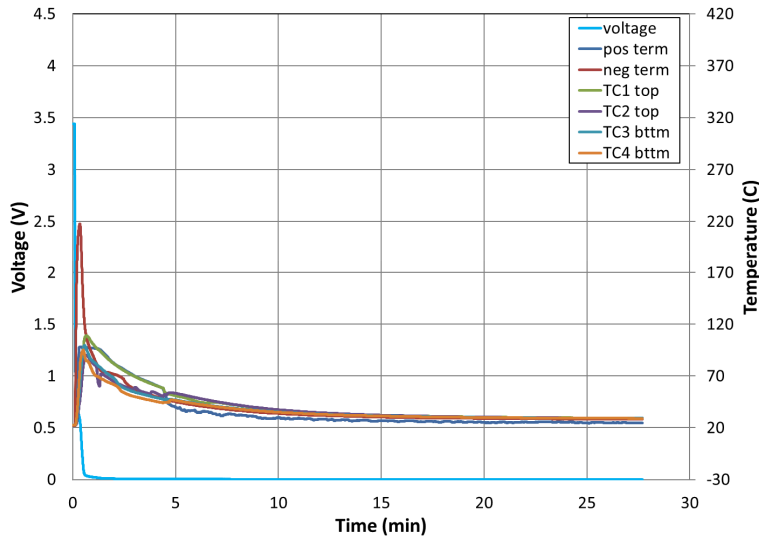
Single cell

- *Results of single cell nail penetration and 1S10P propagation test*
- *26650 LFP cell*
- *Significant increase in intensity and duration of failure event in string*
- *The most basic principle of propagating failure tests is that single cells performance is not necessarily indicative of multi-cell performance*

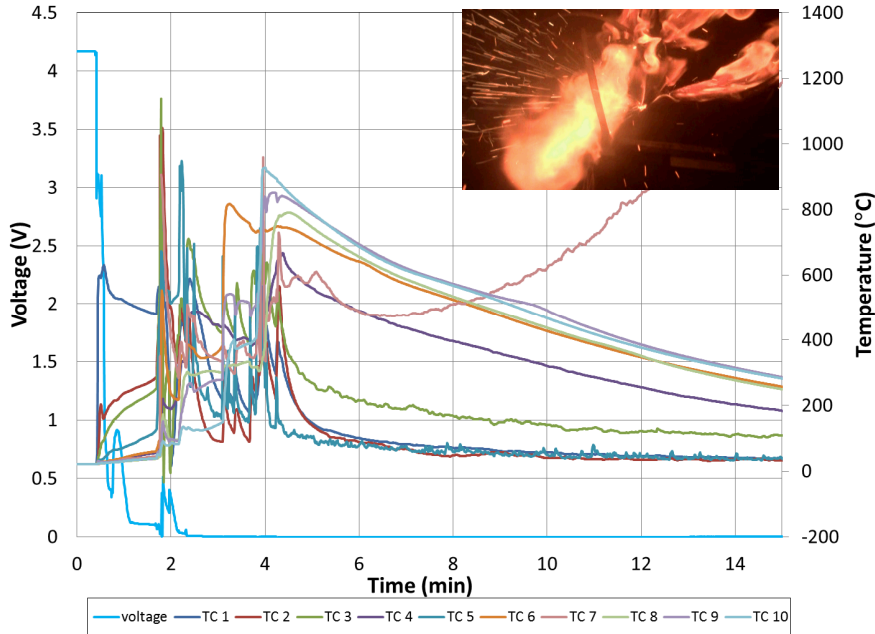
LiCoO₂ - 1S10P(parallel)

- *Previous testing with center cell failure point in LiCoO₂ packs: limited propagation in 10S1P and complete propagation in 1S10P pack*
- *Edge cell failure: complete propagation for 1S10P and a range of responses for 10S1P: limited (cells next to failure point engaged) to complete propagation*
- *Variation also seen depending on location of cell failure*

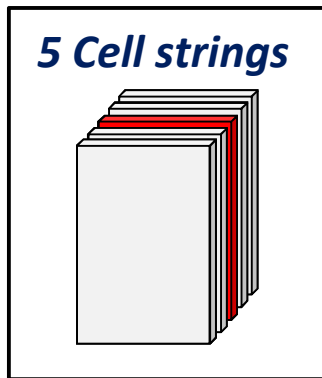
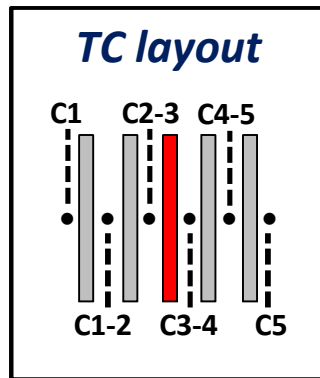
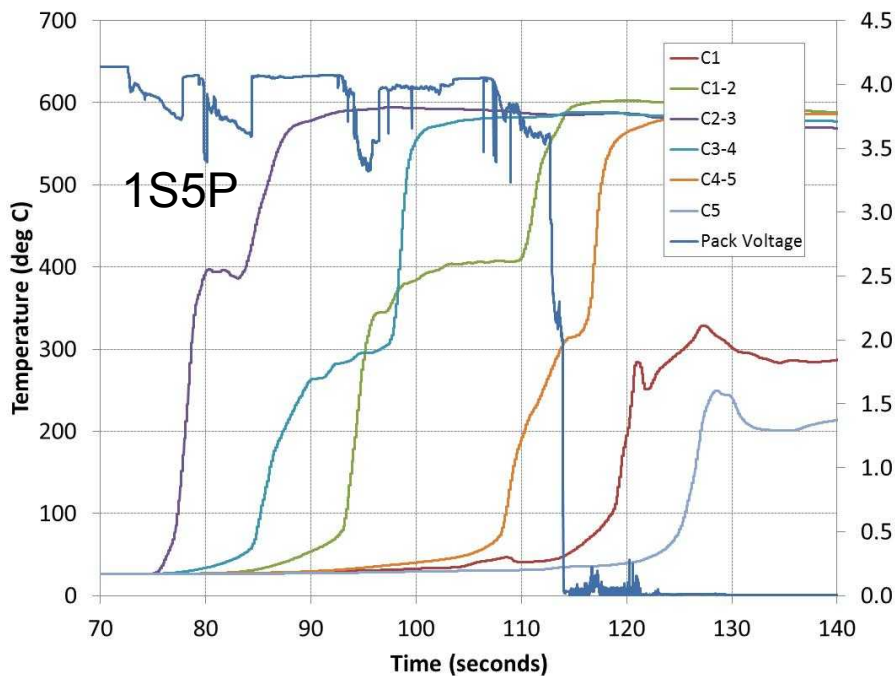
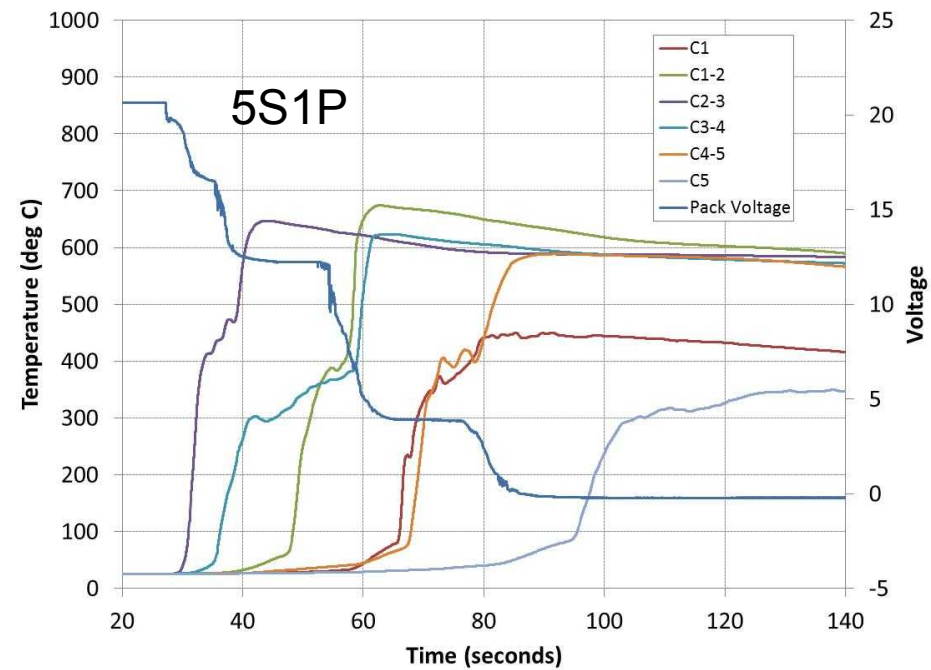
- *5 cell LCO strings*
- *Similar failure time and intensity observed in both configurations*
- *Strong thermal contact between cells controls impact*

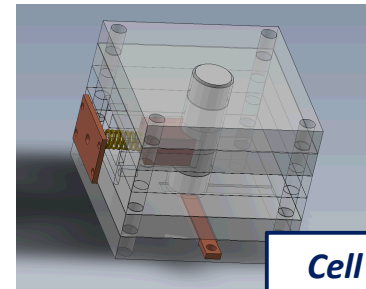
Testing Apparatus

- Failures initiated by mechanical insult to cell 1 which is connected to cell 2 through constantan bridge wire
- Development of new testing fixture to increase reproducibility in FY16 (right)
- Additional effort to maintain electrical connection with cell 1 after runaway event
 - Use of spring on nail to apply opposing force keeping cell from ejecting after runaway (images below)

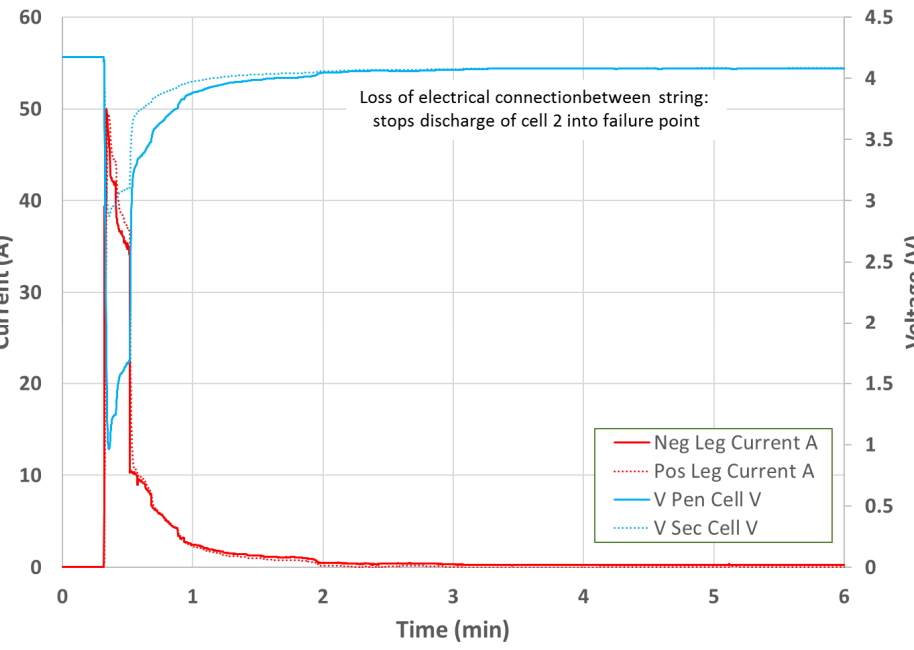
18650 NMC 3Ah cells – 1s2p

- **Peak currents across constantan bridge during failure propagation consistent between setups: ~50A**
- **Total energy discharged into cell 1 varies based on robustness on electrical connection allowing cell 2 to discharge into failure point longer: without spring 0.027 kJ (lost battery connection) and with spring 5.3 kJ**

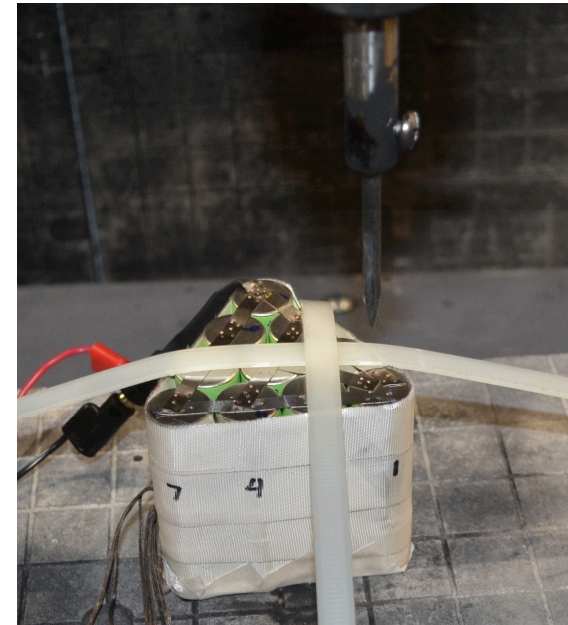
1S10P Battery: Failure point on edge cell

- COTS LiCoO₂ 18650 and LFP 18650/26650 cells
- 1S10P and 10S1P electrical configurations
- Failure initiated by a mechanical nail penetration along longitudinal axis
- **The current effort is focused on understanding the effect on propagation from single cell failure at different locations within 1S10P and 10S1P packs as well as the evaluation of pack design (nickel tabbing, copper bus architecture, and air gaps between cells)**

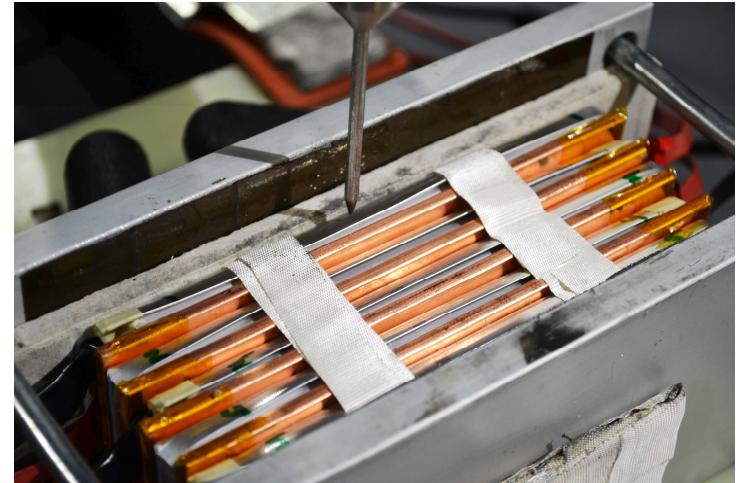
- COTS LiCoO₂ 3Ah pouch cells
- 5 cells closely packed
- Failure initiated by a mechanical nail penetration along longitudinal axis of edge cell (cell 1)
- **The current effort is focused on understanding extent of propagation with inclusion of passive thermal management in the form of heat sinks between pouch cells (aluminum and copper)**

5 cell pack with aluminum or copper spacers between cells

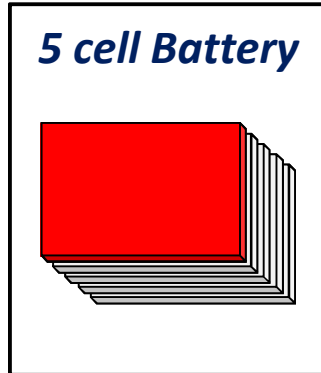
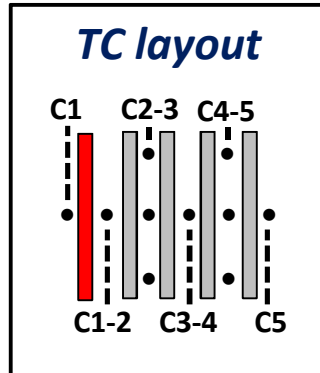
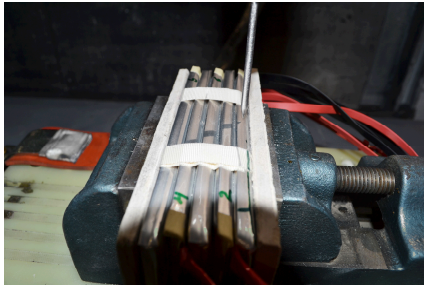
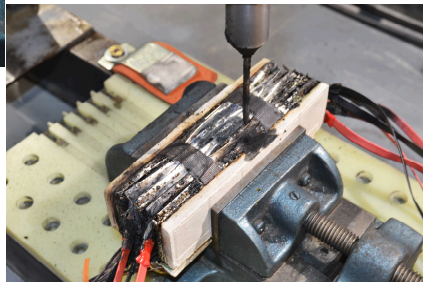
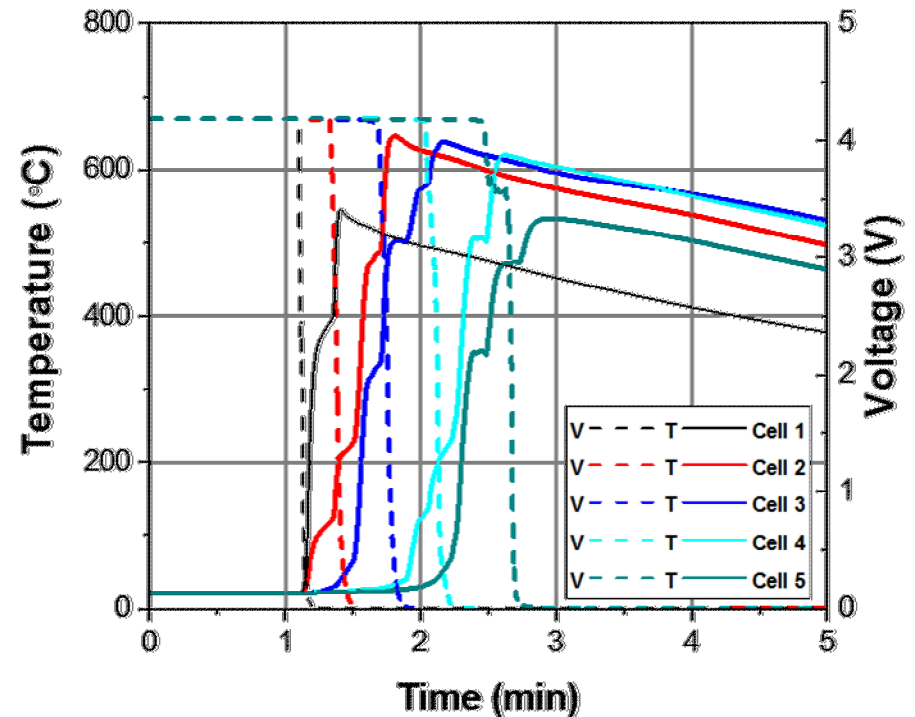
- Successful initiation at Cell #1
- Propagation to adjacent cells
- Cascading failure to entire battery over 60 s

- **Observed complete propagation when cell are close packed with no thermal management**

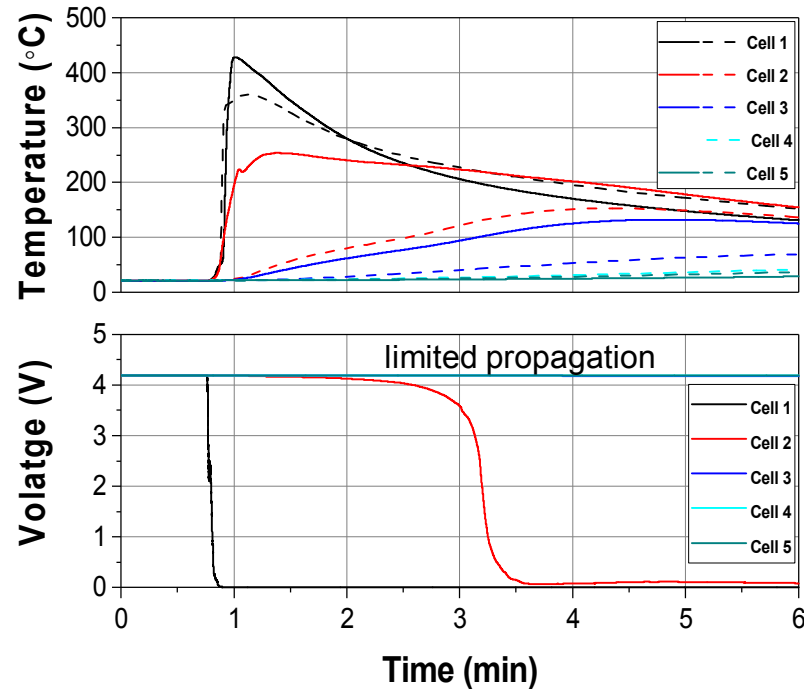
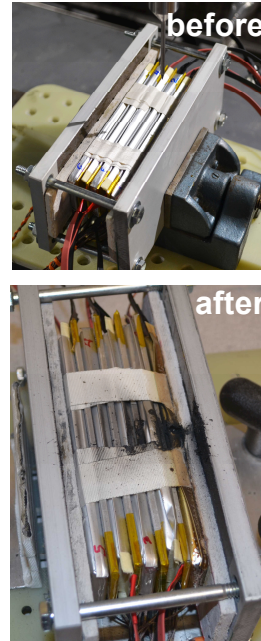
LiCoO₂ – 1/16" thick spacers

- *Addition of aluminum spacers cut to the size of 3 Ah COTS cells was achieved*
- *Failure of cell 1 in both cases were consistent and peak temperatures reached ~400 °C*
- *Limited propagation (from cell 1 to 2) occurred with the thinner material (1/16")*
- *No propagation was realized when space thickness was increased to 1/8"*

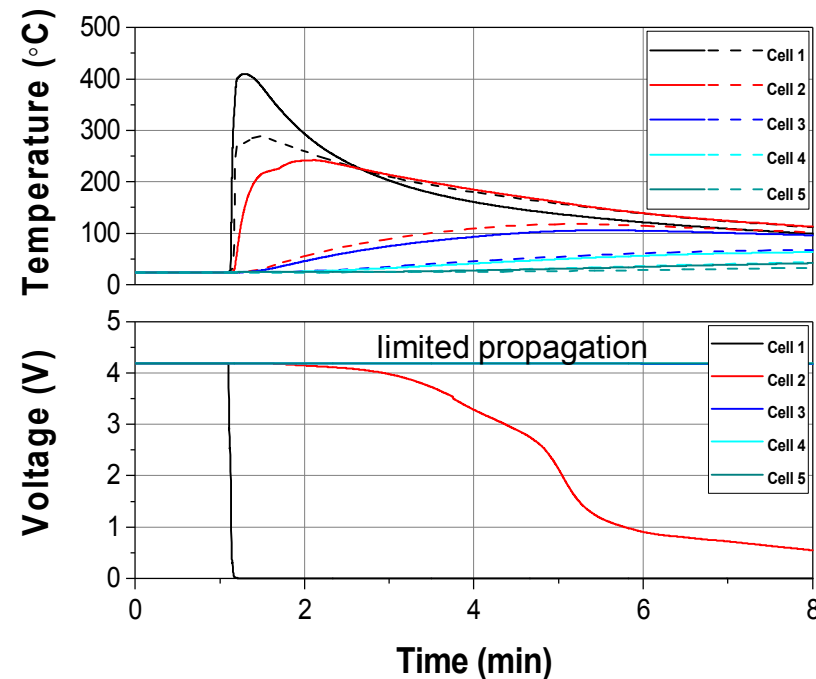
LiCoO₂ – 1/16" thick spacers

- *Addition of copper spacers cut to the size of 3 Ah COTS cells was achieved for comparisons of spacer size and material (Al vs Cu)*
- *Failure of cell 1 in all cases were consistent and peak temperatures reached ~400 °C*
- *Limited propagation (from cell 1 to 2) occurred with the thinner material (1/16")*
- *No propagation was realized when space thickness was increased to 1/8"*

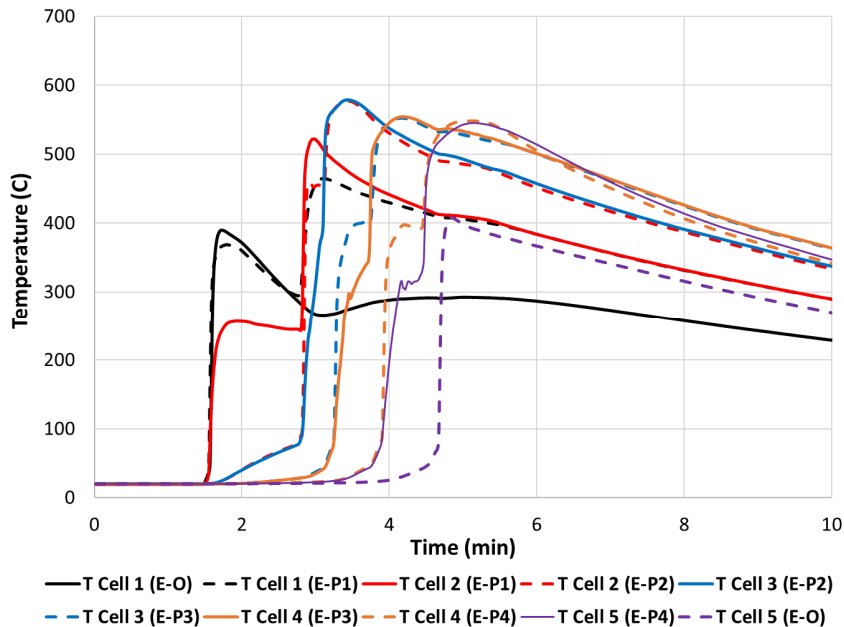
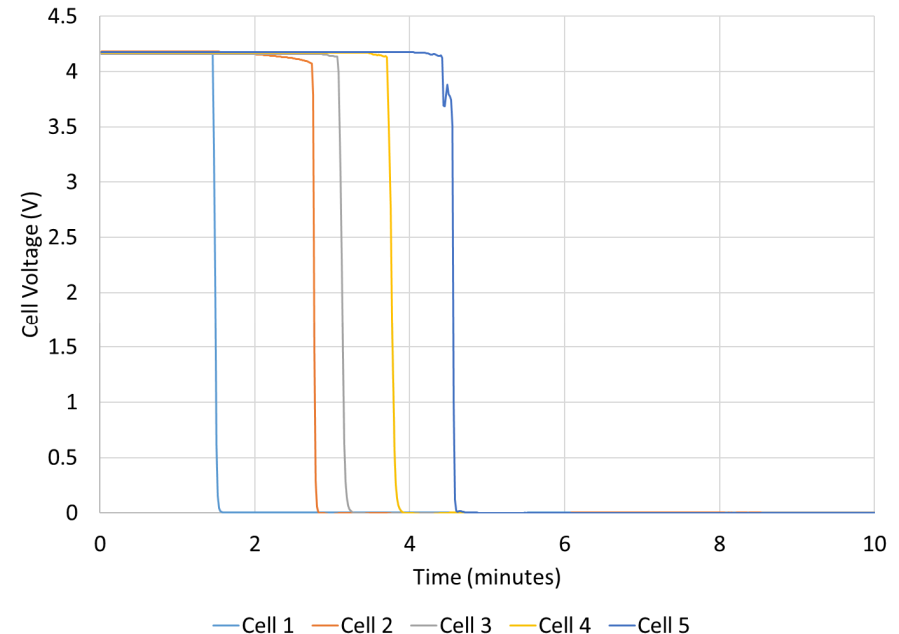
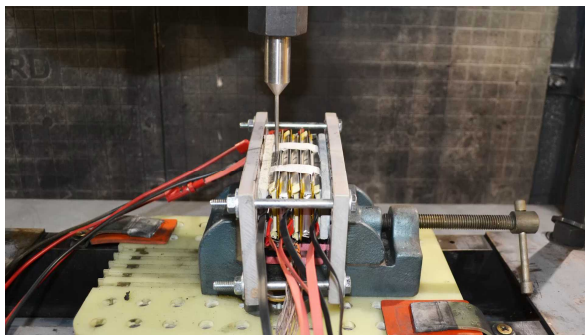
LiCoO₂ – 1/32" thick spacers

- *Aluminum spacers 1/32" thick*
- *Failure of Cell 1 observed initially*
- *Pulsing propagating failure behavior observed over the next several minutes*
- *Entire pack consumed ~4 minutes after initial cell failure*

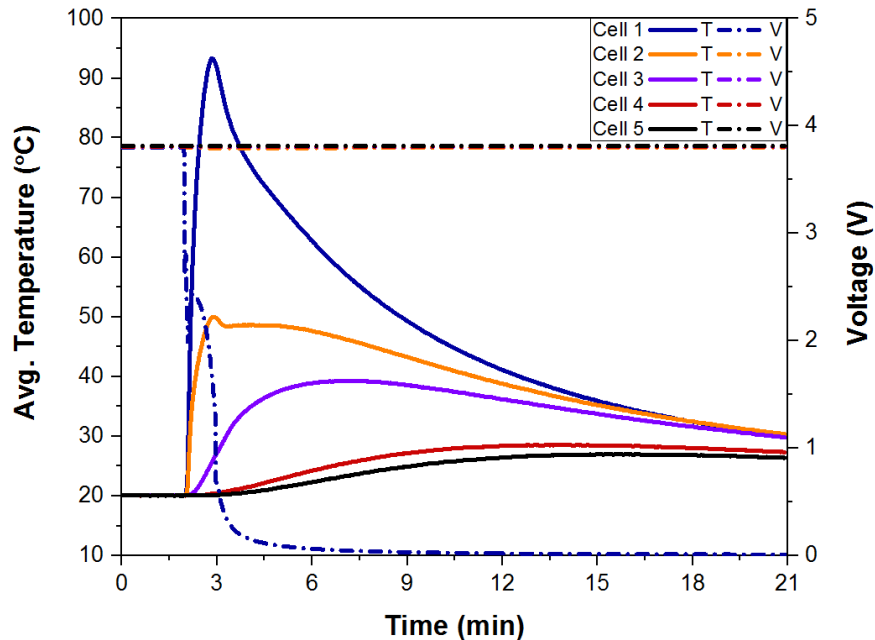
Cells at 50% SOC

- **50% SOC no cell to cell propagation observed**
- **“Pulsing” propagation again observed during failure of 80% pouch pack**
- **Total pack propagation observed after ~4 minutes**
- **80% SOC shows runaway temperatures similar to fully charged single cells**

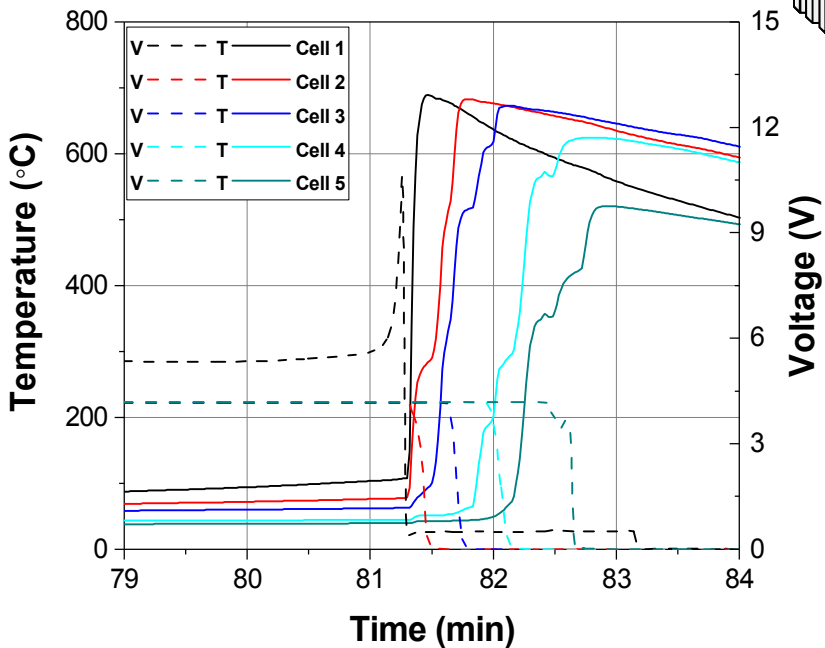
1C overcharge data

- *The overcharged cell failure more energetic than in nail penetration (faster heating rate) but did not impact the overall rate of propagation through the pack (in line with nail penetration)*
 - *peak battery temperatures are comparable for both testing methods*
 - *Complete propagation of all 5 cells was realized in both cases*
 - *Total time for propagation was ~1 min for overcharge and 1 min 20 sec for nail penetration*

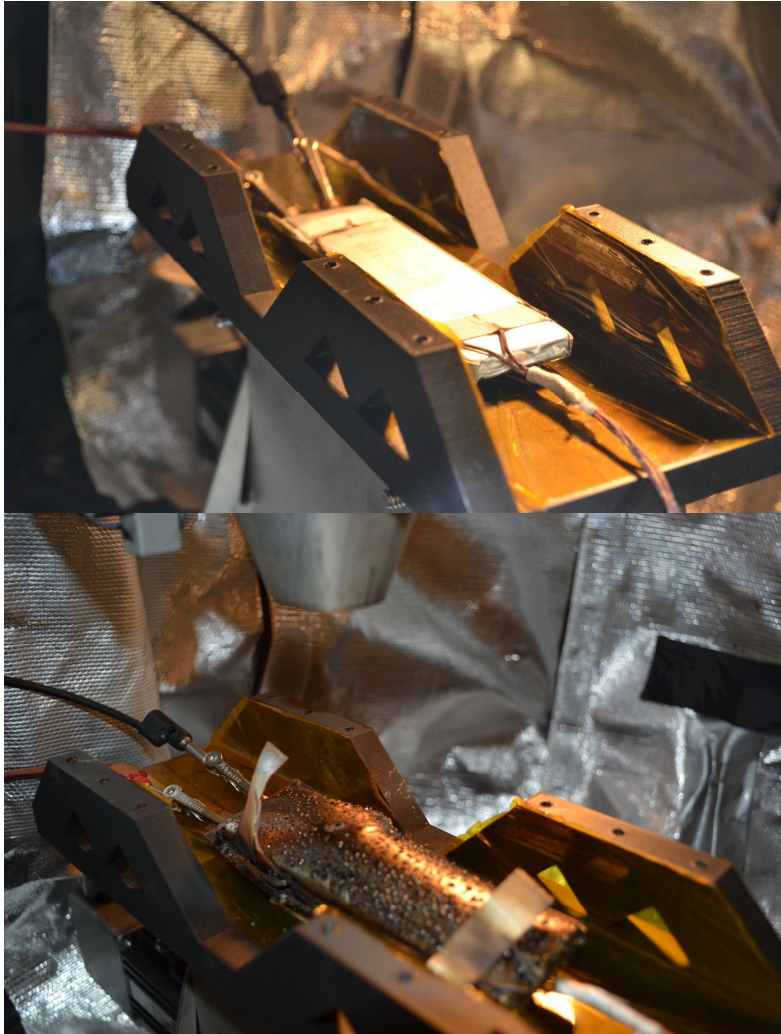
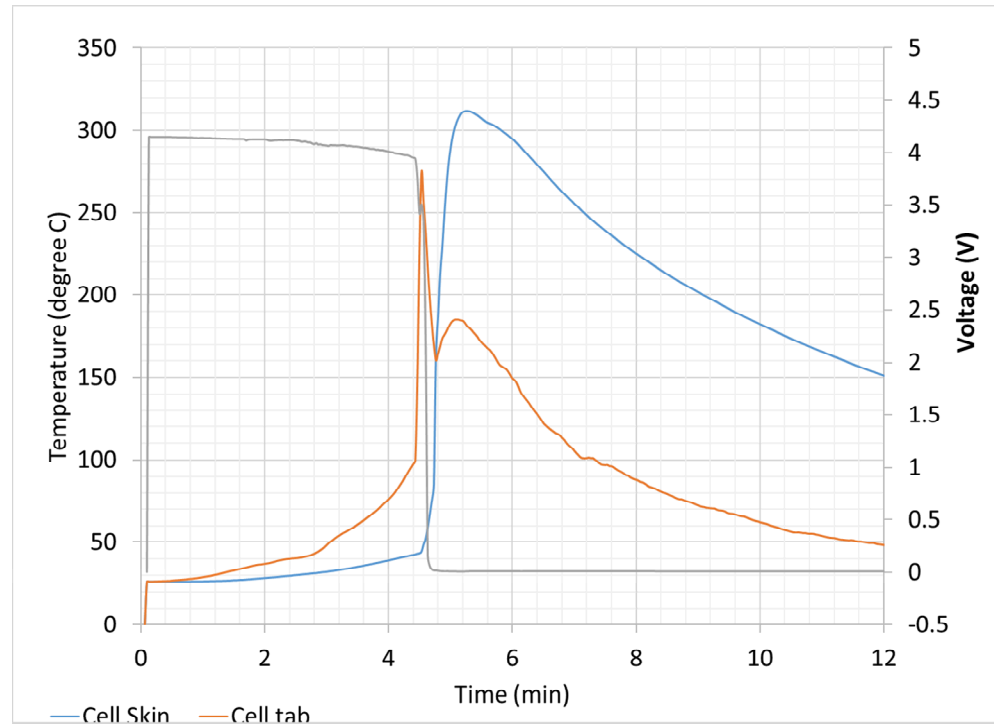
Single cell failure initiated using 40W
pulse laser
~38 J total energy needed for failure
(20 1.9J pulses)

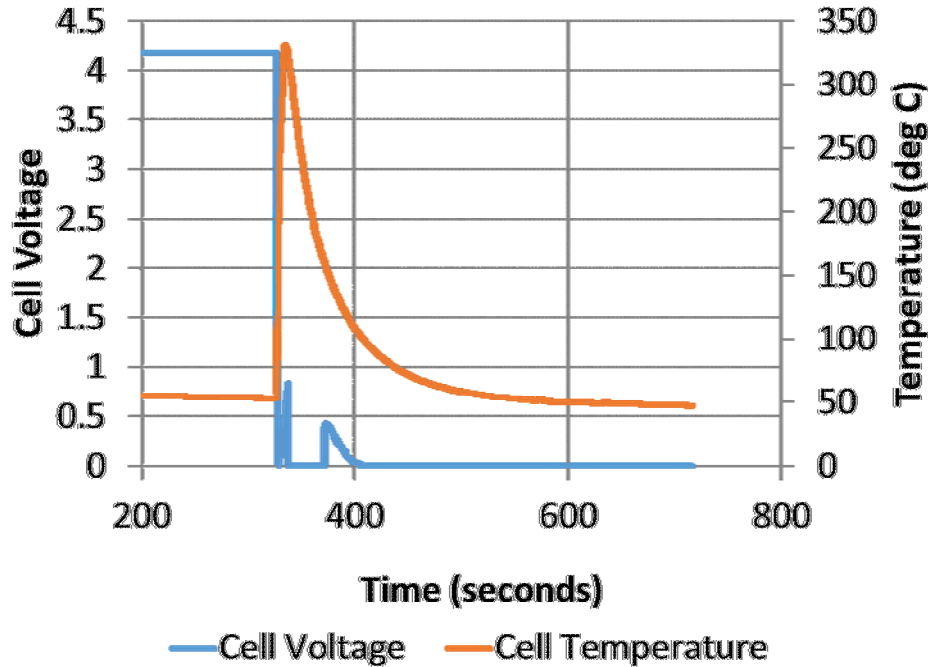
Nail Penetration Failure

- Comparison of failure to nail penetration of same model of cell
- Peak temperatures observed are similar, however the nail penetration shows much higher rate of failure after onset

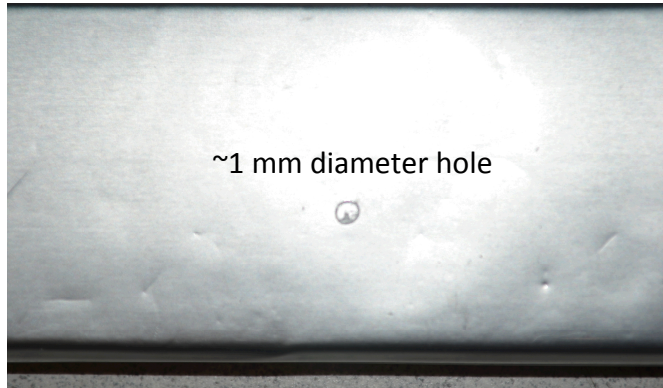
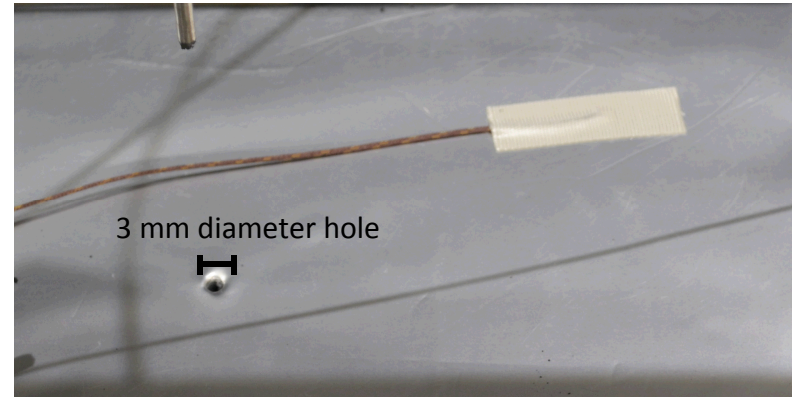
External

- Nail penetration shows significantly more internal damage.
- Internal damage done by laser initiation is very limited to surface layers.

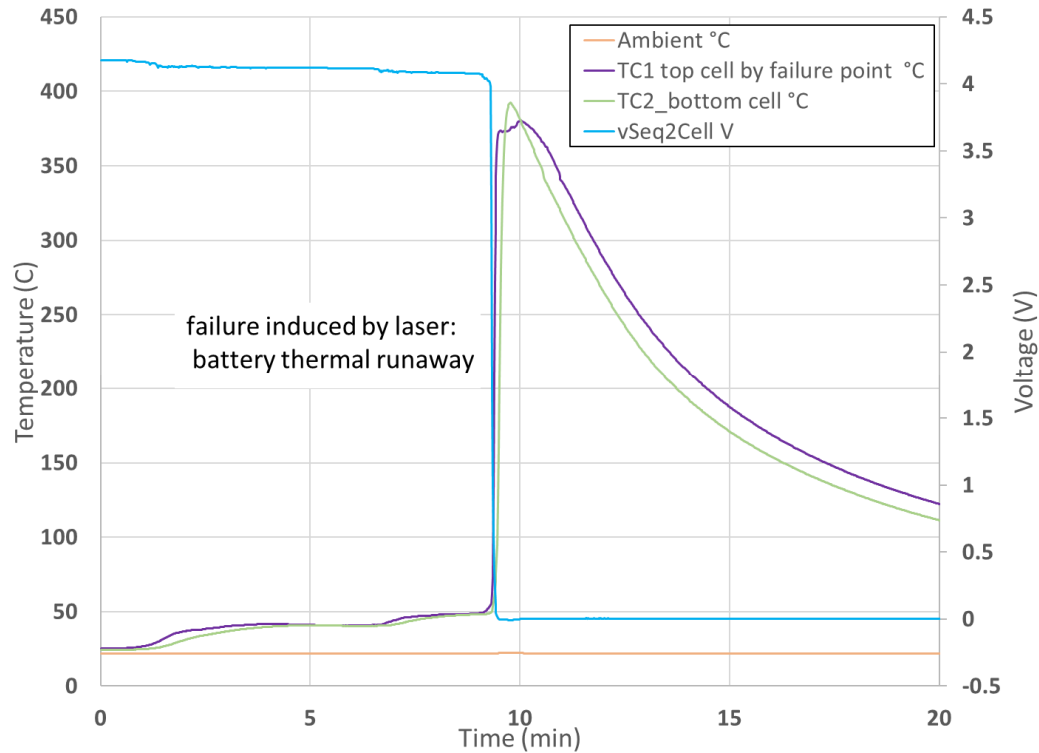
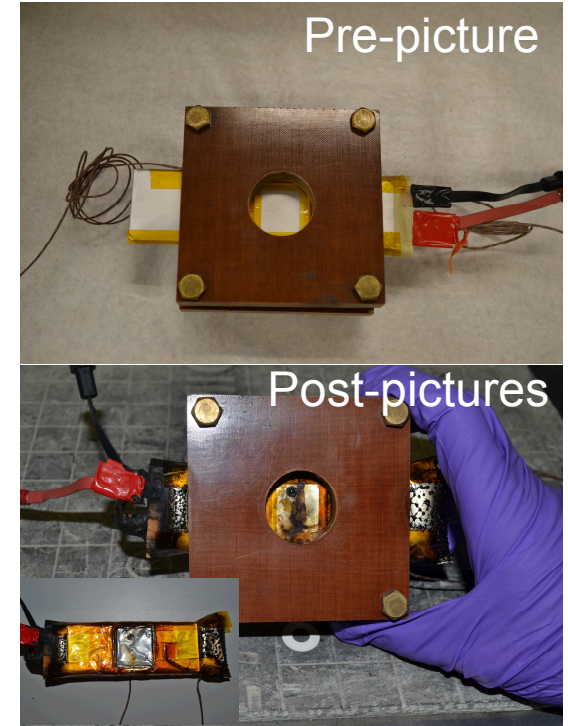
Laser initiated failure through fused silica slide (2mm)

In hopes to reduce the oxygen exposure to hole being produced from laser, an IR transparent slide was used as barrier during testing

- Able to induce failure using laser through silica slide
- Final power setting of 350V, 20ms, 1Hz to induce thermal runaway
 - More energy needed to induce runaway through silica slide
- Maintained seal between silica and pouch cell until full runaway

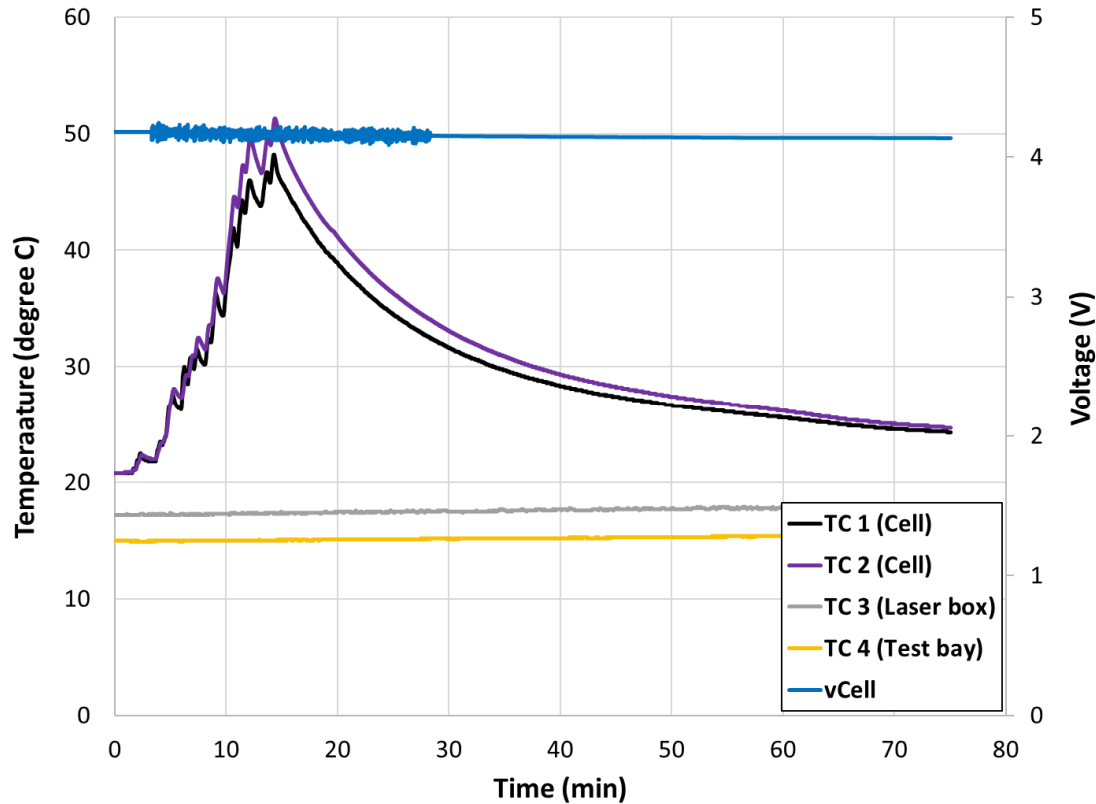
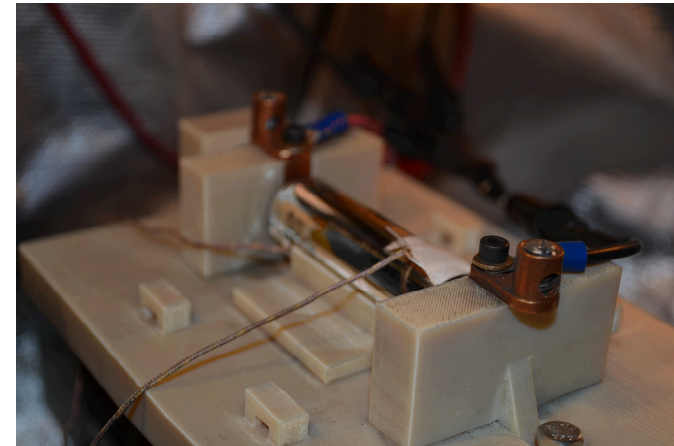
Cylindrical cell tests

- Some cell heating and voltage drop observed
- No thermal runaway initiated
- Visible damage caused to can surface and evaluated with CT

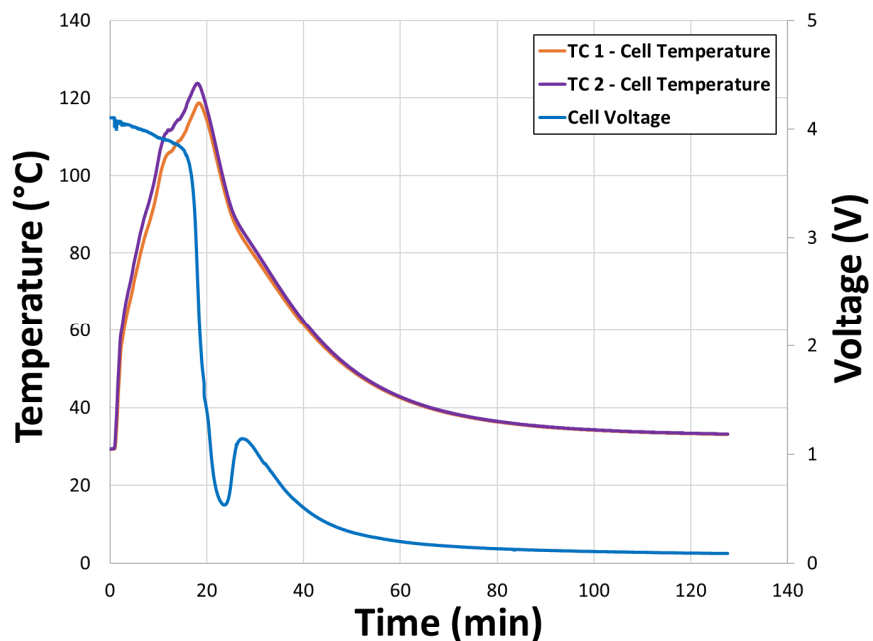
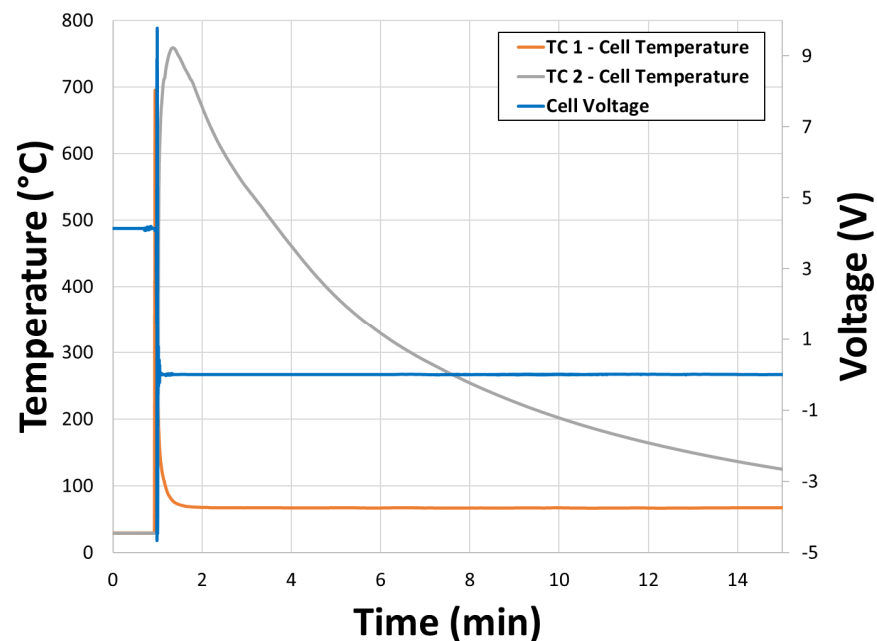
- Some variance observed testing NCA 18650s, but in both cases failure lower impedance than that observed for LCO cells
