## MOTIVATION

Additive manufacturing (AM) has great potential to revolutionize designs. However, for high-reliability applications, the scatter in material properties must be well characterized and understood. Properties of a selectively laser melted additively manufactured aluminum alloy AlSi10Mg were characterized. Multiple defect types from the AM process had impacts on the material properties. Using fractographic analysis, layer thickness of unfused powder on the outer build surfaces of each sample and porosity are found to increase with certain build parameters and locations. These flaws determine the mechanical behavior of each sample and point to important phenomena that need to be considered by designers.

## Laser Powder Bed Fusion and High Throughput Tensile Testing

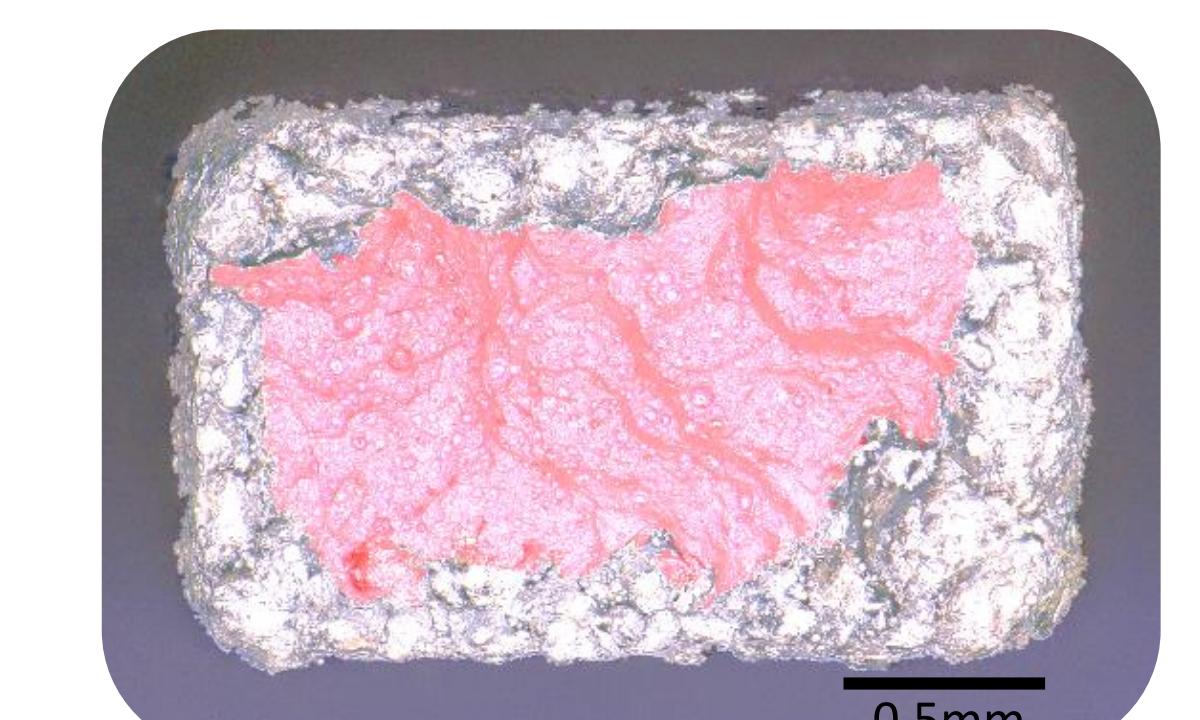
Adjusting for the crust area  
Ultimate Tensile Strength Doubles  
Yield Strength Increases  
Unloading Modulus Increases
