Mechanical Property Variation in Metal Lattice Structures

Amber Dressler, Dr. Carolyn Seepersad
Department of Mechanical Engineering
The University of Texas at Austin

Improve the understanding of how defects impact mechanical properties to enhance designers' ability to manufacture metal lattice structures reliably.

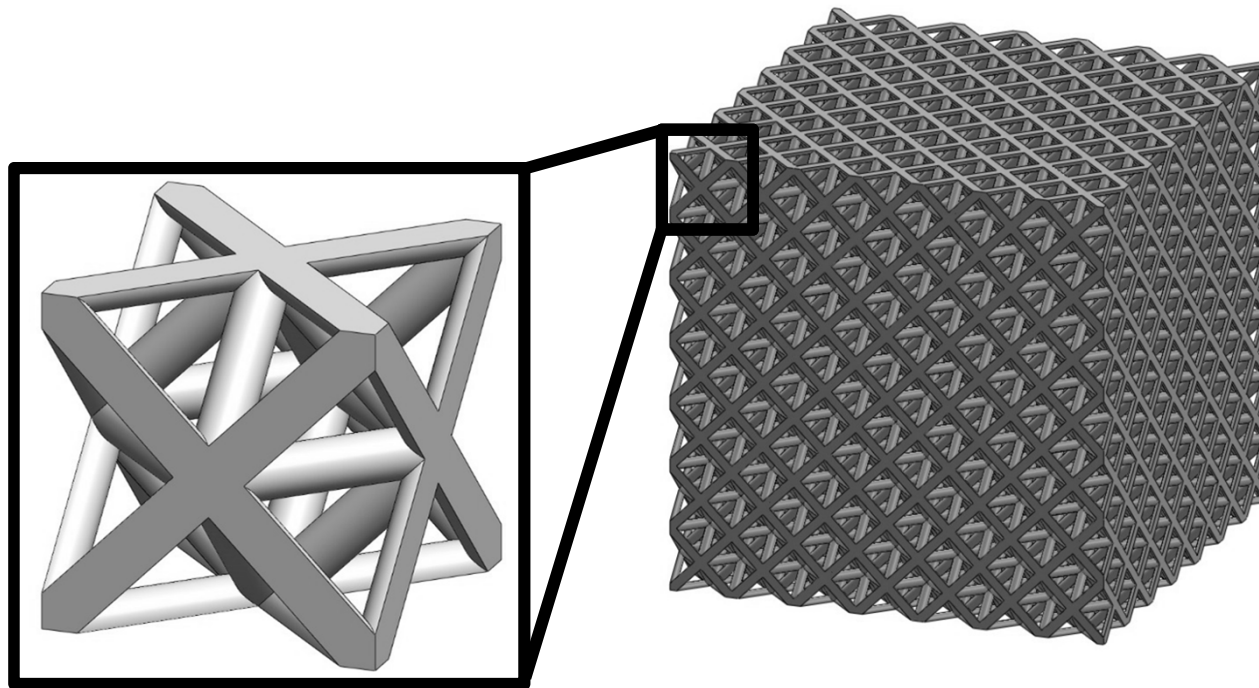
Octet Truss Lattice

- Lattice structures offer favorable tradeoffs between strength and weight
- Structurally efficient due to nodal connectivity

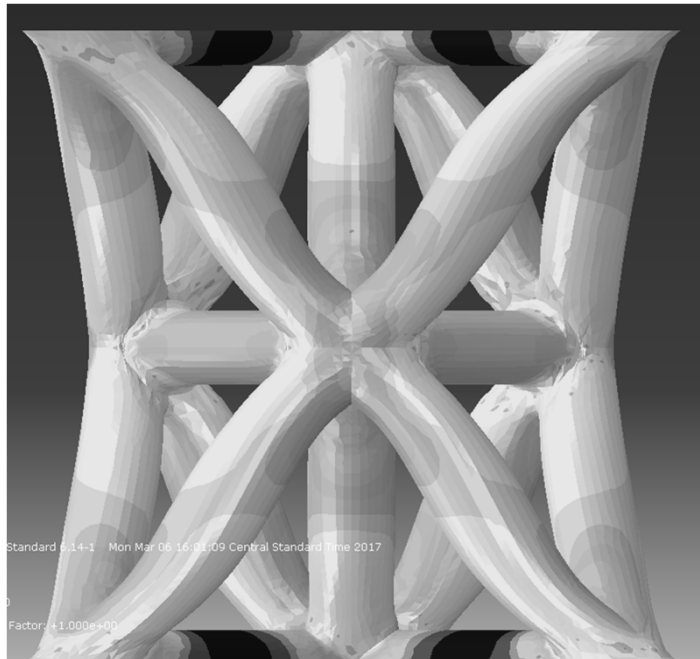
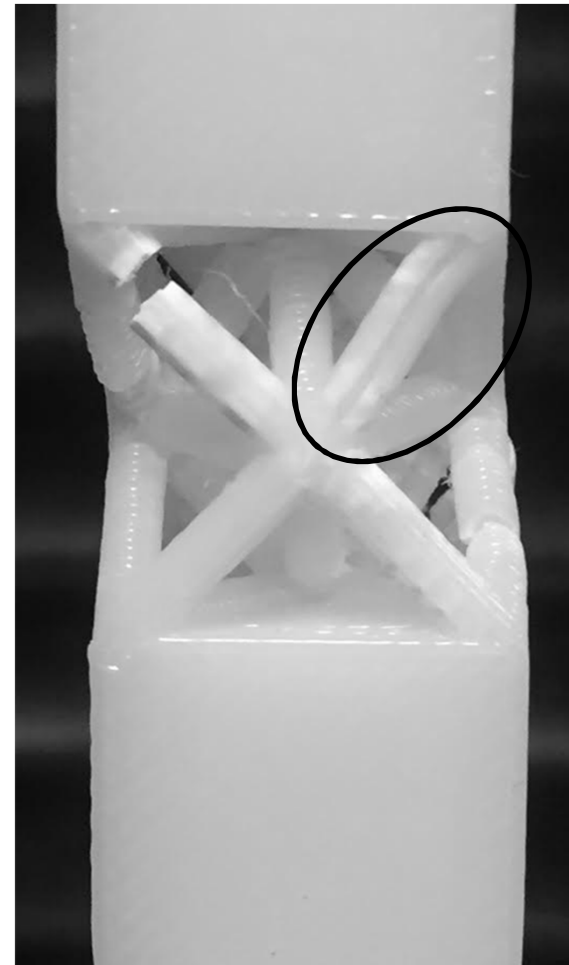
Deformation Studies

Plastic Test

Abaqus Simulation

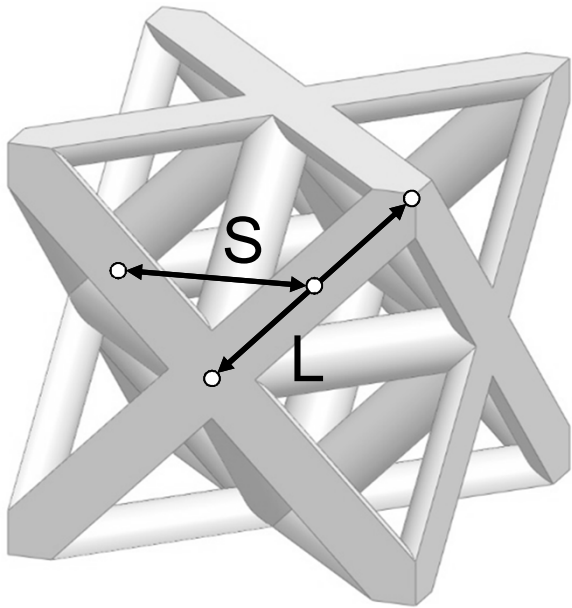
Vertical Strut Builds

- Spacing based on the octet truss design
- Horizontal and vertical copies
- Three different sizes (representing 3, 4, and 5 mm unit cells)

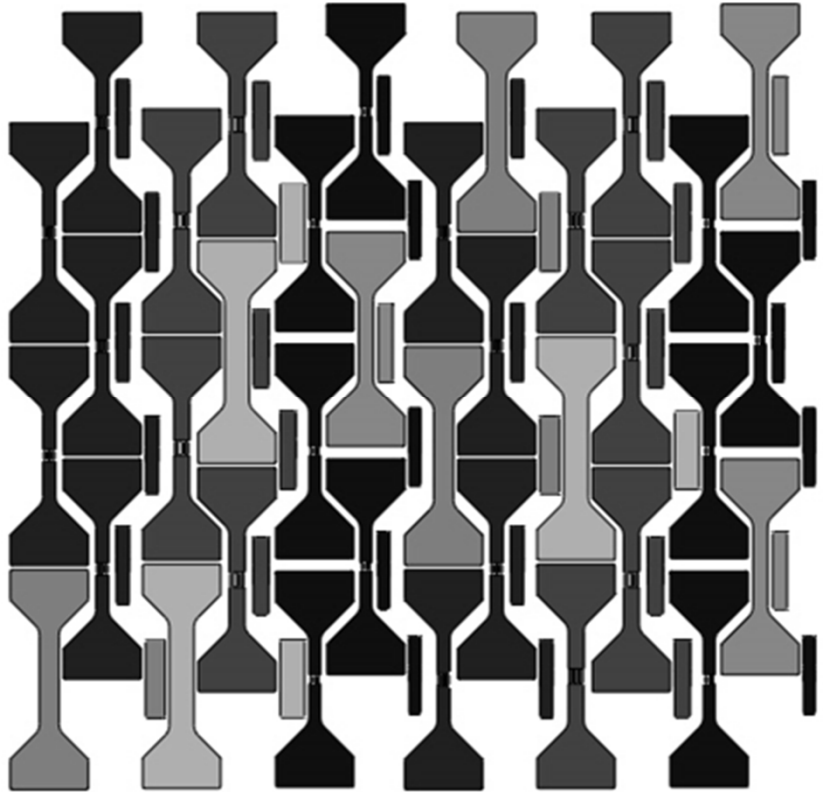
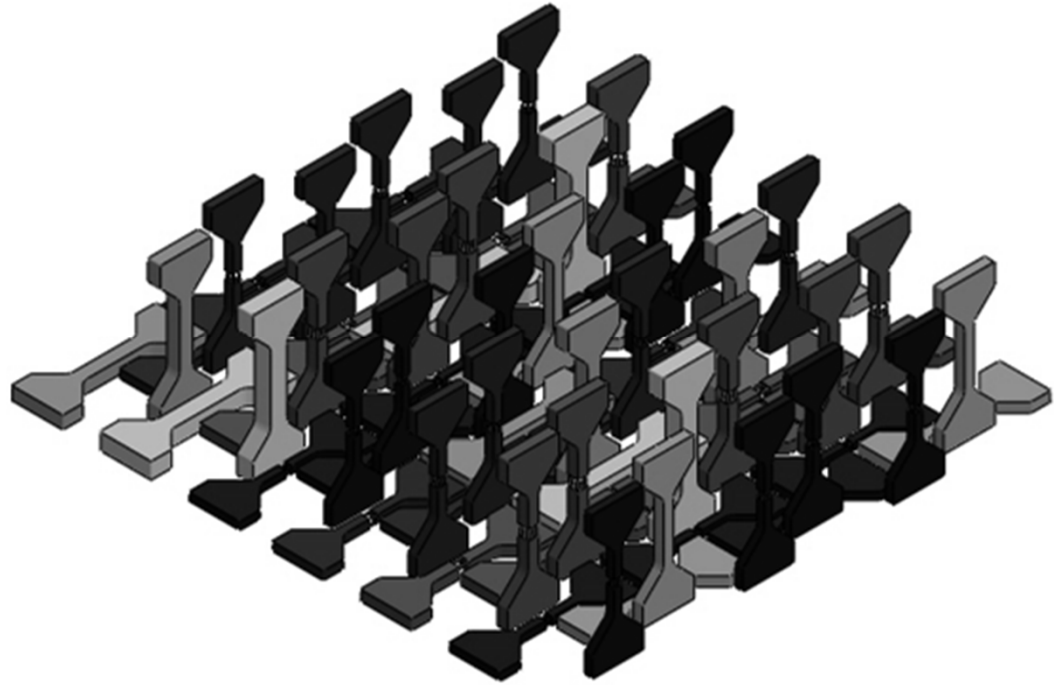
Build Layout

1. DMLS the 17-4PH steel parts on an EOS M270
2. Heat treat while on build platform: Austenitizing by heating (solutionizing) to 1900°F for an hour, then air/oil cool
3. Remove from build platform
4. HIP with the following parameters: 2125±25 °F x 240±60 min x 14.75±0.25 ksi
5. Heat treat again: Austenitizing by heating (solutionizing) to 1900°F for an hour, then air/oil cool, and then complete the H1150 heat treatment.

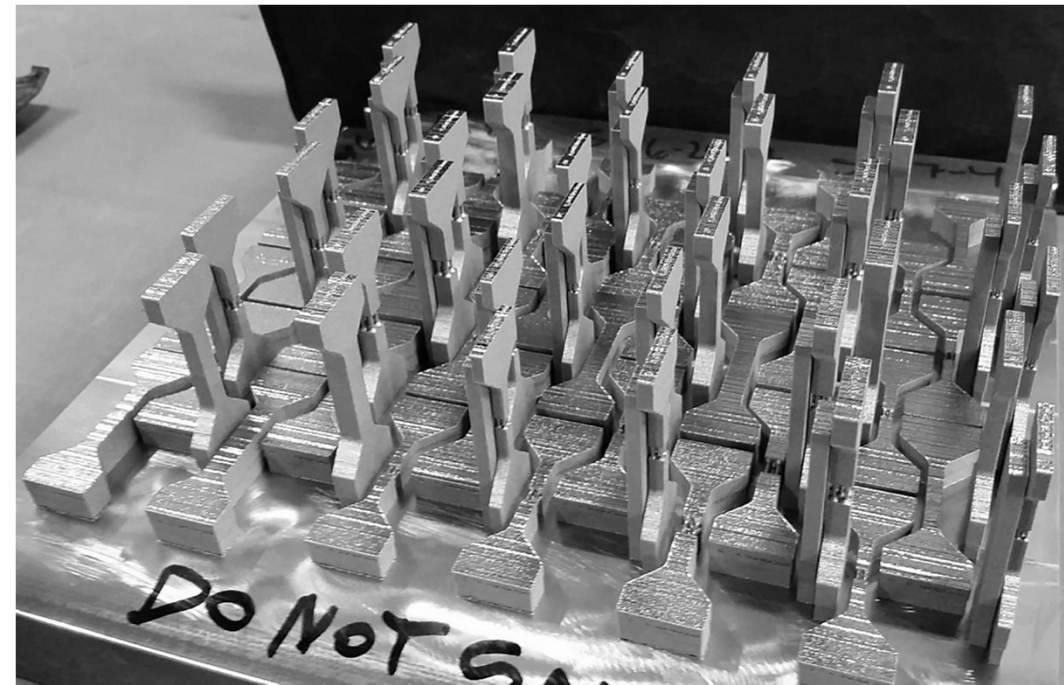
Rebuild Results

Unfortunately, horizontal bars were broken during removal from the build platform.

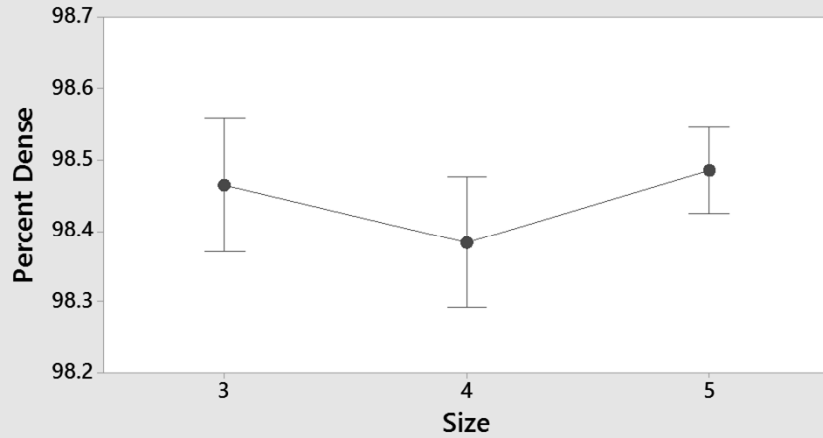
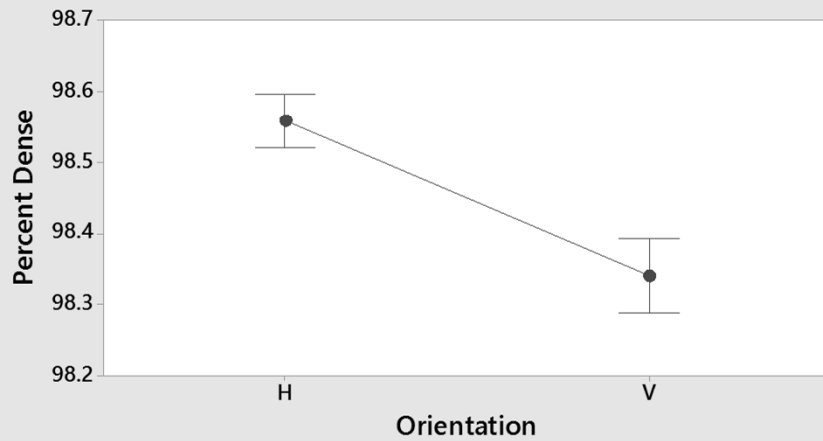
Density Effects-Strut Bars

Interval Plot of Percent Dense
95% CI for the Mean

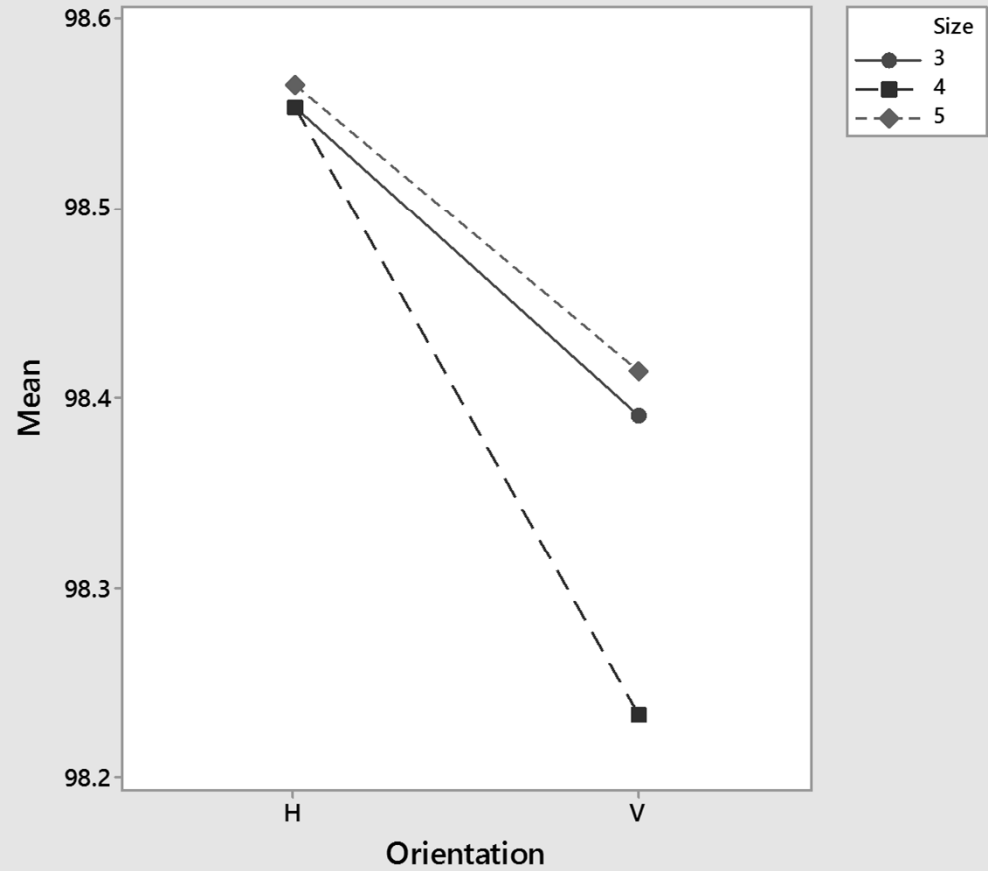
Interaction Plot for Percent Dense
Data Means

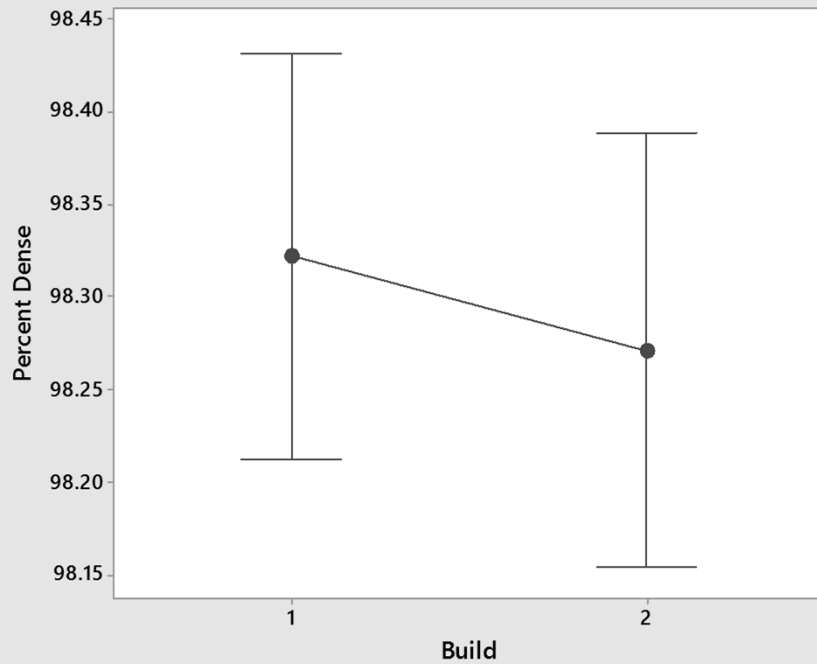
Density Effect-Solid Bars

Interval Plot of Percent Dense_1
95% CI for the Mean

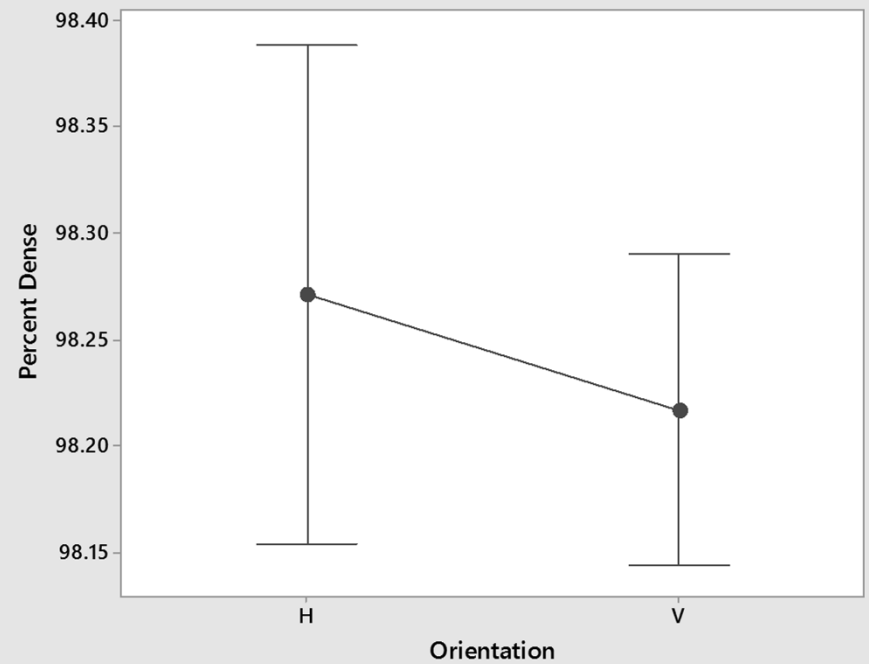
Interval Plot of Percent Dense_1
95% CI for the Mean

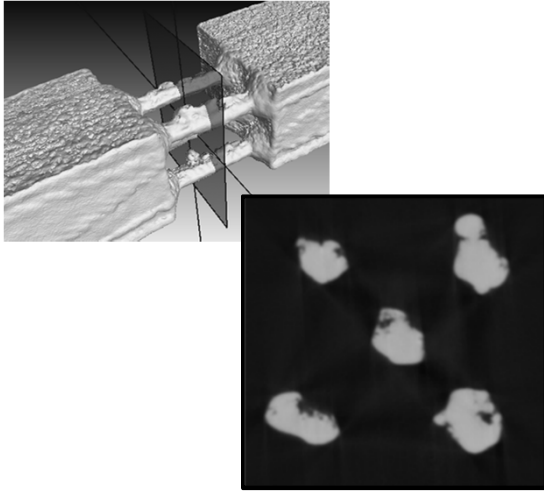
<p>This panel shows a 3D CT reconstruction of a horizontal bar with three 3 mm diameter bars. The 3D view includes a vertical plane and a horizontal plane. The corresponding 2D slice shows four bright spots arranged in a diamond pattern, representing the cross-sections of the three bars.</p>

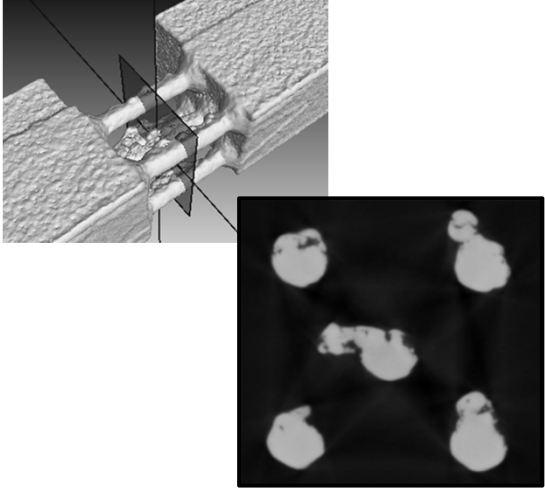
<p>This panel shows a 3D CT reconstruction of a horizontal bar with three 4 mm diameter bars. The 3D view includes a vertical plane and a horizontal plane. The corresponding 2D slice shows four bright spots arranged in a diamond pattern, representing the cross-sections of the three bars.</p>

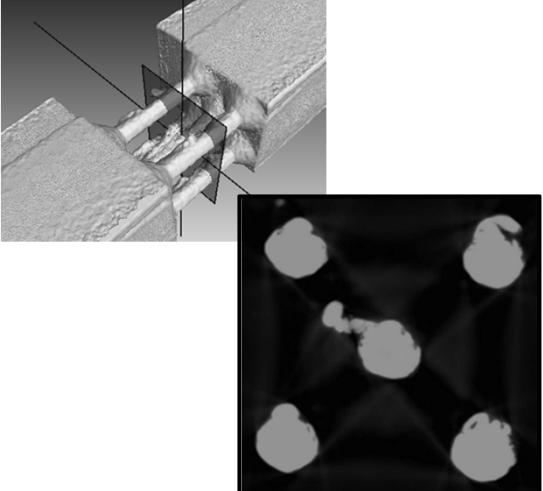
<p>This panel shows a 3D CT reconstruction of a horizontal bar with three 5 mm diameter bars. The 3D view includes a vertical plane and a horizontal plane. The corresponding 2D slice shows four bright spots arranged in a diamond pattern, representing the cross-sections of the three bars.</p>

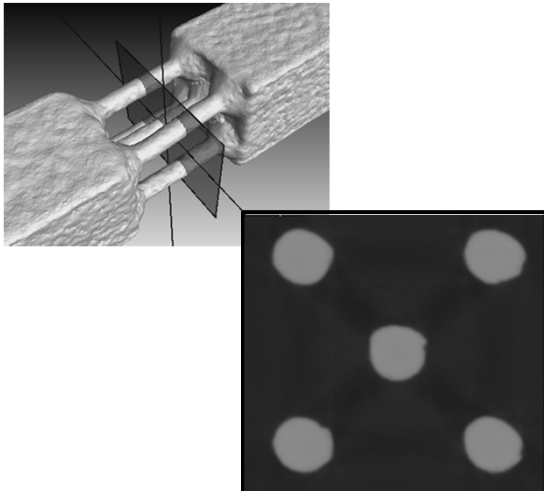
<p>This panel shows a 3D CT reconstruction of a vertical bar with three 3 mm diameter bars. The 3D view includes a vertical plane and a horizontal plane. The corresponding 2D slice shows four bright spots arranged in a diamond pattern, representing the cross-sections of the three bars.</p>

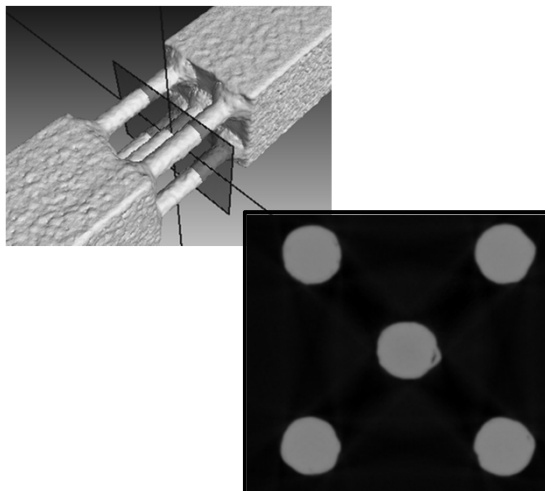
<p>This panel shows a 3D CT reconstruction of a vertical bar with three 4 mm diameter bars. The 3D view includes a vertical plane and a horizontal plane. The corresponding 2D slice shows four bright spots arranged in a diamond pattern, representing the cross-sections of the three bars.</p>

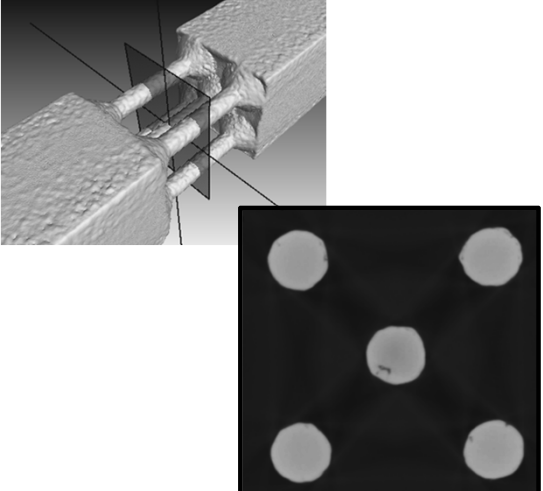
<p>This panel shows a 3D CT reconstruction of a vertical bar with three 5 mm diameter bars. The 3D view includes a vertical plane and a horizontal plane. The corresponding 2D slice shows four bright spots arranged in a diamond pattern, representing the cross-sections of the three bars.</p>

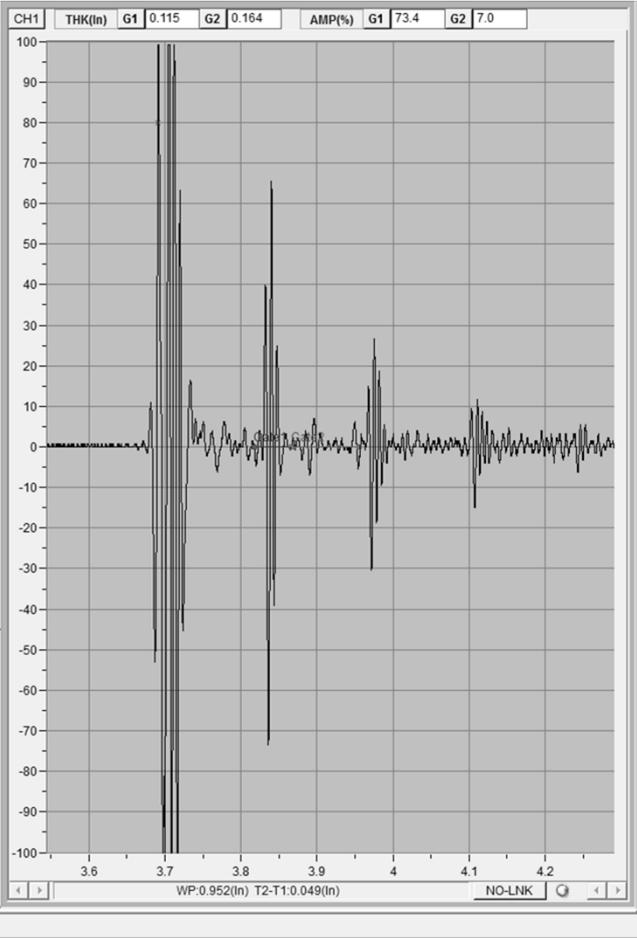
A-Scan

Ultrasonic Testing

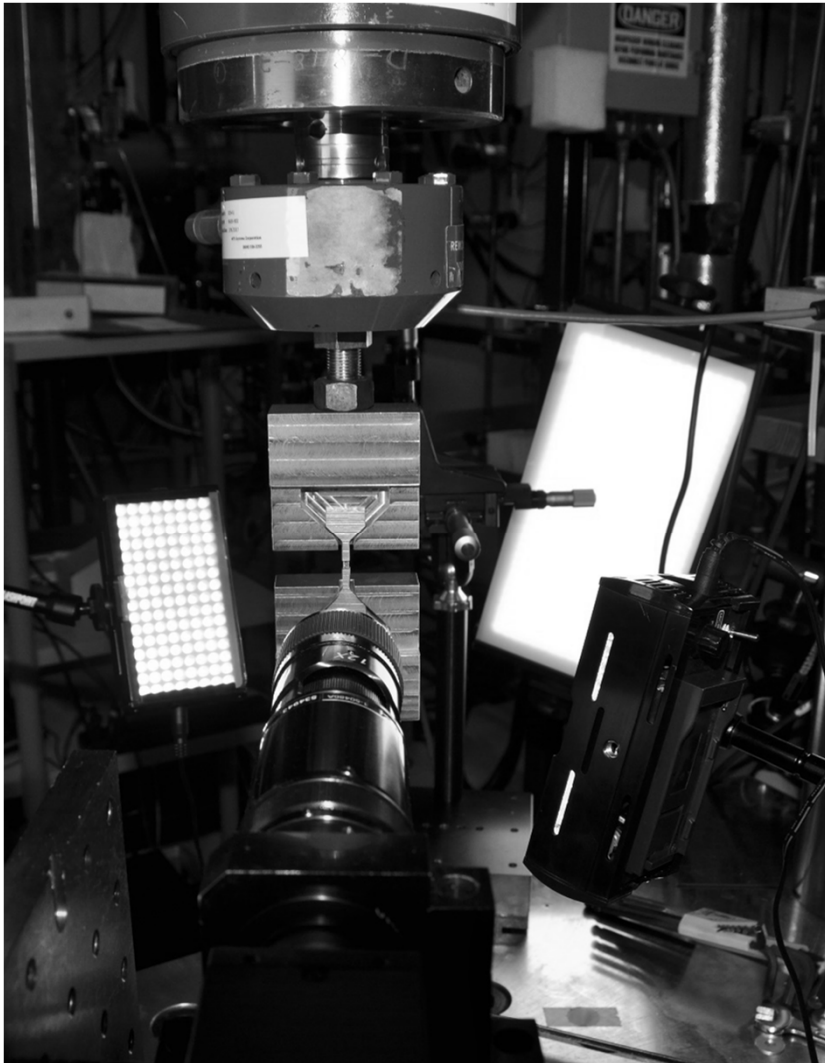
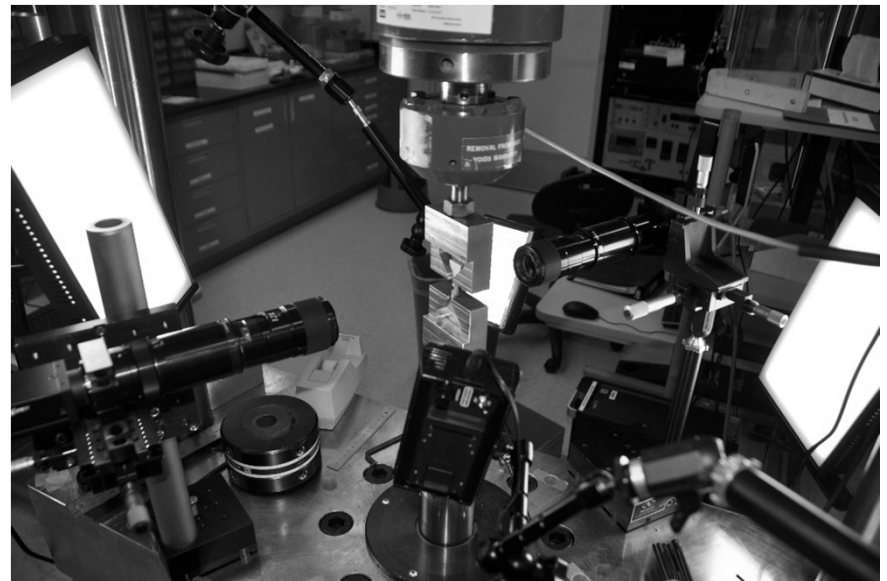
Test Setup

Data Acquisition: 15 Hz

Image Acquisition: 1 Hz

Actuator Rate:

3 mm- 0.225 mm/min

4 mm- 0.3 mm/min

5 mm- 0.375 mm/min

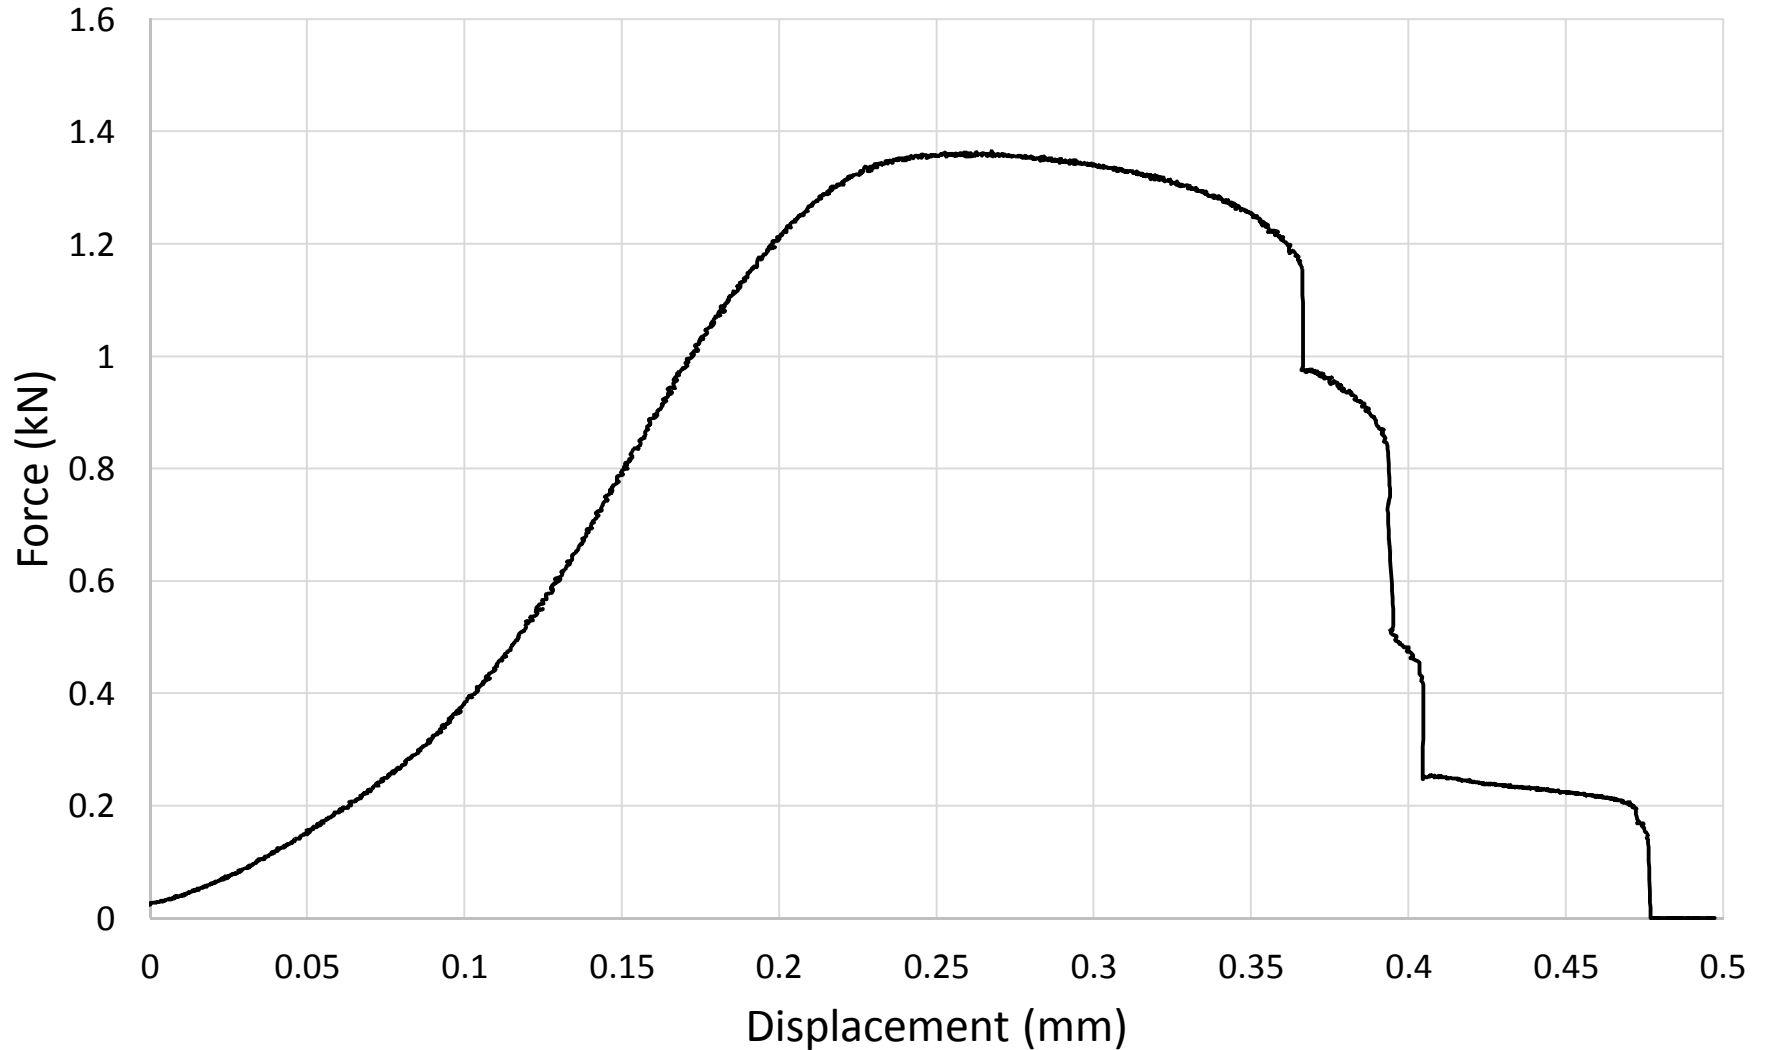
Force-Displacement: Sample 17 (4 mm)

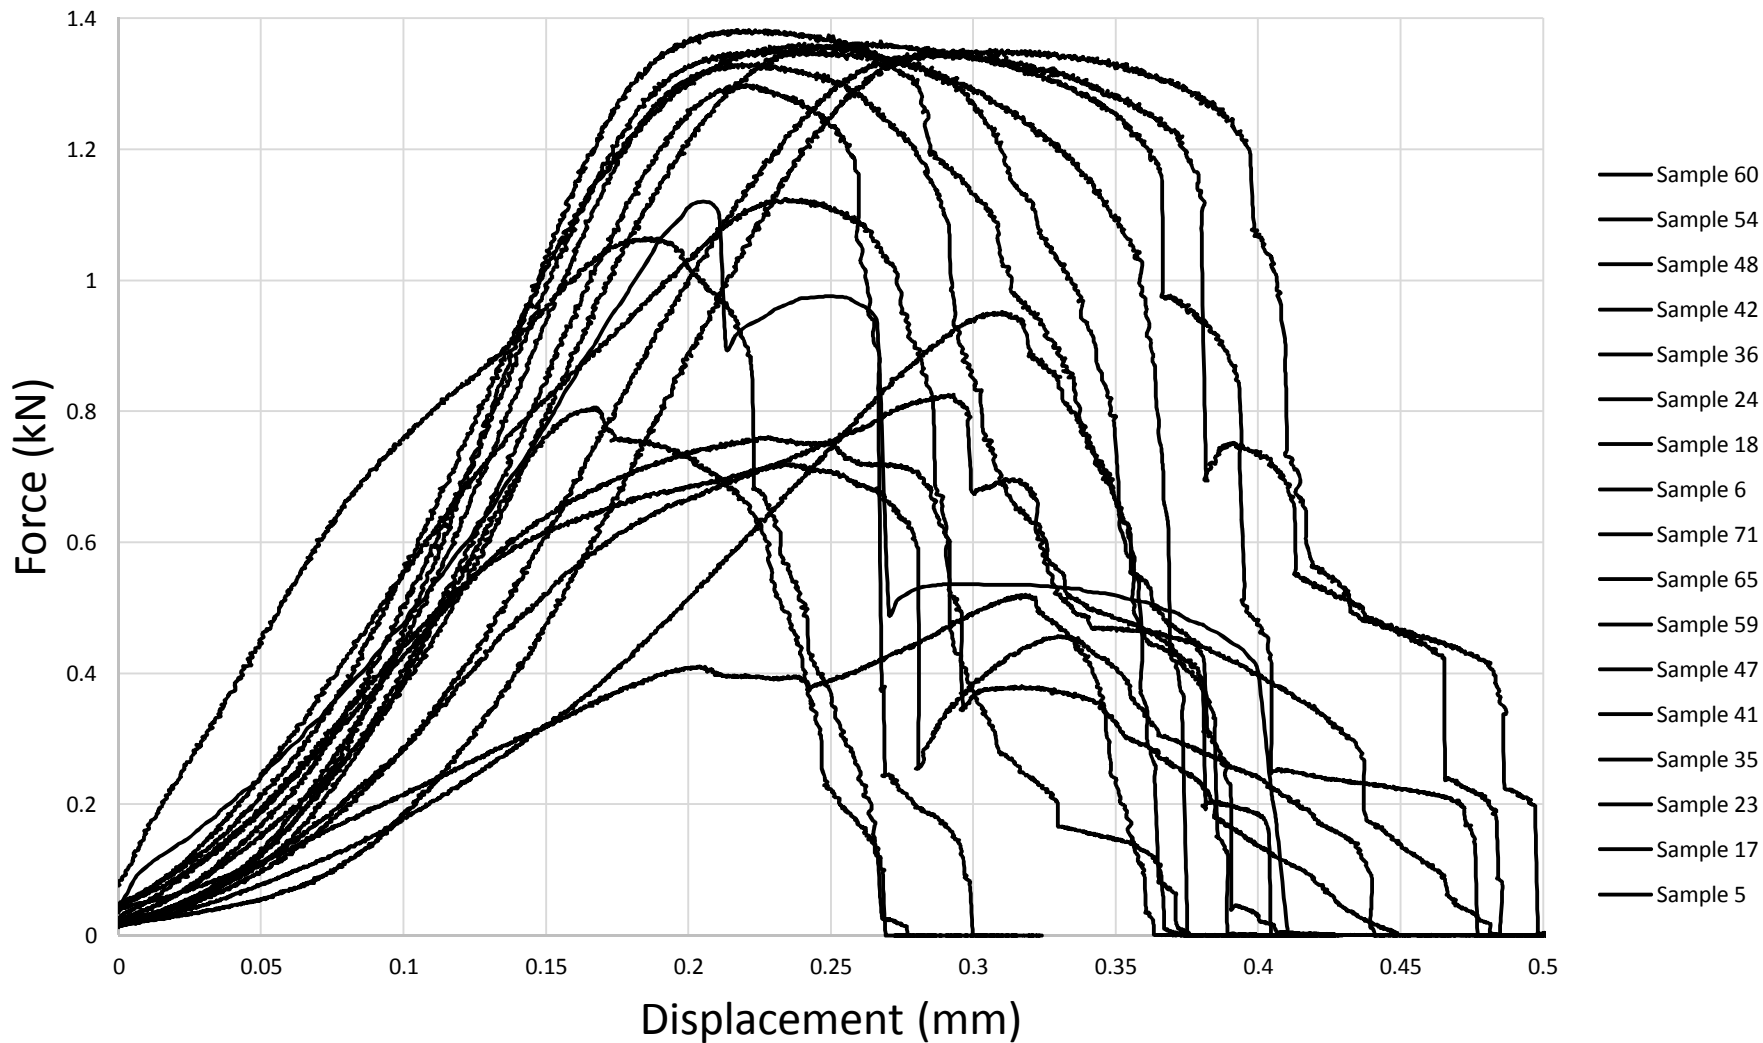
Force-Displacement: 4 mm Variation

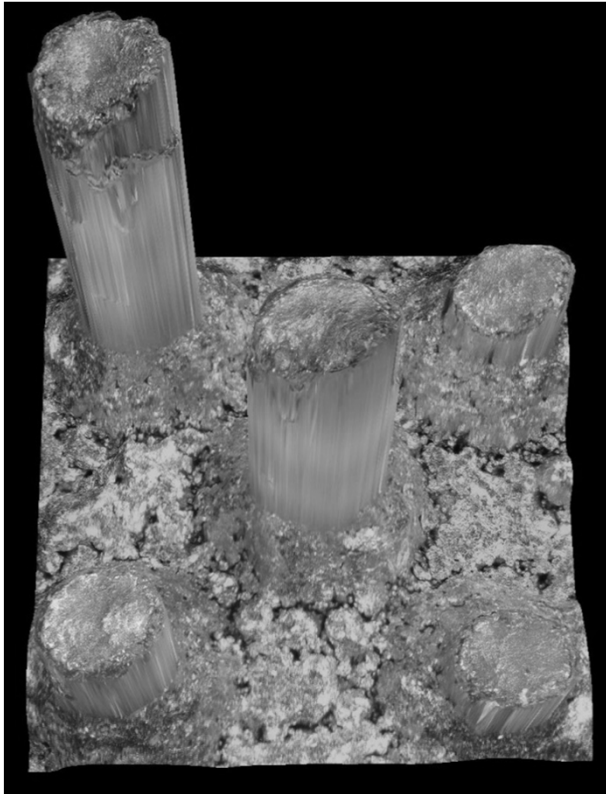
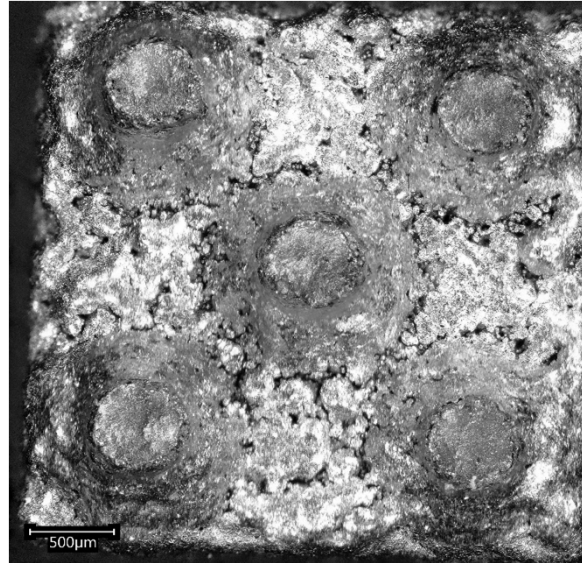
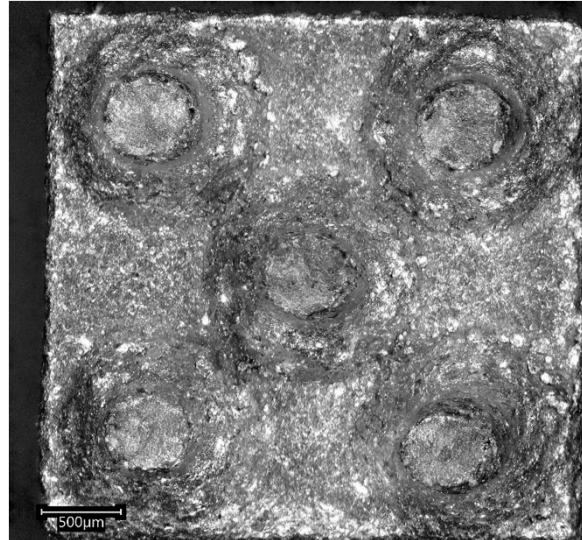
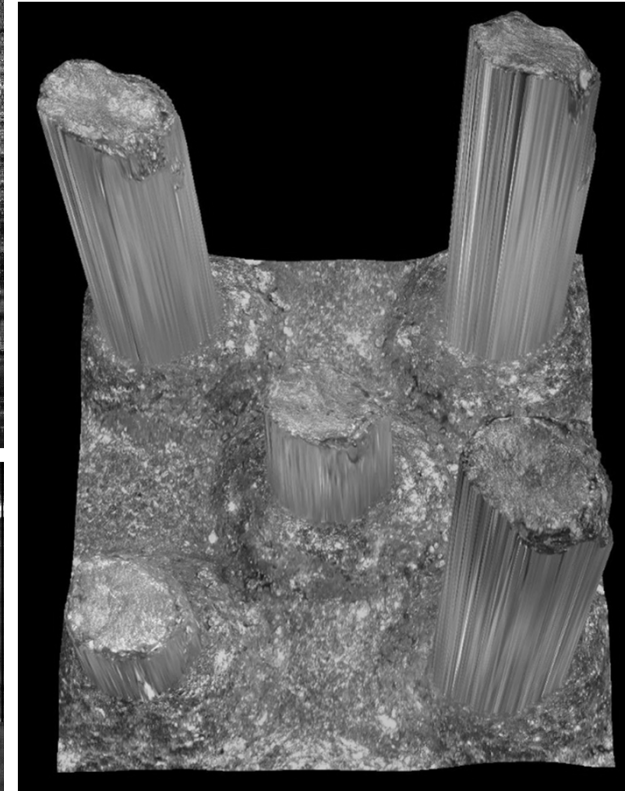
Fractography: Sample 17

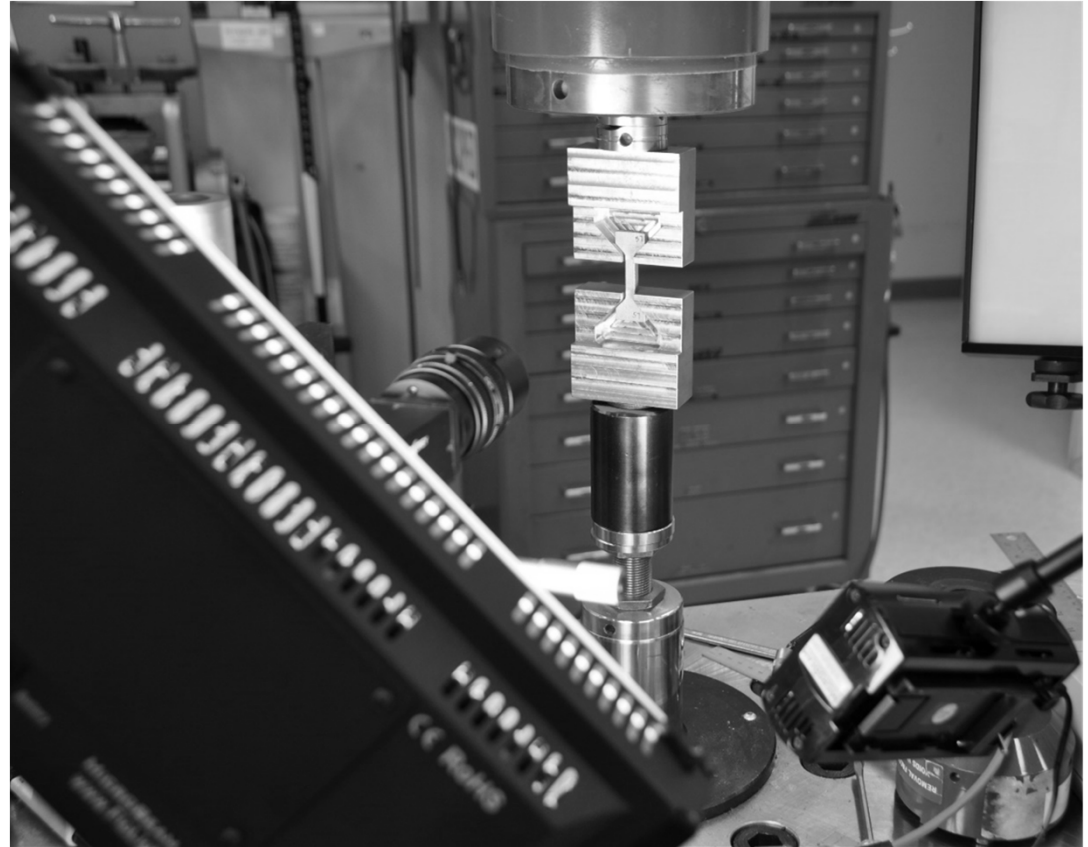
Test Setup

Data Acquisition: 15 Hz

Image Acquisition: Varied

Actuator Rate:

3 mm- 1.9 mm/min

4 mm- 2 mm/min

5 mm- 2.1 mm/min

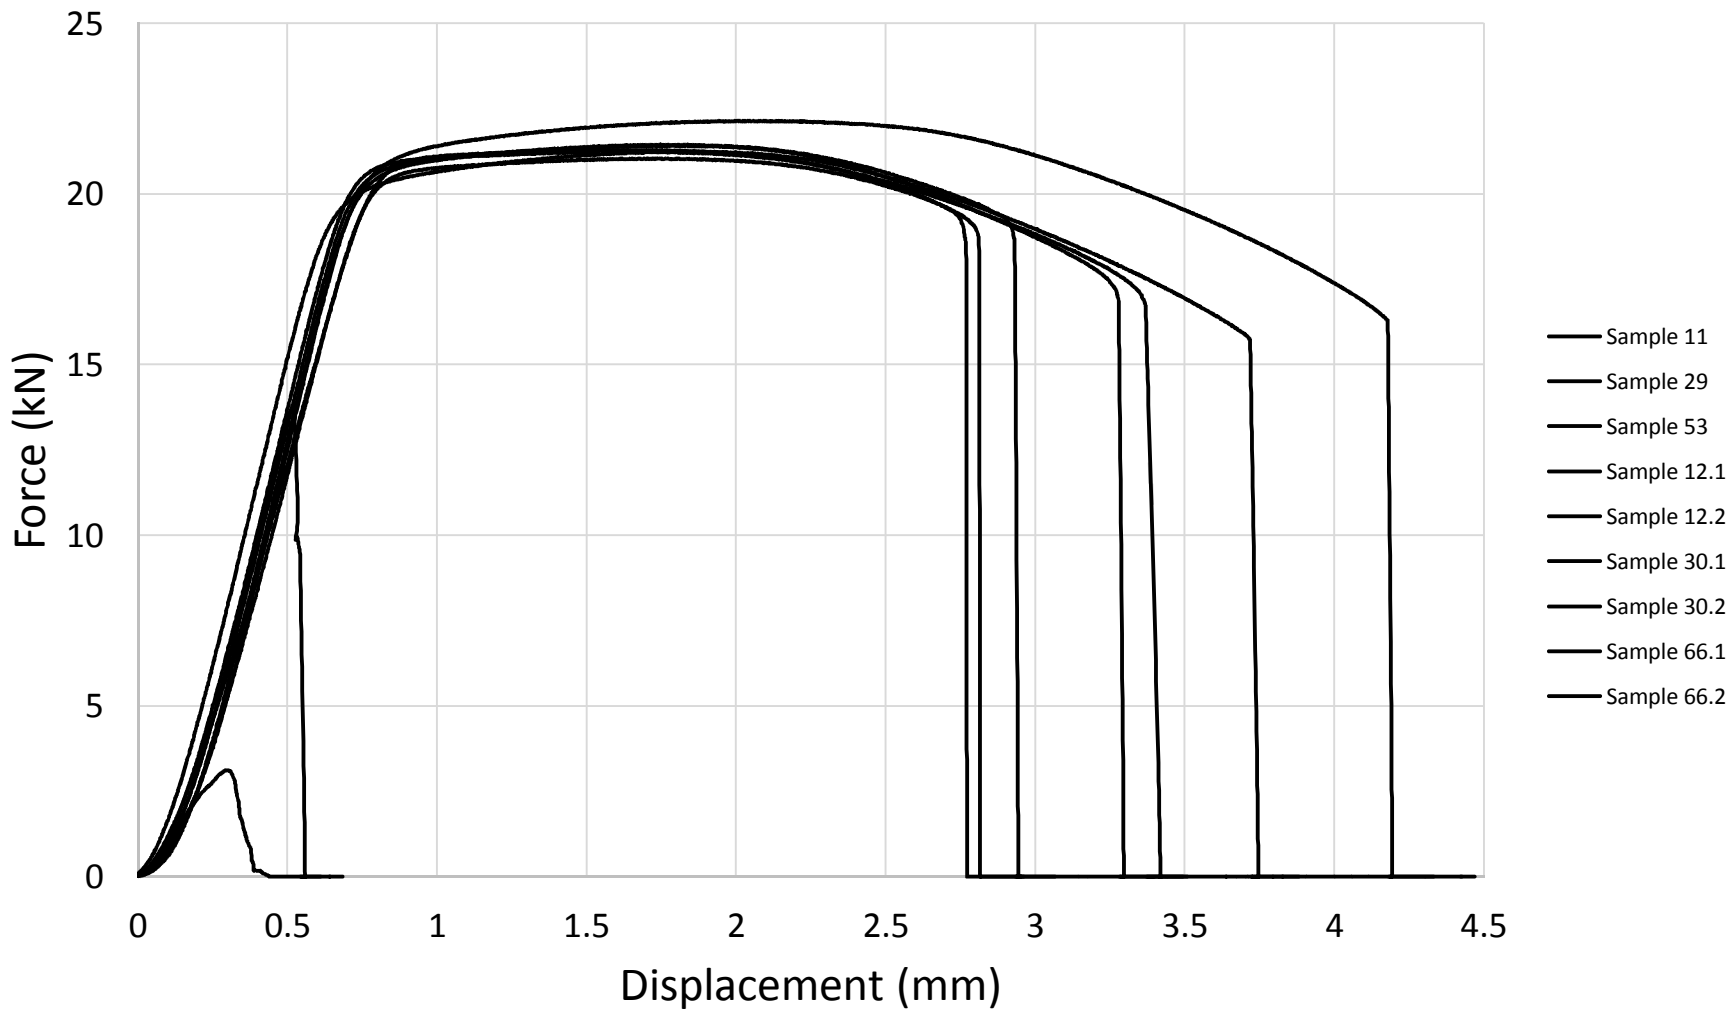
Force-Displacement: 4 mm Variation

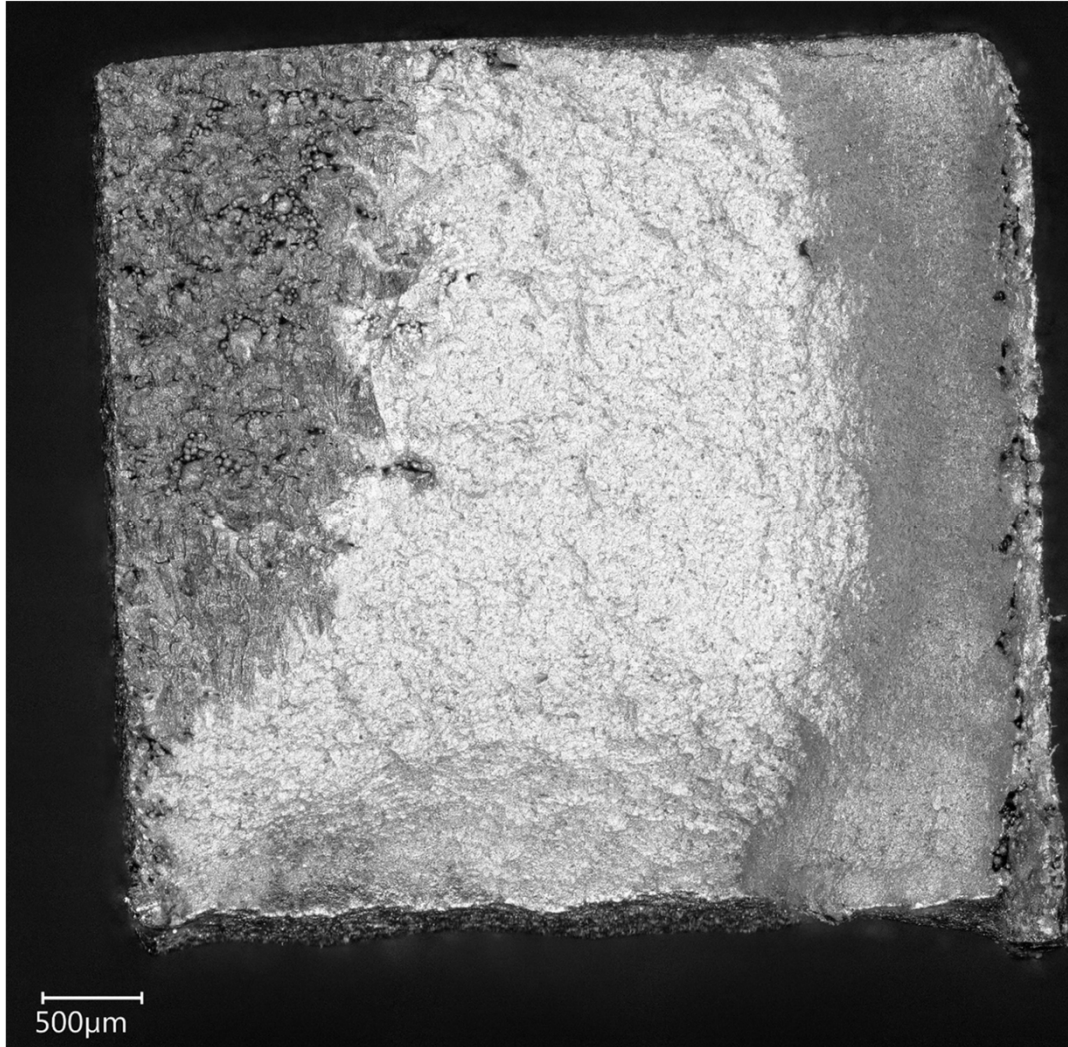
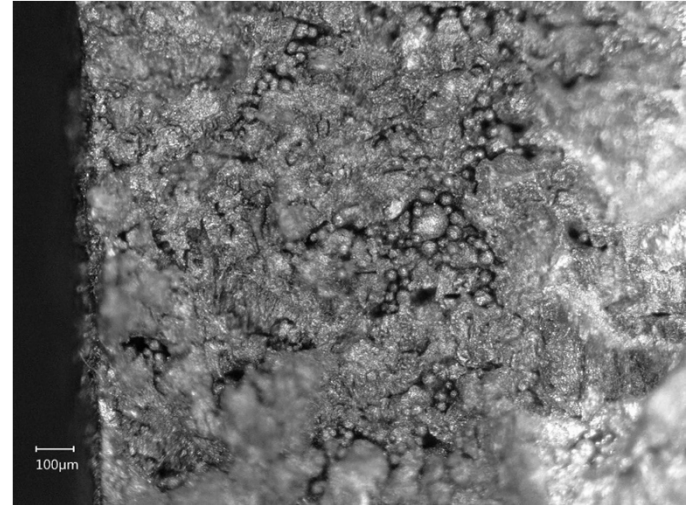
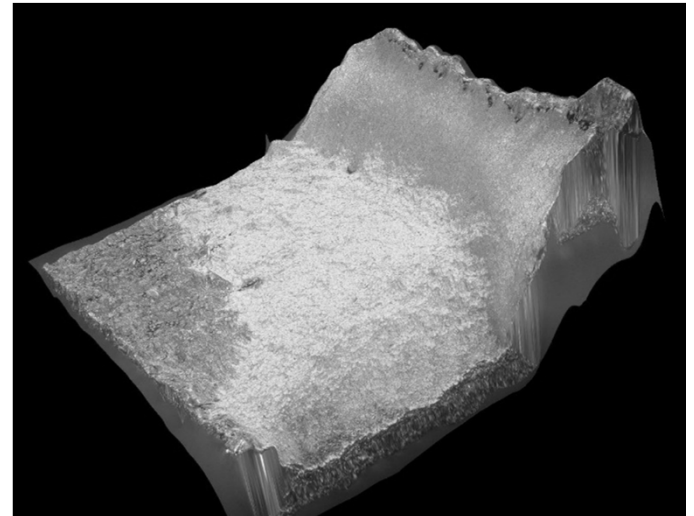
Fractography Sample 12.1

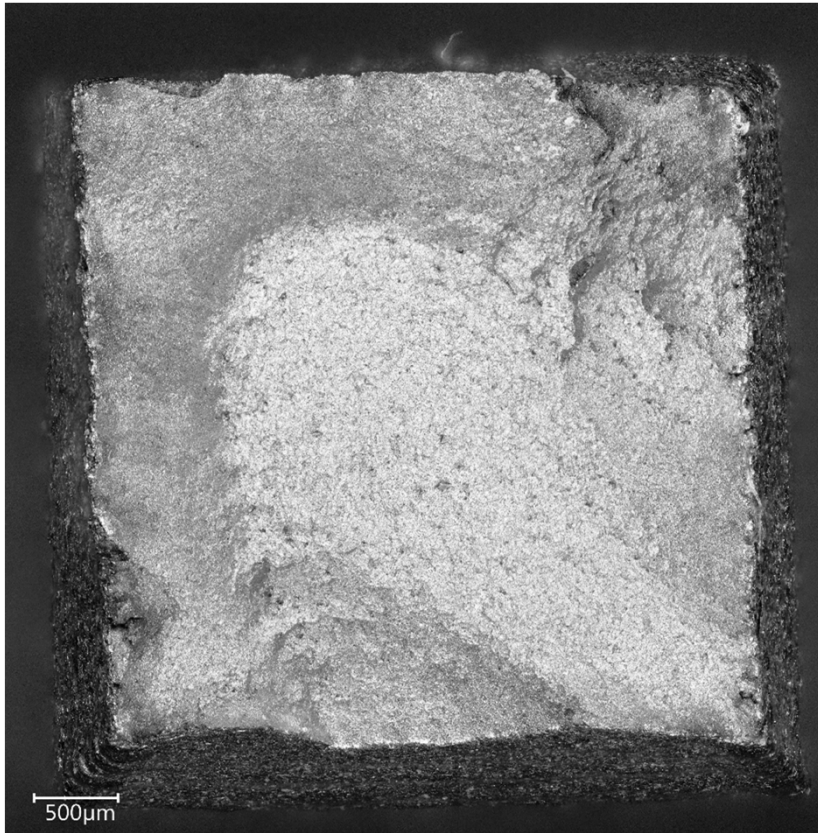
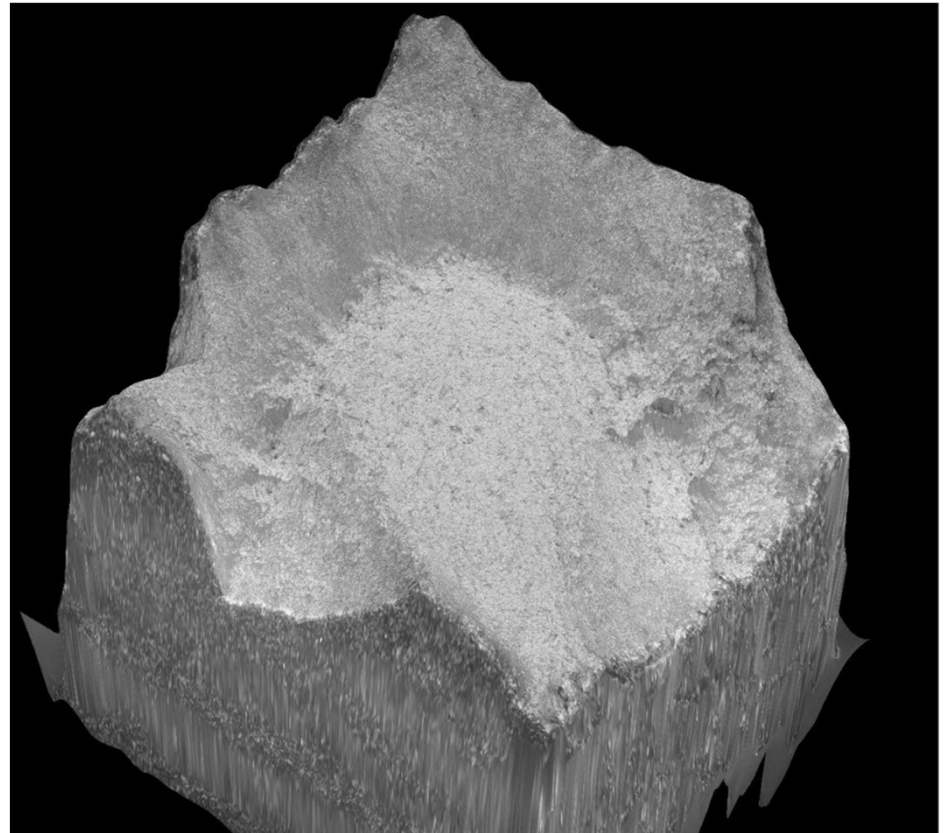
Fractography: Sample 66.1
