Mechanical Property Variation in Metal Lattice Structures

Amber Dressler, Dr. Carolyn Seepersad
Department of Mechanical Engineering
The University of Texas at Austin

Improve the understanding of how defects impact mechanical properties to enhance designers' ability to manufacture metal lattice structures reliably.

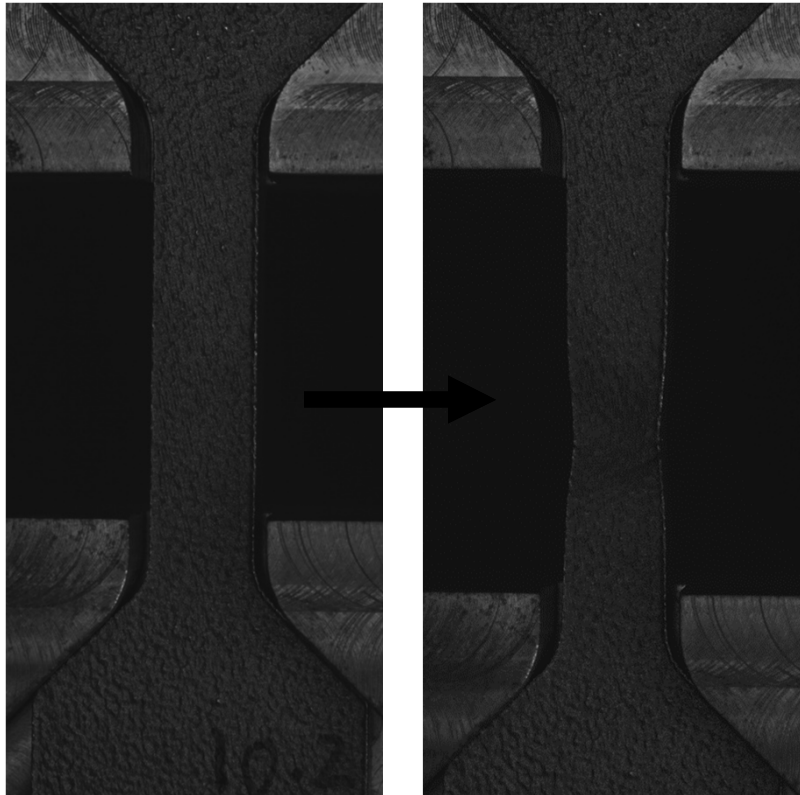
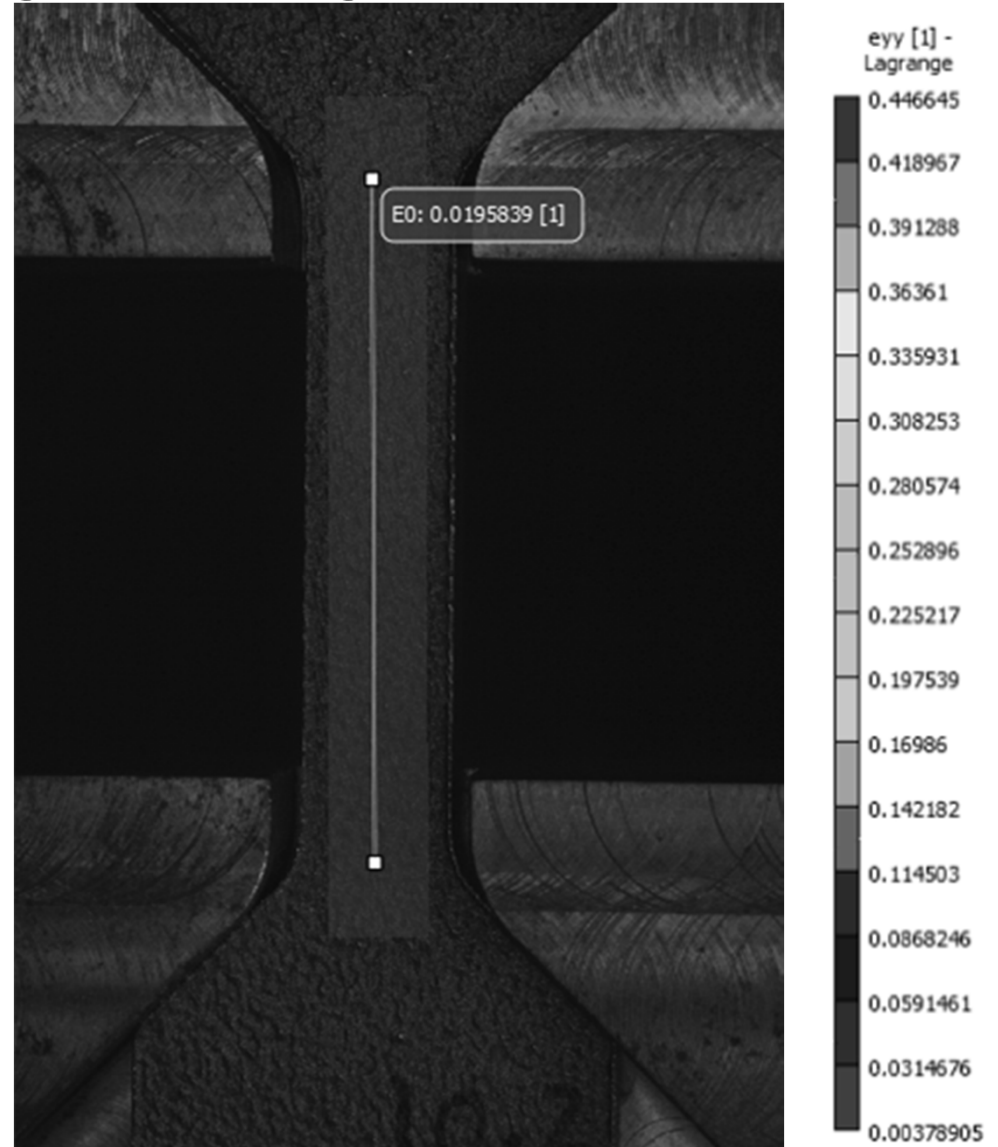
Strain through Digital Image Correlation

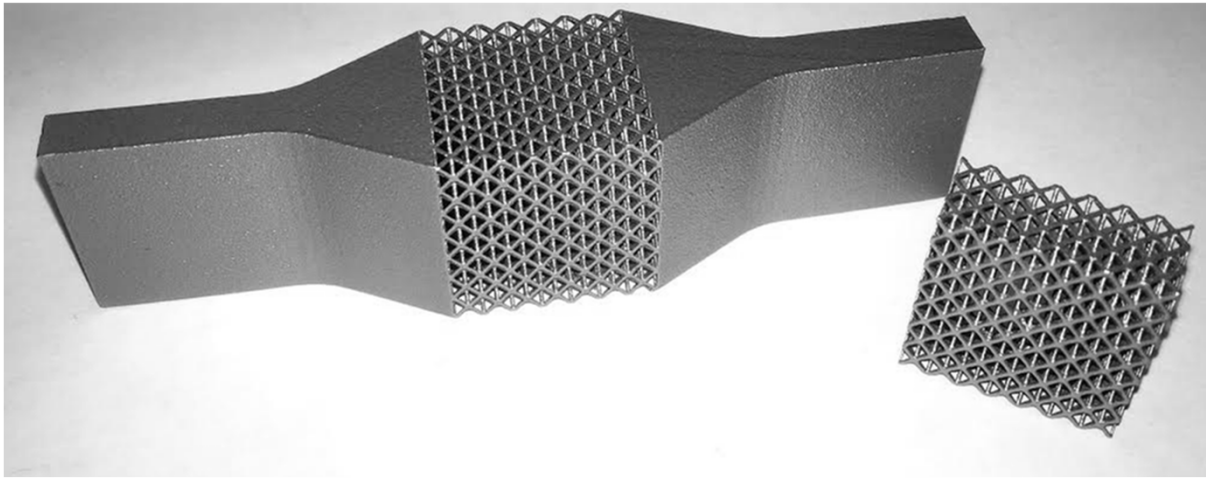
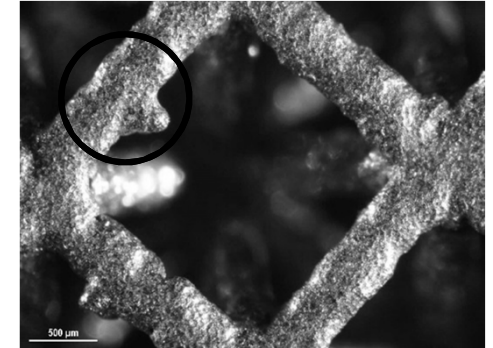
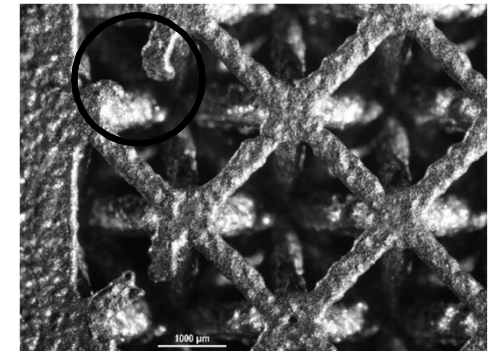
Initial Test Parts

- Small amount of powder remained in the bar
 - Removed with a needle
- Struts were not completely round
- A few struts were missing

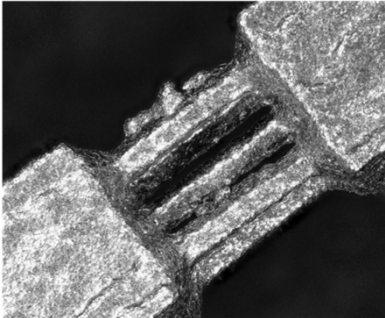
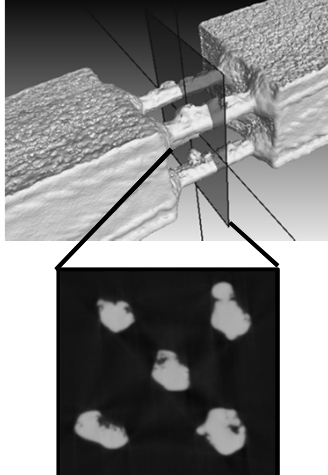
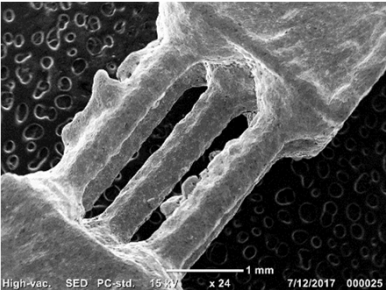
Visual Inspection	Microscope	CT Scan	SEM
3 mm Horizontal Bar
