Dynamic Measurements on Miniature Springs for Flaw and Damage Detection

Daniel P. Rohe
Structural Dynamics Department
Sandia National Laboratories*
P.O. Box 5800 - MS0557
Albuquerque, NM, 87185
dprohe@sandia.gov

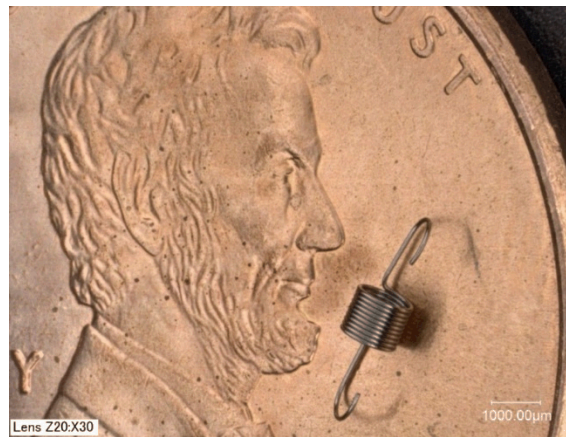
Figure 1: Small spring shown on an penny for size reference.

The spring is much smaller than the objects usually tested in the modal laboratory at Sandia National Laboratories. The wire diameter of the spring was approximately $75\ \mu\text{m}$, and the stretched length of the spring was about 0.5 cm. The mass of the spring was approximately 2 mg. Given that the smallest accelerometer owned by the modal laboratory at Sandia National Laboratories was over 100 times as massive as the spring, and any fixture onto which the accelerometer could be mounted would likely be equally as massive, the approach of identifying spring natural frequencies by measuring on the fixture itself was discarded. Instead, the laser vibrometer system would be used to measure directly on the spring itself.

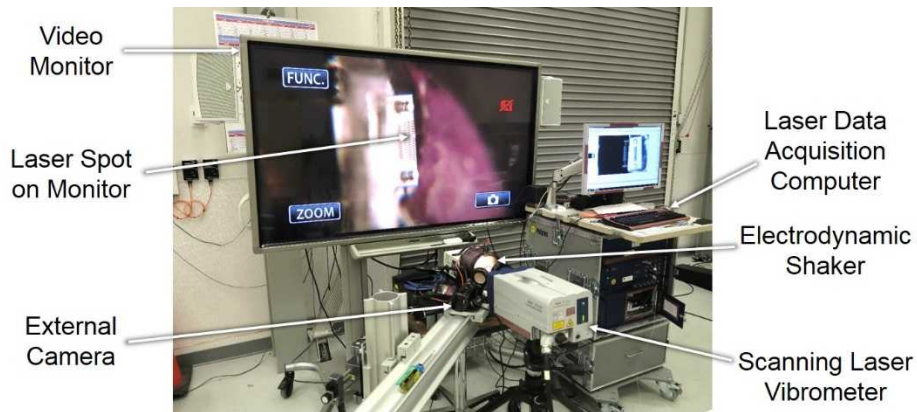
Figure 5: Overview of test setup showing the laser vibrometer, shaker, and video monitor used to find the laser spot.

The SLDV was set up to measure 21 points on each face of the spring. This was supplemented by measurement points on the fixture to verify that it was in fact moving rigidly over the bandwidth of interest. For each test the transfer function between these fixture points and the reference accelerometer was verified to be close to 1. Because the spring is small and the laser spot is relatively bright, it was difficult to determine exactly where the laser spot was on the spring. To aid in finding the laser spot, an external camera was used to view the spring close up, and the video was sent to a large monitor. A ring light was used to brighten the test setup, equalizing the video image exposure between the bright laser spot and the relatively dark surrounding image. This setup is shown in Figure 5.

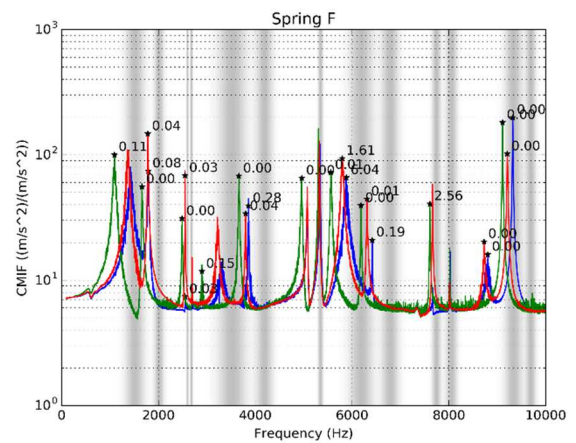
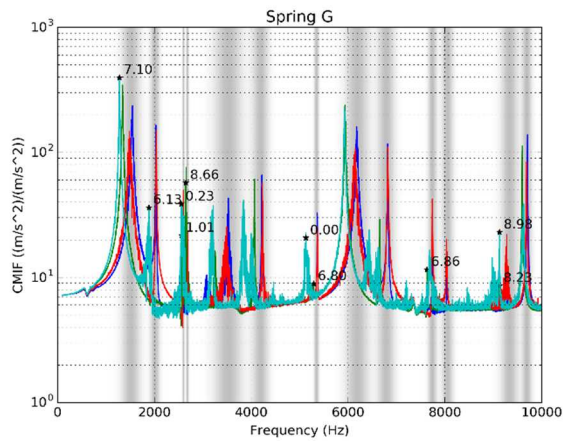
Figure 10: Spring A CMIFs

Figure 11: Spring B CMIFs

Figure 12: Spring C CMIFs

Figure 13: Spring D CMIFs

Figure 14: Spring E CMIFs

Figure 15: Spring F CMIFs

Figure 16: Spring G CMIFs

Figure 17: Spring H CMIFs

Figure 18: Spring I CMIFs

To determine which springs were flawed, natural frequencies of this new batch were compared against the distributions from the unflawed baseline data in Table 1. Comparison of a measured natural frequency to its corresponding unflawed baseline distribution establishes the likelihood of that measurement if the spring were unflawed. If a natural frequency is unlikely to be found in the healthy distribution, it suggests the spring is in some way damaged. For each measured natural frequency, the percentage of the distribution that was farther from the mean than the given natural frequency was computed. Figure 10 through Figure 18 show the CMIFs from each of the blind test springs. The healthy natural frequency distributions are shown as vertical grey bands. Peaks corresponding to natural frequencies where the percentage of the distribution farther from the mean was less than 10% are annotated.

Springs B, E, F, G, and H contain the most peaks highlighted by the 10% metric. Spring F showed the most severe deviations from the healthy distributions. Spring E broke halfway through the testing with only two of four tests completed (it turns out that a spring breaking as it is being mounted is a great indication that it had some kind of damage!). Springs A, C, D, and I had the fewest peaks highlighted by the 10% metric. Spring I had all of its peaks well within the healthy spring distributions. Although we knew prior to this analysis that we should have at most three healthy springs, four of them (A, C, D, or I) did not generate high damage metrics by our method, so all were guessed to be healthy. This was thought to be fair as in practice an analyst would not have *a priori* knowledge of how many damaged springs they would have. Table 2 shows the blind predictions compared to the actual state of the springs. Three of nine assessed states were incorrect, which is not outstanding, especially considering two of the incorrect assessments are non-conservative in the sense that they would accept a flawed article.

The data were re-examined (now with independent knowledge of which springs were actually healthy and which were flawed) to determine where potential oversights in the blind test occurred. On spring G (Figure 16), it was noted that the majority of the unlikely natural frequencies were found in the fourth test, and this test seemed to have a large amount of noise as shown by the CMIF. In the author’s experience with these springs, the increased noise could suggest that the spring was not seated quite right on the pins of the fixture, which could result in the spring sliding or banging on the pin, and might also result in changing natural frequencies. The discarding of a healthy spring is perhaps not as severe of an issue as the acceptance of a flawed spring, however. Spring A and D both show only one or two unlikely natural frequencies, so this metric may not be suitable.

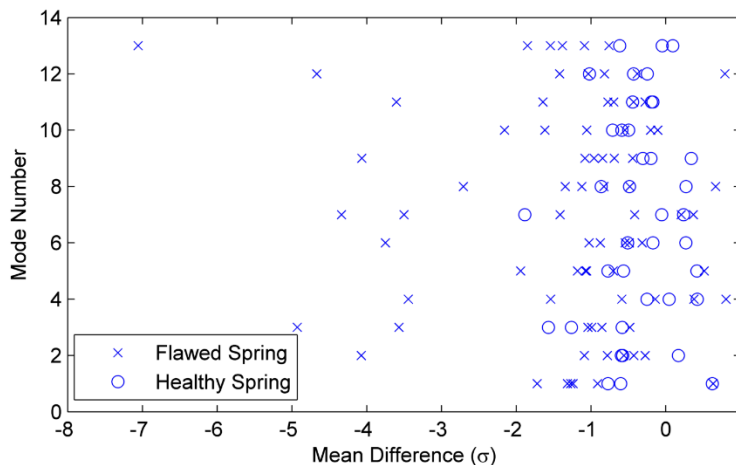
Figure 19: Number of standard deviations of the spring mean from the healthy distribution mean.

The mean first natural frequency of both spring A and D are over one standard deviation away from the mean of the healthy distribution, so this was investigated next. Bias in the mean value of the natural frequency for a given spring was examined for each mode of each spring. Table 3 shows the number of standard deviations of the spring’s mean natural frequency was from the mean of the healthy distributions. Figure 19 shows the same values in graphical form. A trend can be observed where many of the flawed springs have mean natural frequencies lower than the healthy springs, and this is to be expected as all of the imposed flaws would tend to decrease stiffness and lower natural frequencies. However, there are clear exceptions to this rule. Spring B, for example, which is a flawed spring, has mean 1st, 8th, and 12th natural frequencies well over half a standard deviation higher than the healthy spring mean natural frequencies. If an analyst were rejecting springs simply on the basis of seeing a drop in natural frequency, spring B would be accepted while a healthy spring like spring G would be discarded as it has a number of mean natural frequencies that are well below the accepted healthy spring mean.
