Summary of Zirconium Fire Investigations during Spent Fuel Pool Complete LOCAs

S.G. Durbin and E.R. Lindgren

BWR Test Series
Funded by USNRC

PWR Test Series
Funded by USNRC and OECD

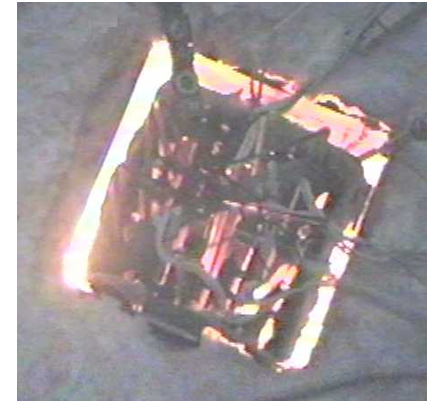
Uniform
Loading

- Assembly power 5.0 kW
 - Situational equivalent of a cluster of 100 day-old assemblies
- MELCOR within 40 K
 - Ignition predicted to within 5 minutes
- Oxygen depletion accurately modeled
 - O₂ reaction kinetics adequately represented

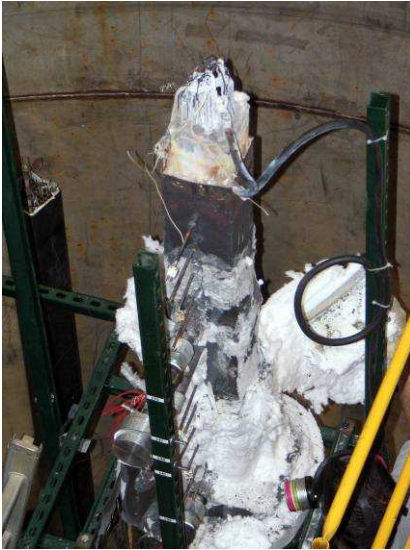
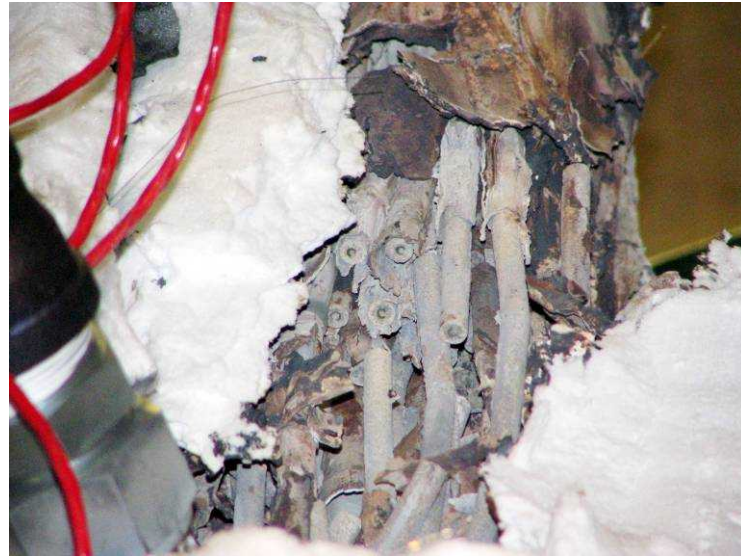
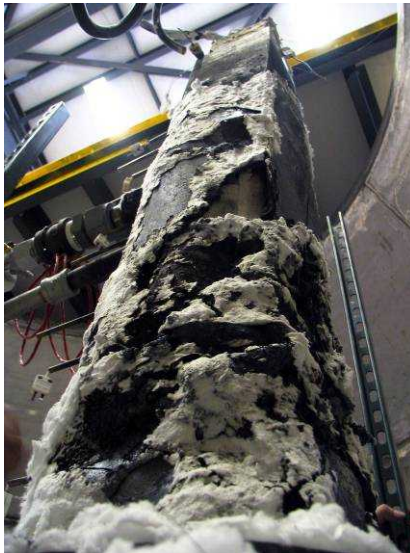
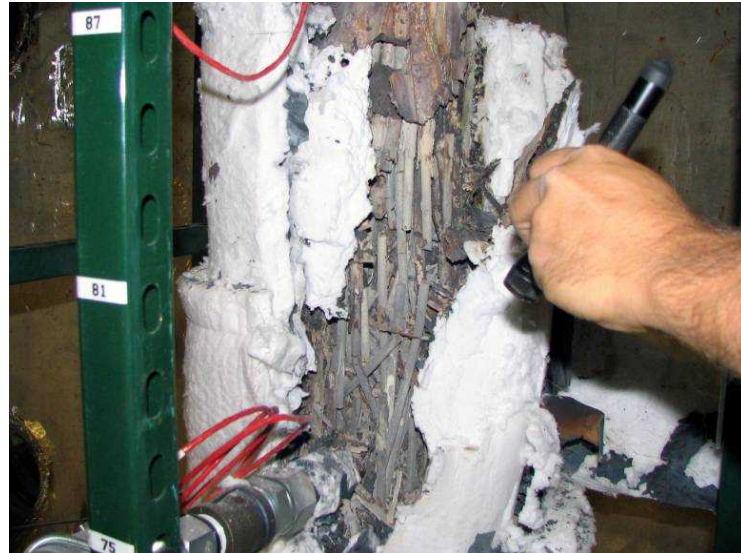
Full Length Zr BWR

- “Hot” center assembly in 1×4 arrangement
 - Equivalent of 15 day-old fuel surrounded by background assemblies
 - Air flow rates and temperatures independently controlled
- MELCOR results within 40 K
 - Ignition modeled to within 10 minutes

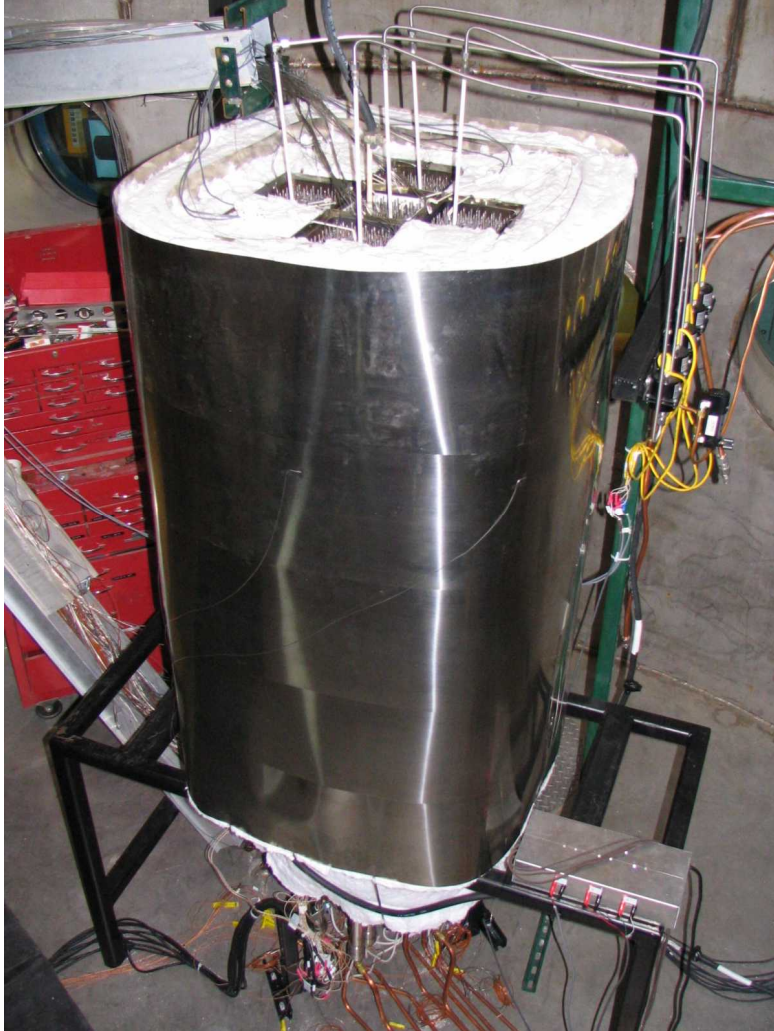
Before

BWR 1×4 Ignition

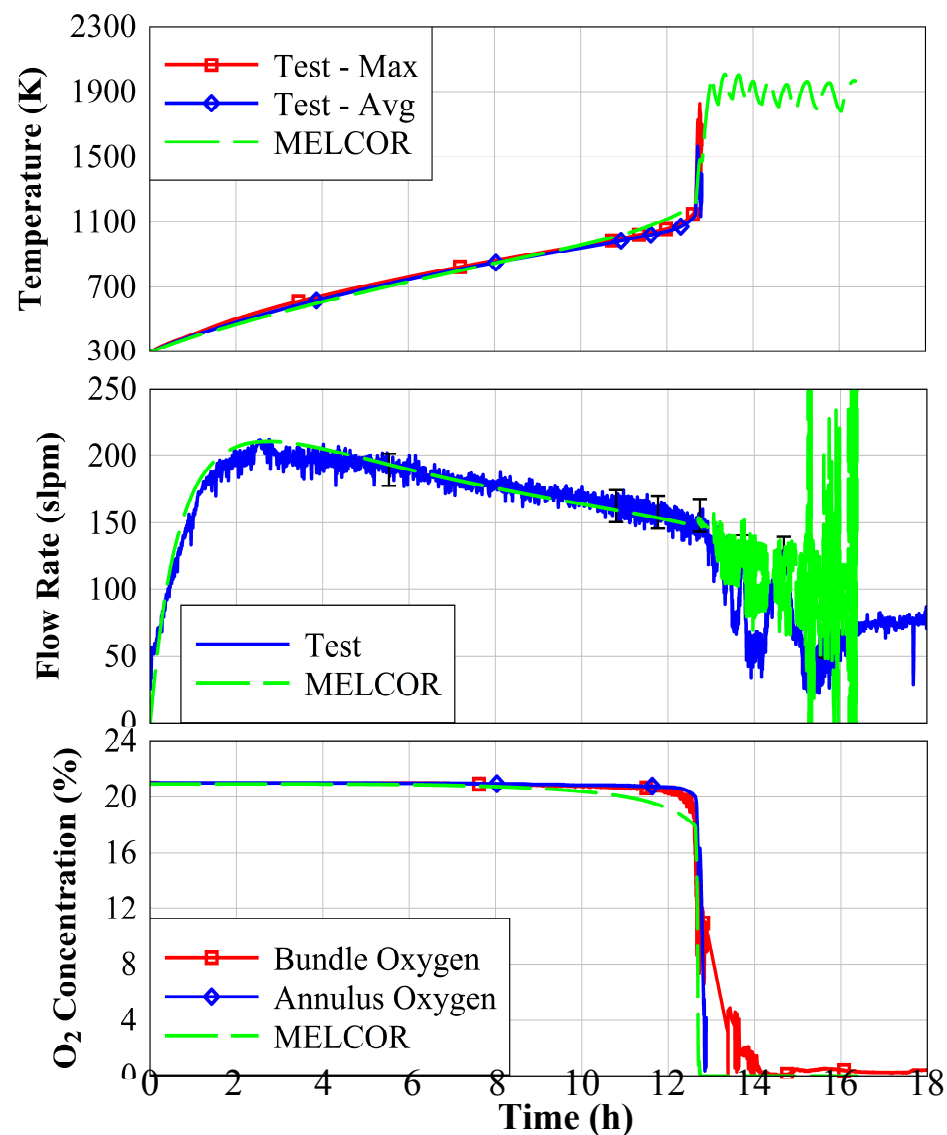
PWR Phase 1 Ignition Test Results

- Assembly power 5.0 kW
 - Situational equivalent of a cluster of 15 month-old assemblies (hot neighbor BC)
- Modeling predicts ignition within 10 minutes
- Thermocouples failed after ignition
 - Sharp transition to breakaway oxidation
 - Oxygen depletion at time of ignition
- Predicted flow rate within experimental uncertainty
- Interesting dynamics on burn-front movement
 - Usually downward to follow oxygen and fresh Zr
