Evaluation of Glare at the Ivanpah Solar Electric Generating System

Clifford K. Ho

Sandia National Laboratories
Concentrating Solar Technologies Dept.
Albuquerque, New Mexico
ckho@sandia.gov, (505) 844-2384

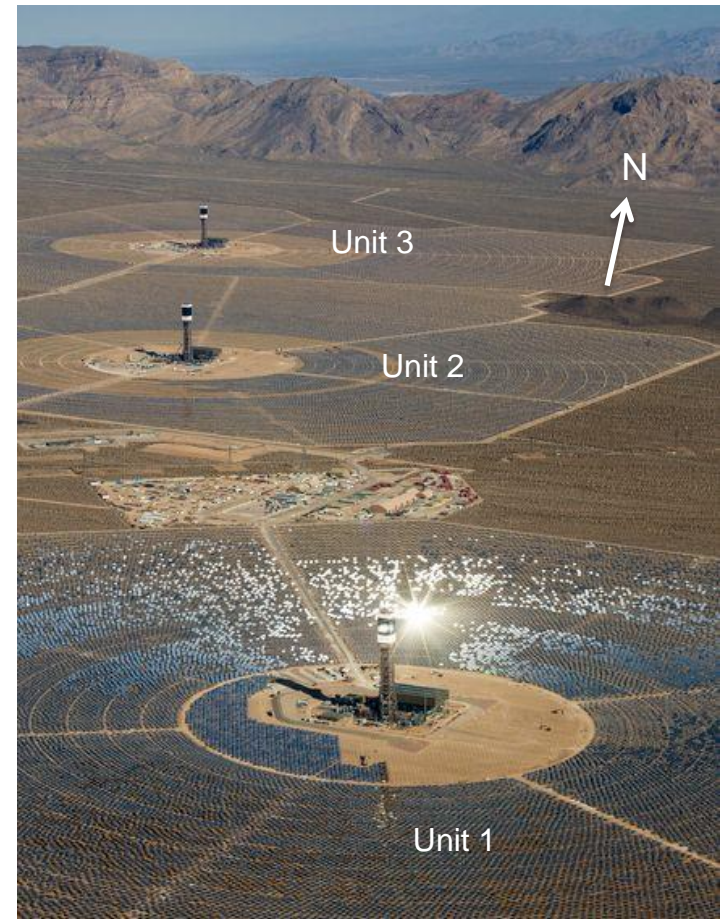
Ivanpah Solar Electric Generating System

- Three power tower units
(377 MW (net) / 392 MW (gross))
 - Unit 1: 126 MW
 - Unit 2: 133 MW
 - Unit 3: 133 MW
 - Each tower 140 m (459 ft) tall
- 173,500 heliostats
 - 2 mirrors/heliostat: 15.2 m²
- Direct steam receiver (22 m tall x 17 m wide + ~16 m of white shielding)
- Dry-cooling
- 14.2 km² (3500 acres) on public desert land in southern California
- Owners: NRG Energy, Google, and Brightsource Energy

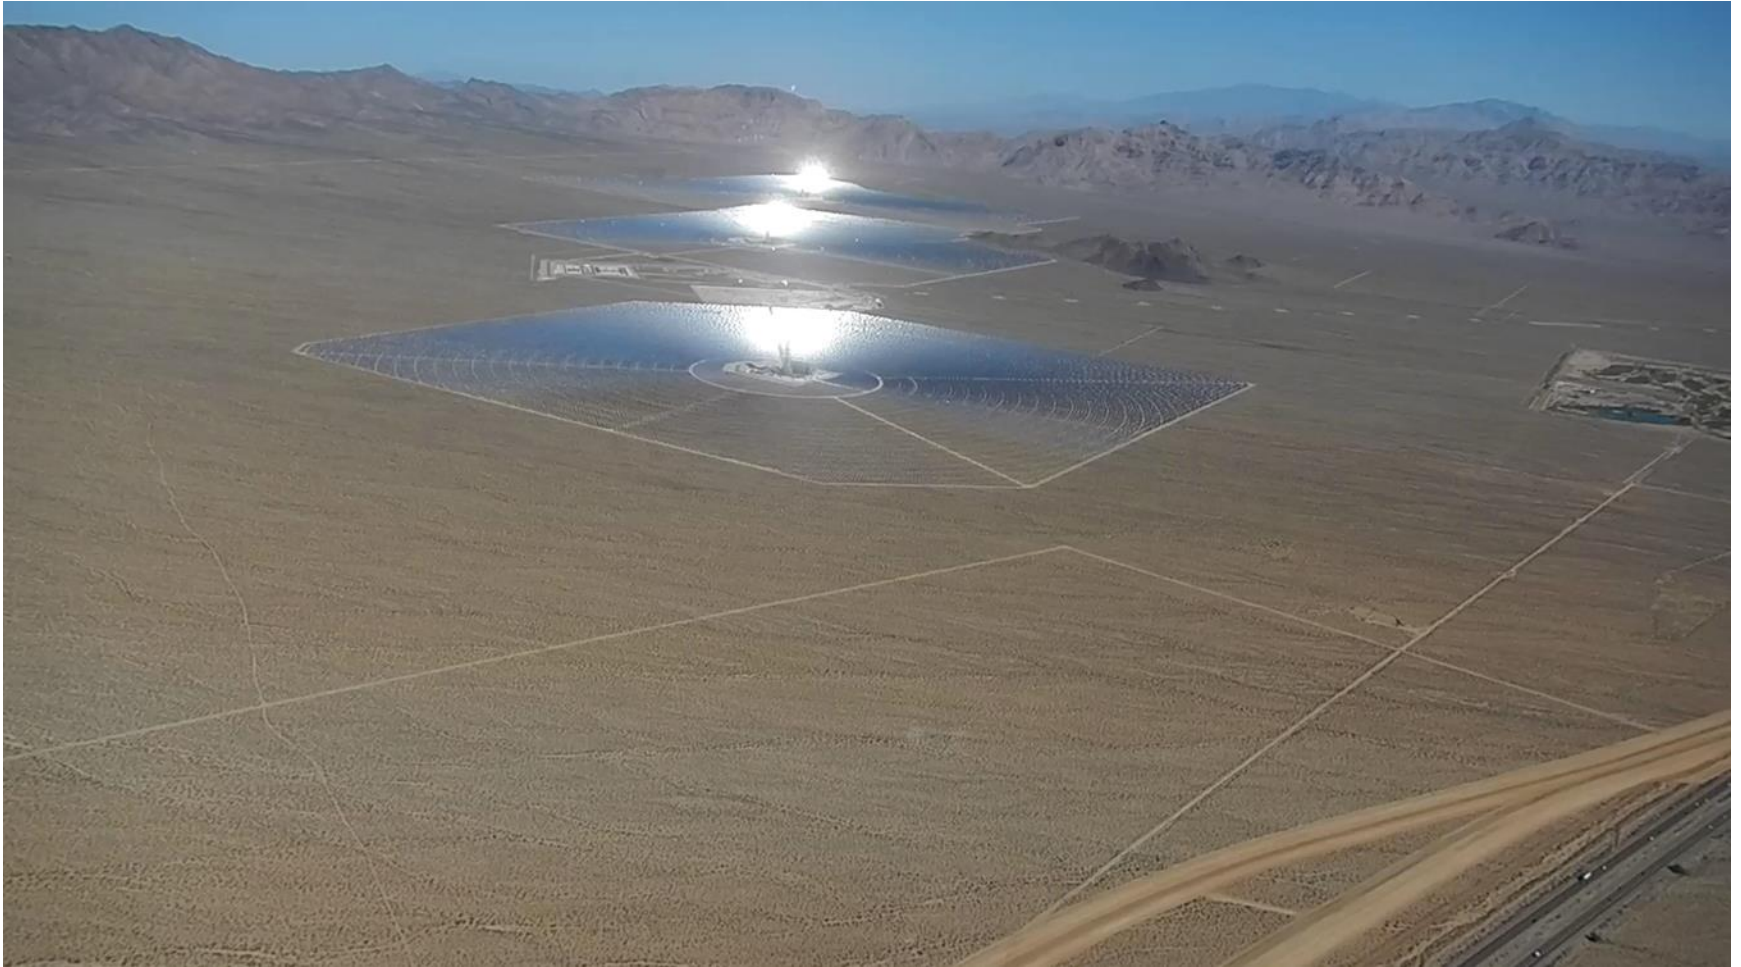
Aerial Glare Video

9:23 AM (PDT), April 24, 2014

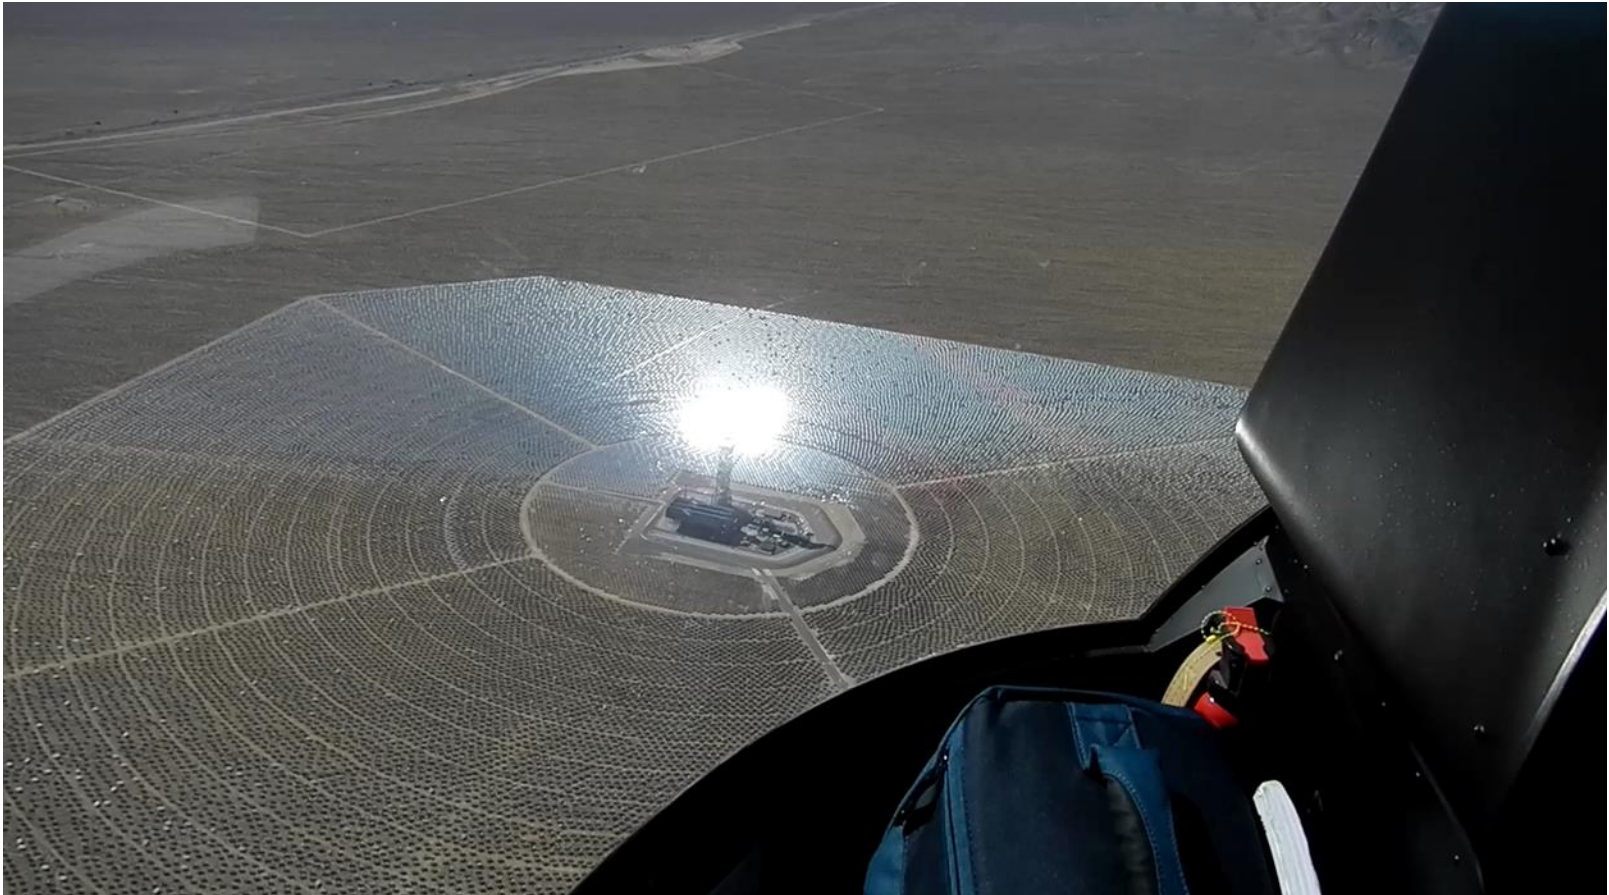
Aerial Glare Video

Glare from Unit 1 heliostats aimed at standby points on **both** sides of the receiver; looking south/southeast (~0.6 miles from tower)

9:29 AM (PDT), April 24, 2014

- Letter to Airmen notifying pilots of potential glare from ISEGS issued by FAA on May 5, 2014
- Develop new strategy for heliostat standby position to reduce number of heliostats that can reflect light to an aerial observer
 - Increase the number of aim points near the receiver and have adjacent heliostats point to different locations
 - Position heliostats vertically in proper azimuth position
 - Bring heliostats up to standby position at top of receiver sequentially as needed
 - Incorporate a glare shield near the receiver that can serve as both the aim point for heliostats in standby mode and a preheater for the water entering the receiver

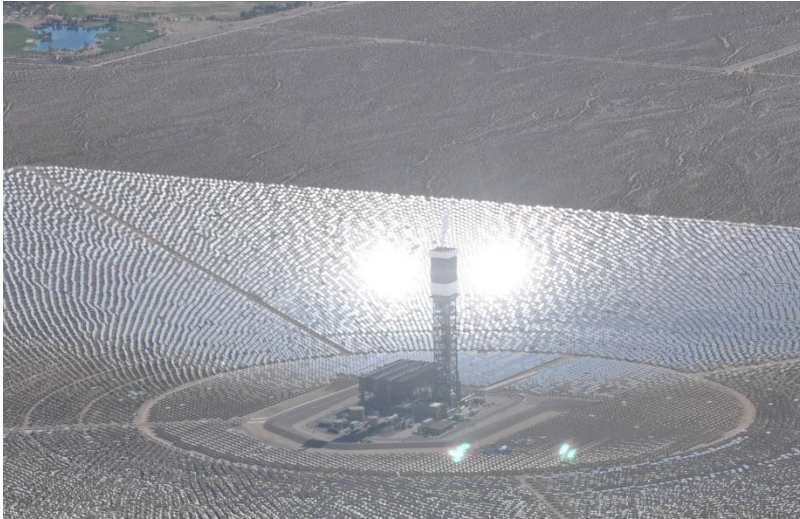
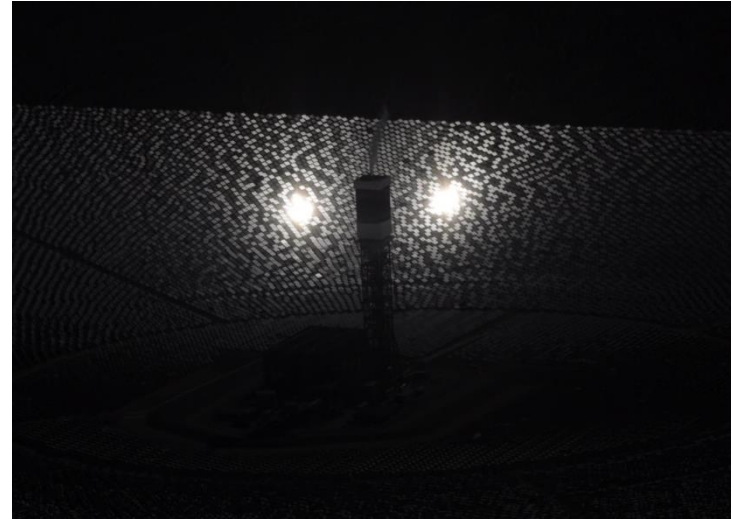
Filtered Images of Heliostat Glare

Looking Northeast at Unit 1, 9:10 AM PDT (~3 miles away from glare)

Image	Tower Unit	Approximate Distance to Glare (miles)	Peak Retinal Irradiance (W/cm ²)	Total Subtended Glare Angle (mrad)	Ocular Impact
DSC 26	1	1	6.39	4.13	Potential for Temporary After-Image
DSC 28	1 (left)	3	5.10	1.60	Potential for Temporary After-Image
DSC 28	1 (right)	3	2.81	1.90	Potential for Temporary After-Image
DSC 08	3	4	2.12	3.64	Potential for Temporary After-Image
DSC 08	3 v2	4	1.98	4.03	Potential for Temporary After-Image
DSC 30	1	6	2.15	3.47	Potential for Temporary After-Image
DSC 65	1	6	4.25	1.60	Potential for Temporary After-Image
DSC 32	1	7	5.45	1.06	Low Potential for After-Image
DSC 34	1	11	5.29	0.586	Low Potential for After-Image
DSC 41	3	15	1.39	0.760	Low Potential for After-Image
DSC 53	3	23	0.112	0.541	Low Potential for After-Image

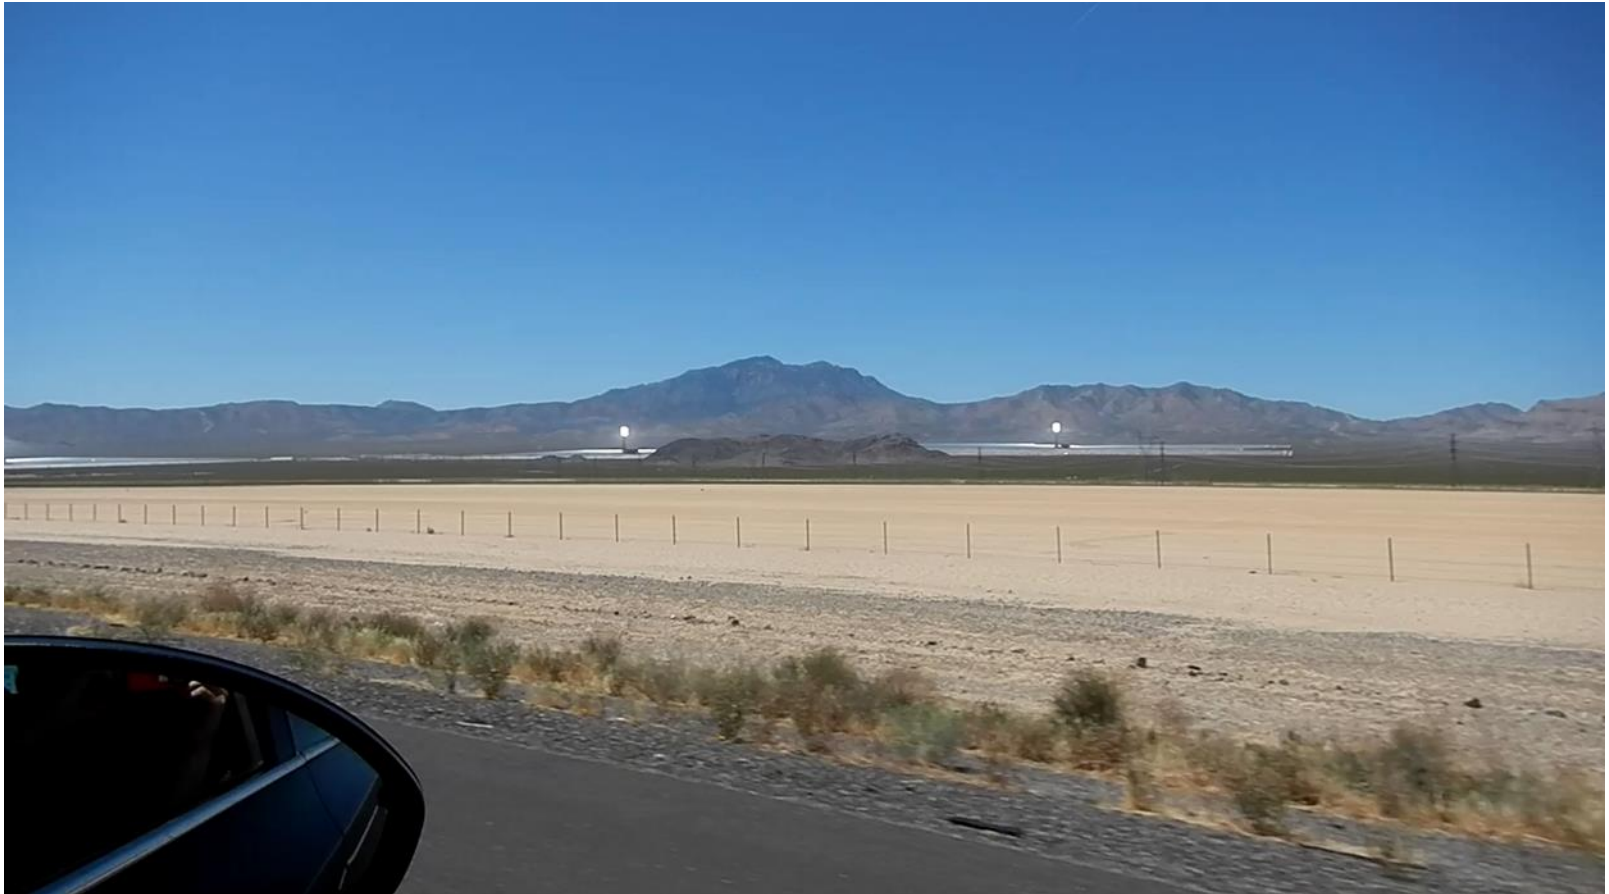
Drive-by Video

~12:20 PM (PDT), April 24, 2014

- Drive-by surveys at three different times of the day did not reveal any ocular hazards
- All data from receiver glare showed a low potential for after-image

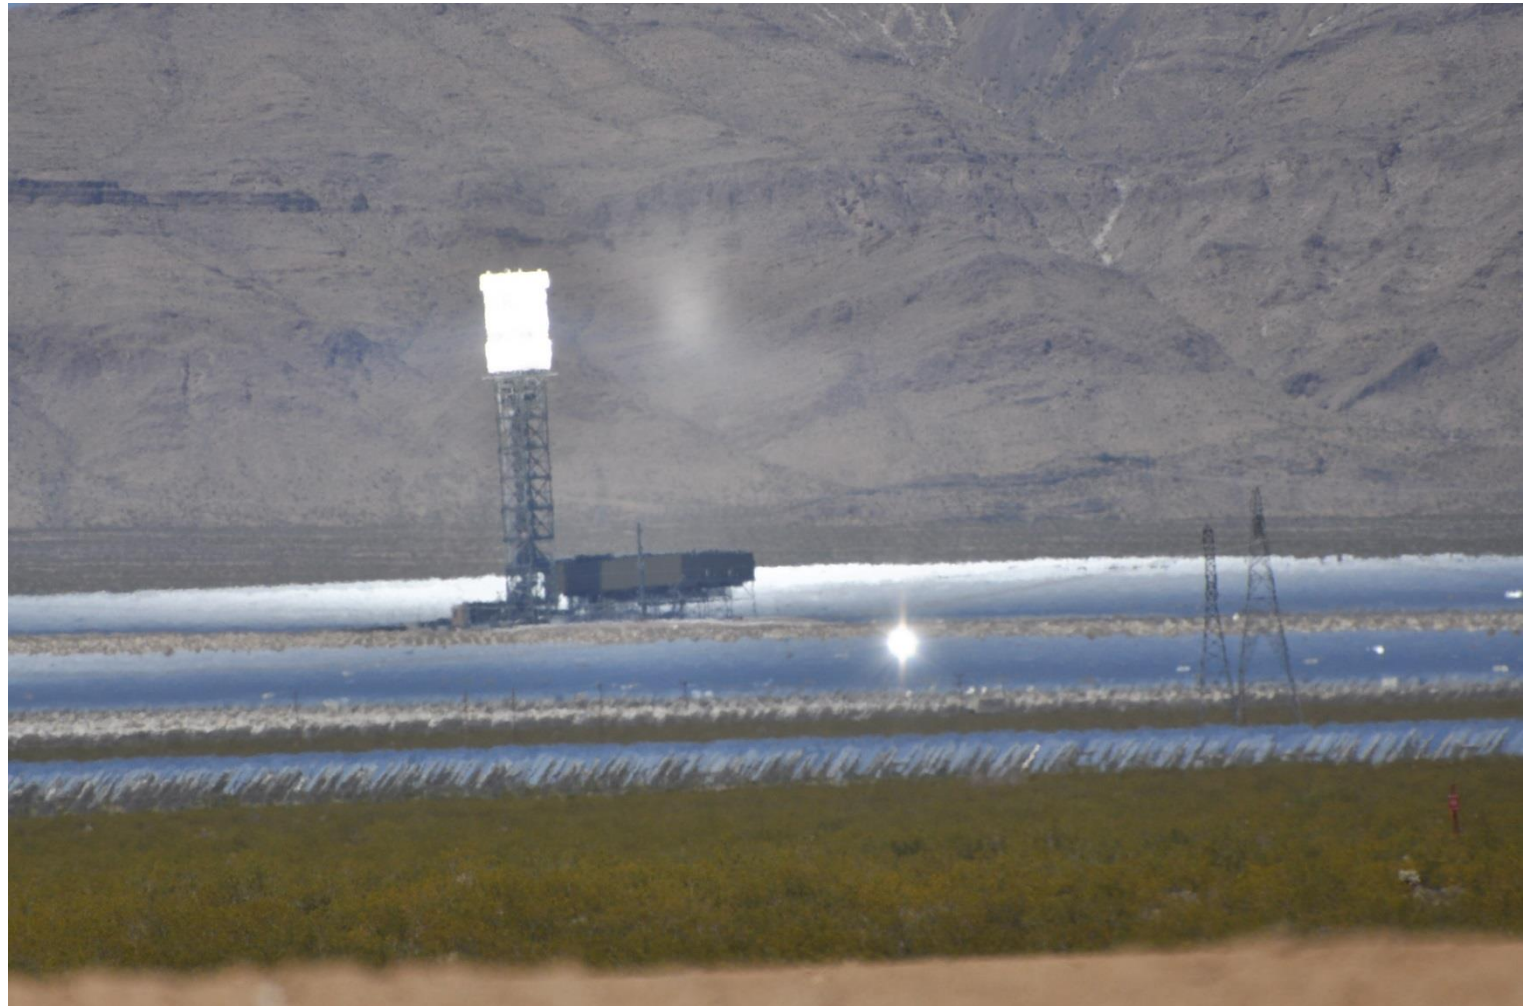
View of Unit 3 Receiver Glare and Rogue Heliostat from I-15

~5 miles

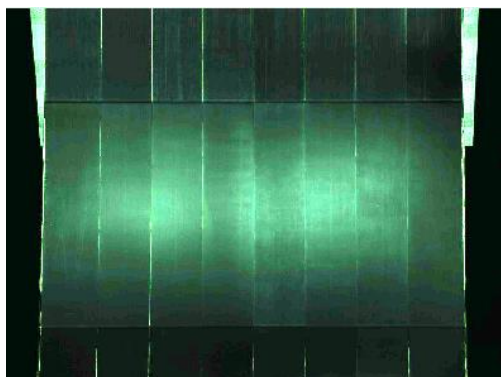
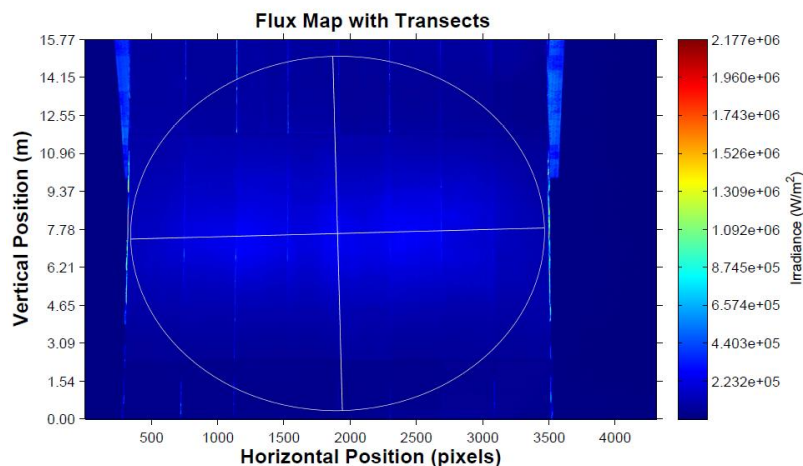
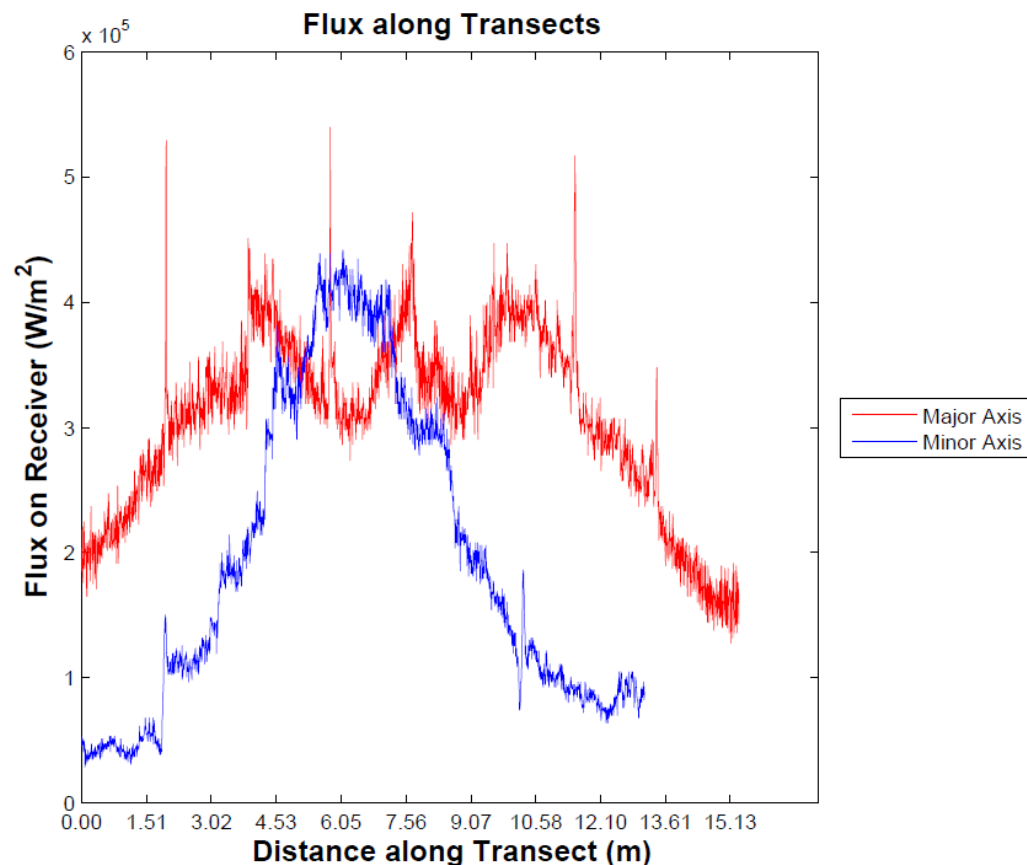
Receiver Irradiance

- Unit 1, East Panel, 265 m away, 3:38 PM PDT
