Annular Core Research Reactor Updates

What is the ACRR?

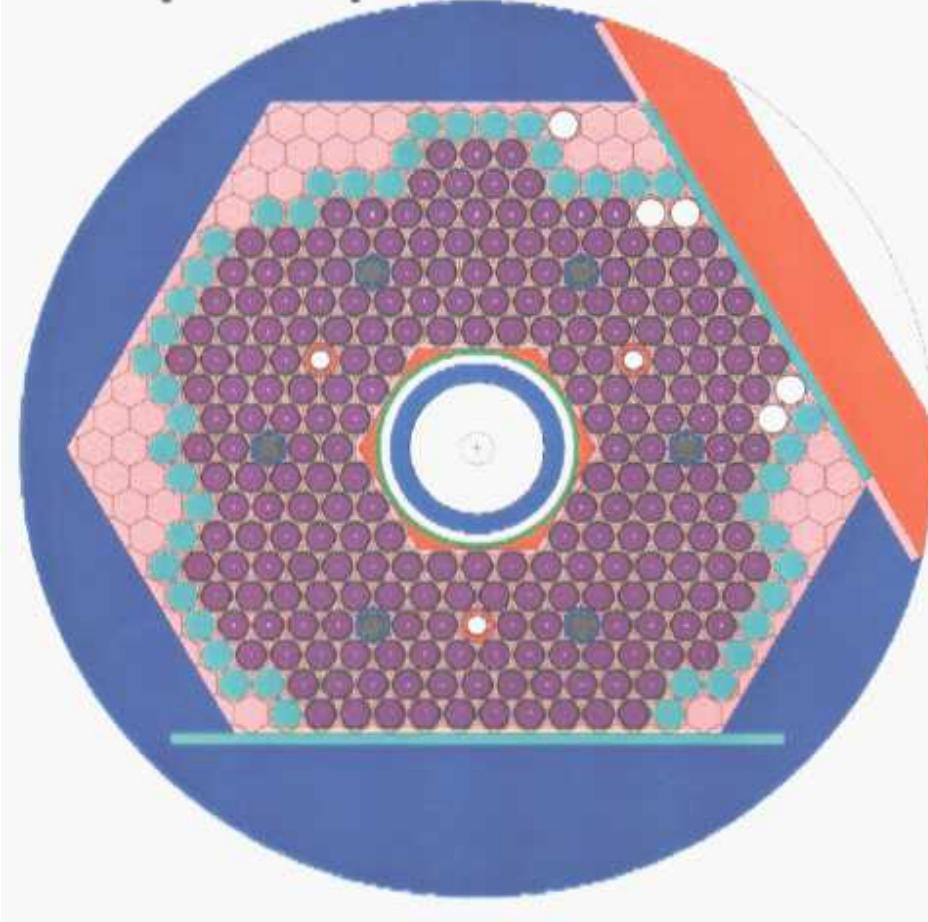
Top Perspective

- The core is formed by fuel elements with their vertical longitudinal axes arranged in a hexagonal grid around a dry irradiation cavity.
- External cavities are installed as needed on the side of the reactor where a flat area on the upper grid plate allows close coupling to the core.
- The dry cavity (9 in) diameter extends the full length of the pool extending through the core

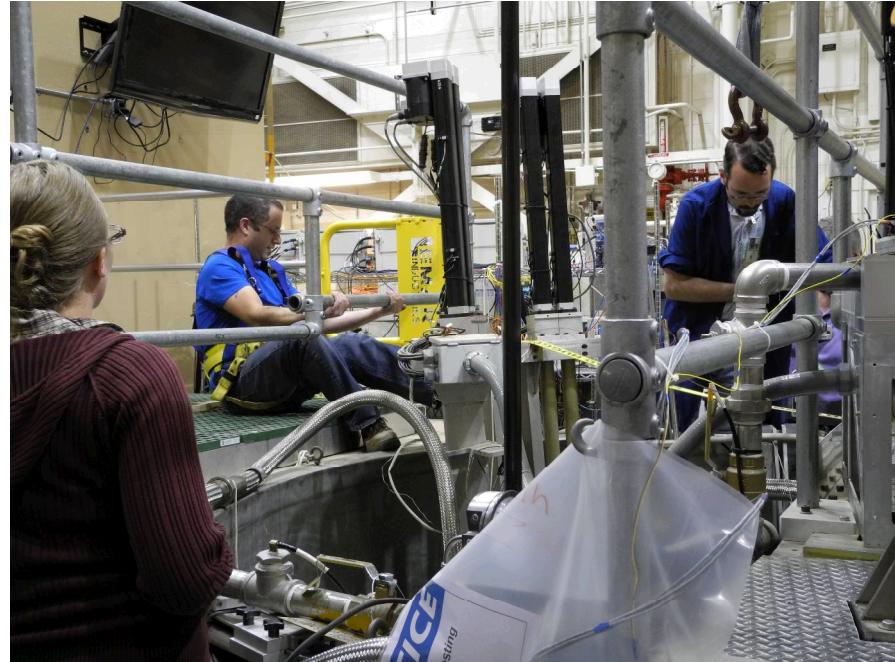
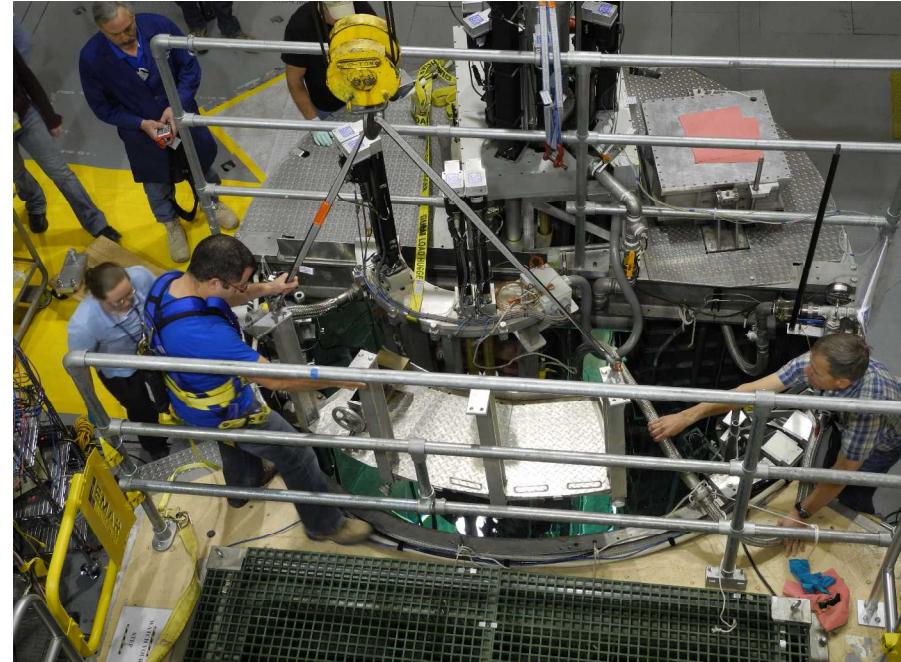
Shield Plug Removed

- FREC-II had not been coupled in approximately 10 years
- Procedures were not clear to new operators, rigging inspections had lapsed, rod control upgrades not tested on FREC-II rods, new hardware in reactor tank in the way

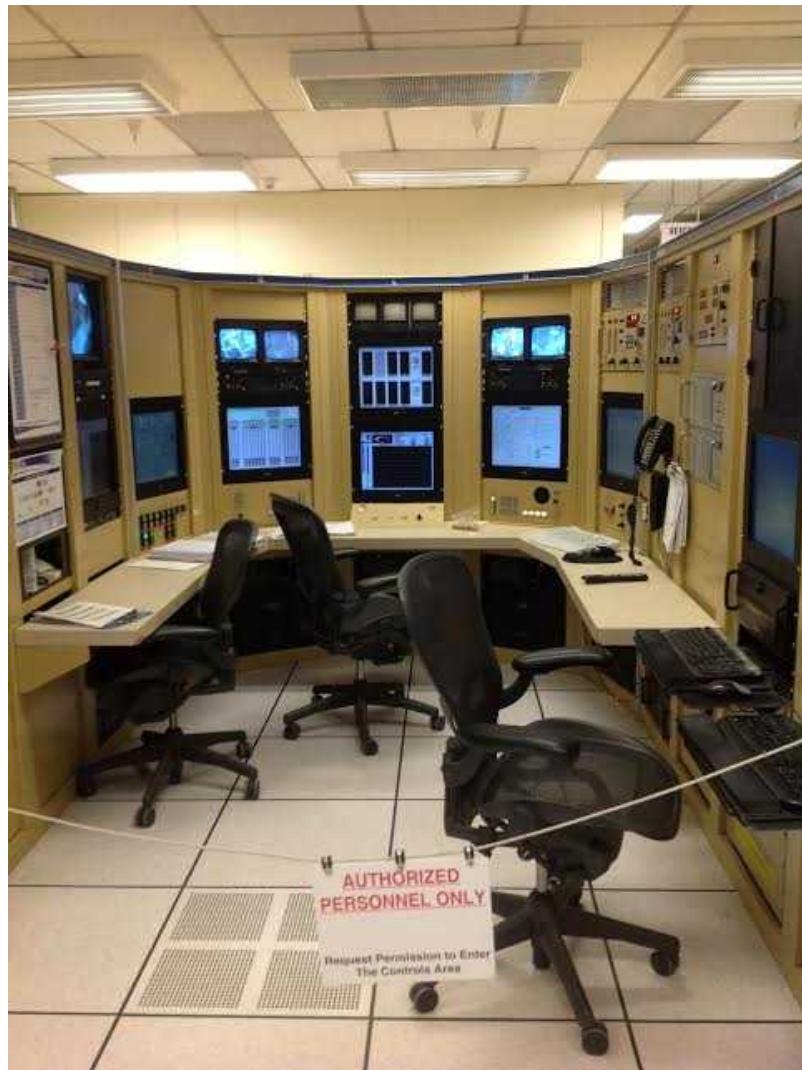
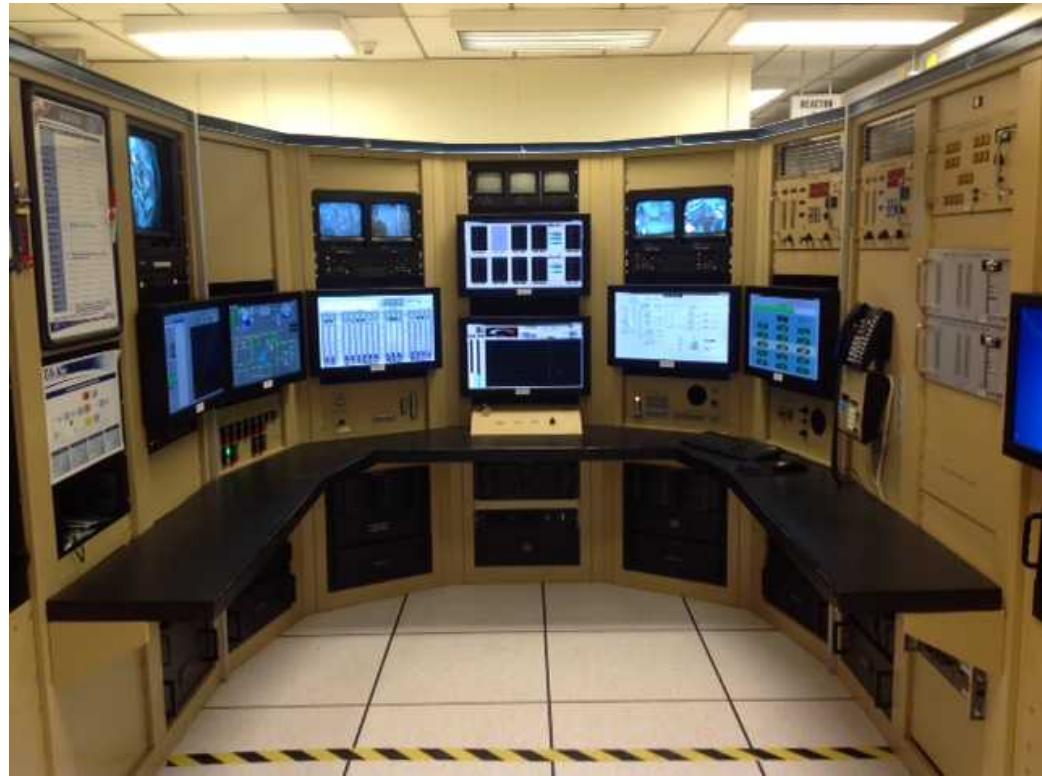
Before and After

- Replacement with new hardware, solid state drive upgrades, monitors.
 - Hardware was difficult to find that supported rod control system integrated hardware and current processors, ram, power supplies, etc.
 - Assembly of computers required some modifications to the cases to allow the programmable multi axis controllers used for rod movement to fit and connect to a PCI slot.
- Upgrading software – not plug and play ☹
 - Upgraded Windows XP to Windows 7 (Corporate requirement), LabView2002 to 2012, PMAC software, Microsoft Office.
 - Required new programming for LabView code to work with PMAC software and timing cards. Software changes needed to be transparent to operator for procedure compliance and best ConOps practices.

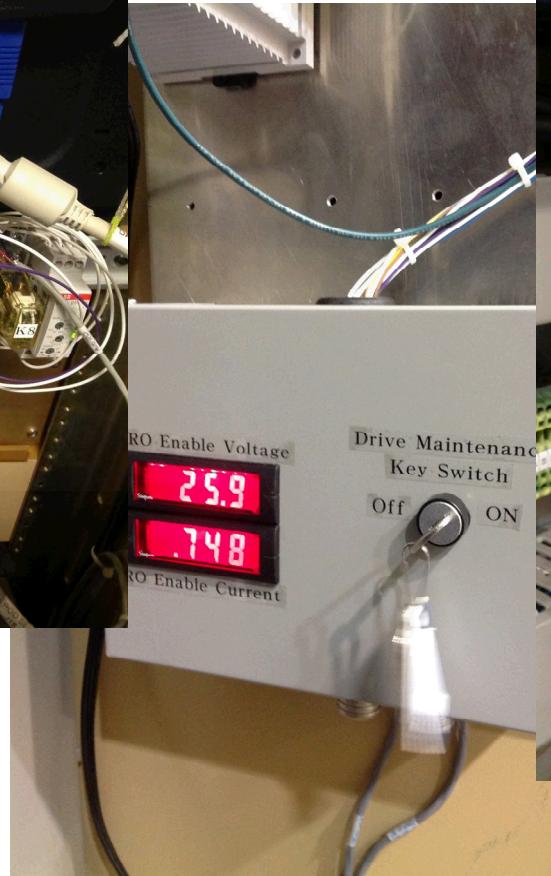
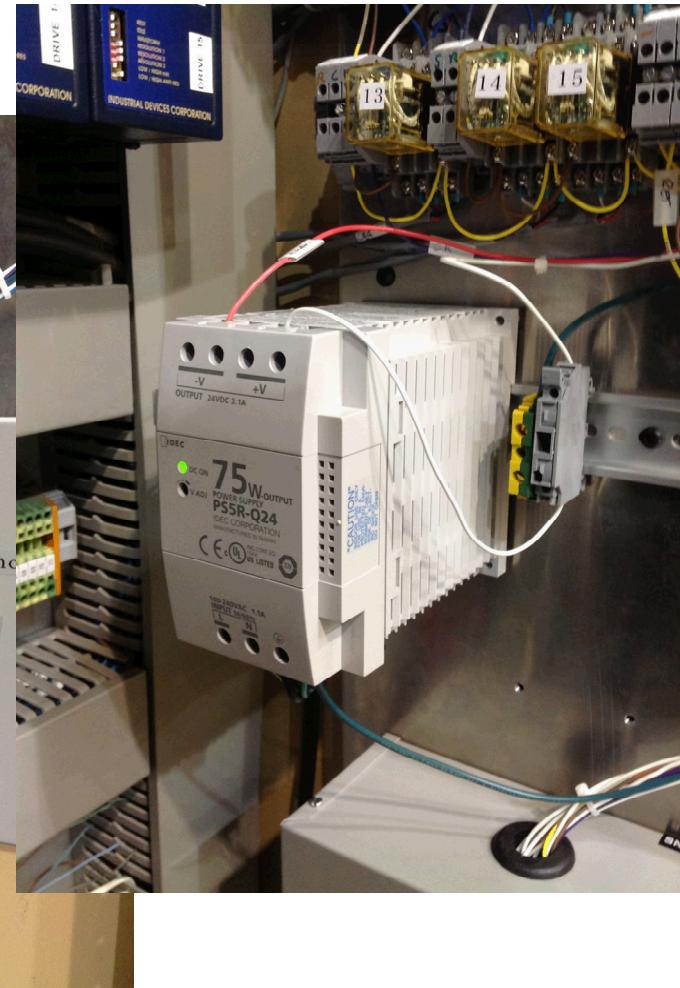
Enable Relay

- Controls rod drive power through LabView Fieldpoint and RO enable circuit.
- The operator must be issuing a command and the drive feedback must be responding to the command
- If not, an error occurs and drive motion is stopped by opening the relays controlling drive motion
- Once the error is reset normal drive motion can occur assuming there are no faults
- Monitors current and voltage to drives for troubleshooting

- Several occurrences of individual rods moving without commands
- One occurrence of control rod bank drives moving outward when commanded in
- Thought to be due to buffer overflows in the computing system for the rod controller
- Major code revision to prevent any more uncommanded rod motion
- Installed temporary modification to prevent rod motion if an error in motion logic is seen. Planning to remove after verification of new program is documented.

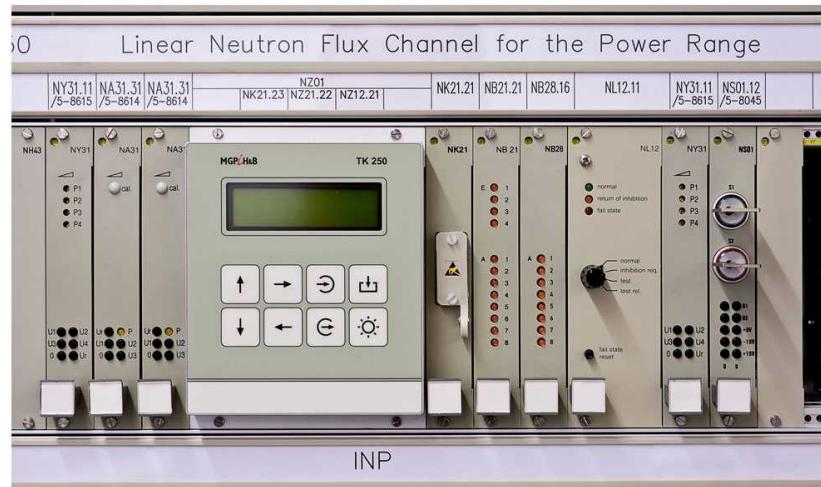
- New neutron flux monitoring equipment from mirion DWK250
 - Easier to calibrate and more user friendly
 - Current flux monitoring has noise induced dropouts for linear scale
