Strength, Fracture and Microstructure of Additively Manufactured Austenitic Stainless Steel

Chris San Marchi, Thale Smith¹, Julie Schoenung^{1,2}, Josh Sugar, Dorian Balch
Sandia National Laboratories, Livermore CA

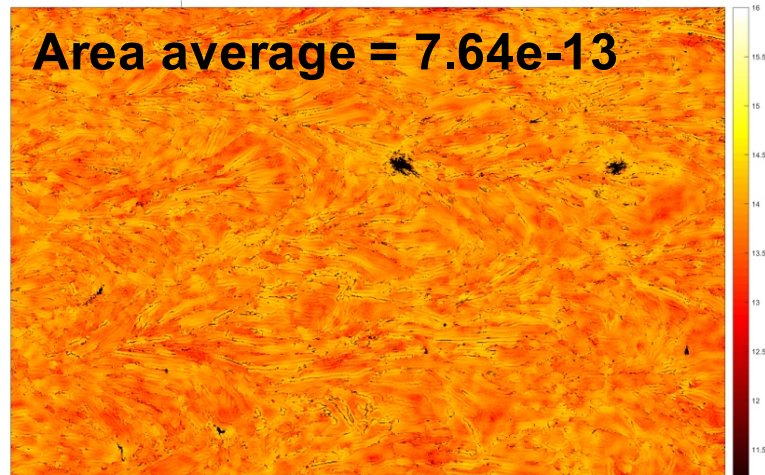
Microscopy: EBSD mapping

Dislocation density (m^{-2}) map

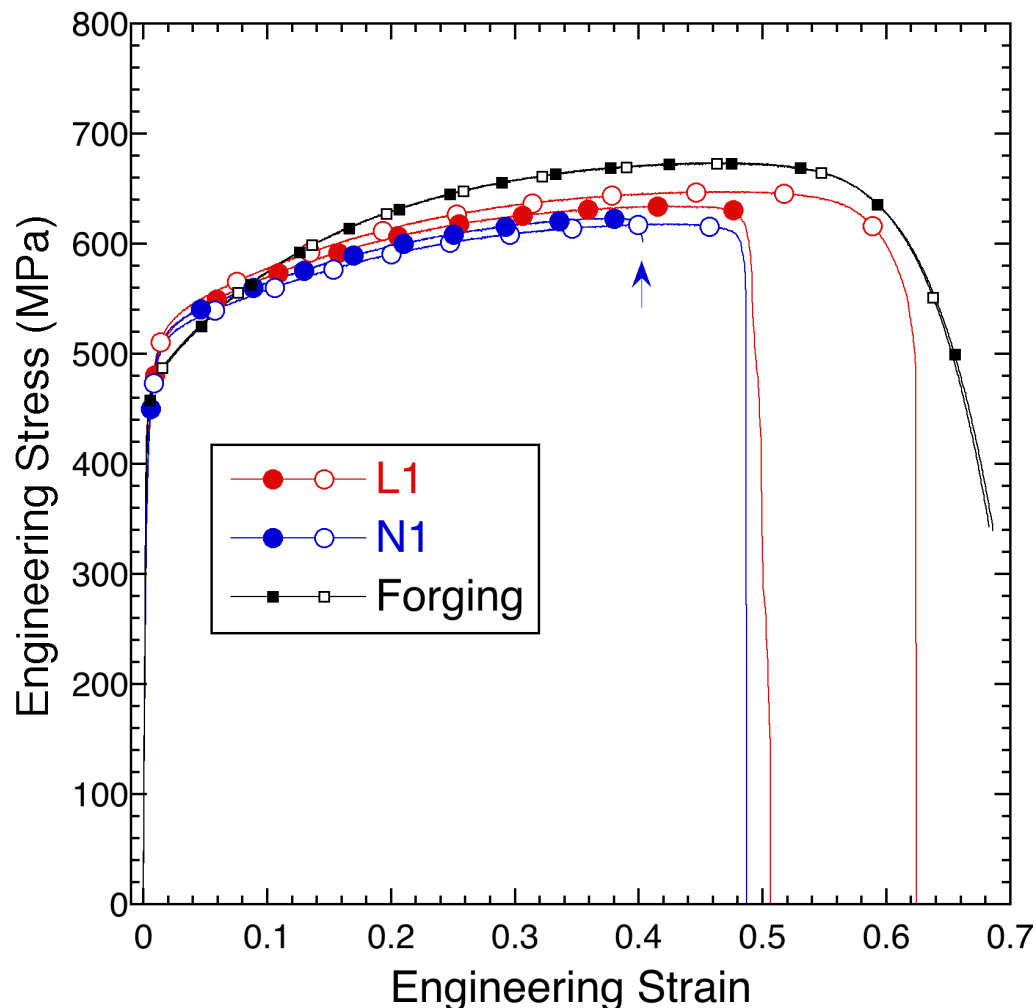
Strength properties are consistent, ductility is variable

- Elongation to failure of SLM material is lower than expected for wrought 304L
- Elongation varies between 40-60% for these two materials

Build geometry	Designation	YS (MPa)	TS (MPa)	EI (%)	RA (%)
SLM Ring	L1	414	641	57	49
SLM Ring	N1	413	621	45	39
Forging	55C	452	674	68	81
Forging	60C	506	694	66	82
requirement		380 520	585 min	35 min	40 min
ASTM A479, wrought bar strain-hardened 316		450 min	585 min	30 min	60 min

- ASTM E8 subsized cylindrical tensile specimens: 4 mm dia, 19 mm gauge
- Nominal strain rate 10^{-3} s^{-1} (constant crosshead)

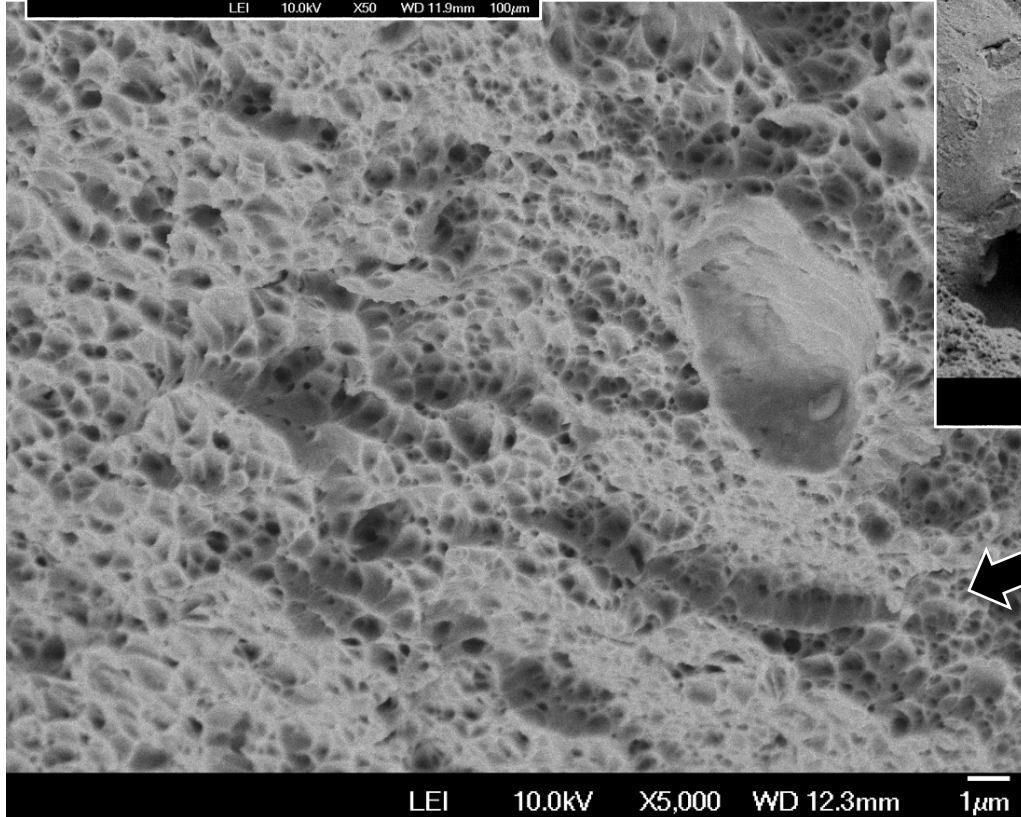
Defects in L1 material

Relatively large defects, "isolated" from one another

Very fine dimples, indicative of ductile deformation processes (microvoid coalescence)

- Dimples are order of magnitude smaller than wrought material

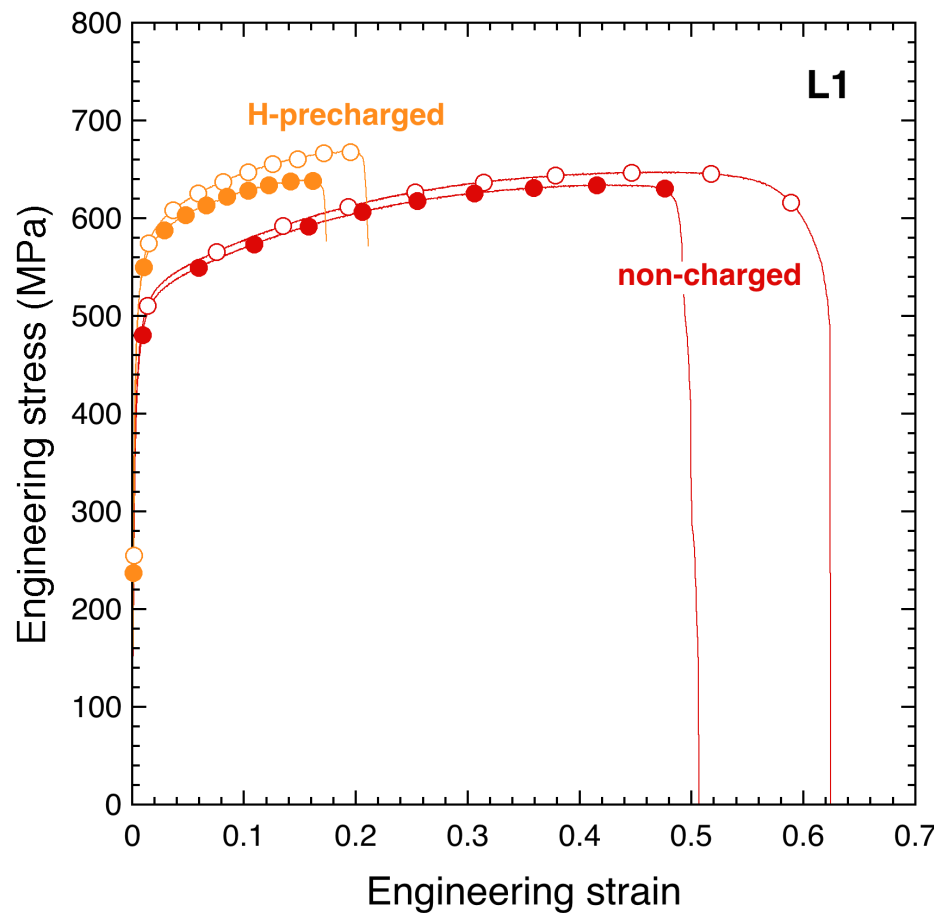
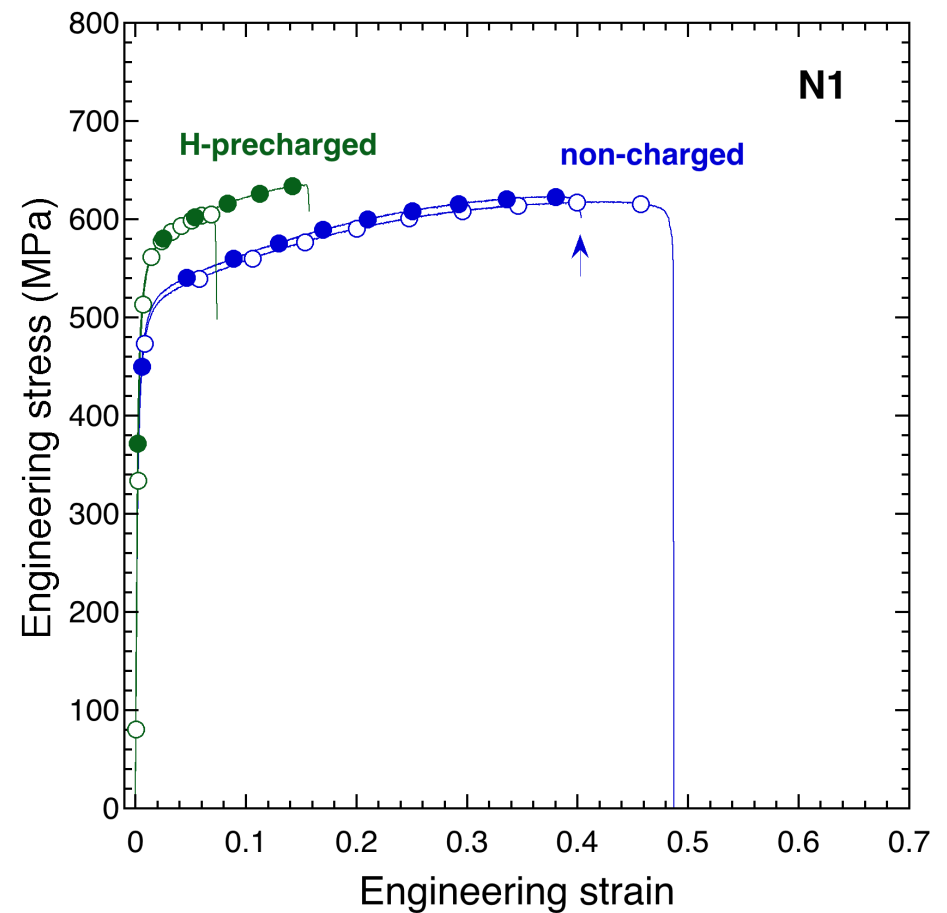
Ductility of SLM 304L is severely degraded when H-precharged

Ductility is lower than expected for H-precharged 304L

Build geometry	Designation	condition	YS (MPa)	TS (MPa)	EI (%)	RA (%)
SLM Ring	L1	AR	414	641	57	49
		H	483	654	19 (17 min)	20
SLM Ring	N1	AR	413	621	45	39
		H	481	621	12 (7.4 min)	13
Forging	55C	AR	452	674	68	81
		H	484	758	58	49
Forging	60C	AR	506	694	66	82
		H	569	784	60	68

- Ductility of SLM 304L is significantly lower than forged 304L in the absence of hydrogen
 - RA = 40-50% (AM) vs RA = 80% (forged)
- Hydrogen reduces ductility in SLM 304L more than in forged 304L
 - RA = 13-20% (AM) vs 50+% (forged)
