Replacement of the High-Pressure Air Tanks for Sandia's Wind Tunnels

**STAI 122nd Meeting
5-7 October, 2014
Modane, France**

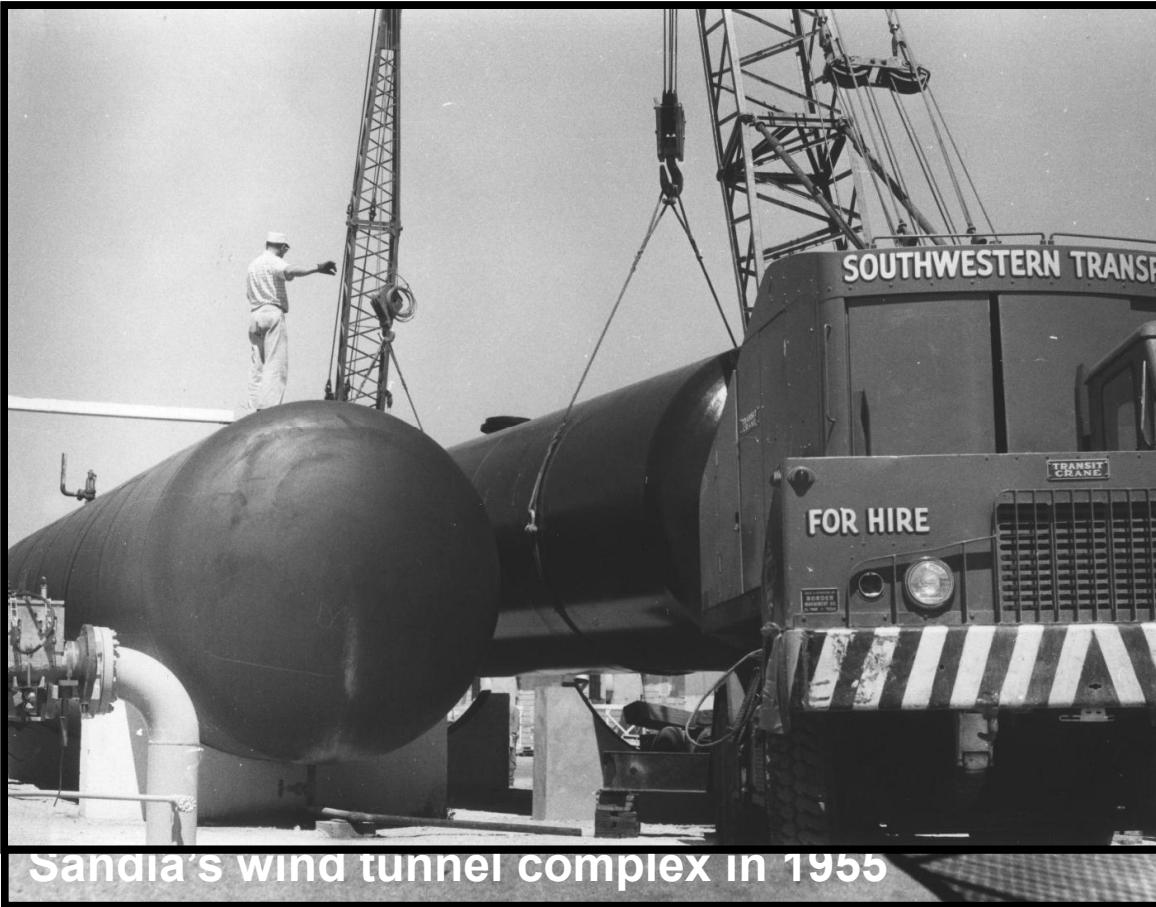
Sandia's wind tunnel complex in 1955

Initially driven by a single tank of 2600 ft³ volume, pressurized to 300 psig (74 m³, 2 MPa).

In 1958, an identical second tank was added.

Also served the Hypersonic Wind Tunnel.

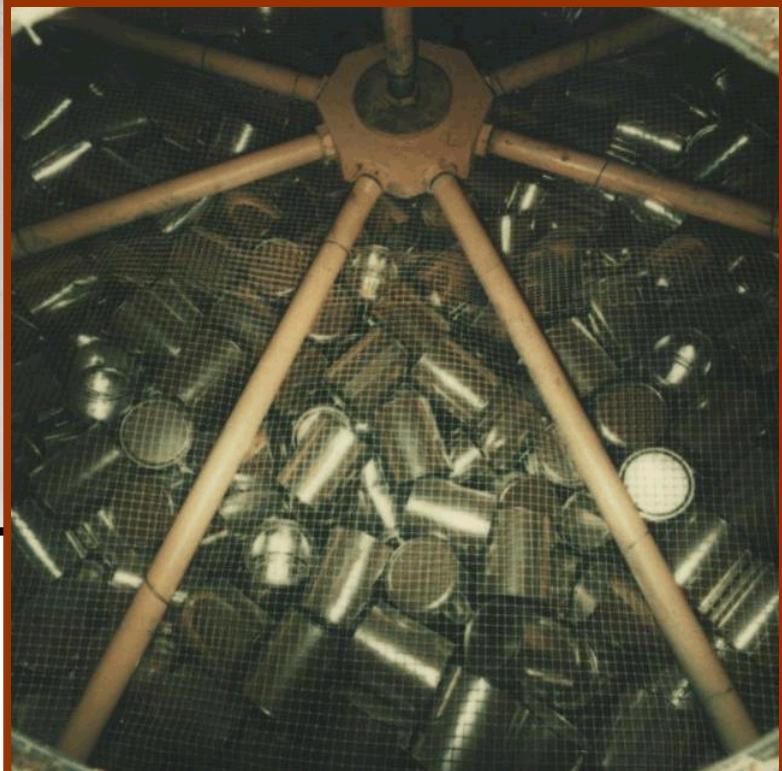
The air tanks were filled with “thermal mass” to maintain the temperature during the gas expansion.

Thermal mass:
100,000 lidless dog food cans per tank

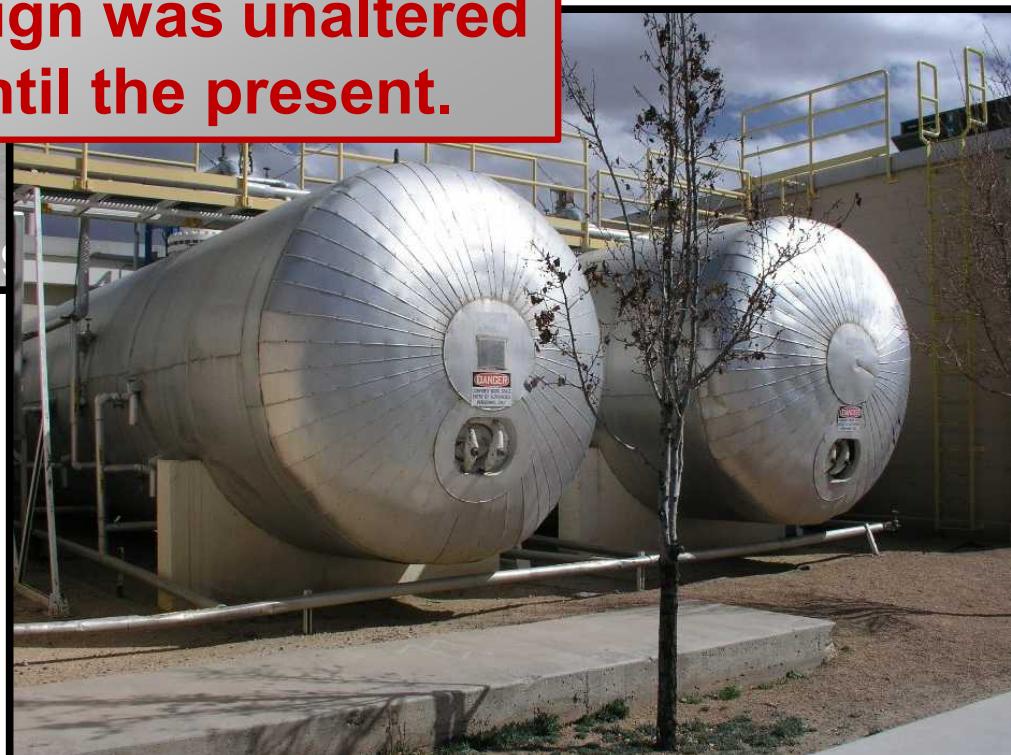
Prone to brittle failure under cold conditions.

Analysis shows leak before burst and risk is only at sub-freezing.

A winter safety risk exists.

This tank design was unaltered from ~1960 until the present.

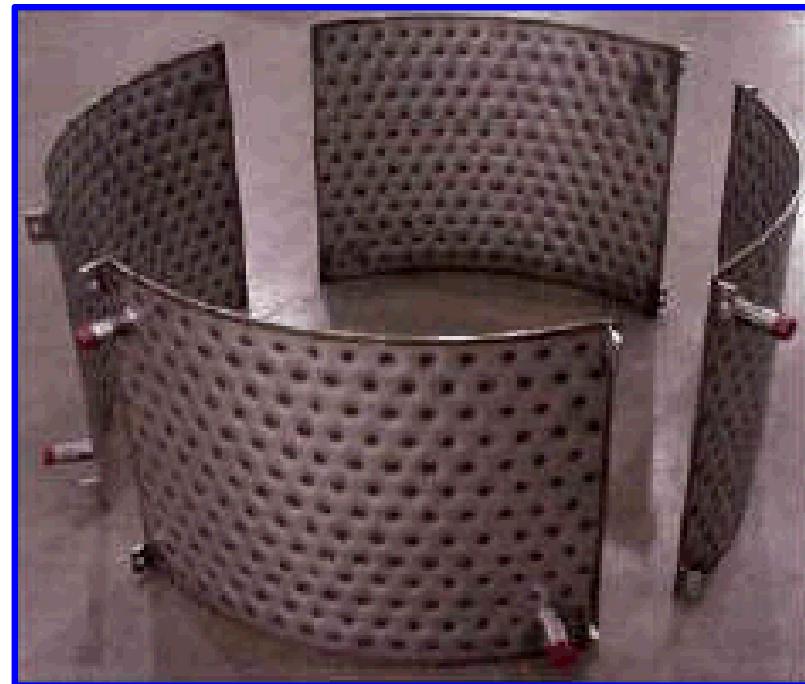
Our Tank Heater Design

We redesigned the steam jackets to use conductive plate coils.

Rolled to match tank diameter and contact by thermal paste.

Fed by existing boilers but all new steam piping.

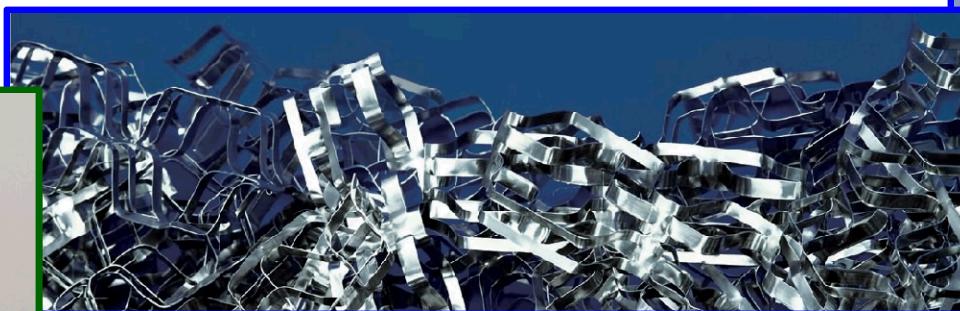
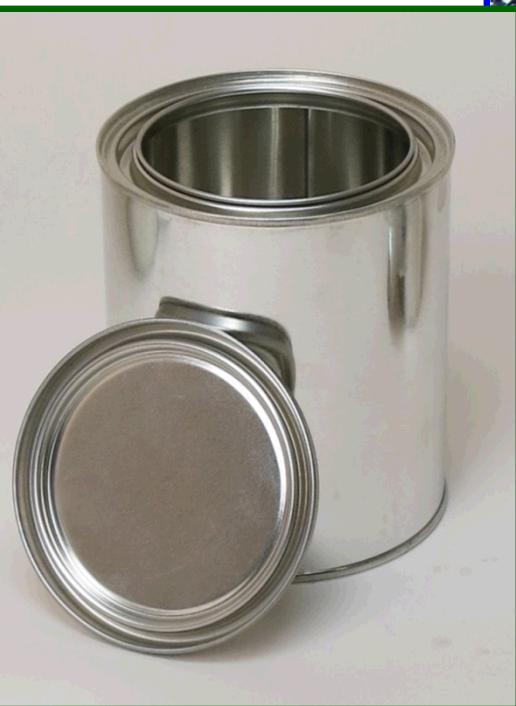
Thermal Fill Material

Consider using metal random packing, which is designed for this purpose.

Too expensive for the required quantity.

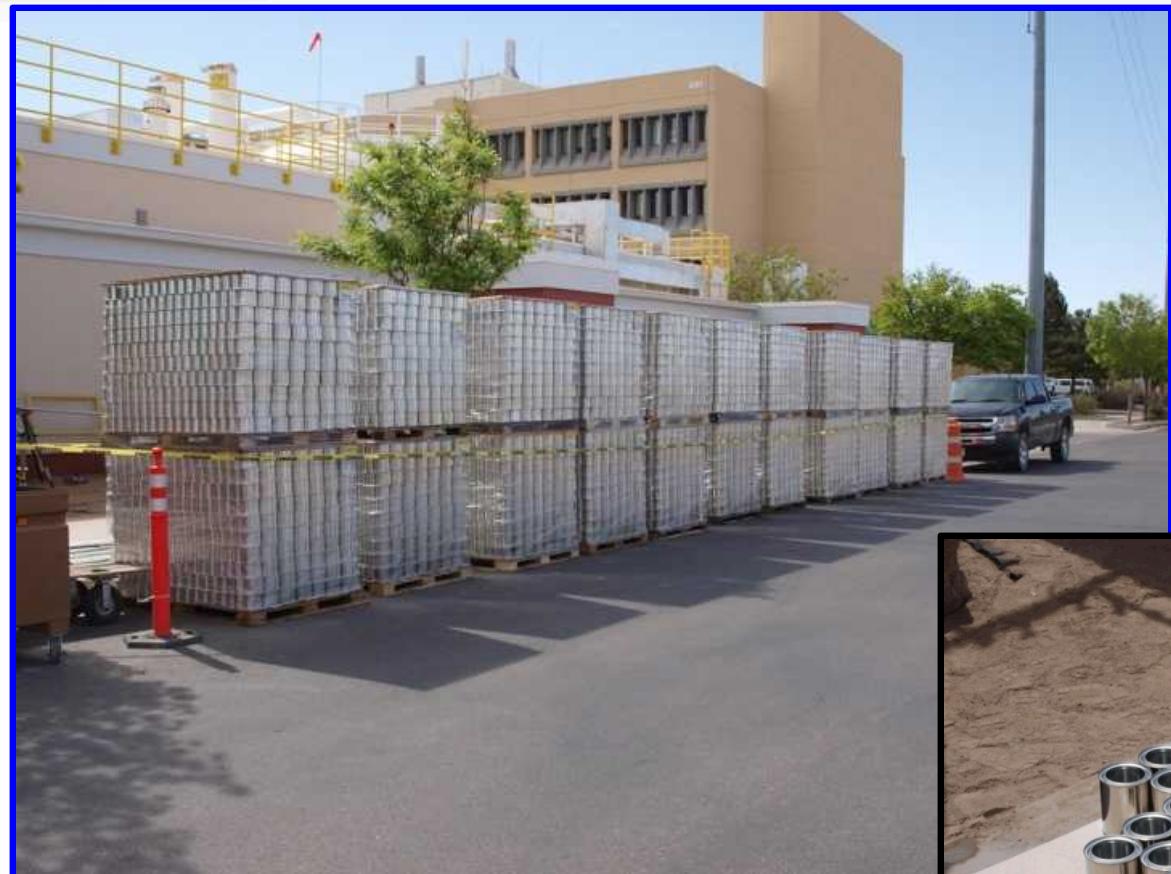
**First to arrive were the cans...
230,000 of them!**

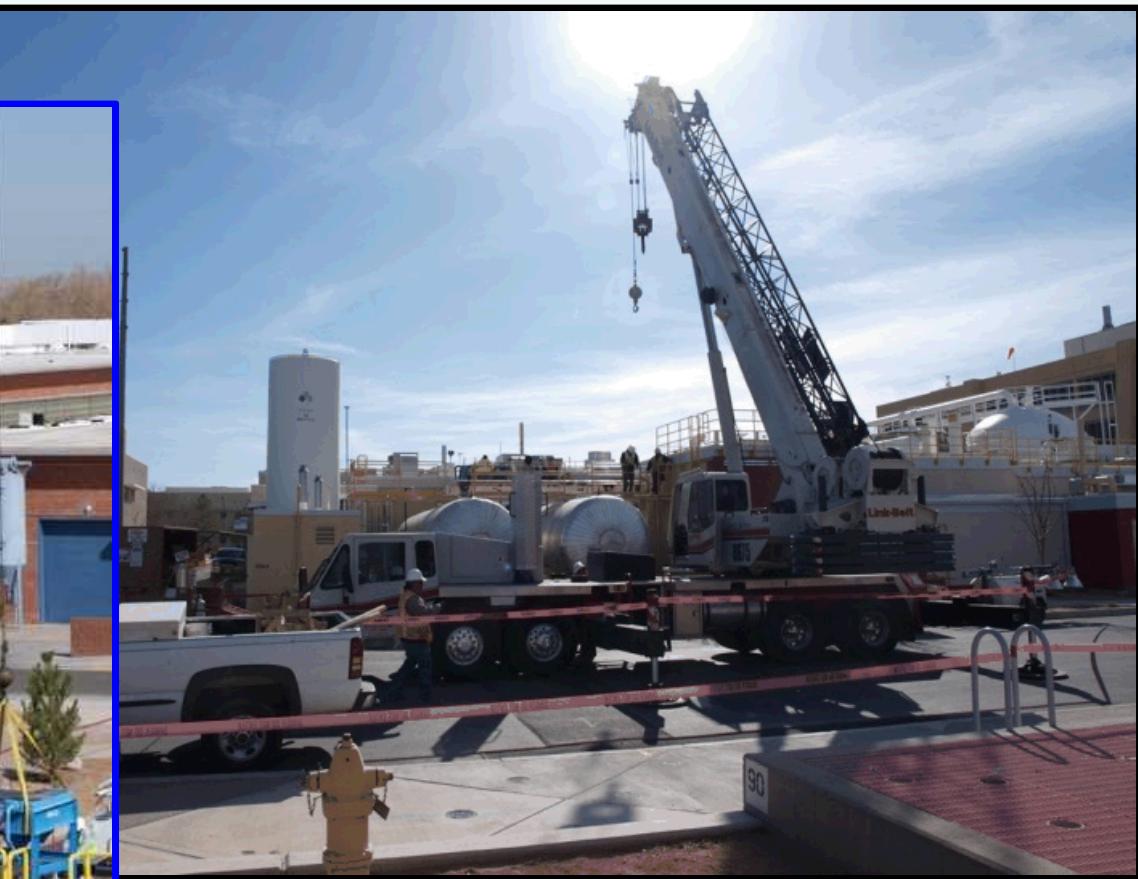
Start by removing the infrastructure surrounding the old tanks.

- Steam piping
- Oil coolers
- Gantry
- Instrumentation

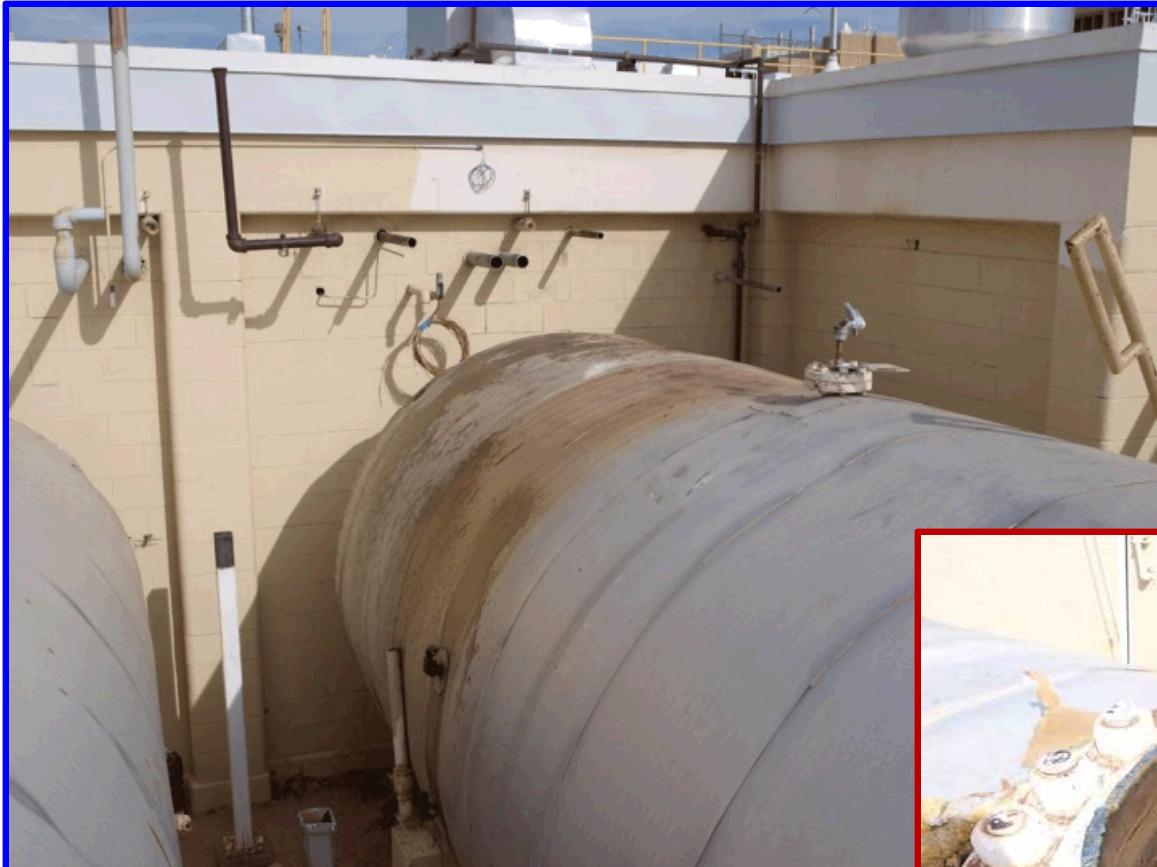
All plumbing was decoupled.

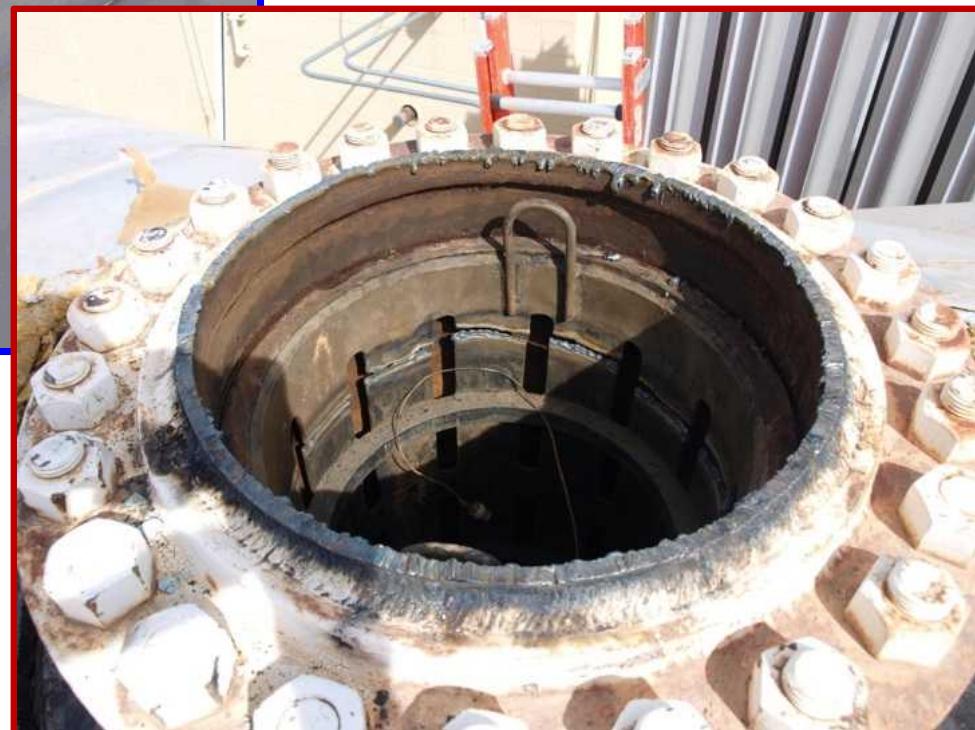
Main pressure lines were cut away as the tank junction.

Render unfit for service so tanks can be scrapped.

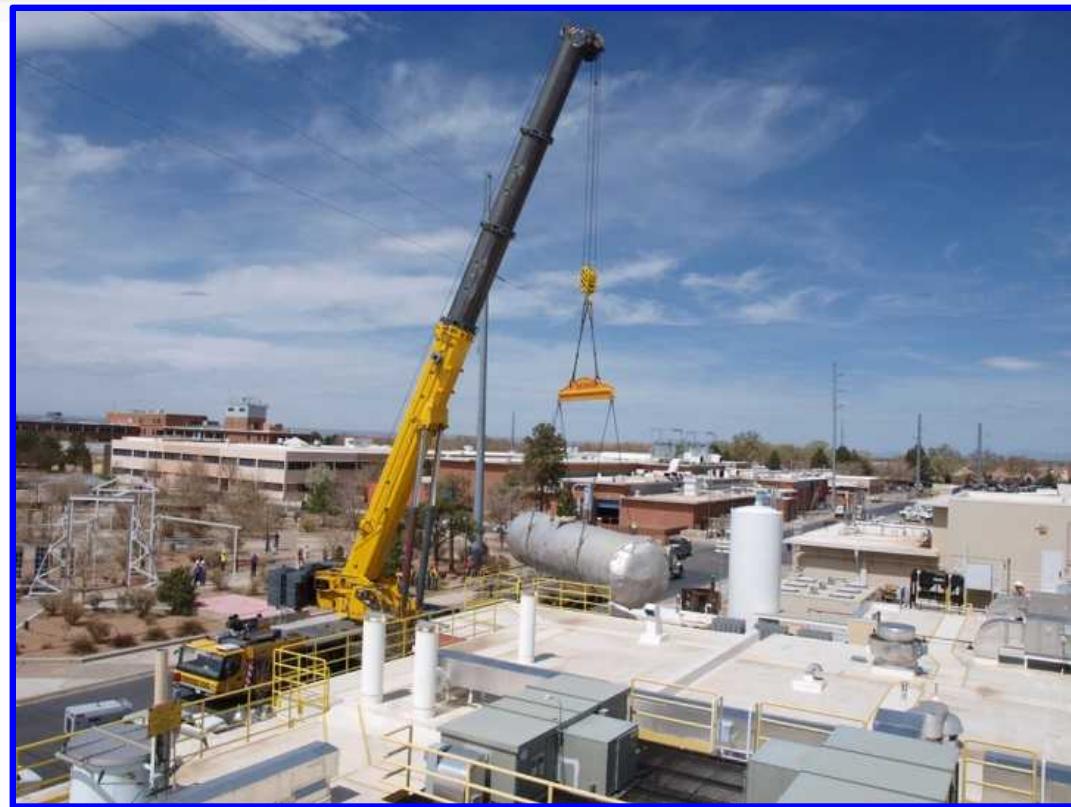
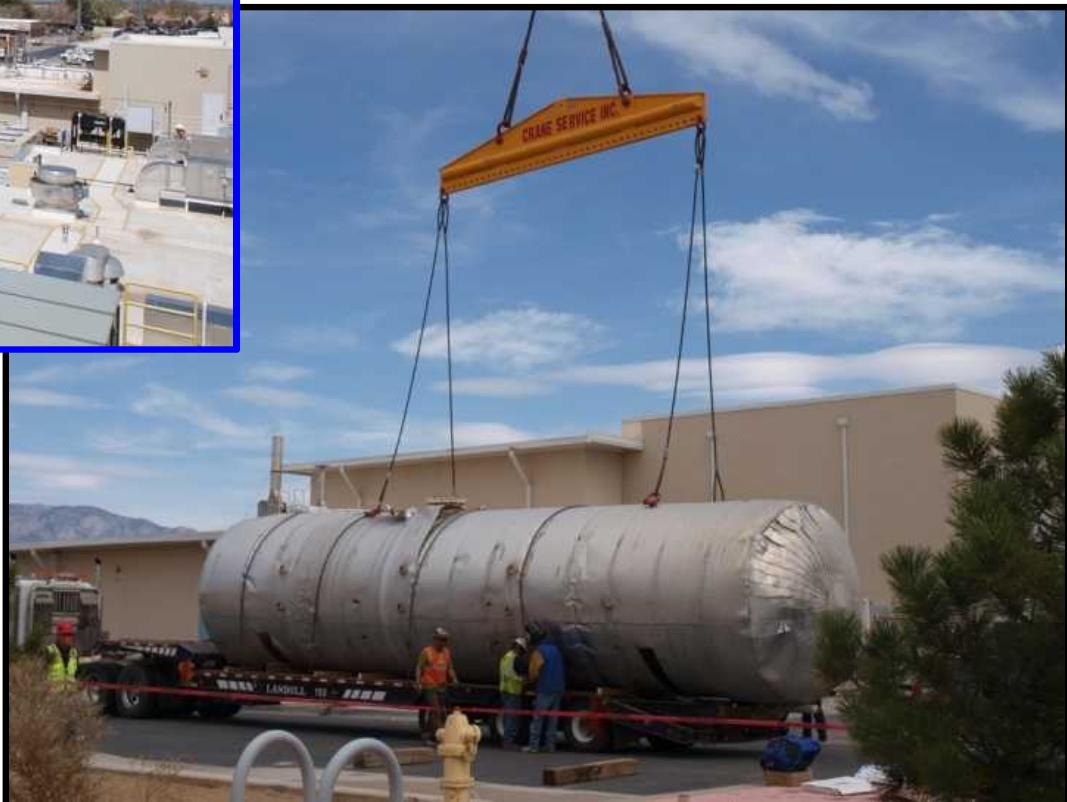
**A large capacity crane was brought in
to move the tanks.**

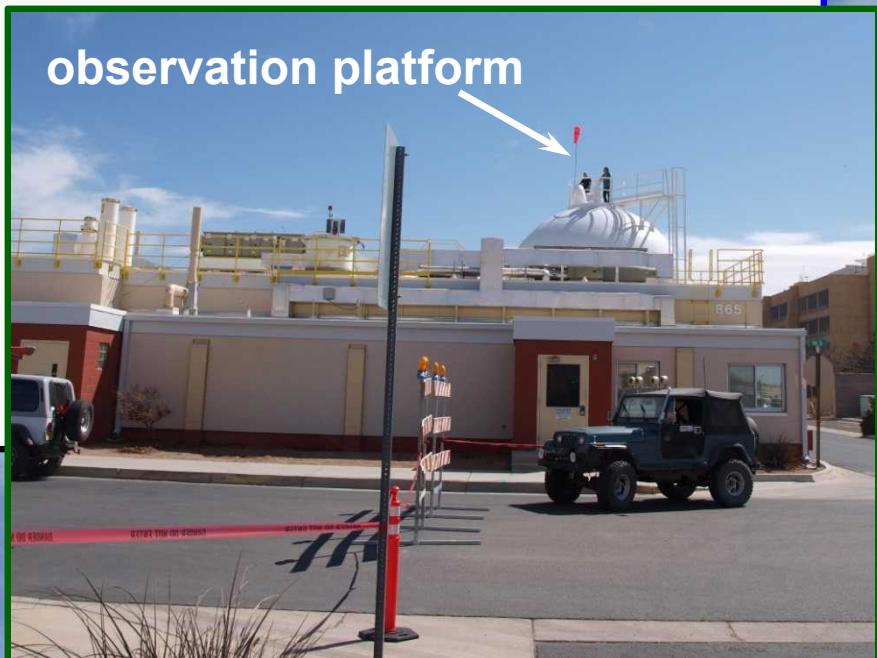
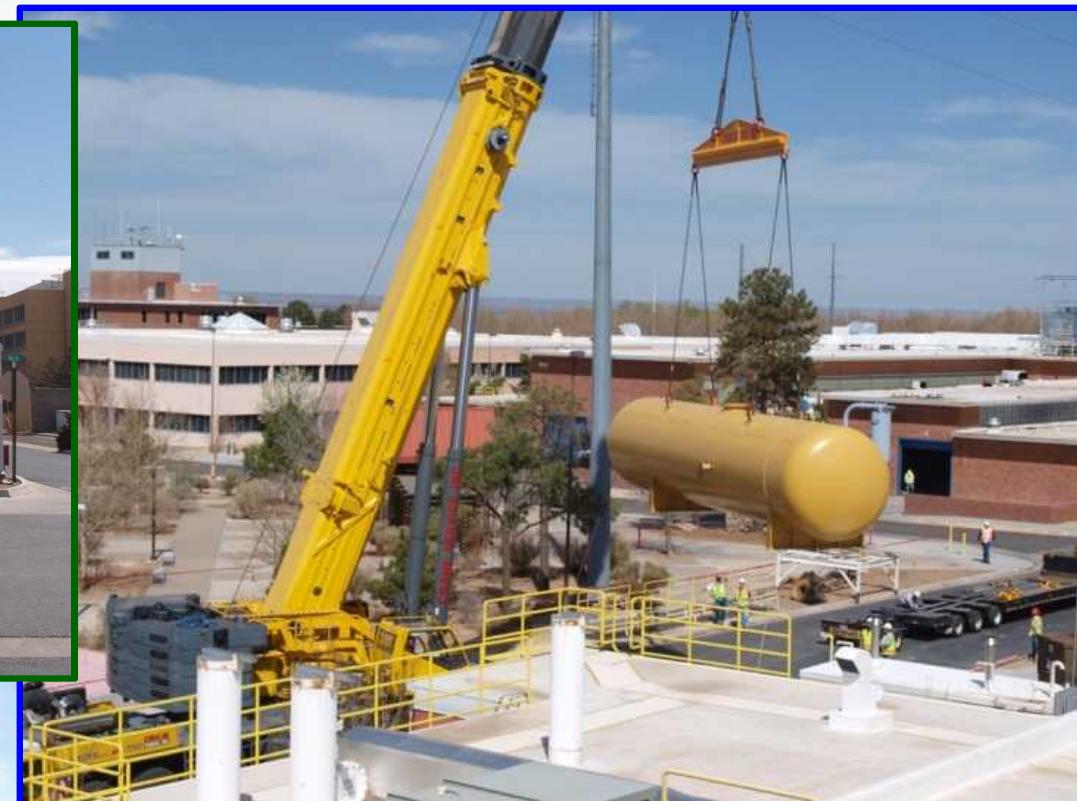
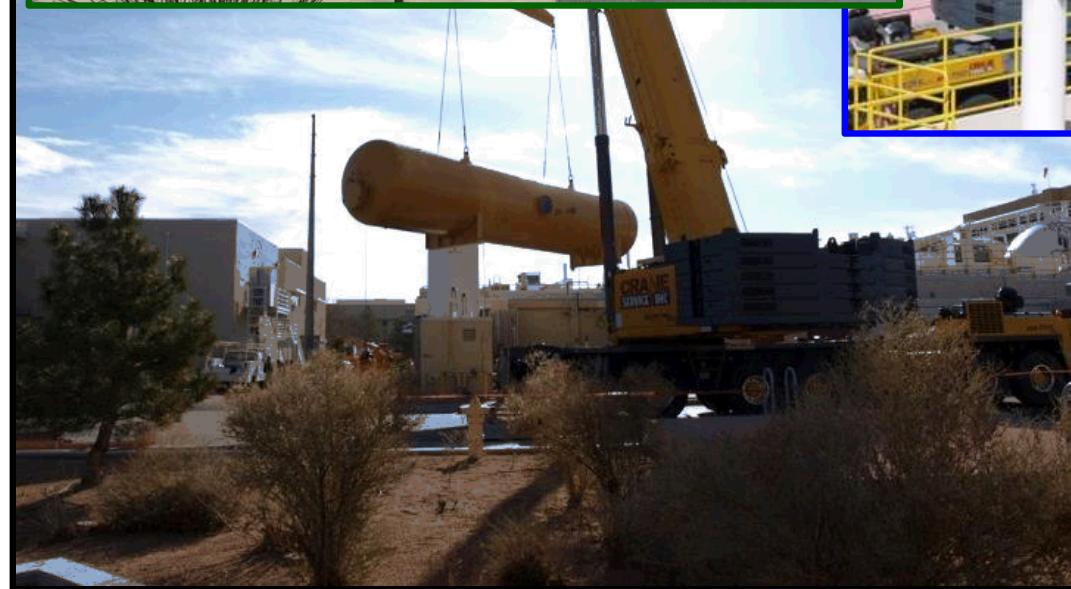
The new tanks were installed the next day.

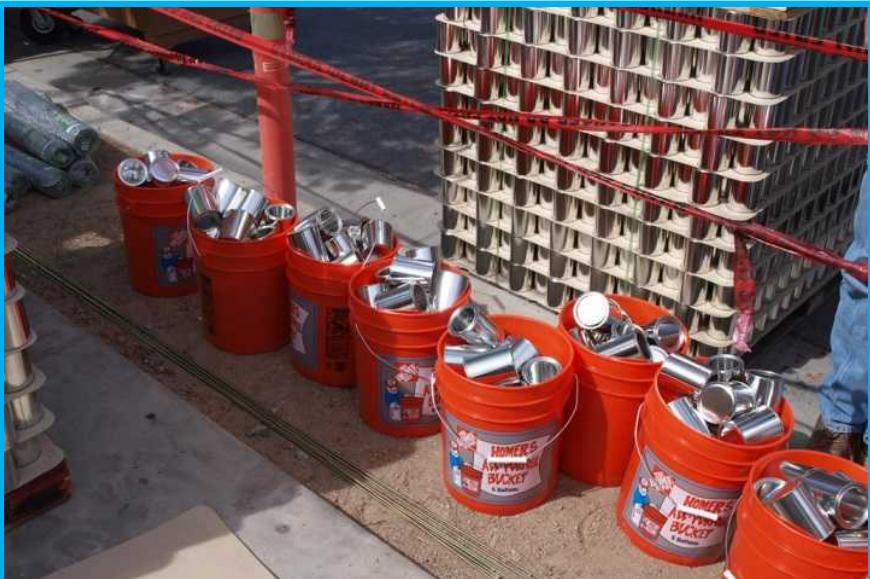
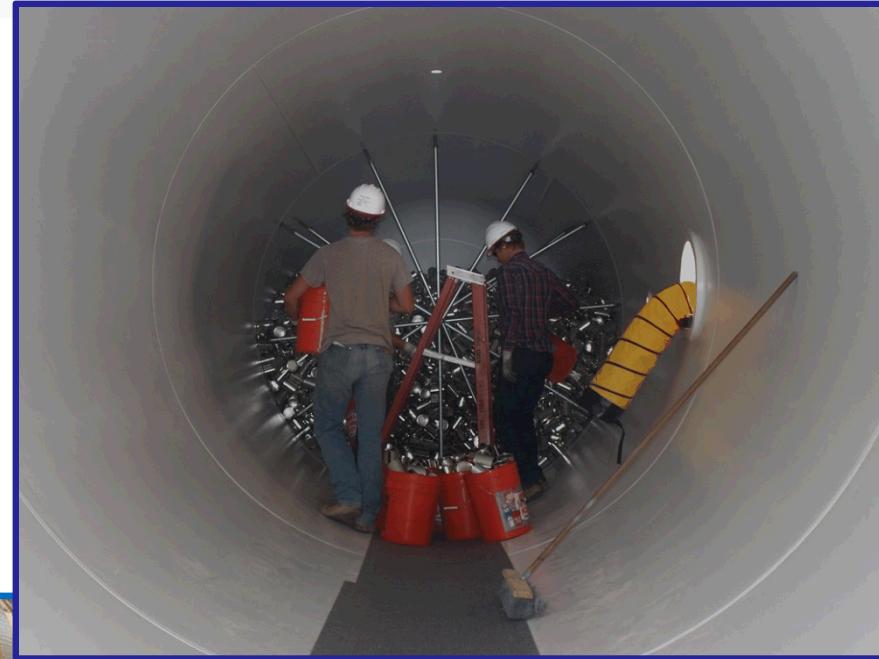
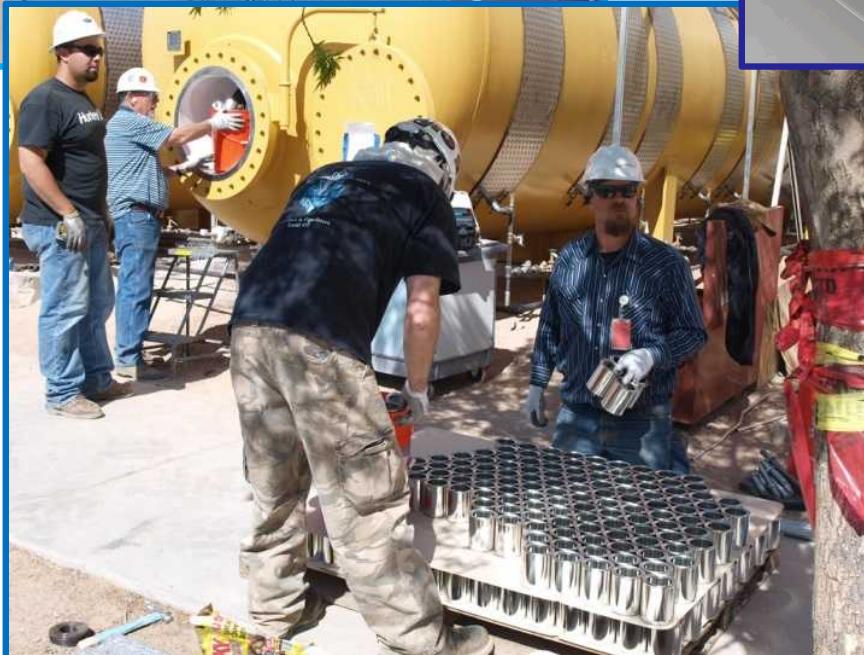
The cans were installed via “bucket brigade.”

Chicken wire every 8 feet provided support.

It required about 6-8 workers and four days.

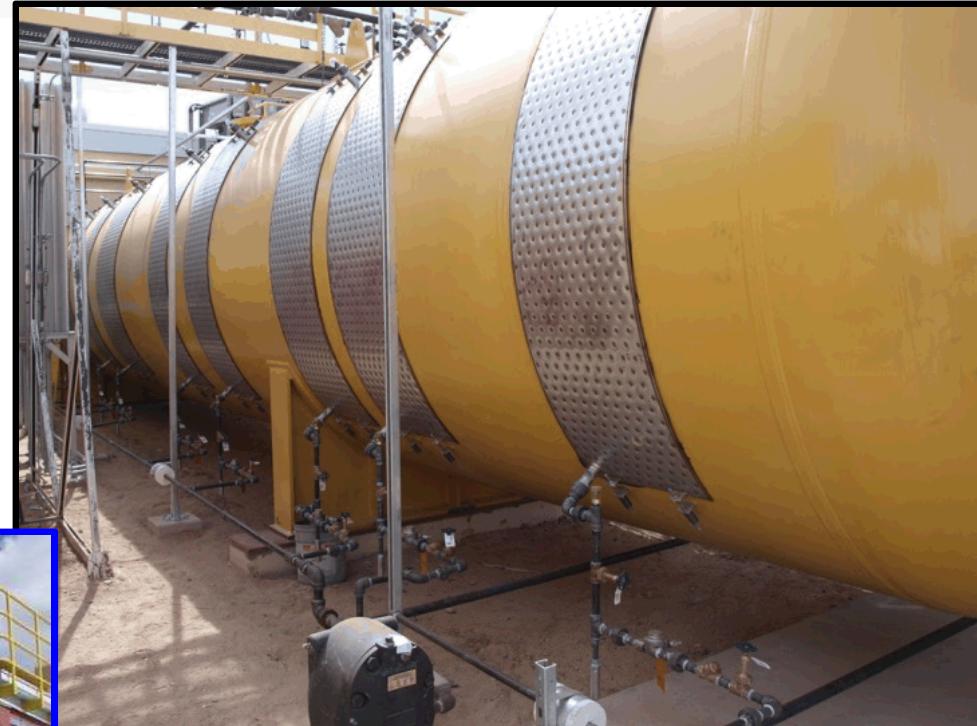
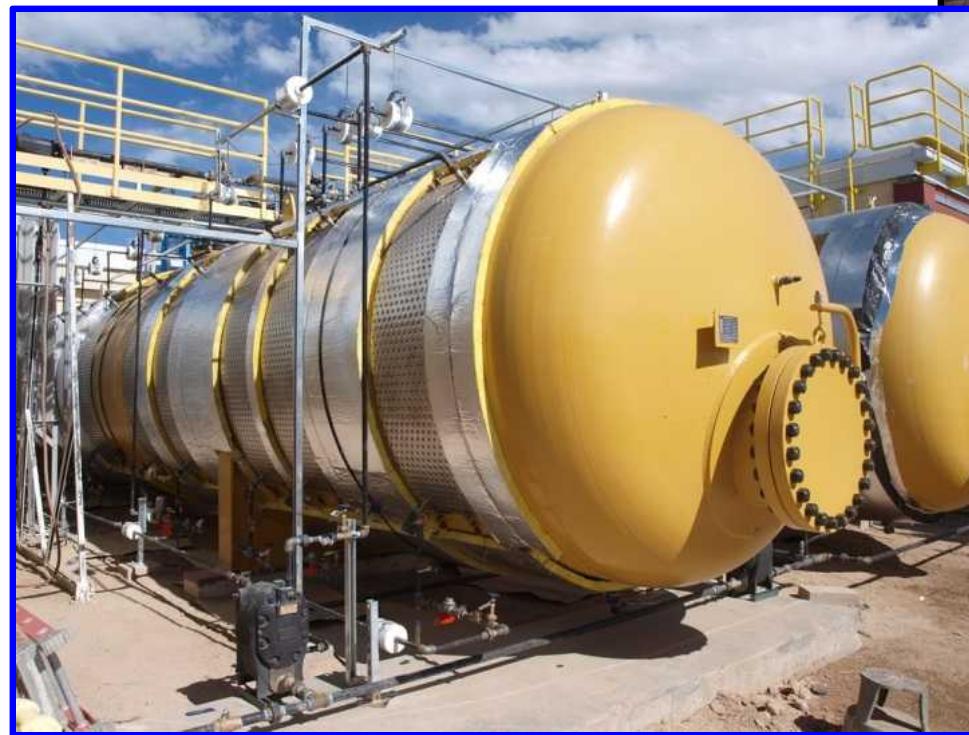
Steam jackets were installed.

Plumbed to a steam system upgraded a few years ago.

2 boilers of 224 MBH

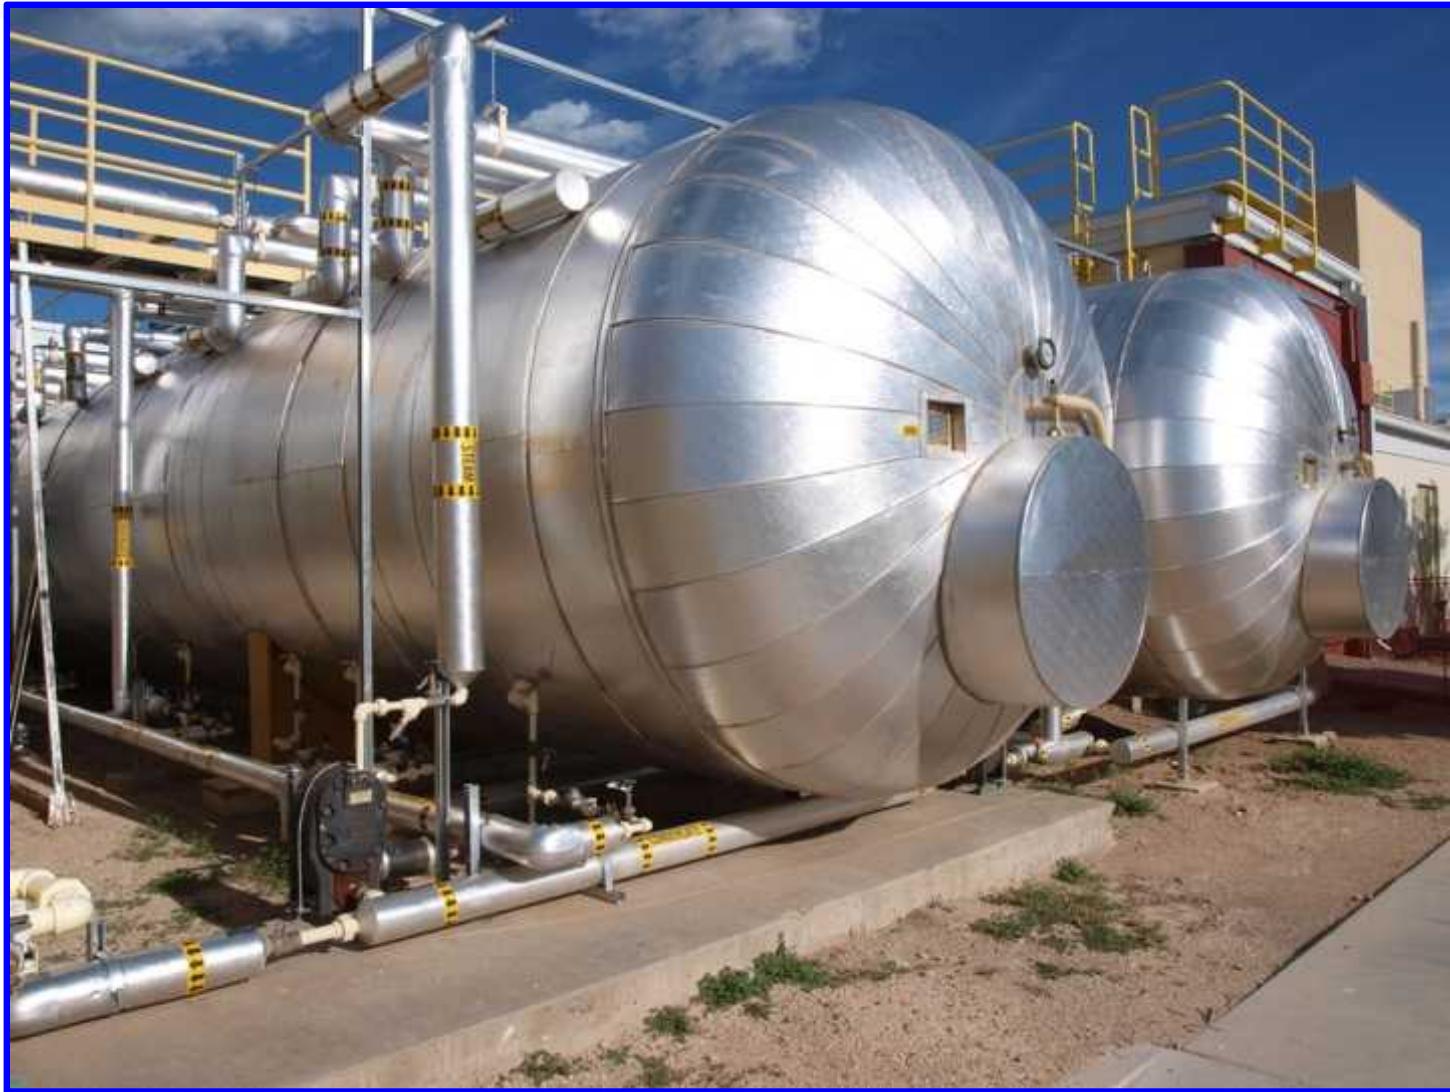
That gives us our final tank configuration.

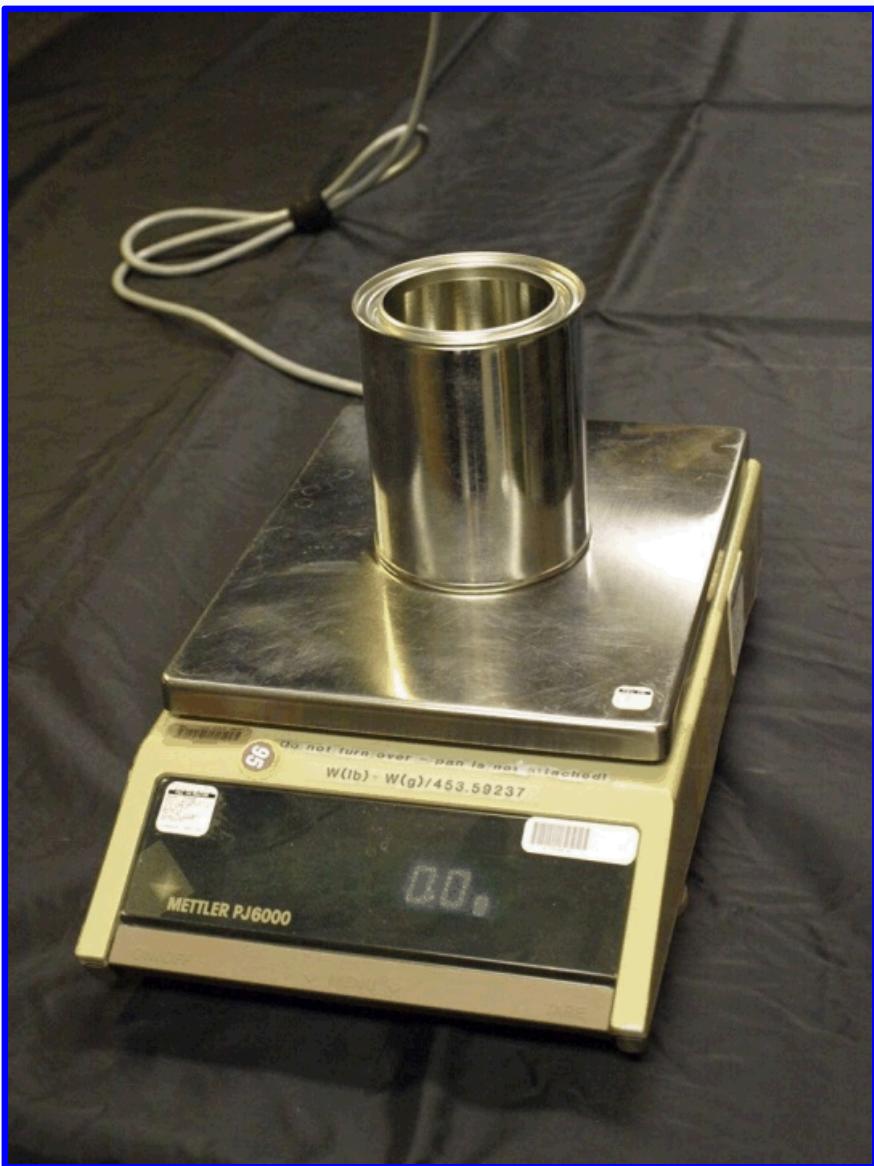
Can Characteristics

Empty, **lidless** can weighs
0.247 lb = 112 g

0.151 lb = 68 g

The contractor did not subtract the weight of the lid as they claimed.

Perform a new analysis with the correct mass:

We **should** be ok.

We built in so much margin that even with the reduced mass, we should get performance equivalent to the old cans.
