Mechanical Properties and Trends in Additively Manufactured Aluminum

Powder bed additive manufacturing

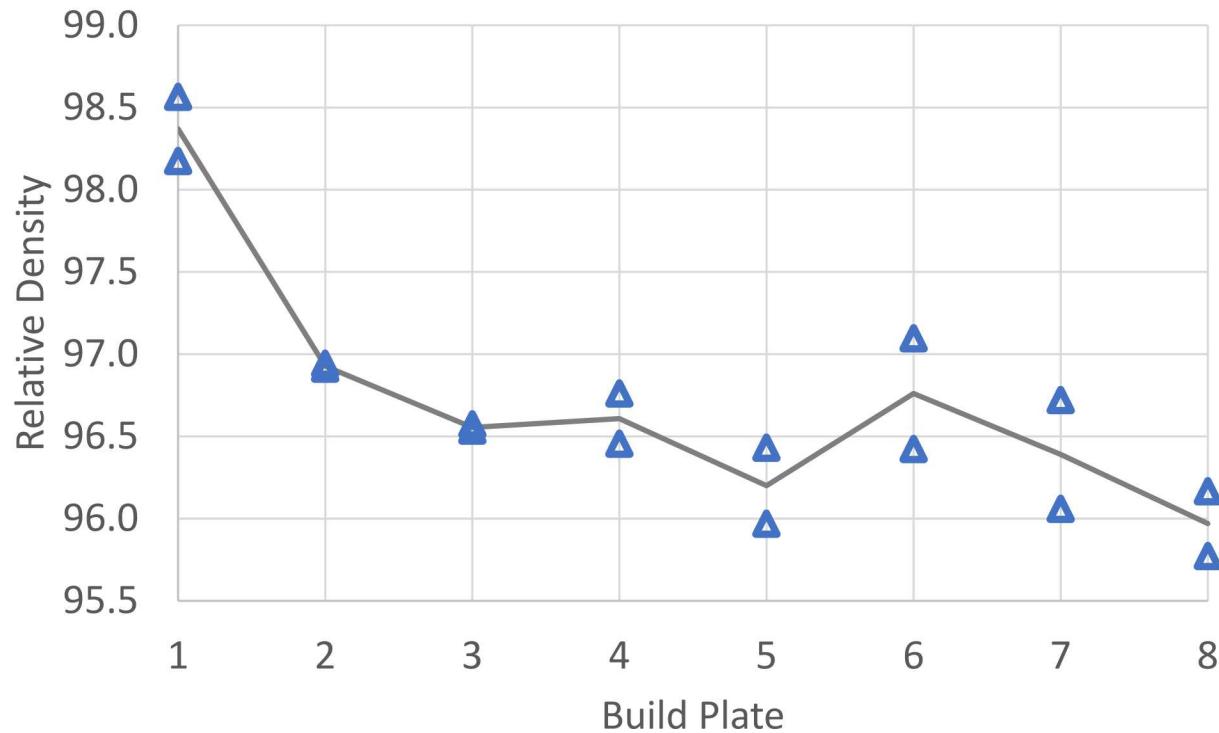
Density measurements follow powder reuse trend

Build	Powder condition
1	Fresh
2	Recycled once
3	Recycled twice
4	Recycled 3 times
5	Recycled 4 times
6	Fresh
7	Recycled once
8	Recycled twice

100% density is 2.67 g/cm^3

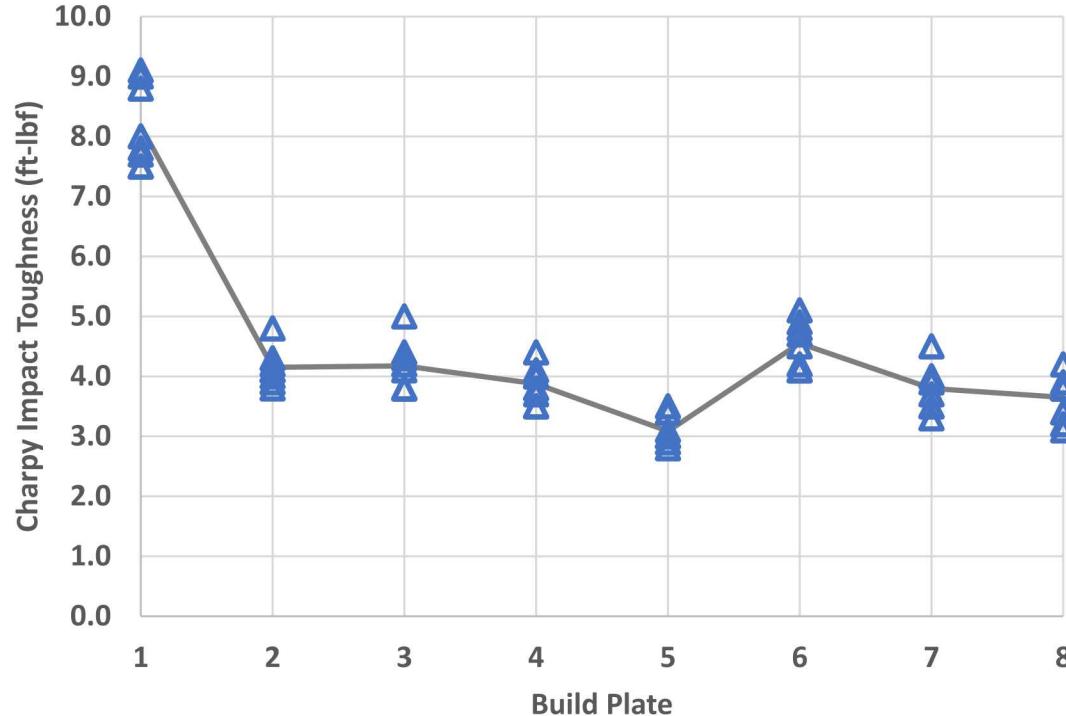
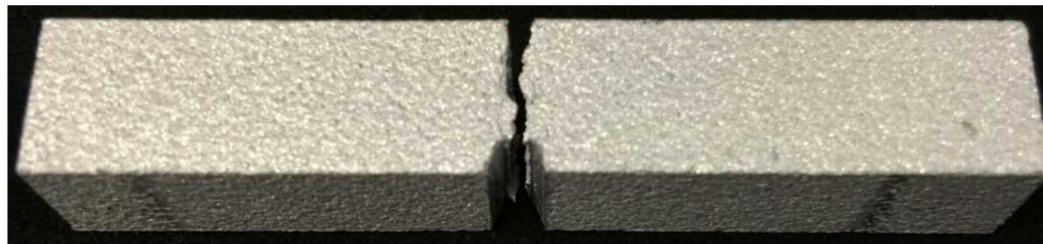
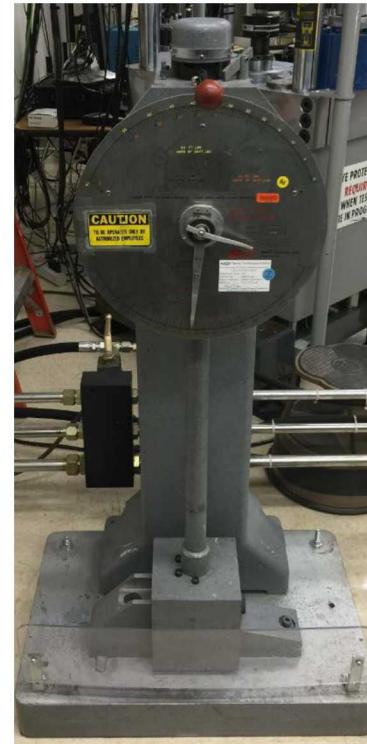
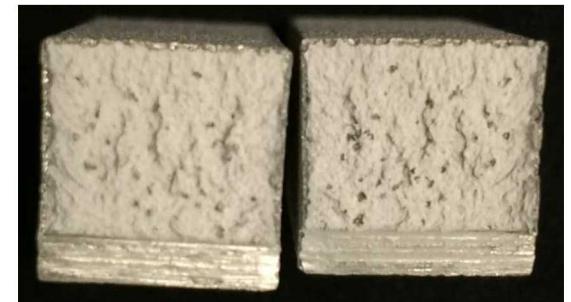
Charpy impact toughness

- Quick results, easy analysis.
- Dynamic fracture directly relevant to application.
- Localized failure to one slice of material.
- Sensitive to overall build quality, perhaps useful for quality control.

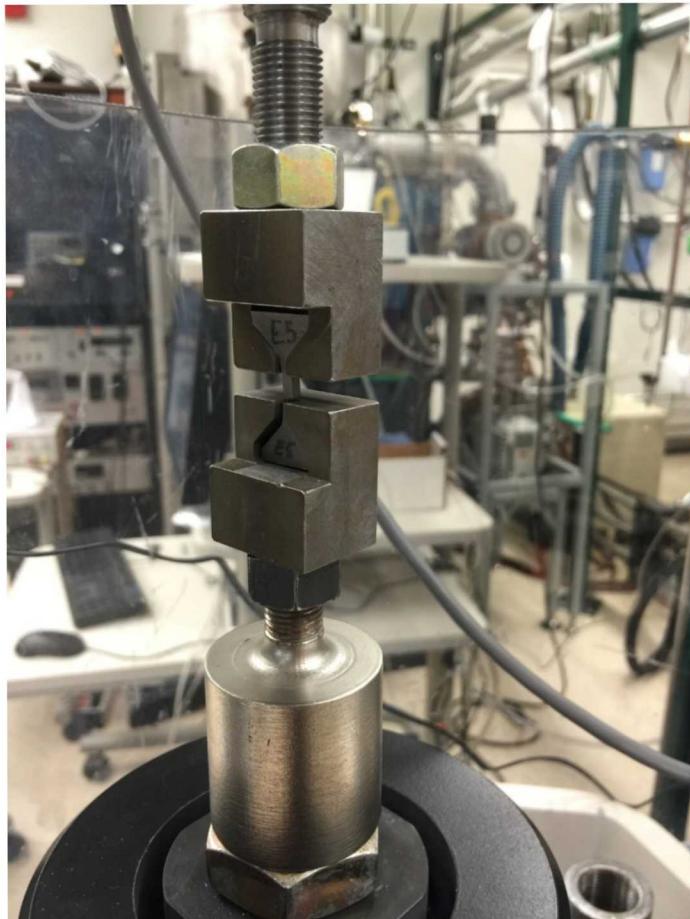
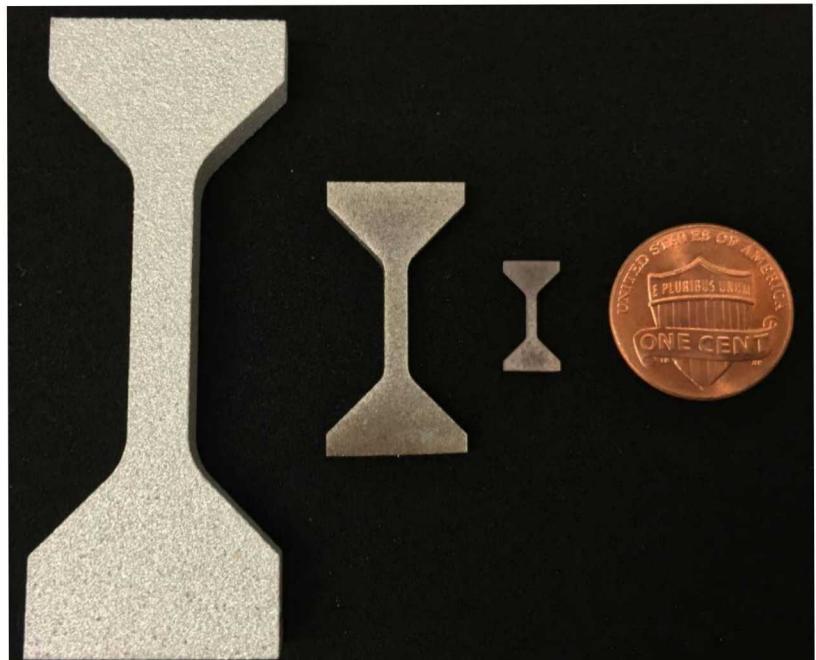
6.25 x 6.25 mm, 2.5 x 2.5 mm, 1 x 1 mm

Small high throughput tension (HTT) specimens

- Large variability in ductility
- Strength variability due to surface material.

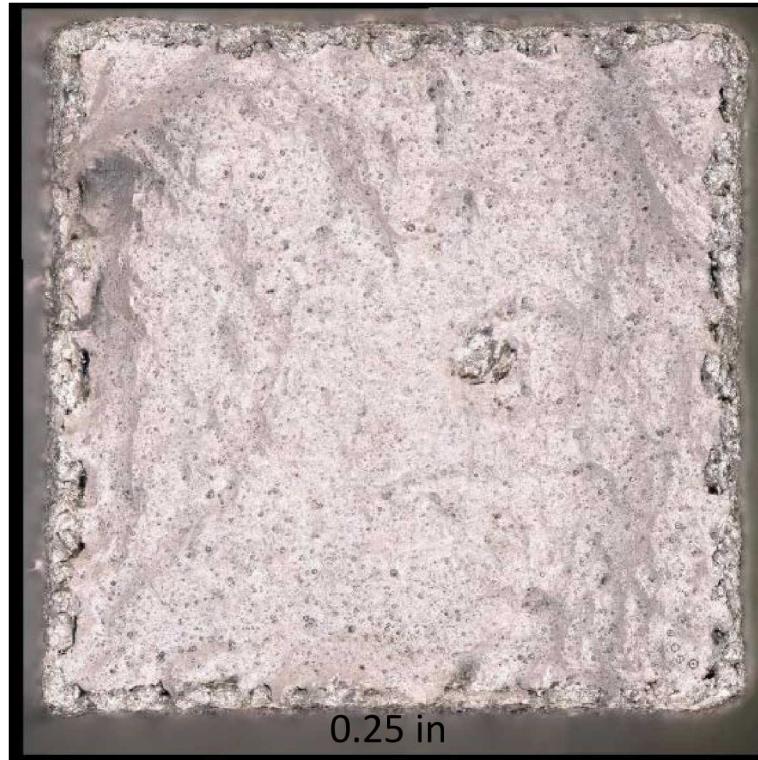
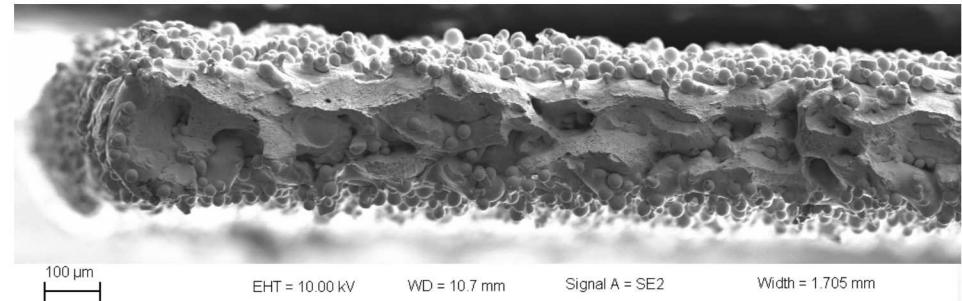
Cross sectional area is difficult to define

- Effective cross sectional area can scale stresses significantly for small specimens.
- Affects modulus, yield strength, ultimate tensile strength.
- Scaling is roughly consistent.
- For now, use “caliper” measurements.

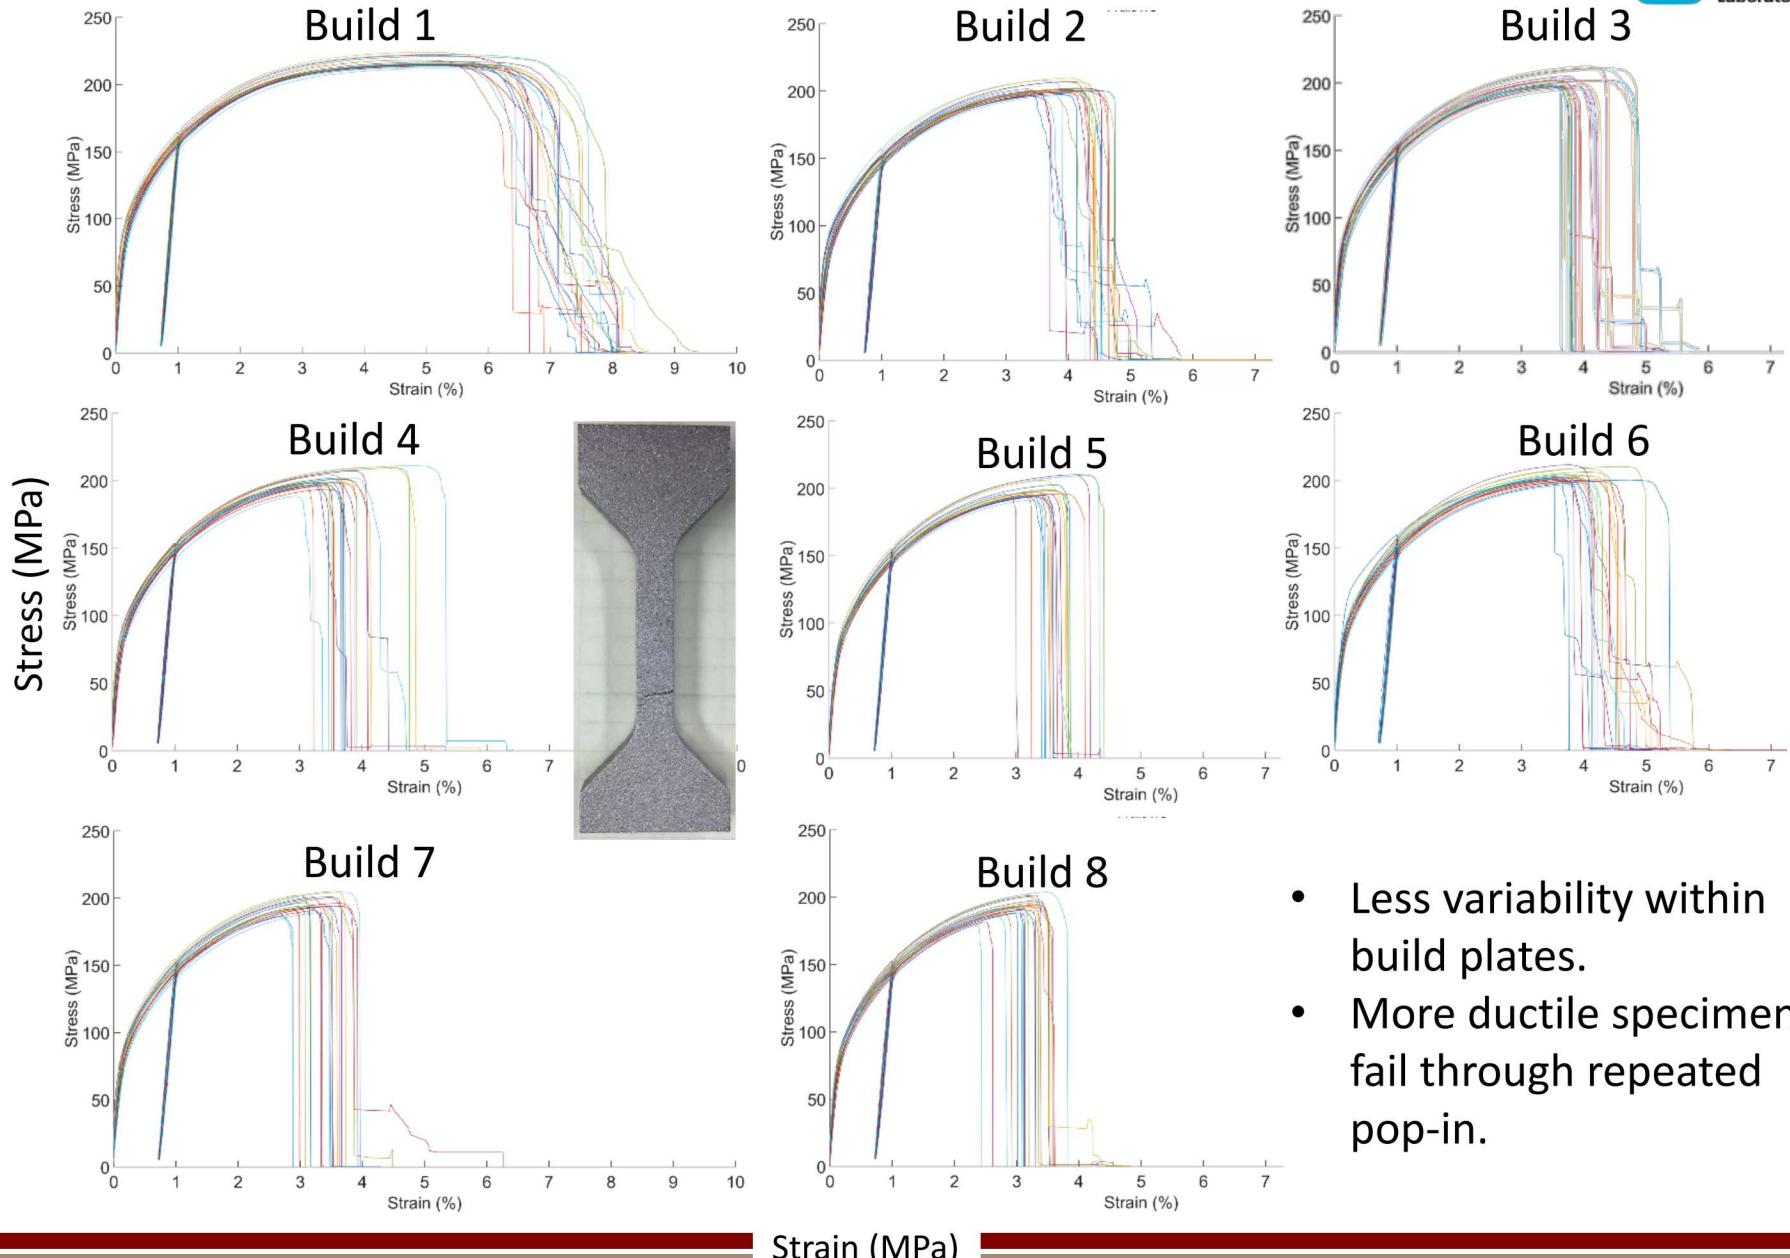
Large high throughput specimens (176 specimens)

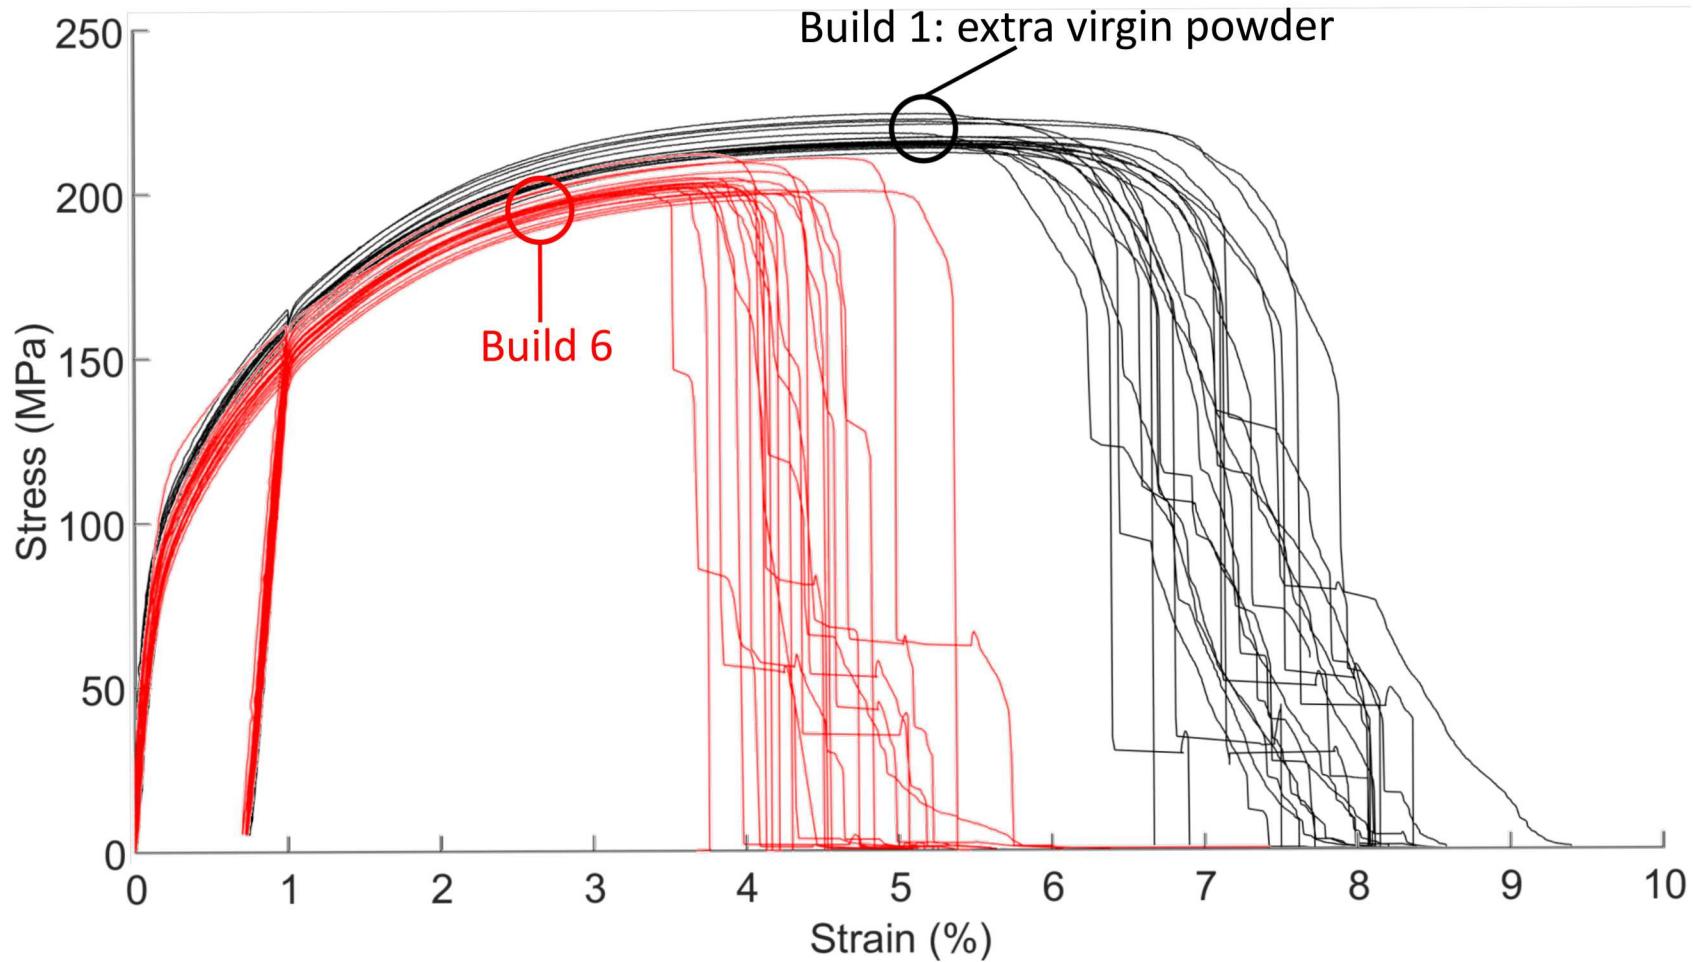
Build's 1 and 6- Fresh Powder

Samples from build 1 have higher ultimate tensile strength and strain to failure than build 6.

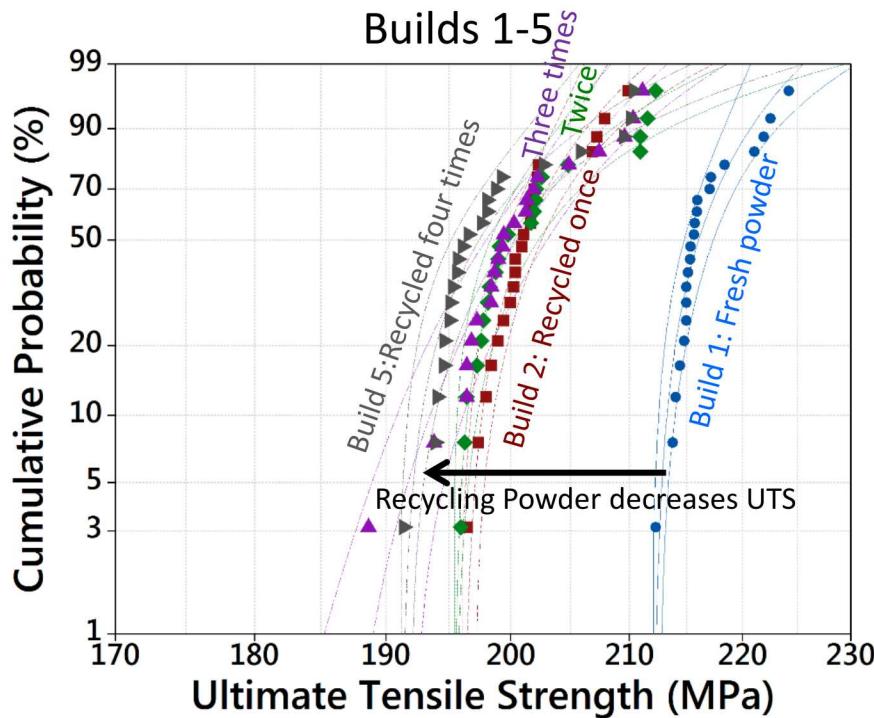
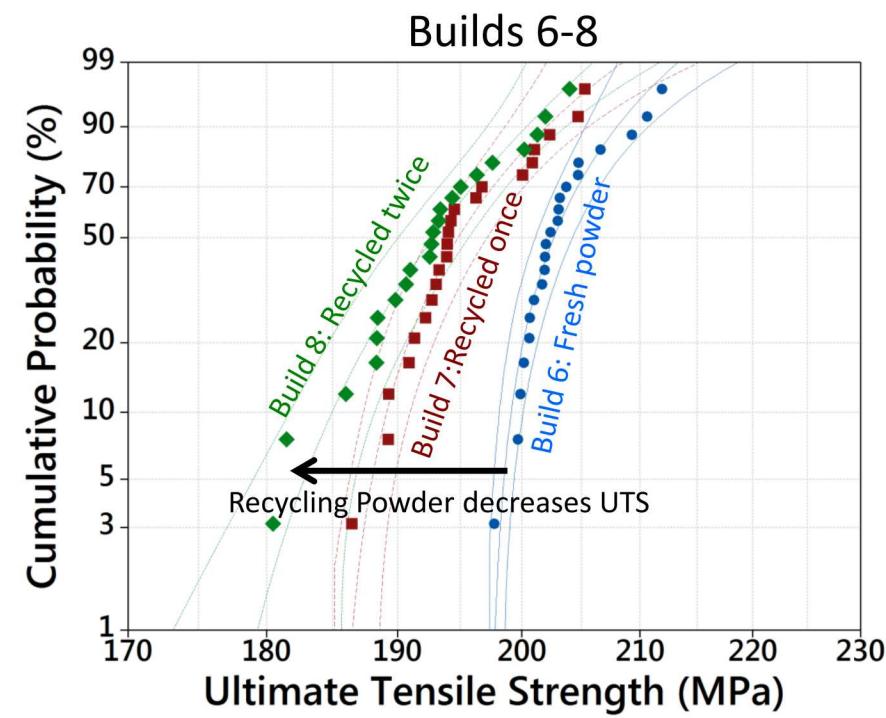
Recycling Powder Decreases UTS Weibull 3-Parameter Distributions

- Recycling powder degrades strength (~10% max).
- Strongest build plates have least variability (steepest slope).
- Possible change in mechanism at upper end of tails.

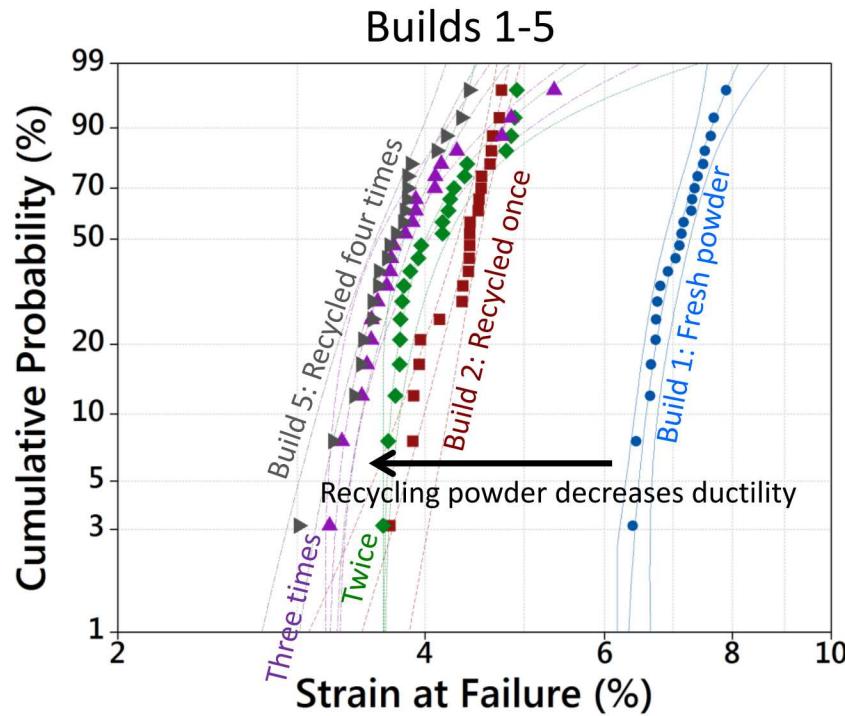
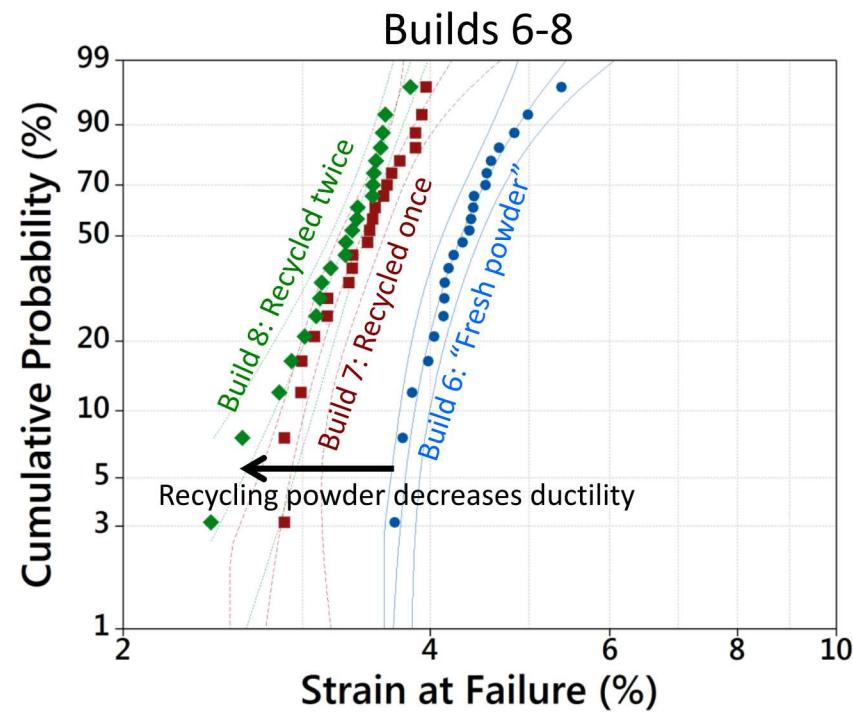
Recycling Powder Decreases Ductility

Weibull 3-Parameter Distributions

- Recycling powder reduces ductility dramatically (~40% reduction).

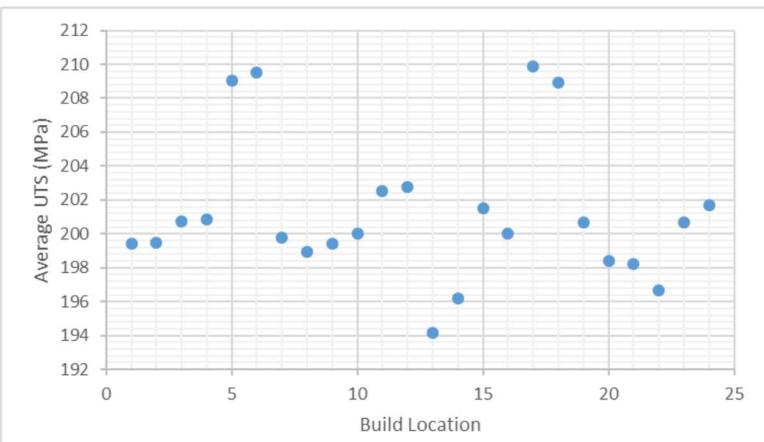
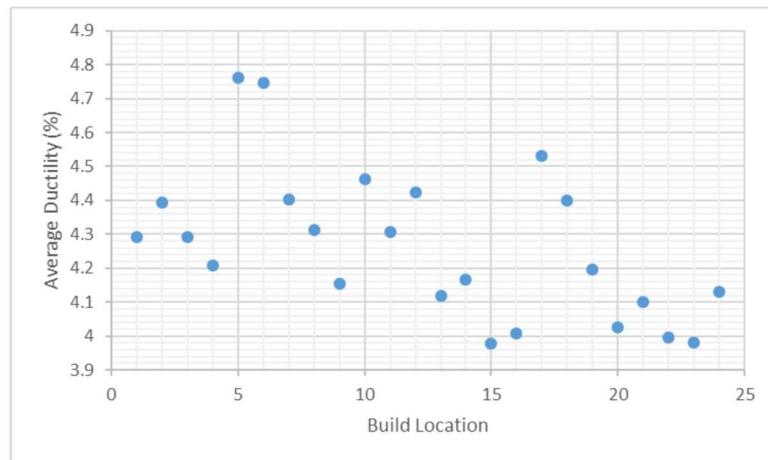
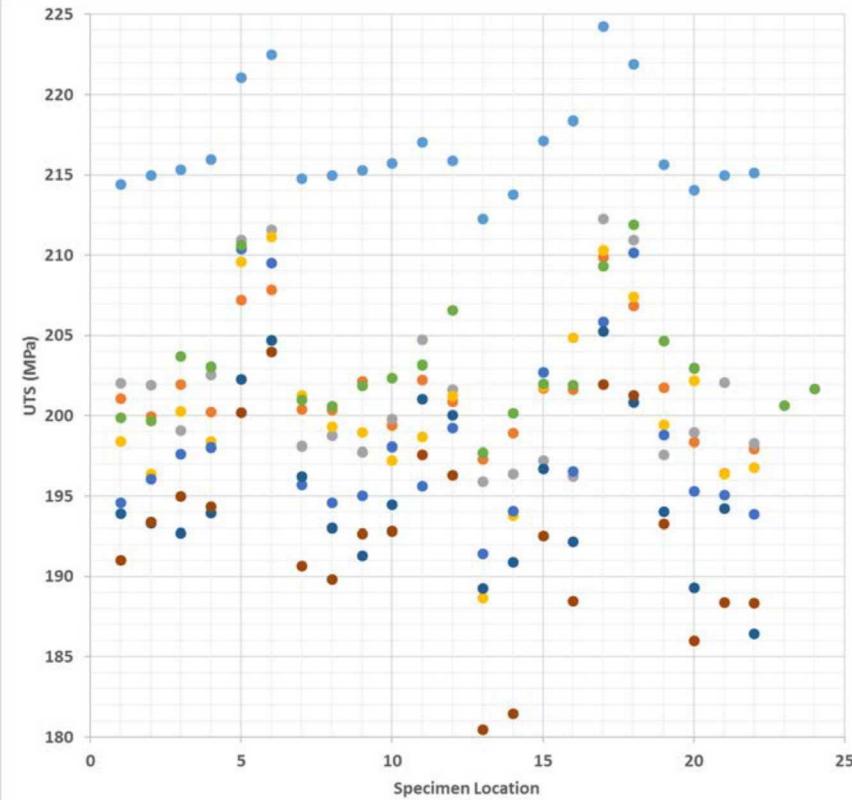
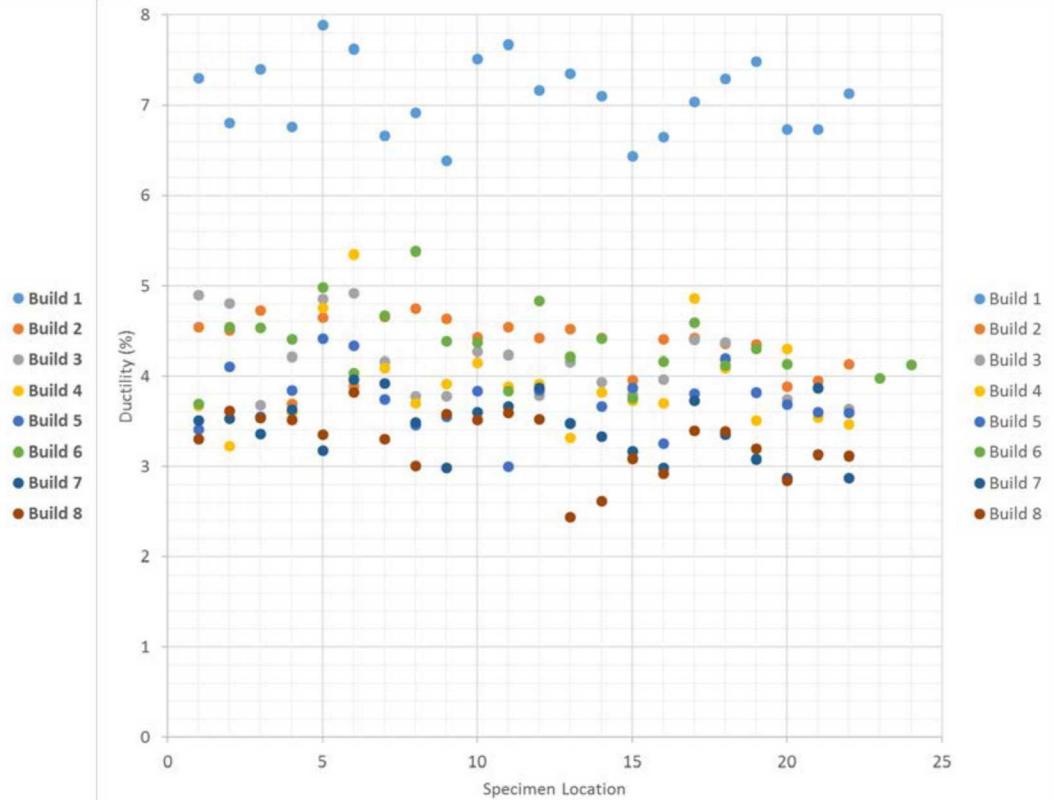
Location dependence of specimen properties

Spatial dependence in tensile strength, regardless of build plate.

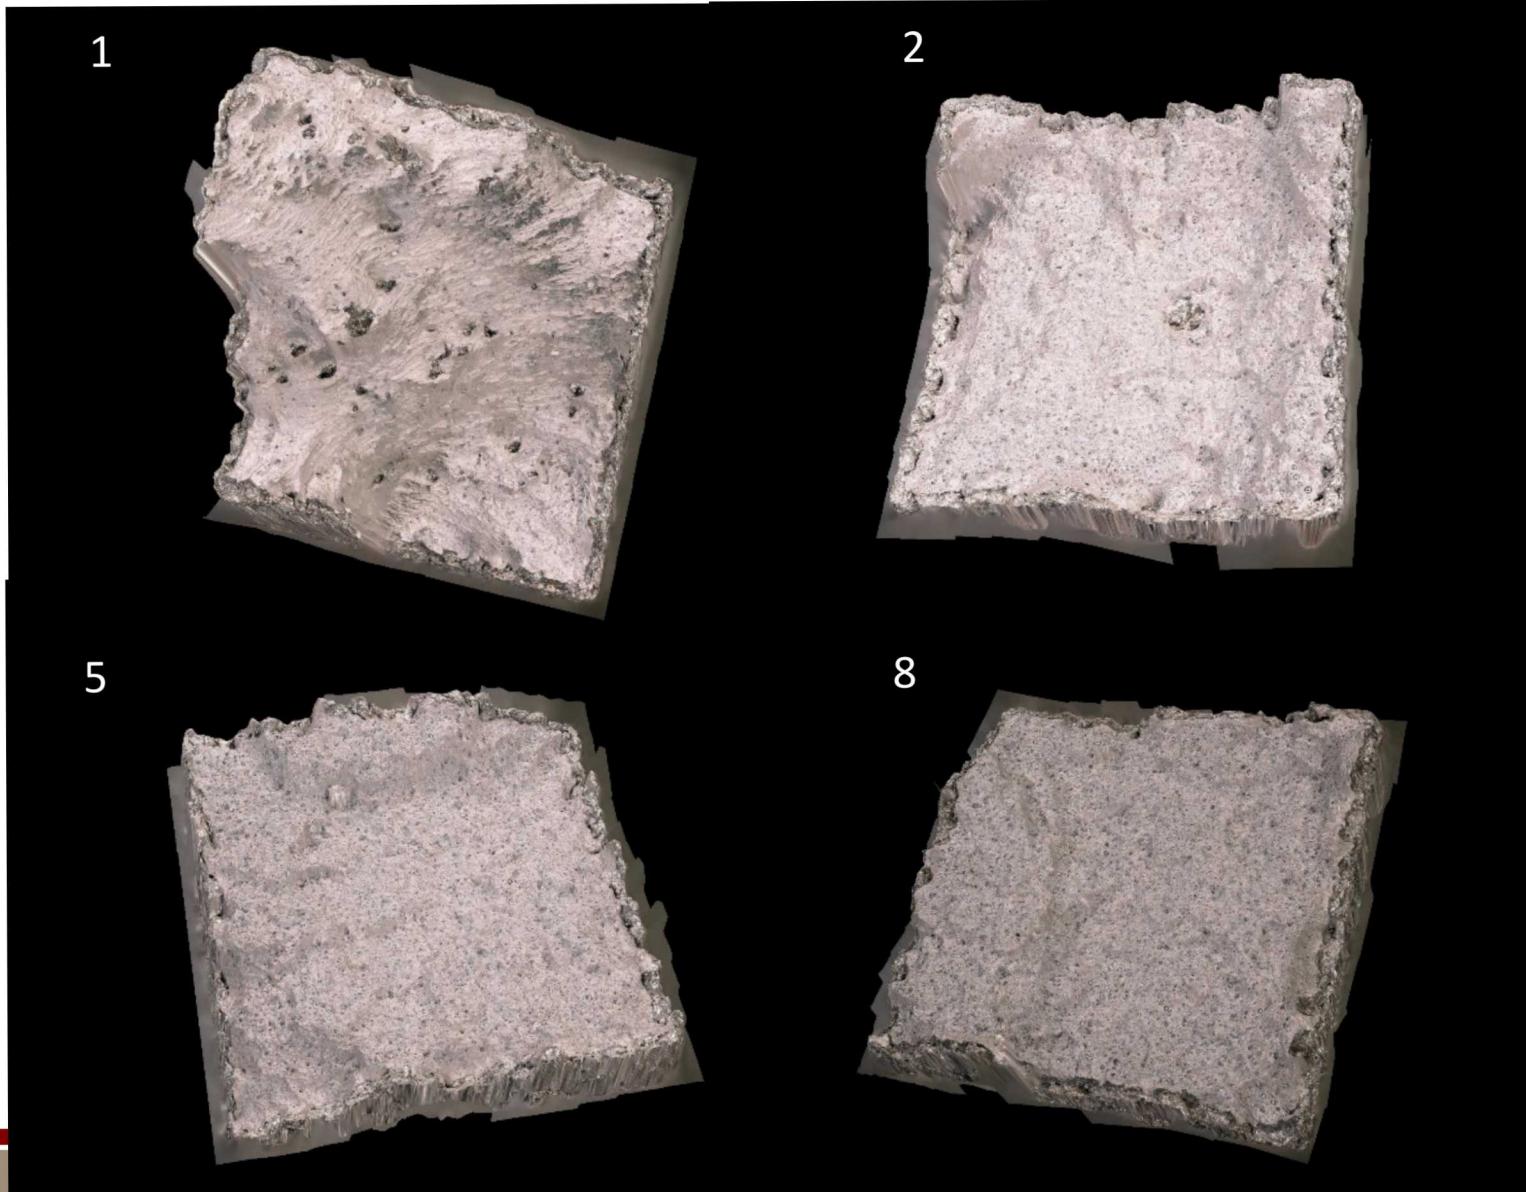
Fracture surface tortuosity appears related to strength and ductility.

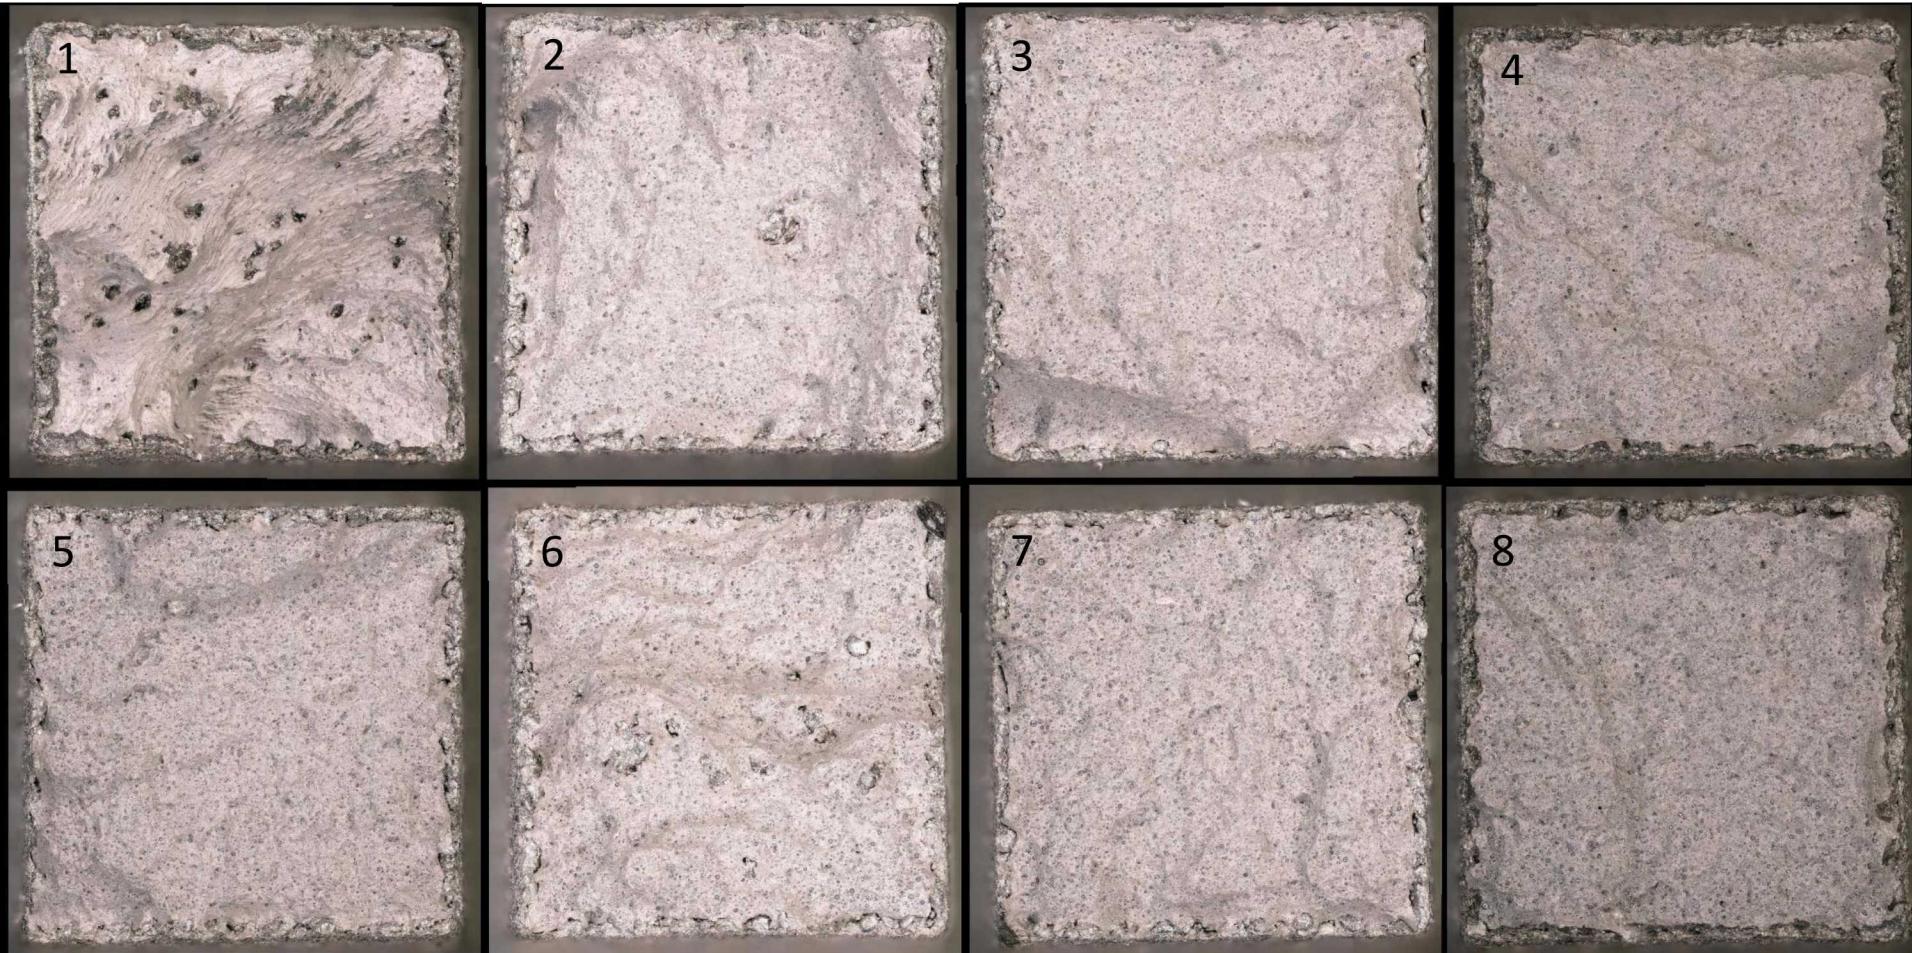
Fracture Surfaces appear to have fewer lack of fusion voids than previous builds- may contribute to ductility consistency.

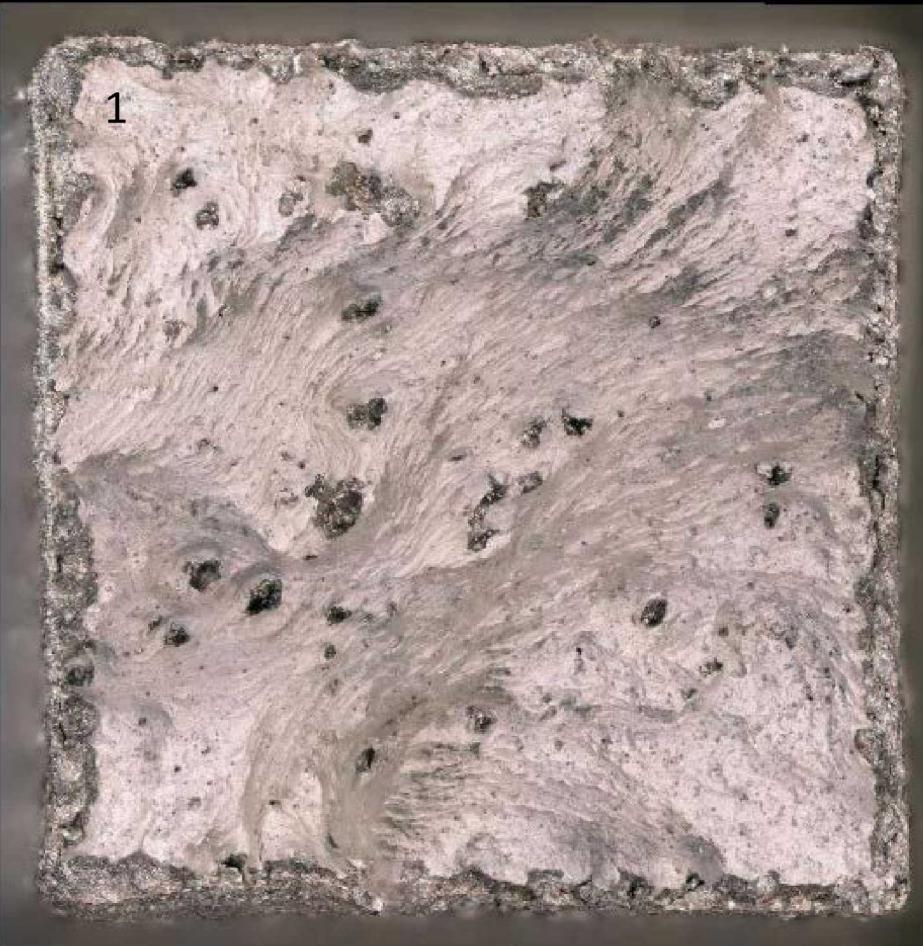
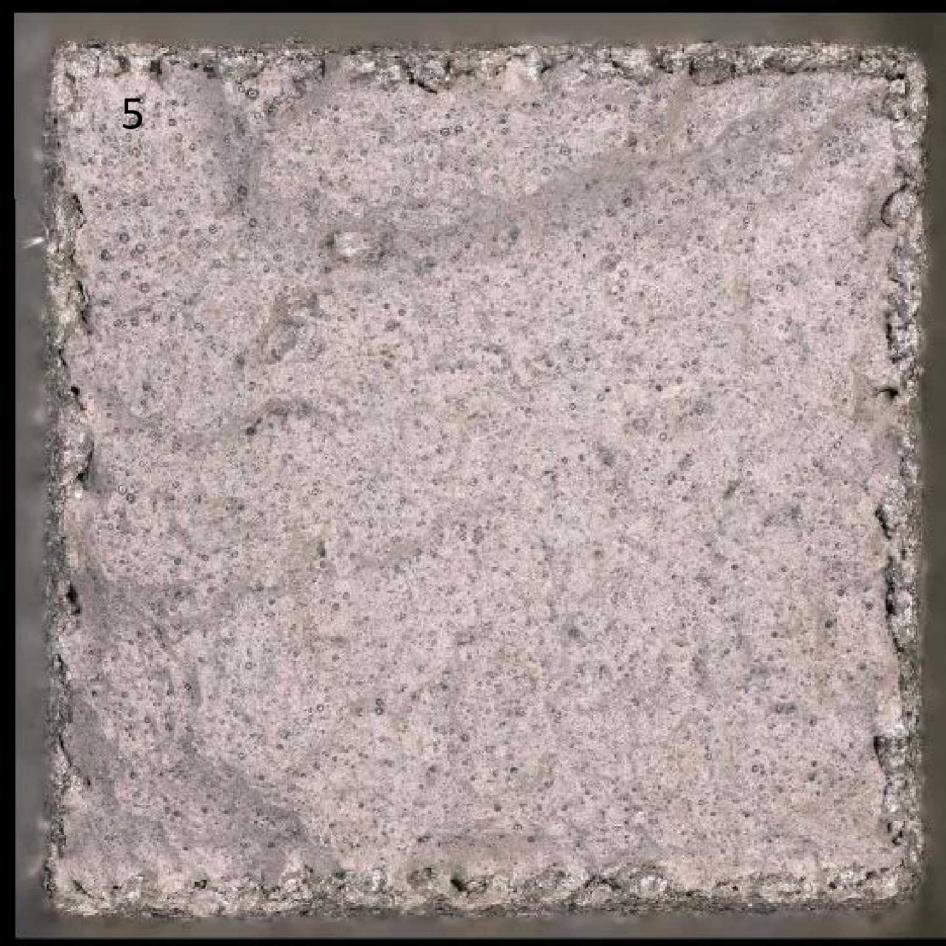
Fracture Surfaces appear to have fewer lack of fusion voids than previous builds- may contribute to ductility consistency.

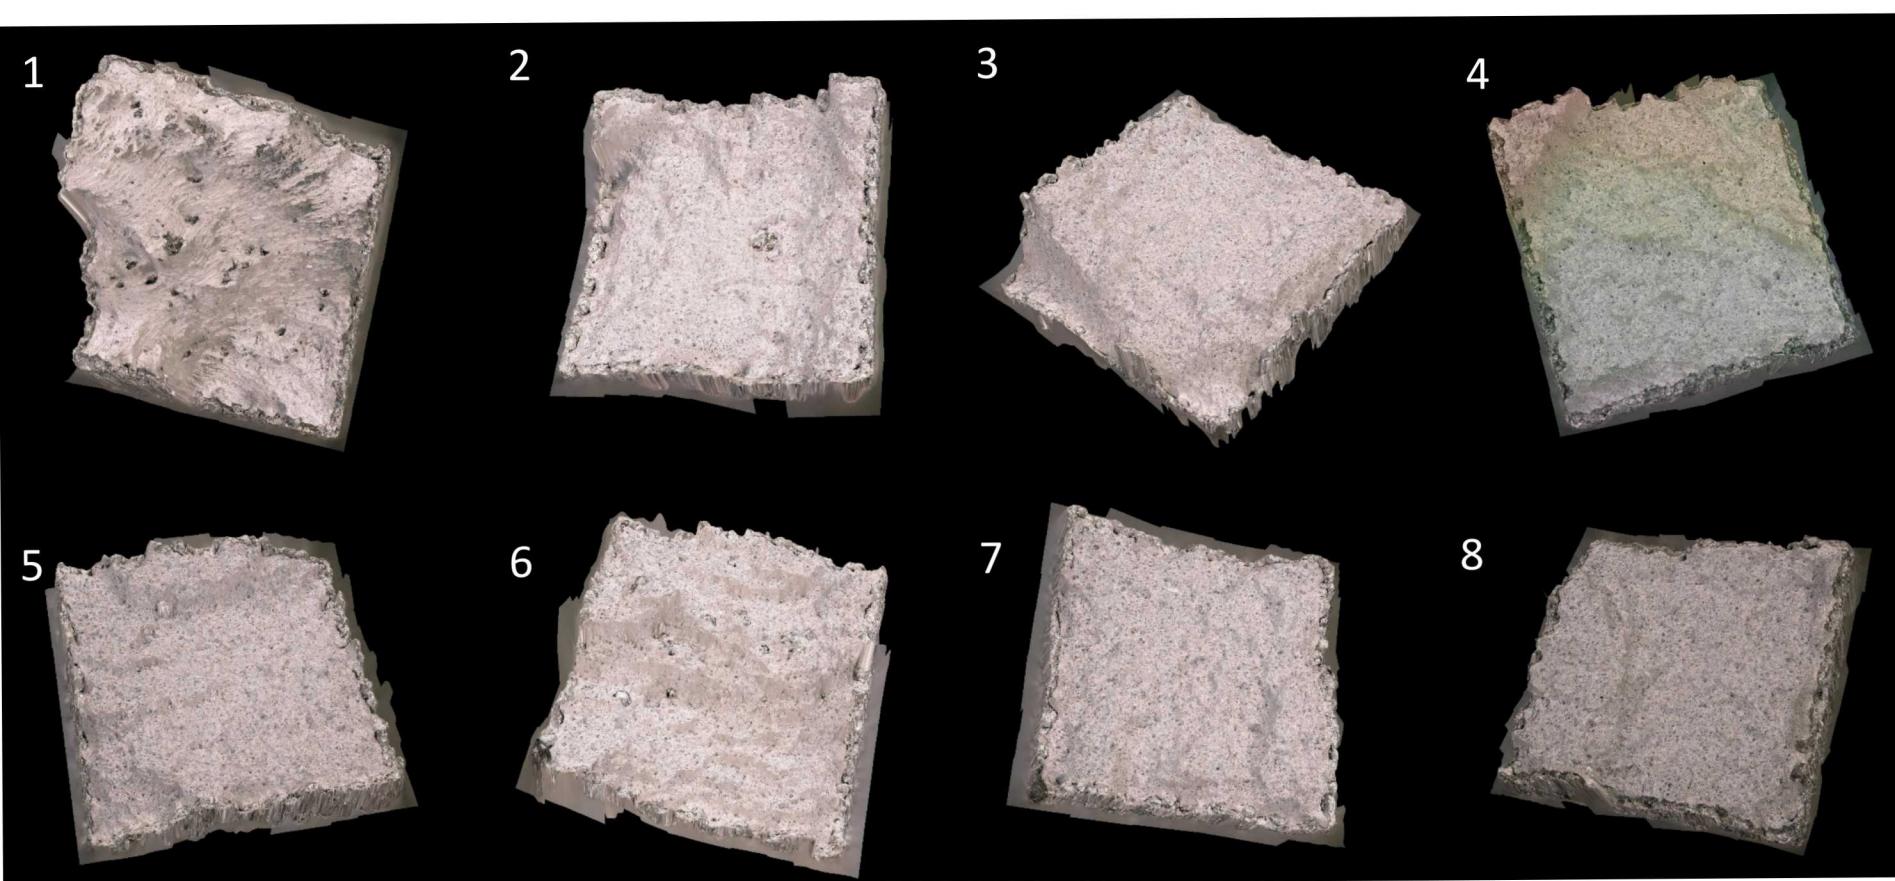
Fracture surface tortuosity appears related to strength and ductility.

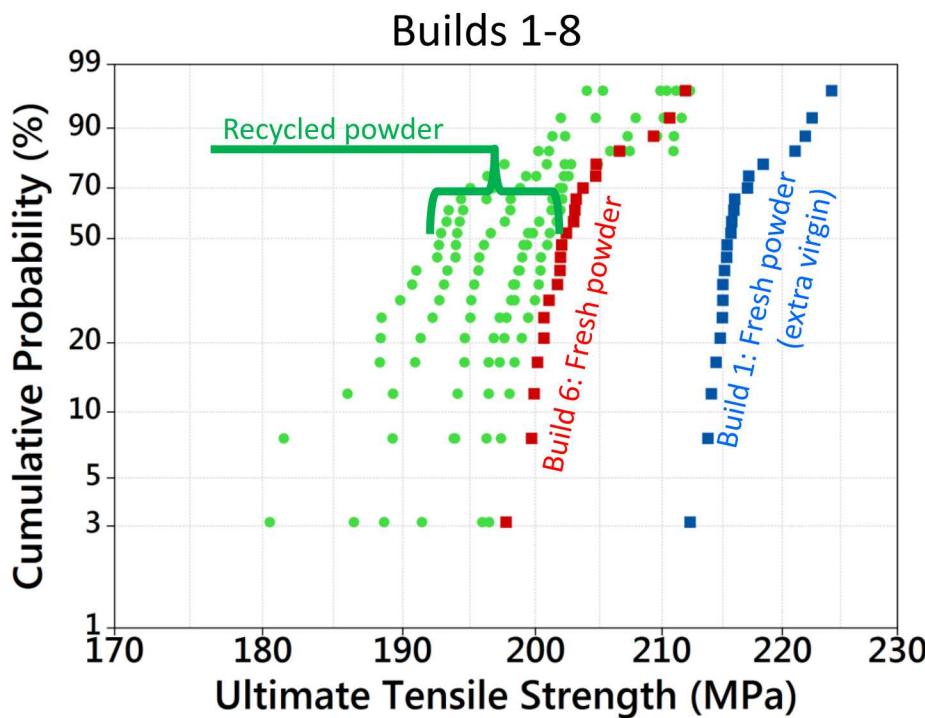
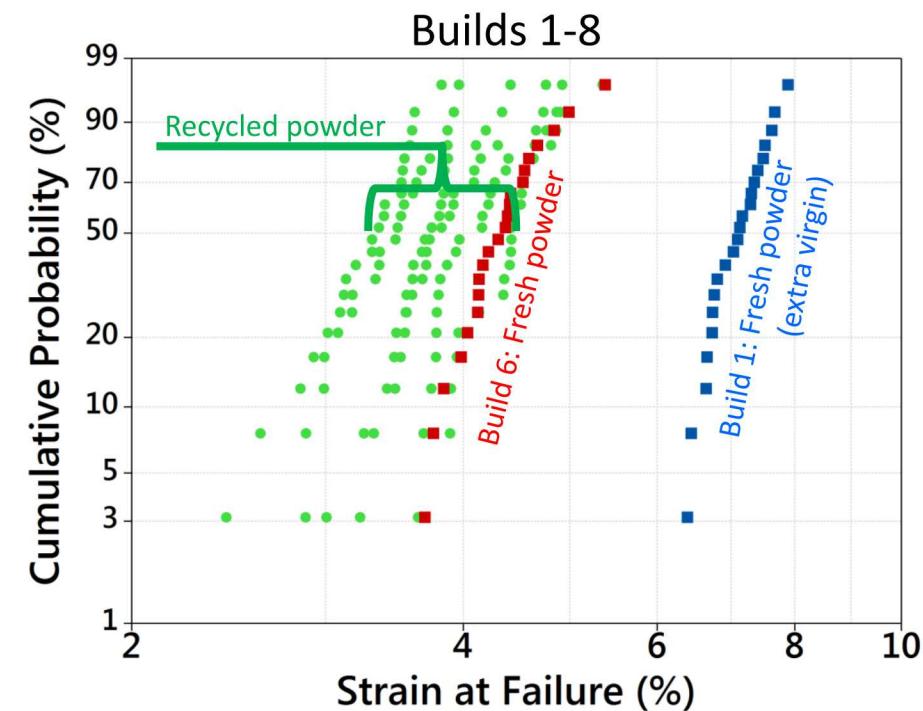
Replot of Weibull 3-Parameter Distributions

Build 6, which was built using fresh powder, performed similarly to samples made with recycled powder, perhaps due to recycled powder remaining in the machine from previous builds. The extra virgin powder from build 1 clearly stands apart from the other builds.

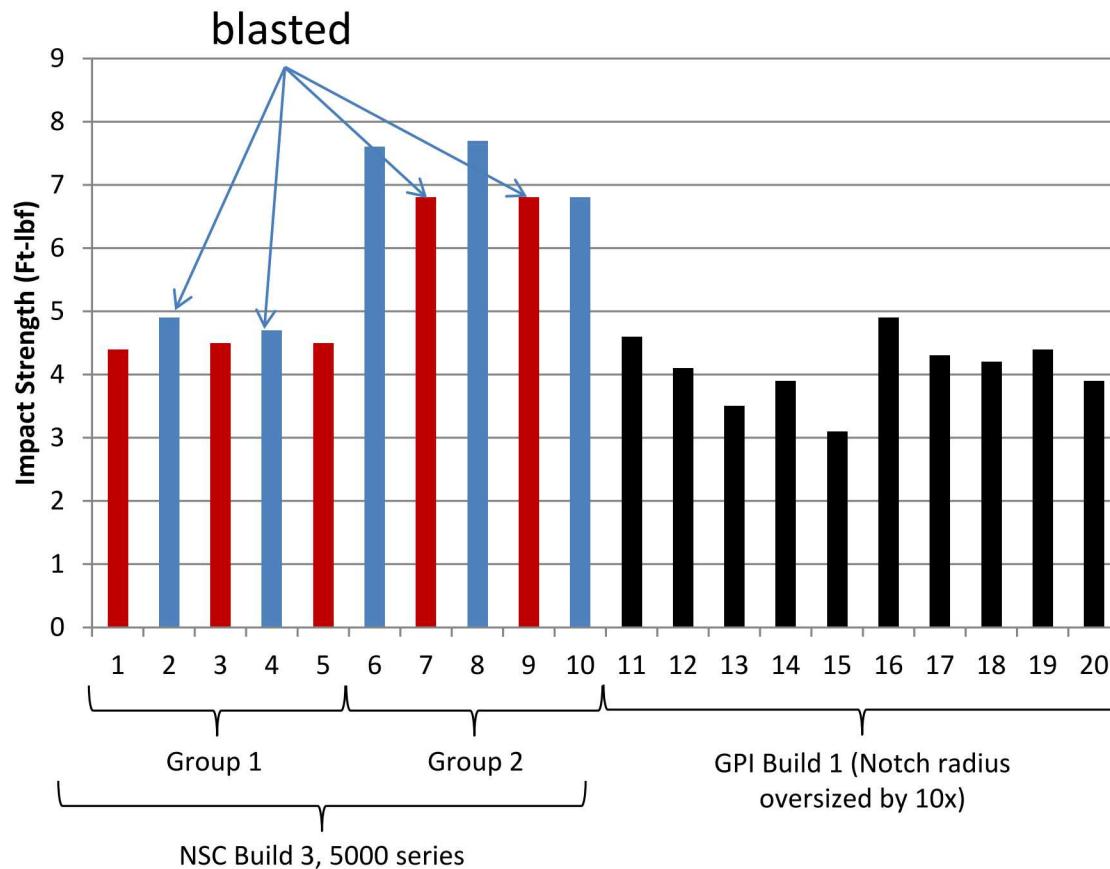
Charpy Measurements 3xxx and 5xxx series

Average (ft-lbf)
Build 3 Group 1	4.60
Build 3 Group 2	7.14
Build 3	5.87
GPI	4.09
Build 3 Group 1 Top	4.47
Build 3 Group 1 Side	4.80
Build 3 Group 2 Top	6.80
Build 3 Group 2 Side	7.37

7075 Al was 3.2
