Mechanical Properties and Trends in Additively Manufactured Aluminum

Powder bed additive manufacturing

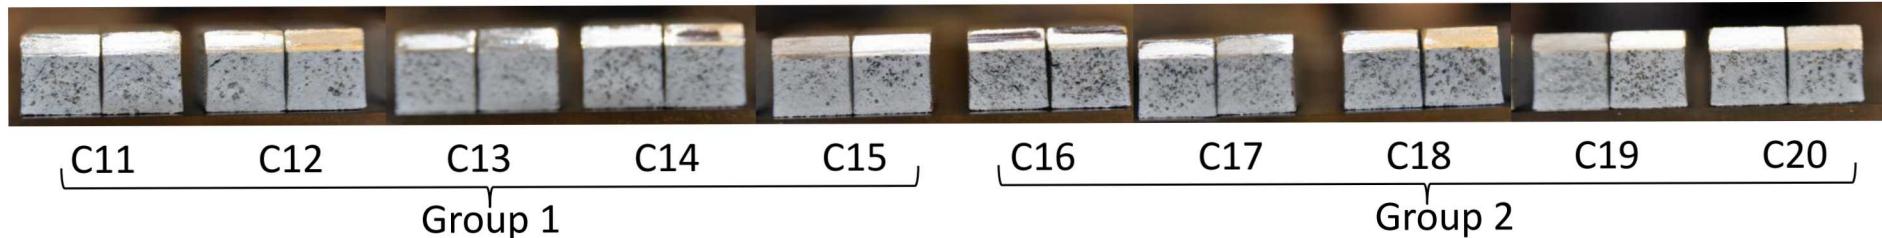
NSC Build 3

Images of Charpy fracture surfaces show voids or intermetallics are prevalent.

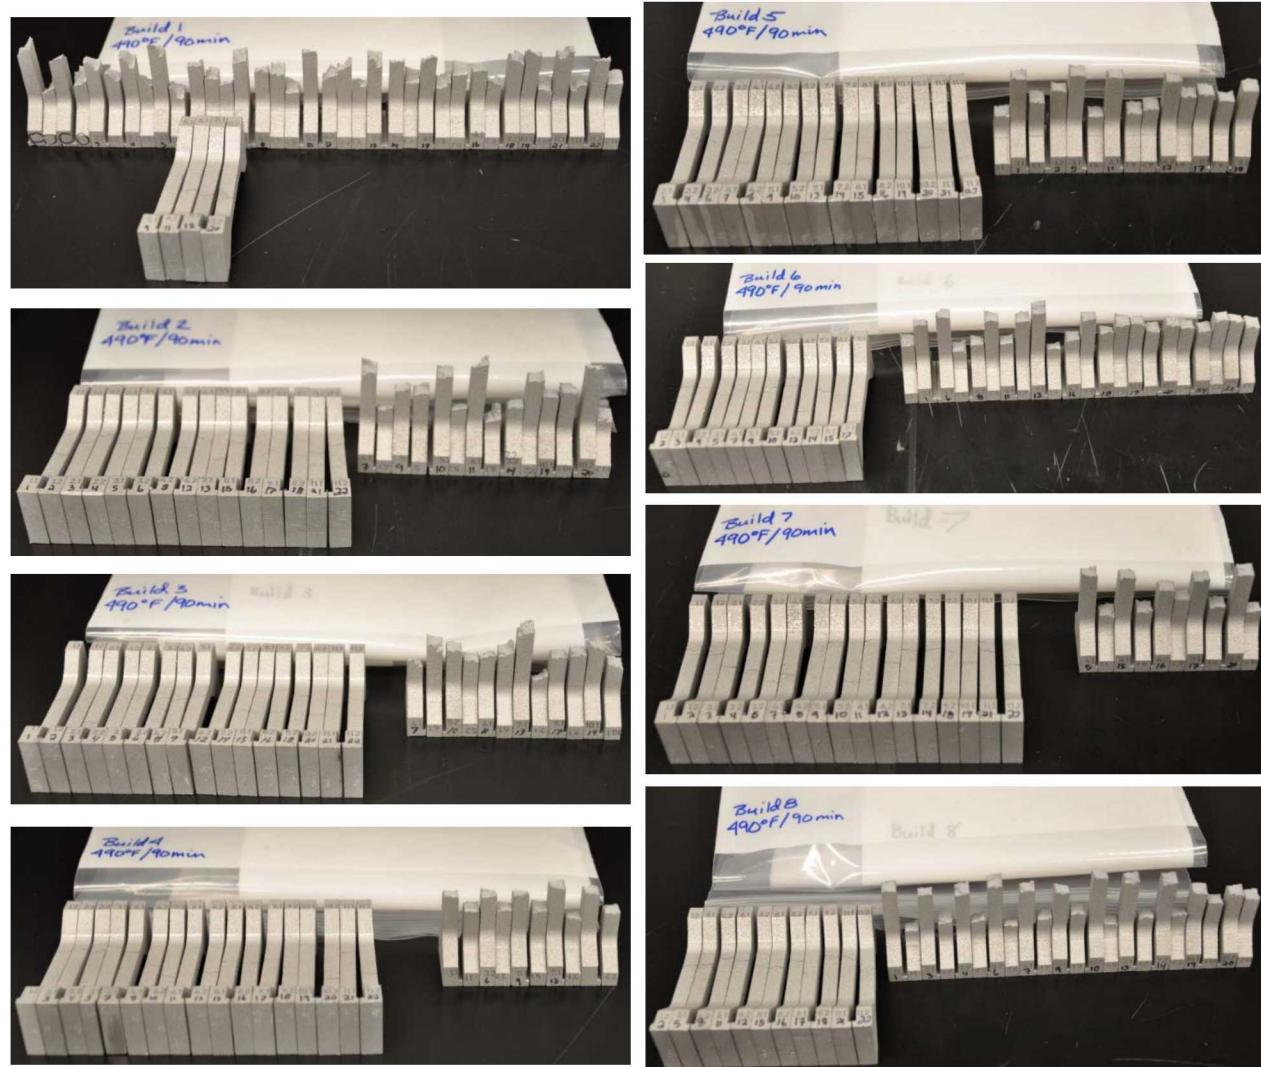
All builds: general fracture locations around same height

- Most specimens fractured about $\frac{3}{4}$ up in the gage section, at approximately the same build height.
- Consequence of hall-petch due to cooling rates during build?
- Build plate 1 has much more tortuous, slanted fracture surfaces.

Specimens that appear intact are fractured, but not completely separated to preserve fracture surfaces.
