# The Mechanical Performance of Sn-Pb Solder Joints on LTCC Substrates

**P. Vianco, S. Williams, B. McKenzie, and A. Kilgo,**

**Sandia National Laboratories\***

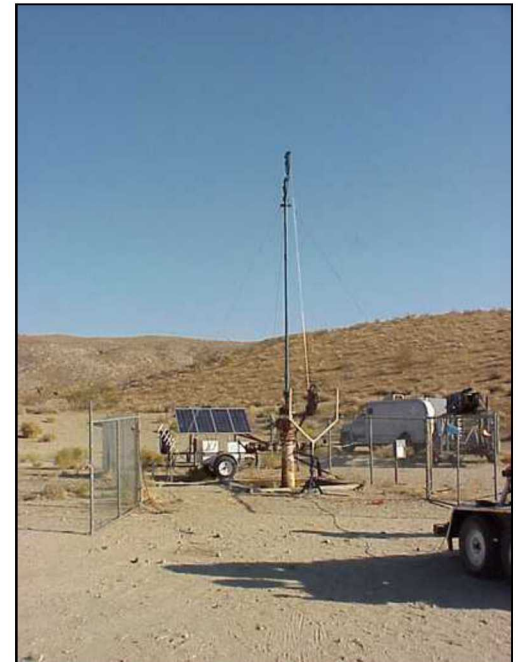
- ◆ Downhole **sensor electronics** can significantly improve the efficiency and reliability of well exploration and production.
- ◆ Oil, gas, and geothermal wells present some of the **harshest service conditions** for electrical equipment.
  - Temperatures: 300°C continuous; 350°C peak
  - Pressures: 15,000 to 30,000 psi
  - Vibration: PDS ( $\text{g}^2/\text{Hz}$ ), 0.01 – 0.1 (0.6 – 3 kHz)
  - Corrosion:  $\text{H}_2\text{S}$ ,  $\text{H}_2$ , brine, superheated steam.

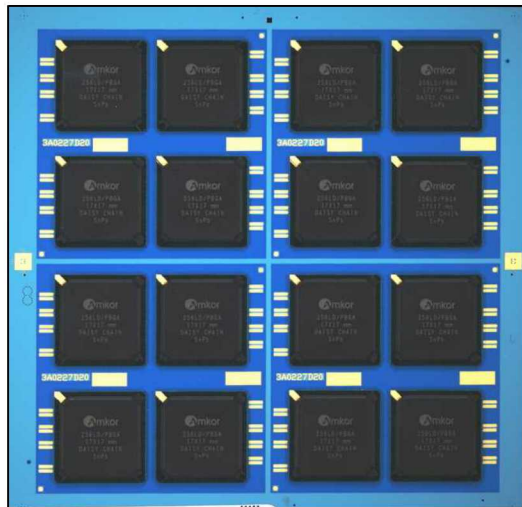
- ◆ **Low-temperature co-fired ceramic (LTCC)** technology can provide the functionality of (organic) printed circuit boards *as well as withstand the high-temperature service of downhole conditions.*
