# KPFM-AM as a *Potential* Tool for Probing Aging Evidence in Materials

Ana Baca, Michael Brumbach

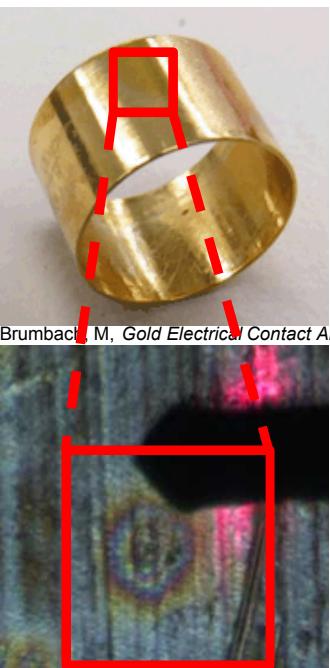
# Gold ring (multilayered structure)

Height Image

Visible evidence of chemical change

Au WF = 5.1-5.47ev  
Cu WF = 4.53-5.10ev

KPFM and potential image correlate to, but need more resolution
